STAFF REPORT: 9/10/2025 REGULAR MEETING

APPLICATION NUMBER: HDC2025-00476

ADDRESS: 14833 STAHELIN

SCOPE: EXPAND DRIVEWAY, DEMOLISH GARAGE, ERECT NEW GARAGE (WORK COMPLETED WITHOUT APPROVAL)

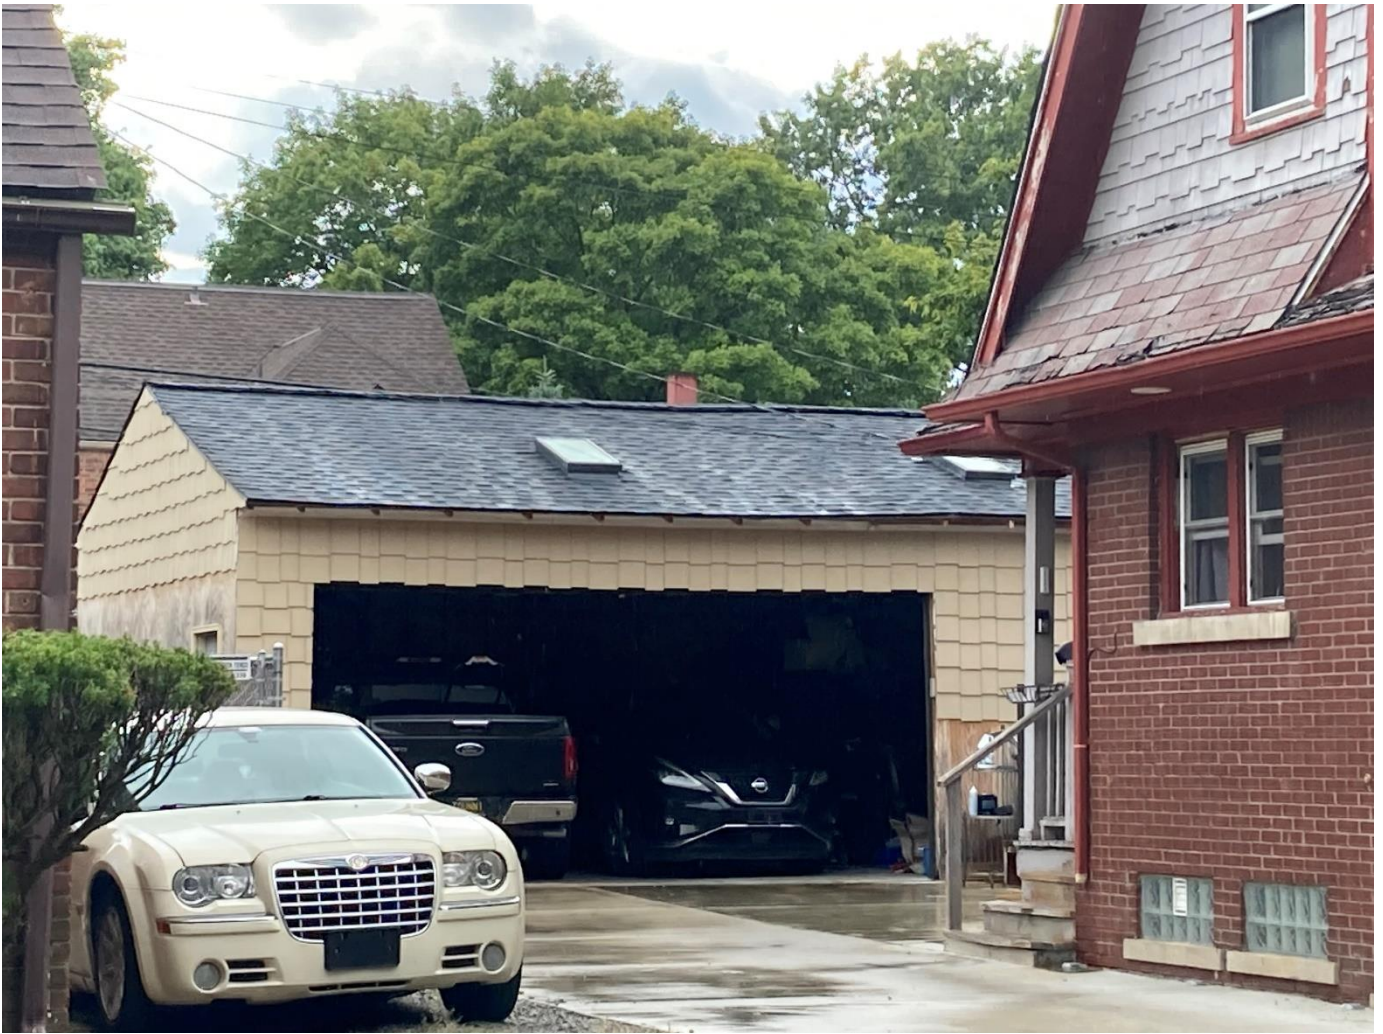
Site photo 2 by staff, 8/26/25, expanded driveway and partial view of new garage.

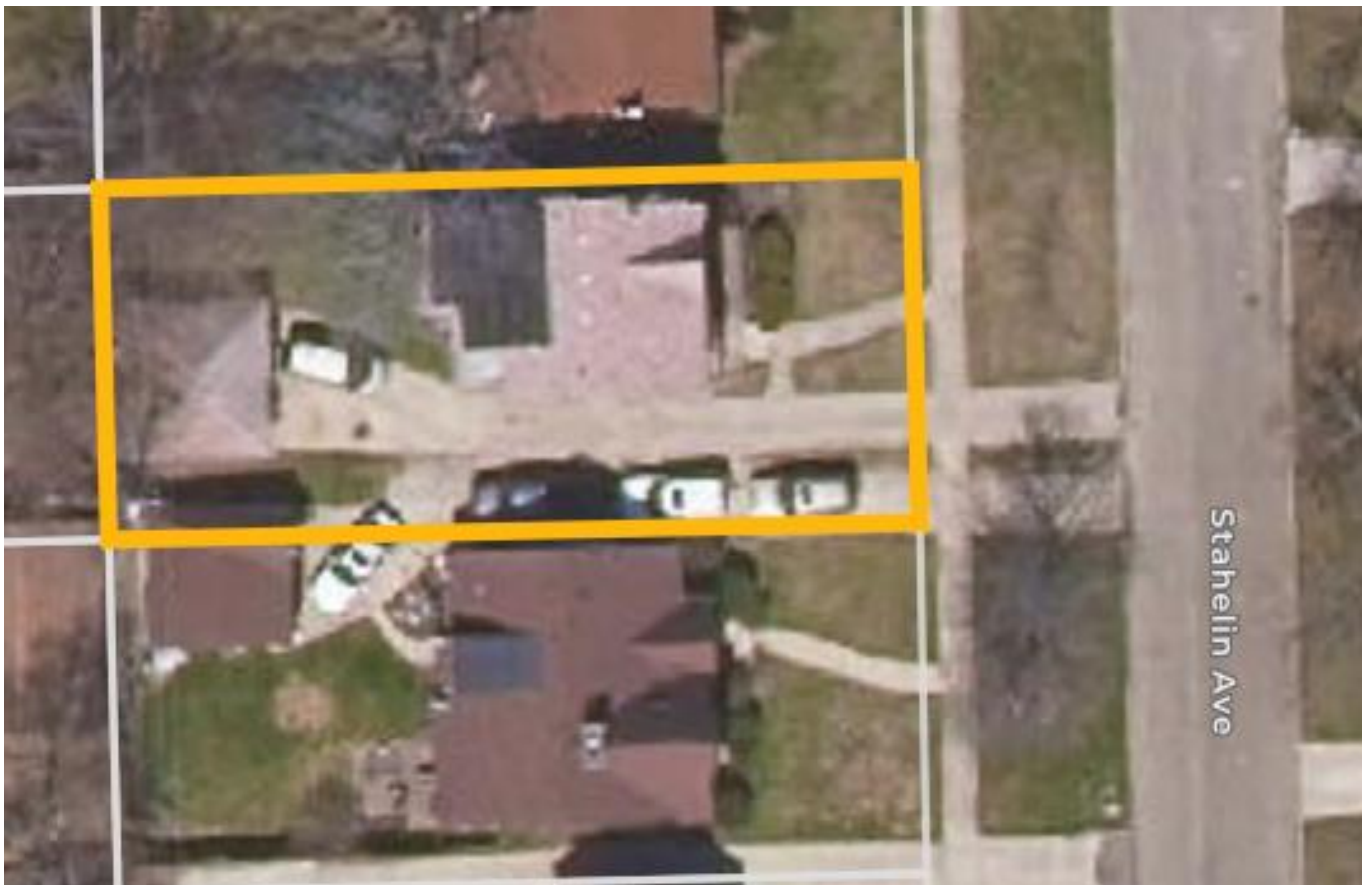
Detroit Parcel Viewer. Aerial view of Parcel 22083667, 14833 Stahelin (outlined in yellow), with the old garage visible in the southwest corner of the lot.

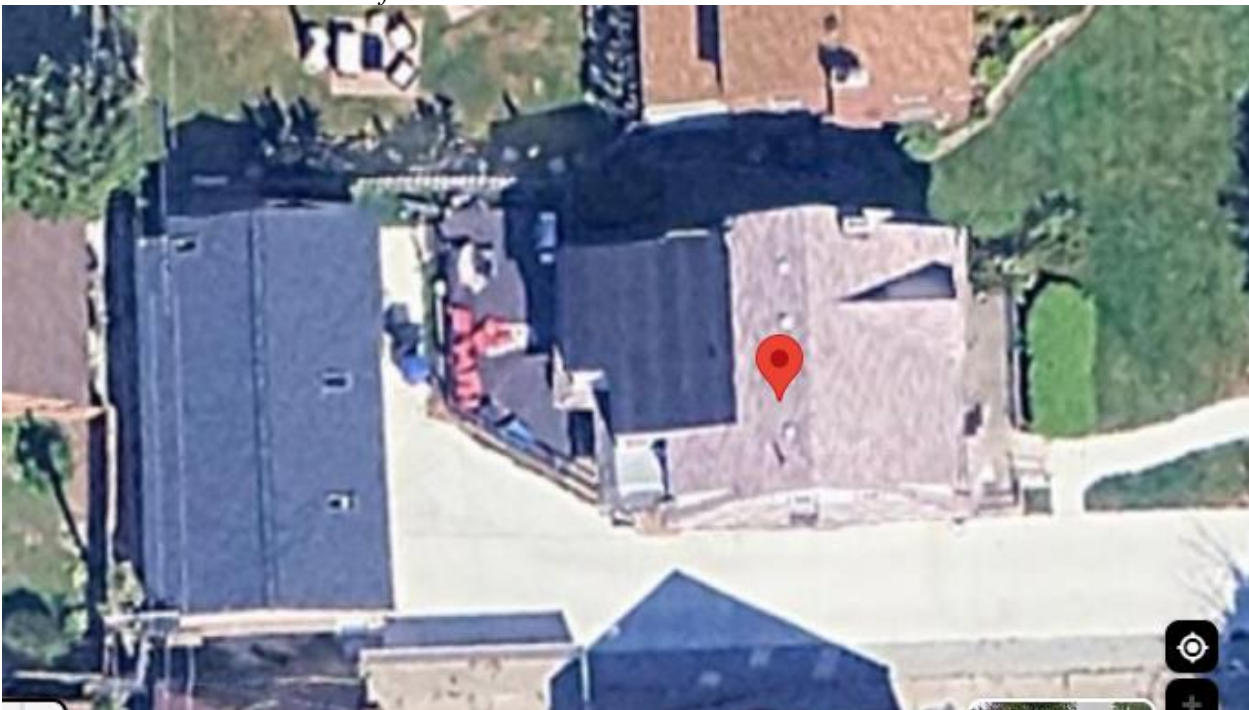
Google satellite view, 14833 Stahelin. The new driveway has eliminated any lawn between 14833 and its neighbor to the south. A rear deck is also visible but that element is not part of this application.

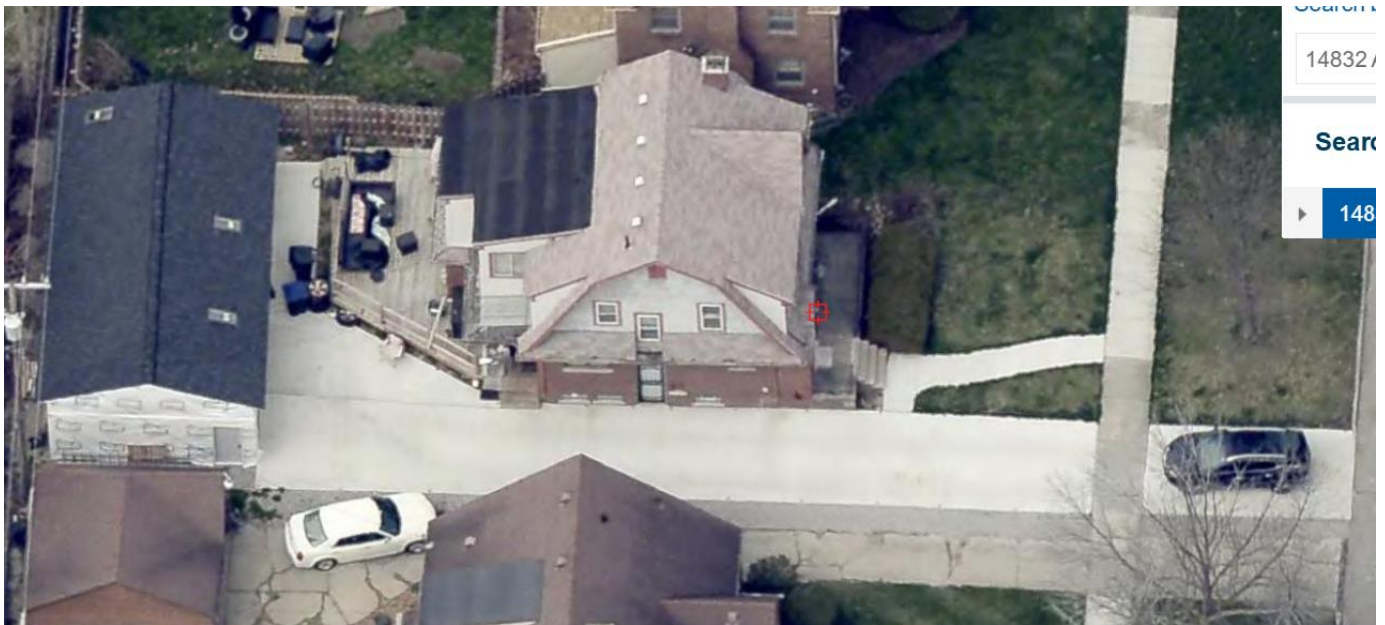
ConnectExplorer, April 2024. With the installation of the new concrete, the small planting strip and approach to the side door, along with any lawn between the houses and the grass behind the house, have been eliminated. A larger garage has been built, and a rear deck has been added. The rear deck is not part of this application.

- The new concrete pad behind the house does not meet the historic district's Elements of Design #14 in that a character-defining feature of the district is that all houses have ample backyards and this new concrete pad has completely changed the nature of the backyard from a lawn/greenspace typical of the district to a completely paved space.

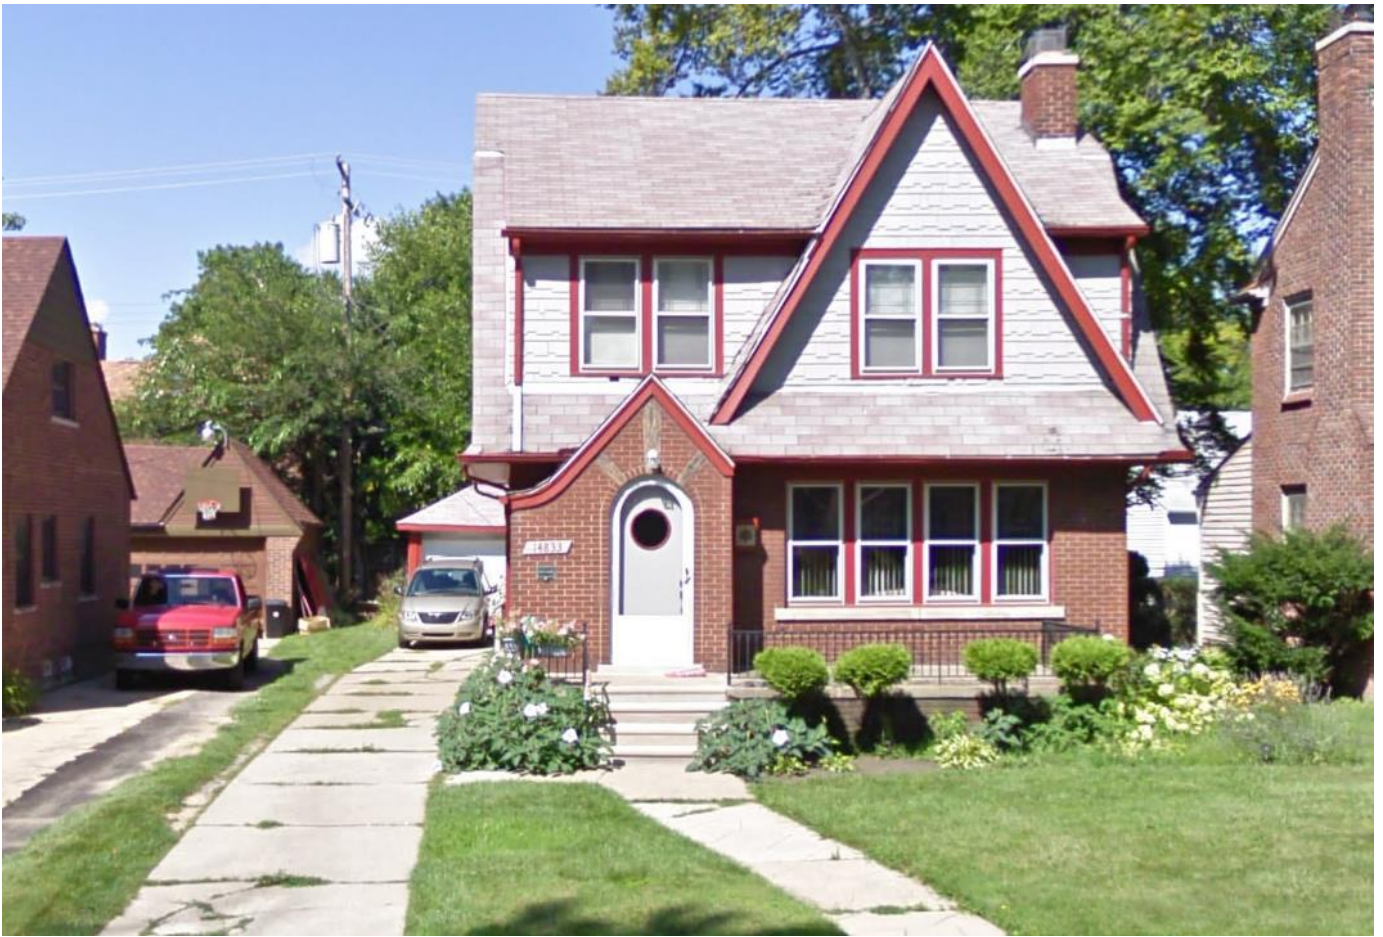
Google streetview August 2009, historic garage, and old driveway visible.

The 2009 Google streetview photo above shows that there was some cracking concrete in the old driveway. The new driveway is wider, and the new concrete pad behind the house eliminated any backyard greenspace. Those changes to the backyard cannot be seen from the front of the house. The new driveway is wider than the old, but staff does not think it is so noticeably different as to be demonstrably incompatible. Rosedale Park’s Elements of Design #13 (“*Relationship of significant landscape features and surface treatments*”) mention that there is typically a single-width driveway leading to a garage. The widened driveway is still single width.

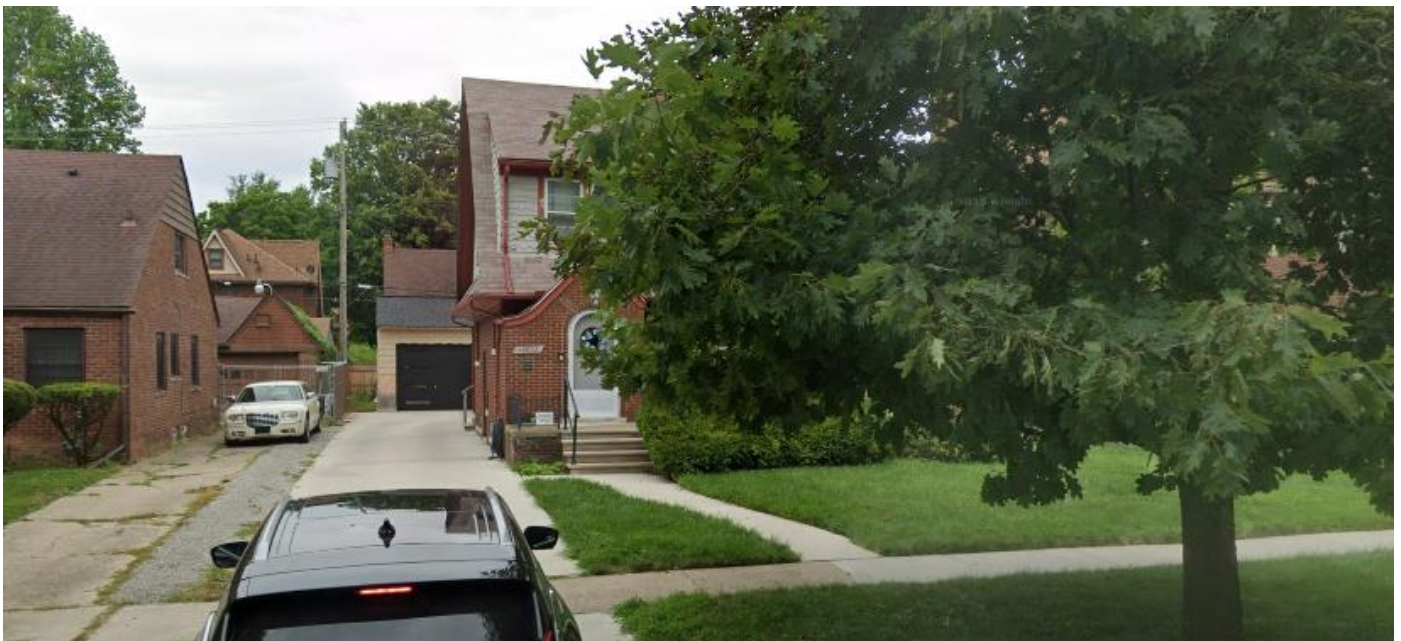
Google streetview July 2025. Wider drive and new garage and garage door visible.

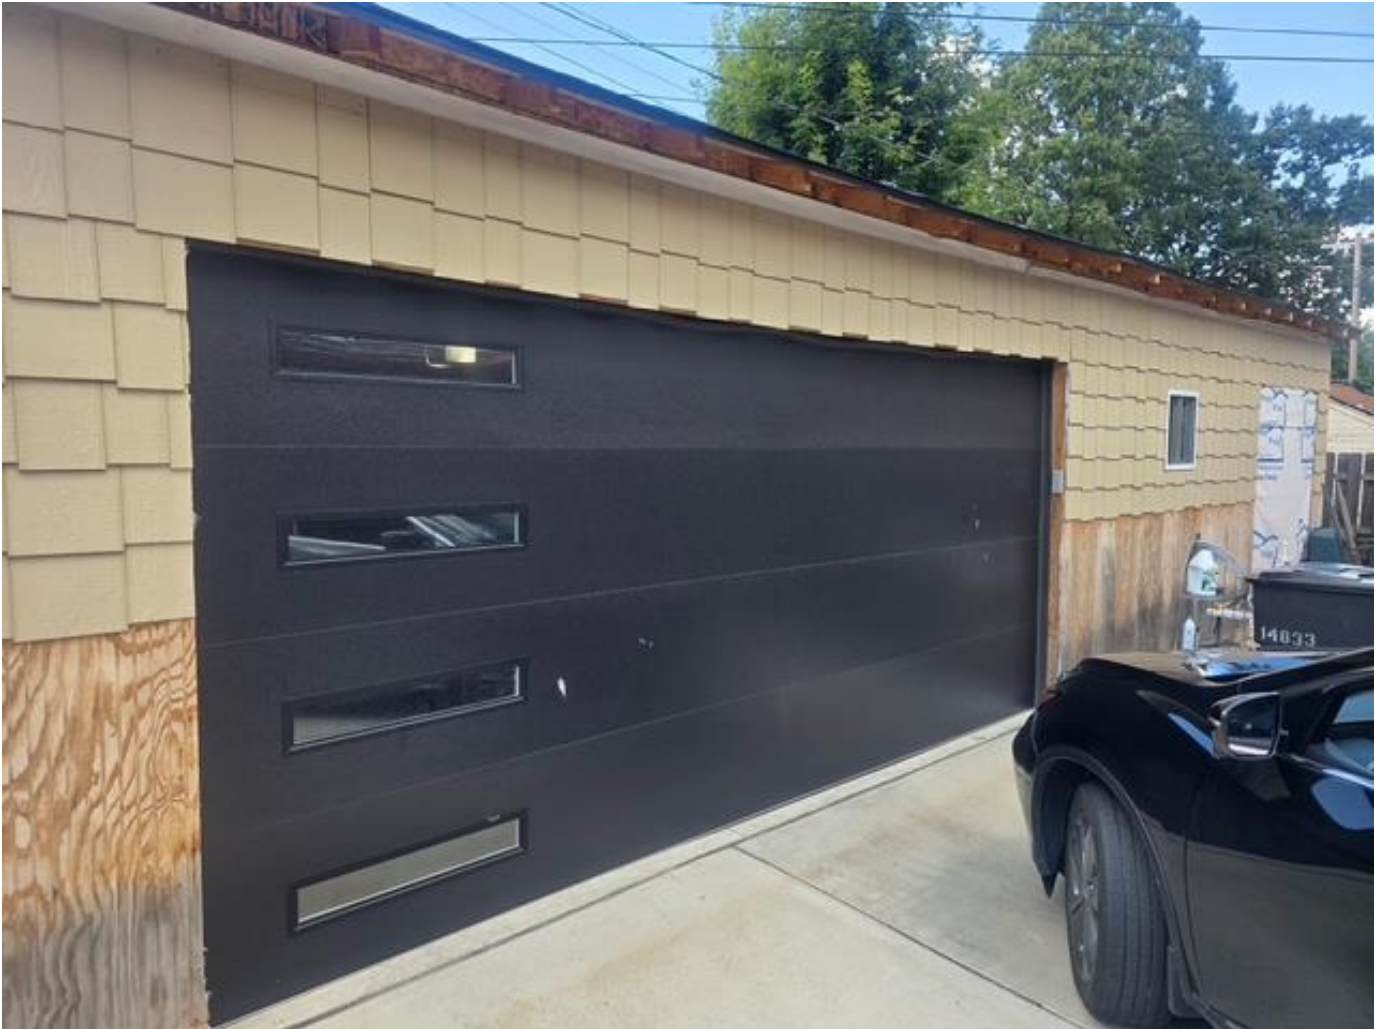
Applicant-provided photo, completed garage, 2025, east elevation. The composite siding, installed garage door, and installed window are visible. Next to the window is the unsided area where the sliding glass door is proposed.

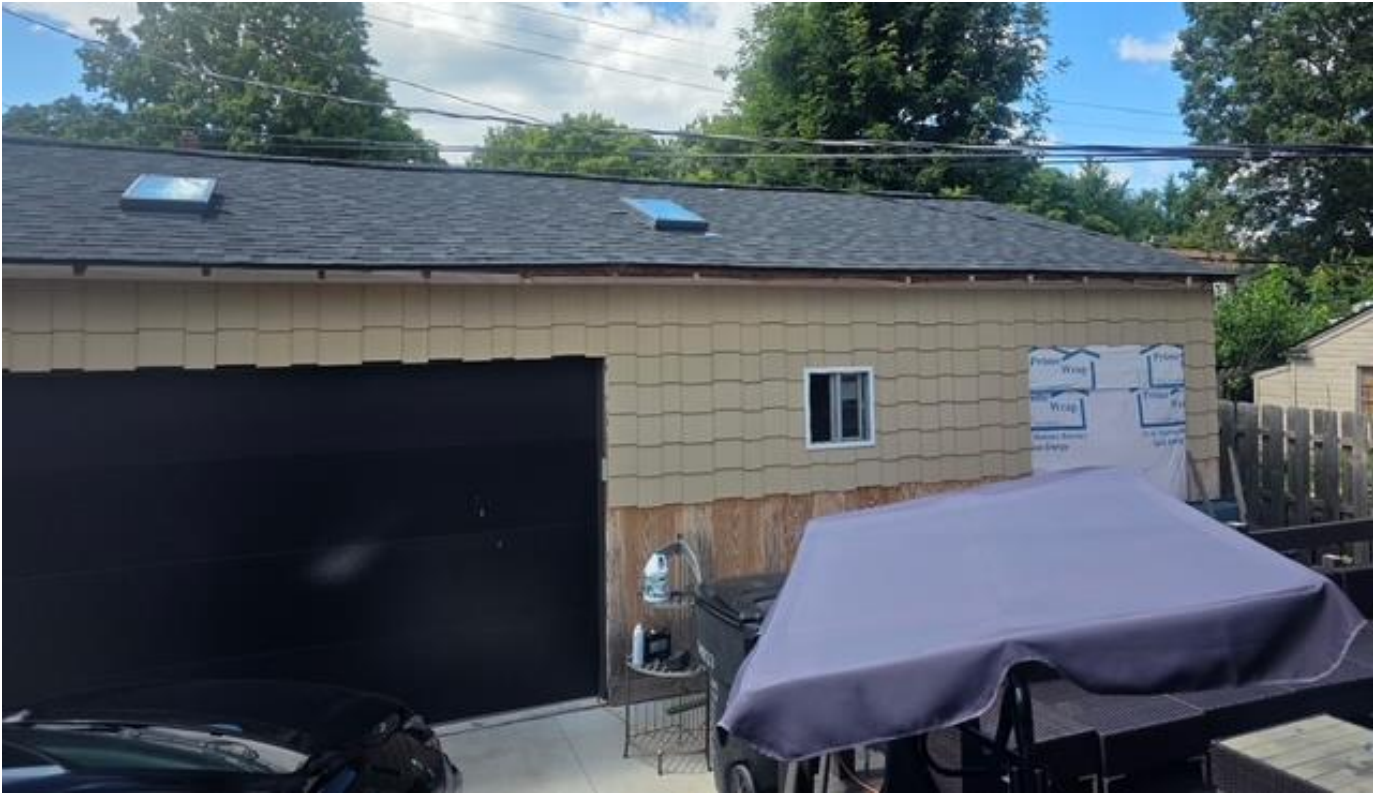
Applicant-provided photo, completed garage, 2025, east elevation. The composite siding, installed garage door, installed window, and skylights are visible. Next to the window is the unsided area where the sliding glass door is proposed.

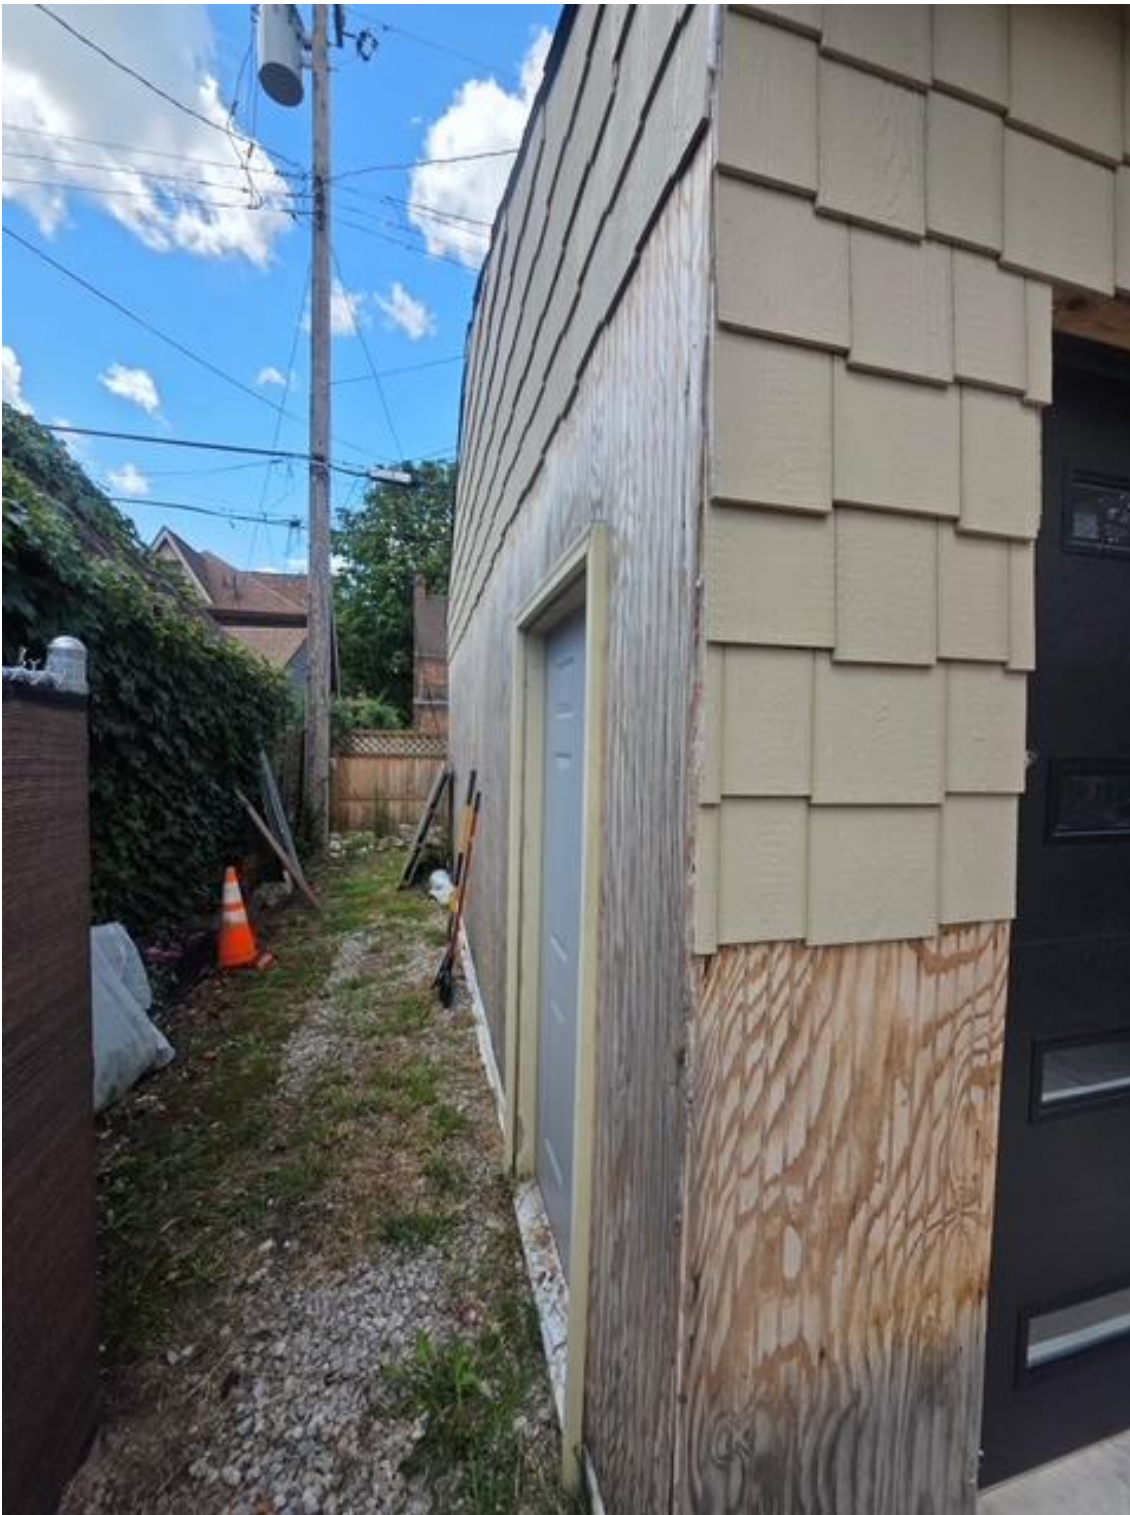
Applicant-provided photo, 2025, completed garage, southeast corner and south elevation, composite siding, unpainted surface, and new steel hinged door visible.

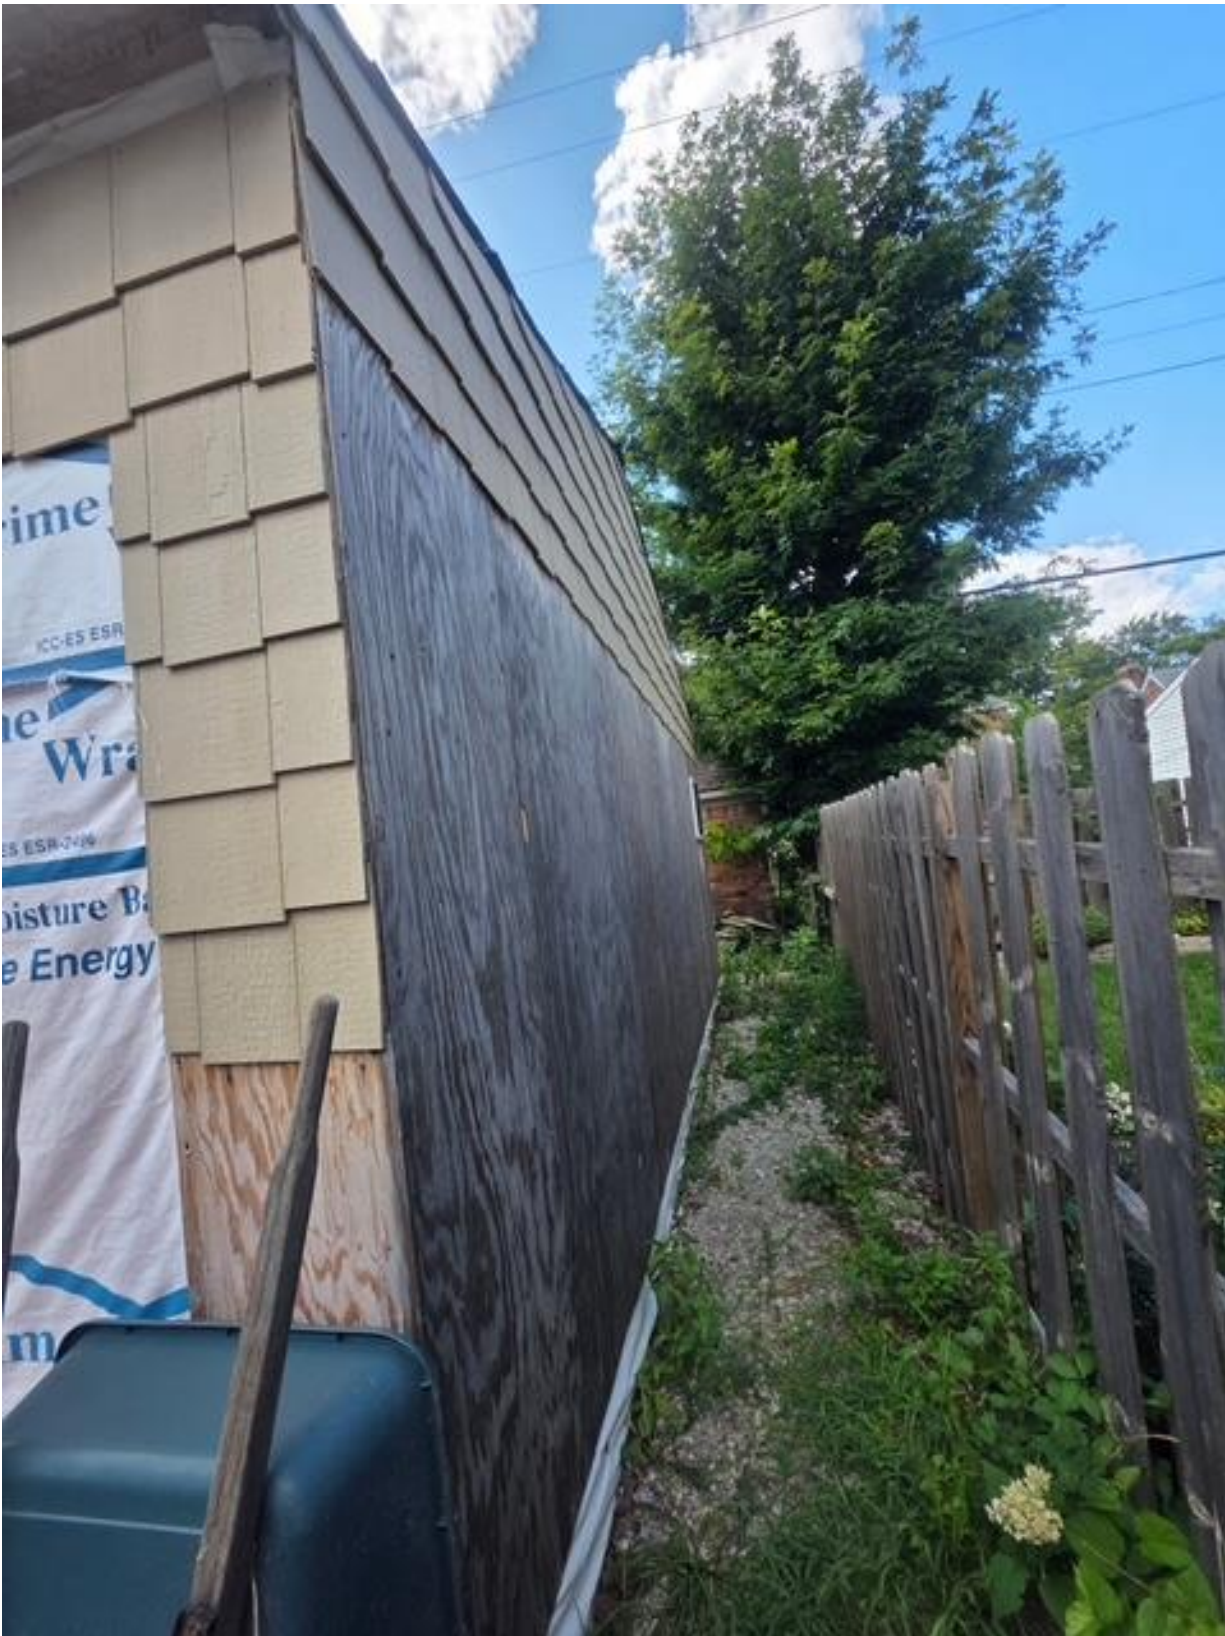
Applicant-provided photo, completed garage, 2025, northeast corner and north elevation. The composite siding and unfinished plywood are visible. A window has been installed near the garage's northeast corner, as per the plan. Materials were not specified.

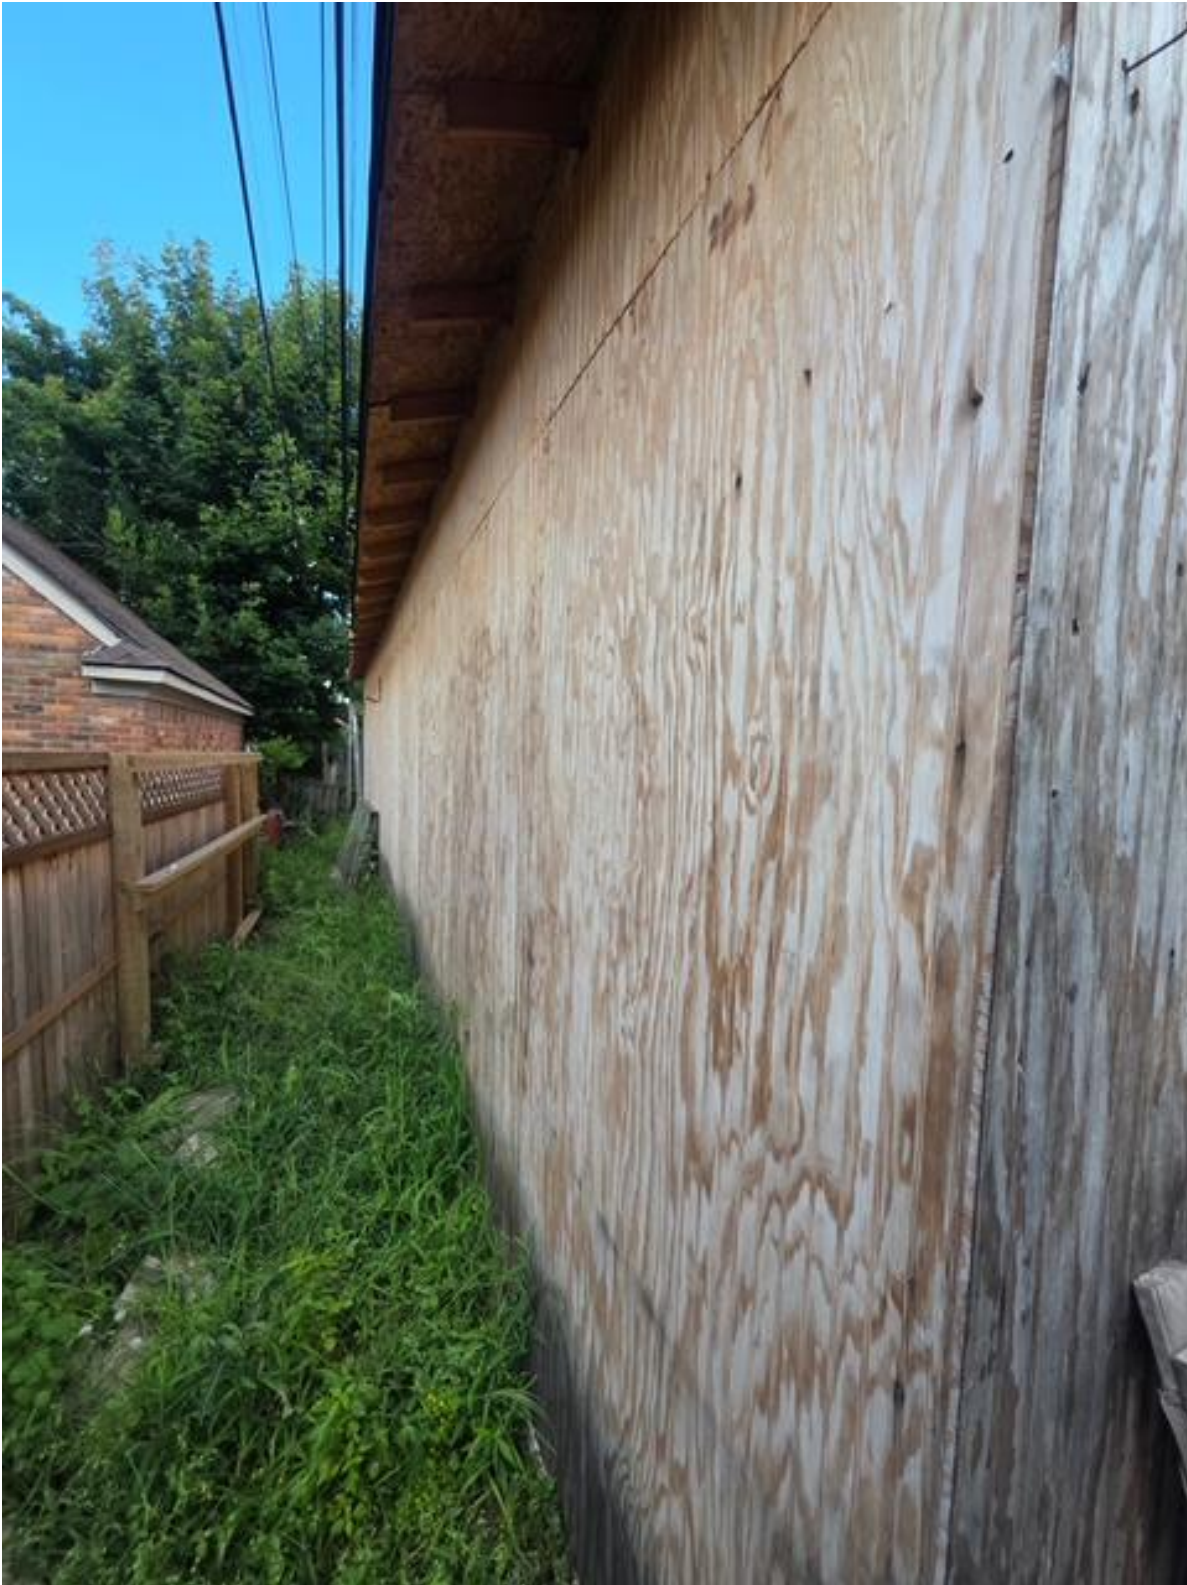
Applicant-provided photo, completed garage, 2025, rear (west) elevation. Unfinished plywood surface visible..
