STAFF REPORT: 09/10/2025 MEETING

ADDRESS: 2491 LONGFELLOW

APPLICATION NO: HDC2025-00446

SCOPE: REPLACE FRONT PORCH COLUMNS, REPLACE WINDOWS, INSTALL LANDSCAPING (WORK COMPLETED WITHOUT APPROVAL), INSTALL PATIO AT REAR YARD

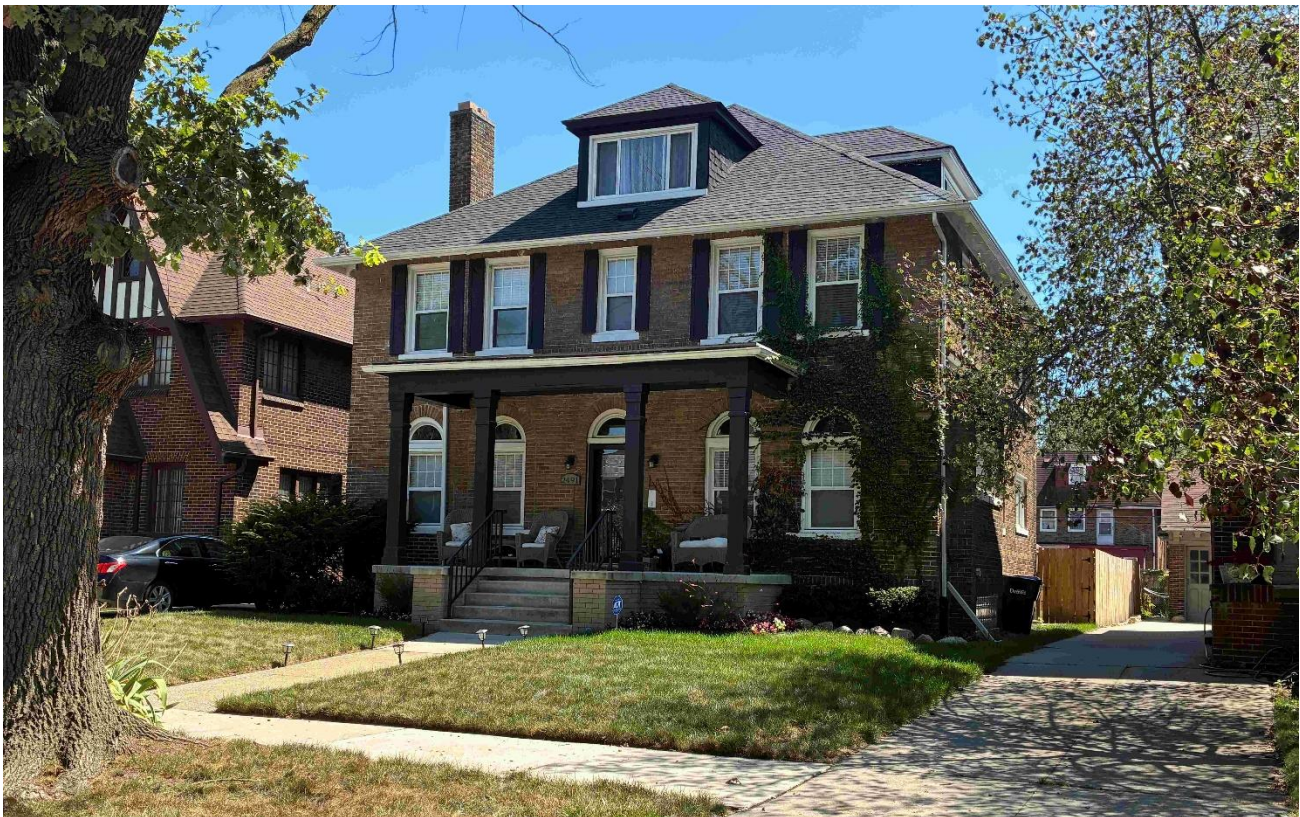
2491 Longfellow. Current appearance. Photo by HDC staff, 8/26/2025

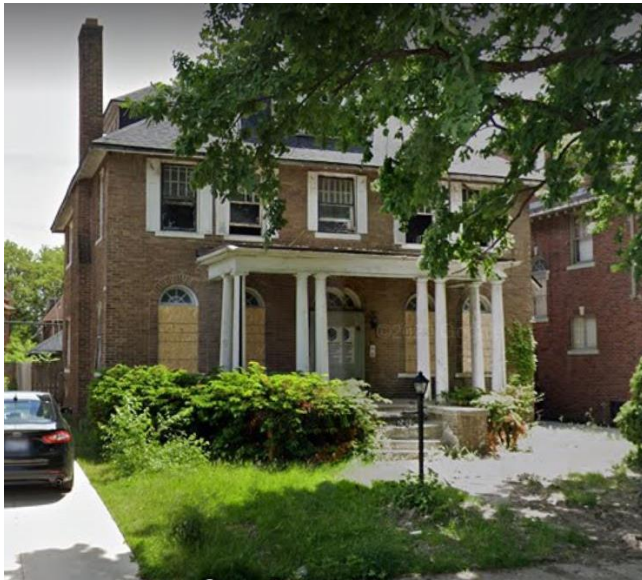
Google Streetview, taken in 2019. Note that there were 8 columns present at the front porch (4 sets of paired columns)

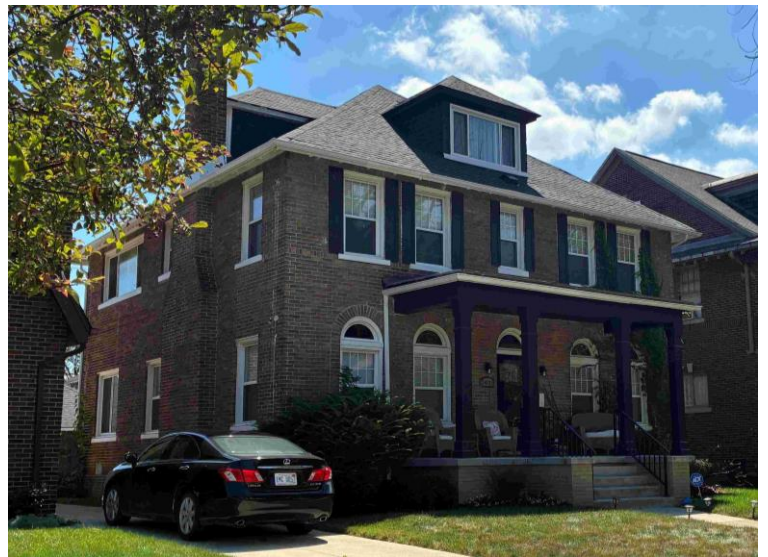
Current appearance, photo by HDC staff

a property be matched in-kind if they must be replaced in order to maintain a property's historic character. It is HDC staff's opinion that the existing columns fall well short of that requirement as they do not match the historic in form, proportion, dimension, and detailing. Also, note that the porch featured eight elegantly tapered, round wood columns prior to the current unapproved work, versus the current four columns at the porch. It is staff's opinion that the replacement of historic columns with the new features greatly alters the porch's distinctive, historic expression. For these reasons, staff recommends that the Commission deny this work item.

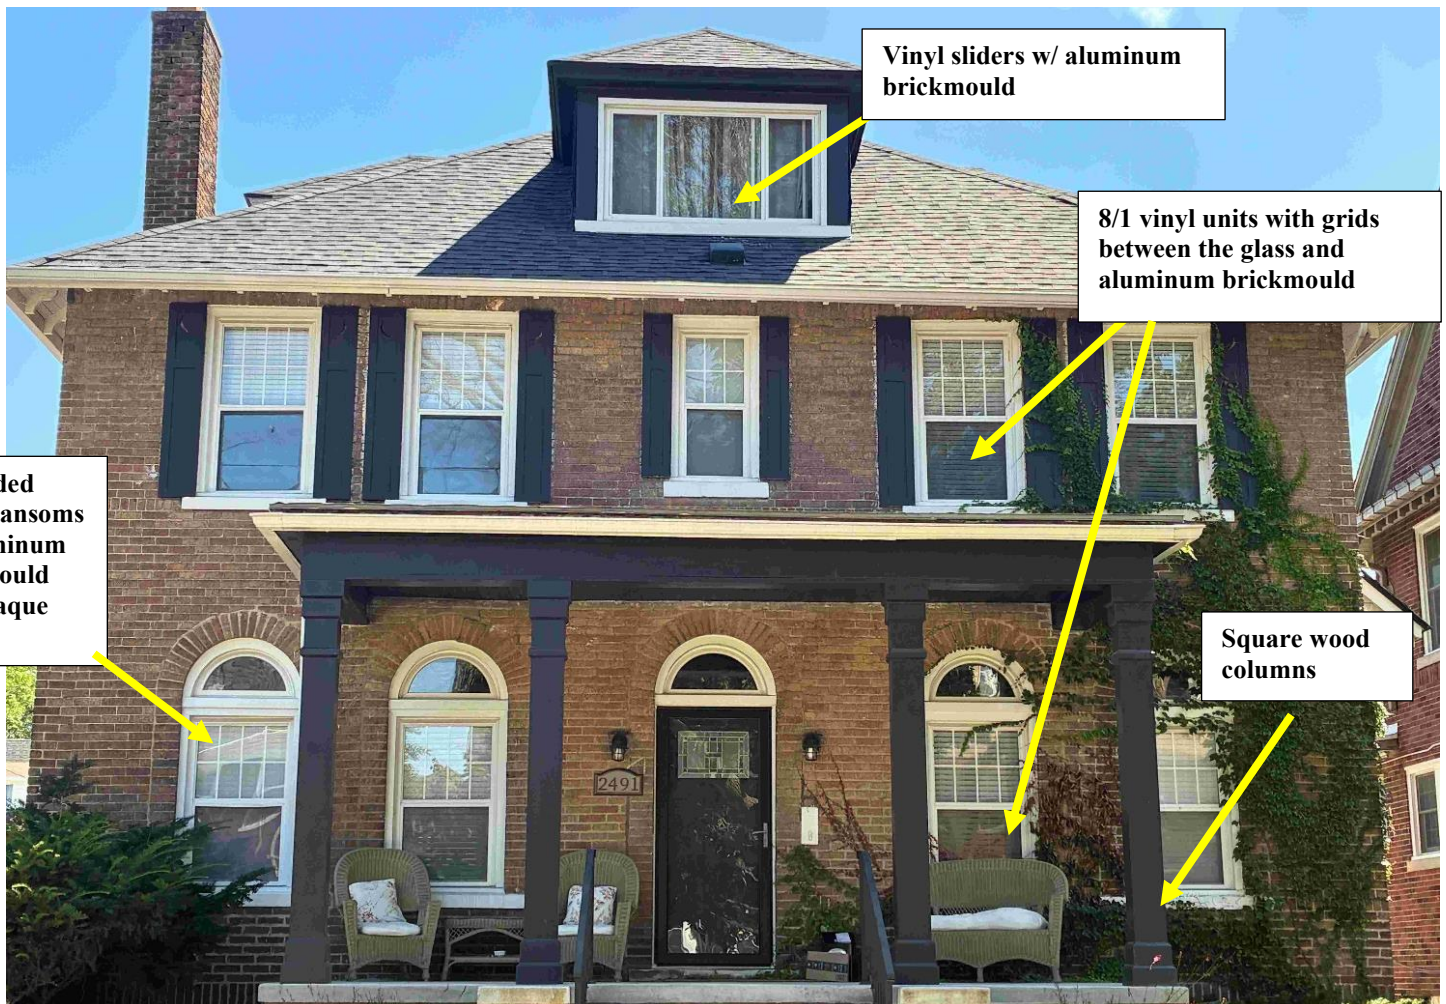
Current condition. Photo by HDC staff, 8/26/2025. Note unsympathetic alterations which have removed elements associated with the building's Colonial Revival style

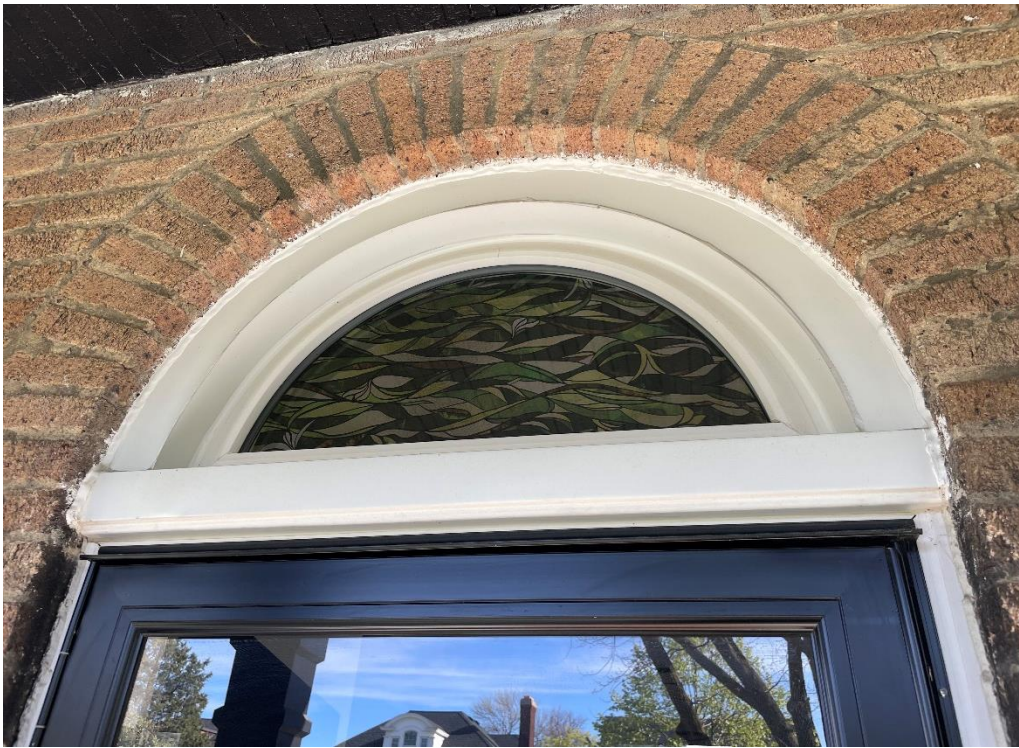
Current condition. Photo by HDC staff, 2024. Detail of incompatible opaque glass, vinyl windows, and aluminum brickmould at front the front façade, first story

- The lite configuration of the existing vinyl operational units does not match the historic throughout
 - The lite configuration/the radial pattern and opacity of the historic transoms at the front facade has not been matched

- The current consumer grade, vinyl windows and aluminum brickmould display a plasticity and flat/thick appearance that does not adequately match the profile/dimensionality and appearance of the historic windows. Also, the muntins between the glass provided a flattened appearance which is inconsistent with a true divided lite window.

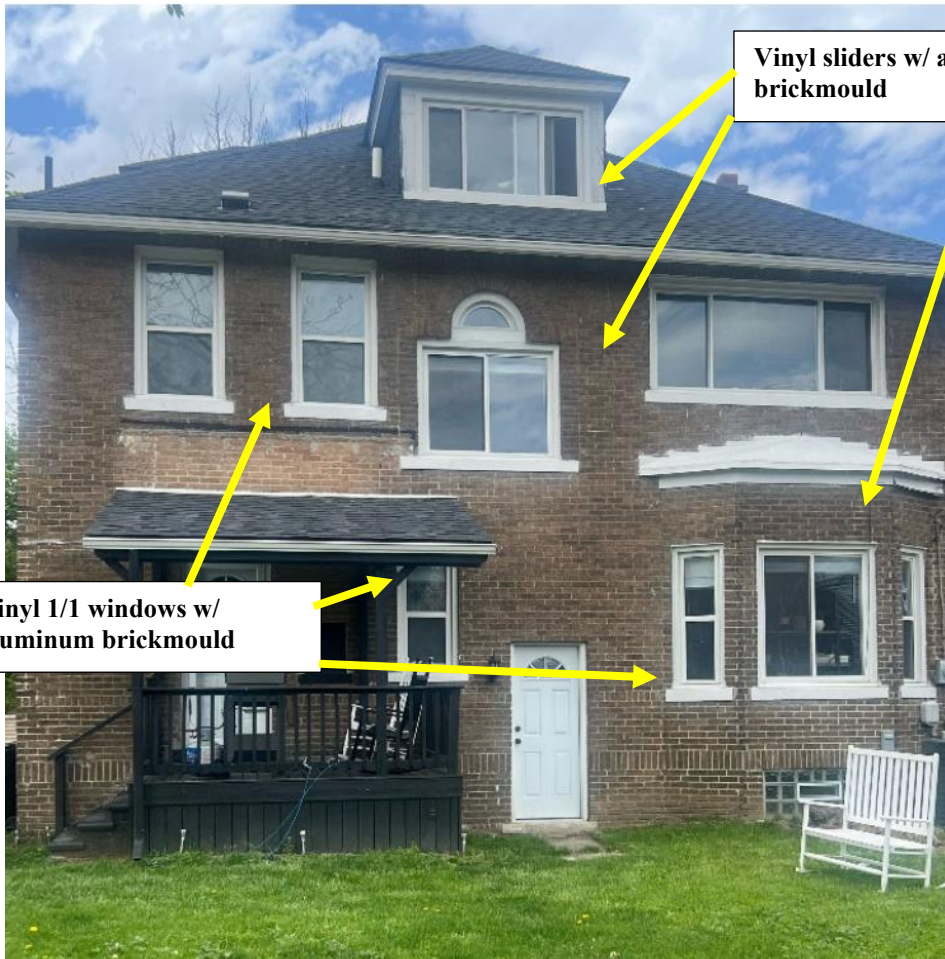
**Vinyl sliders w/ aluminum
brickmould**

**Vinyl 1/1 windows w/
aluminum brickmould**

Rear wall. Note incompatible vinyl windows. Photo by HDC staff, 2024

- The operation of several units does not match the historic, to include the replacement of double hung windows with slider units at the front, rear, and side walls.

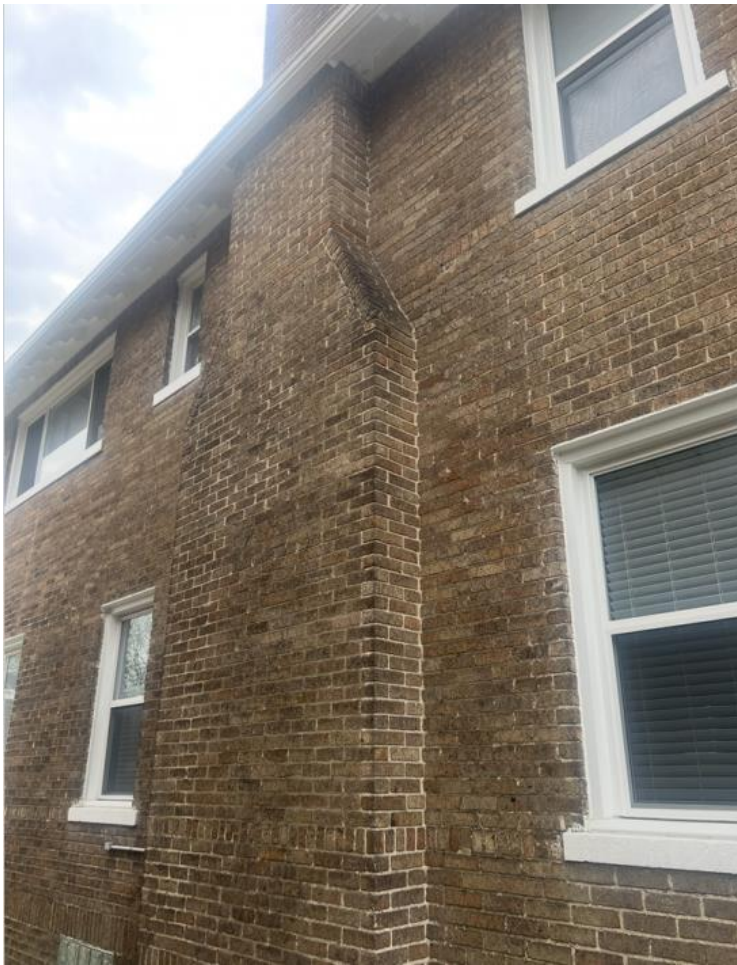
East side wall. Note incompatible vinyl 1/1 and slider units with aluminum trim/brickmould. Photo by HDC staff, 2024

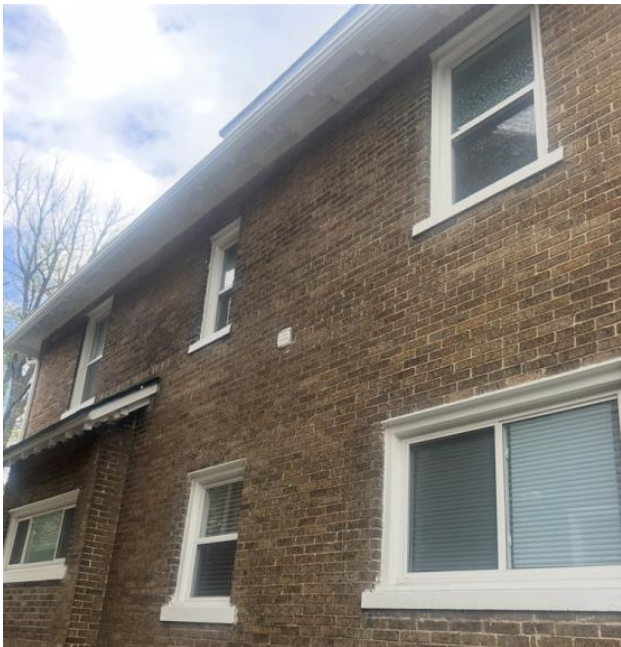
West side wall. Note incompatible vinyl 1/1 and slider units with aluminum trim/brickmould. Photo by HDC staff, 2024

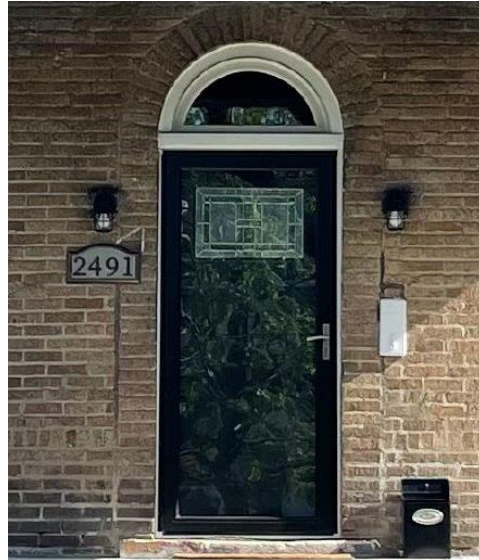
- Staff recommends that the Commission deny the existing/proposed front door because its vision panel presents as a modern interpretation of a Victorian era design detail that is wholly incompatible/incongruent with the simplicity of the building's Colonial Revival style.

Current front door was installed without HDC approval. Photo by HDC staff 2024. The applicant proposes to retain this door

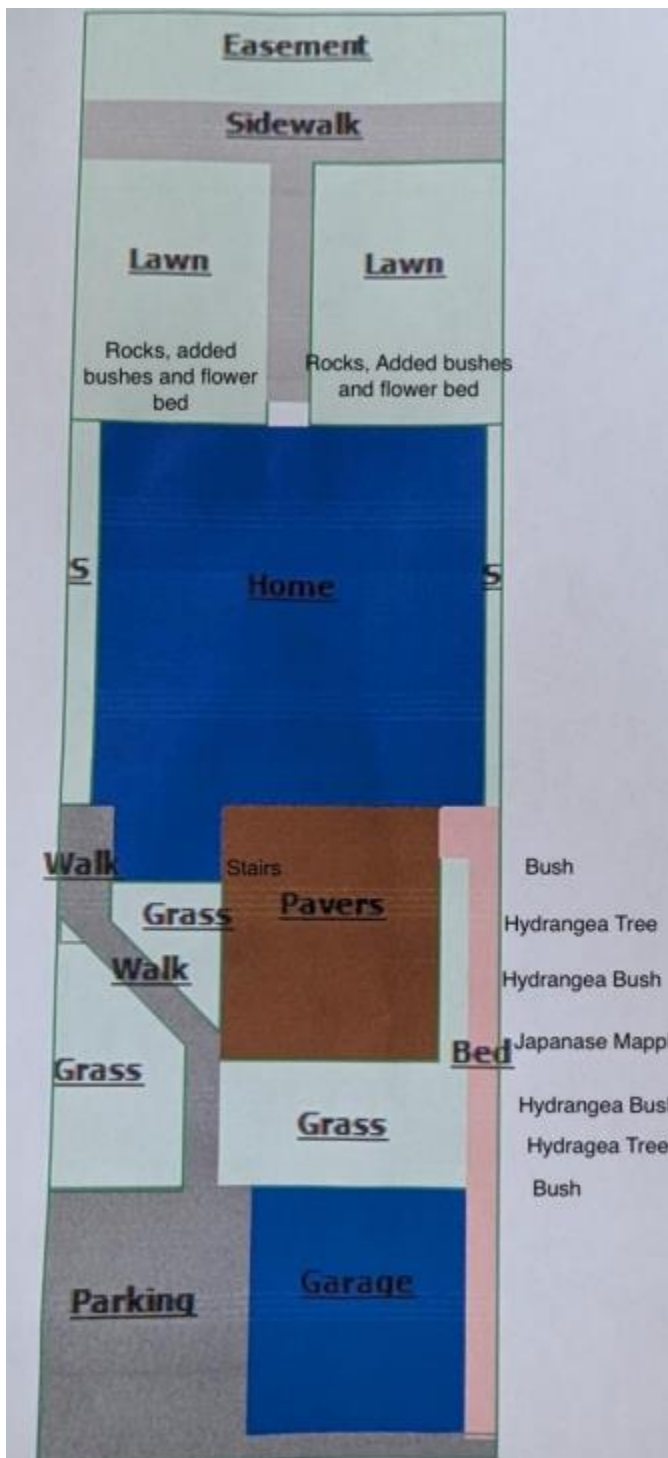
- Staff supports the addition of a patio to the rear yard and new steps which will lead from the existing non-historic rear porch to the new patio. The applicant has noted that the patio will be 300 square feet. However, the submitted site plan does not provide overall dimensions of the backyard, existing buildings, and/or the existing hardscape so the scale of the patio relative to these elements is unknown (see the below). Also, the final material for the patio has not been identified. Finally, note that dimensioned drawings of the proposed stairs (in plan and elevation) which will lead from the porch to the patio have not been provided. Staff recommends approval of these items with the condition that the applicant provide the following to staff for review and approval prior to the issuance of permit:

Site plan, indicating the location of the proposed patio (labeled “pavers”). Provided by applicant.

- Site plan of the backyard which shows the footprint dimensions of all existing buildings, hardscape (walkways and parking pads), planting beds, and the proposed patio

- Drawing of the proposed steps in plan and elevation which indicates its materiality
