STAFF REPORT: 09/10/2025 MEETING

ADDRESS: 4000 TYLER

APPLICATION NO: HDC2025-00504

SCOPE: REBUILD BACK PORCH, INSTALL RAILINGS AT FRONT AND BACK PORCH, REPLACE GLASS AT FRONT FAÇADE WINDOWS (WORK COMPLETED WITHOUT APPROVAL)

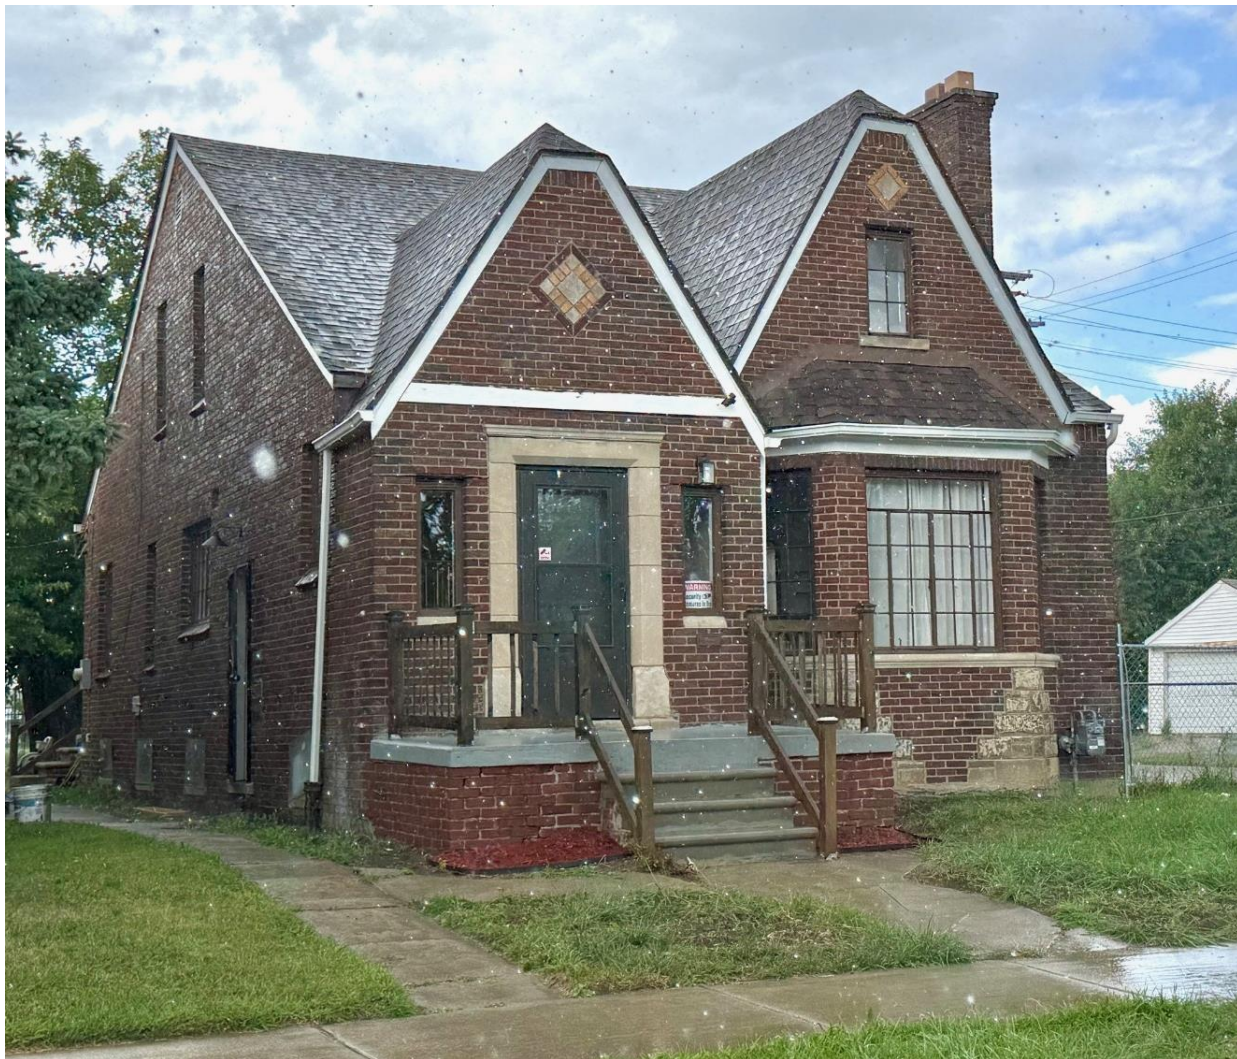
4000 Tyler. Current appearance. Photo taken by HDC staff on 8/26/2025

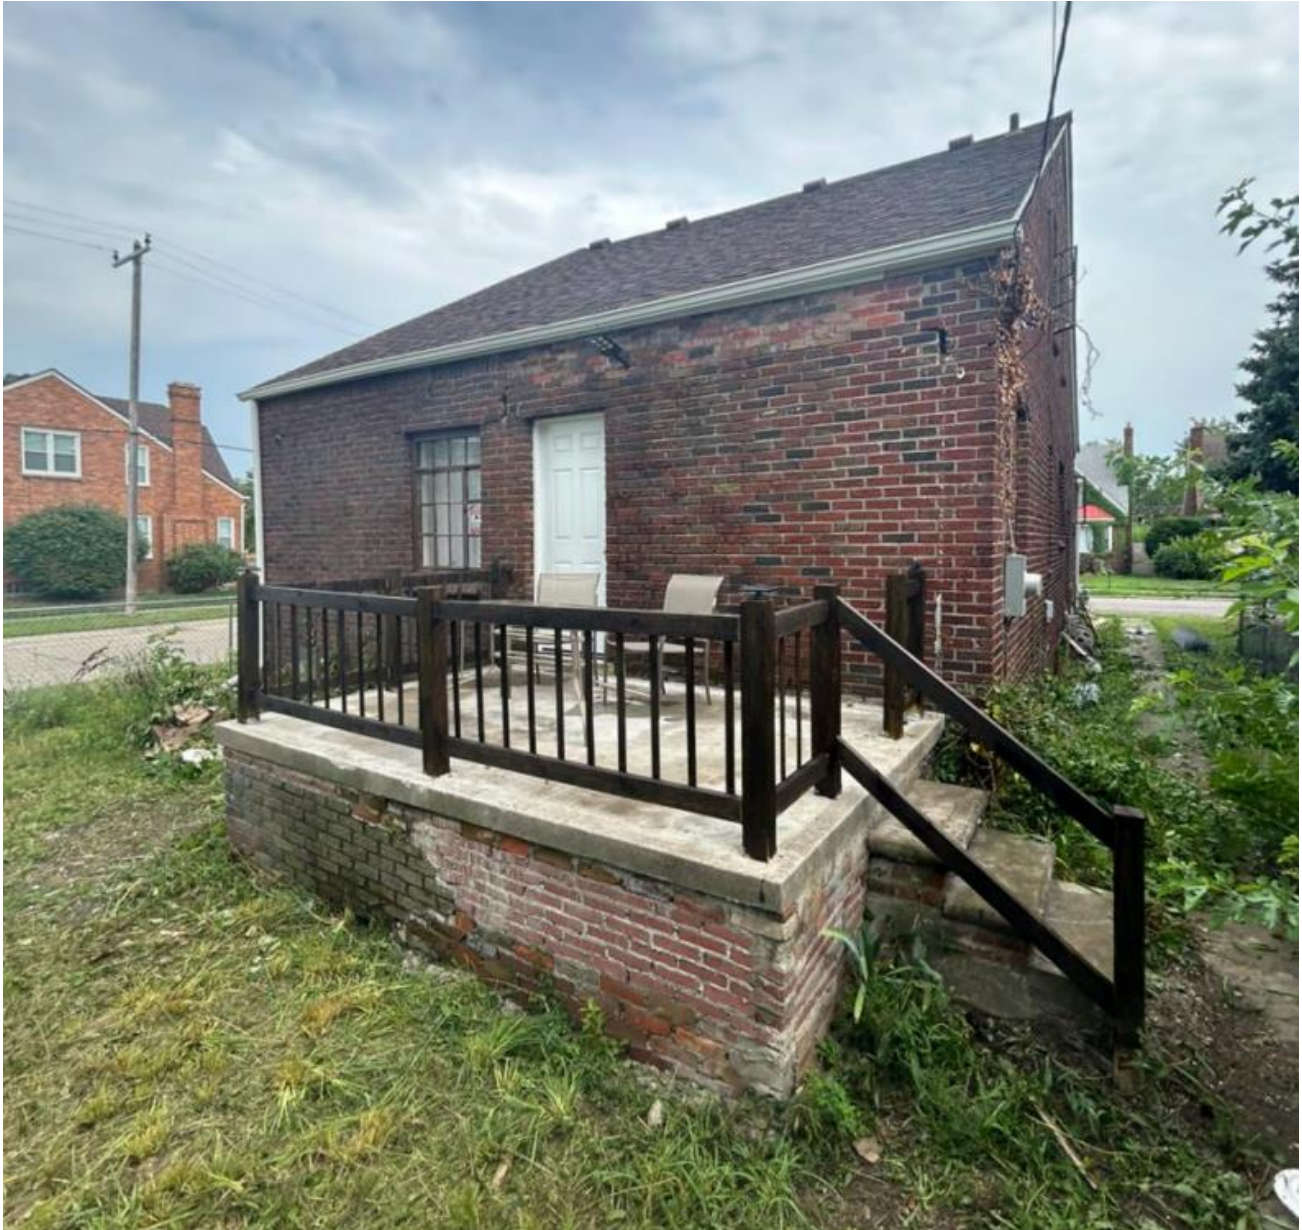
4000 Tyler. Showing rear porch. Photo taken by applicant

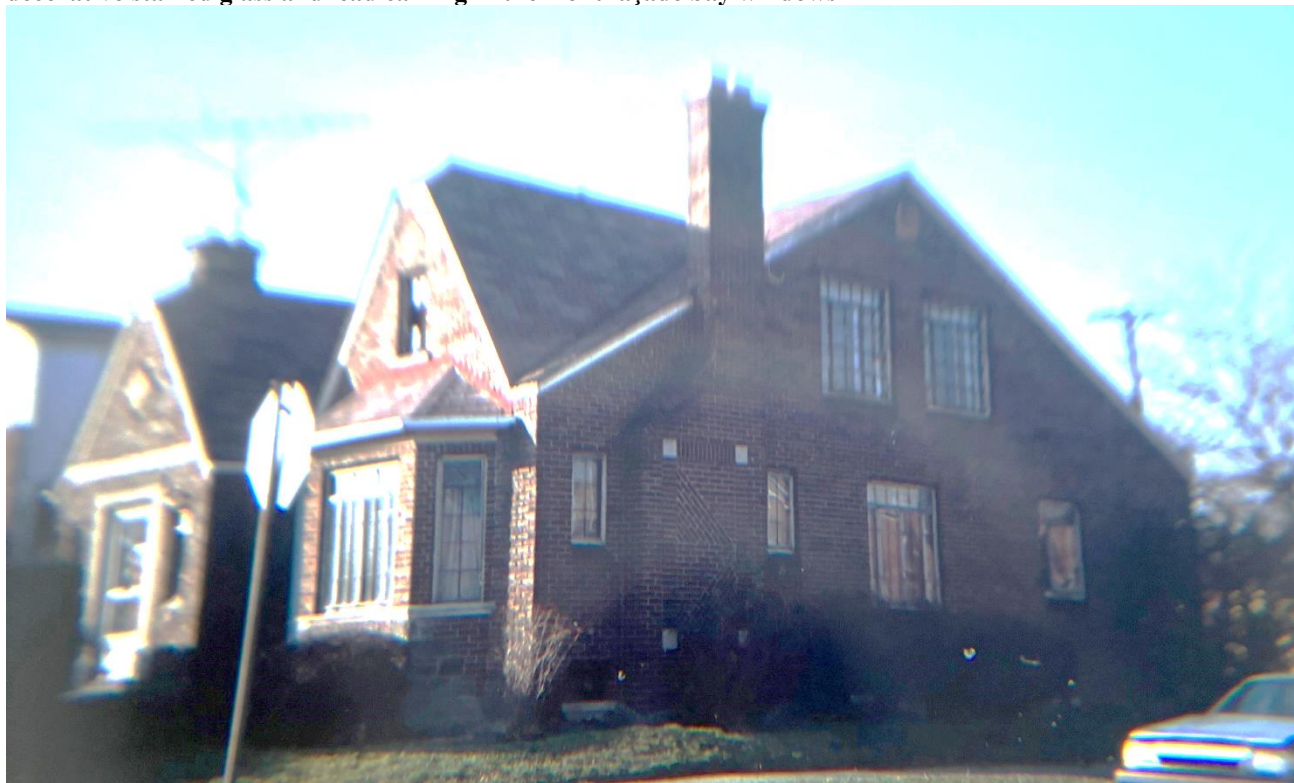
Designation photo, taken in 1999 by HDAB. Note that original front porch and windows remained, to include the decorative stained glass and lead coming in the front façade bay windows

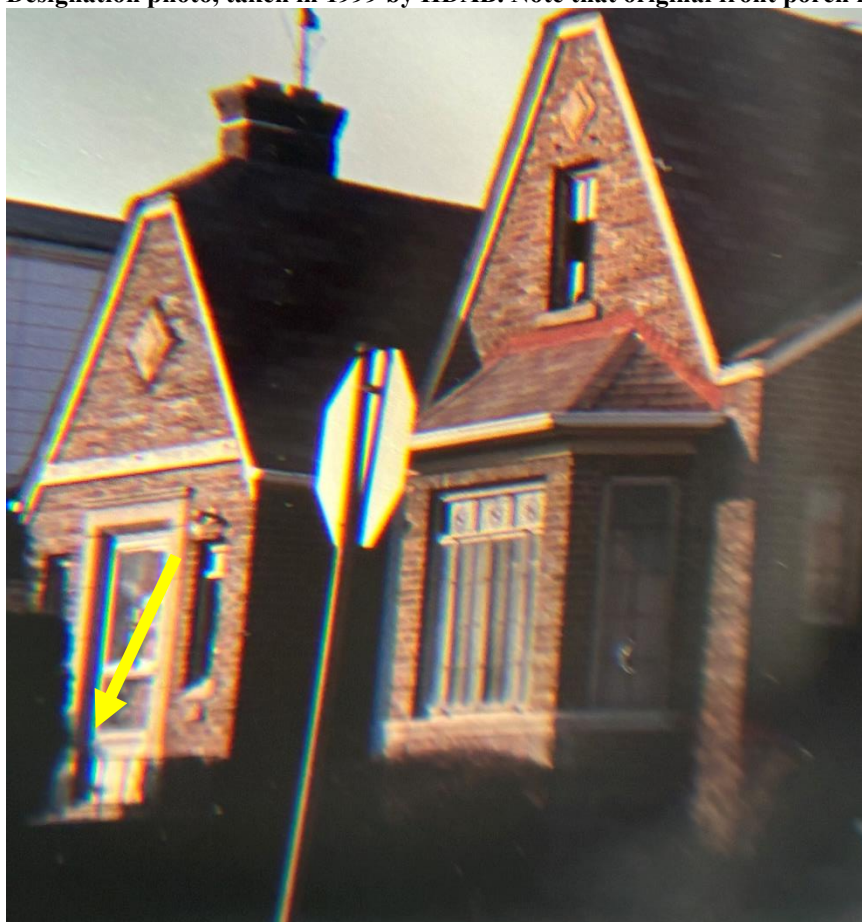
Designation photo, taken in 1999 by HDAB. Note that original front porch railing was present (yellow arrow)

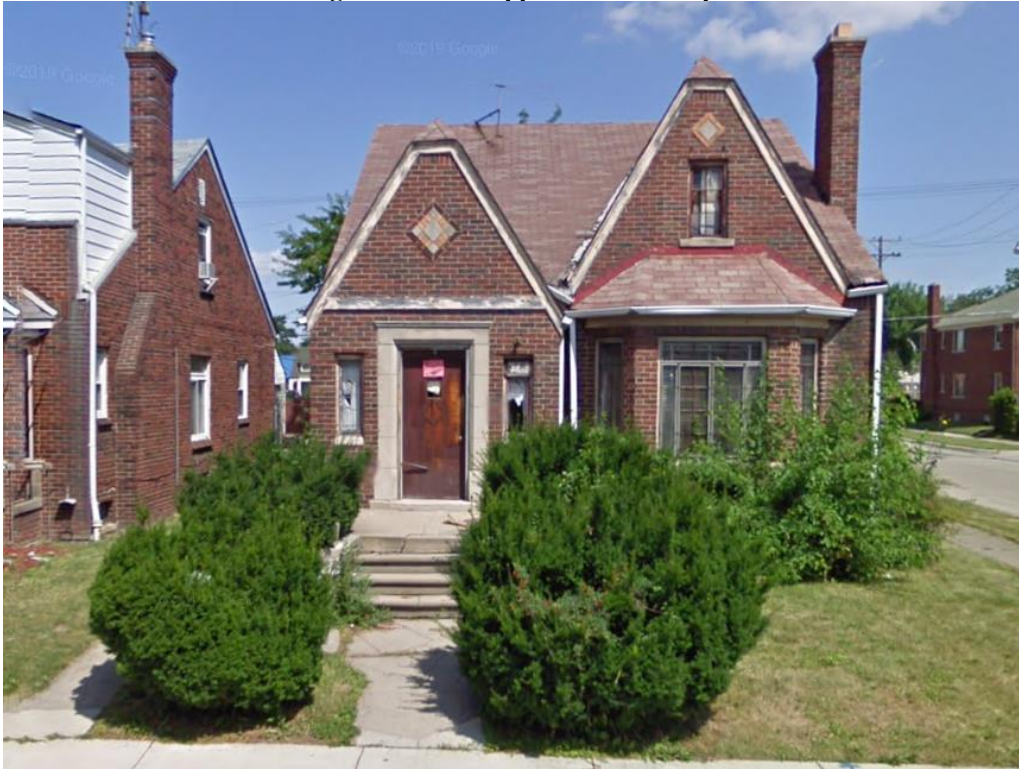
2009, Google Streetview image. Note shrubs are present and front yard and all original windows remain. Also, the front door is not of historic age. The house appears to be occupied at this time.

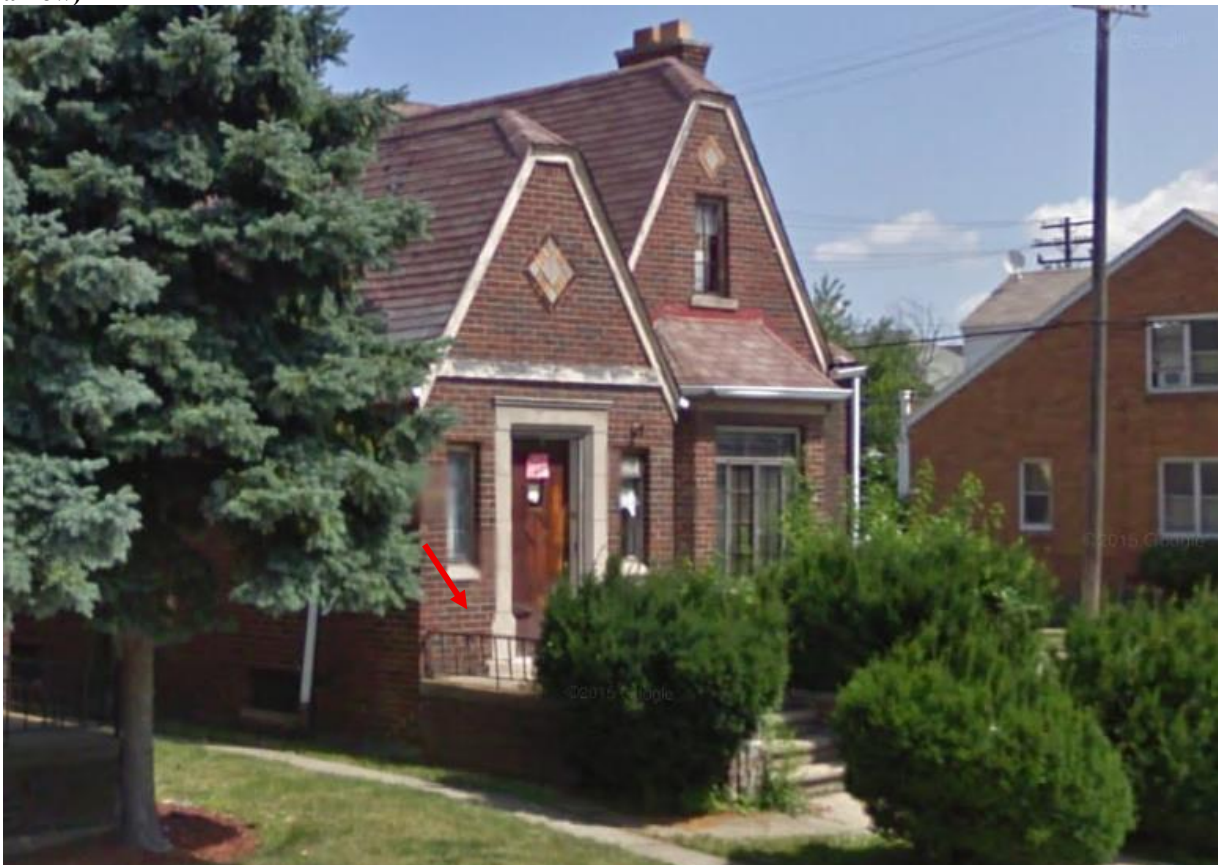
2009, Google Streetview image. Note that the original 24"-high metal railing was present at the front porch (red arrow)

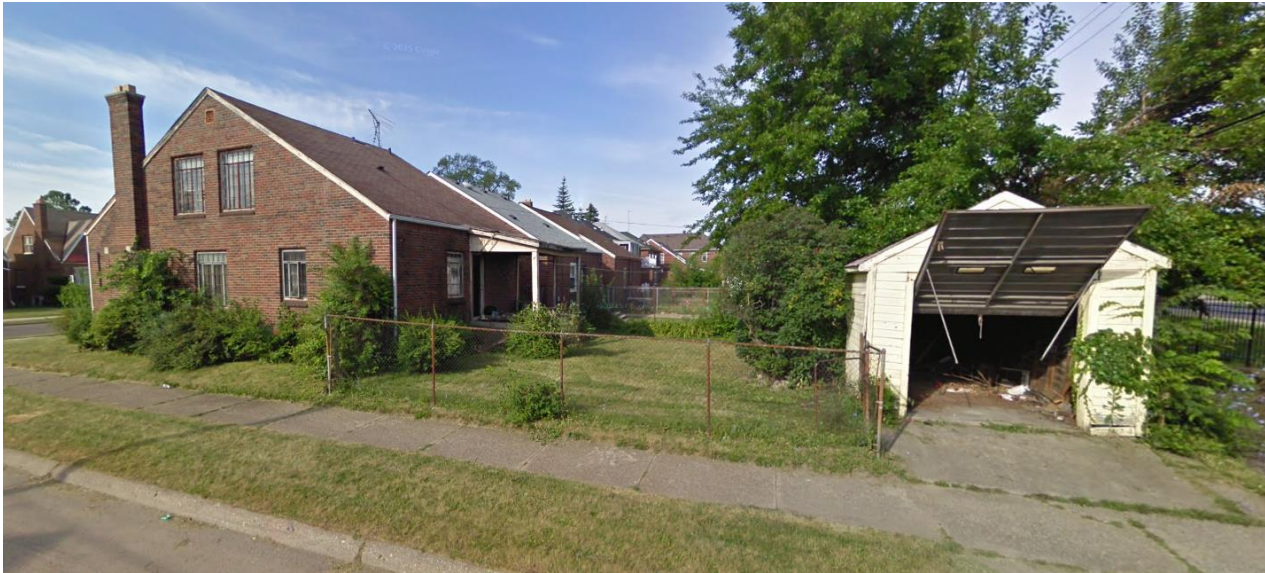
2009, Google Streetview image. Note rear yard fencing, rear porch canopy, and 1-car garage at rear yard. The garage appears to be in poor condition

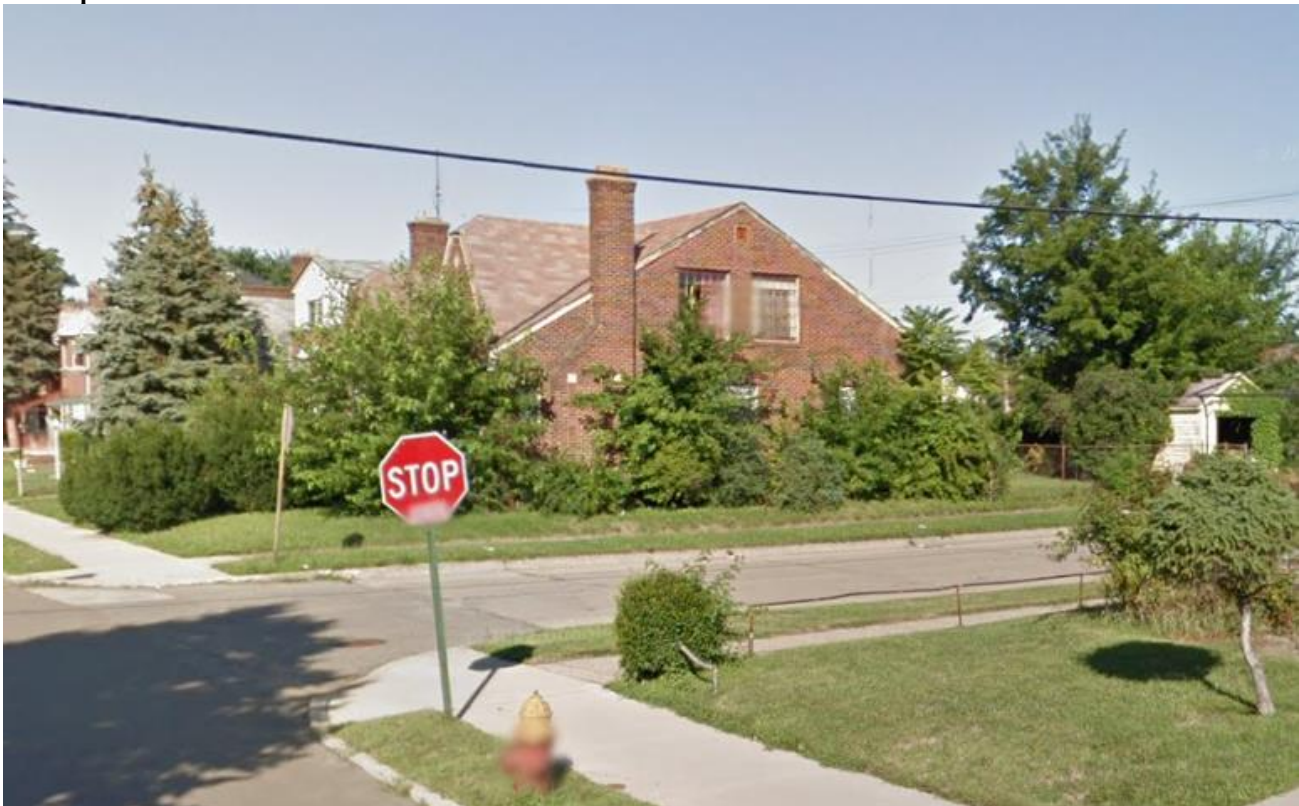
2011 Google Streetview image. Note overgrown foliage. The garage is still extant. The house appears to be vacant at this point.

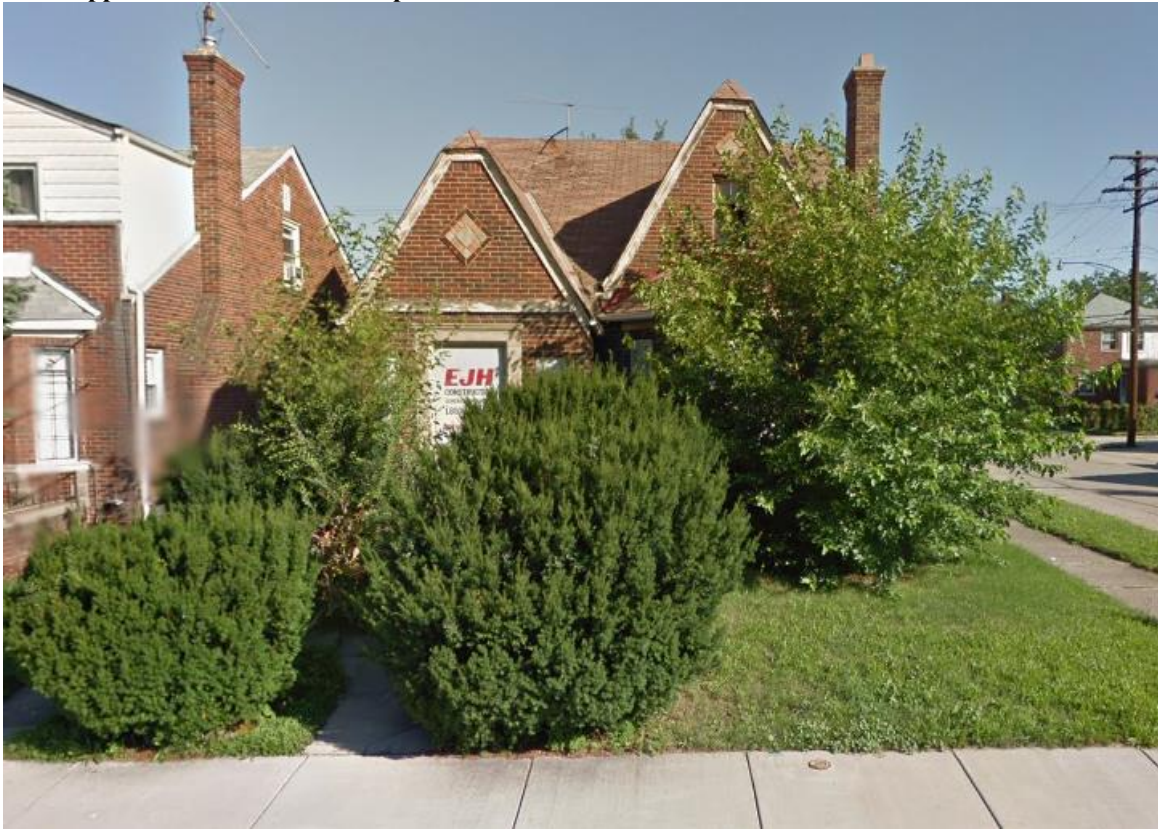
2011 Google Streetview image. Note overgrown foliage. The front door and windows have been boarded up. The house appears to be vacant at this point.

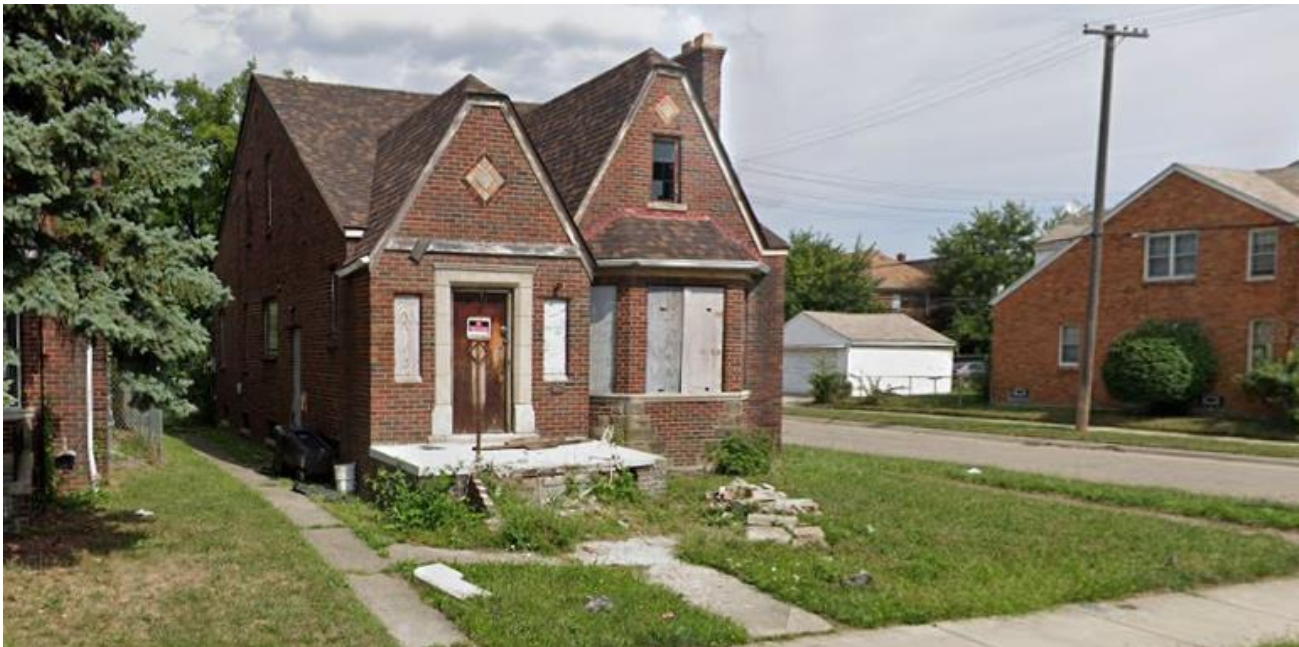
2013 Google Streetview image. Note the poor condition of the front porch and that the railing that was visible in 2009 is no longer present. Also, the front yard shrubs have been removed and a new asphalt shingle roof has been installed.

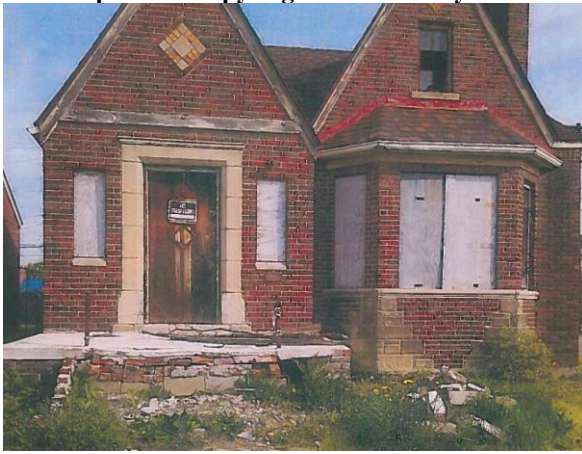
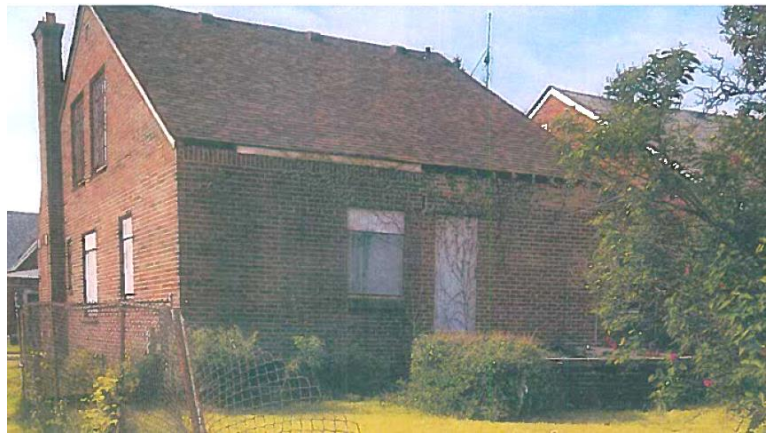
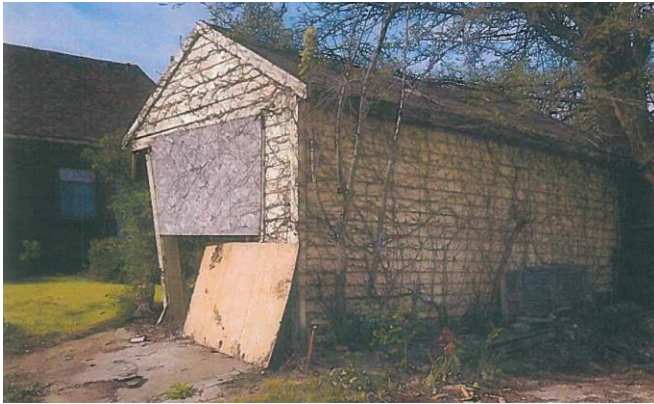
2019, photos submitted to HDC by a former owner. Note that all windows remain boarded up and the rear porch canopy is gone. The rear yard fence and garage remain, but are in poor condition

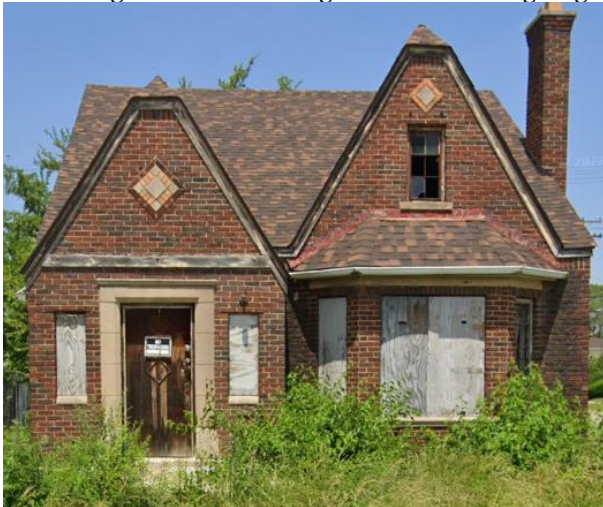
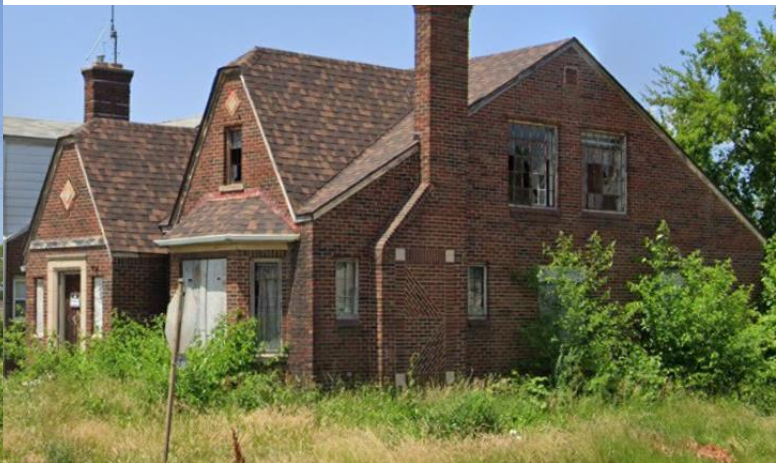
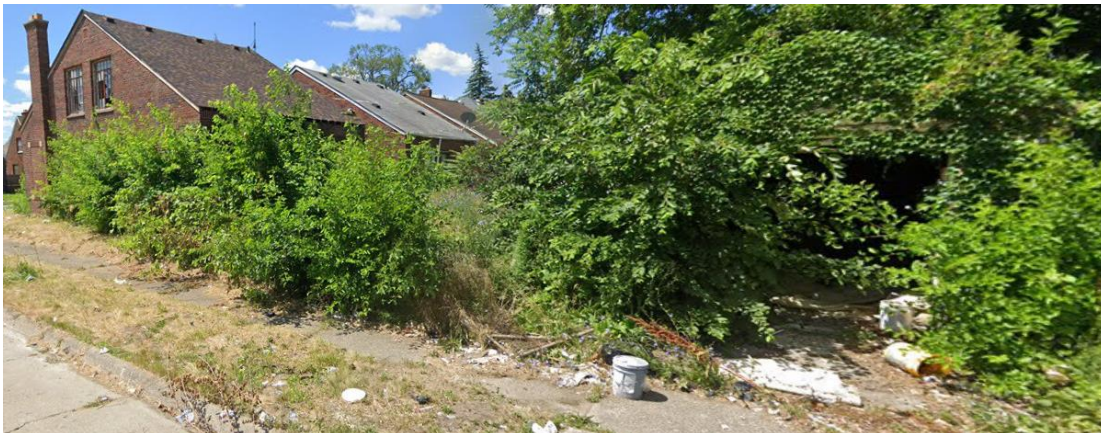
2022 Google Streetview images. Note that the garage and rear yard fencing are gone

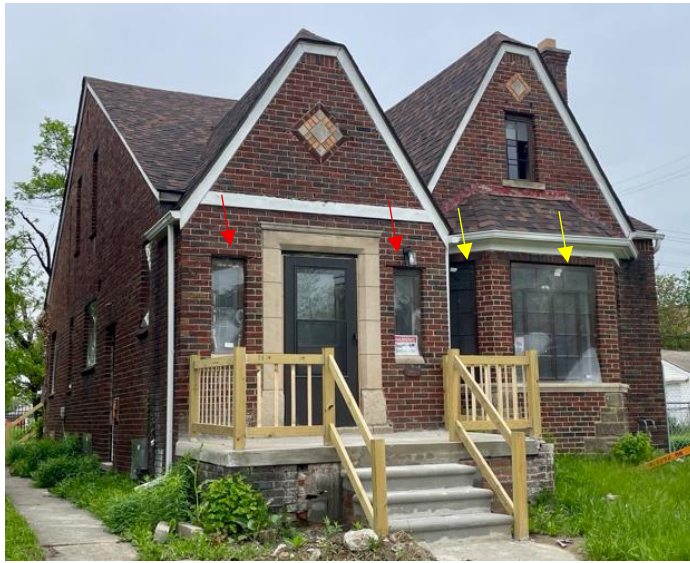
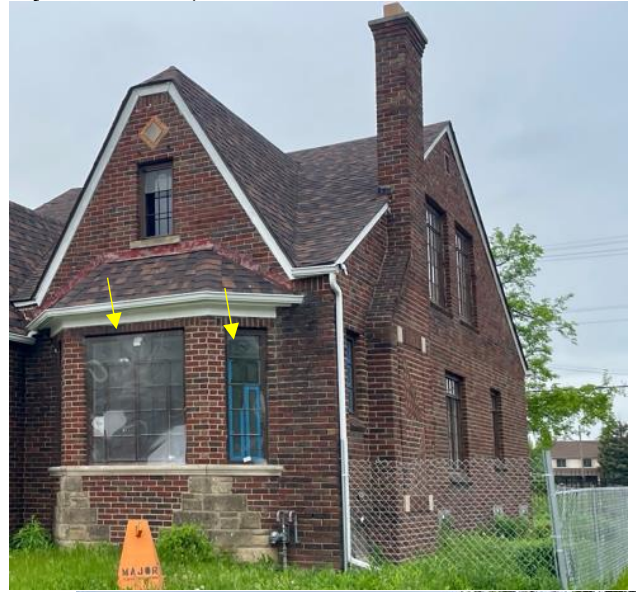
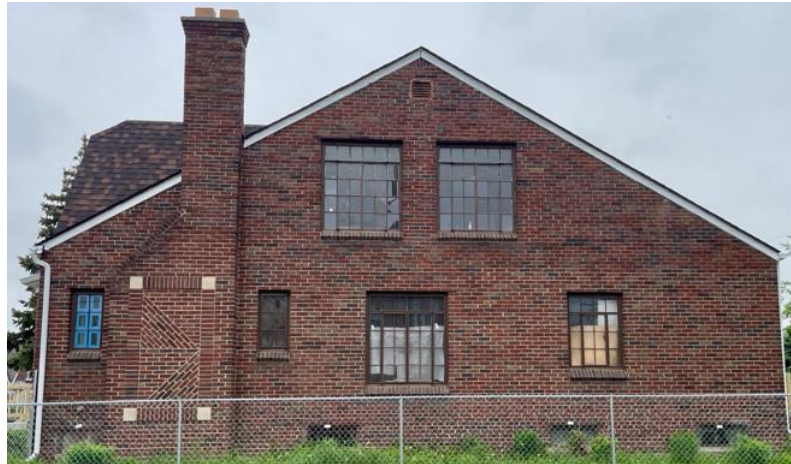
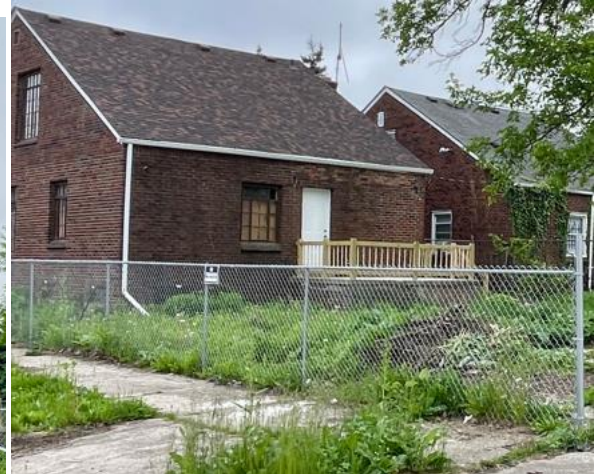
May 2025 photos by HDC staff. Note new fence has been erected, a new front door has been installed, the front and rear porch decks have been repaired and new concrete steps added, new railing has been added to the front and rear porch, and the plywood has been removed from the windows. Also, the original fixed windows with lead coming and stained glass which flank the front door remain, although the window to the right appears to be in poor condition (see the red arrows). Finally, note that the lead coming and stained glass in the transoms at the front façade bay remain in good condition (see the yellow arrows).

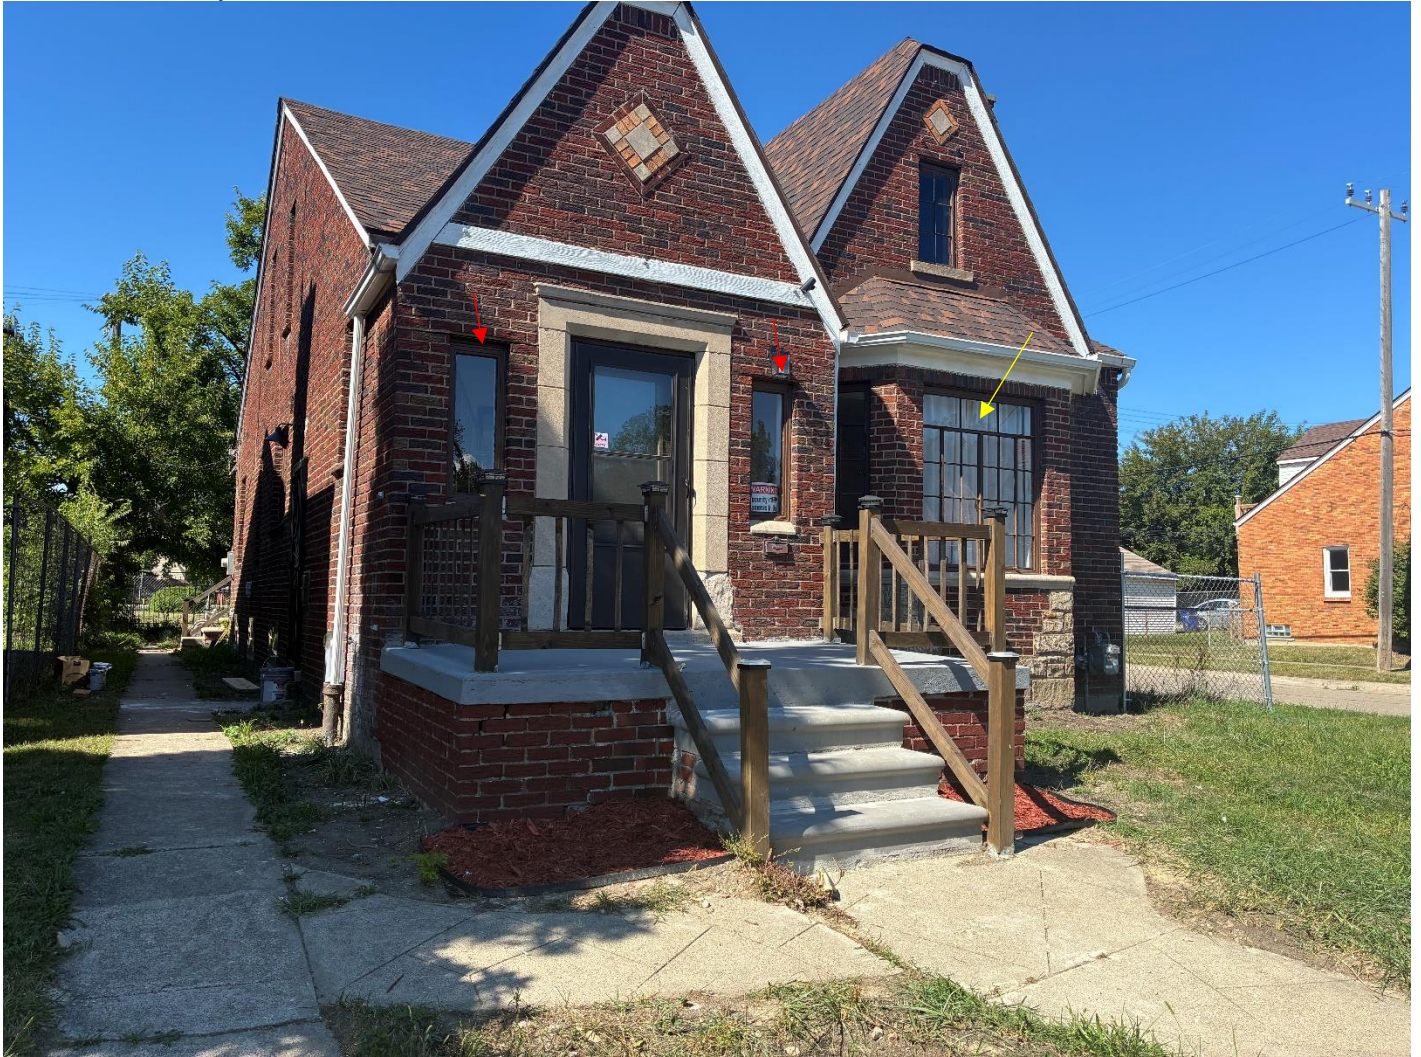
Photos by HDC staff, taken on 9/2/2025, showing current conditions. Note that the character-defining lead coming and stained glass which were present at the windows that flank the front door was replaced with clear glass windows (red arrows) and the lead coming and stained glass in the transoms at the front façade bay (yellow arrows) were removed sometime after May 2025.

- The current application did not adequately demonstrate that the distinctive, character-defining, stained glass and lead coming that was located at the front façade bay's transom and at one window to the side of the front door was deteriorated beyond repair. Additionally, the clear glass which replaced these distinctive decorative elements is not an adequate match.

Recommendation 1 of 2, Denial – Install railing at front and rear porches; replace stained glass and lead coming at the front façade bay transom; and replace stained glass and lead coming at windows that flank the front door

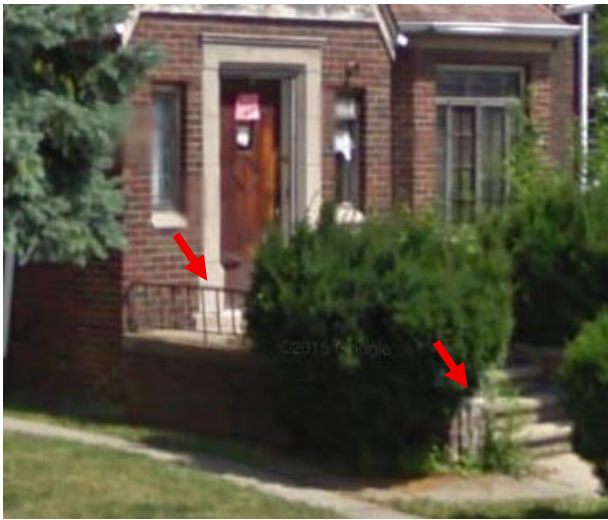
Original railing. Note the low height and simple design and wingwall (red arrows)

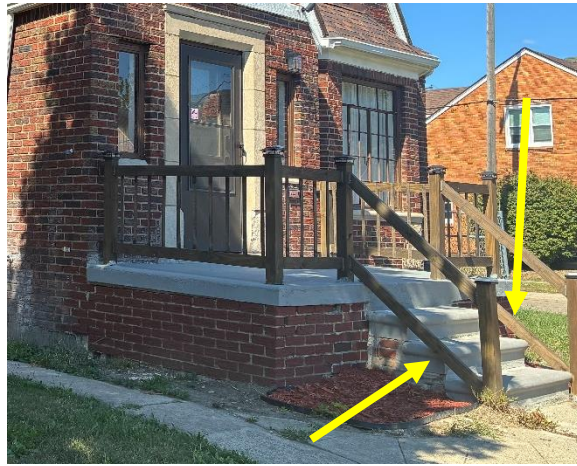
Current railing. Note height, the oversized/chunky newel posts, and the location of the bottom rail (yellow arrow)

- The historic character-defining railing at the front porch was a low, 24"-inch high metal guardrail with simple square balusters that were integrated in between/into the top and bottom rail. The current railing at the front and rear porches does not adequately match the historic as it is inappropriately high and displays an incompatible design to include integrated light fixtures, prominent newel posts, and face-mounted balusters. Also, metal is a better match to the original railing at the front porch that was removed without approval and is more compatible with the material that is commonly used for railings within the historic district.

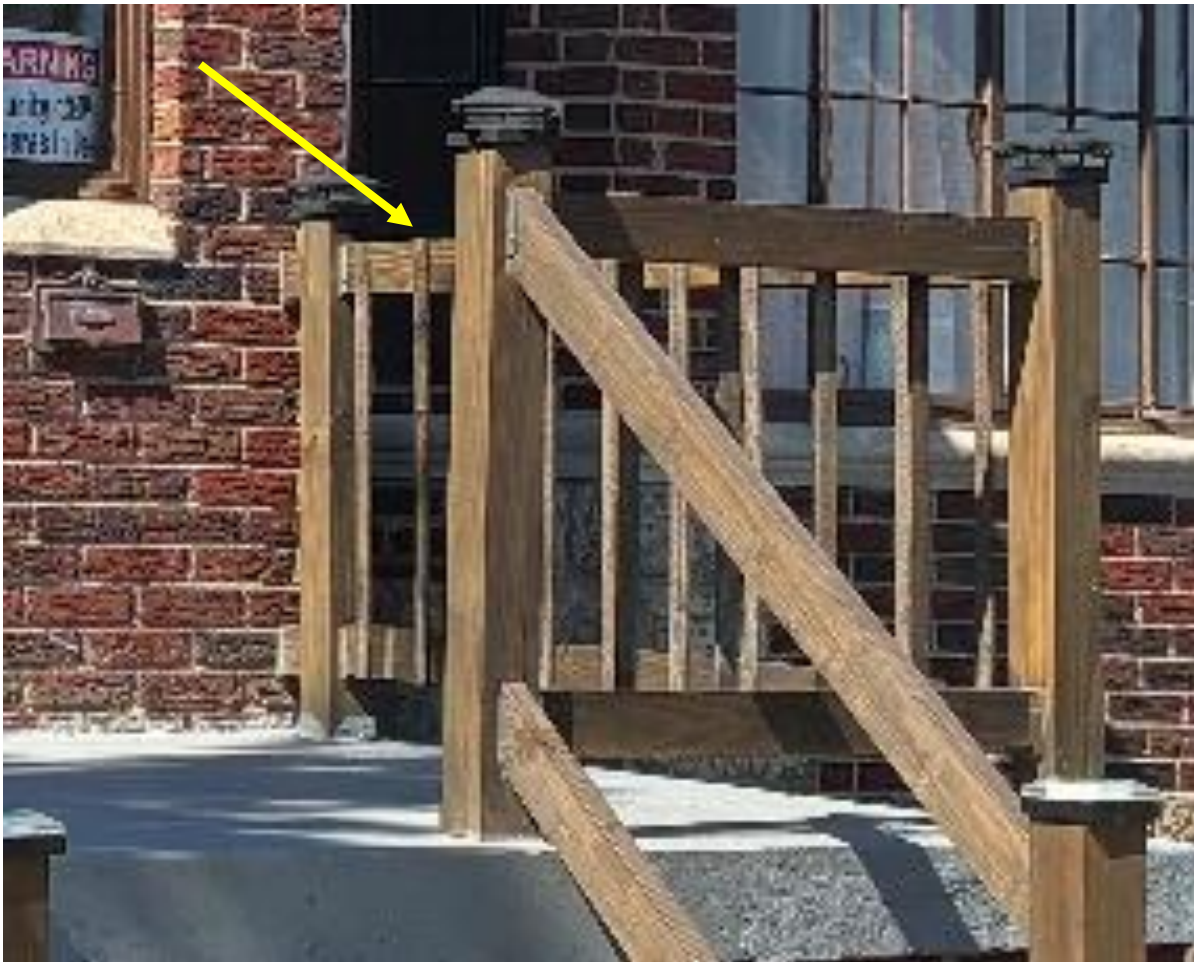
- Also, historic porch railing typically consists of balusters which are integrated into the top and bottom rails (see below graphic). The railings which were installed at the front and rear porches at 4000 Tyler have face mounted balusters, ie, the balusters have been attached to the outside of the bottom and top rails (see the below graphic and photo). Note that it is staff's opinion that face mounted railing systems are only appropriate for modern rear yard decks that represent a contemporary addition to a house and are not visible from the public right-of-way.

Current railing design (at front and back porch). Note that the balusters have been applied to the outside of the top and bottom rails (see red arrow).

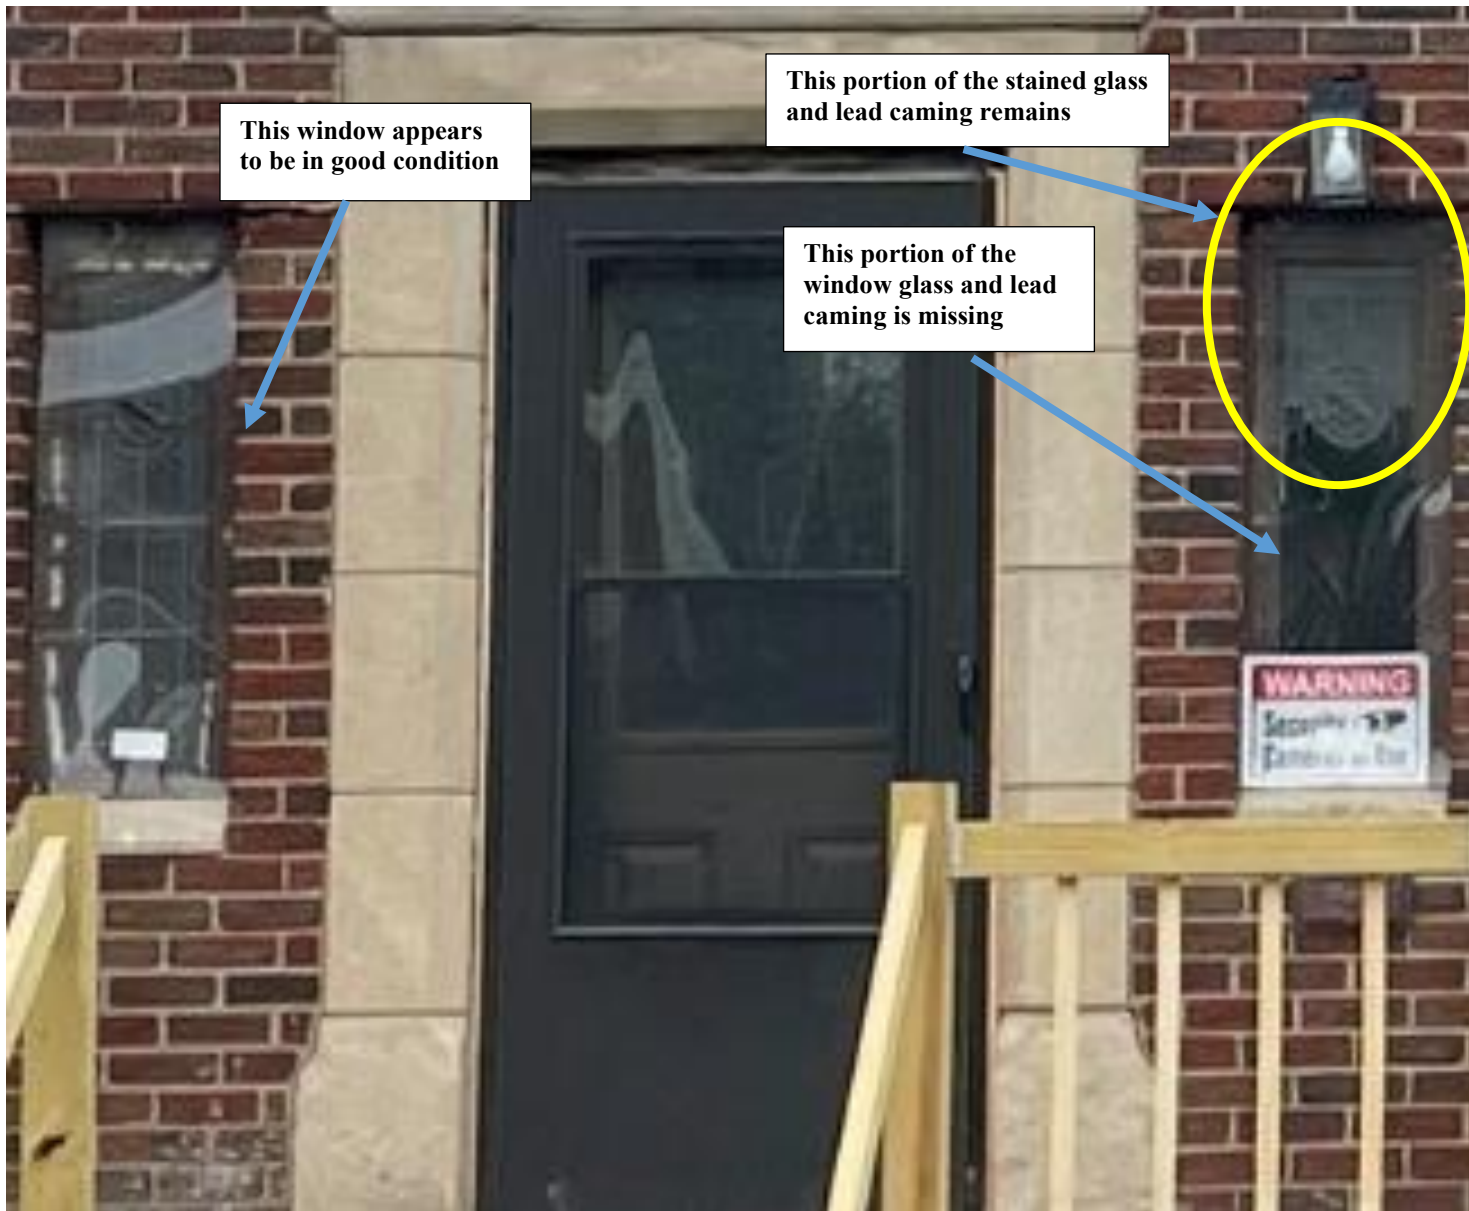
Conditions in May 2025, fixed windows that flank the front door. Note that the window to the right appears to be in poor condition while the window on the left appears to be in good condition. Photo by HDC staff

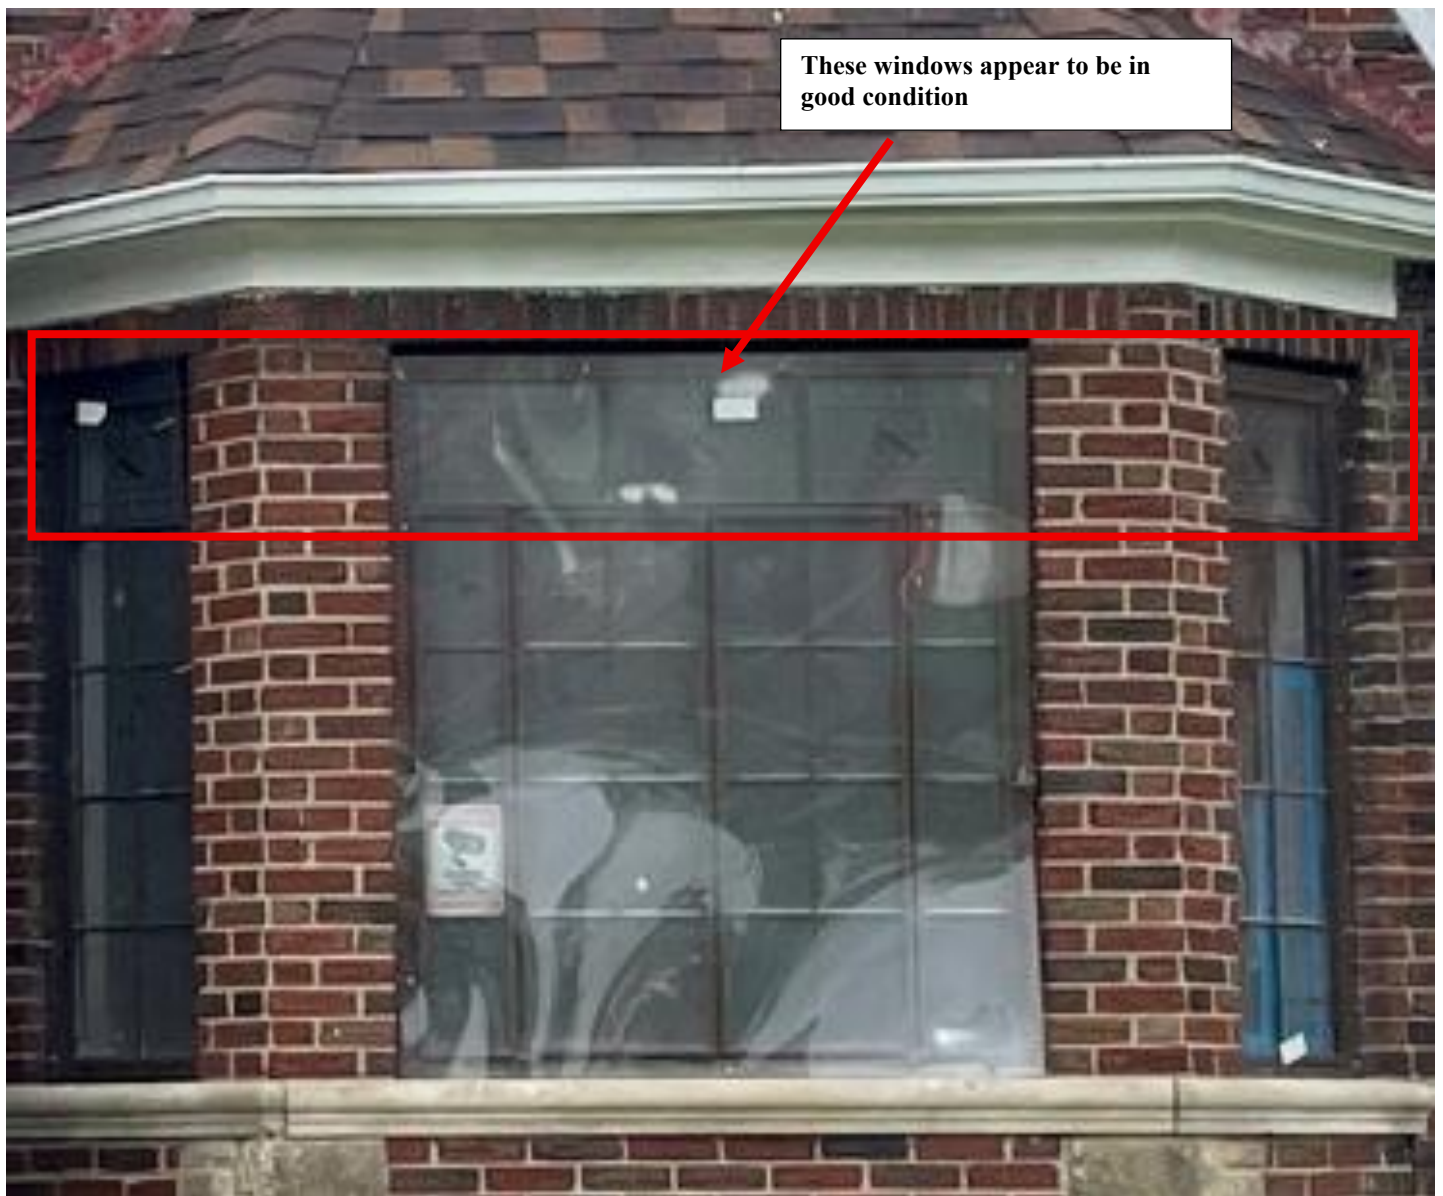
Conditions in May 2025, front façade bay. Note that the decorative transom windows appear to be in good condition.
Photo by HDC staff

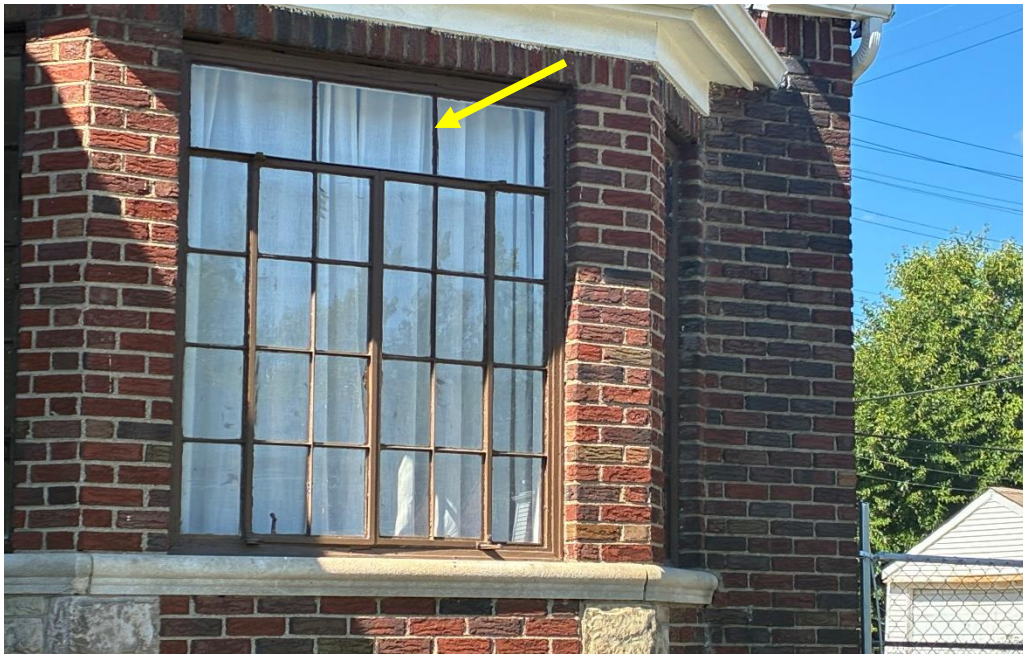
Current condition, 9/1/2025. Photo by HDC staff. Yellow arrow indicates clear glass installed at transom sometime after May 2025
