STAFF REPORT: 09/10/2025 MEETING

ADDRESS: 4000 TYLER

APPLICATION NO: HDC2025-00504

SCOPE: REBUILD BACK PORCH, INSTALL RAILINGS AT FRONT AND BACK PORCH, REPLACE GLASS AT FRONT FAÇADE WINDOWS (WORK COMPLETED WITHOUT APPROVAL)

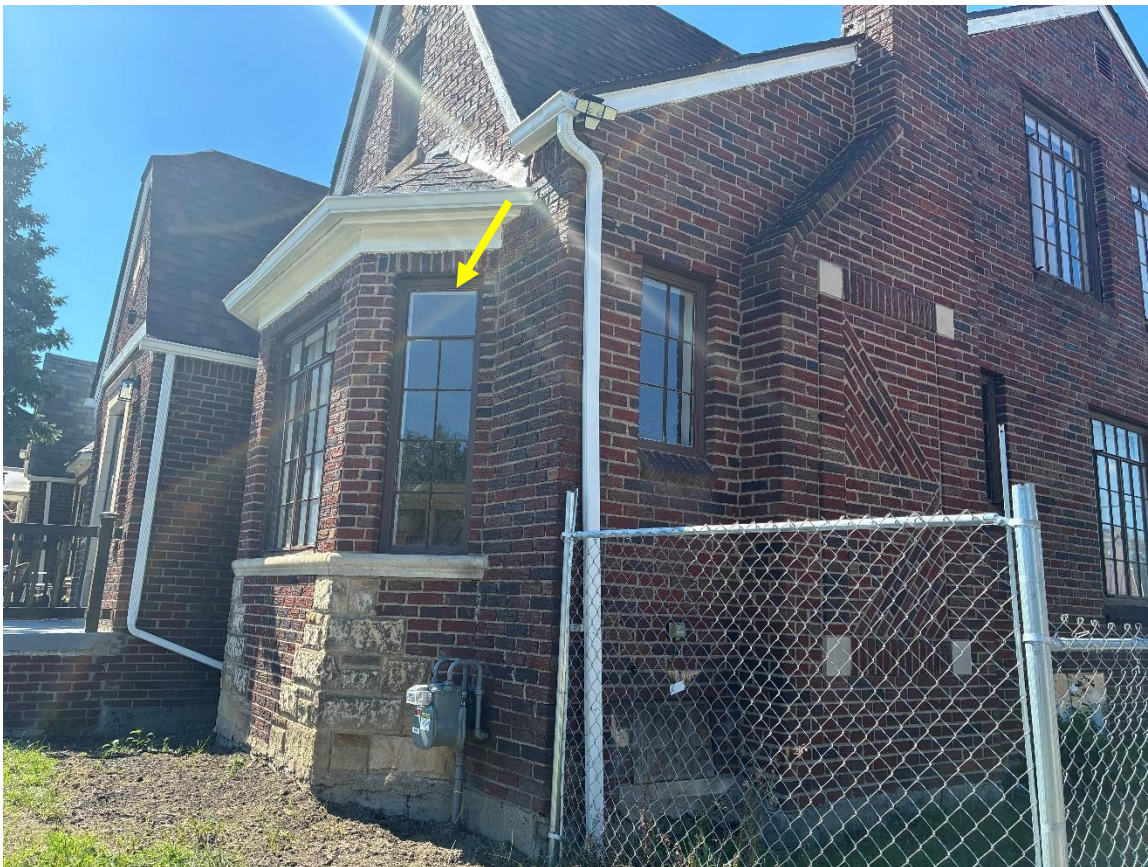
Current condition, 9/1/2025. Photo by HDC staff. Yellow arrow indicates clear glass installed at transom sometime after May 2025

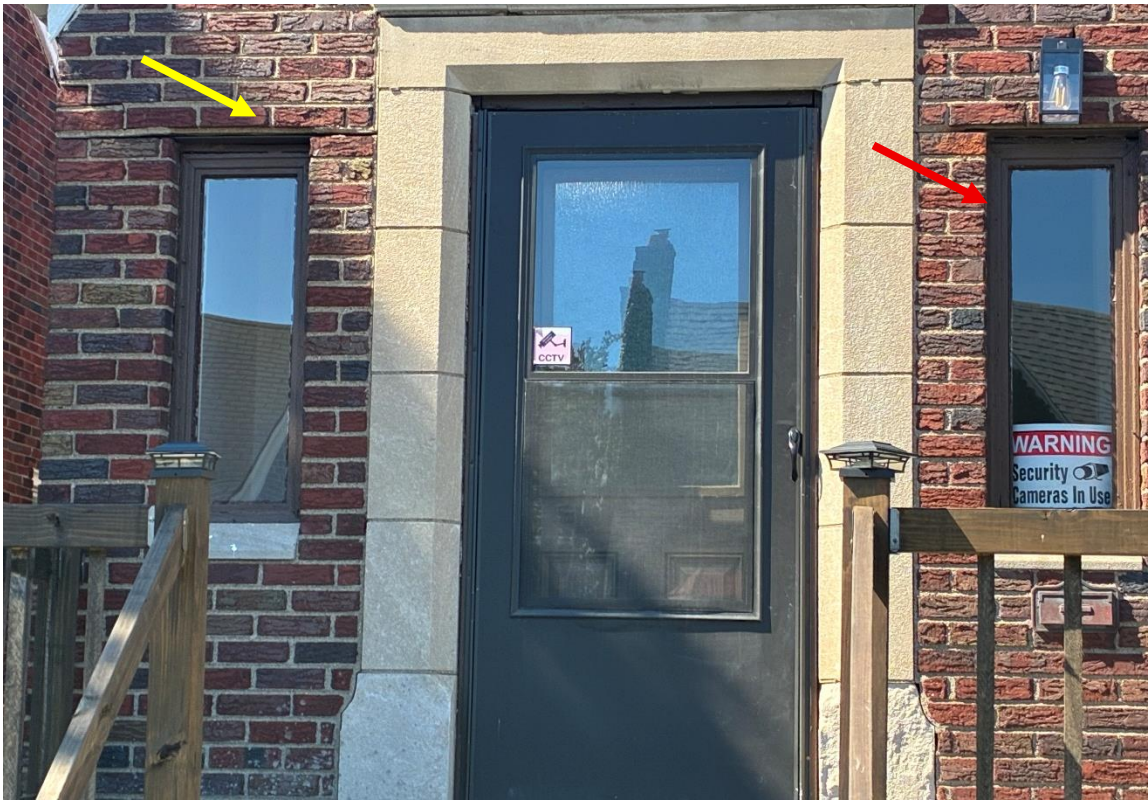
Current condition, 9/1/2025. Photo by HDC staff. Yellow arrow indicates clear glass installed to replace window that appeared to be in good condition in May 2025. Red arrow indicates clear glass installed to replace the stained glass and lead coming above which remained in May 2025
