STAFF REPORT: 9/10/25 REGULAR MEETING

APPLICATION NUMBER: HDC2025-00463

ADDRESS: 4011 TYLER

SCOPE: REPLACE WOOD WINDOWS AND STEEL WINDOWS WITH NEW VINYL WINDOWS

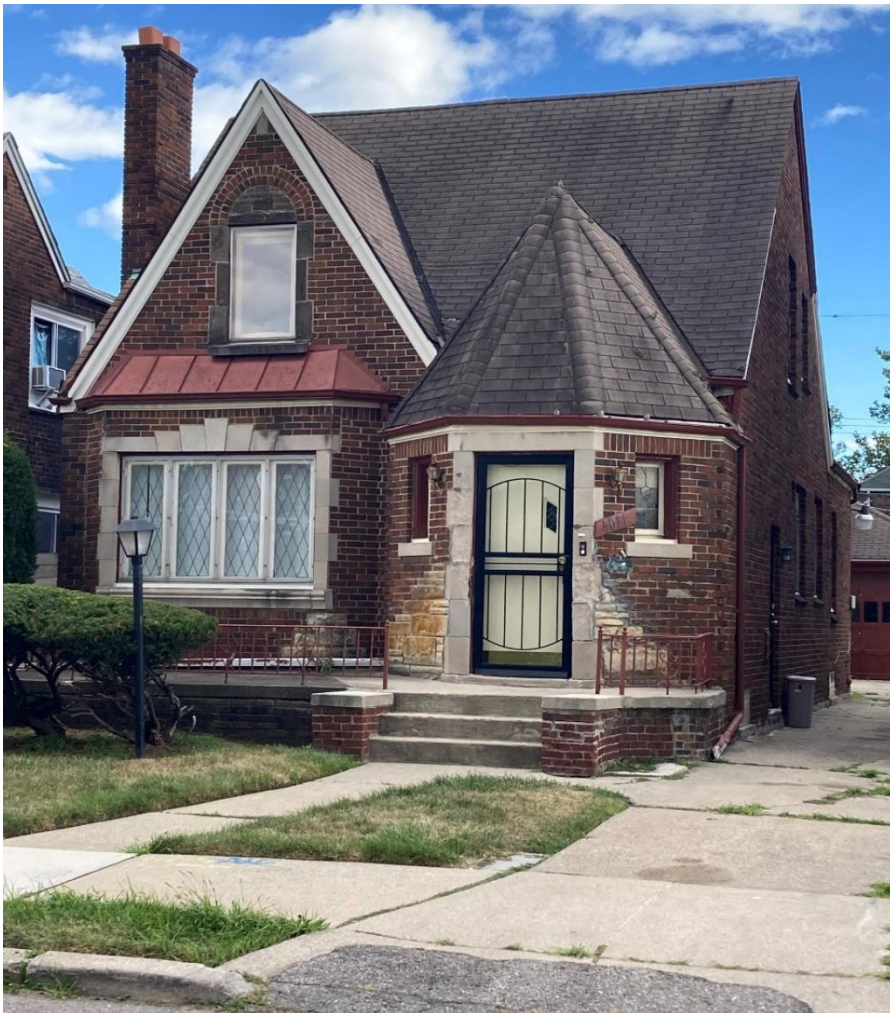
Site visit Photo 1, staff, August 2025. Front of house (north end). The house's prominent chimney is visible on east side.

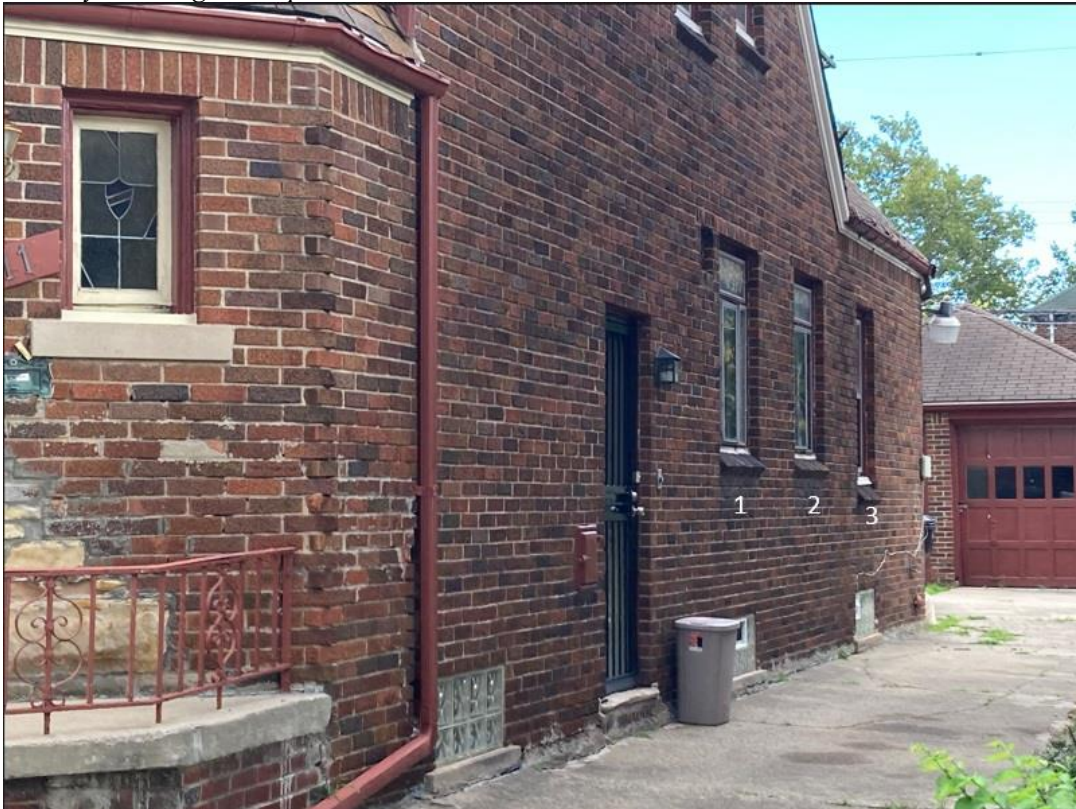
Site visit, Photo 2, staff, August 2025, west side of house along driveway. Steel windows 1 and 2 and wood double-hung window 3 are visible and proposed for replacement. The historic garage is visible at the rear, and near the entry at the front of the house, a leaded glass window with a crest design is visible.

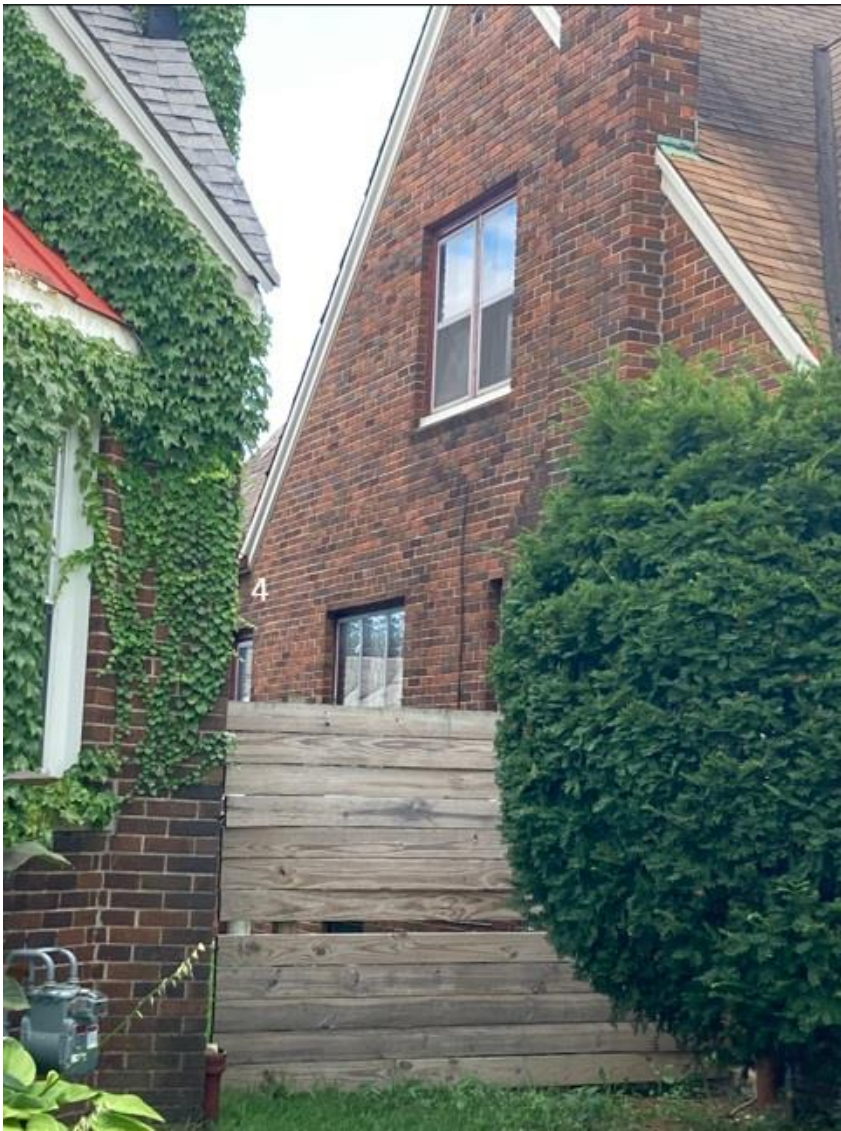
Site visit, Photo 3, staff, August 2025, east side of house. Wood double-hung window 4 is proposed for window replacement.

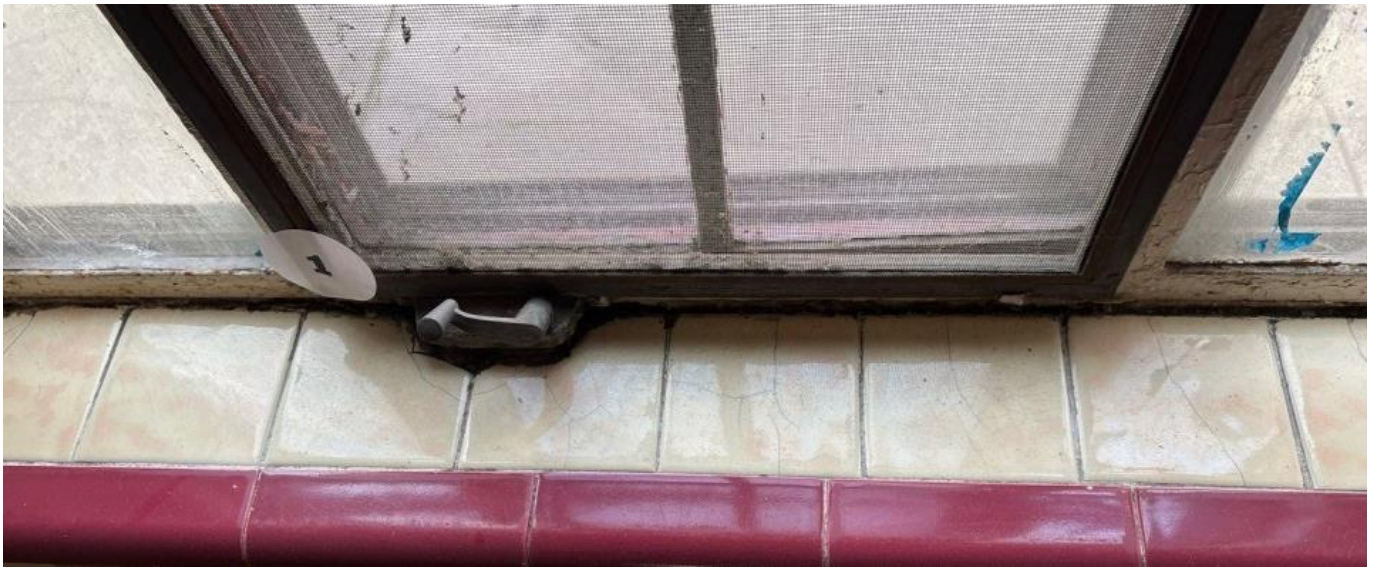
Window 1 interior detail, from application.

- Regarding the steel windows, staff sees the uneven surface under the paint on Window 1 in the detailed photo, but staff doesn't see that elsewhere.
 - While more detailed photographs of each window's condition and/or an assessment from a window restoration professional might help provide more complete information for the commission to make their assessment about repairability, staff's current assessment based on available documentation is that these four windows are not beyond feasible repair.

- The existing historic windows proposed for replacement should therefore be retained and repaired in kind where necessary, as required by the Standards.

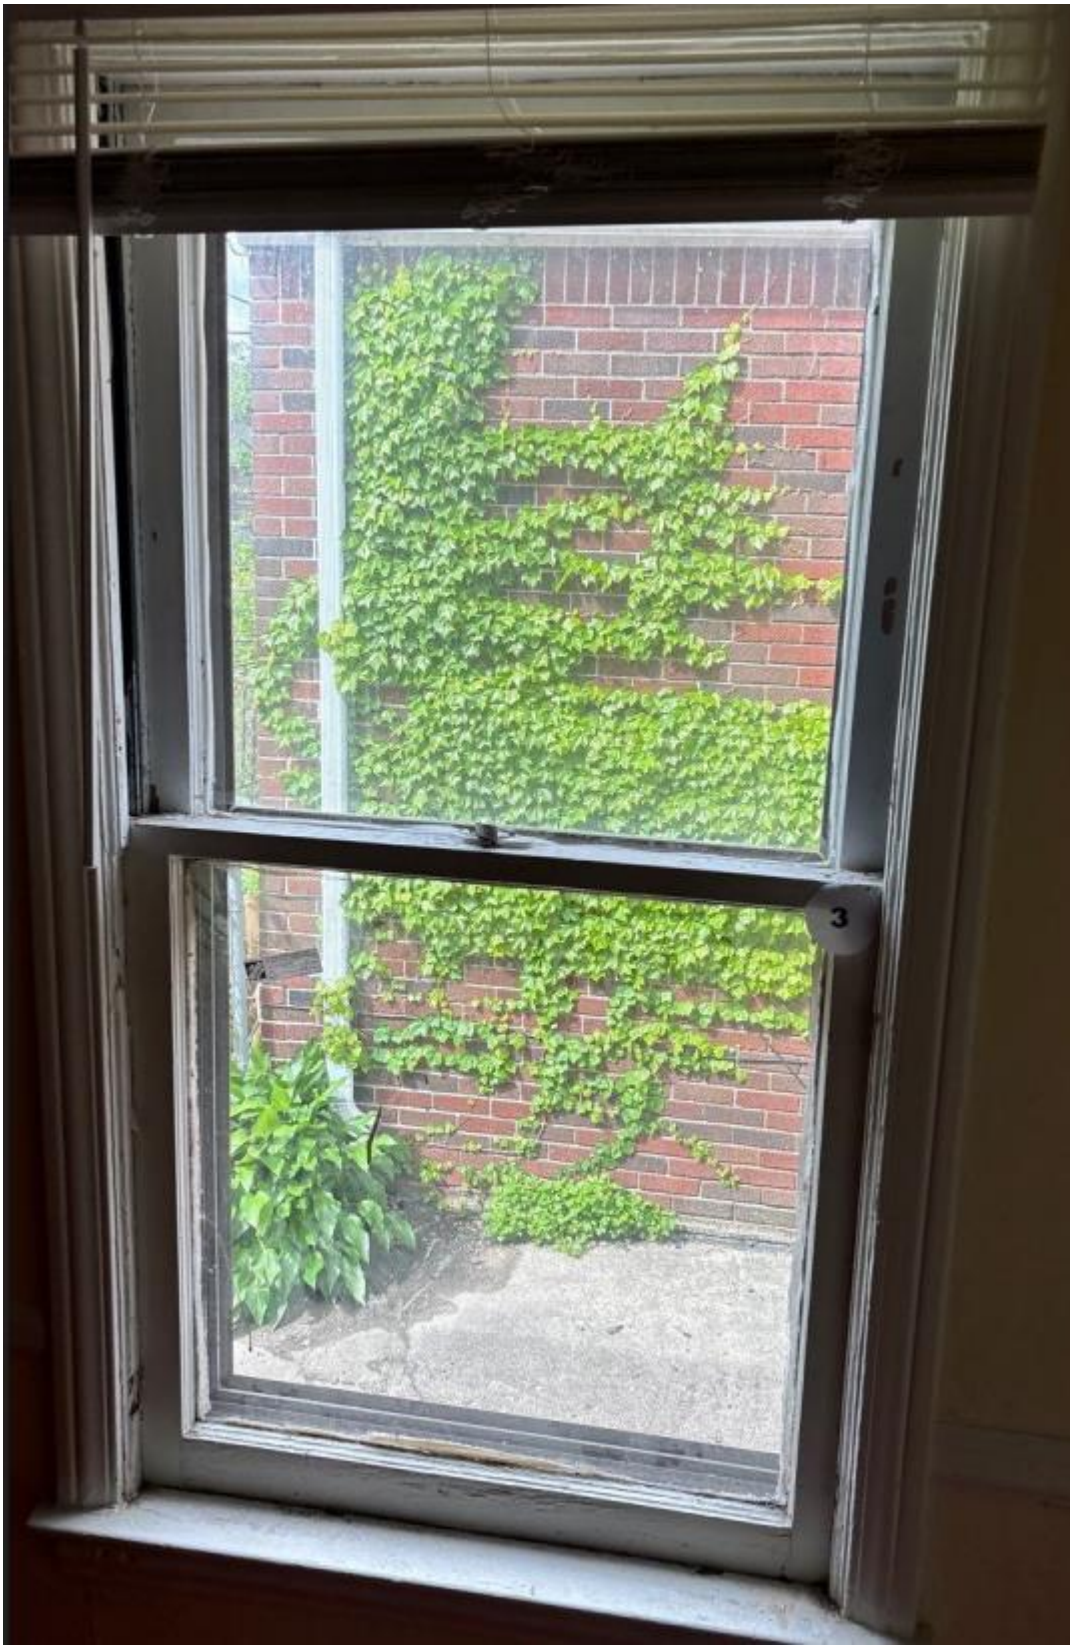
Window 3, interior, from application.

- Staff can see some paint failure on the exteriors of the wood sashes, despite the aluminum storms, and some paint failure near the bottom center of both wood windows from the interior. Staff can't evaluate wood conditions from these photos, however.

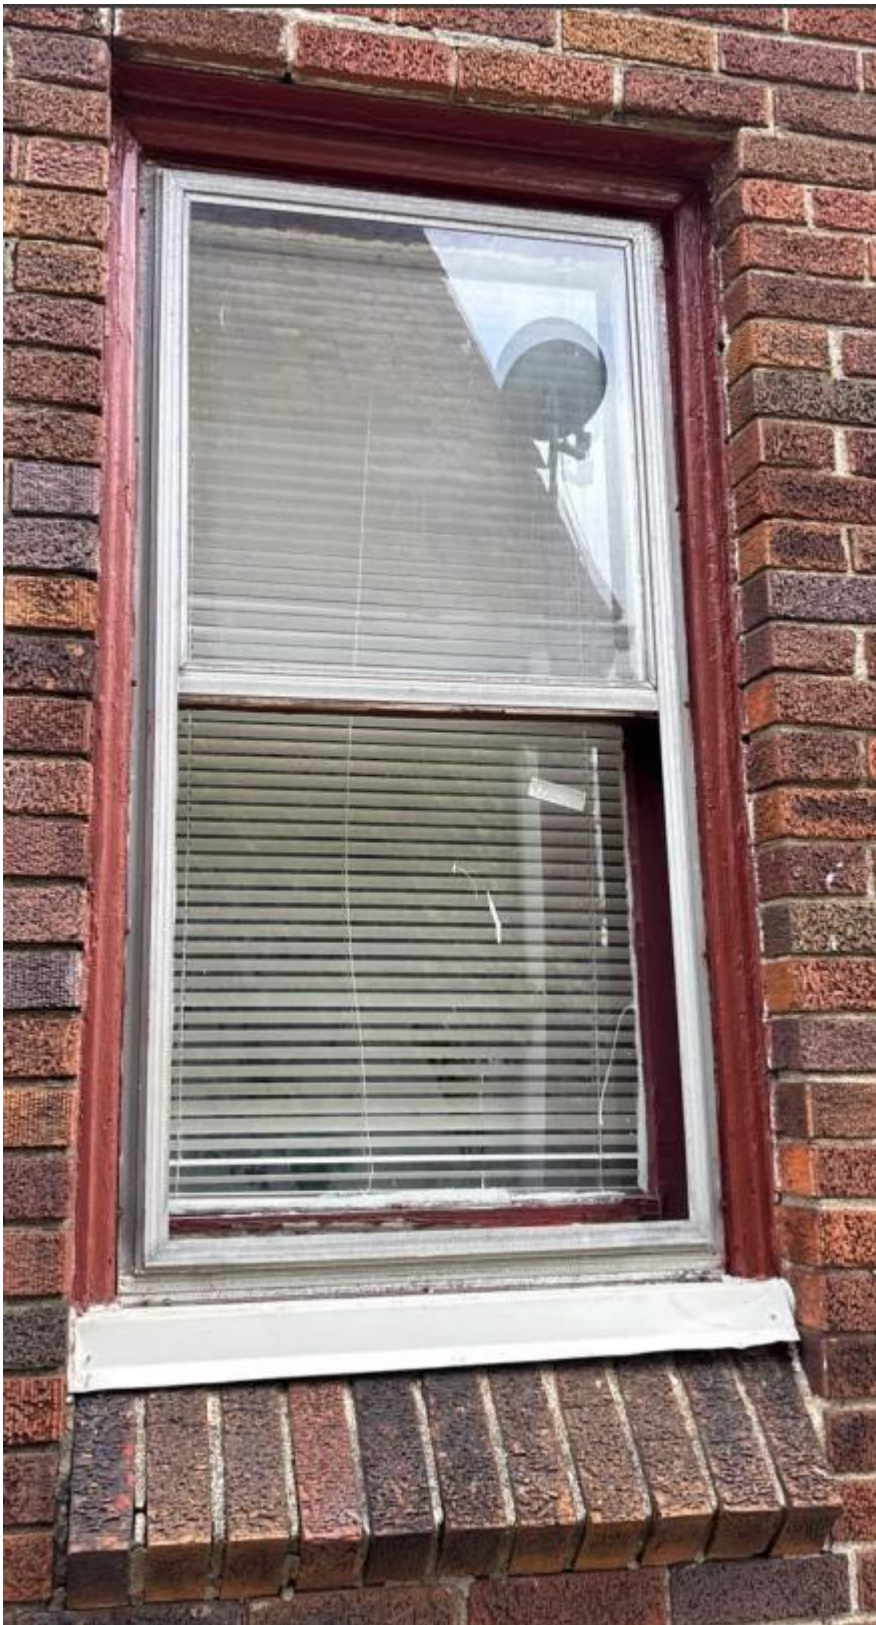
Window 3, exterior, from application.

3 is almost at the rear of the house and not very visible from the front and wood Window 4 is toward the rear of the house, right next to another house, and behind a fence/barrier from the sidewalk, it may be possible to argue that considering dimensions, profiles, finish, and placement, a substitute-material, double-hung window for a wood double-hung window specifically for Windows 3 and 4 might be appropriate if the existing windows are truly beyond repair. Vinyl, however, can't be that substitute material, in staff's opinion, even in these specific instances, since vinyl windows lack dimensionality, have a thick and flat appearance, and have a plastic-like sheen. Additionally, the sash color is an important consideration. The vinyl color proposed is unknown, but vinyl windows are typically white. As mentioned, this house's windows have dark sashes, so a light sash color like beige or white would be inappropriate. **It is staff's opinion that if Windows 3 and 4 are beyond repair, because of their location and secondary importance, a non-vinyl substitute material that closely matched wood in design, color, texture, dimensionality, proportions, sheen, and color could be considered by the Standards and Guidelines and the National Park Service guidance.**
