**STAFF REPORT:** 9/10/25 REGULAR MEETING

**APPLICATION NUMBER:** HDC2025-00297

**ADDRESS:** 4758 STURTEVANT

**SCOPE:** REPLACE WINDOWS, REPLACE GUTTERS/DOWNSPOUTS, REPLACE/RESTORE DOORS, HOUSE/GARAGE ROOF, REBUILD PORCH\* (WORK COMPLETED WITHOUT APPROVAL).

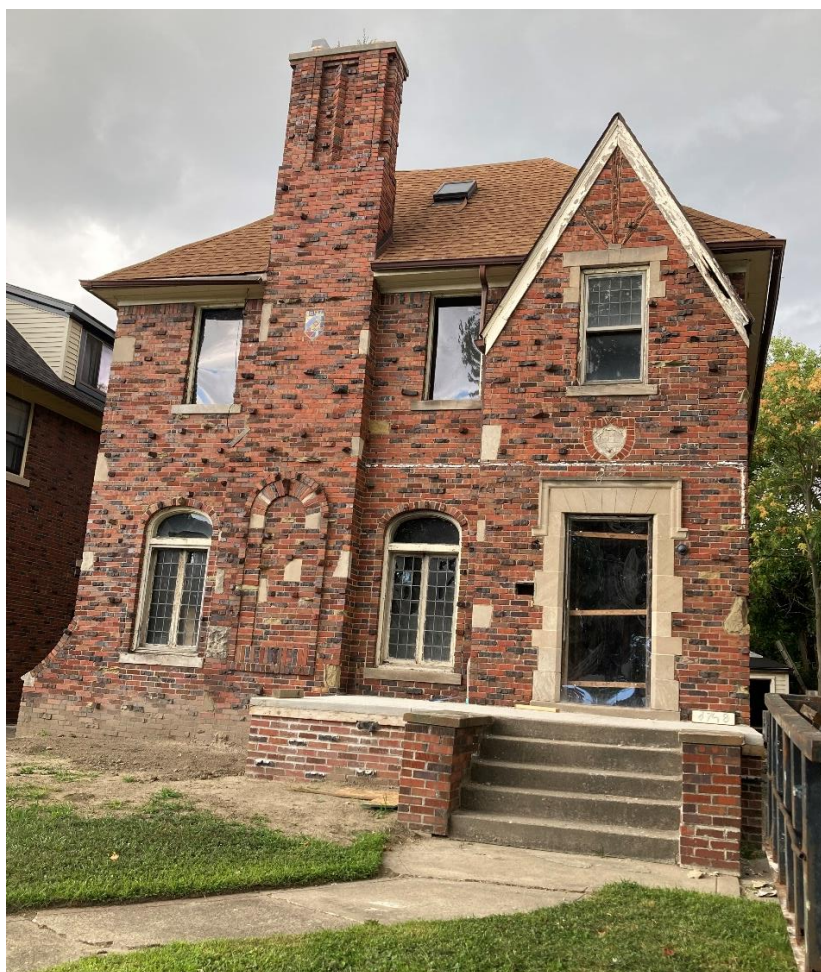
*Site Visit Photo 1, staff. August 26, 2025. Two second-story windows are missing. All five windows on this front façade are proposed for replacement with this application. The restored front door is to be installed. The front porch rebuild is also part of this application.*

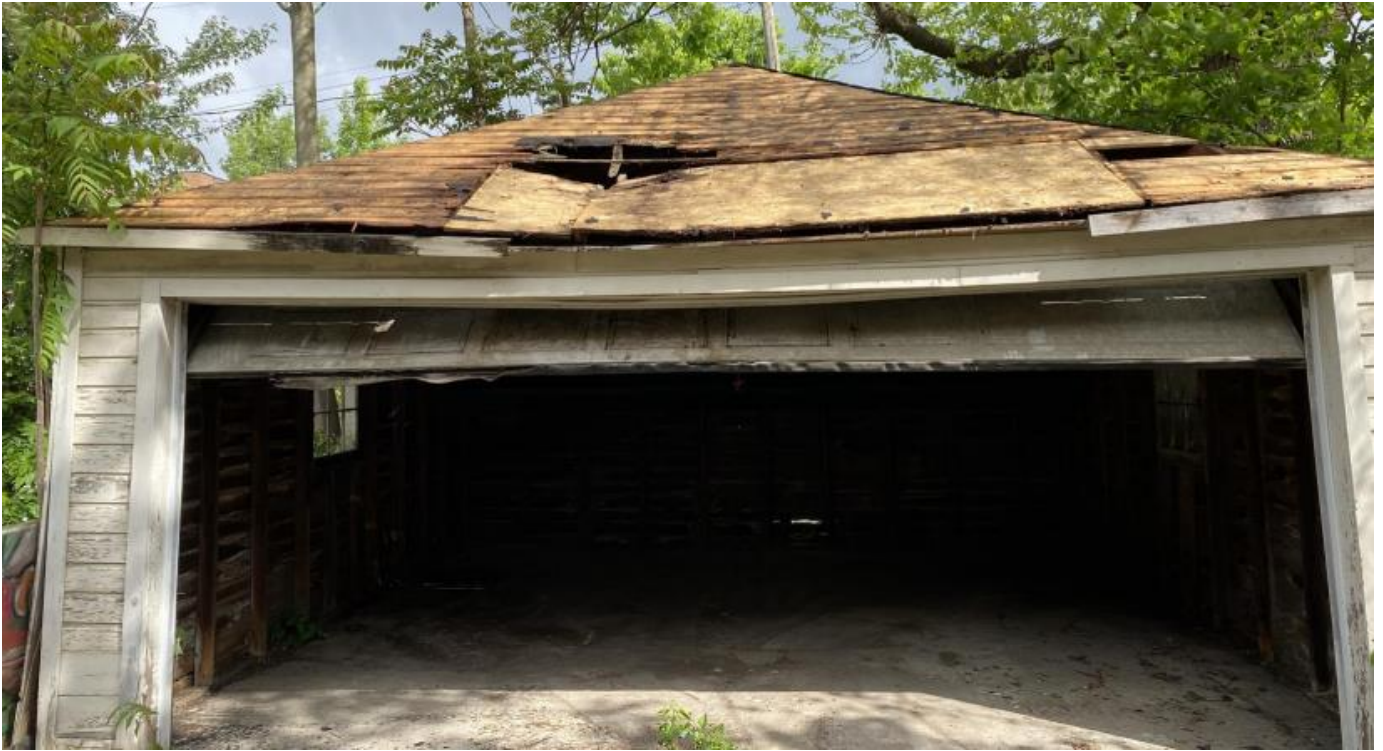
*Applicant-provided photo from application of garage in current condition. Applicant states that the plan is to replace roof and repair and repaint wood siding, replacing in kind as needed. The garage door is not mentioned.*

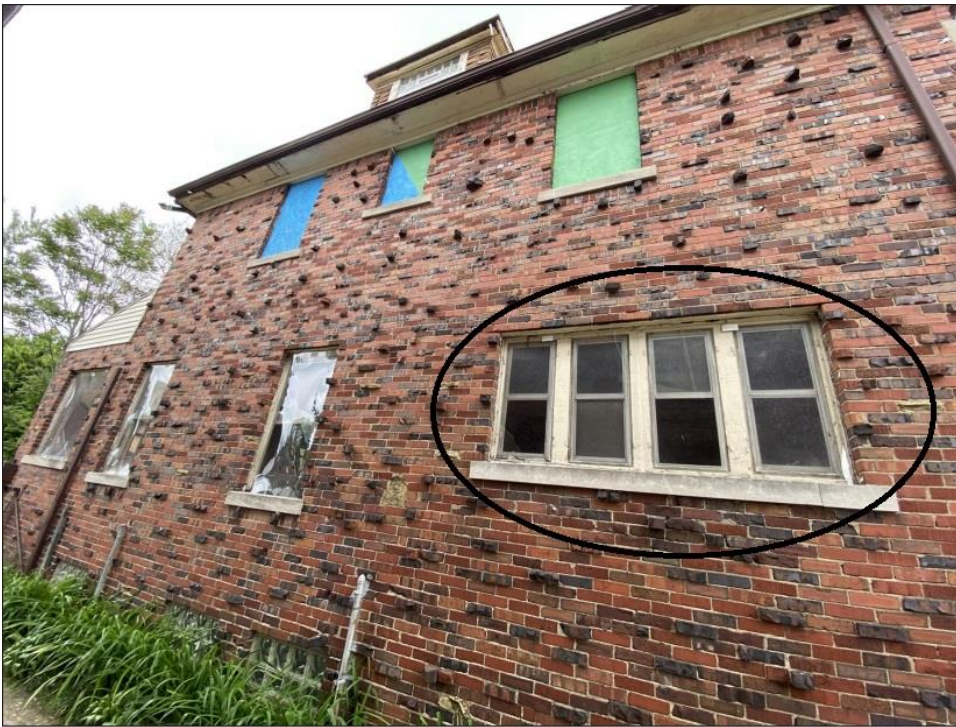
*Applicant's photo from updated application materials, west elevation. Some windows are boarded, some may be missing, but these circled windows with mullions between may be present. Their conditions are not described in the applicant's materials.*

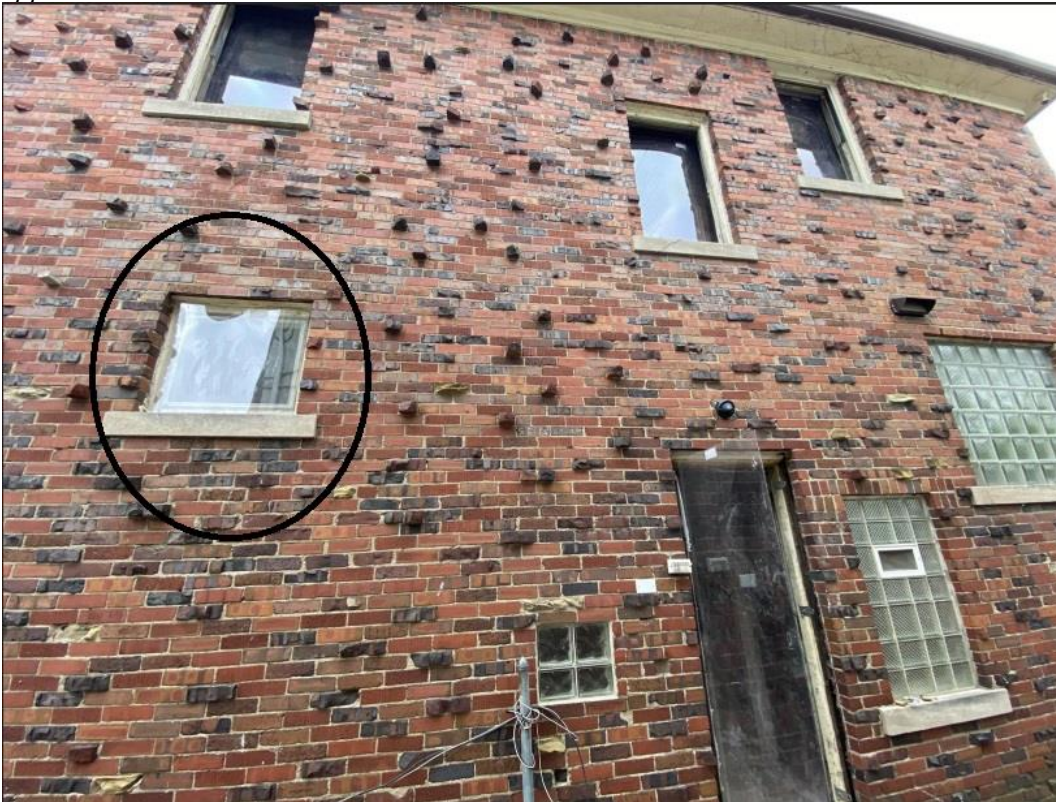
*Applicant's photo from application materials, east elevation. Glass block windows and the circled window remain in place, while others appear to be missing. A Craftsman-inspired door is proposed to be installed in the door opening.*

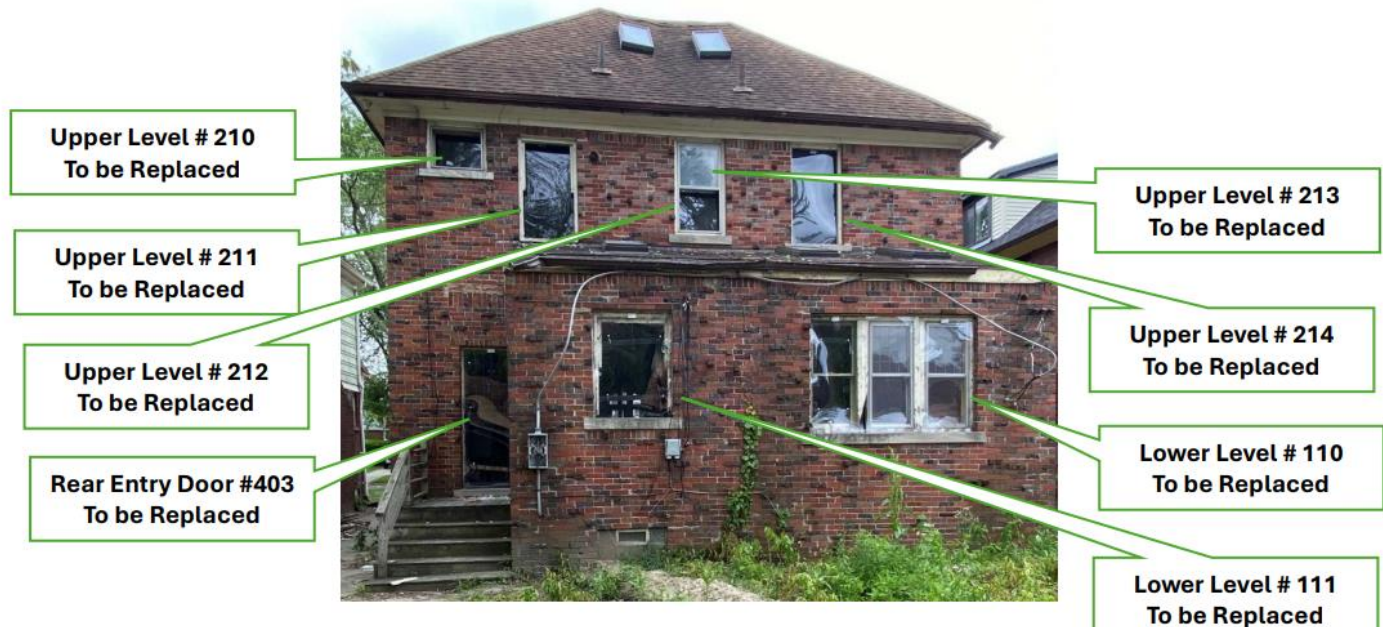
*Applicant's photo from updated application materials, rear elevation. Two windows in "Lower Level #111" are historic wood windows with leaded glass in the upper sash. "Upper Level 210 and 213" may be present. The restored back door is proposed to be installed here.*

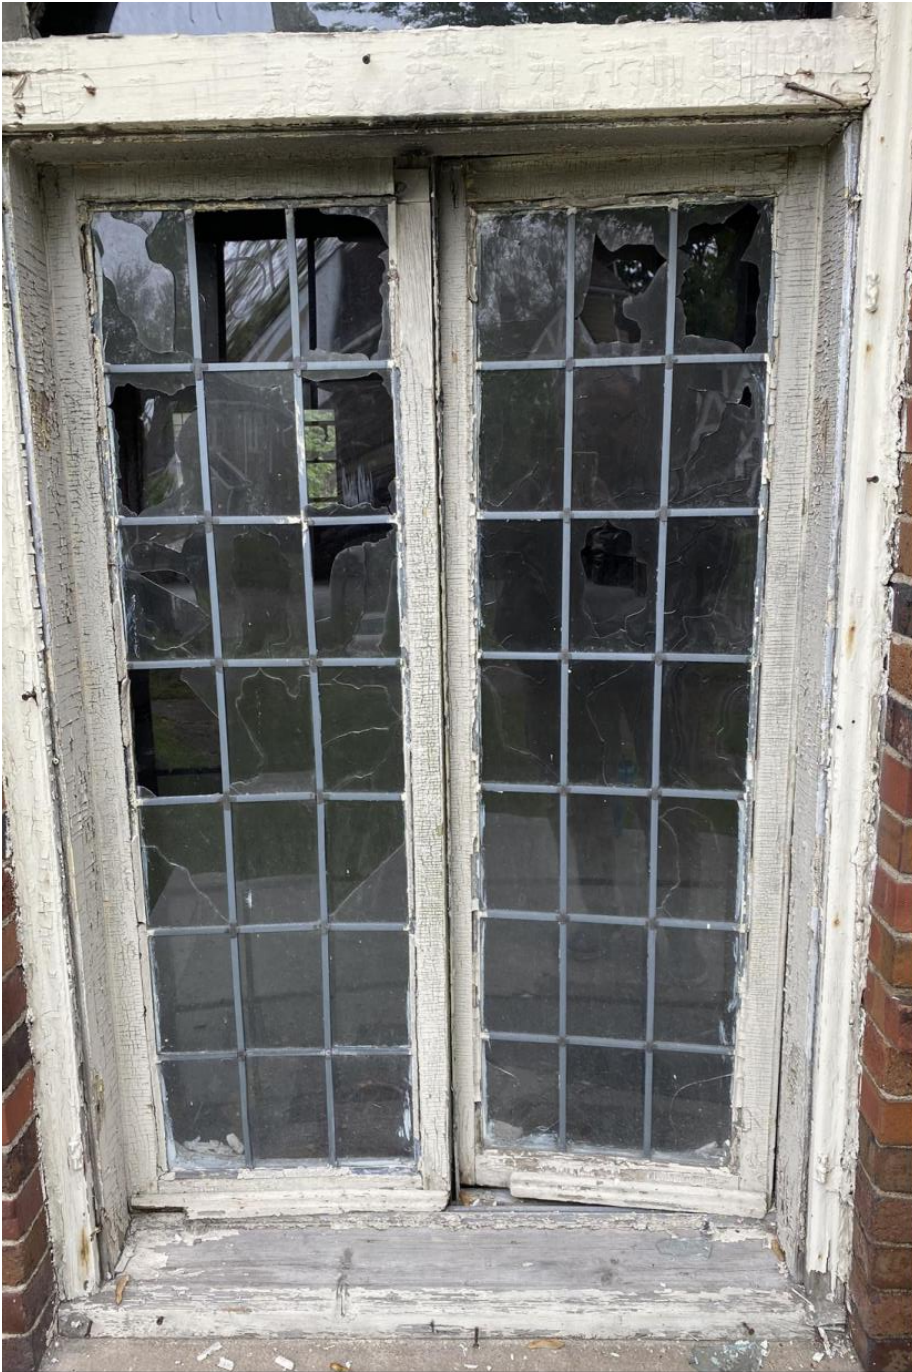
*Applicant's photo from their initial application. First-floor casement windows with leaded glass on the front façade. Cracked paint and some broken glass are visible.*

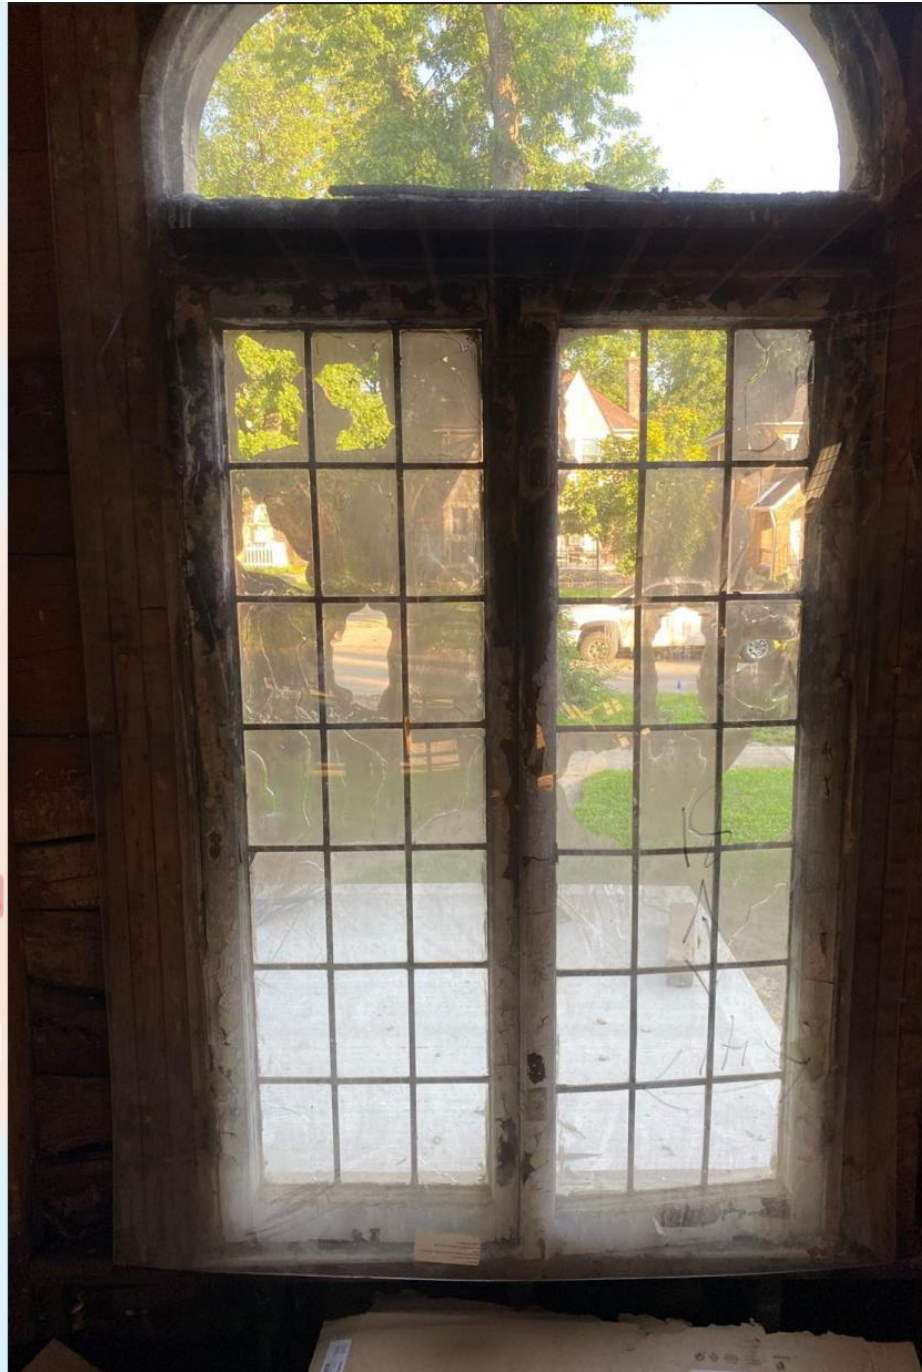
*Applicant's photo from updated application materials. One of the first-floor casement windows from the interior. Some broken panes of glass and some deteriorated paint are visible.*

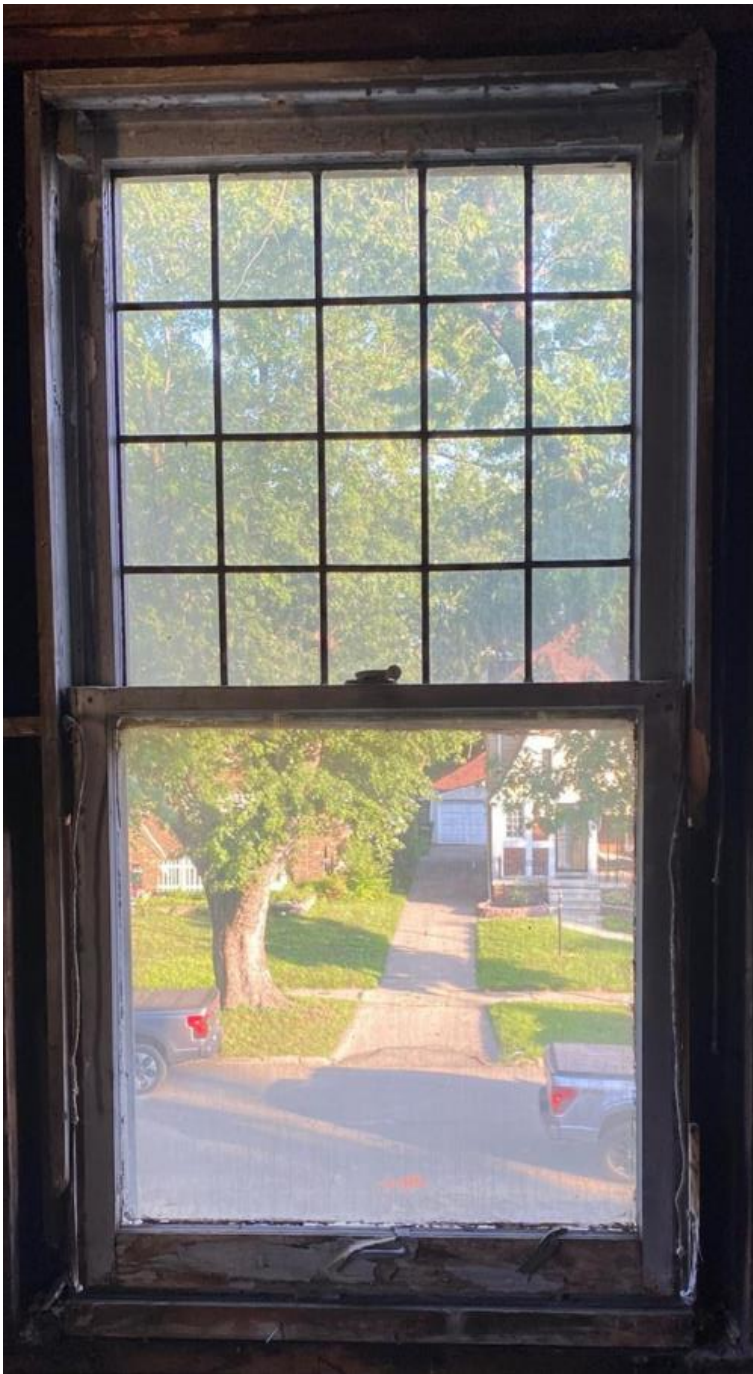
*Applicant's photo, from updated application materials, of the second-floor window on the front of the house that retains its leaded glass. (The other two second-floor windows on the front of the house that looked like this in past photos have been removed.)*

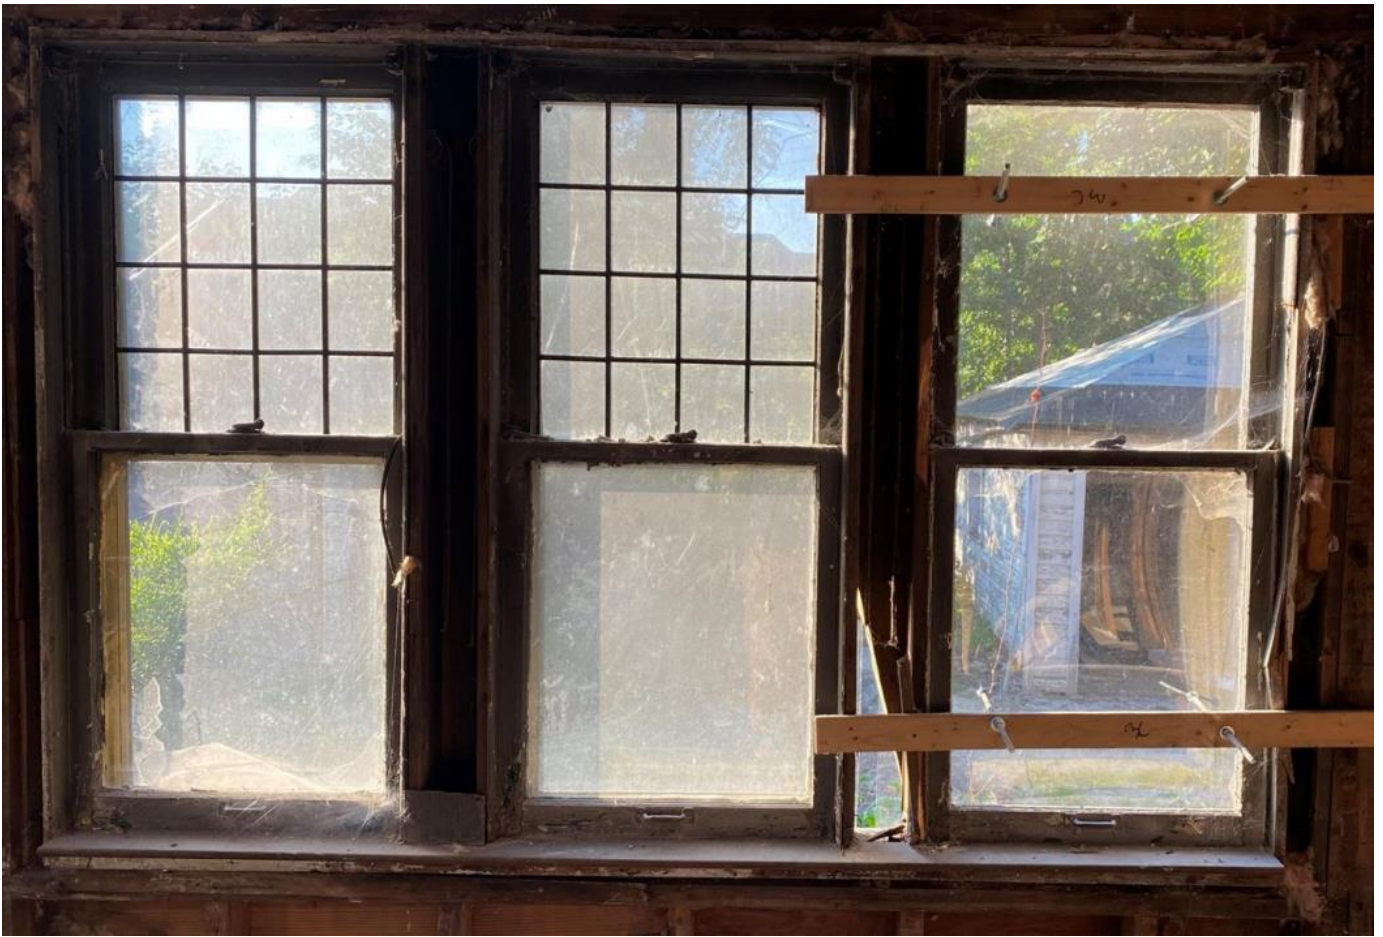
*Applicant's photo from updated application materials that show the first-floor windows on the rear, labeled in the applicant's photo of the rear windows (above) as "Lower Level Window 111." The leaded glass remains in the upper sashes of two of the three windows.*

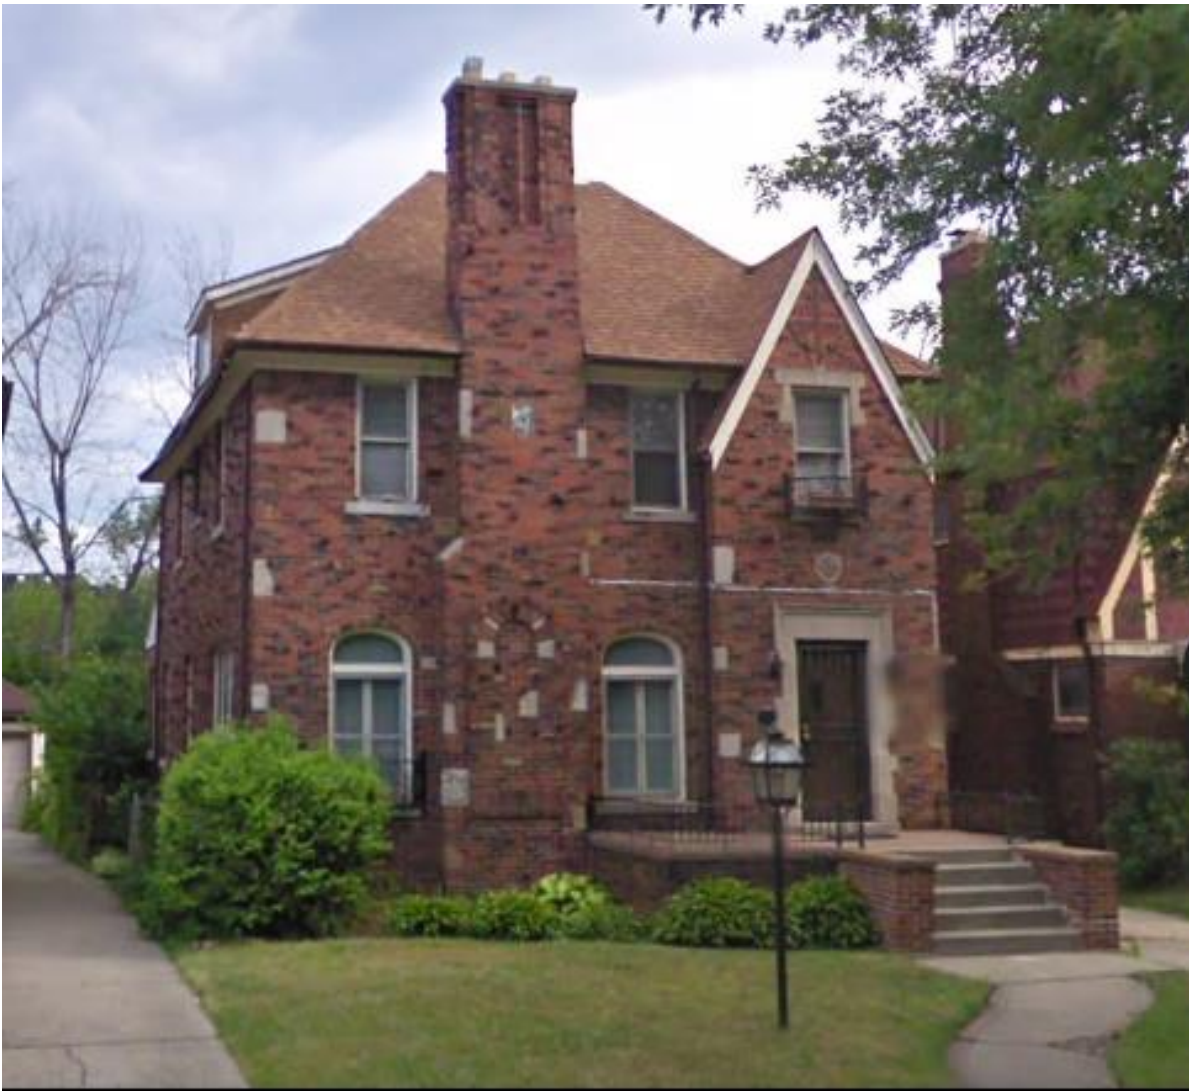
*Google streetview, July 2009. Plantings are in good condition, house's historic features are intact, and the house is well maintained.*

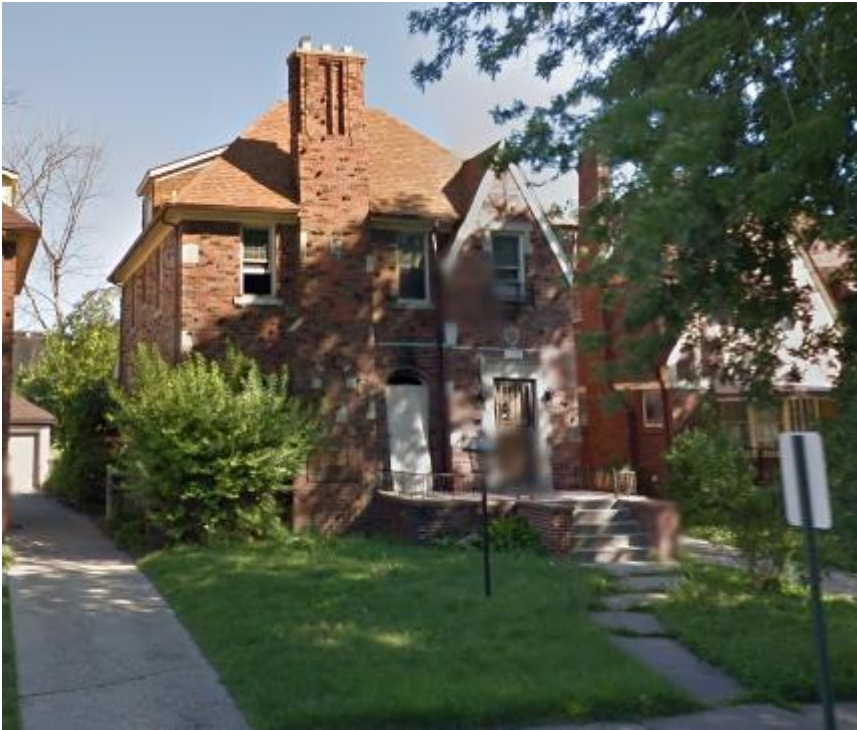
*Google streetview, August 2011. Second-floor windows appear open and a board is leaning against the first-floor window, but the decorative railing below the second-floor window, the low decorative railing around the front porch, and the storm door are all intact. Shrub is overgrown.*

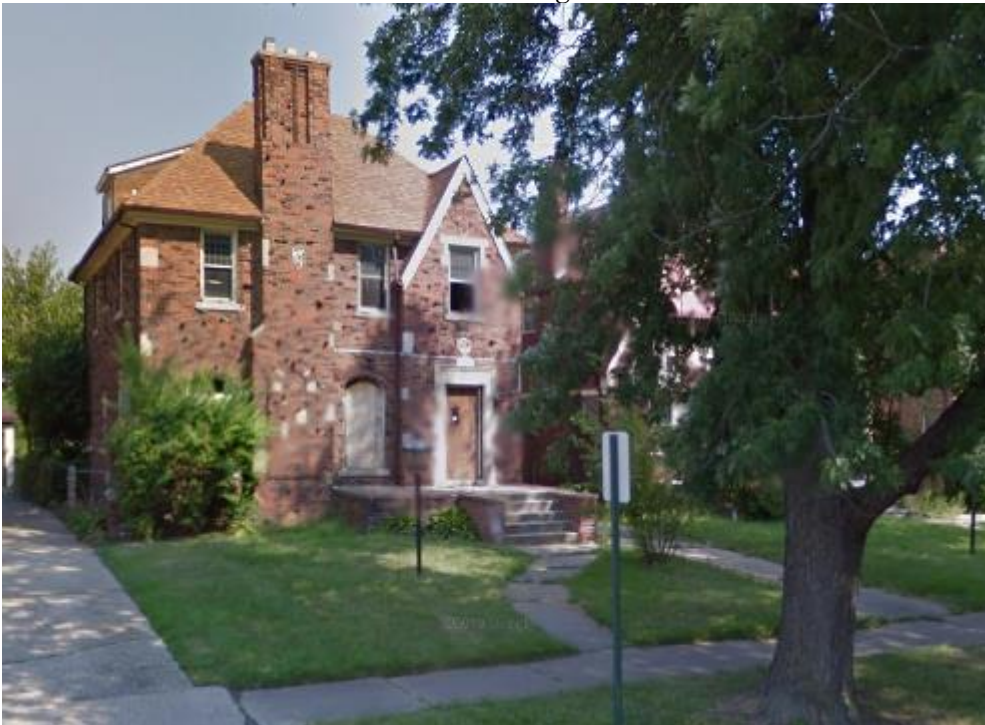
*Google streetview, August 2013. Second-floor windows are in the same position as in 2011. First-floor window is covered or boarded. Exterior storm door, second-floor decorative railing, and low porch railing are all gone. Shrub is overgrown.*

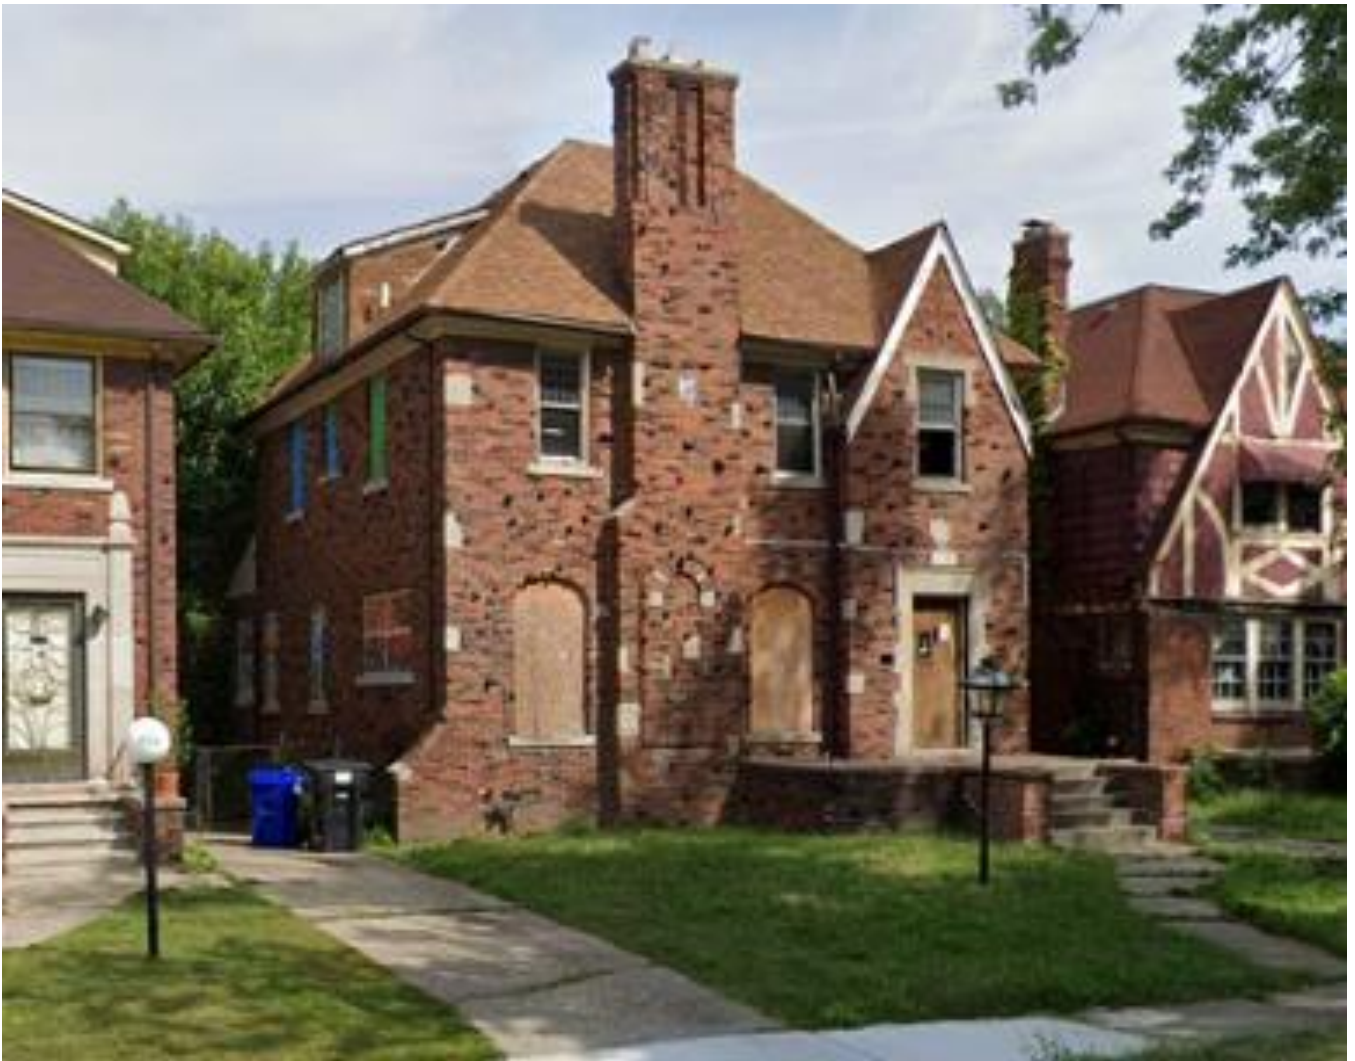
*Google streetview, August 2018. The overgrown bush on the lower left has been removed, the second-floor windows are in the same position as shown in the last photo, and the first-floor windows (as well as all the side windows) have been securely boarded.*

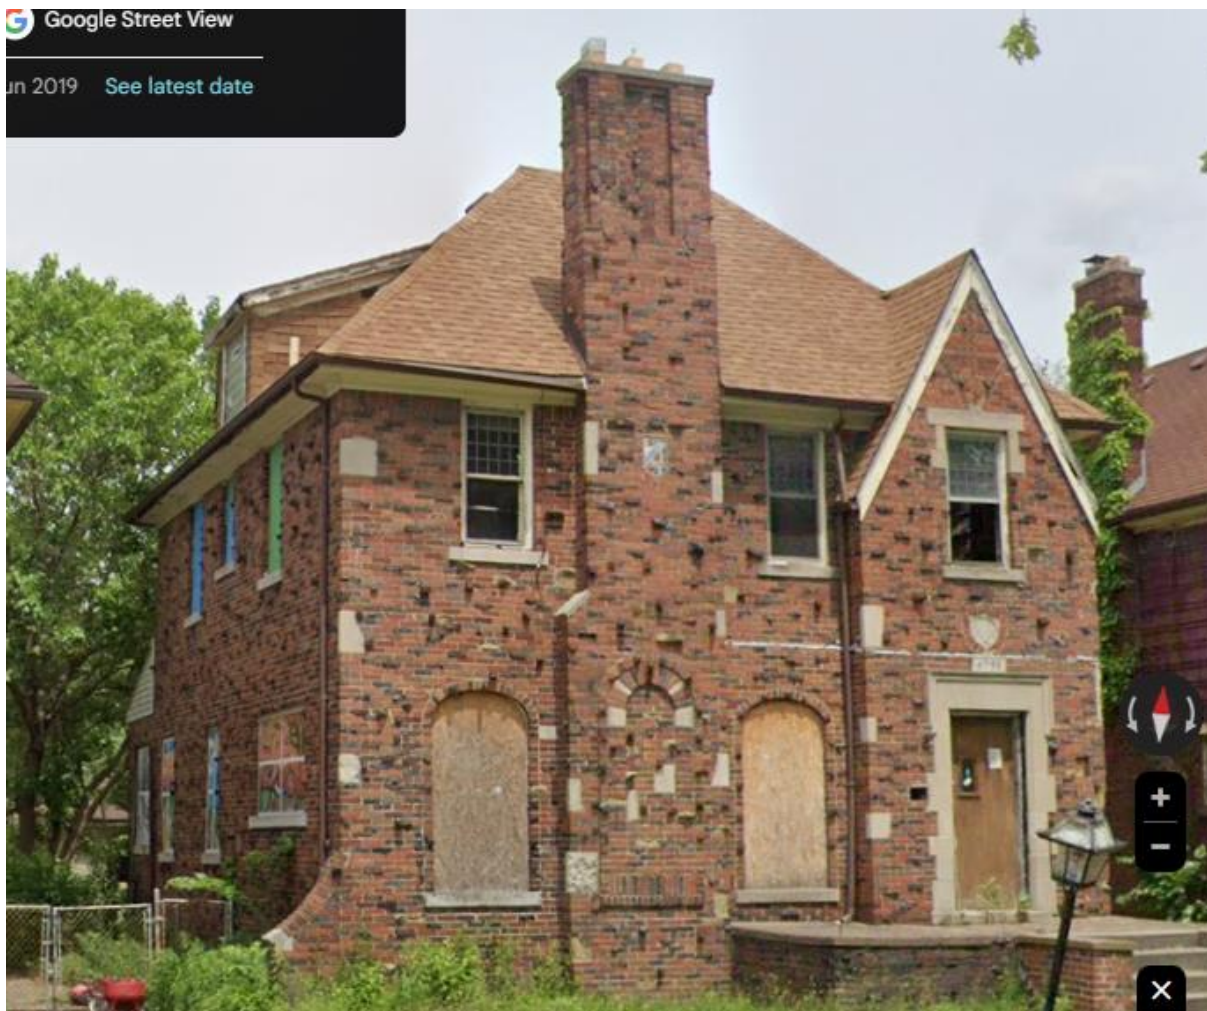
*Google streetview, June 2019. There appears to be no change in exterior conditions from August 2018.*

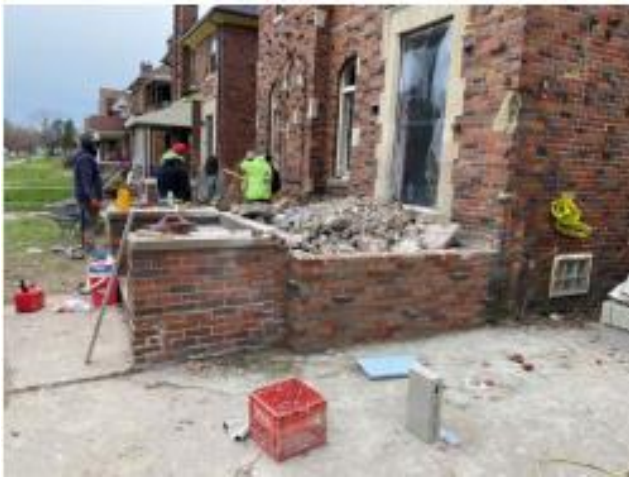
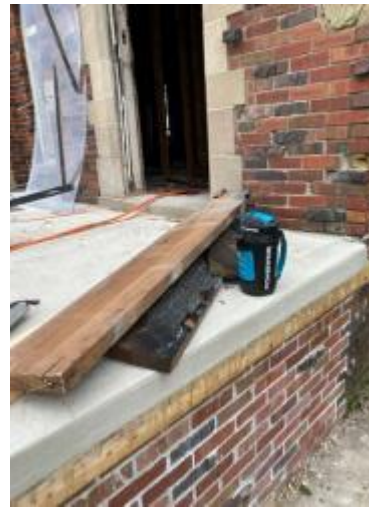
- f. Rebuild front porch (work completed without approval): concrete cap replaced, appears to staff as if bricks for the porch rebuild were salvaged and reused. For the wing walls, bricks are less of a close match, but the design and coping appear to match the original. The mortar used did not match that on the historic house.

*Applicant-supplied photos of the front porch work in progress. It has since been completed.*

- For the front porch rebuild, staff finds that the bricks proposed are generally compatible. The mortar joints, however, are much brighter and more obvious than they were before, changing the character of the porch.

- The bright white mortar used in the front porch’s reconstruction was not compatible with the historic house. The mortar on the historic house and on the porch before its reconstruction was muted, recessed, and almost invisible, and it likely had less cement than the bright white mixture used in the rebuilding. The bright white mortar on the new front porch changes the appearance of the porch.
