STAFF REPORT: SEPTEMBER 10, 2025 MEETING

APPLICATION NUMBER: HDC2025-00530

ADDRESS: 913 CHICAGO

SCOPE: REPLACE SLATE ROOF WITH DIMENSIONAL ASPHALT SHINGLES, REPLACE FRONT PORCH AND COLUMNS, INSTALL FENCE (WORK COMPLETED WITHOUT APPROVAL)

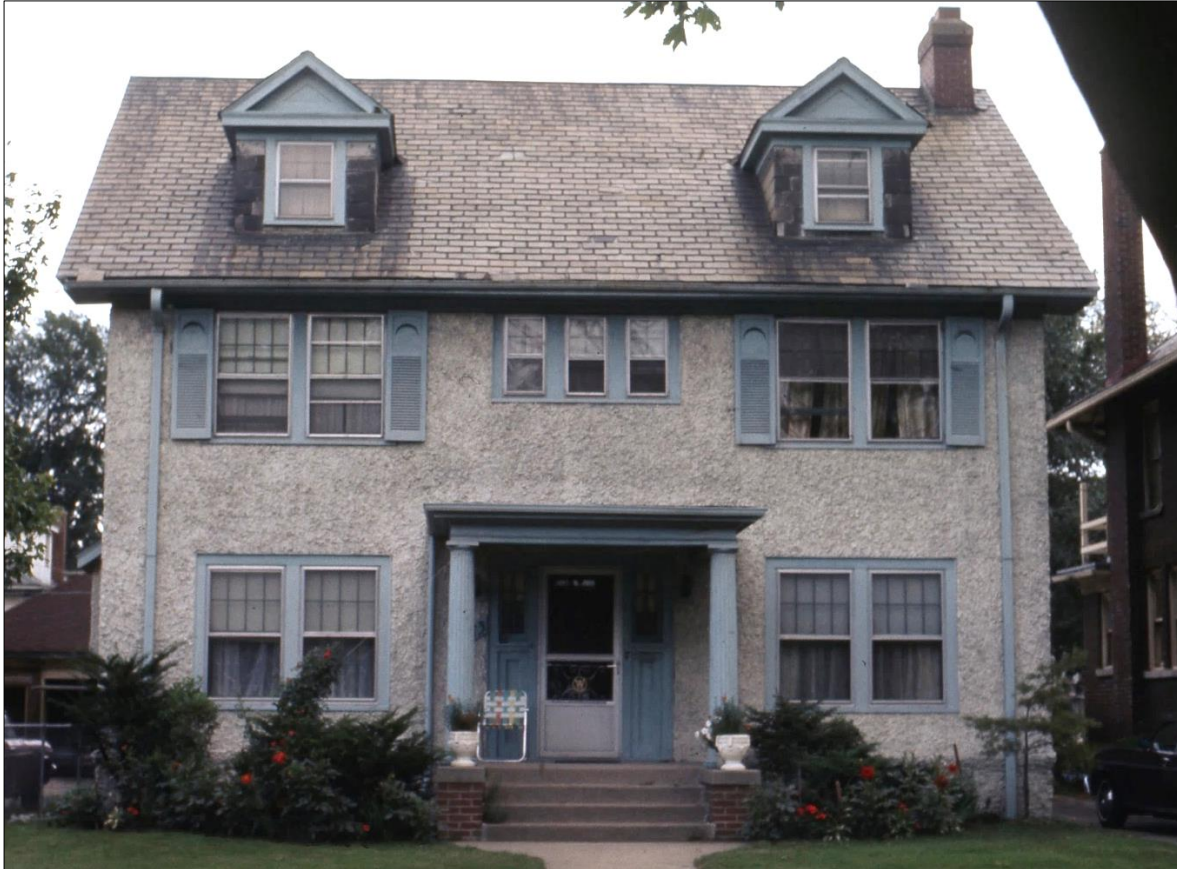
Designation photo, 1974. HDAB. This photo shows the intact slate roof, shutters at second floor, and front porch.

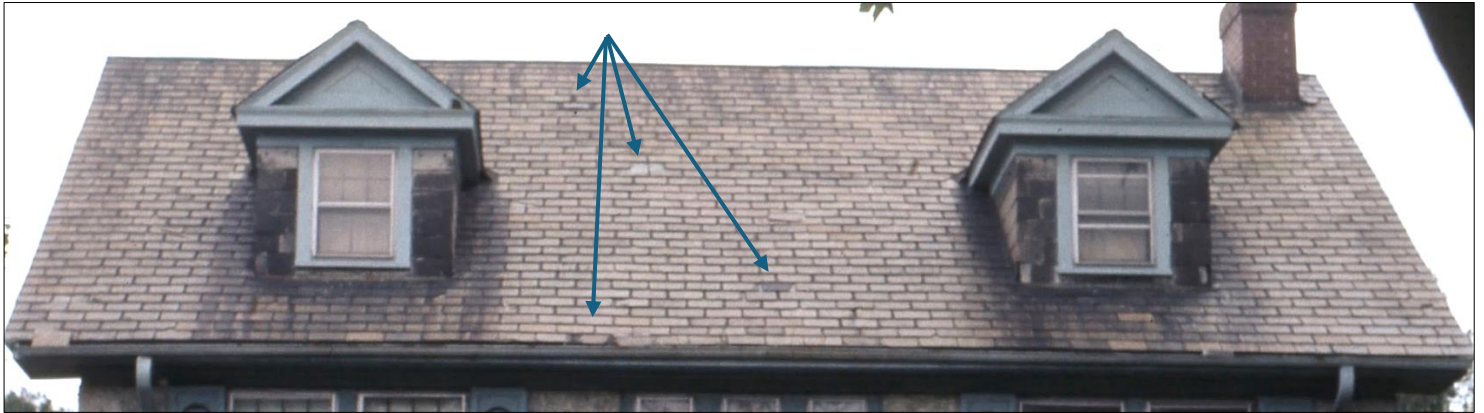
1974, HDAB photo.

- Concurrent to staff's request for additional information from Bruttell, staff conducted the following analysis:
 - Close-up of roof at time of designation (1974) shows at least one missing shingle, a broken shingle, as well as darker areas around other shingles, possibly denoting some type of repair/coverage of roof surface. This visible damage is minimal but as it was present in 1974, this offered opportunities for the exacerbation of deterioration over the following 40+ years.

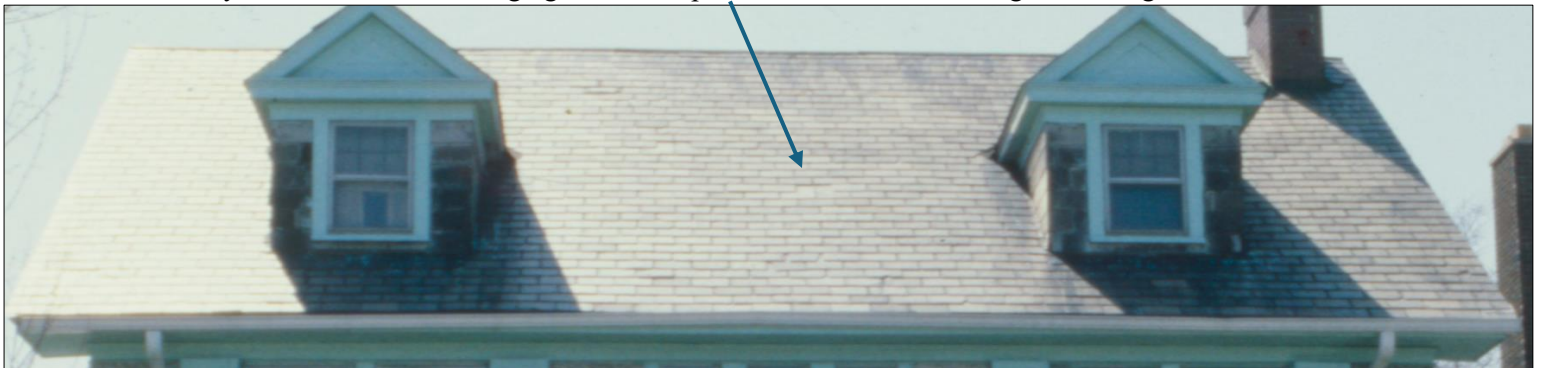
1980, HDAB photo.

- By 1980, even with the high glare of this photo, an additional missing slate shingle is noticeable.

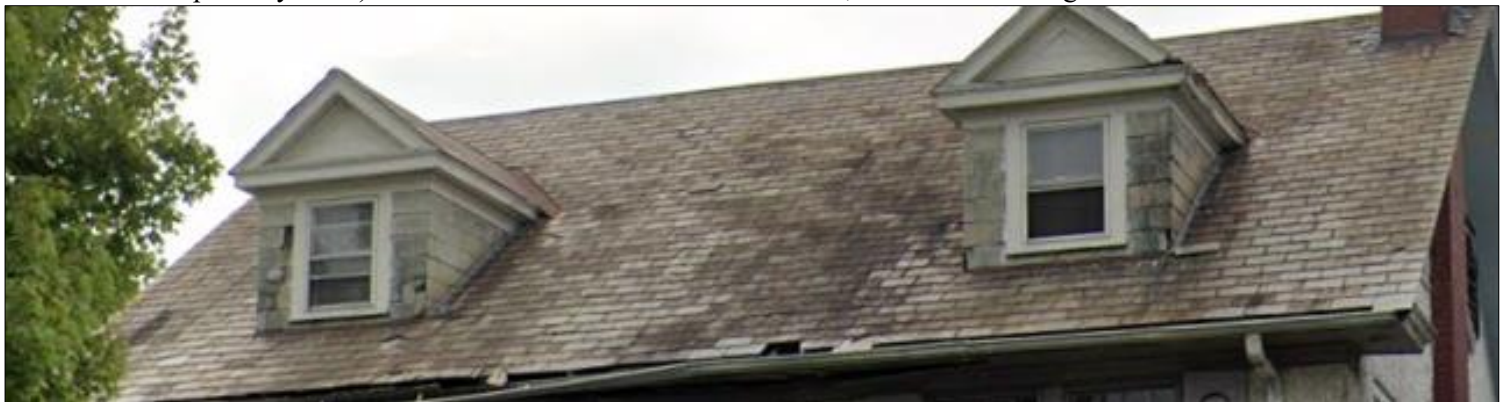
2018, Google street view.

- By 2018, a number of additional shingles are broken or missing. Many decades, dirt, mildew, grime (and possibly moss) collected on the surface of the slate tiles, further weathering the roof.

- Based on the photographic evidence of the house from 1974 - 2018, web research, and Bruttell's analysis, it is staff's opinion that the slate roof was close to the end of its life cycle.

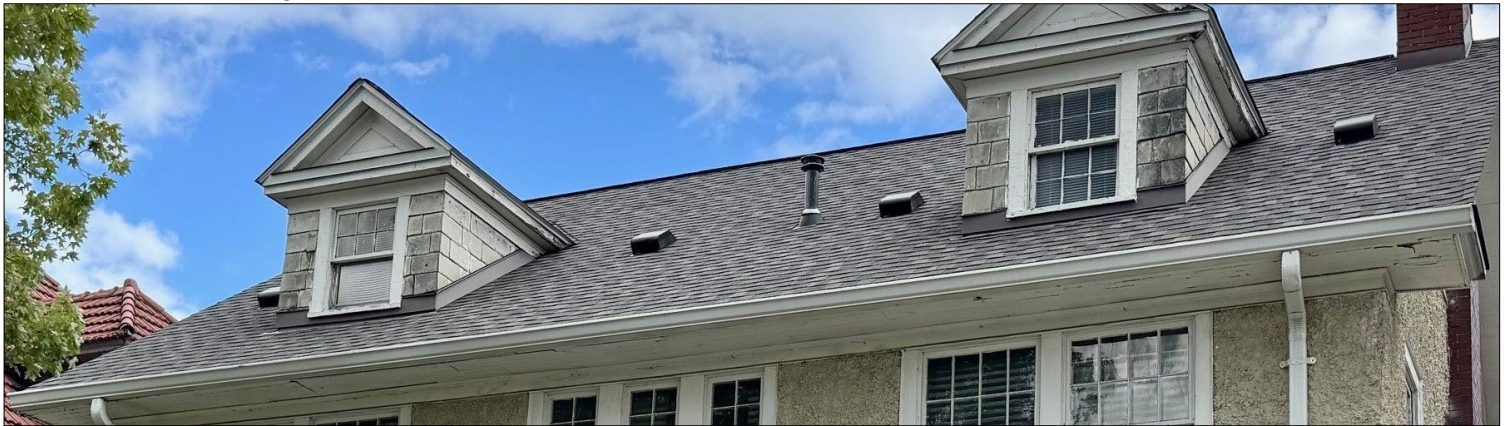
Staff photos, August 2025.

- Dimensional asphalt shingles offer only an illusion of depth, based on different patterns/perimeter shapes of the shingles and applied shading. The front view, due to irregular dimensional shapes of the shingles and sprayed on shadow lines, conveys a smaller scale mottled color and pattern, which is very different against the remaining slate tiles on the dormer walls.

- The installed asphalt shingle roof does not match the old in design, color, and texture.
 - The qualities of the slate roof created a uniform surface, consistent rectilinear pattern and gray color.
 - The irregular dimensional shapes of the installed shingles and sprayed shadow lines create a mottled surface and do not reproduce the clearly defined pattern and flat surface of the slate roof.

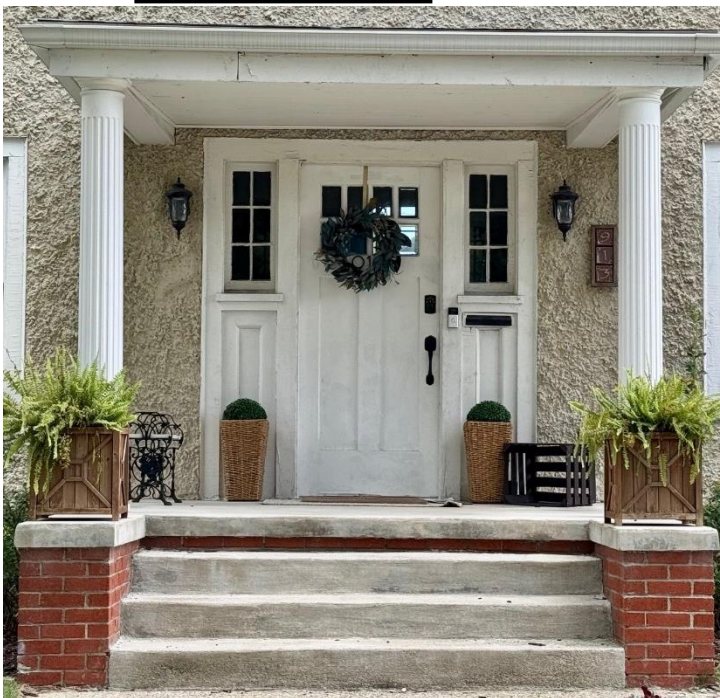
Current Porch - 2025

- Generally speaking, the replacement porch retains the general components of the historic porch, however the details don't often match the historic structure.

- Minor detail - The brick piers are slightly taller (one extra brick course) creating a space between the top stair and porch floor), possibly due to a regrading of the front yard. This alteration does not negatively impact the porch design, as it does not change the height of the porch floor or distance to the roof structure.

- More problematic, based on Google street view images - The upper roof structure had had overhanging eaves and appear to have been removed prior to 2011. This was the component on which the gutters were originally placed (as shown in the 1974 photo). The lower structure was retained but the fascia board was likely replaced and installed on the outer side of the roof structure obscuring the tops of the columns.

- The gutters are installed against the lower roof structure, as the upper portion was not rebuilt. The horizontal trim detail was not replicated on the fascia.

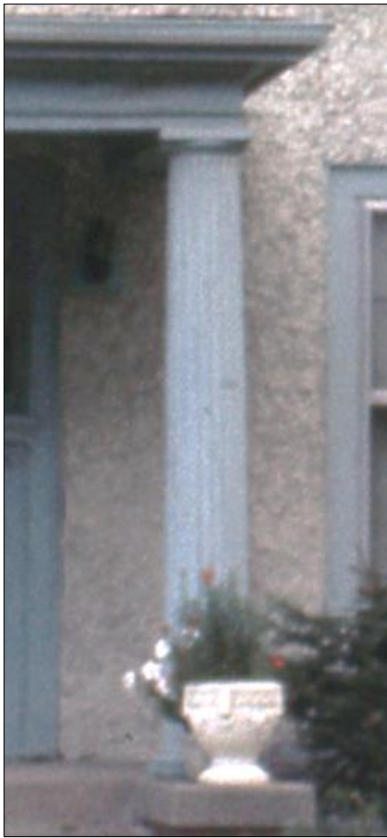
1974 designation photo

Historic column

Fluting extended the full height of the shaft
Unadorned base and capital
Wide and tapered
Placed at the outer corner of roof
Plinth and abacus are present

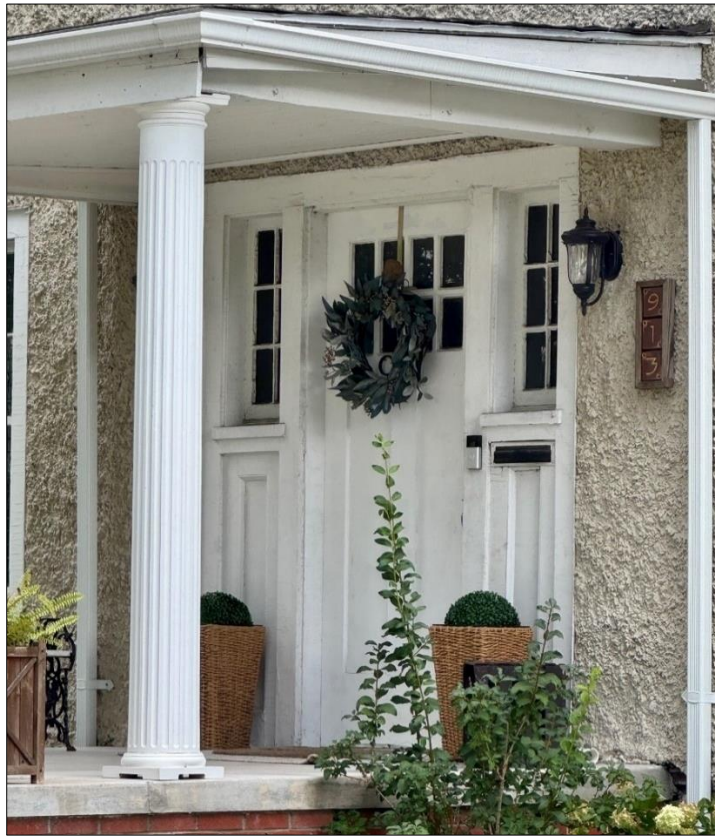
Staff photo, August 2025

New column

Fluting doesn't extend to base and stops many inches from capital
Capital has decorative rings, unlike the historic column
Narrow and consistent diameter
Placed at outer corner of roof but hidden by a new fascia board
Plinth and abacus are present, but they have a different profile

- The historic columns were removed without documentation of their condition. Photos showed some water damage at the bases, but that is not unusual and appeared to be intact and likely repairable. The new columns do not match the old in design, width and profile.

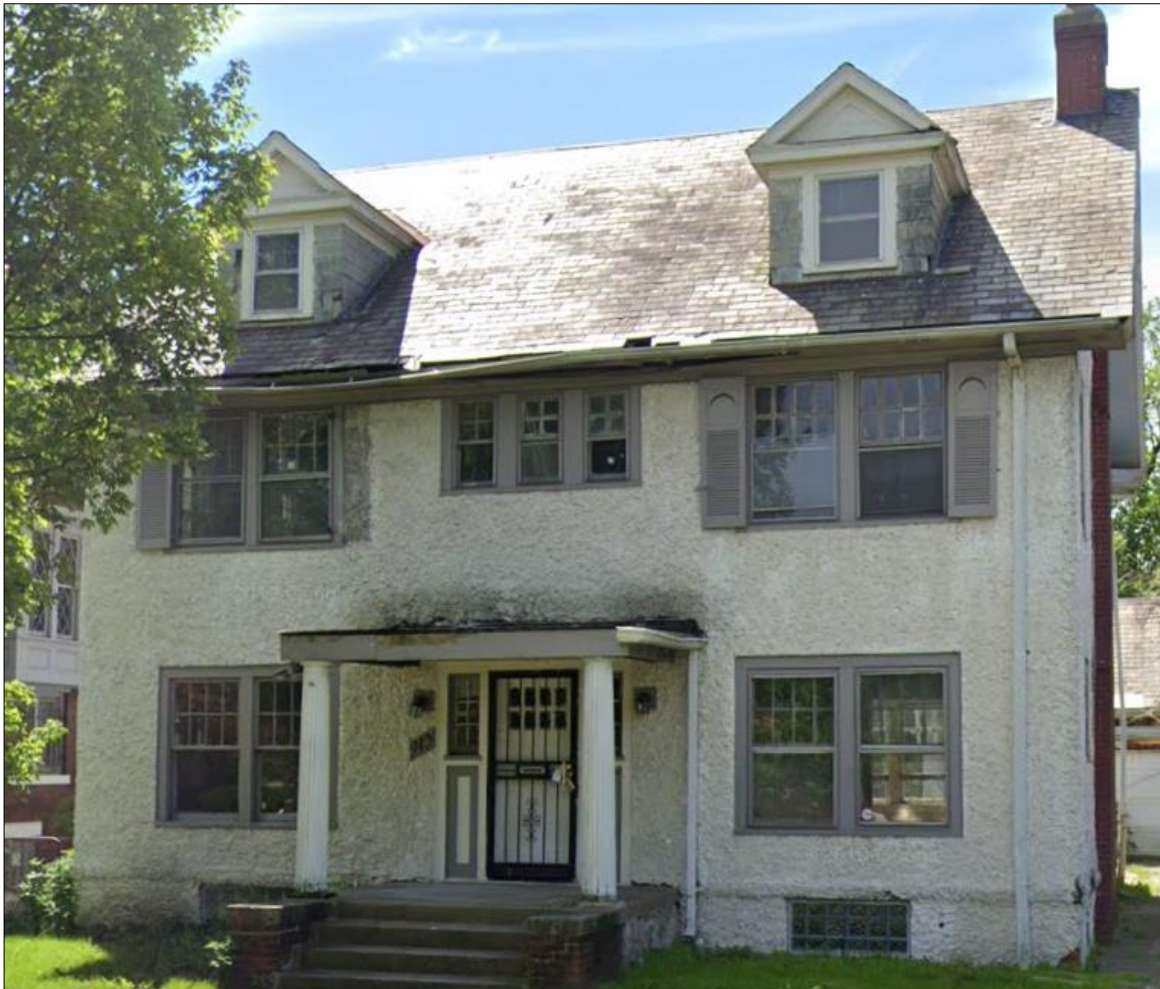
This June 2019 Google street view image is the last documentation of the shutters (three of the four) in place.

- The narrow shutters were likely wood and had a flat panel at the top with a narrow crescent moon cut out; the lower 2/3 of the shutter had ventilation strips.
- It appears that the shutters were removed between June 2019 and March 2022.
- The decorative design and placement of the shutters is a common feature within Boston Edison and can be found on many houses and is a character-defining feature of the property and district.

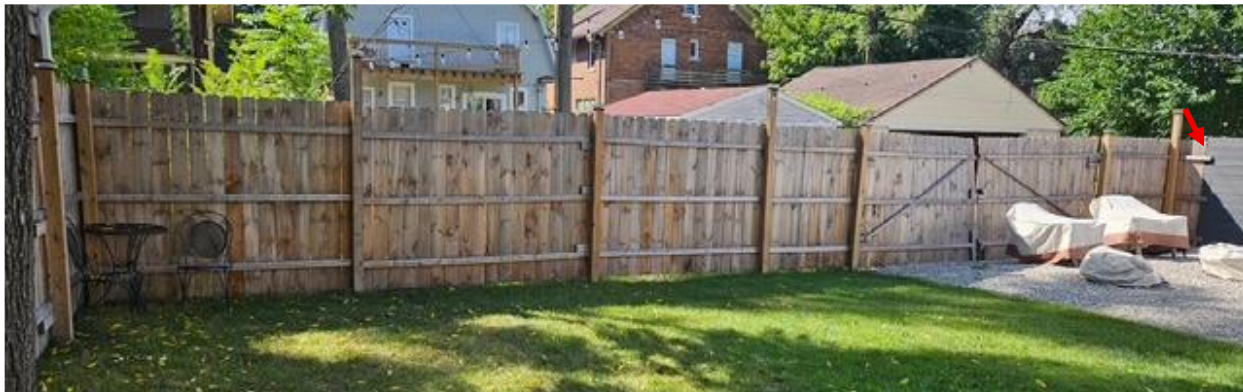
Applicant photos.

- The applicant installed a vertical panel wood privacy fence enclosing the rear yard. It starts at the southeast rear corner of the house, extends to the side/east property line, runs along the east property line to the alley, where it extends across the width of the lot, and returns north a few feet at the west/side property line, adjoining the neighbor's existing privacy fence. A double-gate of same panel design opens to the alley.
- The specification is to apply a natural stain.

- The fence will be painted with an opaque solid color stain or paint. The selected finish and color will be submitted to HDC staff for review.
