**STAFF REPORT:** 9/10/25 REGULAR MEETING

**APPLICATION NUMBER:** HDC2025-00544

**ADDRESS:** 97 ARDEN PARK BOULEVARD

**SCOPE:** PRIMARY ELEVATION WORK, REBUILD PORCHES AT FRONT, REAR, AND SIDE\* (WORK STARTED WITHOUT PERMIT), RESTORE/REPLACE WINDOWS, REPAIR/REPAINT TRIM, REPOINT MASONRY

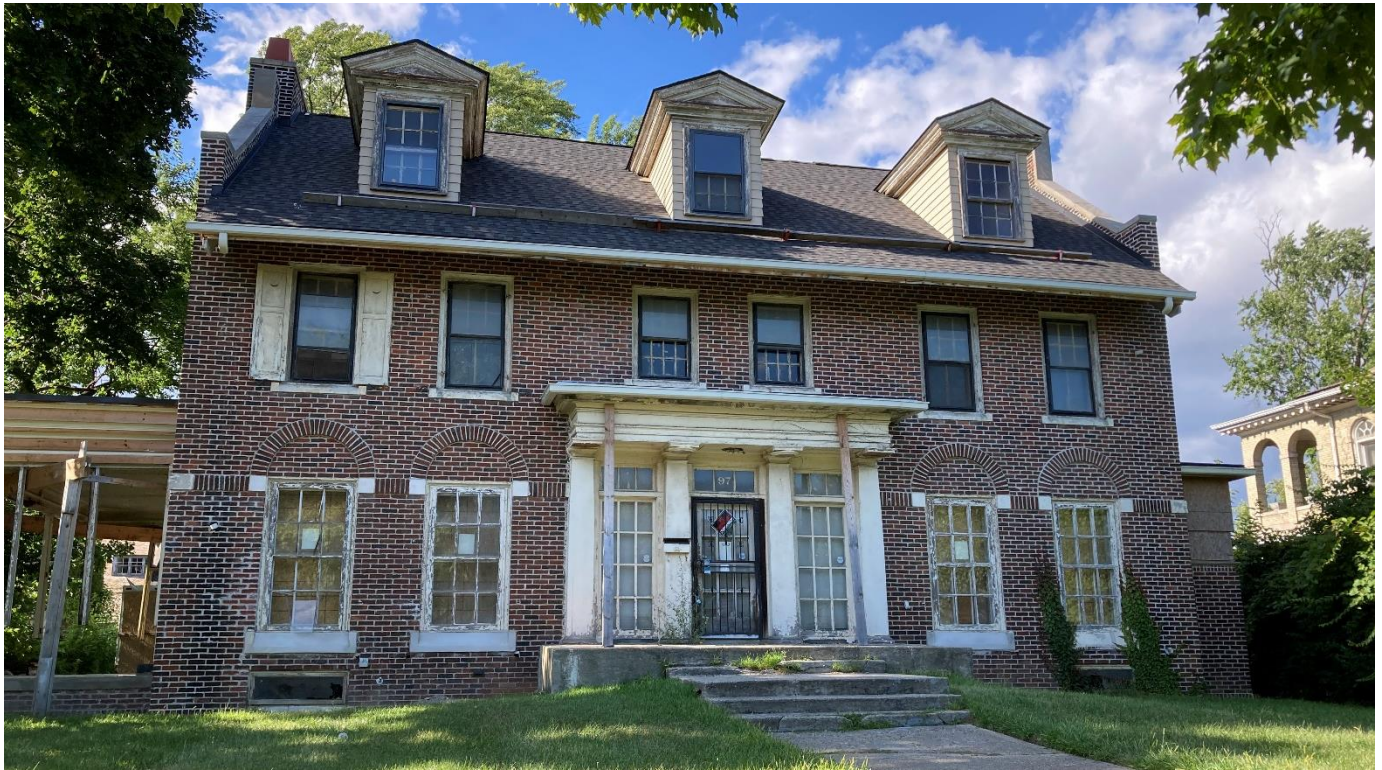
*Site visit, Photo 1, staff, August 2025. Front portico columns have been removed. Historically, they stood in front of the pilasters.*

Staff asked the architect/applicant about the removal of historic columns and he stated that his understanding was that there was a termite issue and a lot of termite damage, and the owner now wishes to restore the missing features.

Restoration	Any Staff-Recommended Conditions
Replace wood columns with wood columns on front portico (4 columns), west porch (2), and rear porch (2)	Wood Melton Classics Tuscan 200TN as specified replacement. Replacement columns must match old in size and proportion as well as material.
Shutters: install three (3) new pairs to match existing	Architect will share product specs with staff for review and approval before work begins
Rear porch: New wing walls	
West porch: New wood pilaster bases to match originals	
West porch: Reconstruct missing enclosed porch on existing (new) porch base	The entablatures on the west porch and the front portico must appear to an observer at the front of the house to be the same.

- If a new front walkway is needed, applicant will apply for that element for staff review and approval.
- Replacement columns must match the old in size and proportion (as well as material); applicant will provide documentation to staff showing that the proposed columns are the same size as the historic.

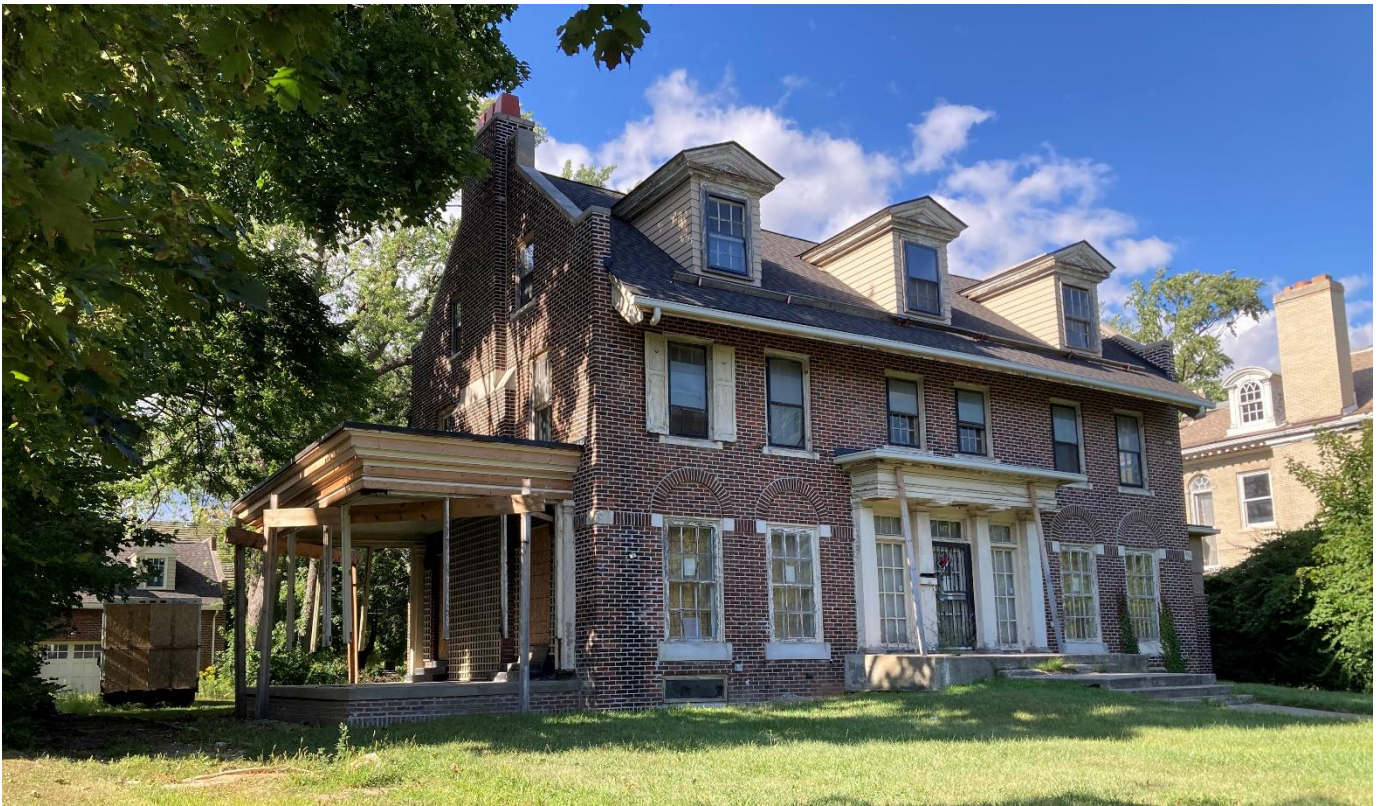
*Site Visit, Photo 2, staff, August 2025. West porch columns have been removed and porch entablature has been rebuilt but also somewhat reinterpreted. See detail photo on page 4.*

- All columns were removed without approval and without documentation that their condition was beyond repair.
- West porch to be enclosed: The existing wood trim, soffit, and fascia elements of the west porch have been built but not to plan. The entablature has many layered cornices and the resulting proportions are not compatible with the historic house. The entablature should be rebuilt as per the submitted plan to match the entablature on the front portico. The west porch should not be more detailed than the historic front portico to avoid detracting from it.

- The west enclosed porch's entablature must match that of the front portico. Applicant will provide detailed drawings of the entablatures of both the historic front portico and the new proposed west porch to staff for review and approval.

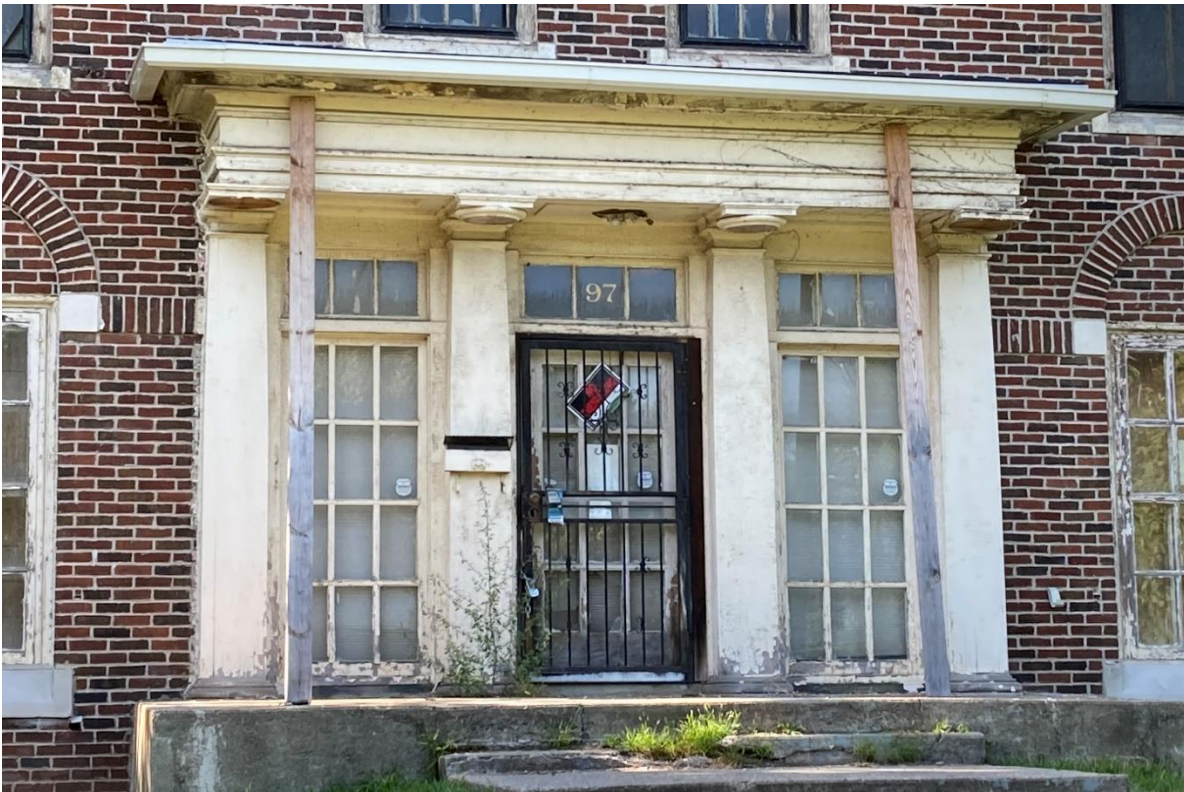
*Site Visit, Photo 3, staff, August 2025. Front portico, columns have been removed.*

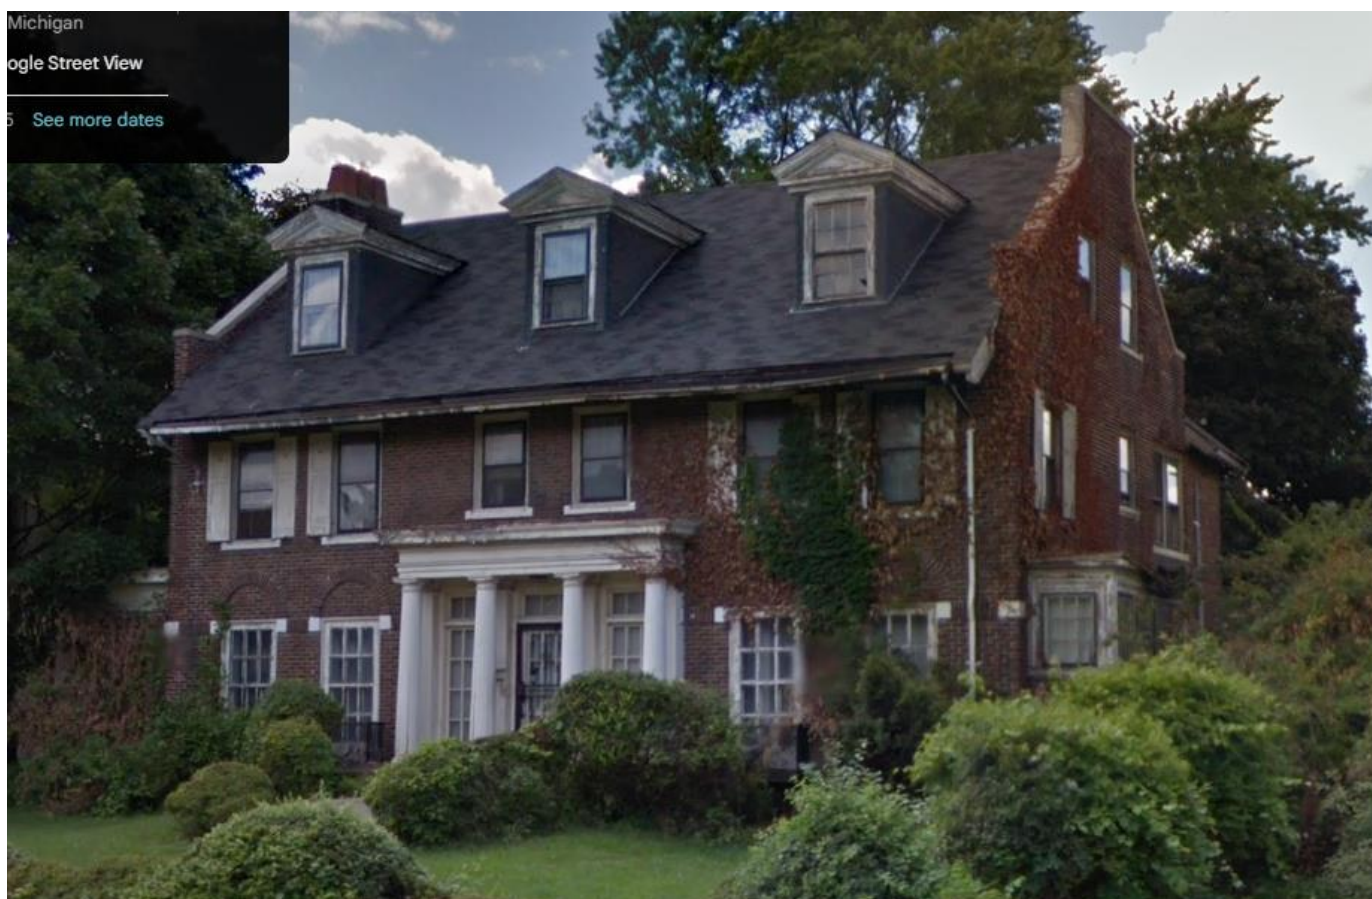
*Google streetview, August 2015. The columns in the portico and the windows in the east-side bay are all present here.*

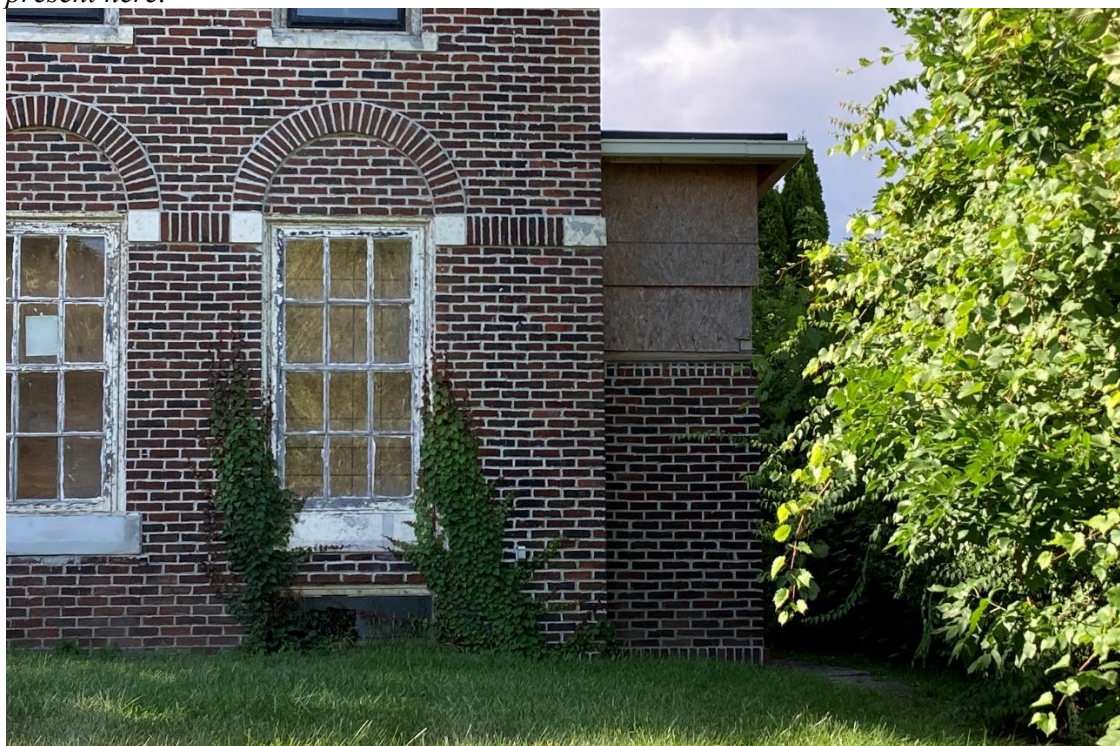
*Site Visit, Photo 4, staff, August 2025. East bay with boards where windows were.*

Rehabilitation	Any Staff-Recommended Conditions
Install missing windows on east bay	Applicant will clarify final muntin pattern and placement (upper sash only or both) for staff before work begins
Rear porch: New wood deck	Pressure-treated wood must be painted when cured.
Rear porch: Aluminum rail	The rail should be a traditional design in painted wood instead of black aluminum

- For the east bay window replacement, applicant will submit final muntin pattern and placement (upper sash only or both sashes) for staff review and approval before work begins.

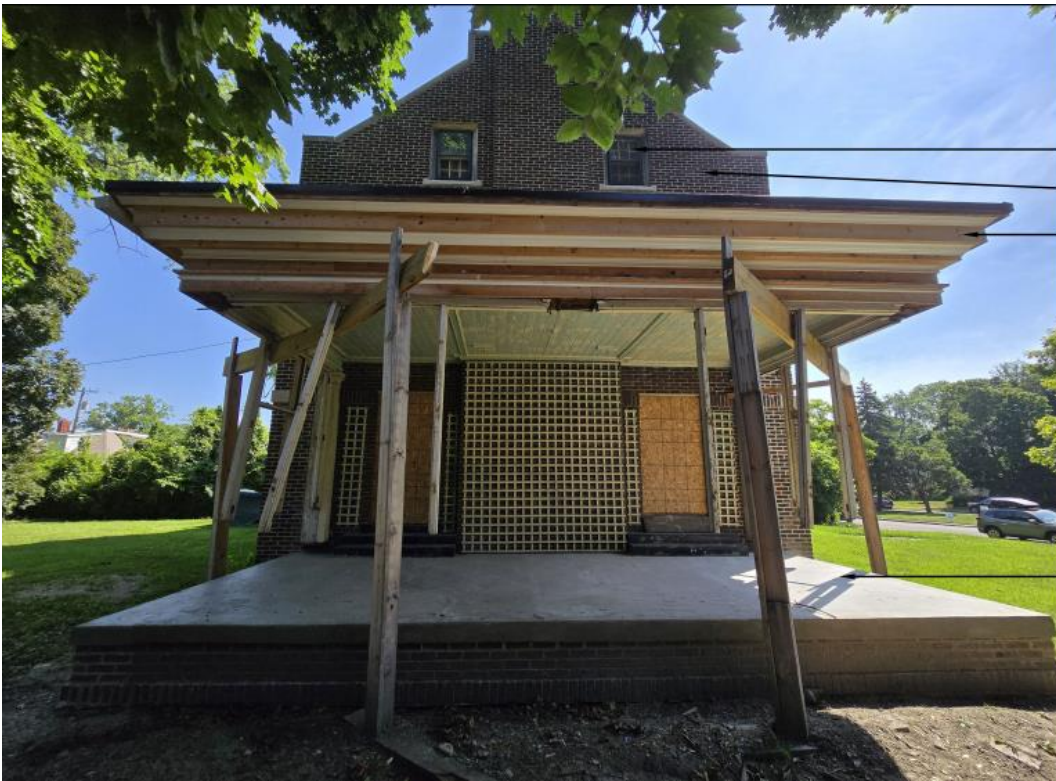
*Applicant Photo, west elevation. Columns are missing. New brick base, concrete cap, and entablature has been built.*

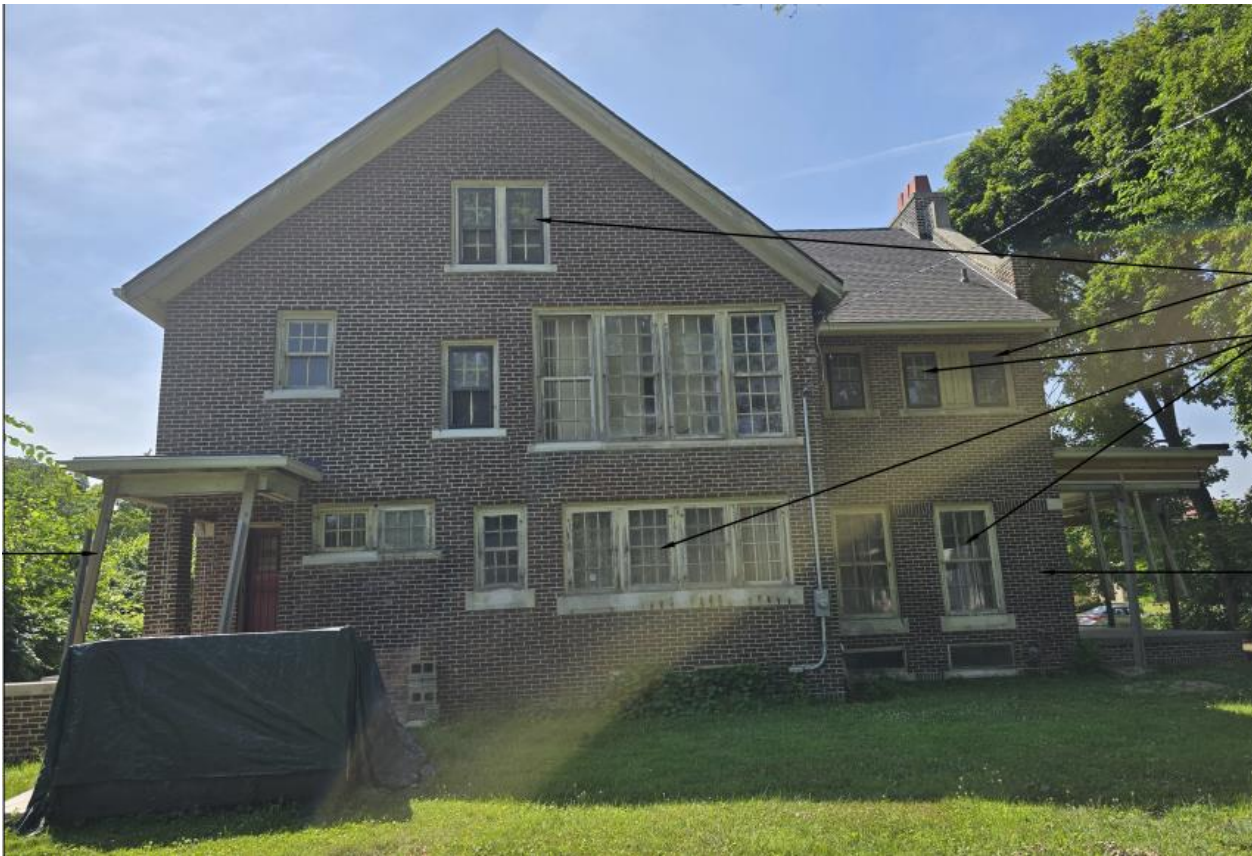
*Applicant Photo, rear (north) elevation, current conditions. Rear porch columns are missing.*

4. Rear porch:
  - a. New wood deck
  - b. Aluminum rail
  - c. New wing walls to match original
  - d. New steps
  - e. Repair and repaint (to match existing) wood elements as needed (trim, fascia, soffit, etc.)

- f. 2 wood columns like front porch
5. Enclosed west side porch
  - a. Repair and repaint (to match existing) wood elements as needed (trim, fascia, soffit, etc.)

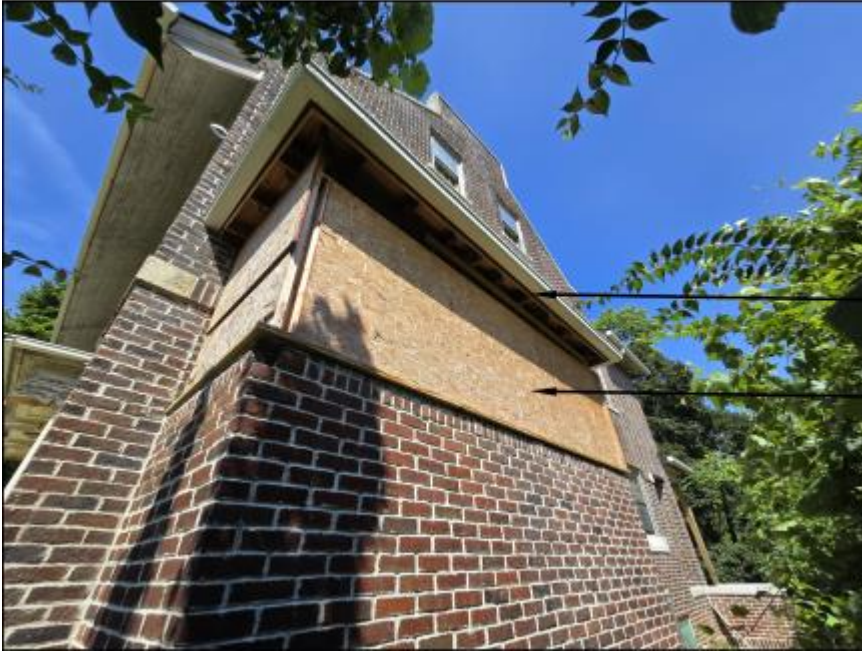
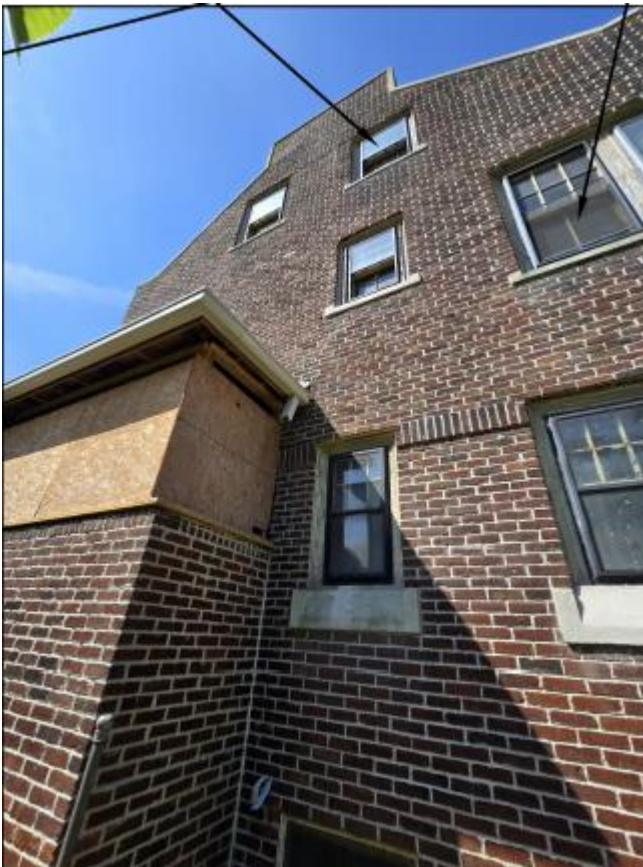
*Applicant Photos, east elevation, missing windows behind the boards.*

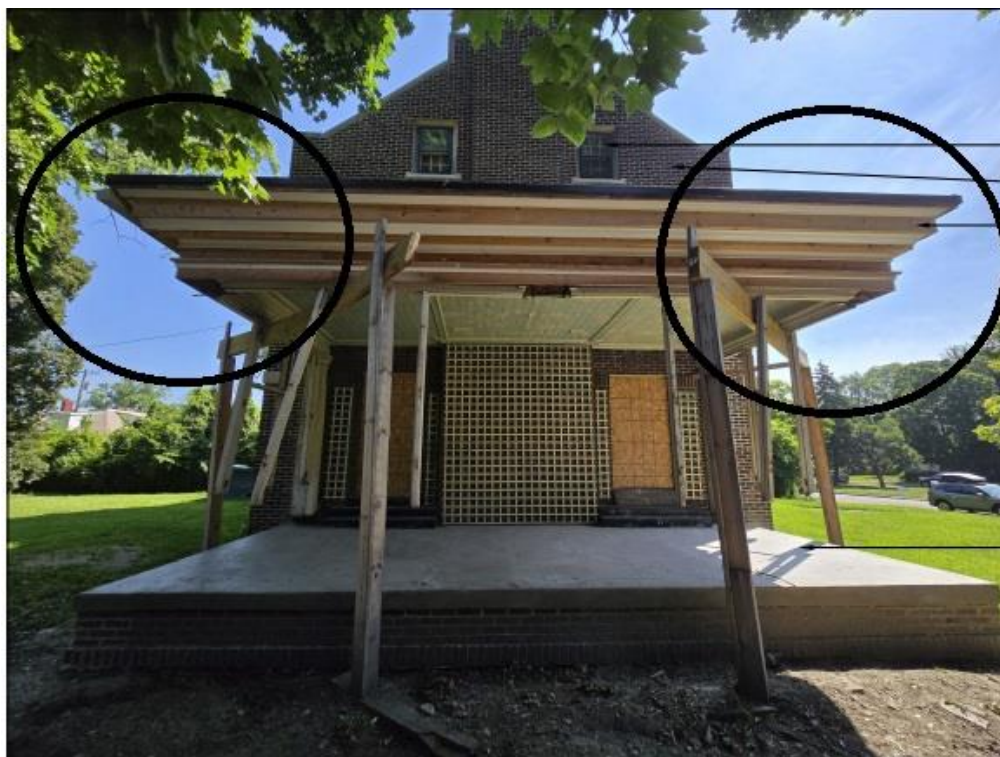
*Applicant photo, current conditions, west elevation, entablature as it has been built. Colonial Revival houses were designed with Colonial houses in mind, and Colonial houses themselves looked to Italian Renaissance precedents. These precedents emphasized classical details. An important classical detail is the use of classical columns, each capped by an entablature composed of a cornice, frieze, and architrave. A classical cornice projects somewhat over a frieze and architrave that are approximately flush with each other in profile. In this design, a cornice projects over a slightly smaller cornice over a slightly smaller cornice, creating multiple layers of cornices stacking onto a frieze and architrave that appear very recessed.*

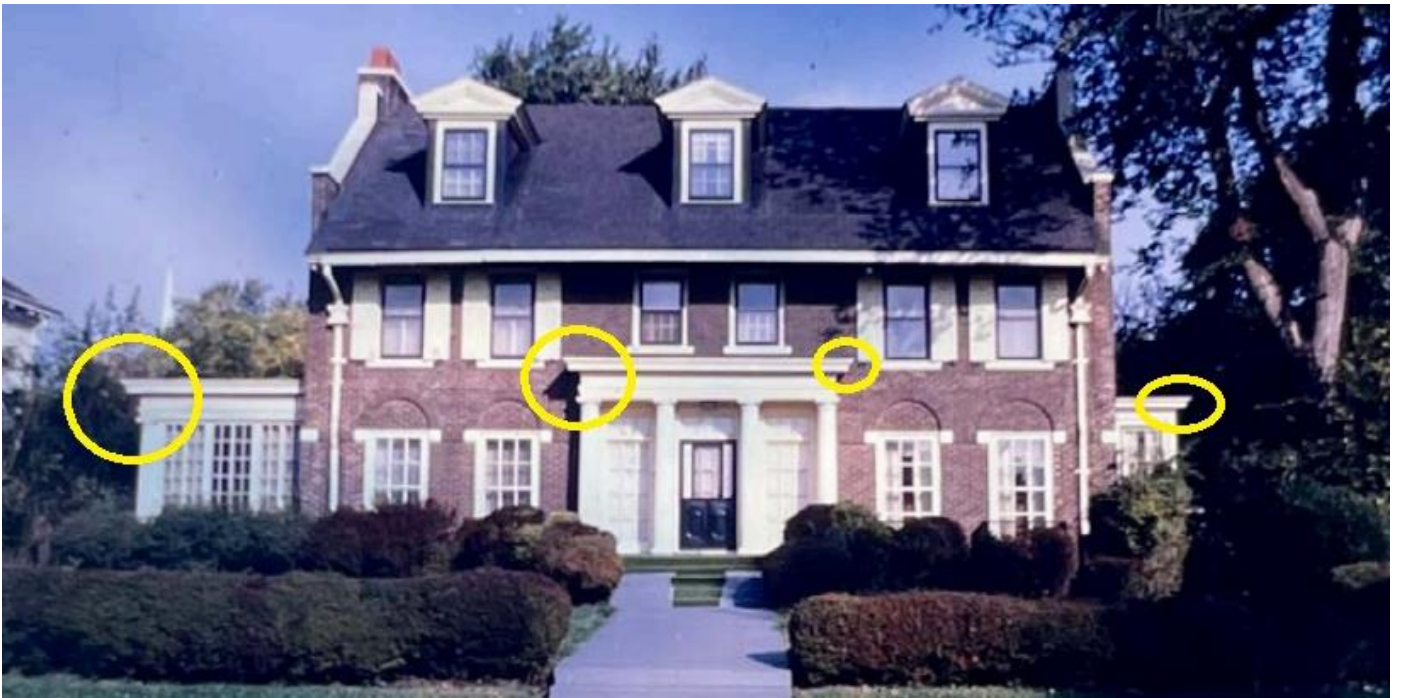
*1981 designation photo with entablatures circled. The same classical entablature above the classical column both on the west and on the front portico is important to this house's design, character, proportions, and balance.*

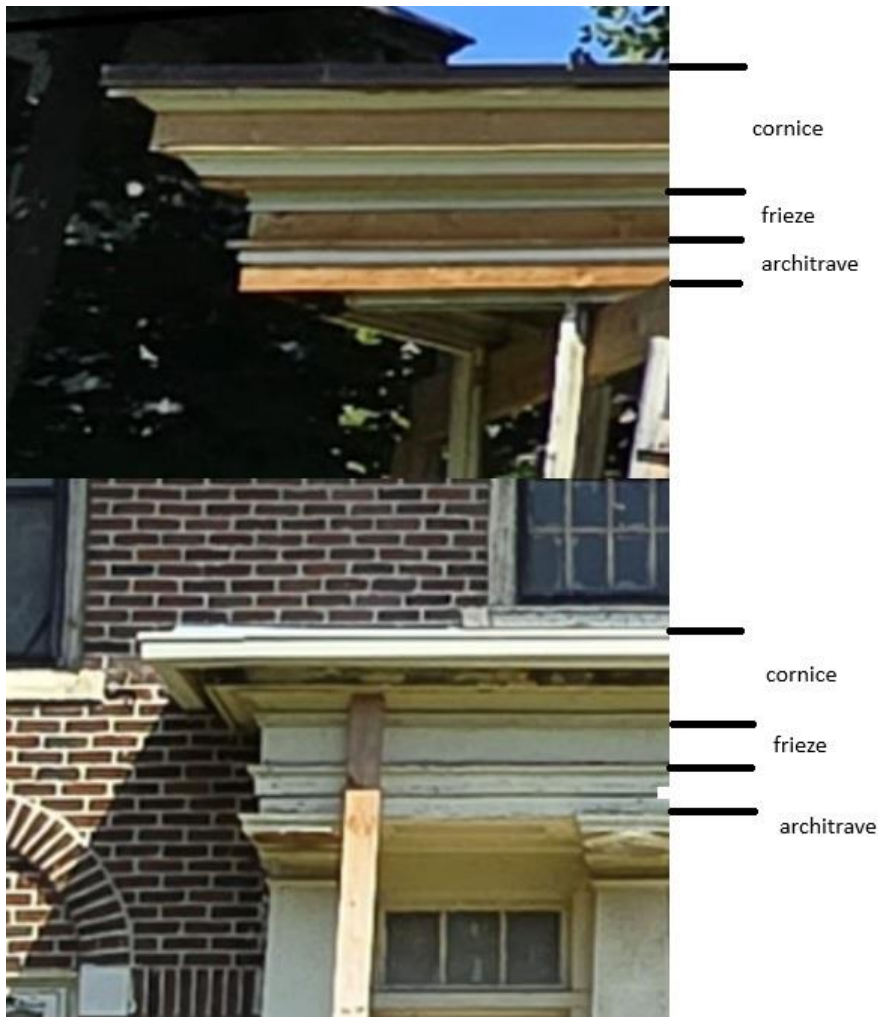
*Detail from applicant's materials. At top is the new entablature on the west porch that will rest on the column when installed. On bottom is the historic entablature on the front of the house. The detailing and proportions are different when they should be the same, based on the historic (front) feature.*

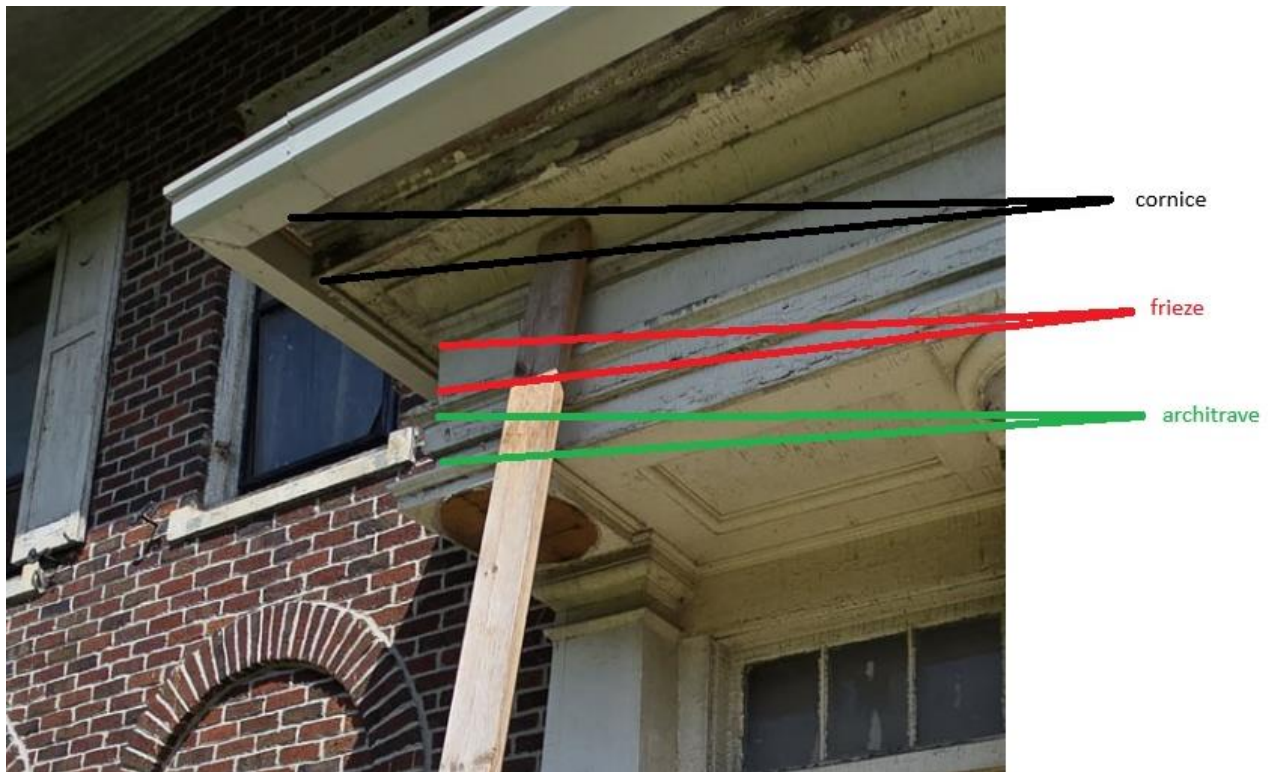
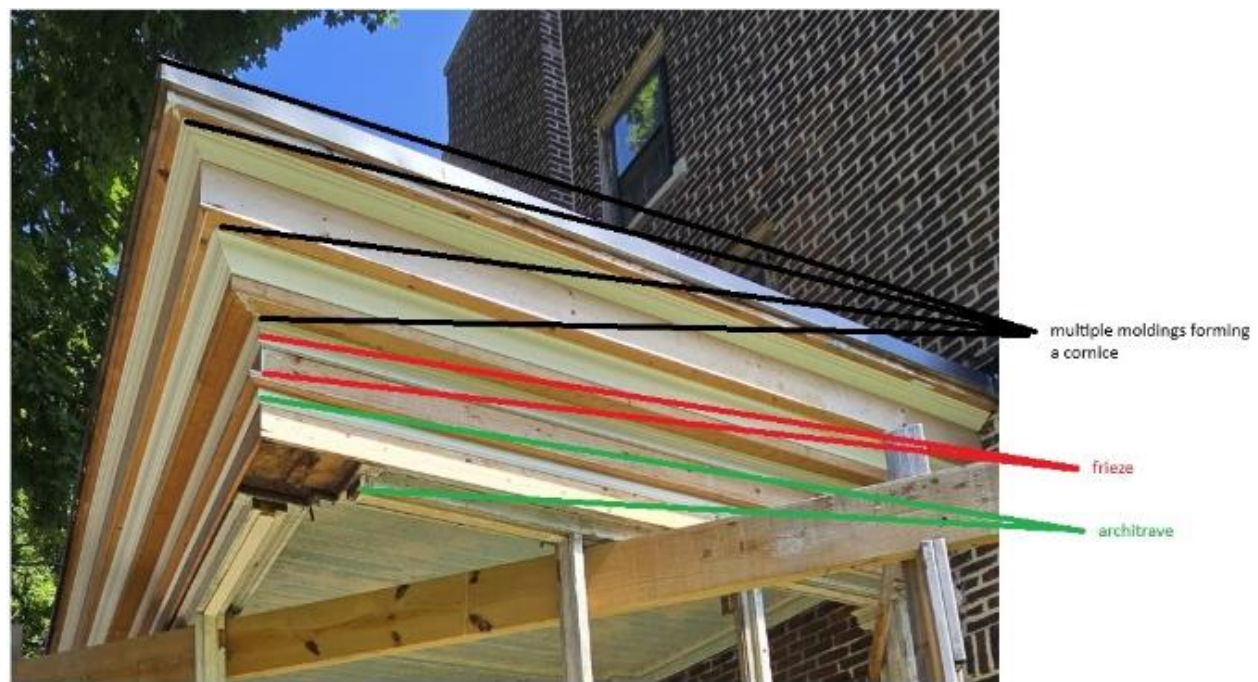
*Comparing the front historic feature (top) with the newly built feature on the west porch (bottom), using photos from the applicant's materials. The historic cornice projects out over the frieze and architrave. It seems that the modern construction stacks trim to progress from the frieze to the roof.*

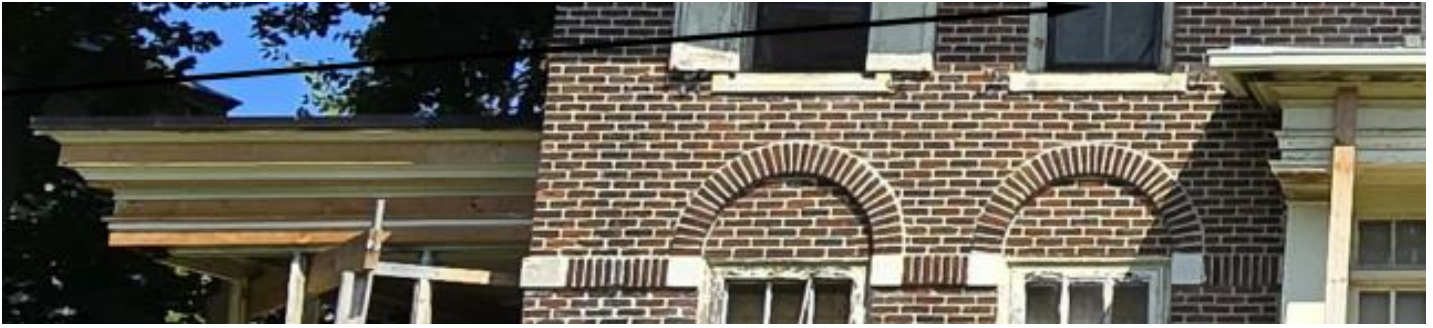
*Detail from applicant's materials, west porch entablature and portion of front portico entablature. It appears to staff from this angle that it is intended for the west entablature to copy the front historic one, but to add a fascia above the cornice for a gutter. Even if this is the case, staff remains uncertain that the west and front entablatures will appear to an observer on the sidewalk to be the same as is necessary for this house's design, proportions, and balance.*

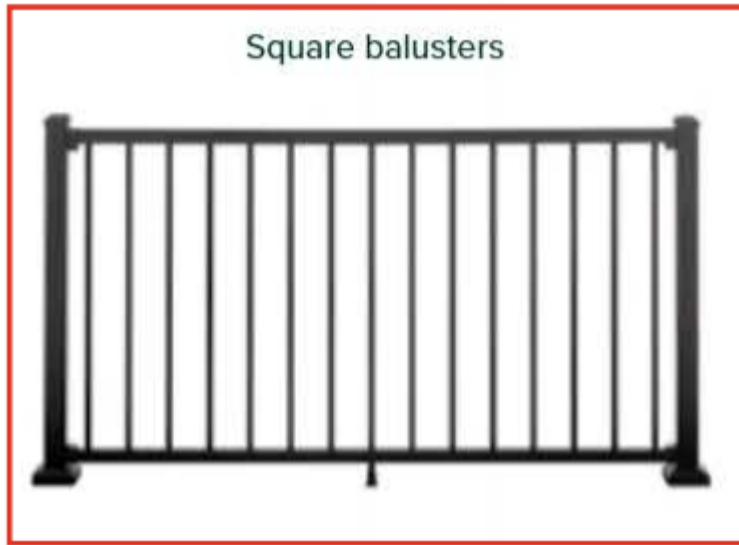
- Rear porch: Wood deck and stairs are proposed to be pressure-treated wood. Staff suggests the condition that all pressure-treated wood must be painted when cured. Unpainted/clear-coated wood is not a typical historic condition.
- Rear porch: A contemporary aluminum rail (see below) is proposed. In staff's opinion, using a black contemporary rail on the rear porch is incompatible with the house's historic character. It is staff's opinion that a simple wood railing painted to match the column on this small rear porch, perhaps lower than proposed and with a simple booster rail to increase the height for safety, would be more compatible with the historic house than the proposed rail. If a 36" black rail is desired in the hope that it disappears visually, perhaps a railing could be sourced that has a more traditional appearance and proportions than

the very contemporary and spindly rail proposed. Staff's recommendation is that the architect submit a rear porch railing to staff for final approval.

*From applicant's materials, proposed rear porch railing.*

- On the rear porch, any pressure-treated wood used will be painted when cured.
- For the rear porch, a different rail will be submitted for staff review and approval.
