STAFF REPORT: 10/08/2025 MEETING

ADDRESS: 1760 VAN DYKE

APPLICATION NO: HDC2025-00522

SCOPE: INSTALL VINYL SIDING; INSTALL VINYL WINDOWS

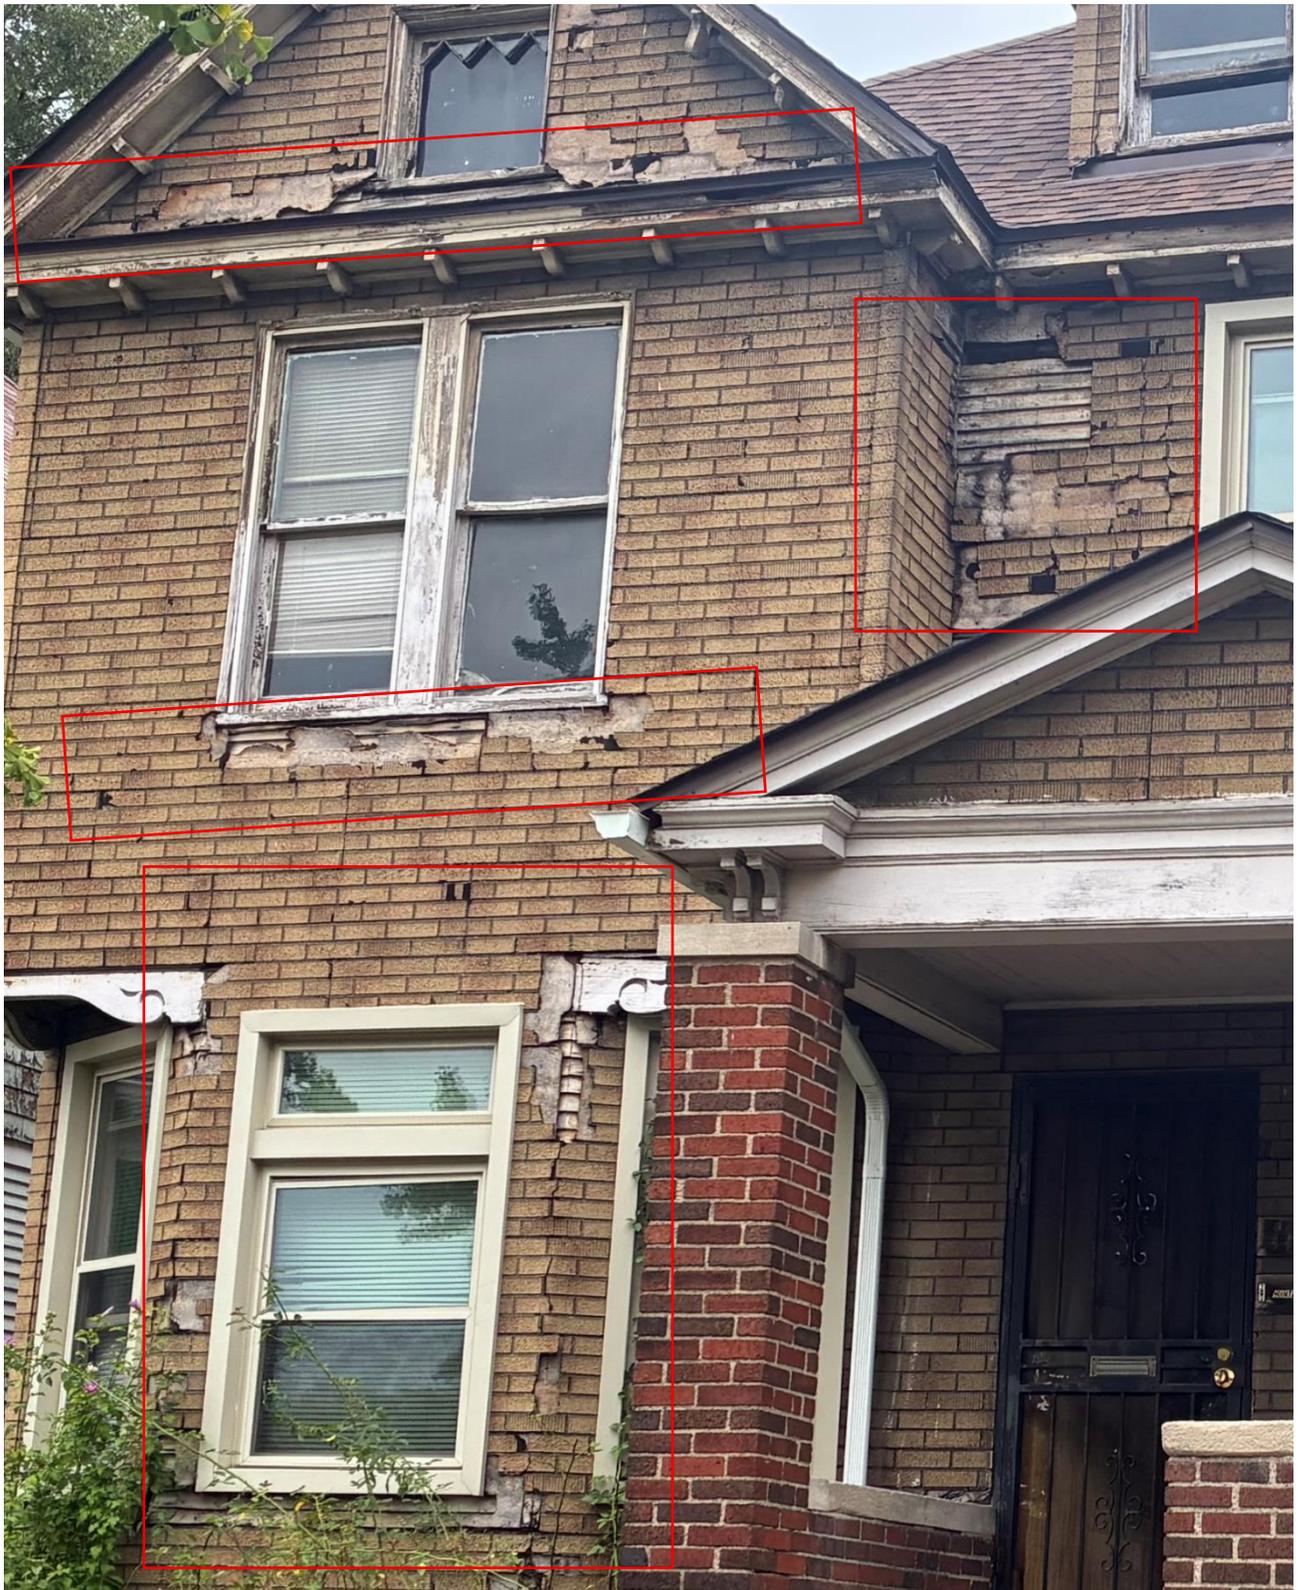
See the below pictures of the areas of the deteriorated faux brick/asphalt siding. Note the areas where the siding has fallen off completely, leaving the historic lapped wood siding fully visible, and the areas where the outermost surface of the siding has peeled away, leaving the fiberboard and or tarpaper beneath (the black and light brown areas) visible. Note that the black

areas on the wall do not appear to be “holes” where the original wood siding has rotted away from the wall.

Front façade. Areas outlined in red show deteriorated faux brick/asphalt siding Photo taken on 9/22/2025 by HDC staff

It is therefore staff’s opinion that retaining and repairing the original siding, if possible, is the most appropriate treatment for the siding at this property, will greatly enhance the building’s historic character, and further restore historic character to the West Village Historic District. If the wood siding beneath is deteriorated beyond repair, then new wood siding which matches the existing should be installed.

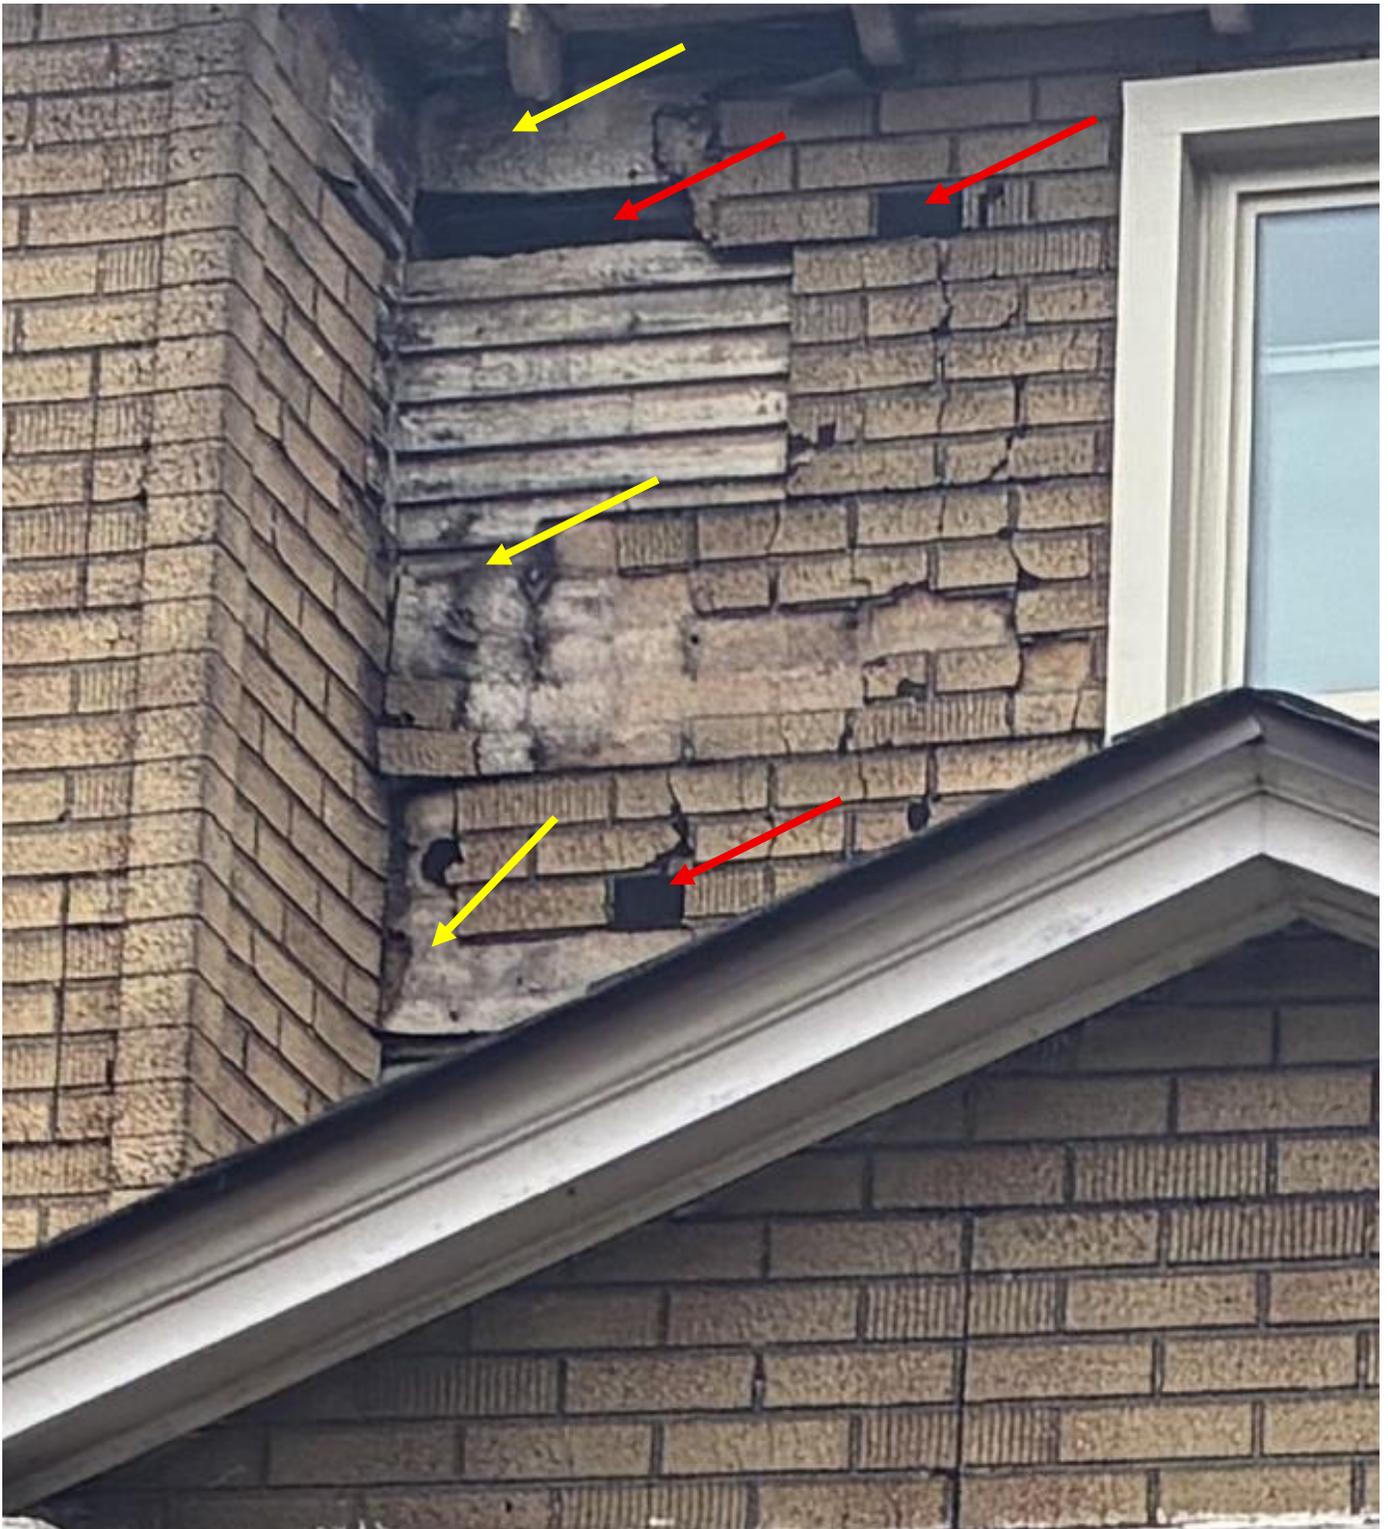
Front façade, detail. Red arrows indicate area where the top “granular” layer has separated from the siding. The yellow arrows indicate the tarpaper beneath the stamped fiberboard, which has been directly applied to the wood. Photo taken on 9/22/2025 by HDC staff

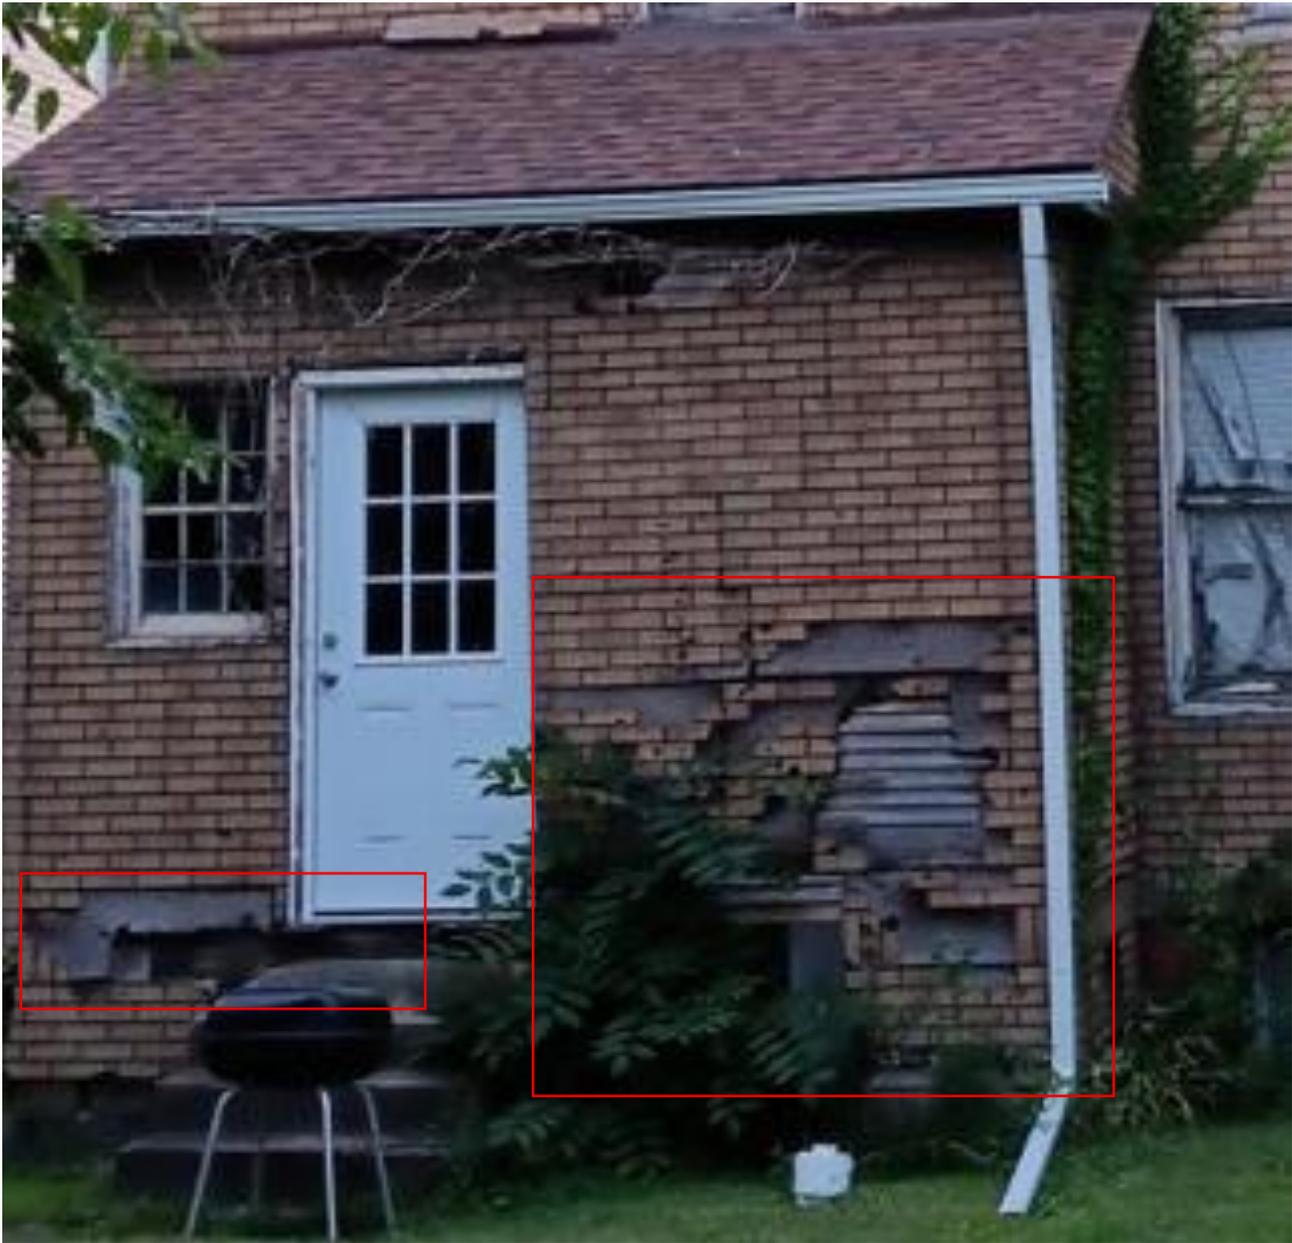
Rear façade. Areas outlined in red show deteriorated faux brick/asphalt siding Photo taken applicant.

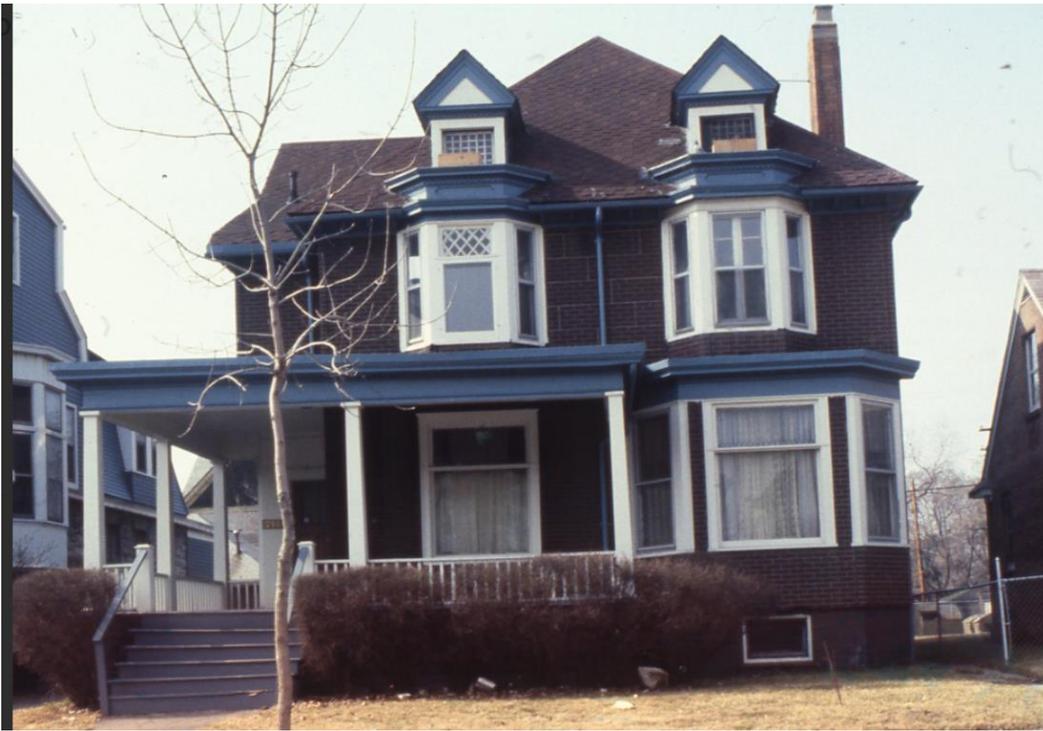
715 Van Dyke (BEFORE), designation photo. Note faux brick/asphalt siding

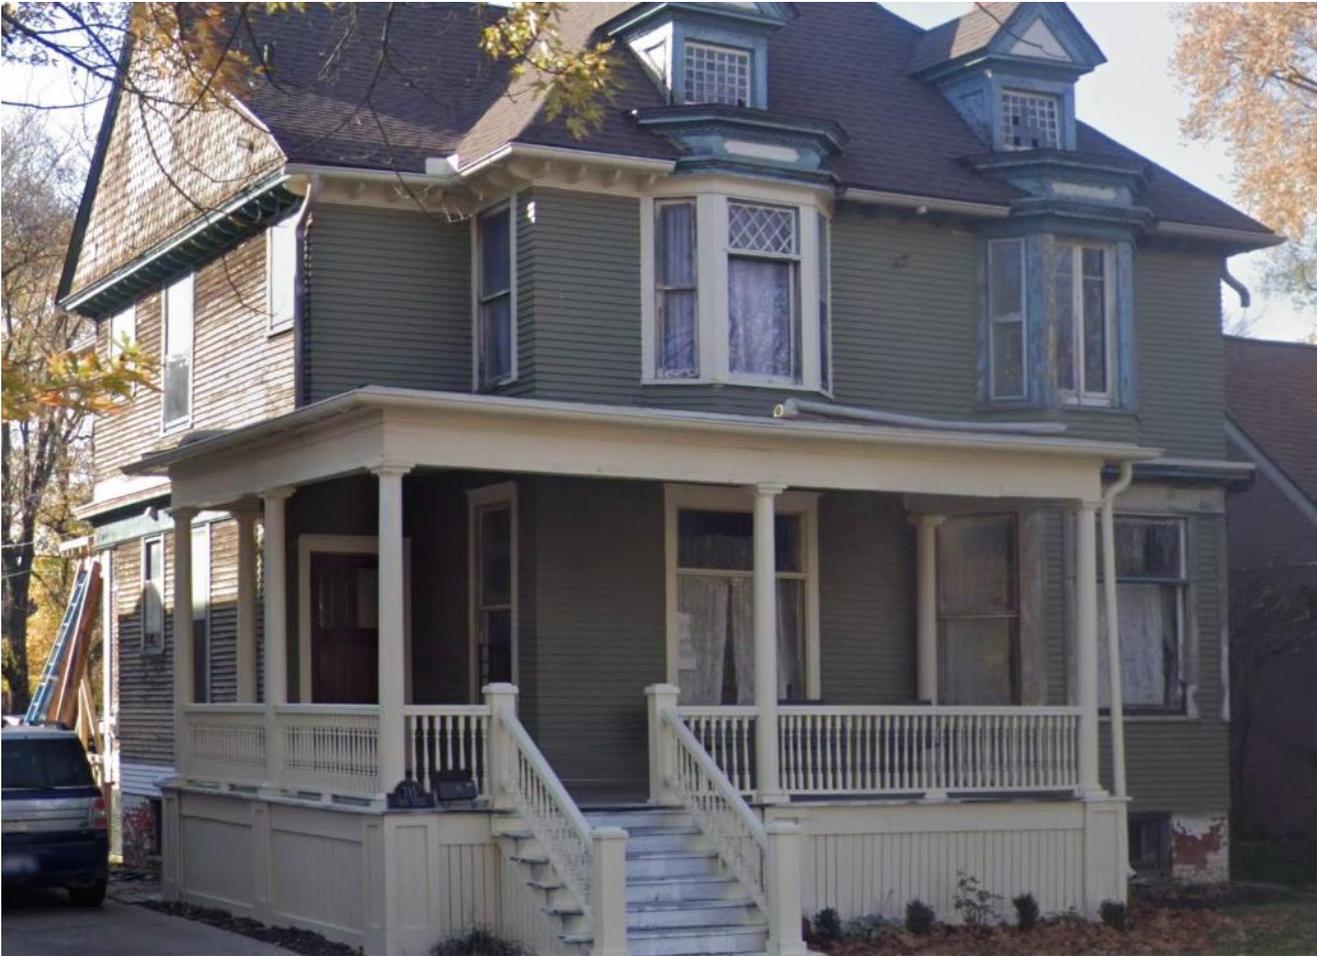
715 Van Dyke, (AFTER) Google Streetview 2023. Note lapped wood siding.

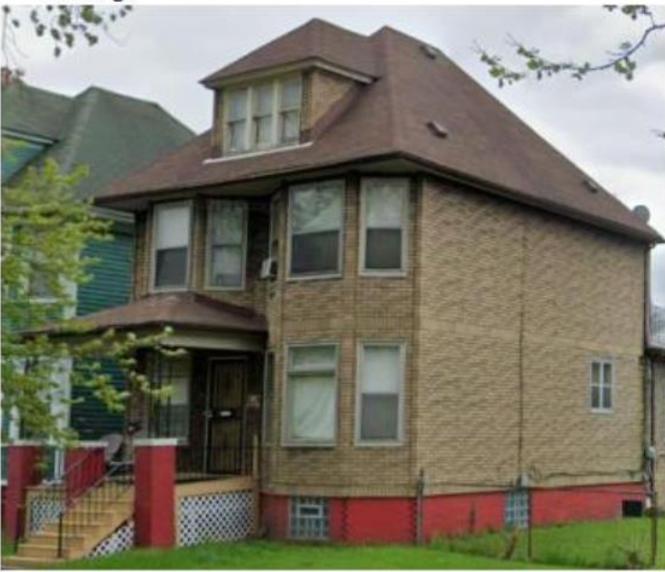
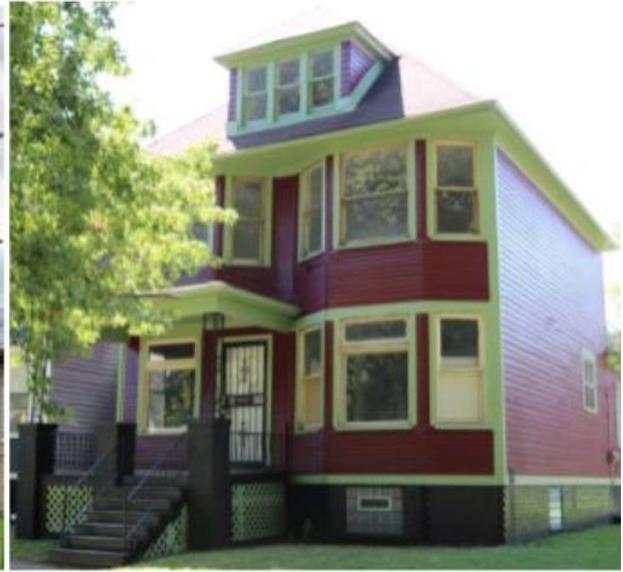
1773 Parker, Google Streetview 2019 (left), with faux brick/asphalt siding (BEFORE). Photo at right taken by HDC staff in 2024, showing original/repaired lapped wood siding (AFTER)

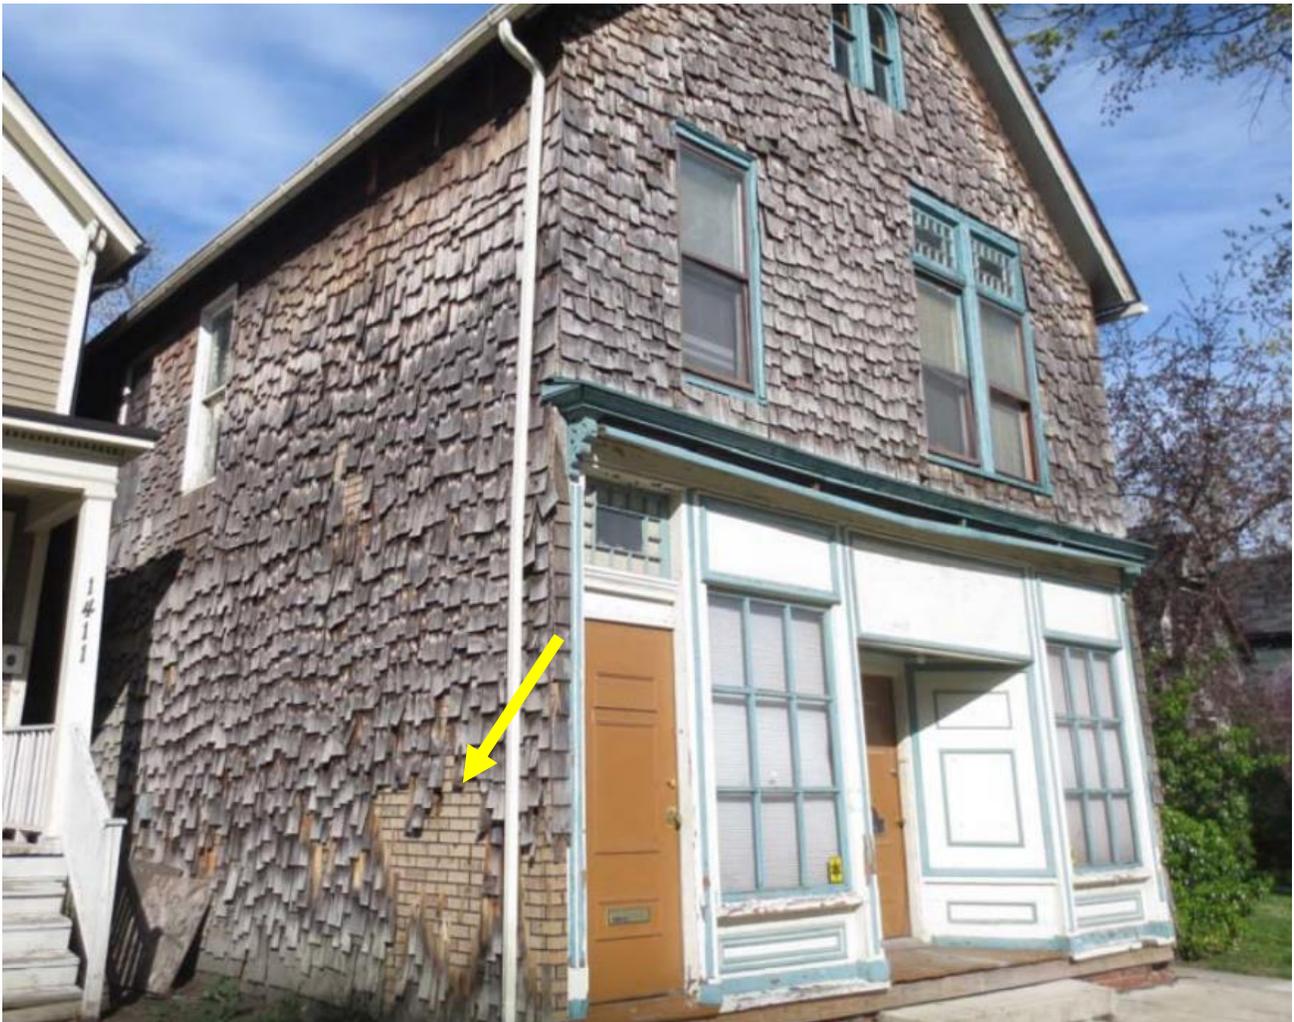
1417 Van Dyke (BEFORE), Google Streetview 2013. Note the presence of faux brick/asphalt siding (yellow arrow) underneath wood shake.

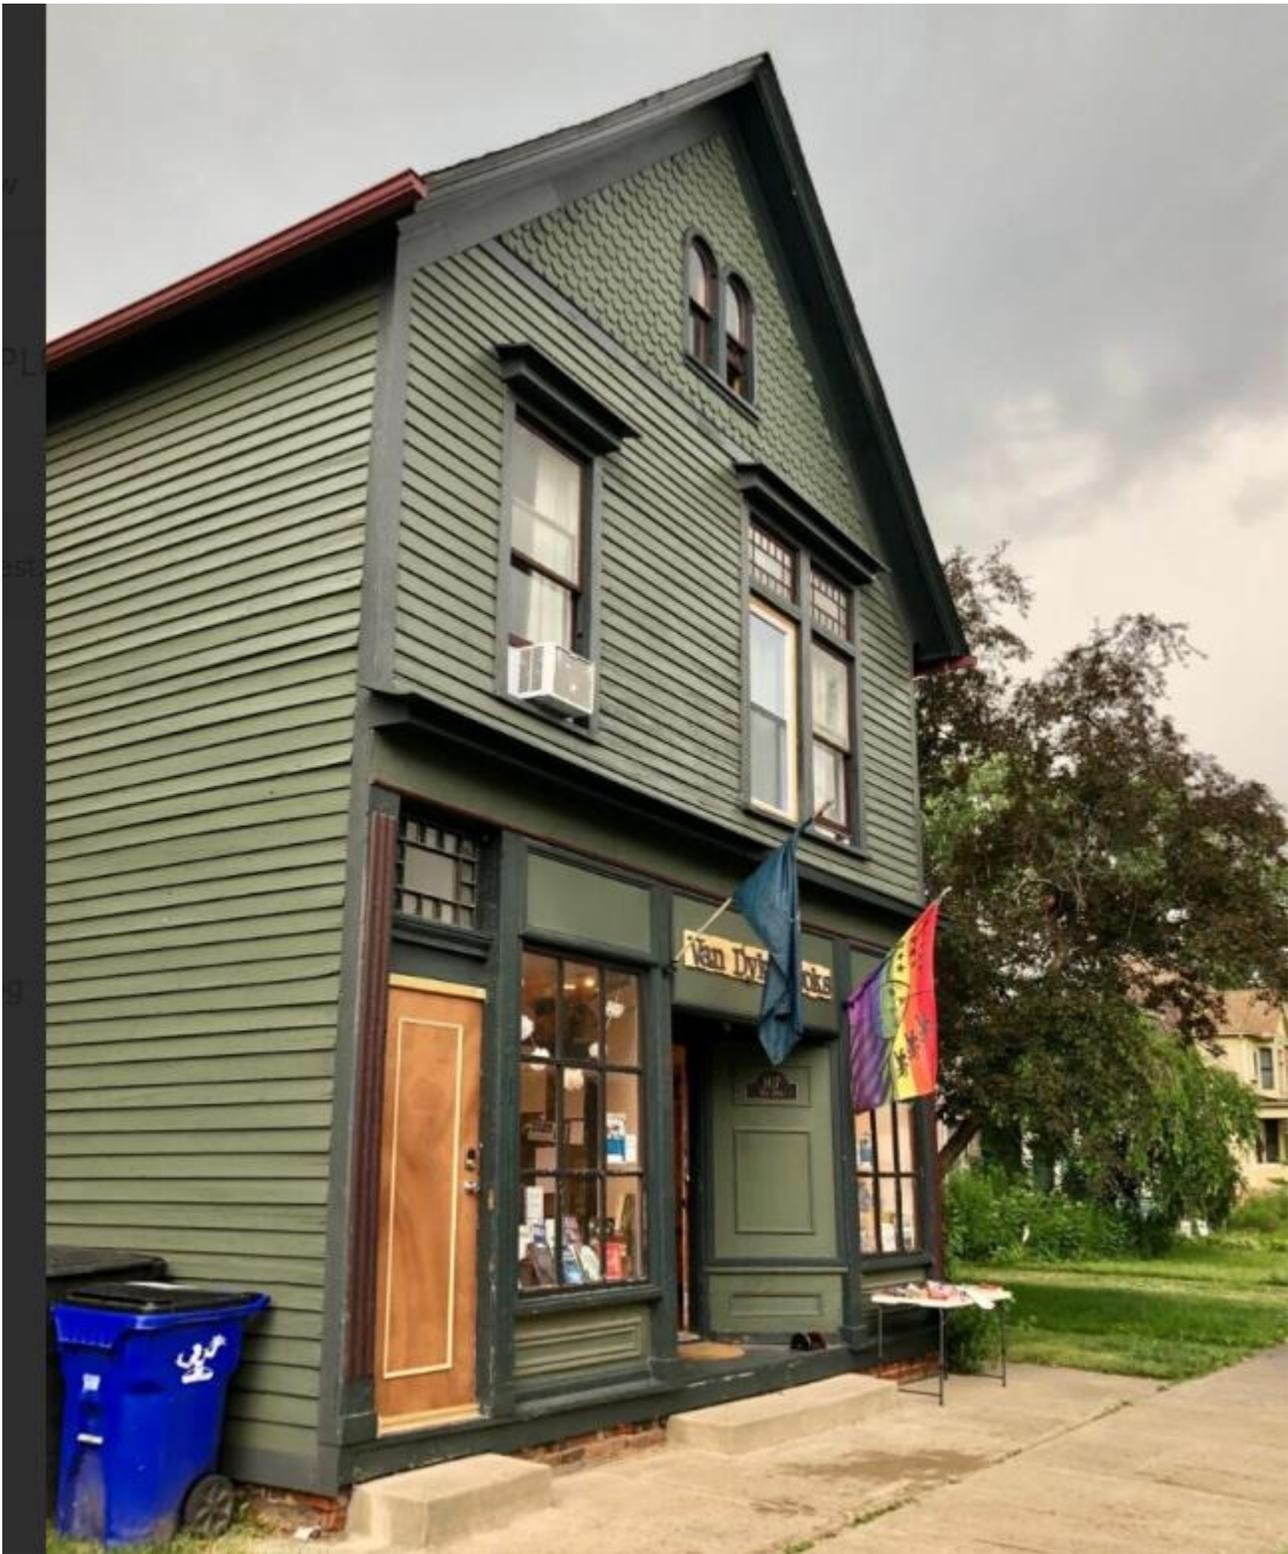
1417 Van Dyke (AFTER), 2024 by HDC staff. Note original lapped wood siding is now revealed and restored
