**STAFF REPORT: OCTOBER 8, 2025 MEETING**

**APPLICATION NUMBER: HDC2025-00577**

**ADDRESS: 19219 WARRINGTON DRIVE**

**SCOPE: REMOVE EXISTING WOOD ROOF SHINGLES AND REPLACE WITH ASPHALT ROOF ON HOUSE AND GARAGE**

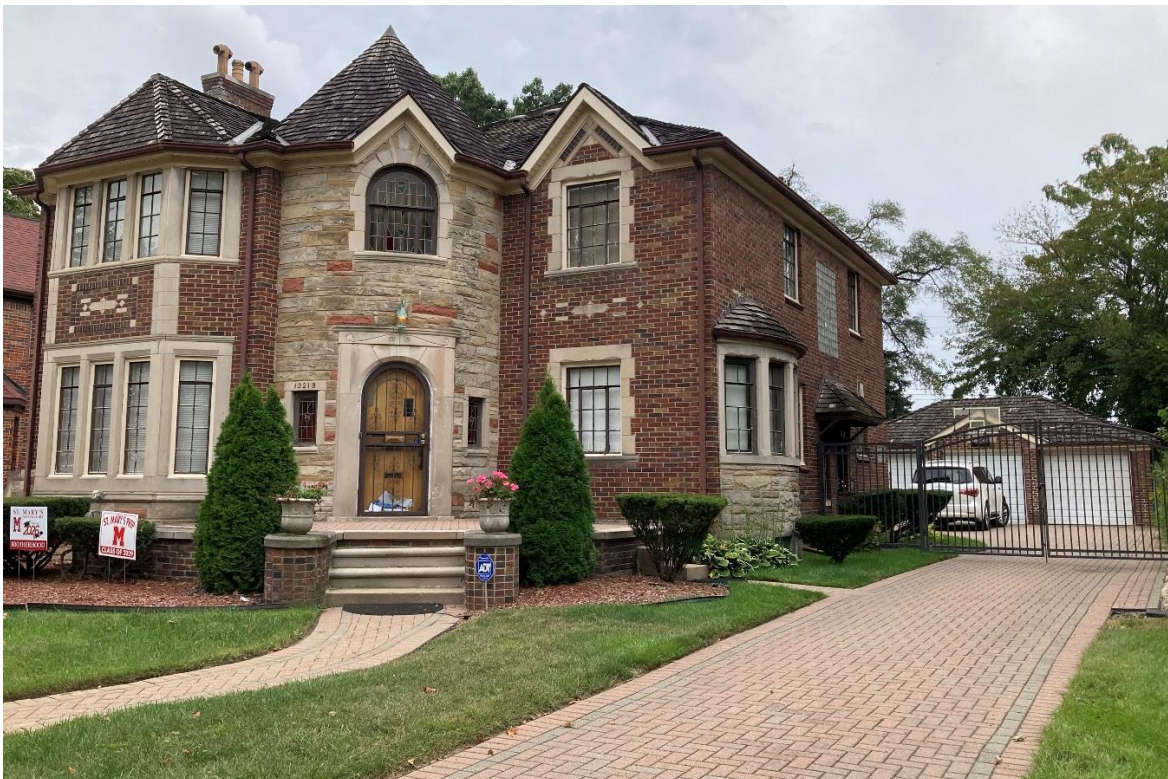
*19219 Warrington Drive, front (east) façade, north side, and garage, September 2025, staff photo. Wood shingle roof evident on both house and garage.*

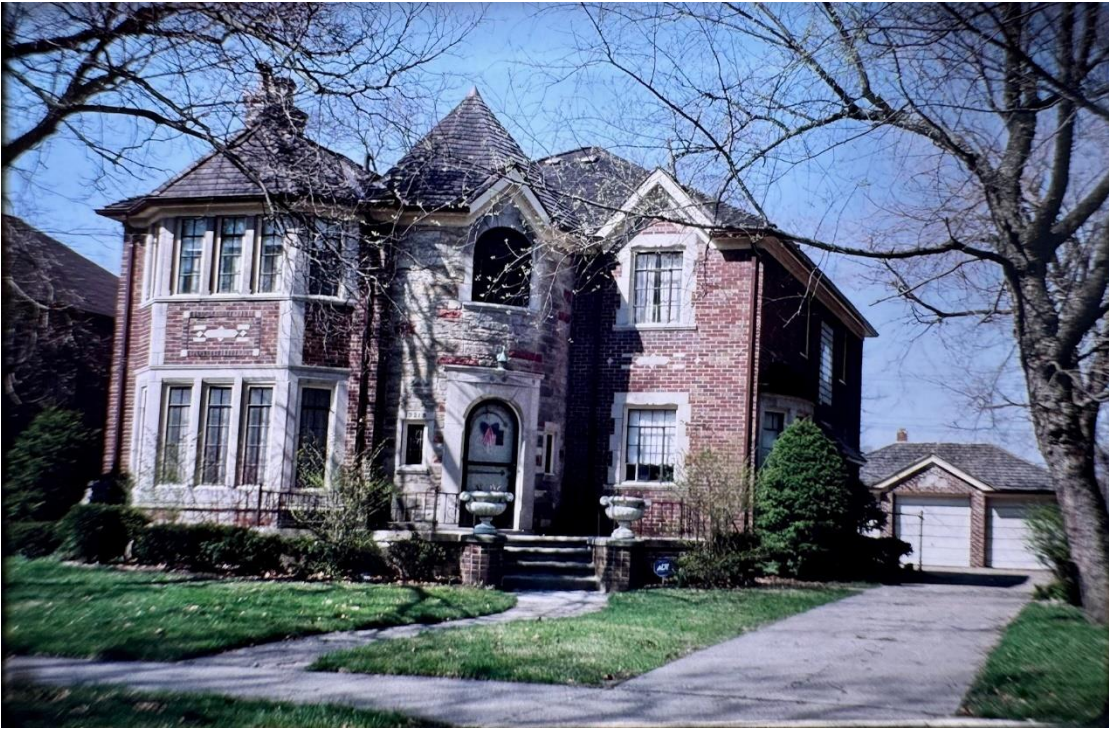
*19219 Warrington Drive, Sherwood Forest, Designation Photo, 2002. Wood shingles were on the house and garage at the time of designation.*

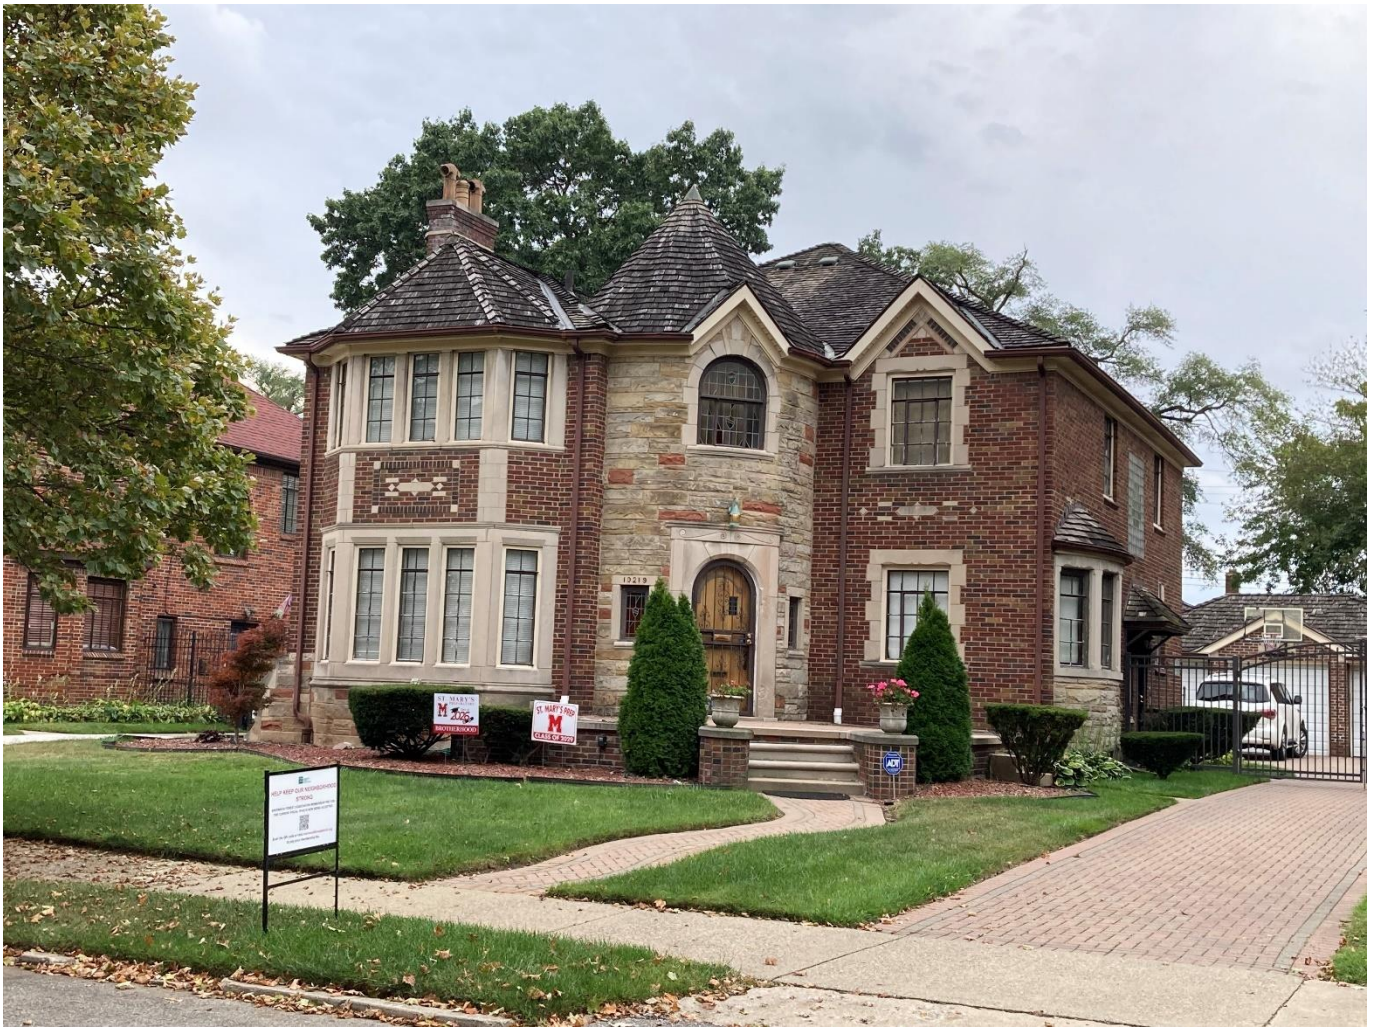
*19219 Warrington Drive, front (east) façade, September 2025, staff photo. Wood shingle roof evident on both house and garage.*

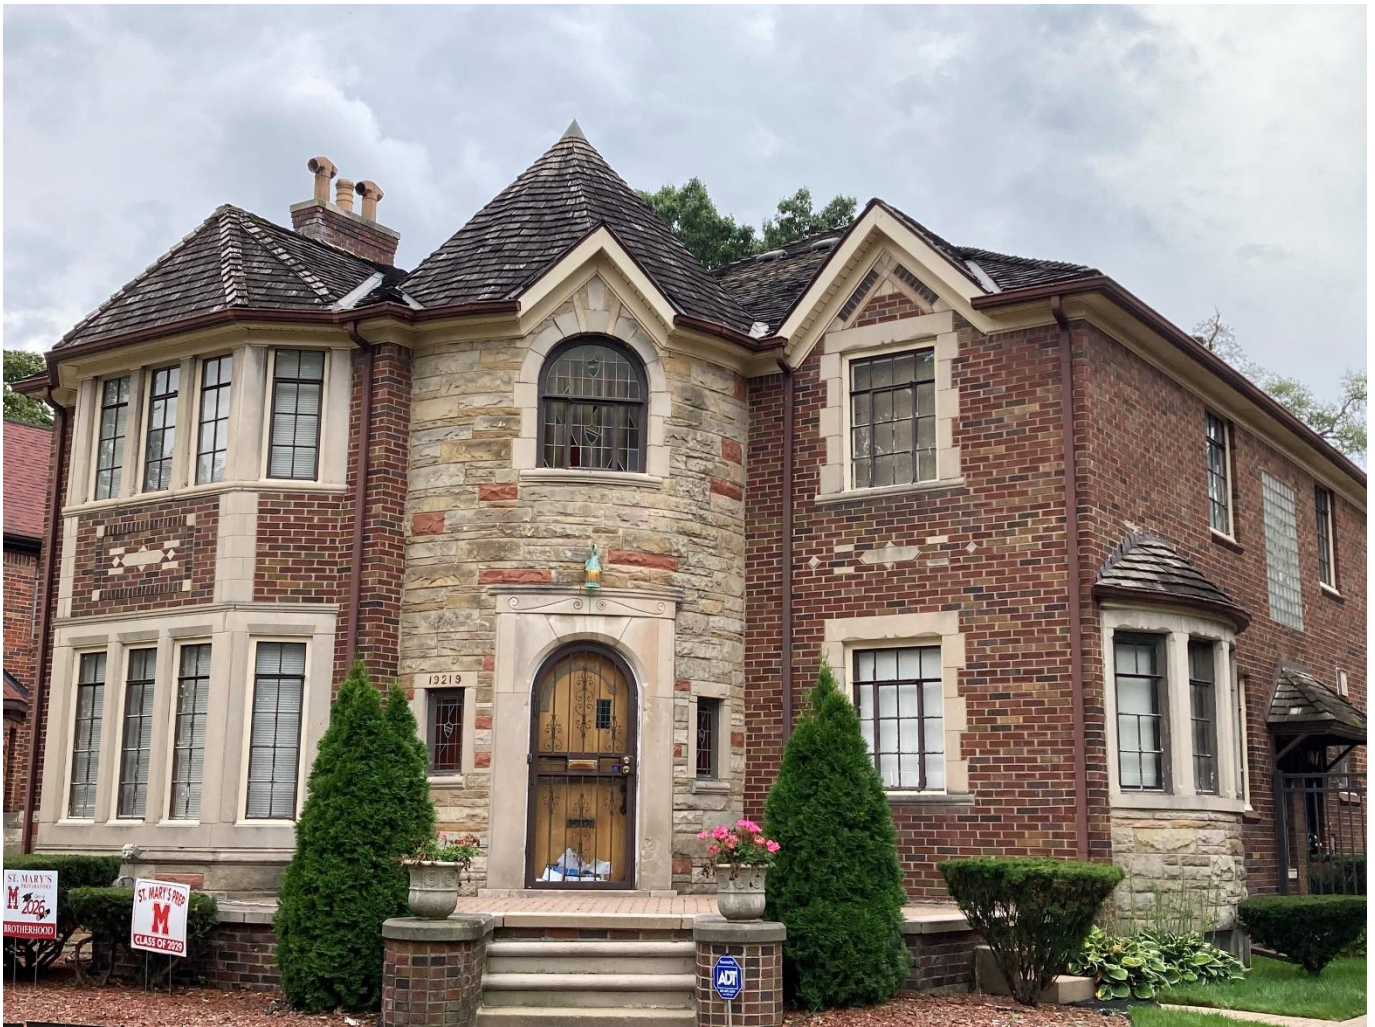
*19219 Warrington Drive, front (east) façade and some of the north side visible, September 2025, staff photo. Wood shingle roof evident on both house and garage.*

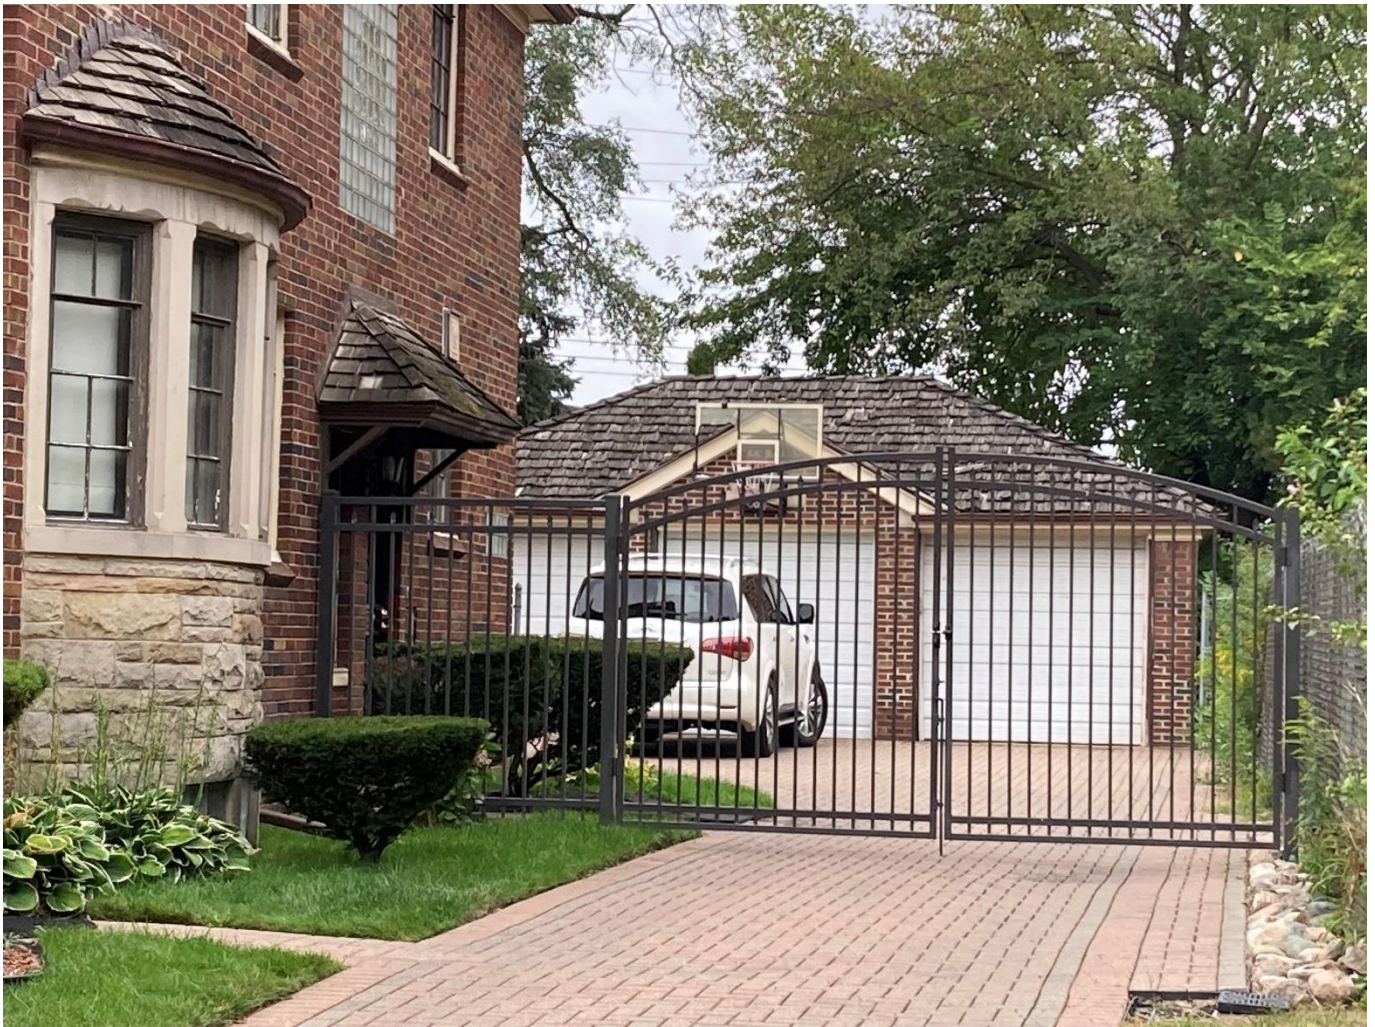
*19219 Warrington Drive, north side bay window and side door elements and garage's east side, September 2025, staff photo. Wood shingle roof evident.*

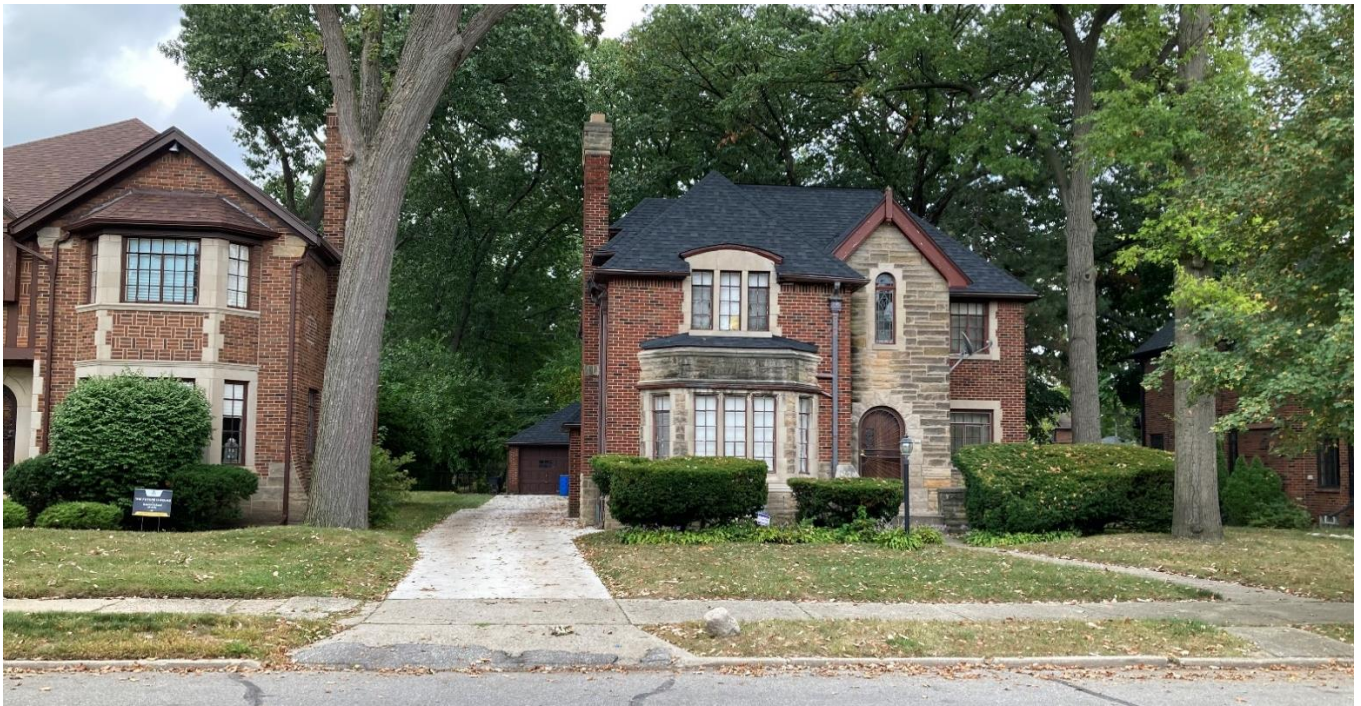
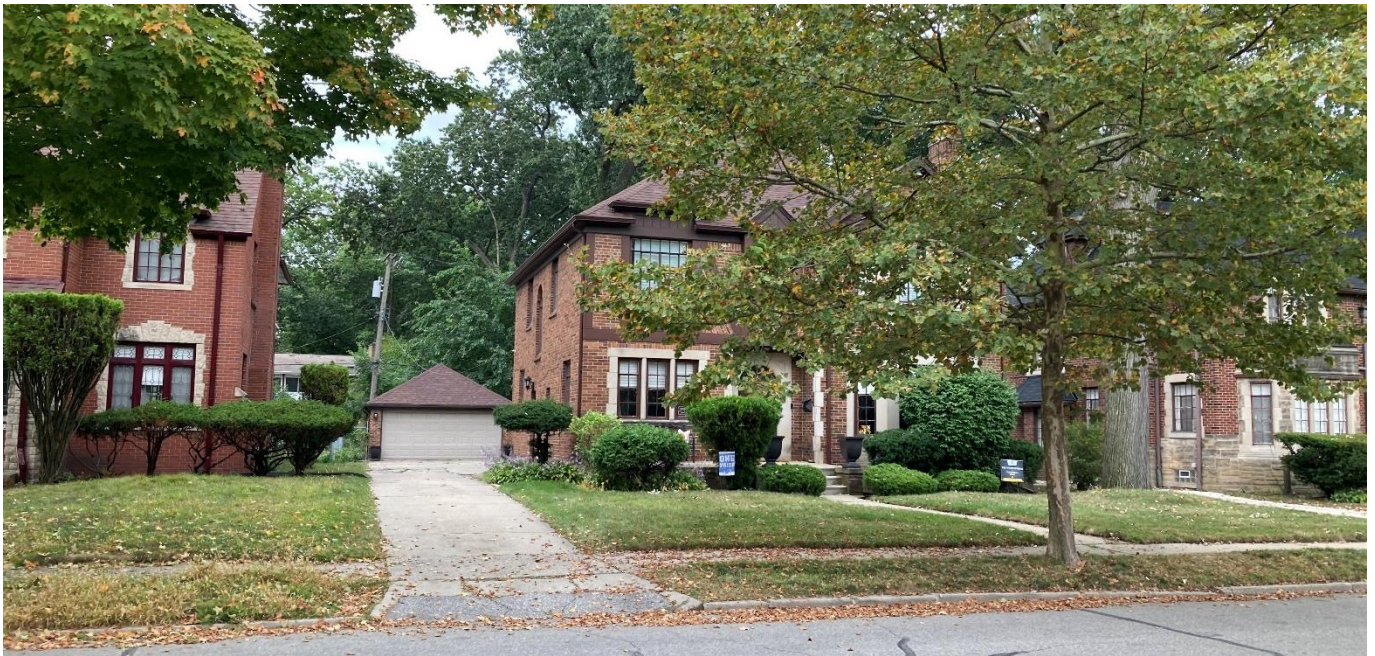
*The two houses above are neighboring houses to 19219 Warrington and their garage roofs match the house roofs.*

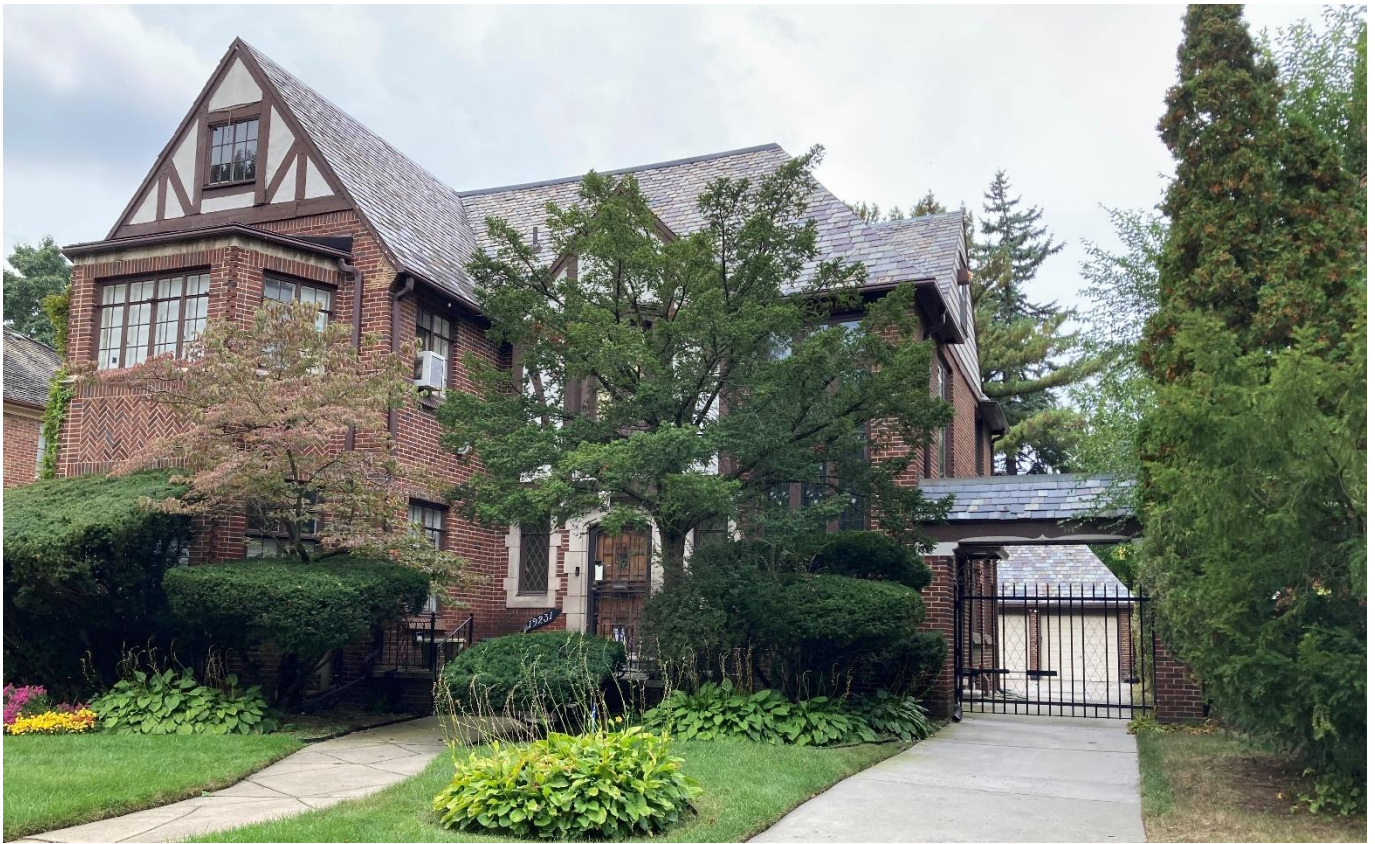
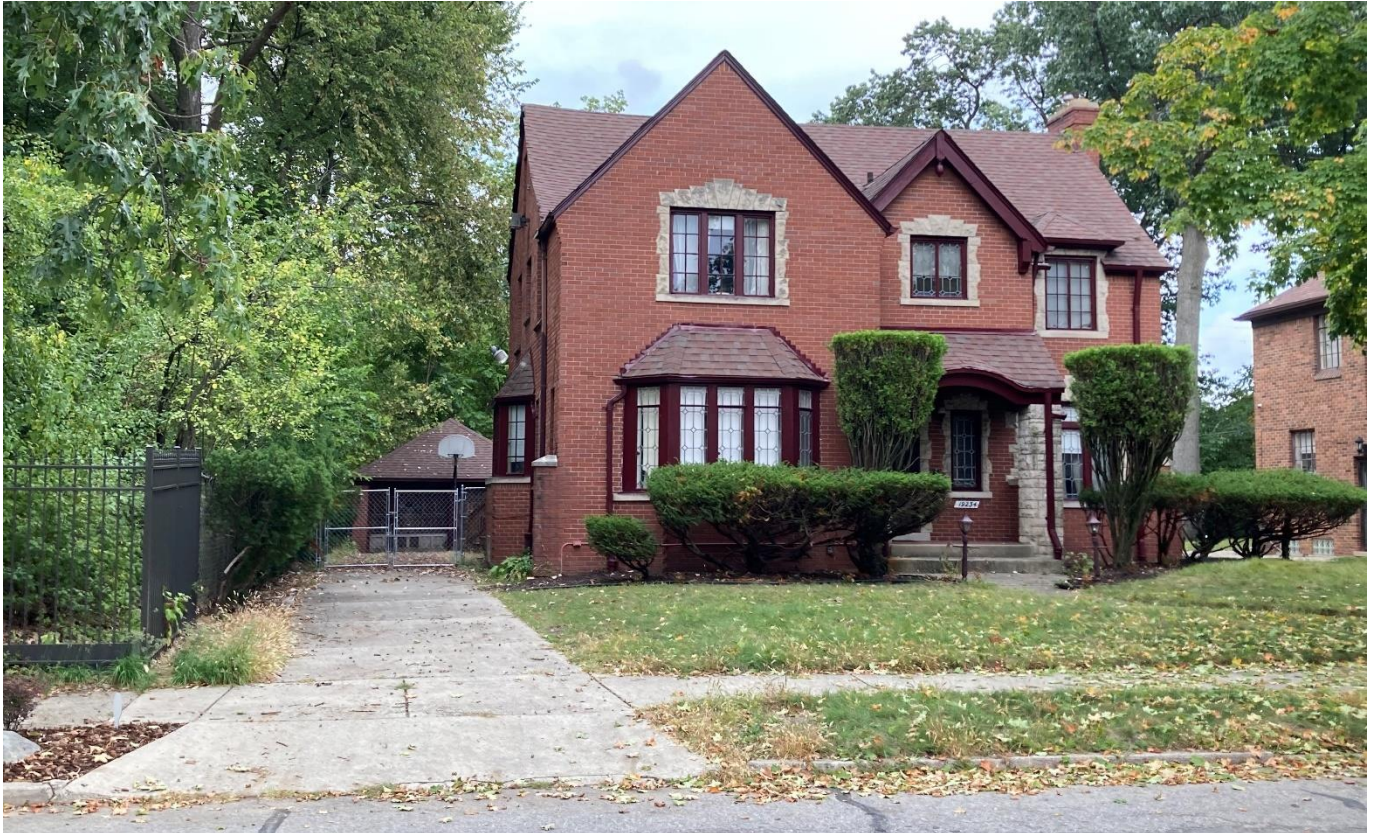
*The two houses above are neighboring houses to 19219 Warrington and their garage roofs match the house roofs.*
