**STAFF REPORT: OCTOBER 8, 2025 MEETING**

**APPLICATION NUMBER: HDC2025-00591**

**ADDRESS: 2233 PARK AVENUE (AKA IODENT BUILDING)**

**SCOPE: REPLACE WOOD WINDOWS WITH ALUMINUM-CLAD WOOD WINDOWS**

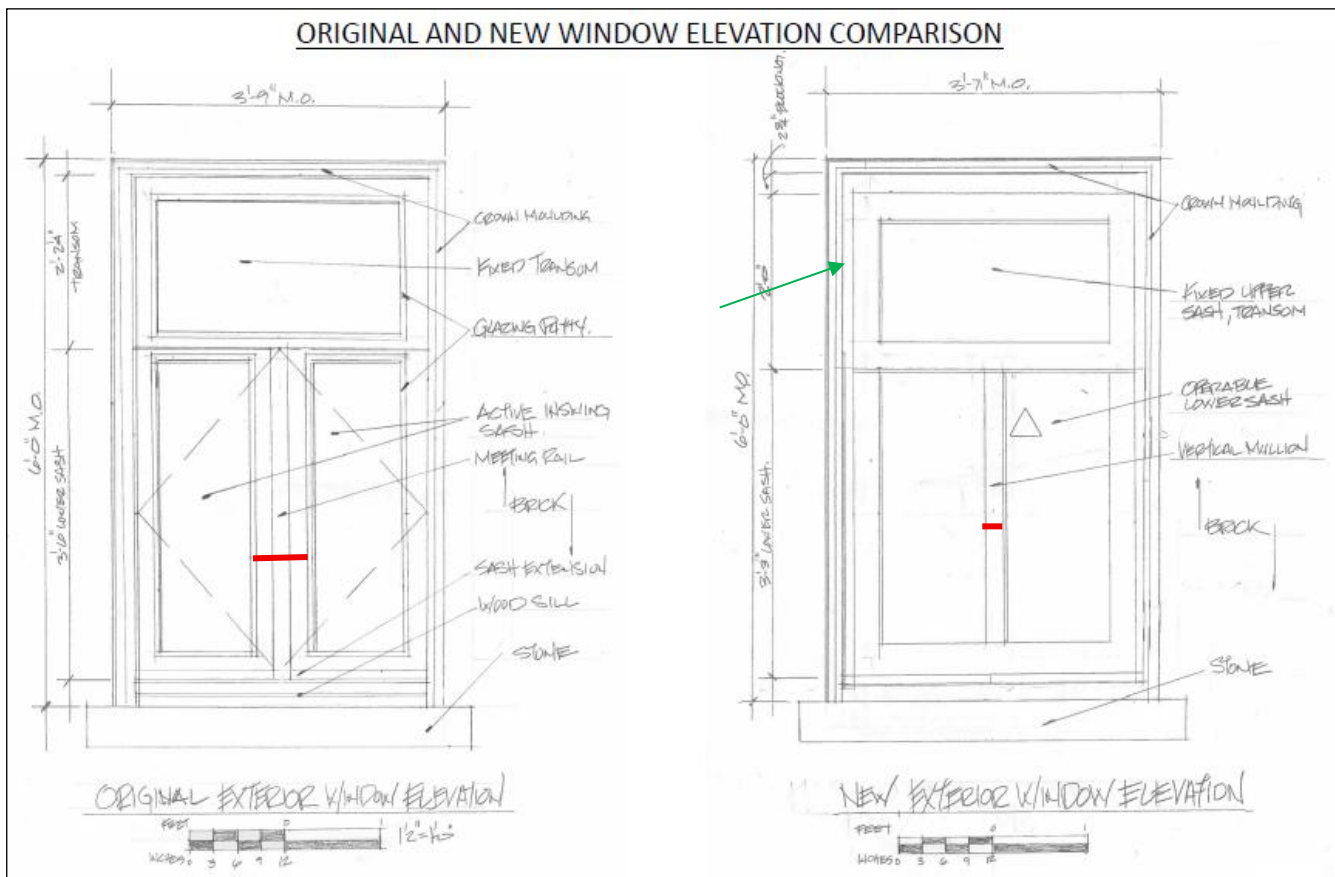
Applicant comparison drawing. The new window elevation shows the extra framing a replacement window has (green arrow), basically a frame within a frame, which is common with most replacement windows and, depending on the details/profile and dimensions of the existing window framing, can offer a widely varying appearance (i.e., much thicker frames and less glass size) to the replacement window when compared with a wood framed historic window.

Measuring the drawings, it appears the width of the original window's vertical element (interior stile of each window frame and central mullion) equals approximately 7" in width, which is more than three times wider than the 2" width of the applied muntin proposed for the replacement window (red horizontal lines).

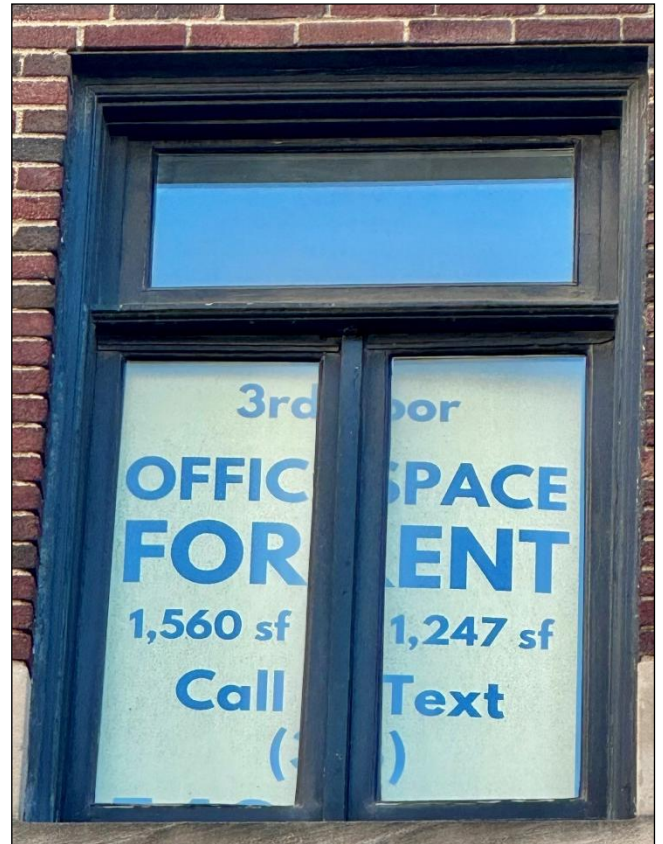
Staff photo, May 2025

Above: Staff photo of one of the historic windows that shows the level of detail and dimensionality to the original framing and mullion.

- The perspective of the building in the above photo offers a clear view of the proportional width of the vertical element created by the closed French windows against the width of the fixed transom’s lower frame, creating an equally dimensioned “T”.

- It is staff's opinion that the existing historic windows are a distinctive character-defining feature of the building. The "T" design creates a uniform division of the window opening, equaling emphasizing the horizontal and vertical patterns of the stone detailing on the three primary exterior walls.
- The applicant's photos of the historic windows (an interior and exterior photo of each historic window is included in the application documents, only one opening is shown here) show wood frames that don't appear to be deteriorated beyond repair; they are intact and retain a smooth paint finish. The level of deterioration to the exterior framing is greater but is proportional to its daily exposure to the elements. The 100+ year old windows appear to be repairable, with most weathering at the horizontal components.

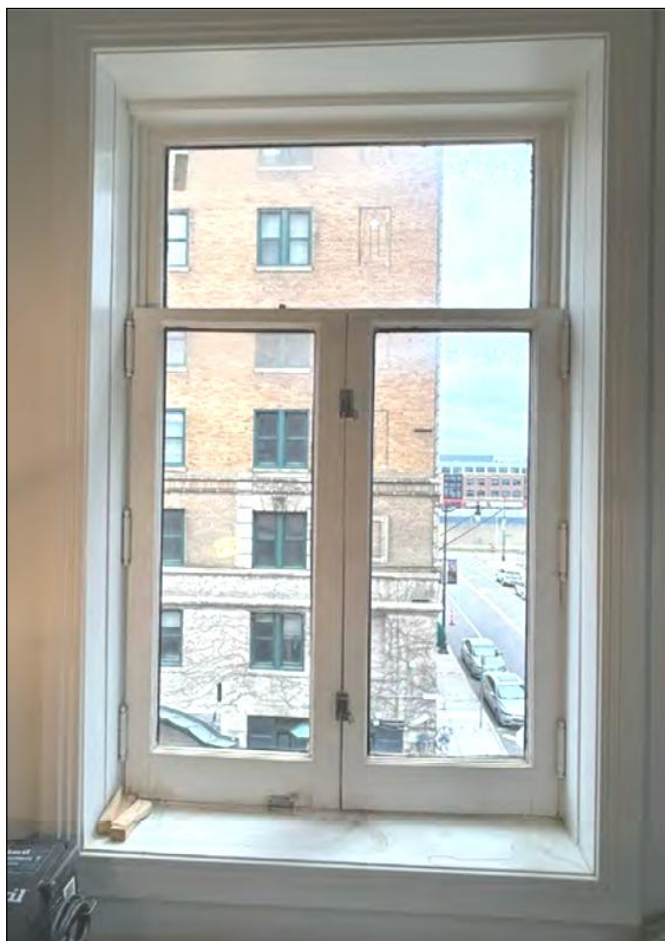
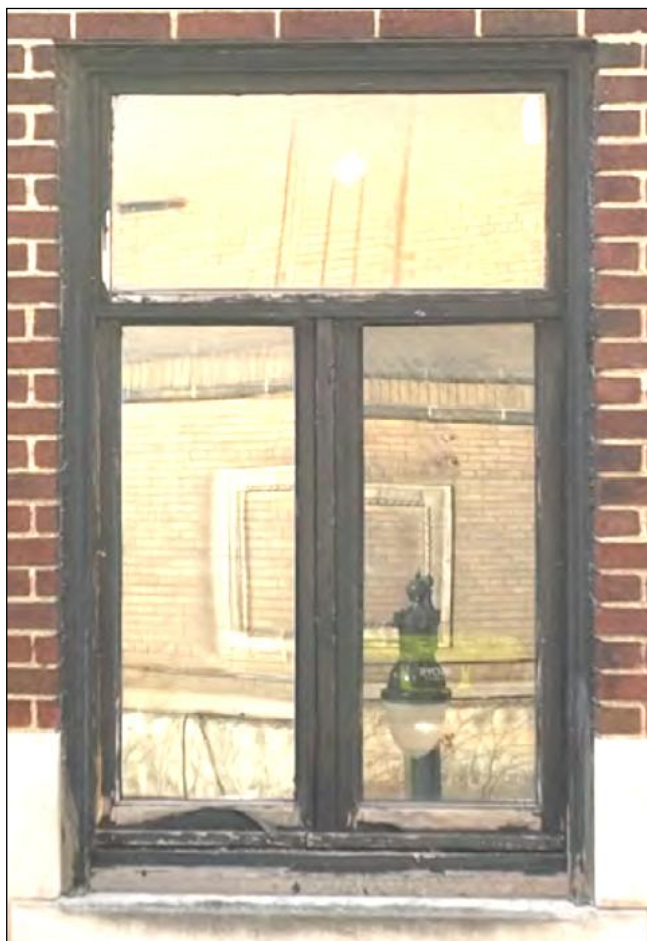
*Window #301 from applicant's documents.*

- The applicant's "Existing Window Building Survey" offers a numerical condition assessment but does not include a correlating written assessment detailing the problems and assessed deterioration of the historic windows. It isn't clear to staff the methodology of the factors used to determine the repair classifications. All original windows were given numbers of 3 (partial replacement) or 4 (total replacement) in conflict with staff's visual assessment; none of them had a 2 (stabilization) or 1 (routine maintenance).

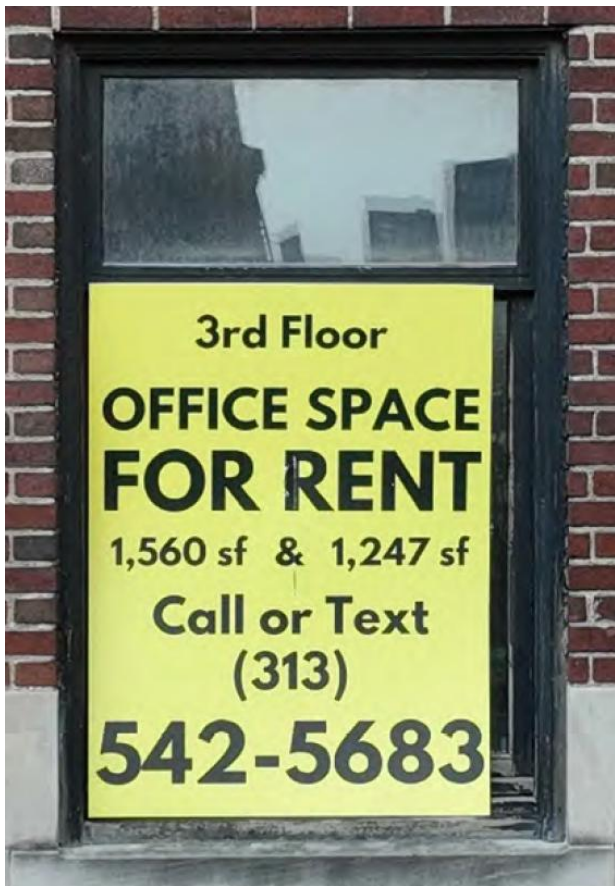
*Window 304 -facade*

- It is staff's opinion that the wood brick mould is a distinctive character-defining feature and is one of the most visible components of a window opening due to its proximity to the masonry wall. The deteriorated areas appear to be at the sill while the remaining vertical and horizontal surface appear to be in good condition. Therefore, this trim does not appear to be deteriorated beyond repair, so its full-scale replacement is not warranted and does not meet Standard 6.
