**STAFF REPORT: OCTOBER 8, 2025 MEETING**

**APPLICATION NUMBER: HDC2025-00129**

**ADDRESS: 863 IROQUOIS (A.K.A. MARTIN S. SMITH II HOUSE)**

**SCOPE: REPAIR/REPLACE LIMITED TRIM AND STUCCO, REPLACE FRONT PORCH COLUMN, REPLACE RIBBON DRIVE (WORK STARTED WITHOUT APPROVAL)**

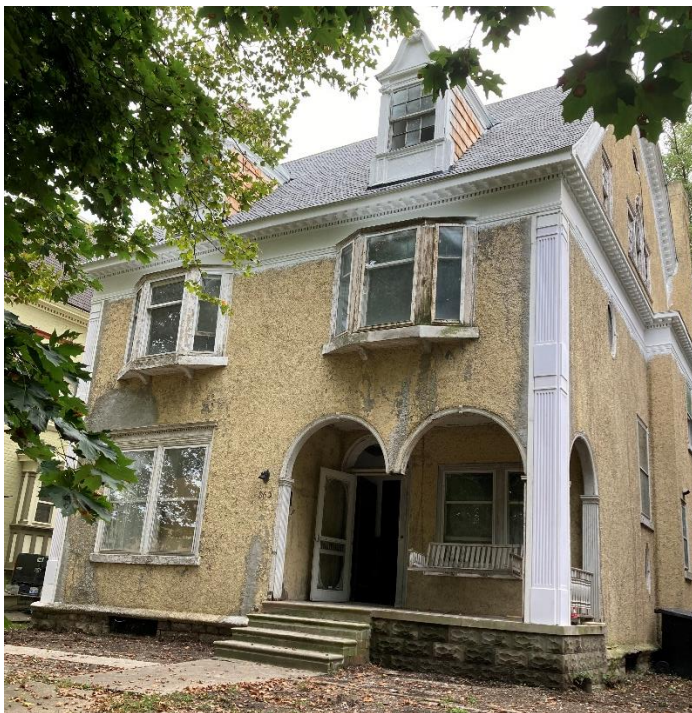
*863 Iroquois, front (east) façade, September 2025, staff photo. Column is missing and vinyl corner boards have been installed.*

- The vinyl corner board trim pieces at the northeast and southeast corners of the house will be removed and replaced with trim that is compatible for the house and meets the Standards. The applicant will submit a replacement corner board proposal to staff for review and approval before the certificate of appropriateness is issued.
- A dimensioned drawing of the porch guardrail and handrail for the steps (if one is proposed) will be submitted to staff for review and approval before the certificate of appropriateness is issued.
- The ribbon driveway will be retained. The concrete may be replaced, but the driveway's form as two ribbons of concrete with dirt between and on either side to support grass must be retained. An updated site plan and quote/contract for the work will be submitted to staff before the certificate of appropriateness is issued.

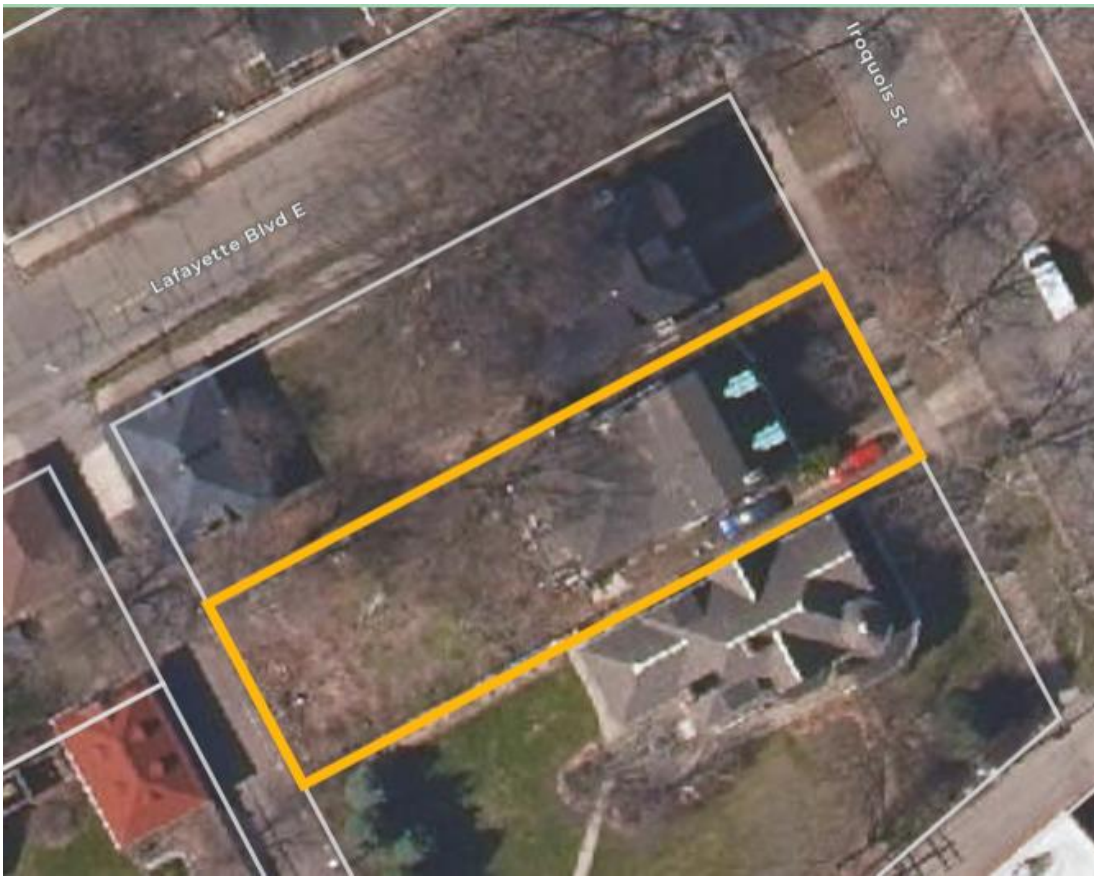
*863 Iroquois, Detroit Parcel Viewer. It appears that the dormers are roofed in copper. The roof work permitted in May specifically excluded work on the dormers.*

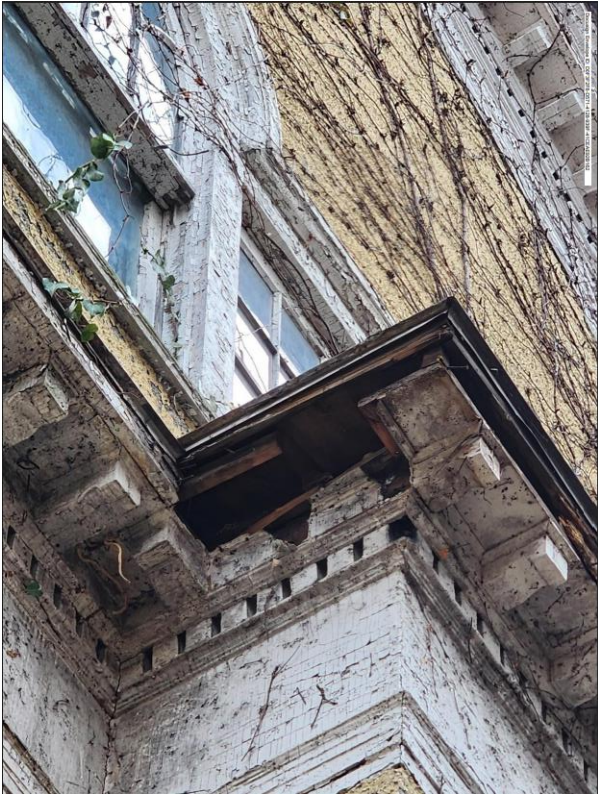
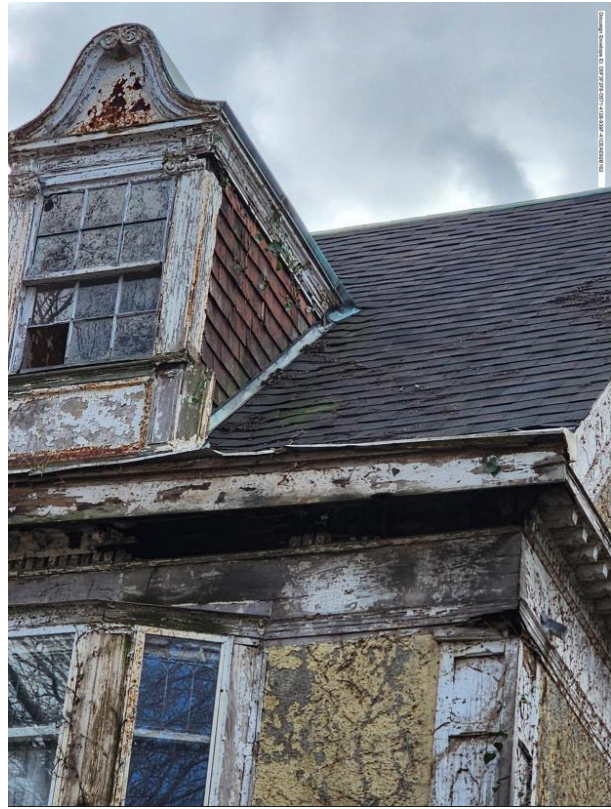
*Applicant photos of wood trim conditions, April 2025. Ornate trim detailing is evident, along with missing and damaged pieces.*

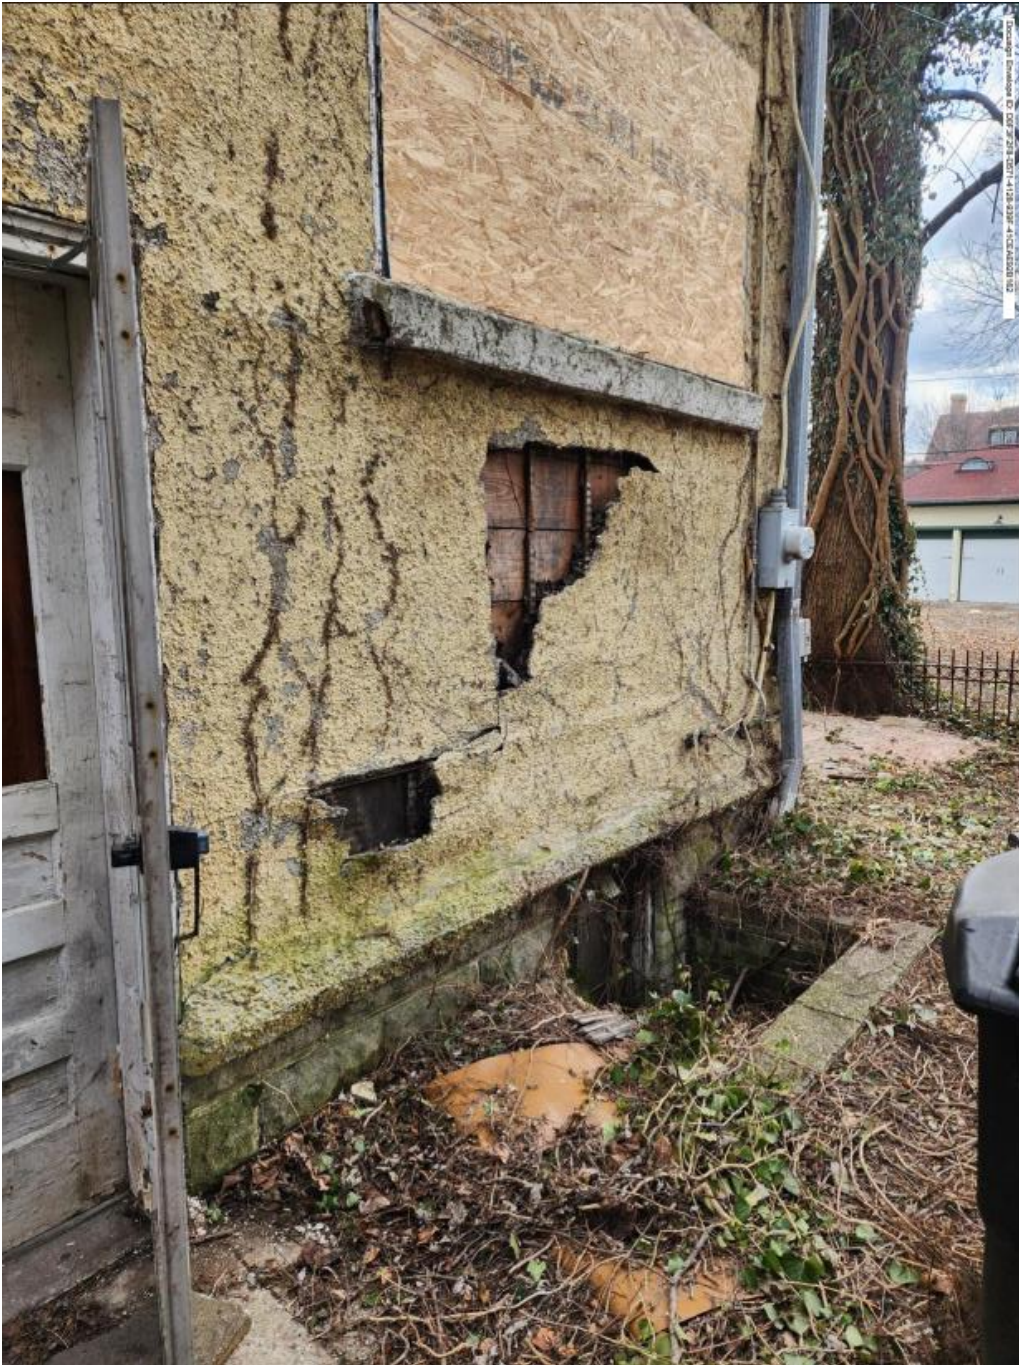
*Sample stucco repair needed, applicant photo, April 2025.*

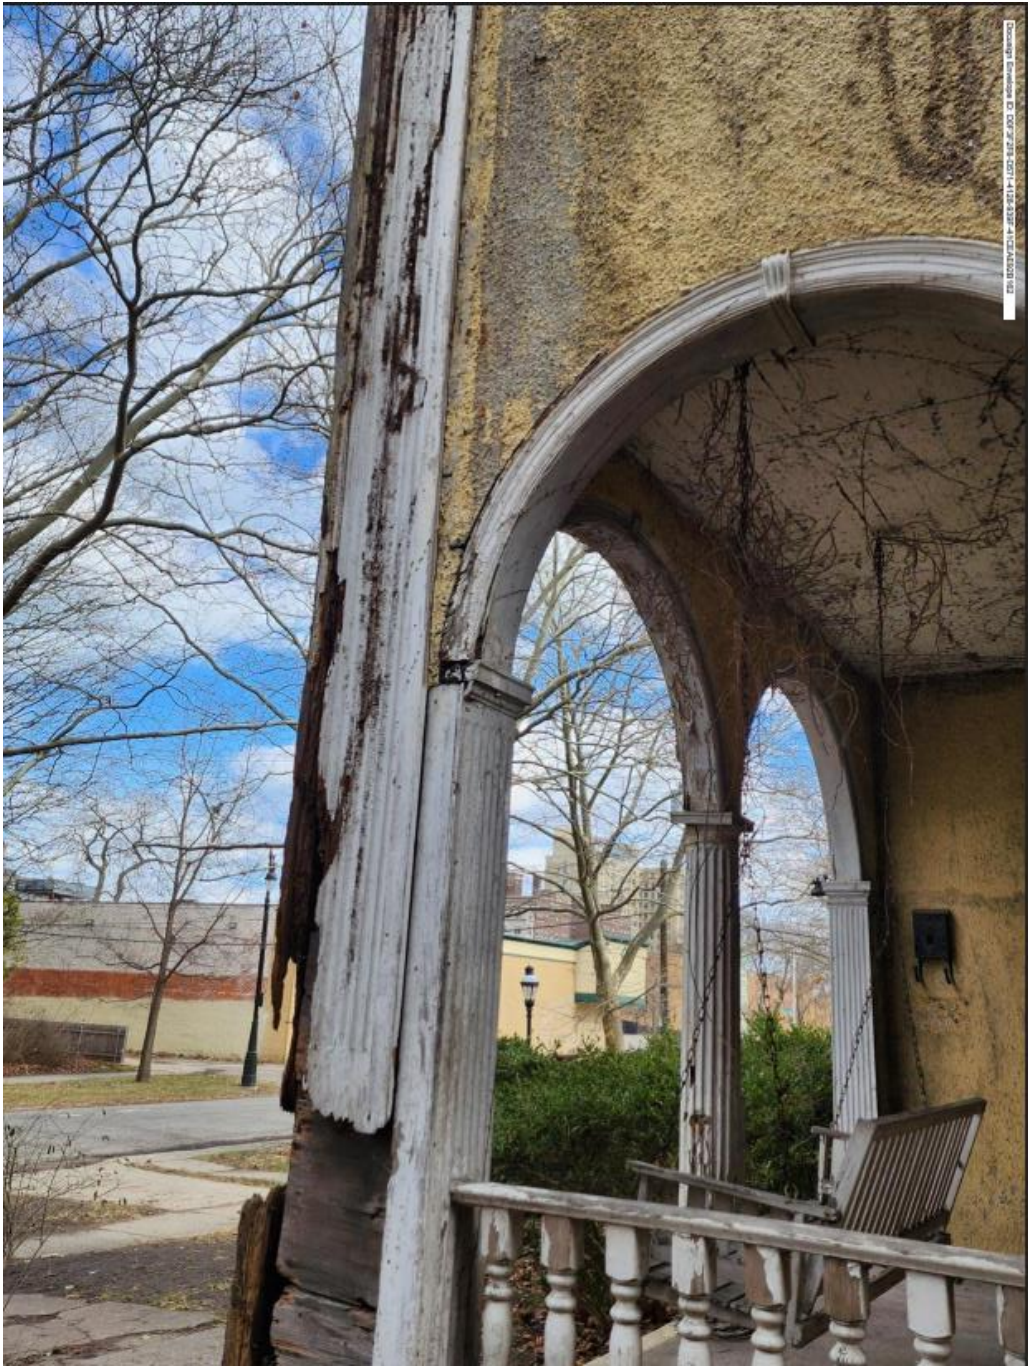
*Northeast corner of house, deteriorated corner board visible. Wood pilasters, column, and guardrail are all visible, April 2025, applicant's photo. In Applicant's Cycle 3 response on May 5, applicant described that the porch's column, corner boards, and trim would be replicated in wood exactly. Applicant clarified on September 3 (Cycle 4 application materials) that the porch's wood pilasters will be retained and preserved but the corner boards have been replaced.*

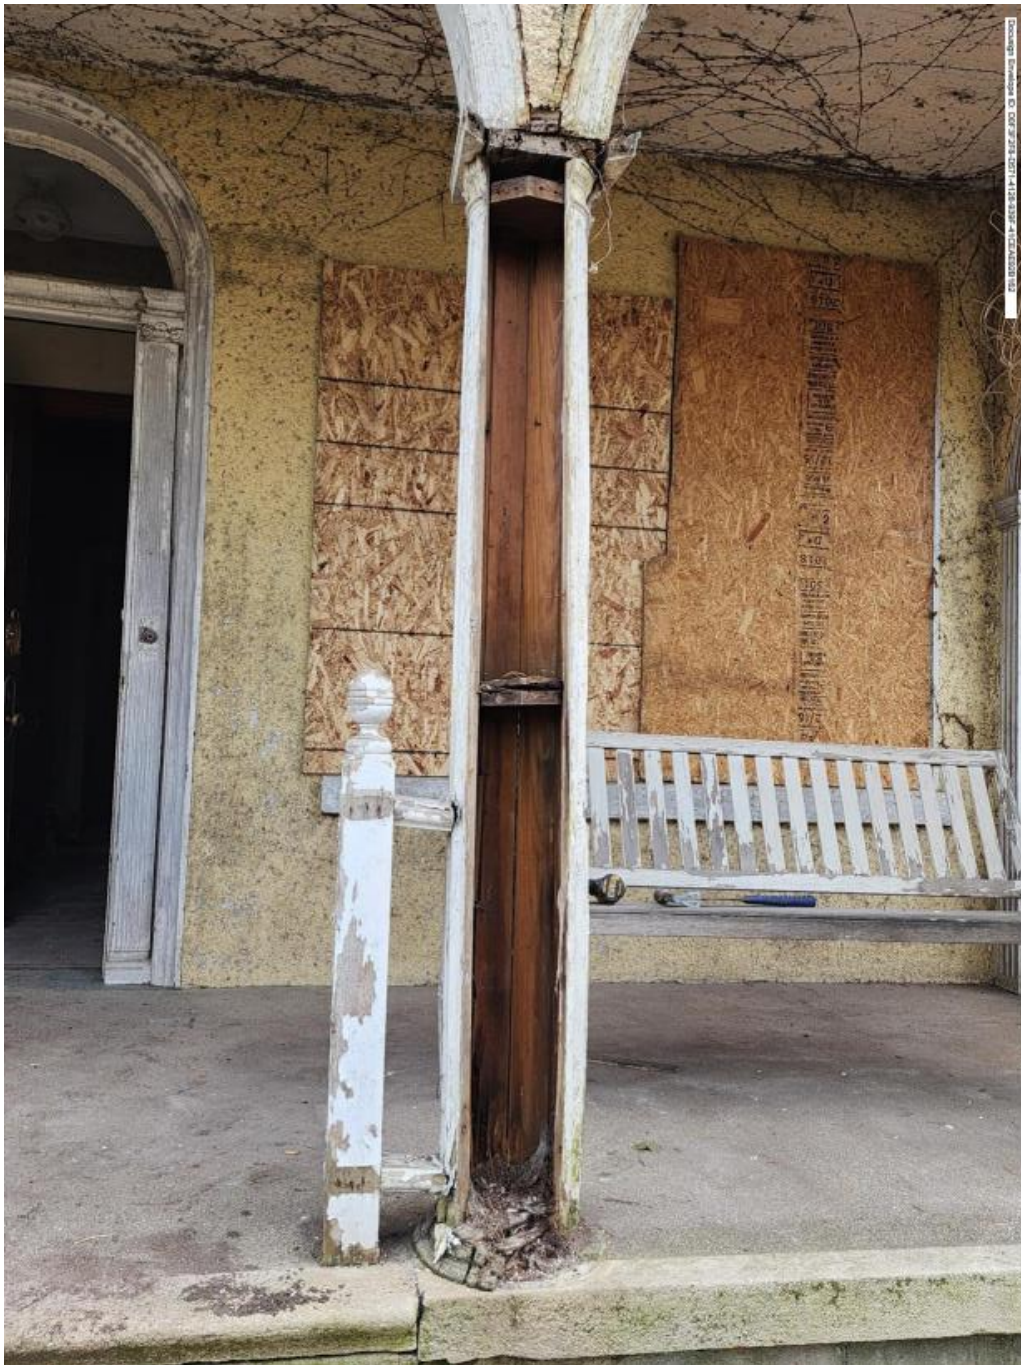
*Applicant's photo, April 2025. Porch column half removed, base is in poor condition. Newel post visible to support the handrail for the steps.*

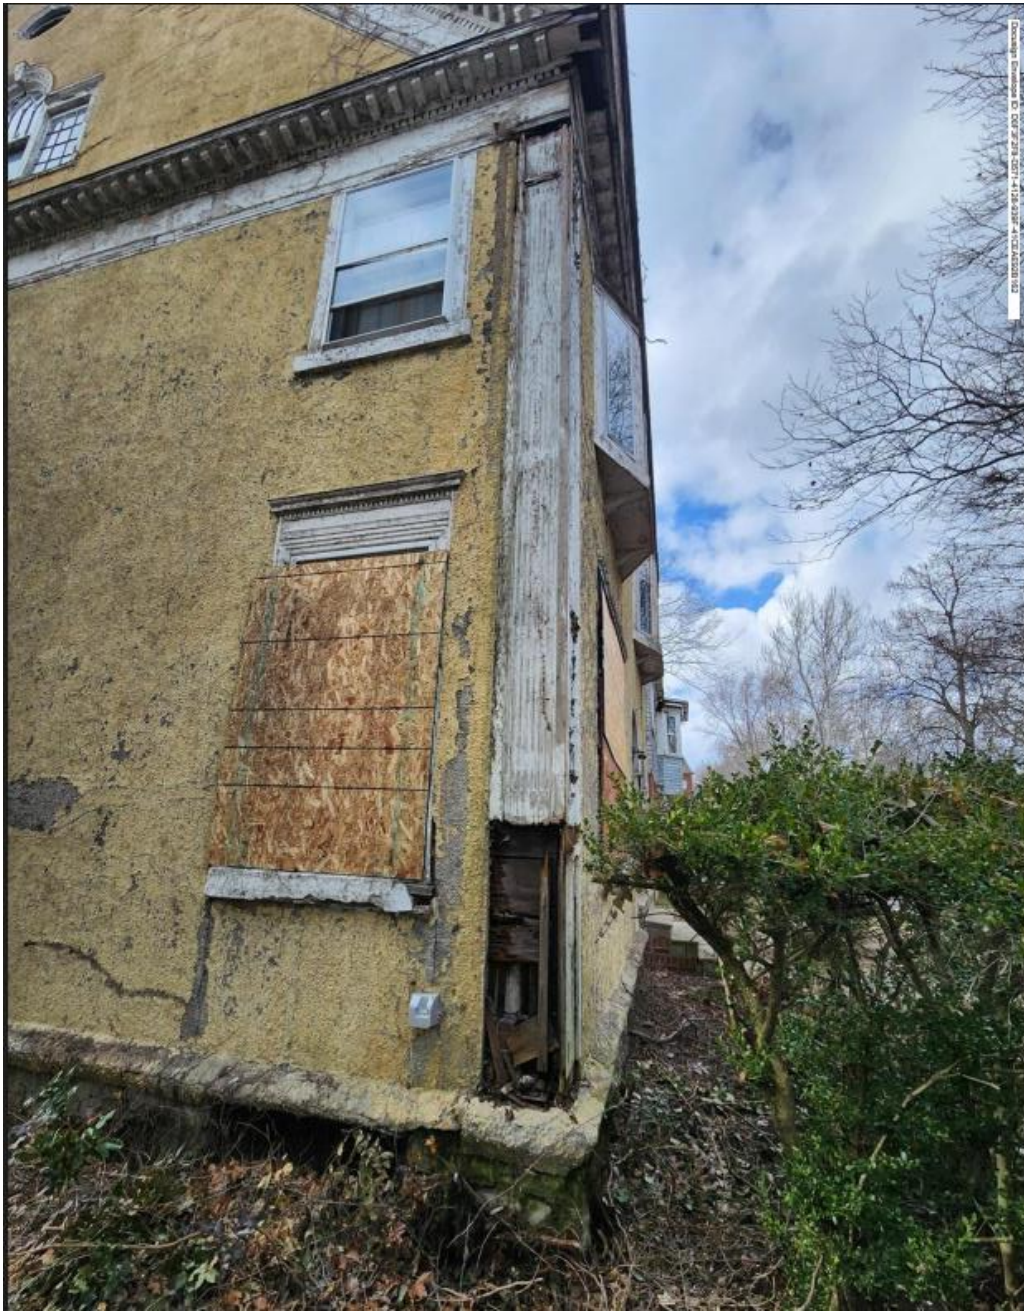
*Applicant's photo, April 2025. Southeast corner corner board, partially removed. The elaborate trim details and ornate windows are visible here on the house's south side.*

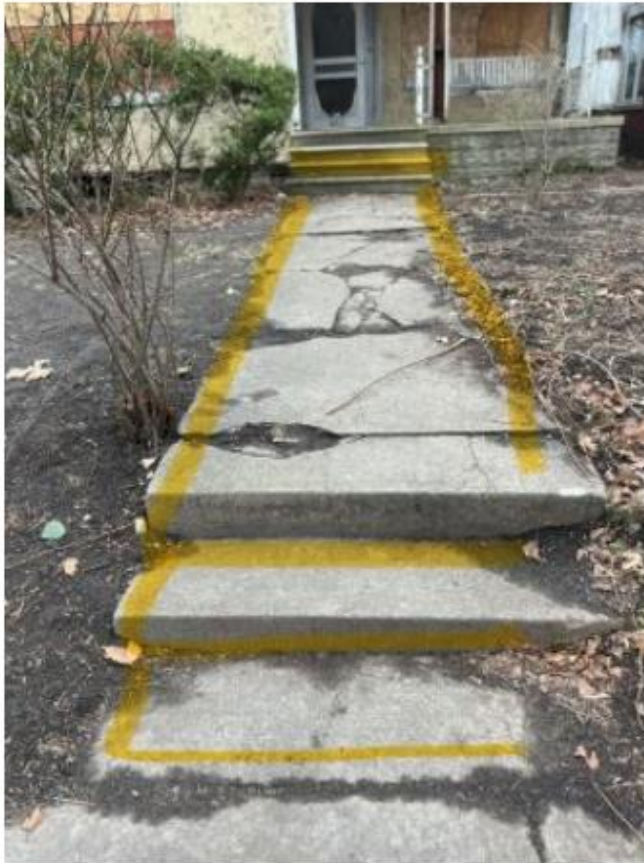
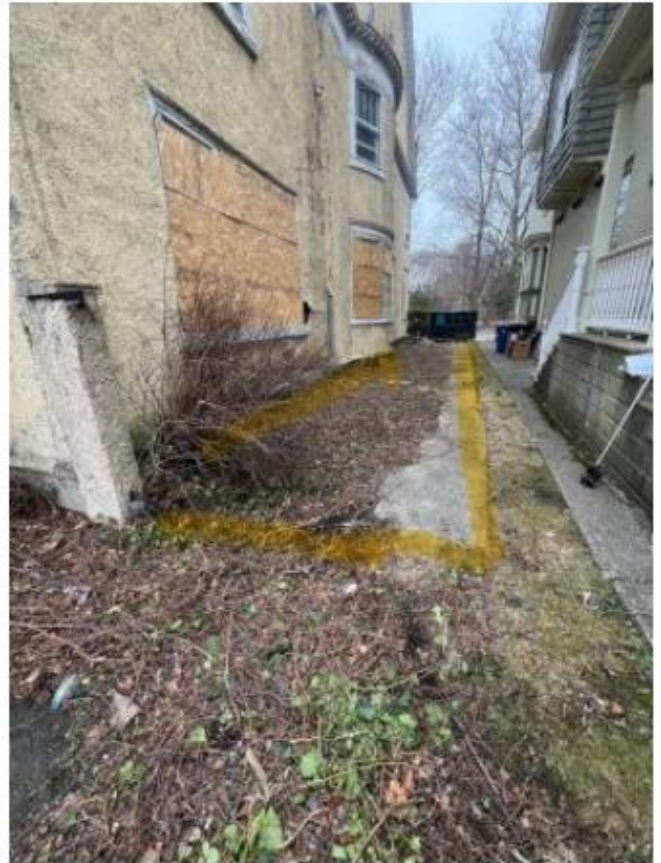
*Applicant's April 2025 photos of the walkway and driveway where concrete removal and new concrete installation are proposed. The limestone front porch steps were initially included in the April scope of work, and then the applicant indicated in a later clarification (May 5 2025, Cycle 3) that they would instead be preserved.*

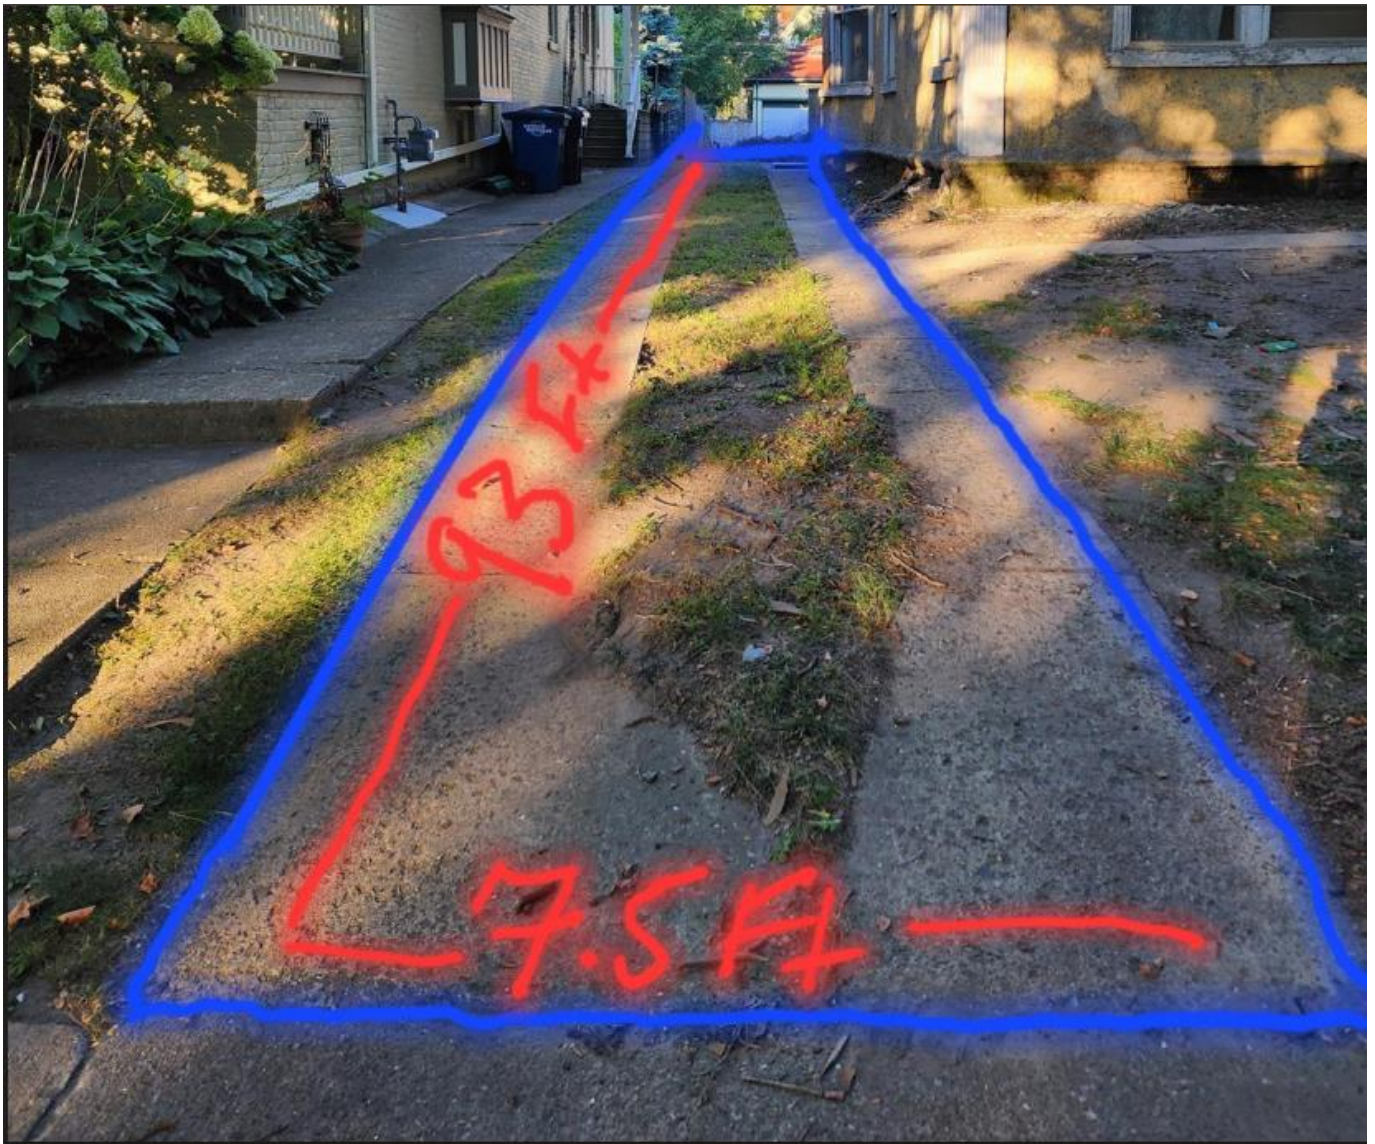
*Applicant photo of new proposed driveway location, from September 2025 Cycle 4 materials. Driveway currently is a ribbon drive, and it is proposed to become a solid, full-width concrete drive.*

The applicant's marked-up photo from September showing the driveway at 863 Iroquois shows a strip of green remaining on either side of the concrete ribbons, eliminating only the green strip between. However, as 1438 Iroquois shows, above, the solid concrete drive looks different from the street than the narrow ribbons. The green strips on either side would soften the effect of the drive, but that center island of green between the concrete ribbons is probably the most effective at breaking up the driveway and softening its effect. A ribbon drive has been present at 863 Iroquois since the time of designation, and probably for many years prior to designation. A building permit application on file in the Planning Department sought to replace the concrete ribbon drive with the same in 1981. If it needed to be replaced in 1981, it very likely was on this site in this form since cars (and garages) became commonplace in the 1920s. As such, it seems to staff that the ribbon drive at 863 Iroquois is a historic feature of the site and should be preserved. It appears to be a somewhat unique condition in the immediate neighborhood worthy of preservation.

- A dimensioned drawing for the porch railing (and handrail if there will be one) would help ensure compatibility and compatible proportions.
- The proposed removal of the concrete ribbon drive and installation of a solid drive does not meet the Standards because the ribbon drive is a historic feature of 863 Iroquois and should be preserved. The driveway interrupted by greenery/grass also better satisfies the district's Elements of Design by intimating walking paths to the rear of the property, and those walking paths are a feature of the district.

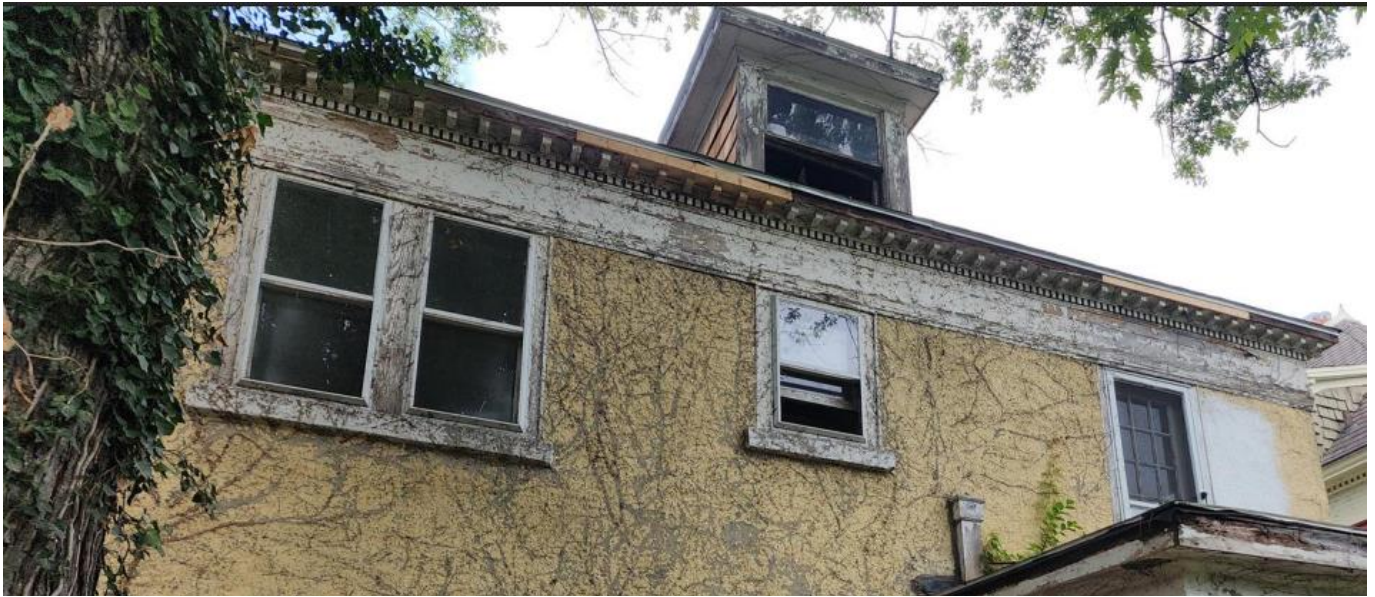
*Applicant's photo, September 2025, some like-for-like wood trim repairs are visible.*

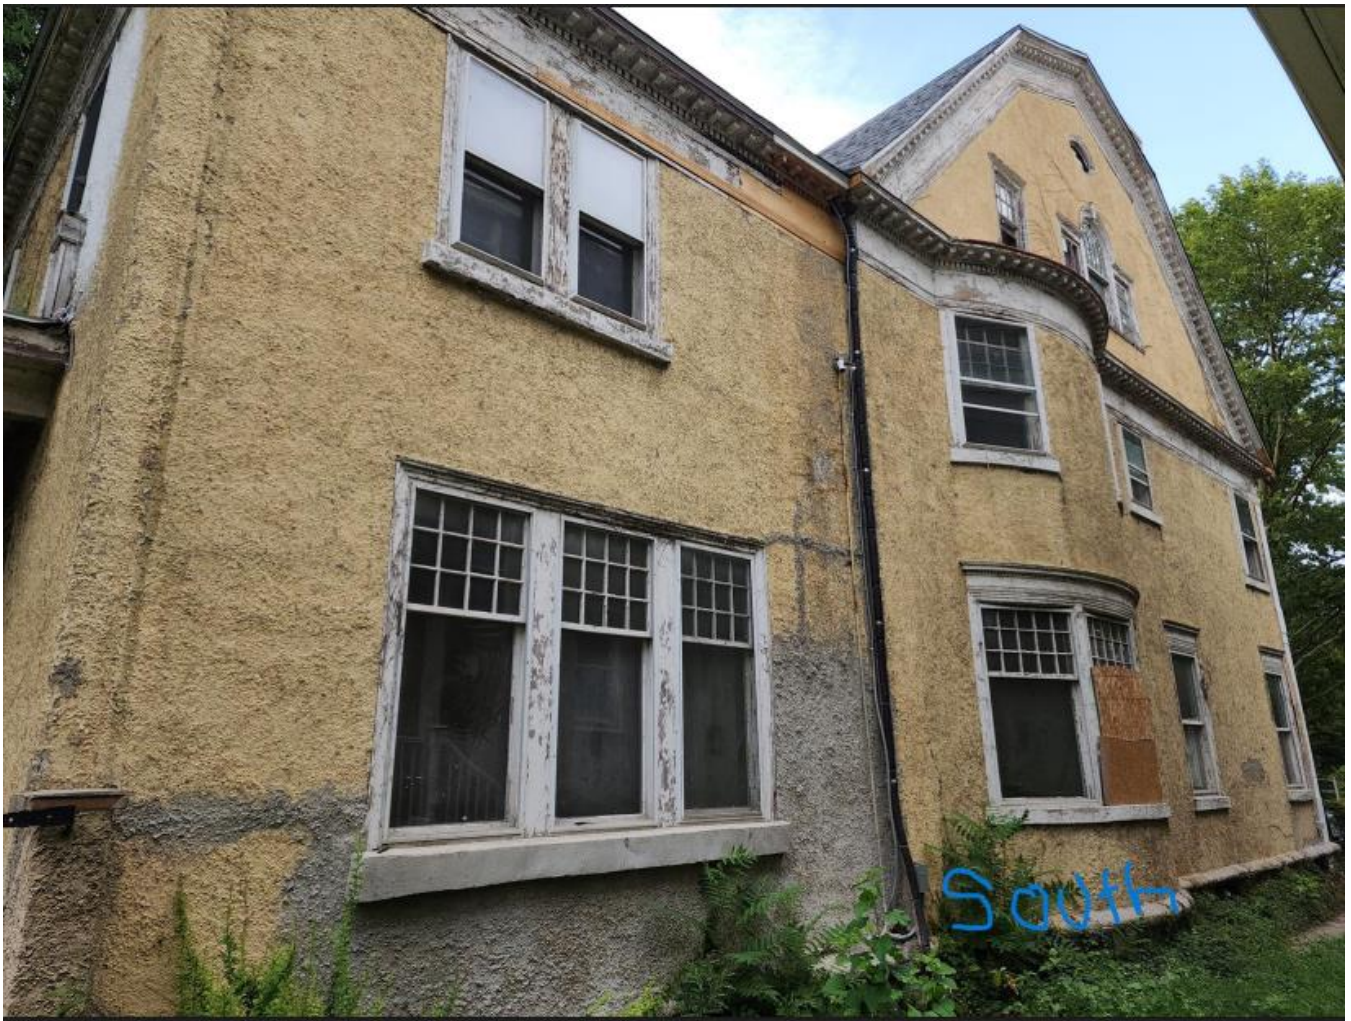
*Applicant's photo, September 2025, from Cycle 4 application materials. Some like-for-like wood trim repairs are visible, as well as some of the house's highly detailed windows mentioned previously.*

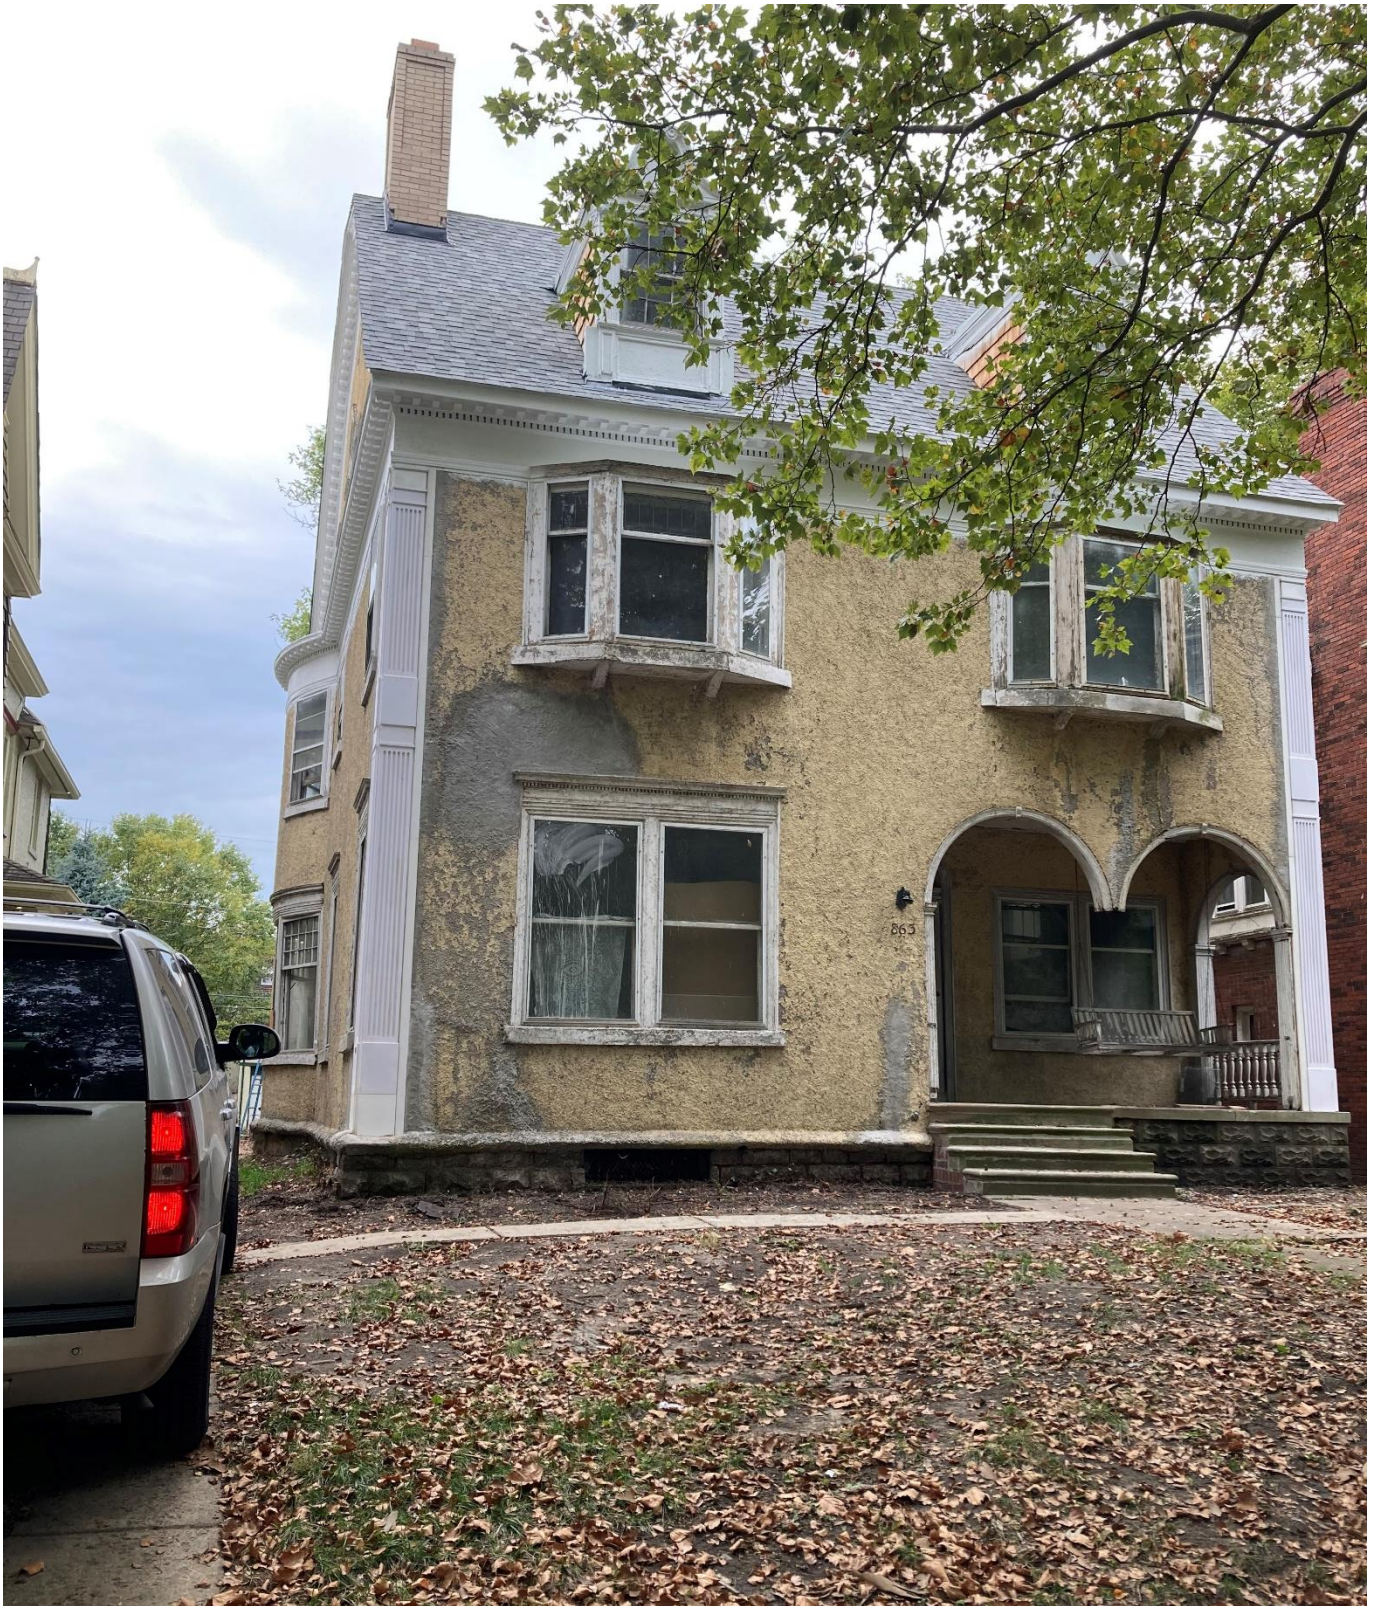
*East (front) end of house, with south side barely visible, trim repairs in cornice complete, vinyl corner boards installed, some stucco repairs have been started, and porch column is missing, staff photo, September 2025.*

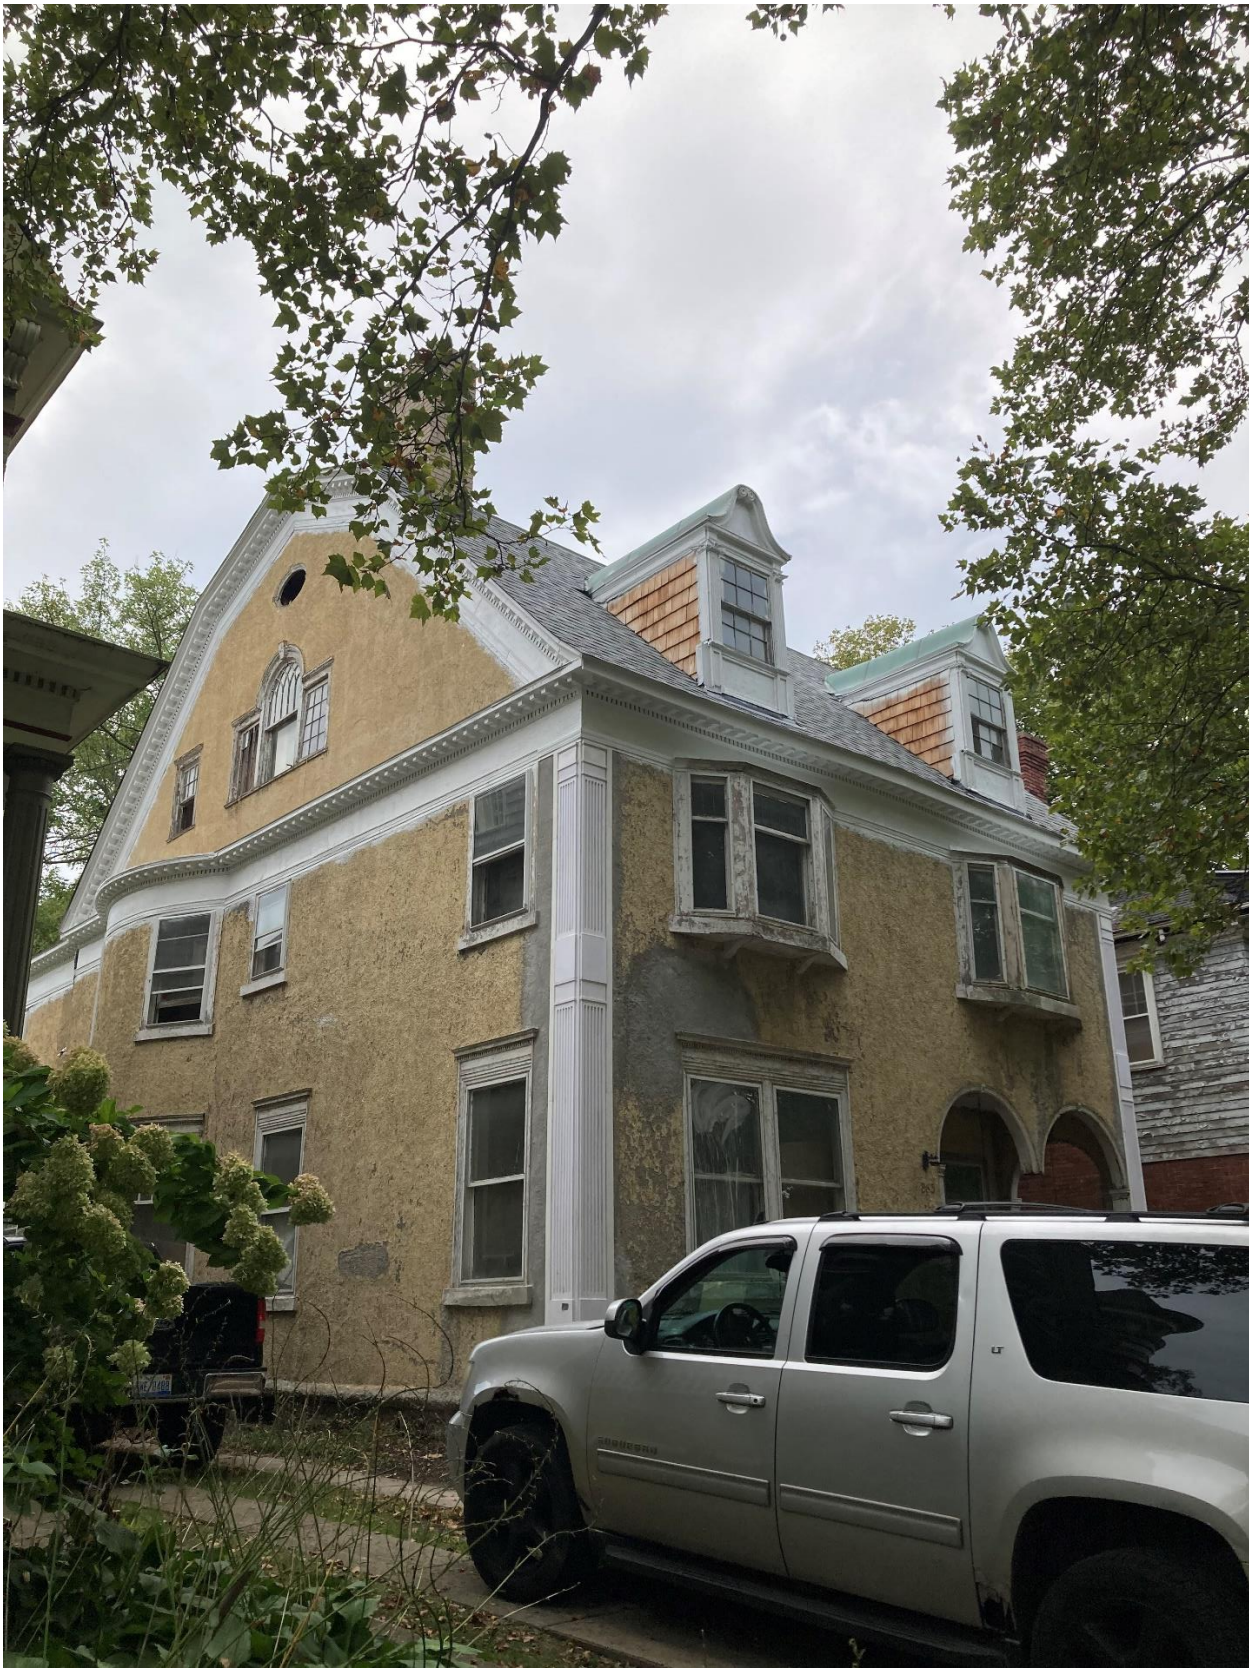
*Staff photo, September 2025, more of the south side is visible, along with the ribbon drive. Copper roofs on dormers are visible.*

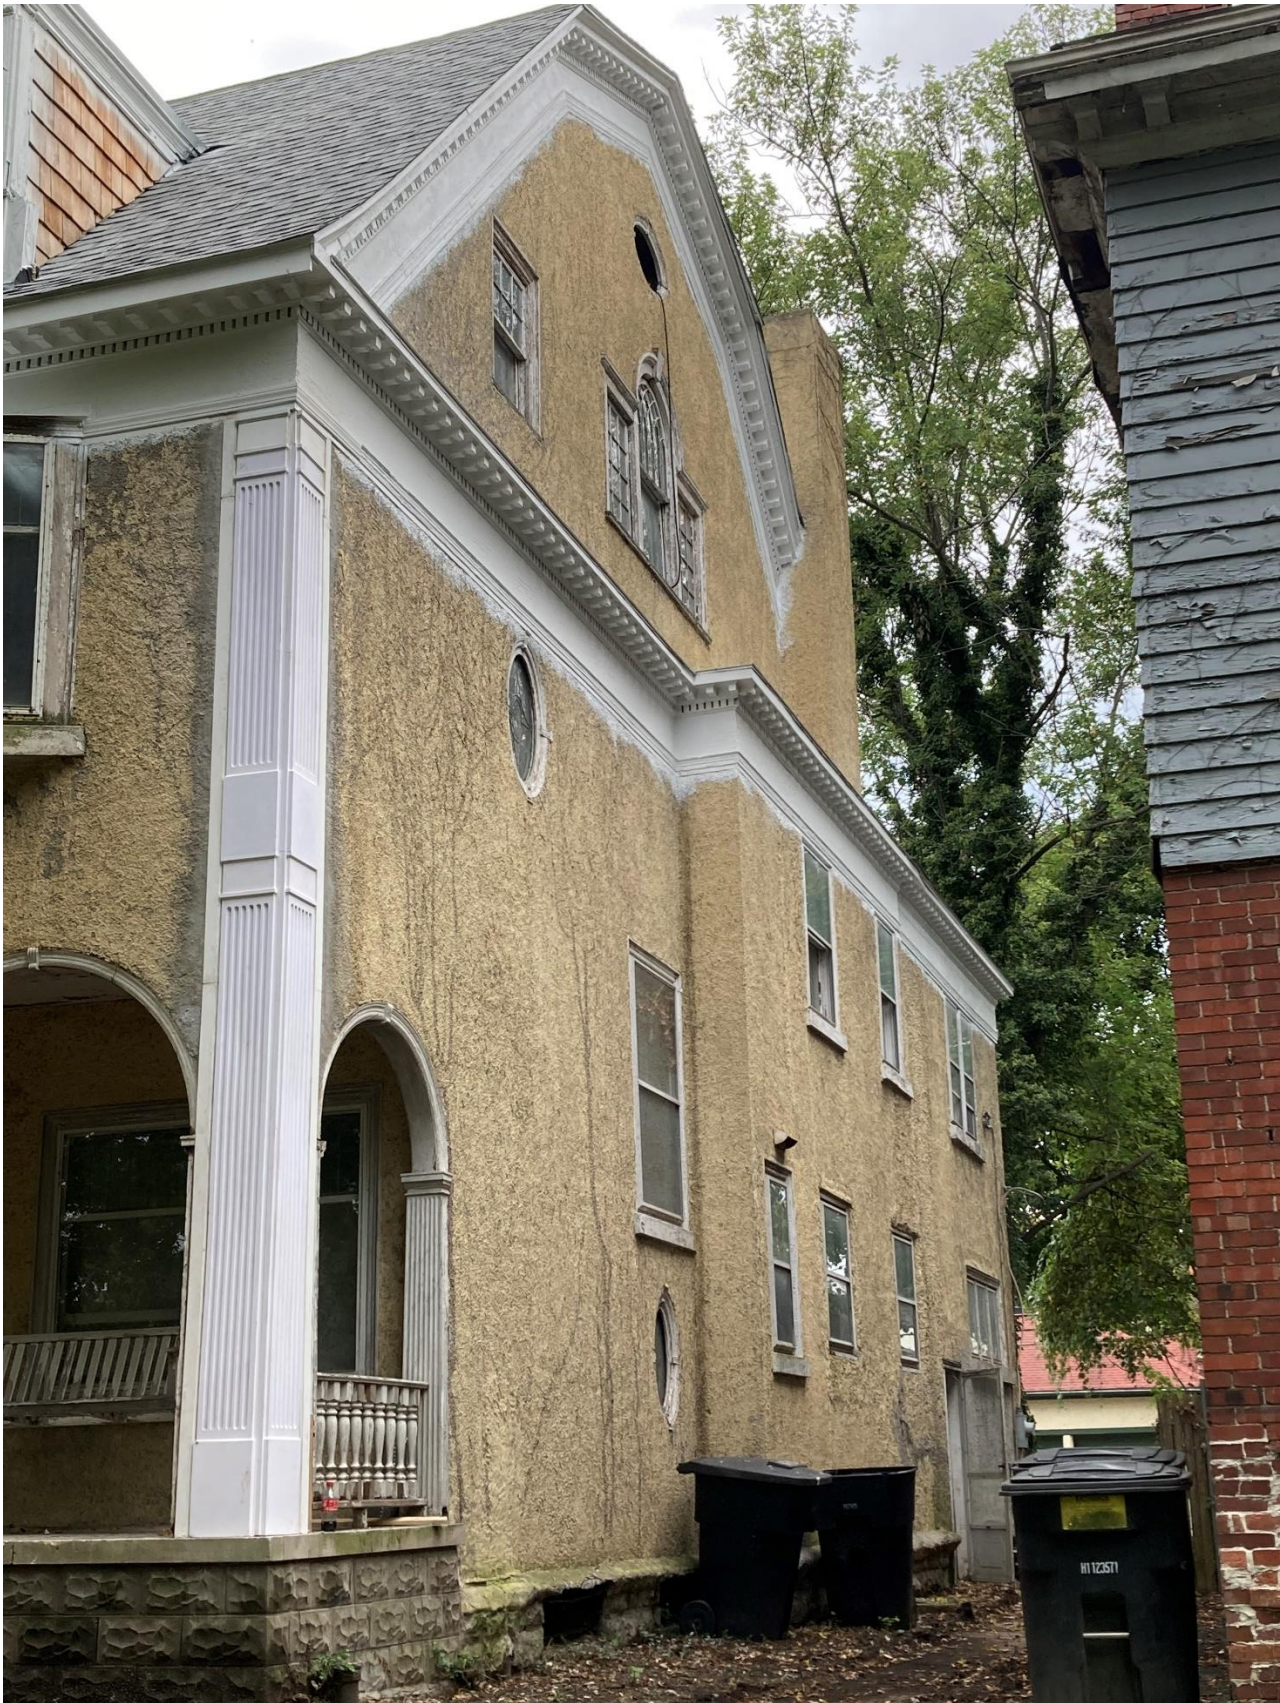
*Staff photo, September 2025, northeast corner with vinyl corner board and north side visible.*

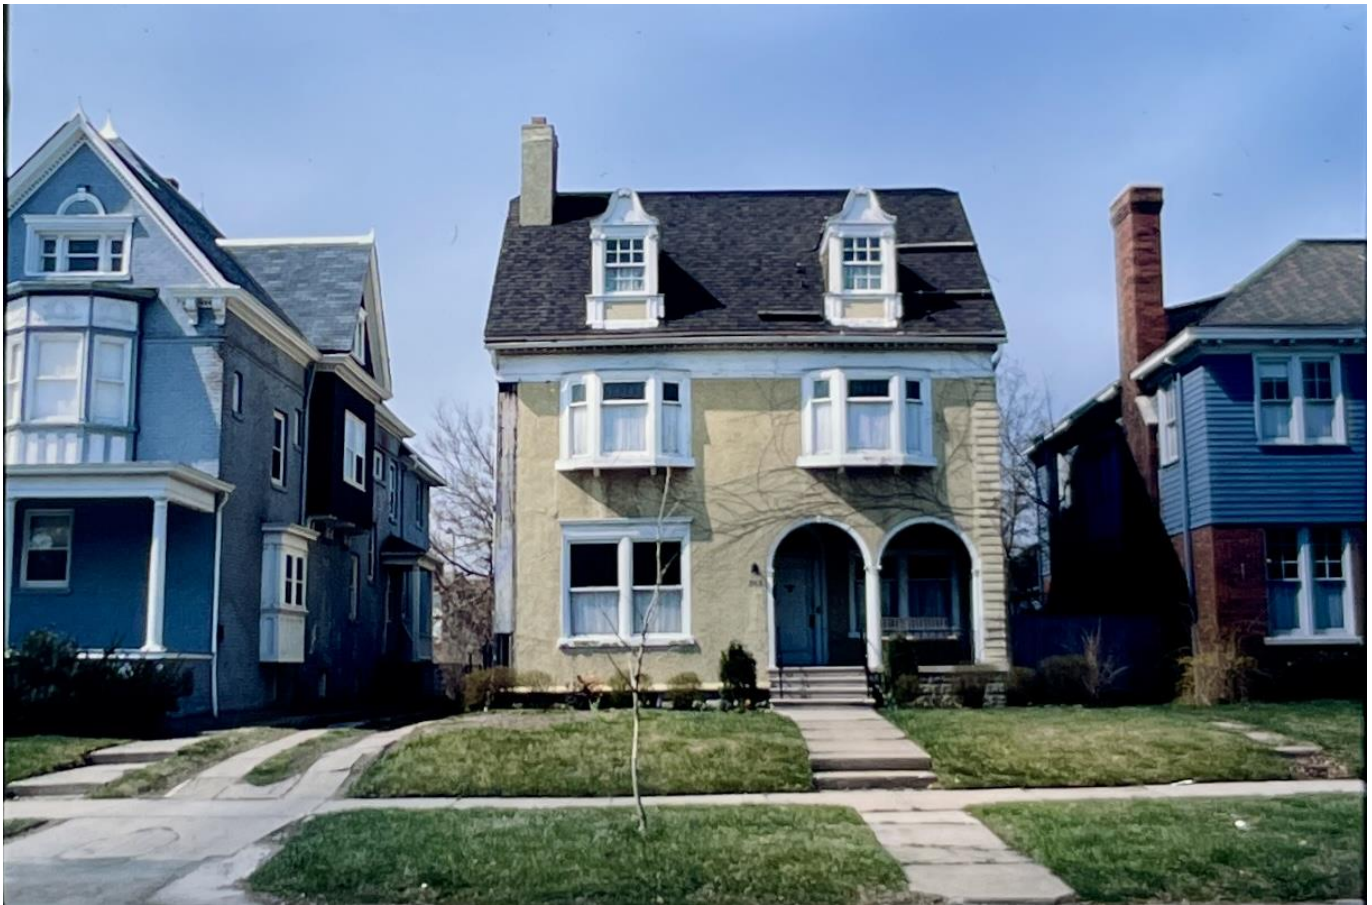
863 Iroquois, slide from PDD file, April 1980. Ribbon drive and quoins at northeast corner evident, but they are missing from the southeast corner.

- It appears from photos that the southeast corner quoins disappeared by 1980, but staff has no record of the removal/alteration of the quoins in HDC approval records.
