**STAFF REPORT: OCTOBER 8, 2025 MEETING**

**APPLICATION NUMBER: HDC2025-00129**

**ADDRESS: 863 IROQUOIS (A.K.A. MARTIN S. SMITH II HOUSE)**

**SCOPE: REPAIR/REPLACE LIMITED TRIM AND STUCCO, REPLACE FRONT PORCH COLUMN, REPLACE RIBBON DRIVE (WORK STARTED WITHOUT APPROVAL)**

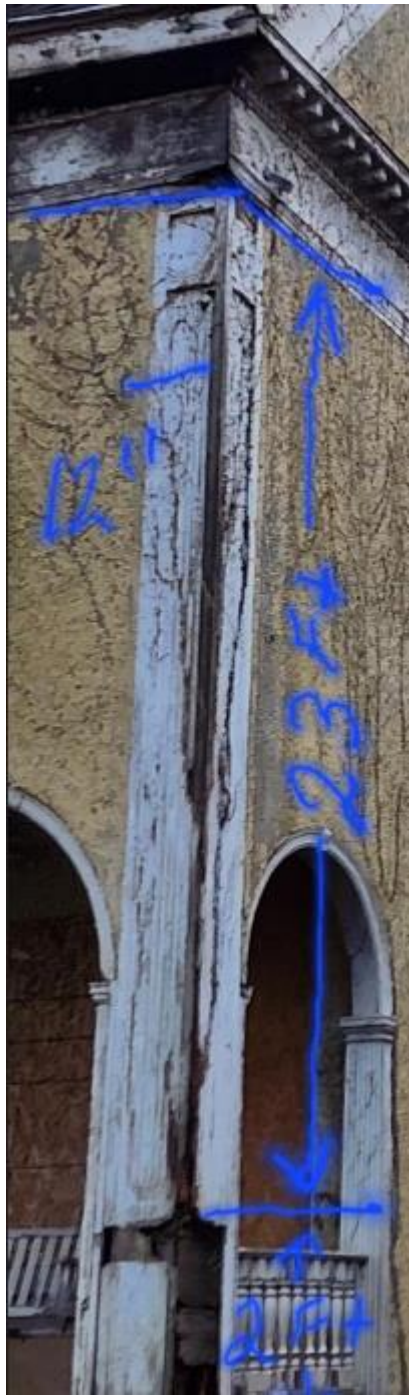
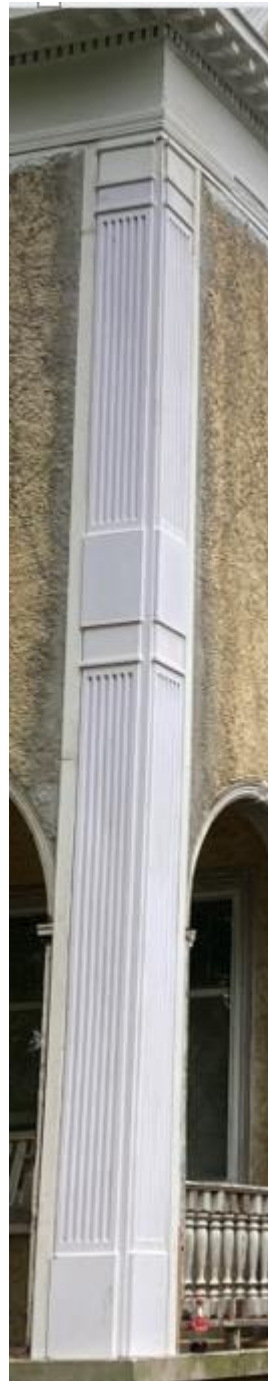
- Regarding the vinyl pilasters being proposed as corner boards, the Secretary of the Interior's Standards for Rehabilitation require that the corner boards that had been in place should have been repaired if possible, and if repair was not possible, they should have been replaced in kind as close as possible in design, color, texture, and, if possible, materials. (An alternative approach the Standards and Guidelines would allow could have been that the quoining at the corners shown in 1979 photos could have been restored, but that is not the submitted proposal.) The submitted proposal is to use vinyl trim to replace the wood. The trim that had been in place was compatible with the pilasters and column on the front porch and was a continuous 23 feet from top to bottom (see photo below), with fluting from the decorative cap to the decorative base. The proposed (installed) material is not compatible with wood because of its texture and sheen. The proposed (installed) design is not compatible because instead of continuous fluting from cap to base, the proposed is two pieces of trim instead of one, so there is a cap and base on top of a cap and base. That is not an adequate in-kind replacement of the material that was there. The vinyl is incompatible with this historic house and does not meet the Standards (1) because of its incompatible texture and sheen, (2) because the limits in available sizes of the material necessitates a historically incorrect installation and design, and (3) because vinyl is not a traditional material contemporary with the period of significance.

*Applicant's photo of previous corner boards with continuous fluting from cap to base (left, from Cycle 4 materials), compared with the vinyl trim now installed that has the fluting interrupted by an extra base and cap midway (right, staff's September photo). The vinyl's sheen and texture are also incompatible, and it appears to meet the stucco differently than the wood trim had previously. There appears to be an extra seamed band of trim over the nearby stucco that was not there before.*

- The proposed (installed) vinyl corner board trim is incompatible with the historic house and its period of significance and does not meet the Secretary of the Interior's Standards for Rehabilitation because of its material, texture, sheen, design, and installation. Further, it diminishes the historic character of the house. The installed vinyl trim also does not meet the Elements of Design for the district.

- The vinyl corner board trim pieces at the northeast and southeast corners of the house will be removed and replaced with trim that is compatible for the house and meets the Standards. The applicant will submit a replacement corner board proposal to staff for review and approval before the certificate of appropriateness is issued.
- A dimensioned drawing of the porch guardrail and handrail for the steps (if one is proposed) will be submitted to staff for review and approval before the certificate of appropriateness is issued.
- The ribbon driveway will be retained. The concrete may be replaced, but the driveway's form as two ribbons of concrete with dirt between and on either side to support grass must be retained. An updated site plan and quote/contract for the work will be submitted to staff before the certificate of appropriateness is issued.
