STAFF REPORT: 10-08-25 REGULAR MEETING

APPLICATION NUMBER: HDC2025-00243

ADDRESS: 14501-14523 EAST JEFFERSON

SCOPE: DEMOLISH THREE (3) COMMERCIAL BUILDINGS

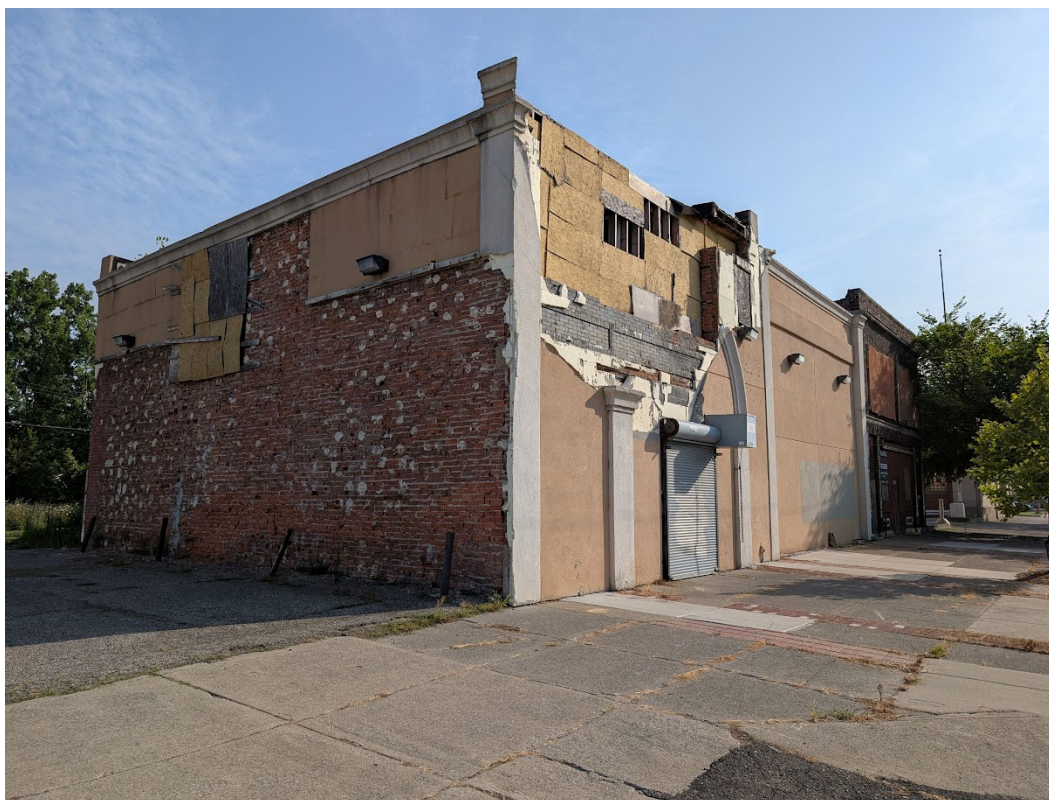
View of 14501-14521 East Jefferson from the corner of Marlborough. 14521 East Jefferson is the brick fronted structure at far right; the other two buildings are clad with non-historic dryvit. Staff photo, July 24, 2025.

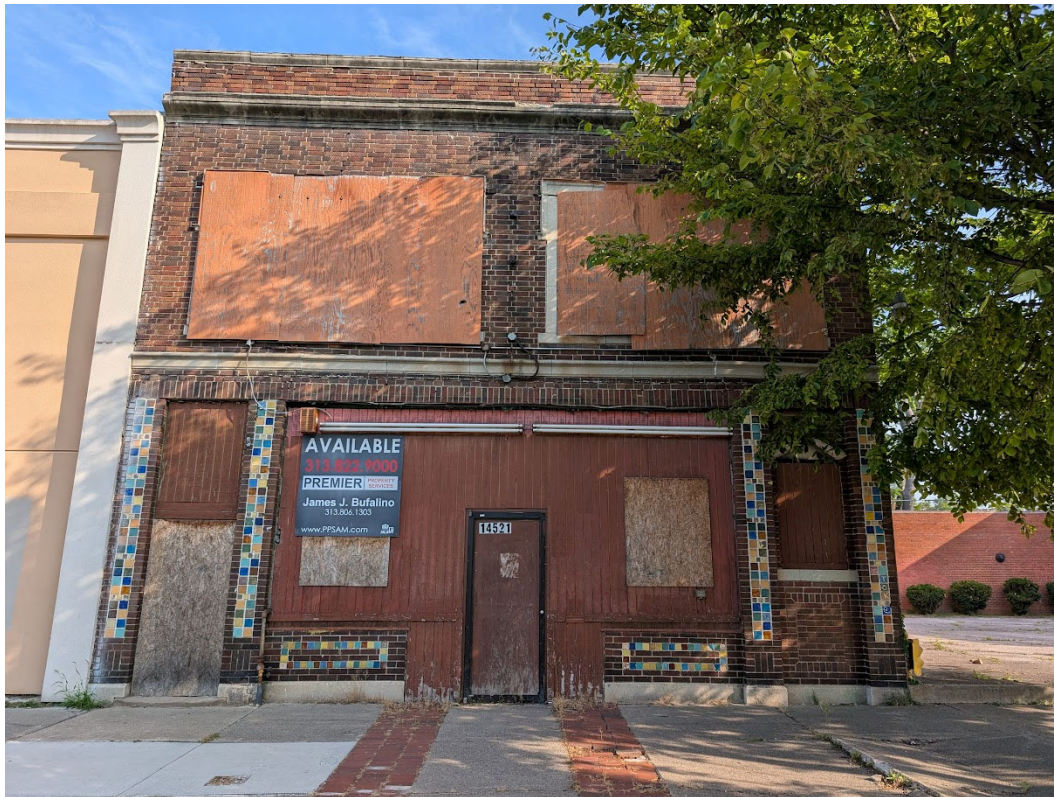
View of 14501-14523 East Jefferson, the easternmost building, and the only one of the three exhibiting contributing historic character, in staff's opinion. Staff photo, July 24, 2025.

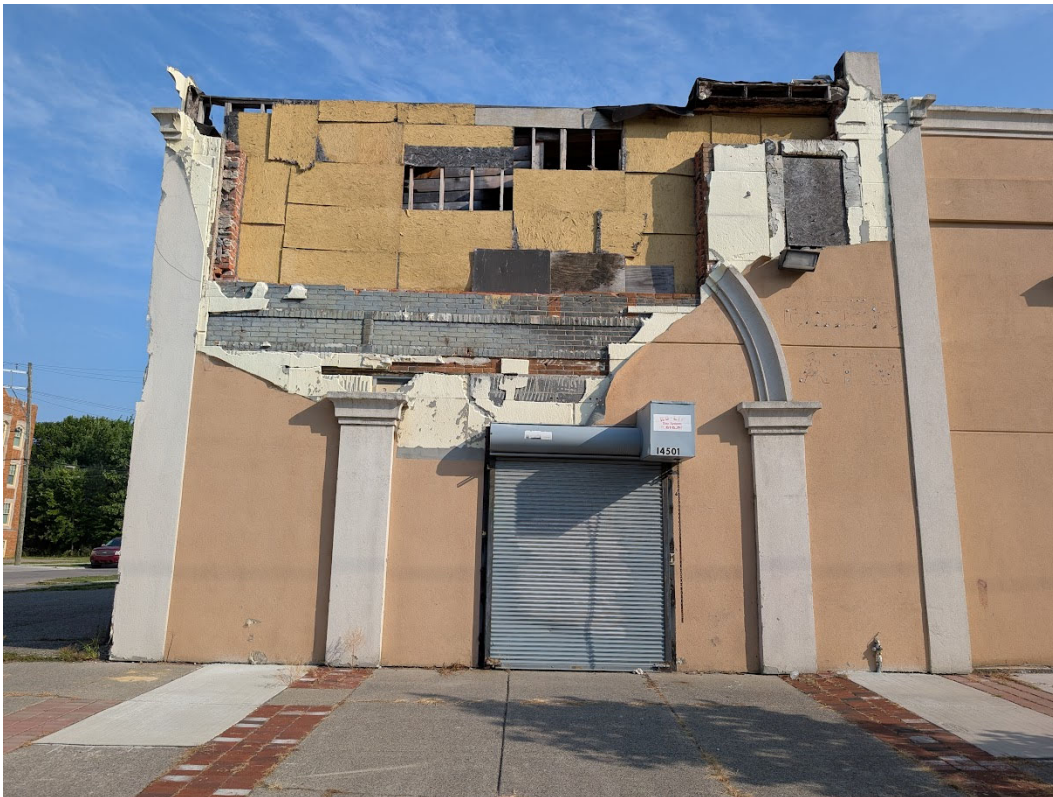
View of the westernmost building under review, sharing an address of 14501 East Jefferson; originally known as 14507-09 East Jefferson (refer to Sanborn map later in this report). Staff photo, July 24, 2025.

- This building is beyond reasonable repair and staff assesses that it is eligible for demolition under a Certificate of Appropriateness. As discussed above, the structure suffered a major conflagration circa 2008 and was never properly repaired. It has further suffered neglect and decay since that time. There is currently no remaining roof structure of note, and the entire first floor diaphragm has collapsed into the basement. Large portions of the brick façade are missing or obviously compromised. Concerning the historic integrity of the easternmost building, separate from its condition, staff concludes there is little to none remaining. There is some historic brick still present, but it exists out of context. The entire second story has been lost.

Staff recommends that the proposed work will be appropriate according to the Secretary of the Interior's Standards for Rehabilitation and the Jefferson-Chalmers Historic District's Elements of Design, as the building is a non-contributing resource beyond economic and technically feasible repair.

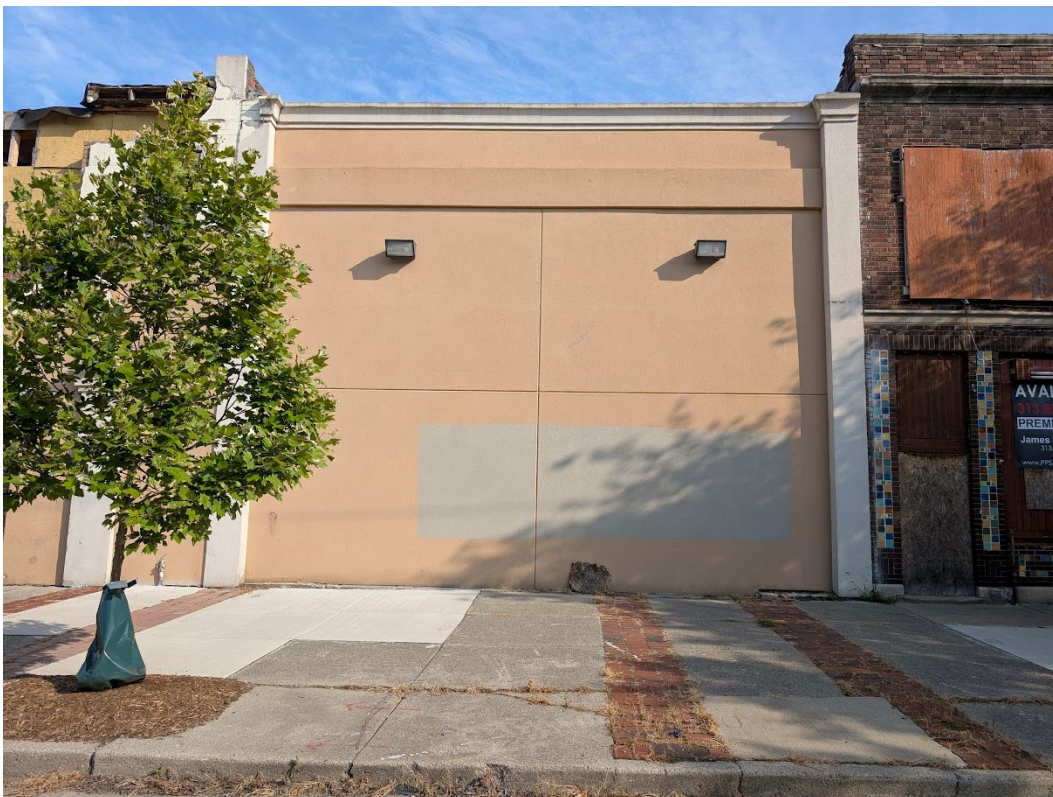
View of the center building under review, sharing an address of 14501 East Jefferson; originally known as 14513-15 East Jefferson (refer to Sanborn map later in this report). Staff photo, July 24, 2025.

- Staff does not find that the building, considered individually, has been documented to be beyond reasonable repair.
 - Additionally, staff is not convinced that the building has lost all of its historic integrity, based primarily on photographs in our archives showing historic features extant during the illegal construction of the dryvit façade in 2010. As such, staff recommends that the center building be

- Based on the points above, staff recommends that the Commission deny the current application for demolition of the central building, pending the following actions, which will qualify it for further demolition review by your body per the Commission's Rules of Procedure:

- Receipt of additional documentation (photos, videos, walk-thrus) of the building showing condition, and status of structural/systems and their interdependence with the westernmost building

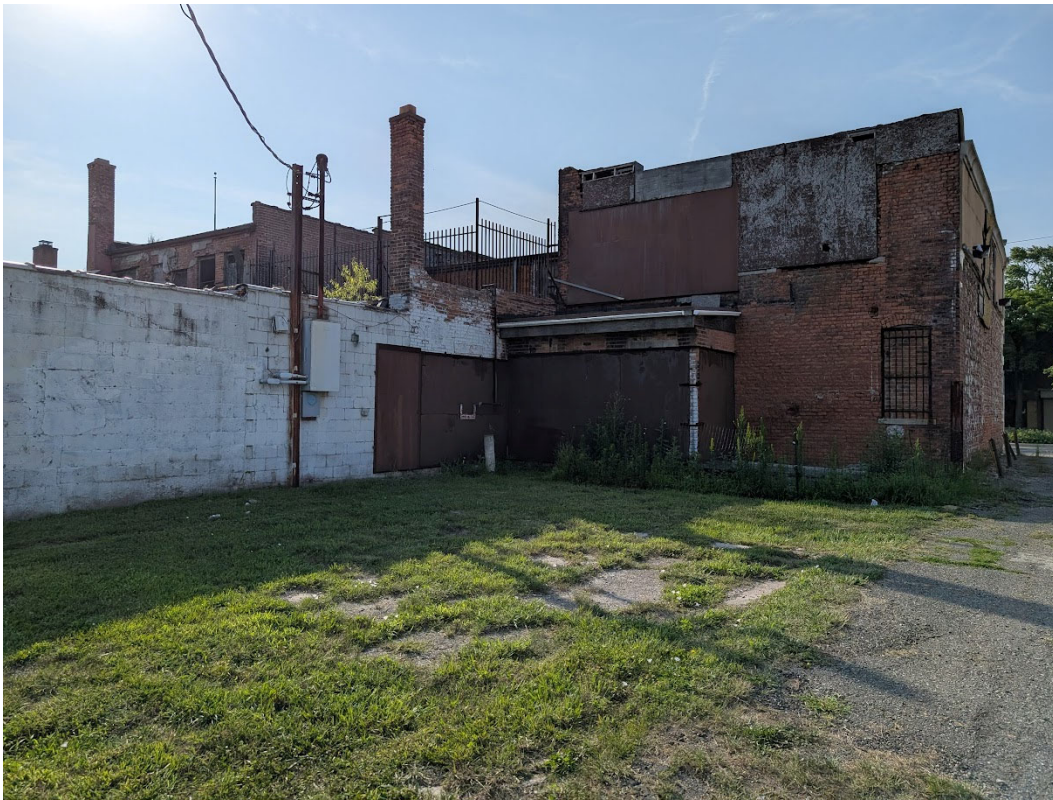
Rear view of buildings, looking south. Westernmost building at right. Staff photo, July 24, 2025.

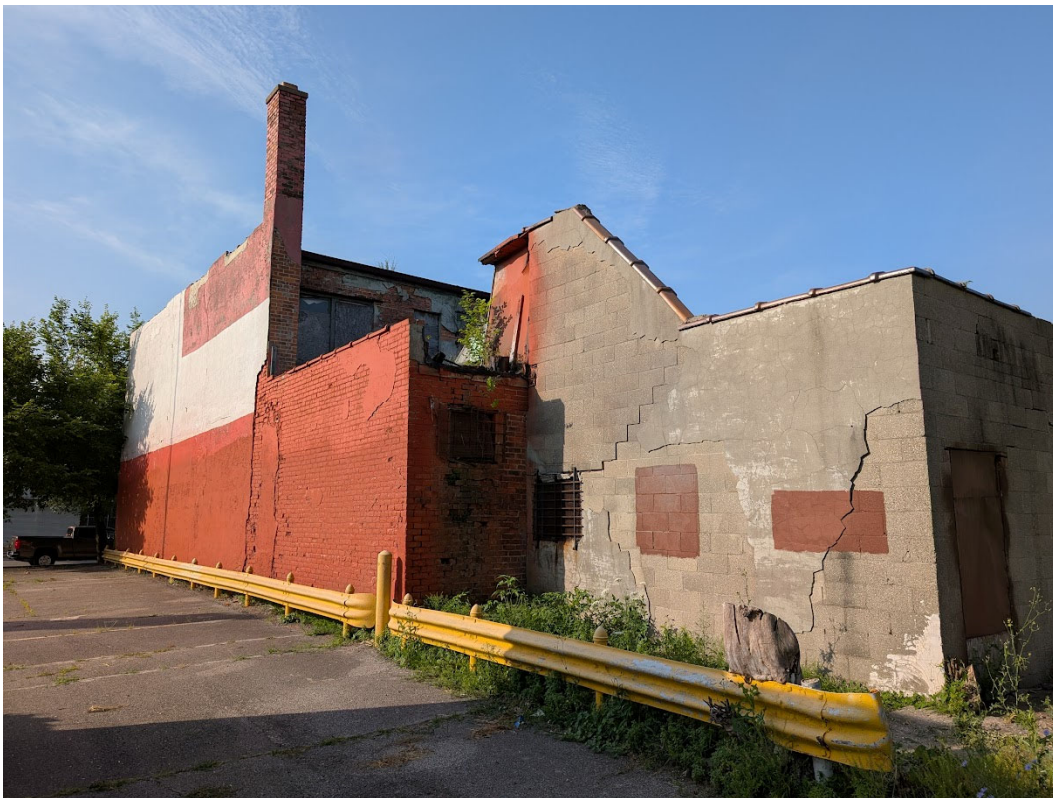
Rear view of 14521 East Jefferson, looking south. This is the rear of the easternmost building. Staff photo, July 24, 2025.

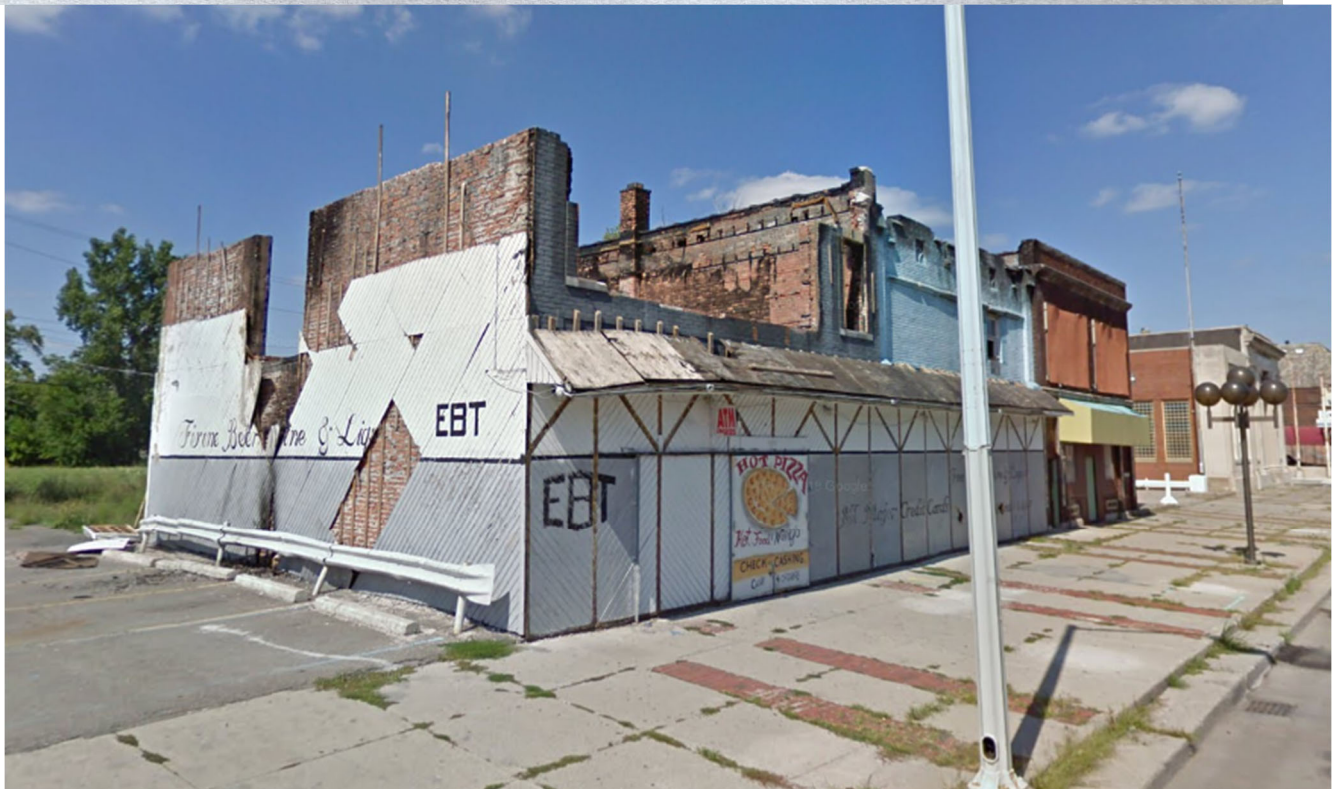
Google Street View image from August 2009, showing substantial fire damage to westernmost building. Note second story wall separating this building from the center building, apparently intact.

- Shortly after district designation, the westernmost building (at that time still referenced as 14507 East Jefferson, its historic address) suffered an apparently catastrophic fire removing the roof and most of the second floor. However, the structure was rebuilt (to an unknown extent) with no approvals from HDC, nor evidently a permit from BSEED. Additionally, a new EIFS/dryvit exterior cladding system, with garish and amateurish "classical" styling alien to the district's character, was added without approval. HDC staff identified the work in violation, which prompted an after-the-fact review by the Commission at the November/December 2010 Meetings. The proposed EIFS/dryvit cladding was denied by your body, yet was apparently never removed or remedied. A FOIA request from the building's owners was

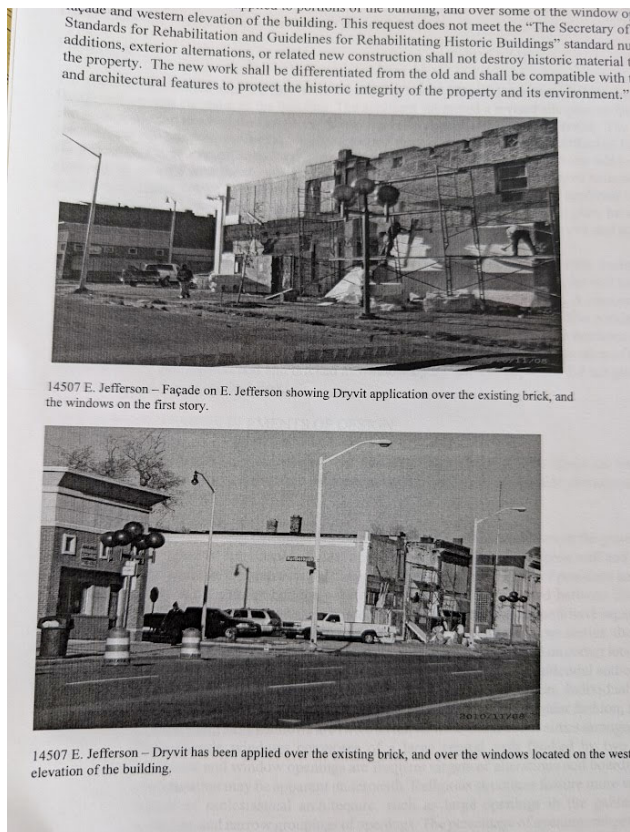
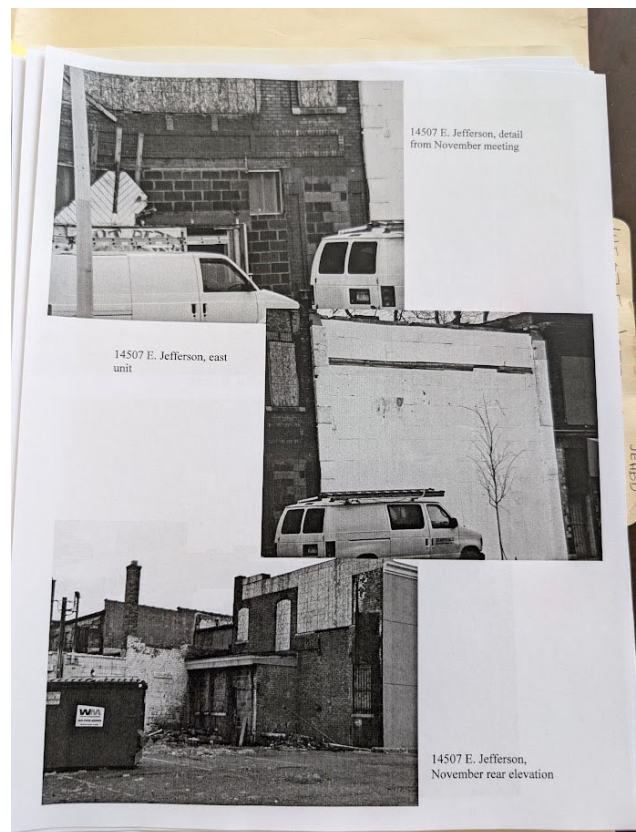
From HDC files, 2010-11: HDC staff photos of the work being performed in violation (installation of the EIFS/dryvit cladding system).

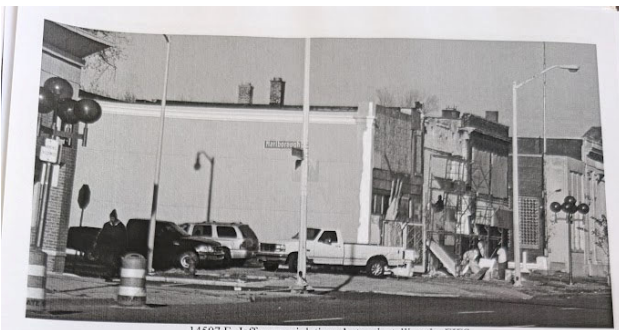
Historic details visible at 14515

- It is important to note, as HDC staff did at the time, that historic brick details were exposed during the work performed in violation, confirming Ms. Savage's earlier analysis that such important architectural character may have survived the 1986 recladding. If the 2010 work in violation had not occurred (i.e., the completion without permit of the EIFS/Dryvit system), it is clear that substantial historic character could have been recovered at the center building (14515 East Jefferson), reclassifying it as a **contributing building** to the district. This observation has implications for the present application, since violations run with the property and remain the responsibility of the present owner.

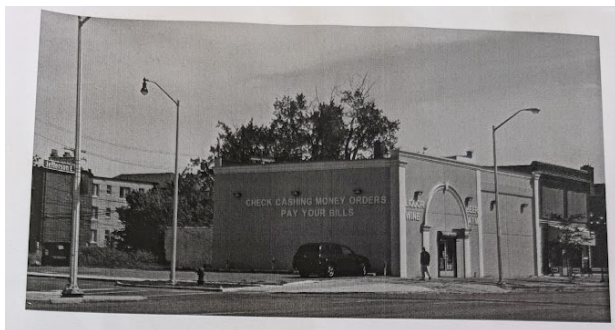
14507 E. Jefferson, present condition

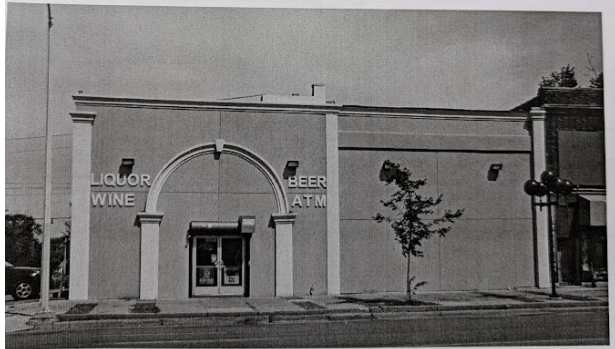
From HDC files, 2010-11: HDC staff photos of the work performed in violation (installation of the EIFS/dryvit cladding system), and the final result. Note the apparent historic brick details exposed at the center building (14515), clearly visible in the lower left image (yellow arrow). Note also that the reconstruction of 14507 (westernmost building) did not apparently include the rebuilding of the brick front façade (red arrow), though some brick detail was still extant below this damaged area.

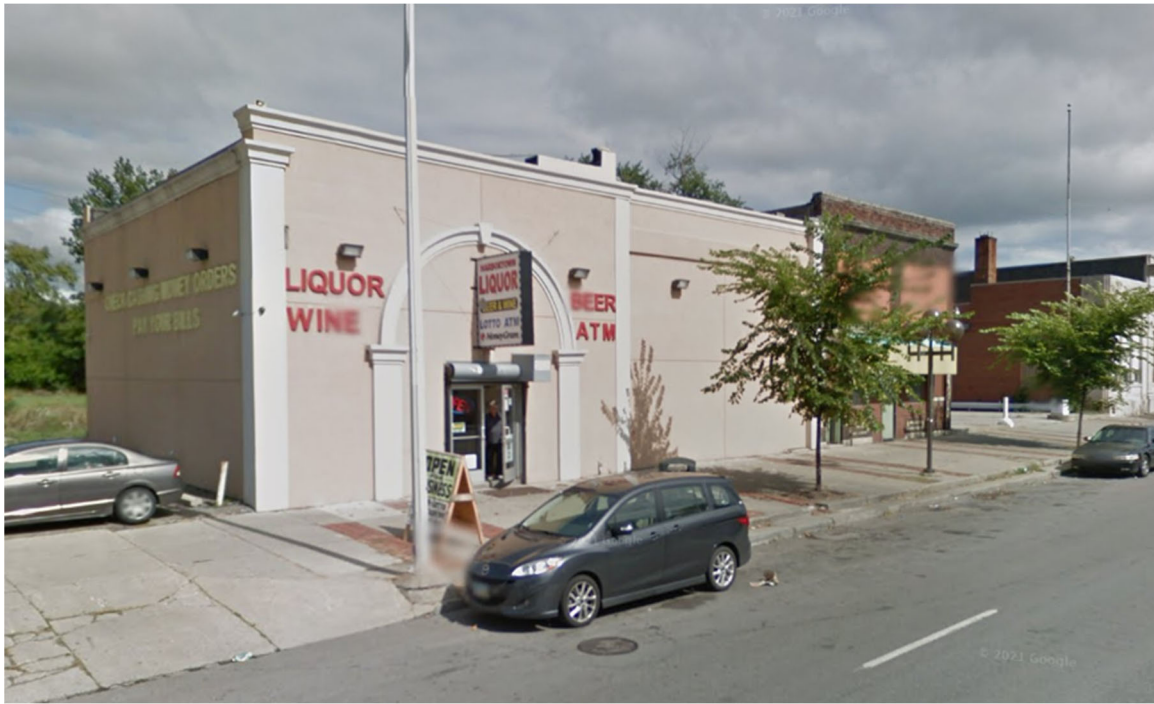
Google Street View image from September 2013, showing the store in operation with the incompatible EIFS/dryvit façade system.

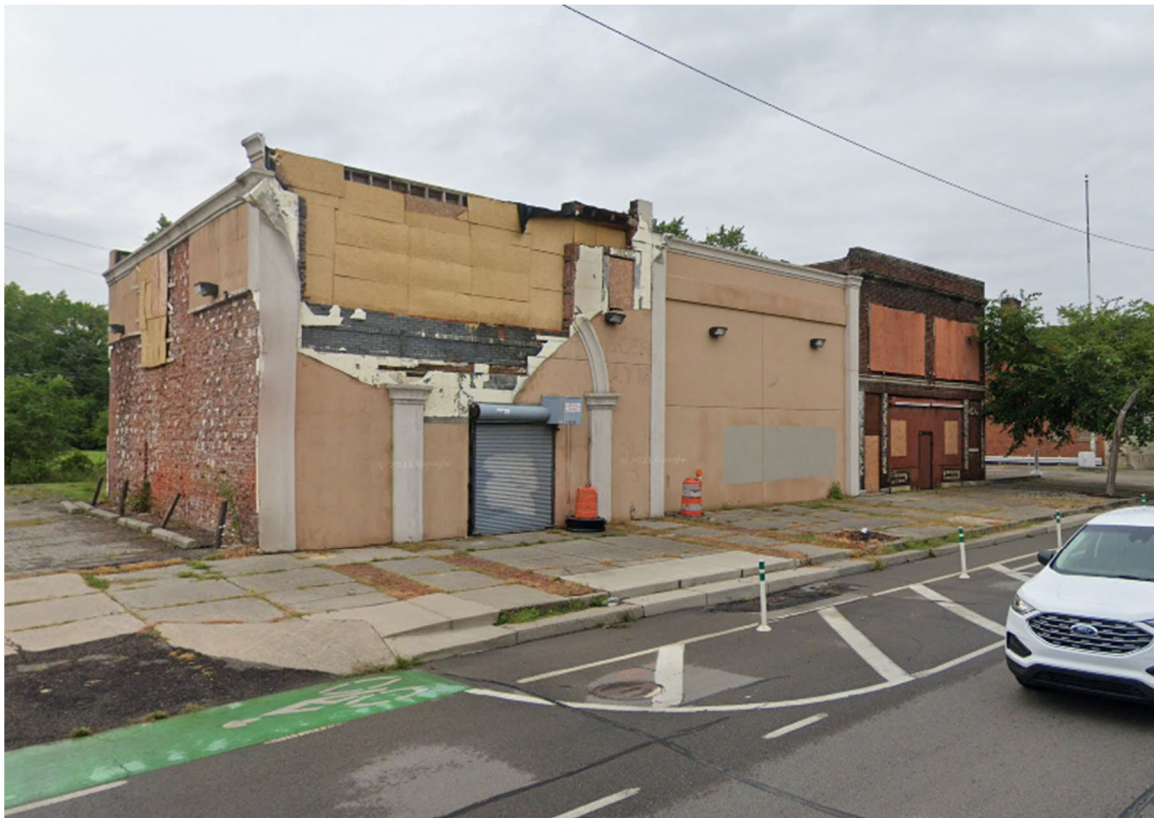
Google Street View image from August 2021. At least four years after closing the store, the unapproved façade system has apparently collapsed at the side and at the front, revealing what appear to be haphazard repairs of the original damage from 2009.

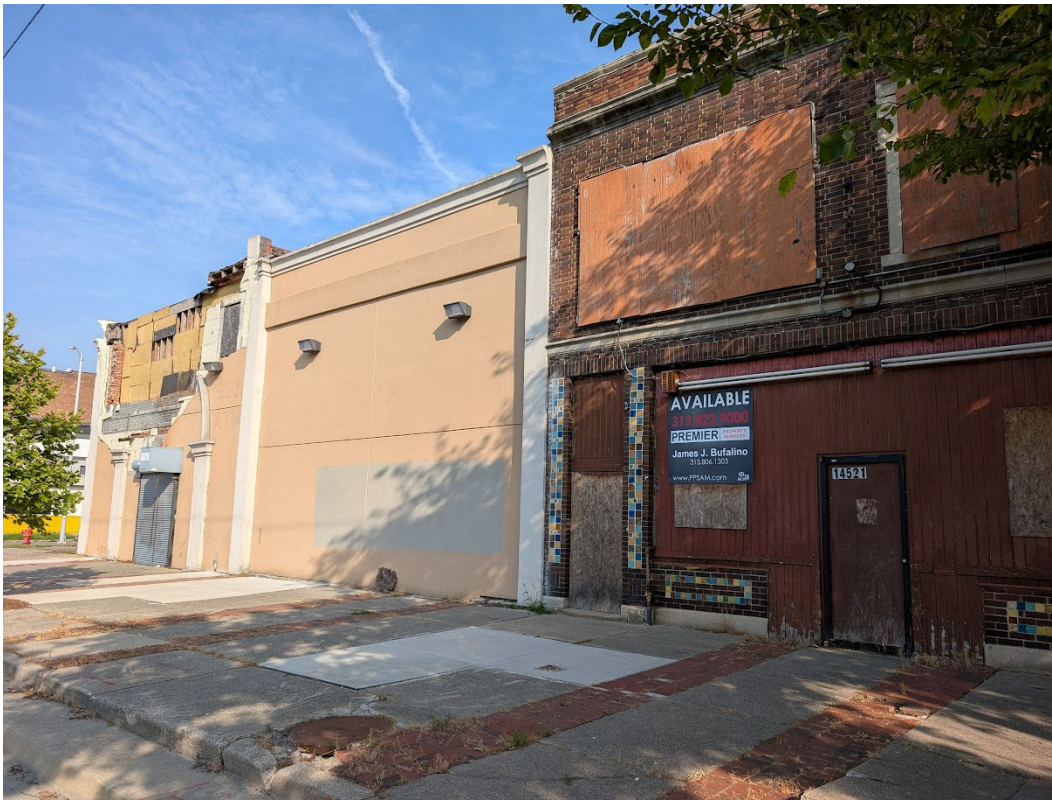
Current view towards the combined buildings, showing the remains of the incompatible cladding installed in violation in 2010.. Staff photo, July 24, 2025.

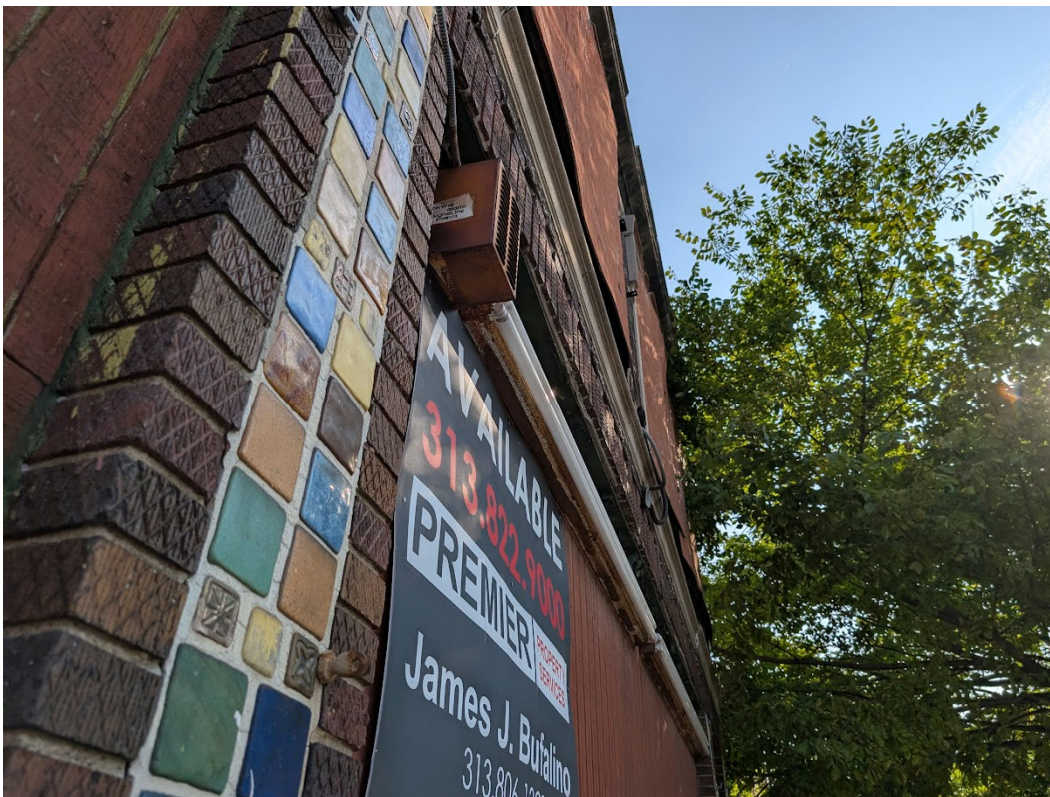
Detail view of the brown brick/stone façade of 14521 East Jefferson Staff photo, July 24, 2025.

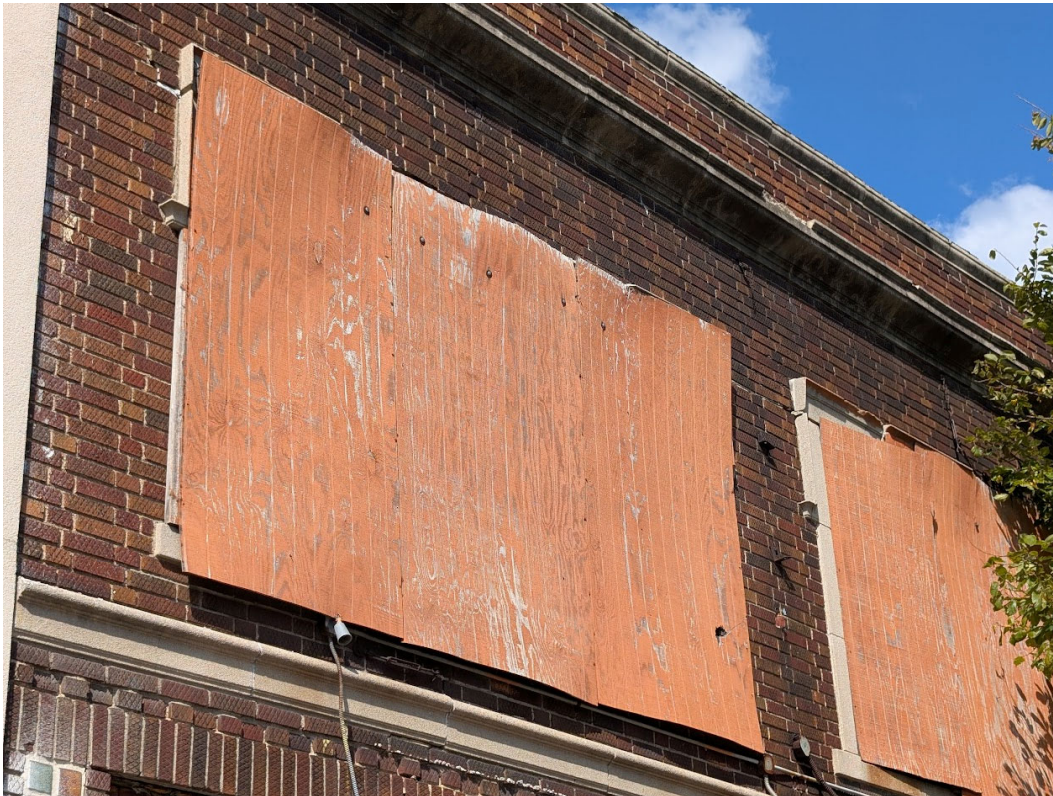
Detail view of the second story facade of 14521 East Jefferson. Note intact cast stone and ornamental brick. Staff photo, September 26, 2025.

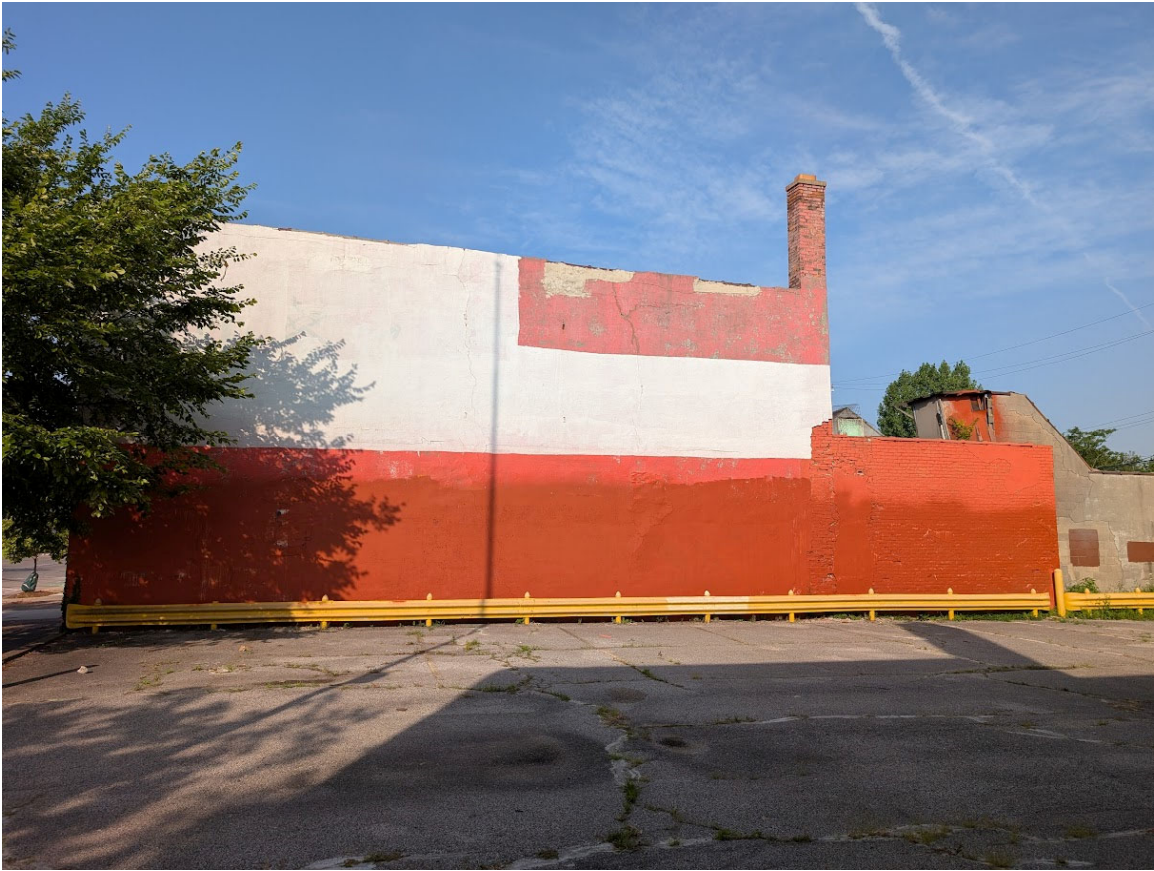
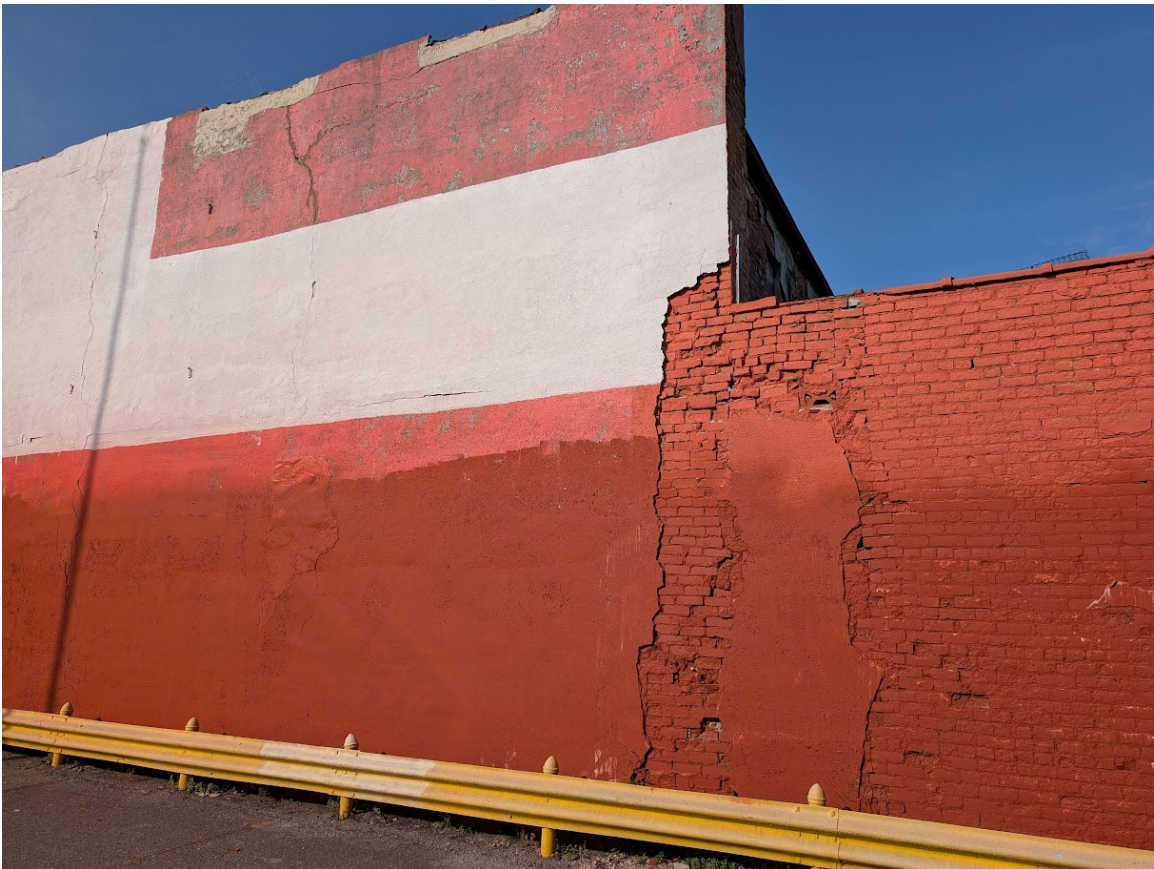
- The below images show the subject exterior wall visible at this building (to the east). Though cracks in the cementitious overcoat are apparent, and some of this coating has detached from the brick, staff does not agree that the brick wall is unstable or in any compelling manner different than a typical 100-year old brick commercial building. Further documentation or clarity should be provided to support the engineering conclusions, in staff's opinion.

Above and below: east-facing structural side wall at 14521 East Jefferson Staff photos, July 24, 2025.

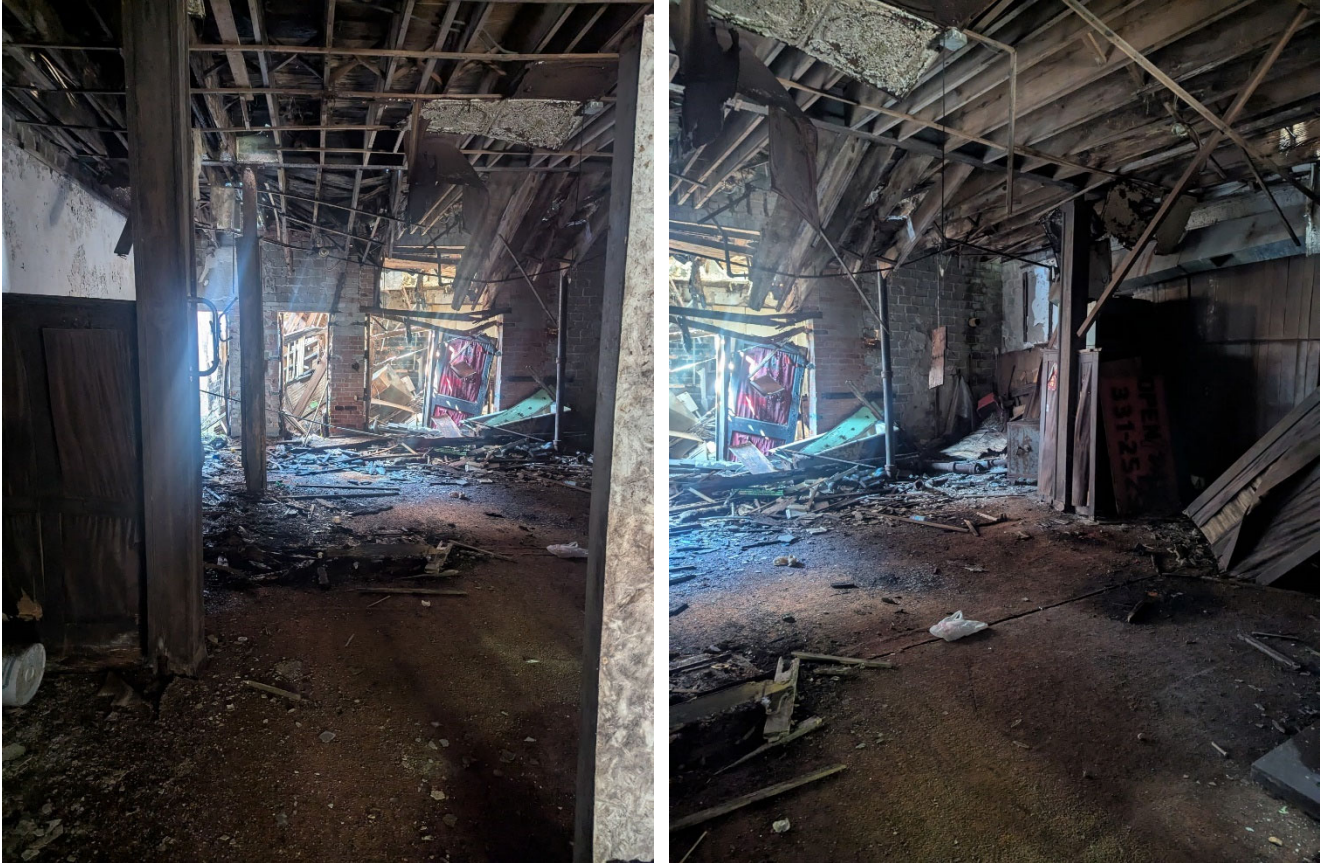
- Staff was not able to inspect the interior of this building during our visits to the property, other than peering into the locked doorway. We noted intact walls and floors, and small areas of daylight above suggesting some degree of roof failure. The applicant subsequently followed up with the images below, available in full resolution on the website. The view is apparently of the rear half of the building, looking towards the rear. A partial area of floor collapse is visible, with greater destruction apparent in the single-story portions of the building extending towards the alley (those areas in sunshine). If this is the greatest area of damage found in the building, the main mass of the building is repairable, in staff's opinion. Many historic preservation projects begin from a point of much higher deterioration than this:

Applicant's interior photos of rear of 14521-523 (easternmost) building submitted to staff.
