APPENDIX A
HISTORIC RESOURCE INVENTORY
APRIL 2020
FORT WAYNE HISTORIC DISTRICT

HISTORIC FORT WAYNE LANDSCAPE COMPONENTS

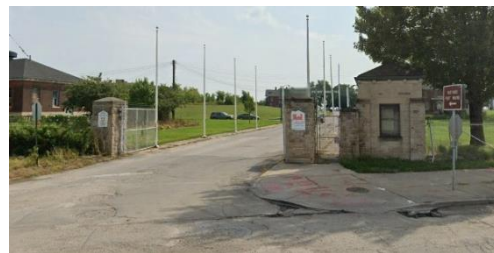
MAIN ENTRANCE GATE

The gate appears to be in good condition.

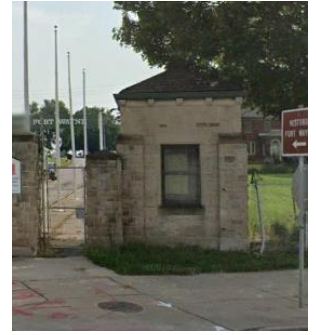
Building 229: SENTRY BOX

No longer in use as a sentry box, the building appears to be in good condition.

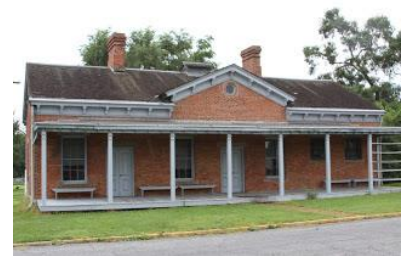
Although the exterior of Building 205 appears to be in good condition, it shows signs of wood deterioration, particularly at the eaves, fascia and front step.

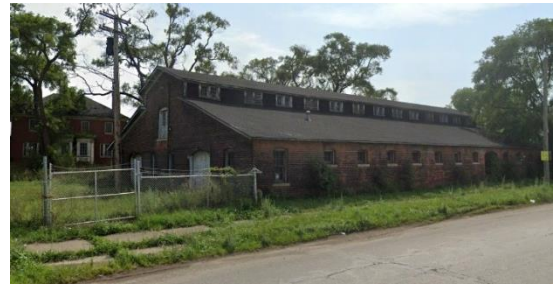
This building is very utilitarian and serviceable but in poor condition from lack of maintenance. The brick masonry exhibits signs of rising damp conditions. Wood trim, paint, and the roof show signs of weathering as well.

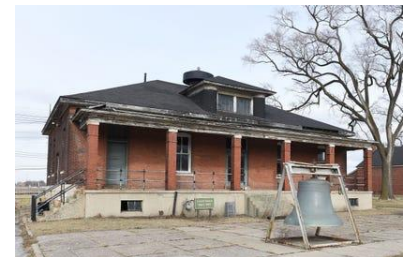
Structural deficiencies in the roof were corrected and a new asphalt roof was installed in 1984. Visible on the exterior is brick and mortar deterioration, weathering of wooden elements such as windows and eaves, missing rear steps and the installation of anachronistic steel rear doors. Currently in use, the Guard House appears to be adequately maintained.

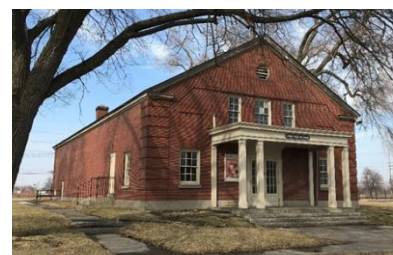
The building appears to be in good condition, though wood elements, such as windows and cornices, show signs of weathering. Damage to the roof structure was repaired in the 1980s and a flat shingle asphalt roof was applied.

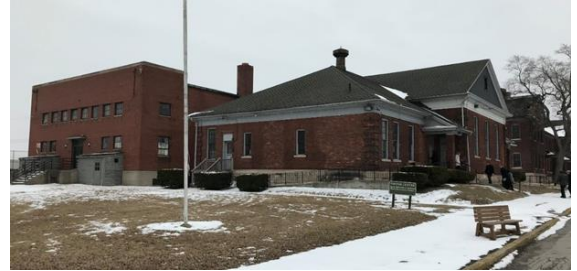
Originally constructed as an enlisted men's recreation center, it was adapted as the fort's visitor center when Fort Wayne was regularly open to the public in the 1970s. Today the building is still fully operational and in use for meetings and recreational activity, although the interior of the earlier building was radically changed and no longer retains its original features. This building has been kept in active use and is in relatively good condition.

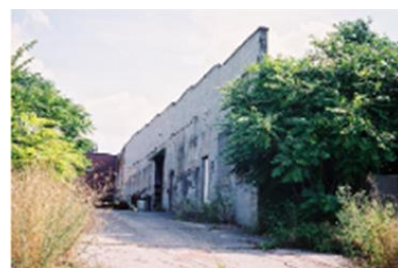
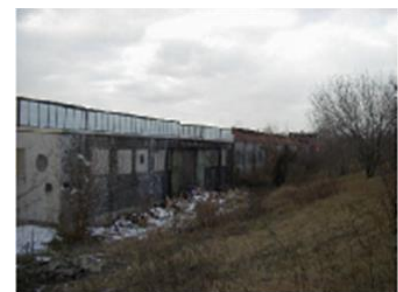
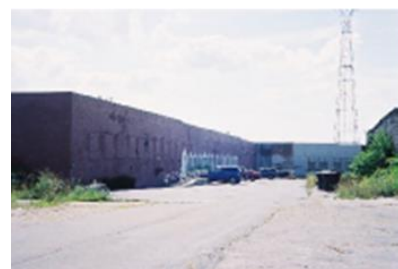
Warehouse 2B, although its construction is identical, is in better condition than Warehouse 2A, which has a damaged envelope. Warehouse 2C has additional interior finishes and is in very good condition.

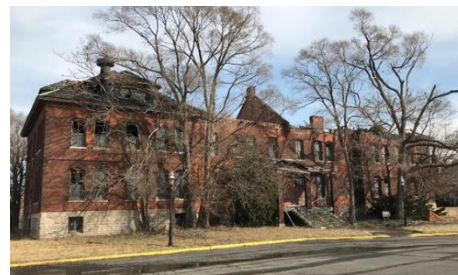
The entire building is in severely deteriorated condition and open to the elements. The roof has collapsed and many openings are boarded. Where they are not, window glass and door panels are absent. Brick and mortar show extreme signs of weathering. However, the foundations appear intact.

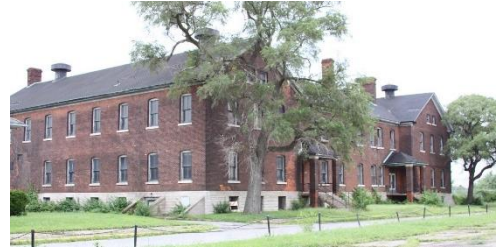
During the 1970s and 1980s, the south half of the building had been rehabilitated as collections storage facilities for the Detroit Historical Museum, including lighting and HVAC improvements. Both halves of this large building are presently unoccupied and share deteriorated roofing, eaves, brick, and fenestration.

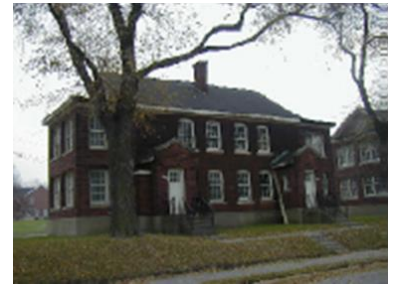
The general condition of this building is very poor and has been impacted by deteriorating and collapsing roof structures. Missing doors and windows, rusted lintels and deteriorated mortar and brickwork are also major problems. The foundations appear to be intact.

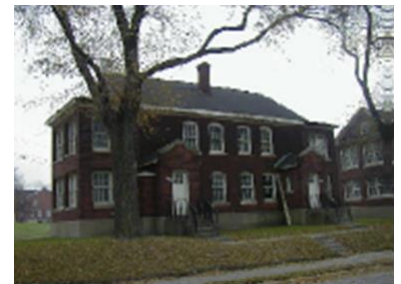
Building 213 resembles Building 212 in appearance and condition.

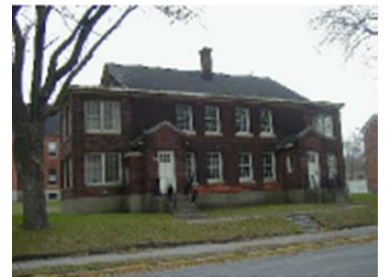
Building 214: NON-COMMISSIONED OFFICER'S DUPLEX

The earliest among the otherwise-identical Buildings 212, 213, and 214, this differs from the others in that it features jack-arch masonry openings over windows, as opposed to segmental arches on the others. Also, visible eaves feature a modillion cornice. Its poor condition is similar to Buildings 212 and 213.

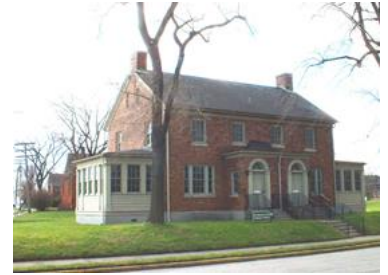
Remaining in use, the building is in good condition.

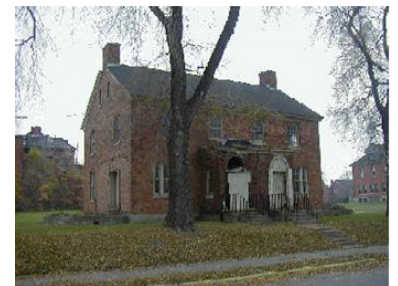
Building 211 is open to the elements and appears to be in very poor condition. Roof structures are visible and show signs of deterioration. Steel lintels are rusted, and some windows and doors are absent or boarded.

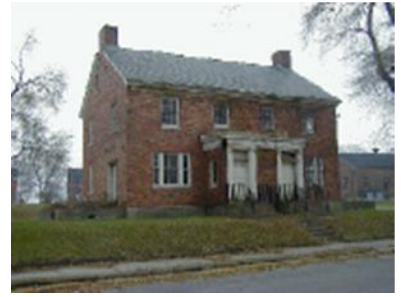
This building is in a similar state of disrepair to Building 211.

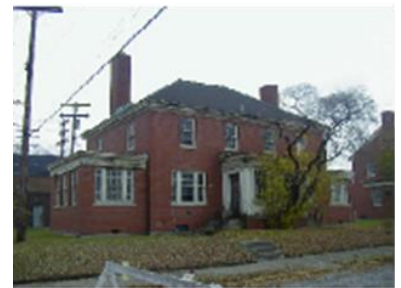
The general condition of this building, like its three companion buildings and like much of NCO Row, is very poor. It is exposed to the weather through deteriorating and collapsing roof structures. Missing doors and windows, rusted lintels and deteriorated mortar, brickwork and concrete are also major problems. The foundations appear to be intact.

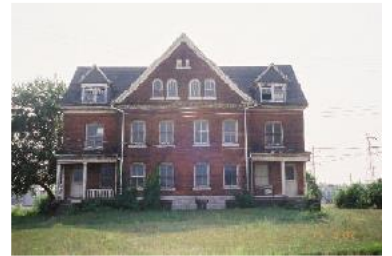
Building 102 is generally in poor condition. Brick and mortar, asphalt roof shingles, and wood elements, such as windows, dormers and cornices, display deterioration. The ashlar foundations remain in good condition. The building is otherwise unchanged from its original exterior configuration, except for the addition of a brick masonry trash enclosure, of unknown date, at the rear.

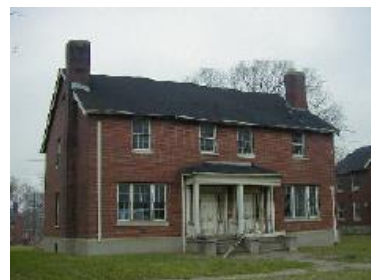
The foundation of Building 105 is in good condition, but the asphalt roof shows extreme wear with structural damage to the framing within. The 1930s brick facade shows rusted lintels, which have shifted the brick veneer. The front porches have masonry deterioration as well. Wooden elements, such as fascias, porch columns and windows, have been painted in recent years. Interior features and details, such as fireplaces and trim, are still intact; their condition varies.

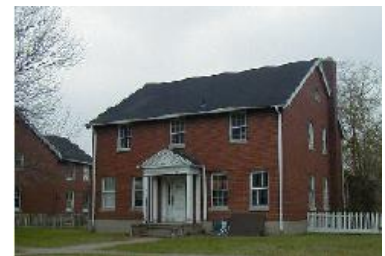
Building 109, like others with brick veneer façades applied in the late 1930s, exhibits signs of rusted lintel, which has led to jacking and cracking of the brick veneer. The front porch has masonry deterioration as well. Its roof shows some deterioration at the valleys.

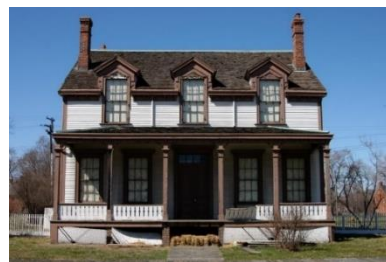
As this building was restored and maintained as a house museum from 1986 into the 2000s, it has been kept in good condition. An exception is some moderate weather-related deterioration of wood elements such as porches, window surrounds and trim.
