**STAFF REPORT:** 10/08/2025 REGULAR MEETING      **PREPARED BY:** L. SAINT JAMES  
**APPLICATION NUMBER:** HDC2025-00461 & HDC 2025-00464  
**ADDRESS:** 2011 & 2025 ORLEANS  
**HISTORIC DISTRICT:** LAFAYETTE PARK/MIES VAN DER ROHE  
**APPLICANT:** RAYMOND SINCLAIR / THE HOME DEPOT  
**2011 ORLEANS PROPERTY OWNER:** DOUGLAS THEDFORD / TRUDY THEDFORD  
**2025 ORLEANS PROPERTY OWNER:** FRANCINE BURGESS  
**DATE OF PROVISIONALLY COMPLETE APPLICATION:** 08/25/2025  
**DATE OF STAFF SITE VISIT:** 09/24/2025

**SCOPE:** REPLACE HISTORIC ALUMINUM WINDOWS WITH FIBREX WINDOWS

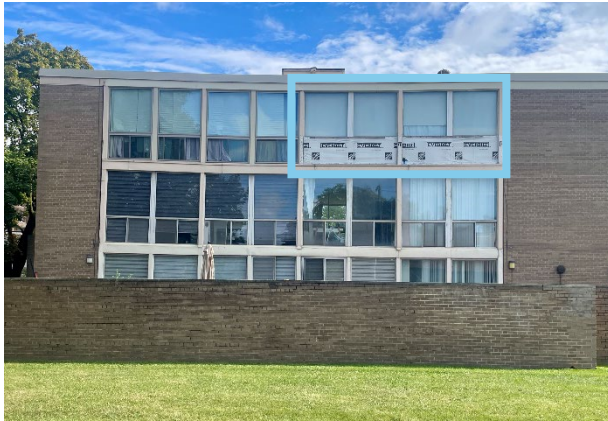
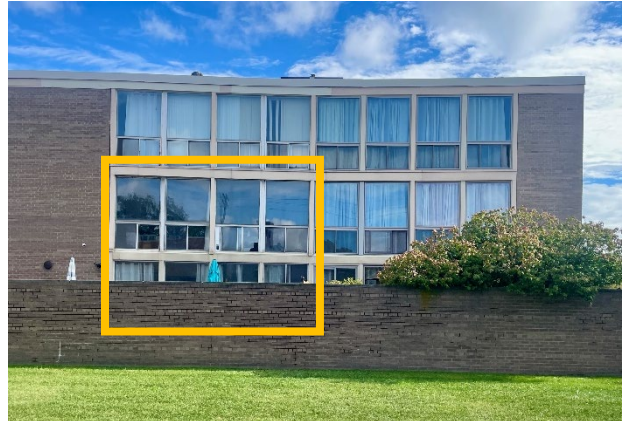
*Staff photos, 09/24/2025. North elevation.*

- There is a total of five (5) sections of windows between both units that are proposed to be replaced.

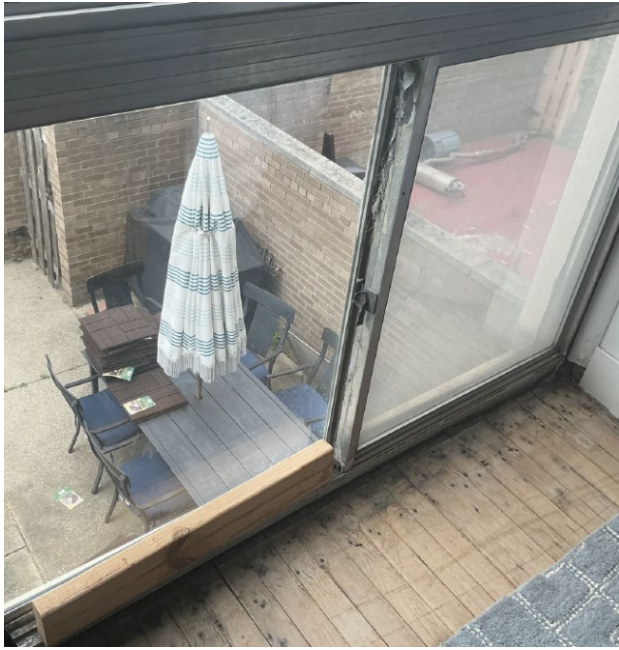
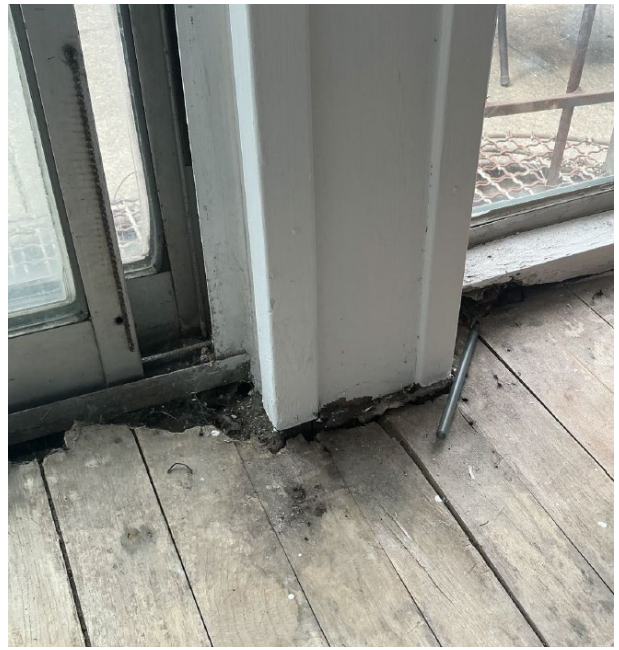
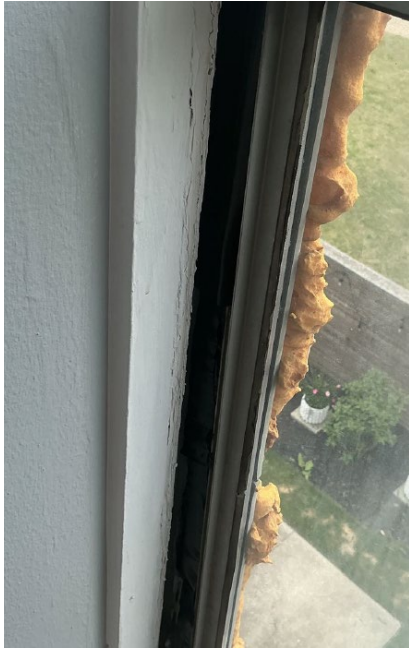
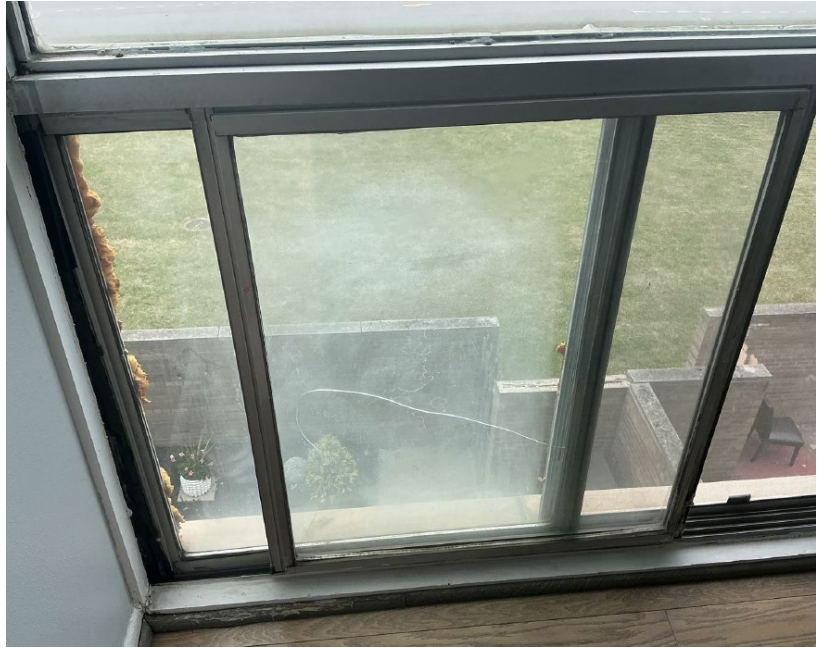
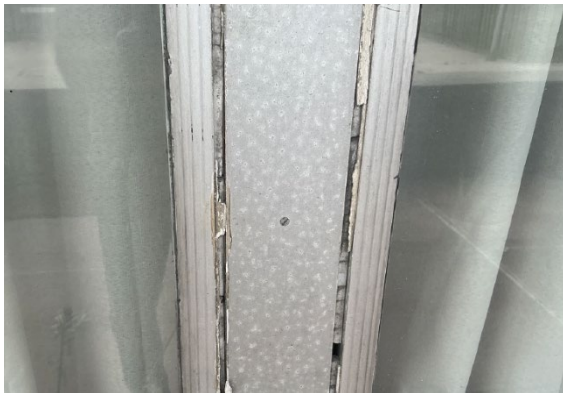
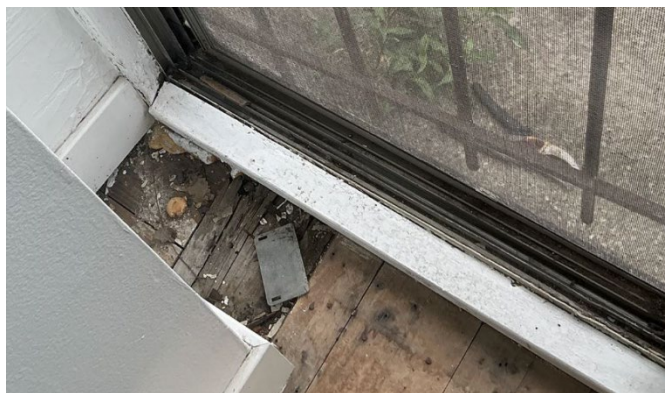
- The applicant states “The building currently retains its original window units, which are aluminum-framed, early-generation double-pane glass panels installed during original construction circa 1966. While these windows were once modern in appearance and functional for their time, they now exhibit signs of significant wear, energy inefficiency, and safety concerns.” They also provide the following descriptions of the existing conditions:
  - *Structural and Operational Deterioration: Many of the current windows have rusting or pitted frames, compromised locking mechanisms, and non-functional sashes, creating not only aesthetic issues but also safety and egress concerns.*
  - *Moisture Infiltration: Several units have reported water penetration at the window perimeters, creating risks of mold, interior damage, and long-term structural decay.*

*Photos from application of existing conditions*

- Although the existing aluminum window systems are distinctive and historic character-defining features, considering the amount deterioration, it is staff's opinion that the existing historic aluminum window systems are beyond reasonable repair.

- Though the existing historic aluminum windows appear to be deteriorated beyond feasible repair, the proposed windows are not in-kind matches to the historic windows at this property.
