STAFF REPORT: 10/08/2025 REGULAR MEETING

APPLICATION NUMBER: HDC2025-00531

ADDRESS: 2224 W. BOSTON

SCOPE: WIDEN DRIVEWAY AND SERVICE PATH, REPLACE CONCRETE PORCH FLOORING AND WALKWAY

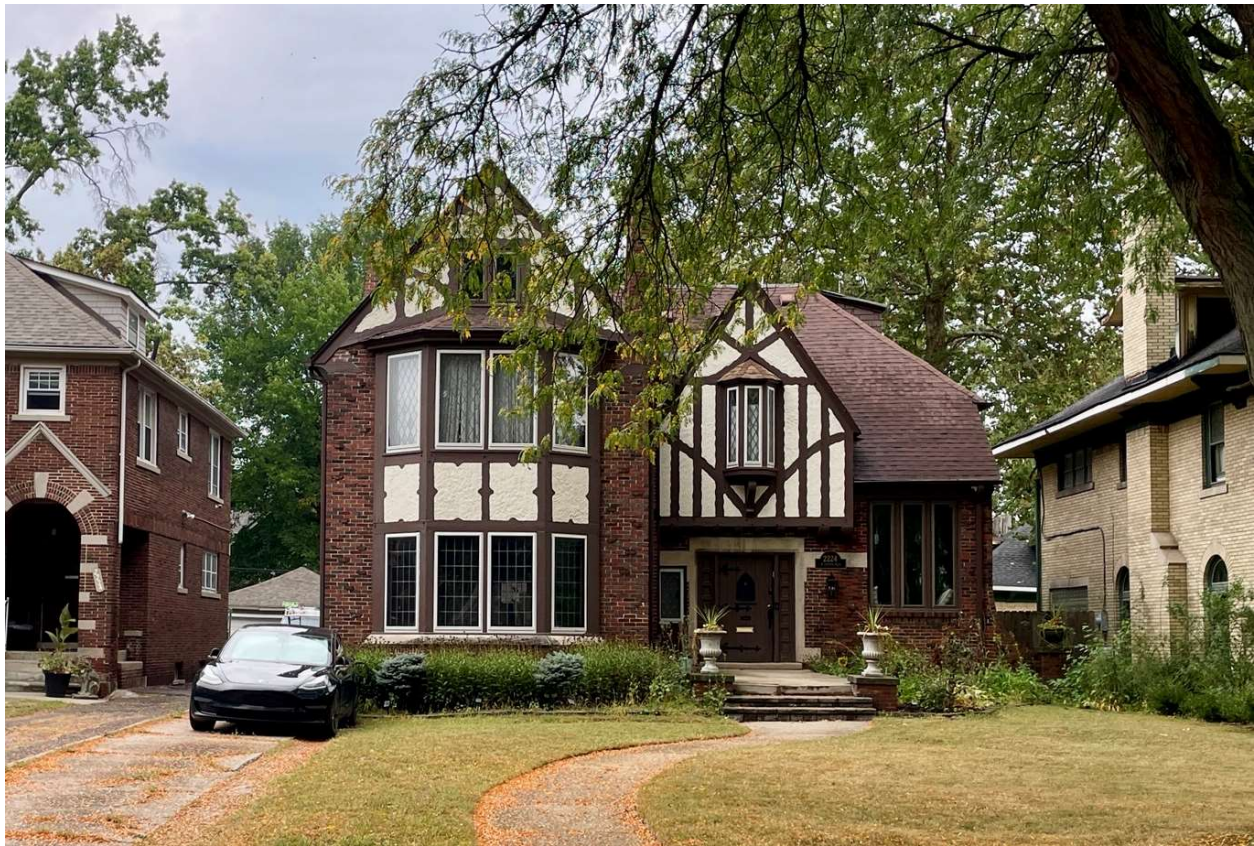
Staff photo, 09/24/2025

Built in 1924 by architect William H. Kuni for Frank J. MacDonell, this Tudor Revival home in Detroit's Boston-Edison Historic District features a red brick façade with decorative half-timbering and stucco in the front-facing gable. The structure has a steeply pitched roof and a prominent two-story bay window. Windows include leaded glass on the bay and a narrow diamond-pane window above the door. The house is set back from the street with a mature tree and has a 'shared' style driveway on the left (west) side of the front property.

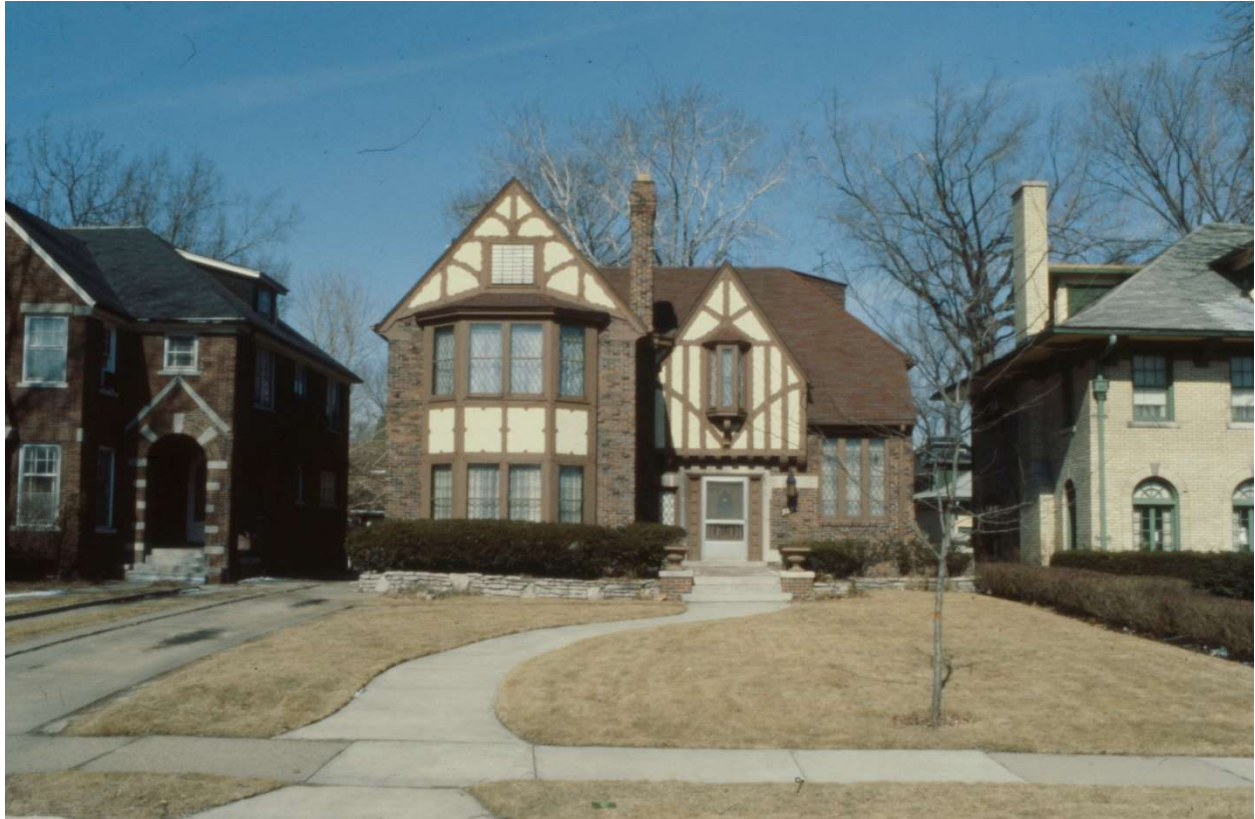
HDAB photo, 1980

- Sometime between 1974, at designation, and 1980, the curved, brick walkway was replaced with concrete. Staff was unable to locate approval documentation for this alteration.
- Staff field observations for the Boston-Edison Historic District's 'shared' driveways are as follows:
 - The placement/design of the driveways do not extend beyond the side wall of the house and into the front yard.

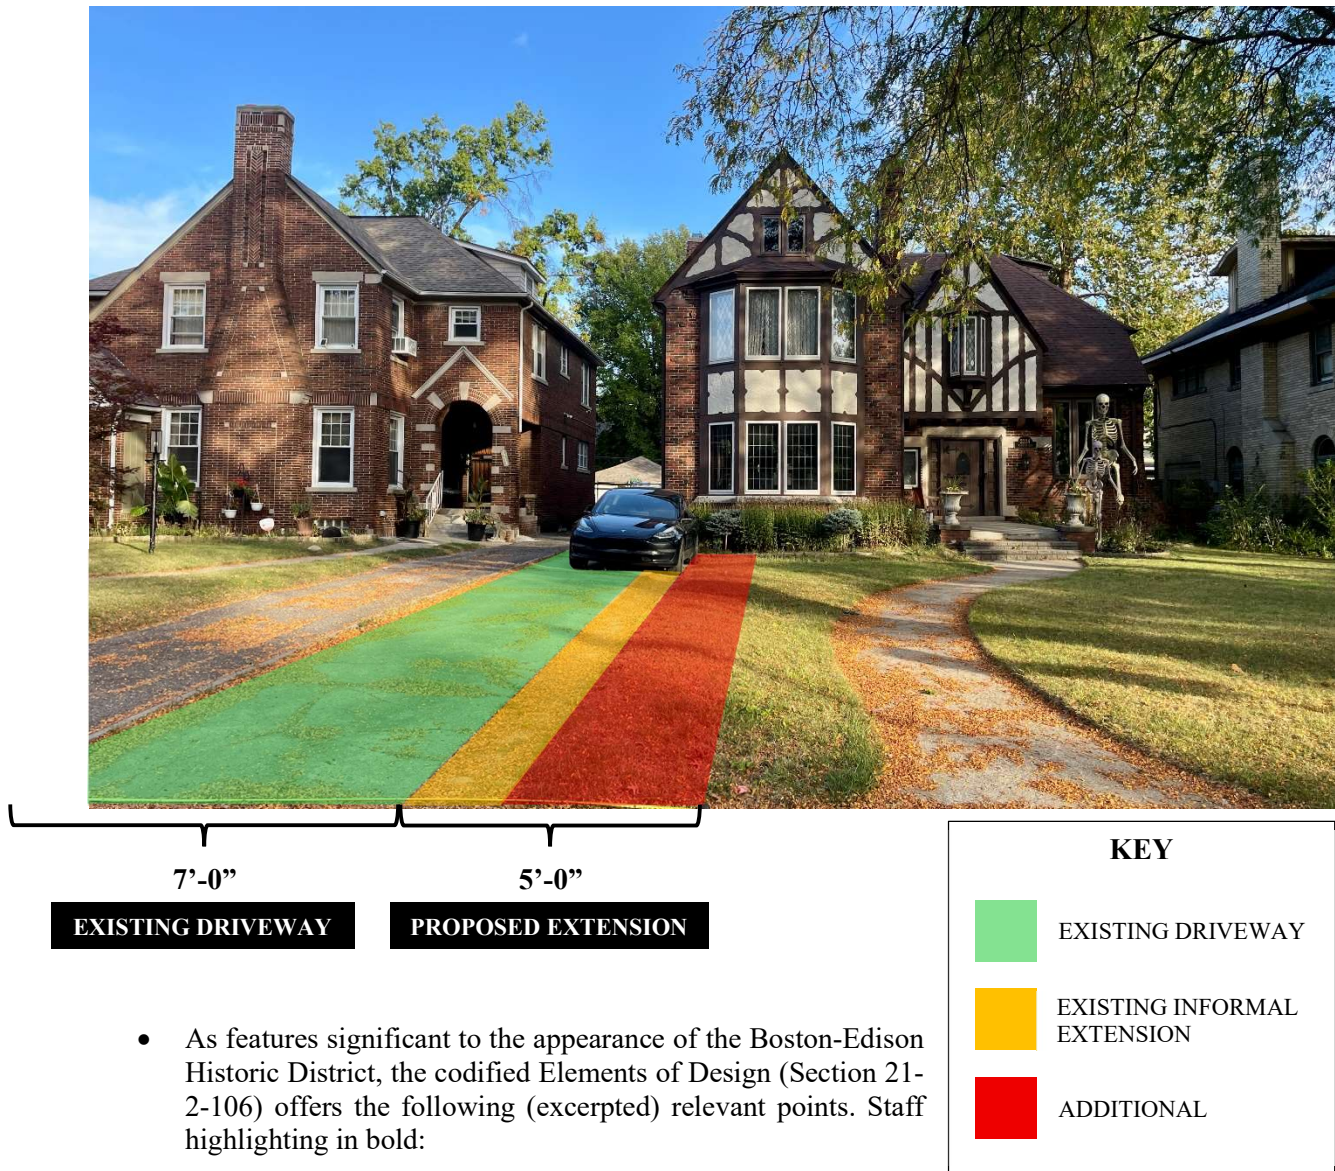
- The applicant proposes to widen the driveway from the existing 7'-0" to 12'-0". Staff notes that, in practice, the current parking use has already informally extended the driveway's width into the yard by approximately 1'-4".

- Considering the importance of front lawns throughout the district and the precedent that driveways typically do not extend in front of houses, staff finds the proposed driveway extension to be inappropriate. The applicant also proposes to widen the service path from the driveway to the entrance from 2'-0" to 5'-0". Though the current 2'-0" width is very narrow and could be widened slightly, a 5'-0" width removes a substantial amount of lawn directly in front of the house. The service path, in staff's opinion, should also remain secondary to the front walkway. Staff suggests that widening it to 3'-0" may be compatible with the context. This is also the minimum accessible width for wheelchair access.

- The driveway width will not exceed 7'-0"
- The service path width will not exceed 3'-0"

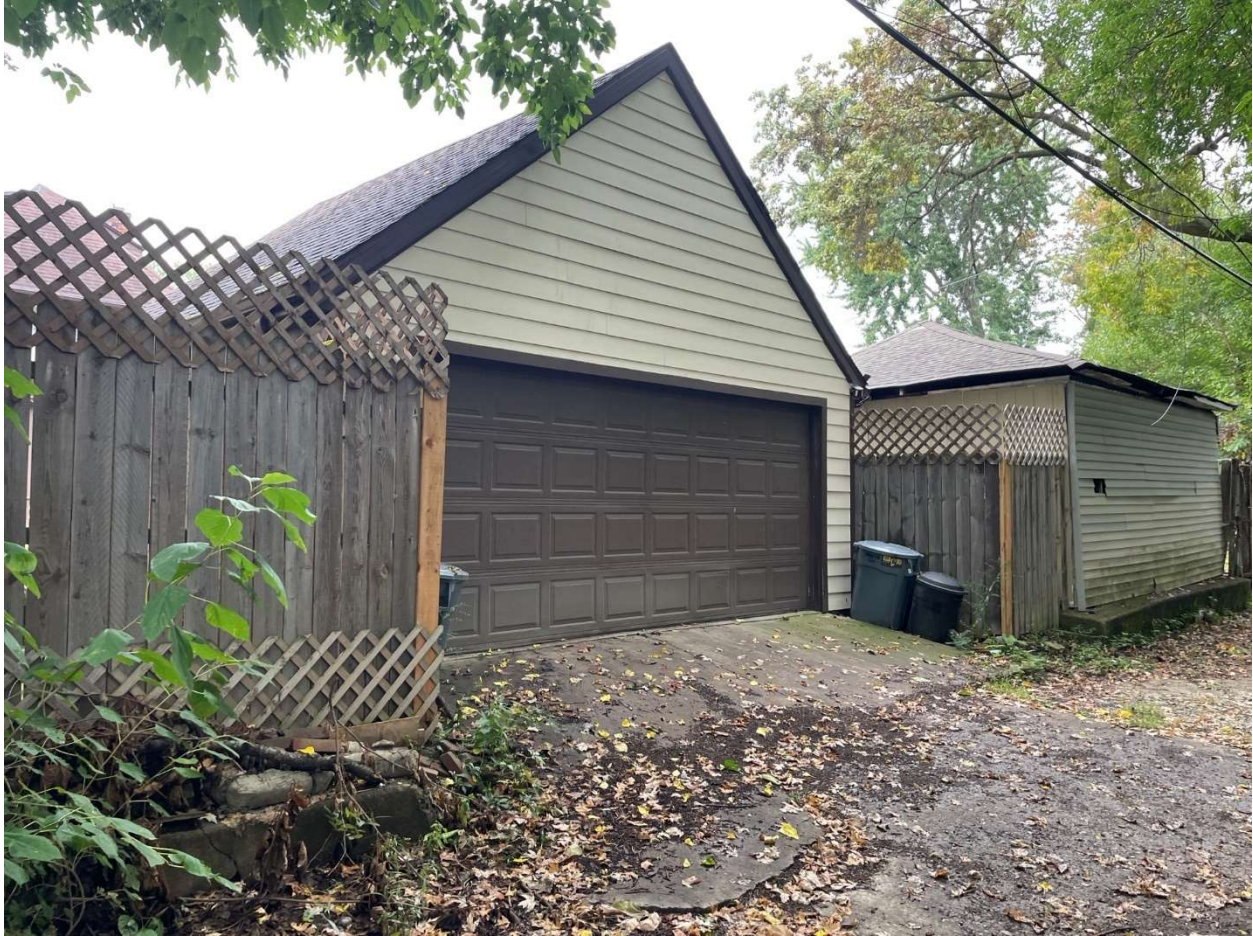
Staff photo, 09/24/2025

- Although this application seeks to widen the front-yard driveway area currently used for parking, it is important to note that the garage, built in 2019, includes a double door facing an accessible alley, providing off-street parking within the garage.

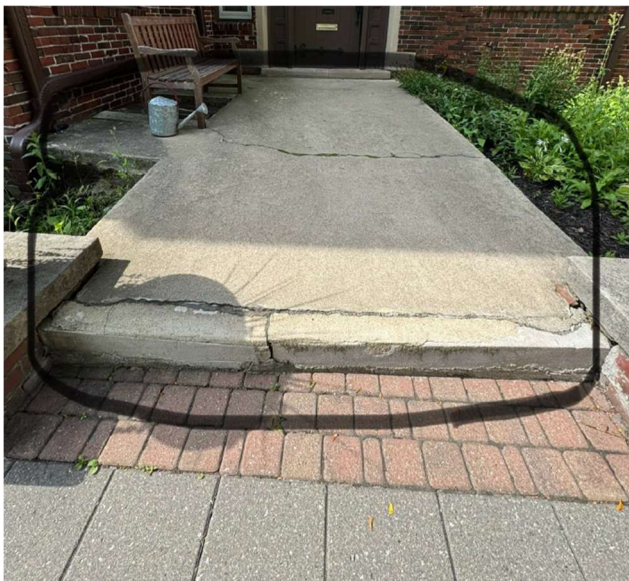
Photos with mark-ups from application

- The applicant states that the existing condition of the concrete driveway, service path, walkway, and porch are cracked and in poor condition. Staff agrees, as this is evident from the conditions shown in the photos provided with the application.

Recommendation 2 of 2 – Certificate of Appropriateness – Replace driveway, replace and widen service path, replace walkway, and replace porch concrete
