ADDRESS: 8002 KERCHEVAL

APPLICATION NO: HDC2025-00640

HISTORIC DISTRICT: WEST VILLAGE

SCOPE: REPLACE SIDING WITH FIBER CEMENT SIDING

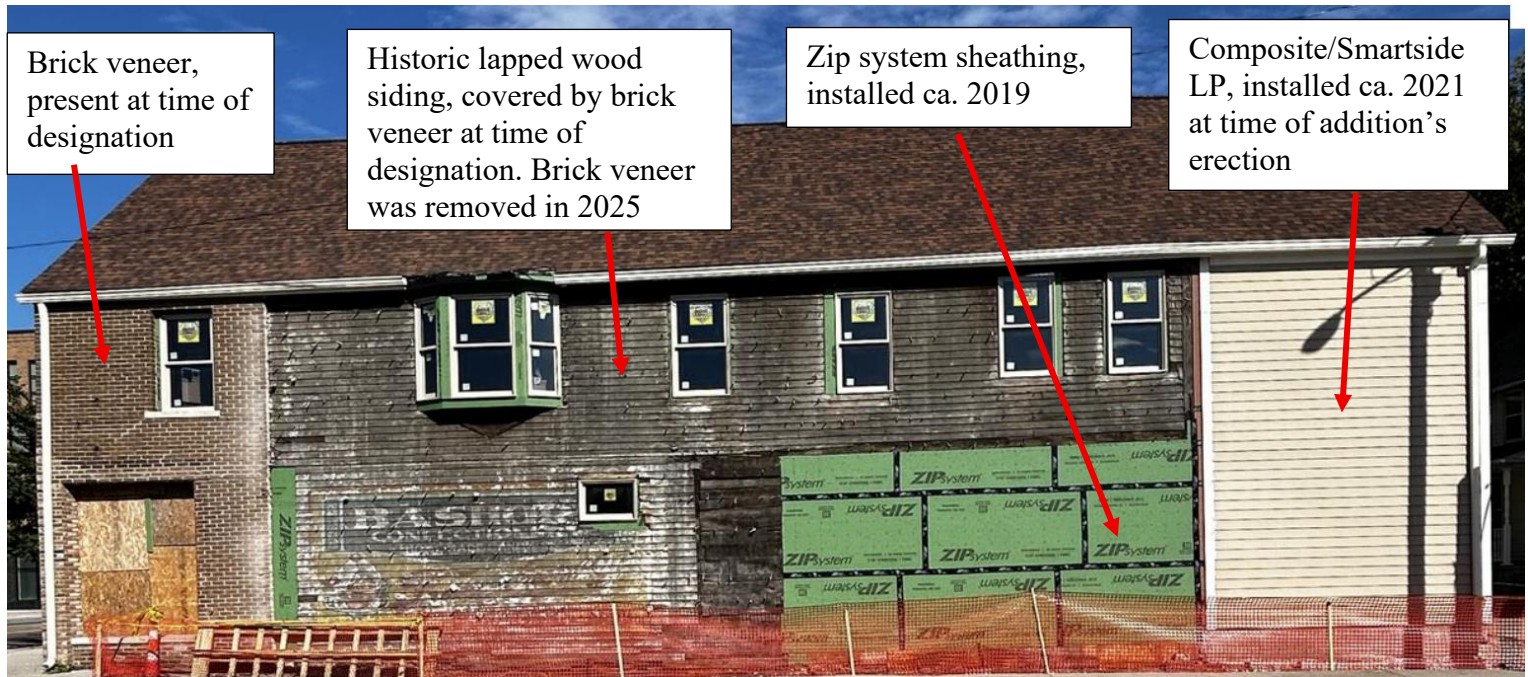
8002 Kercheval, west/side elevation. Current condition. Photo by applicant, notes added by staff.

- The historic wood siding at the side elevations has only recently been revealed after the removal of the brick veneer and asphalt/Insulbrick siding. Staff was able to view the condition of the siding from the public right-of-way and did not find that it was deteriorated to an extent that merits its wholesale removal as proposed. Also, the application does not provide documentation that the historic wood siding is deteriorated beyond repair.

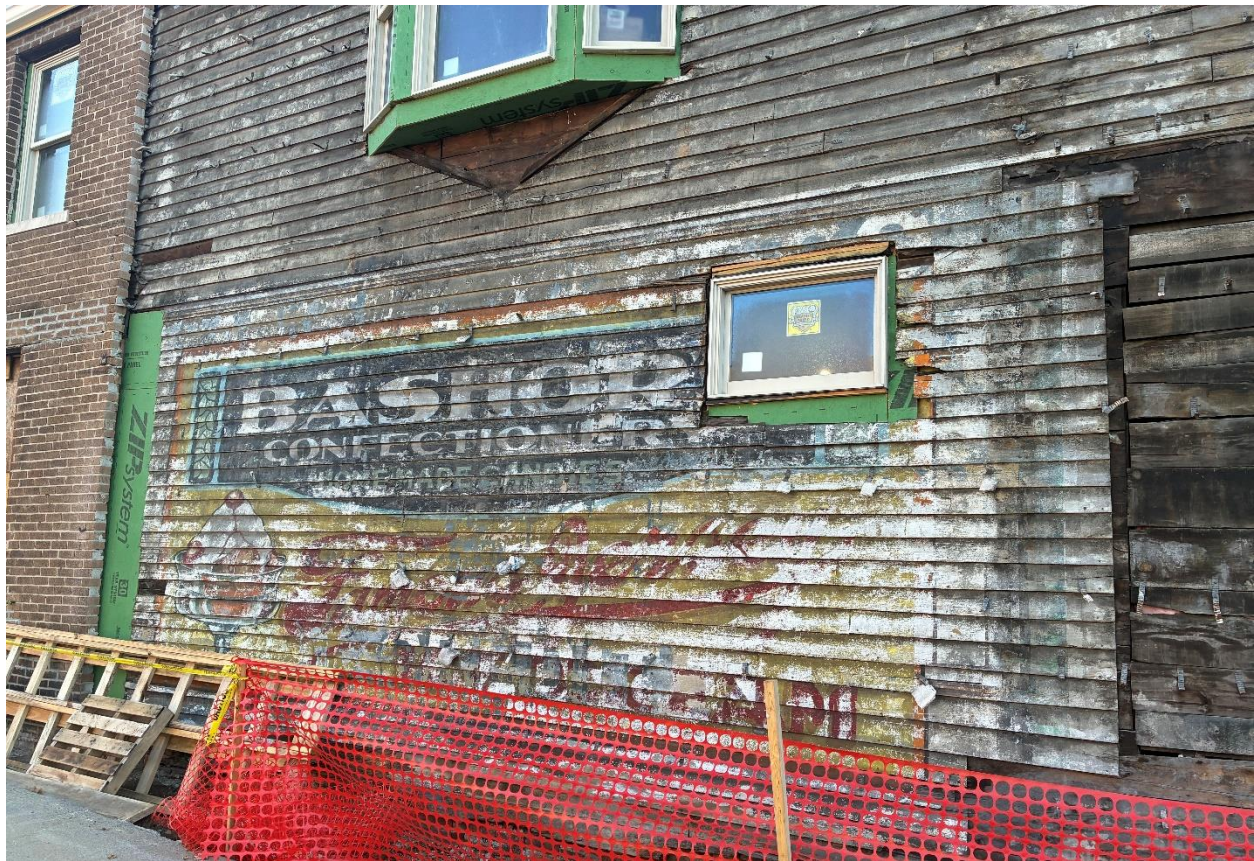
8002 Kercheval, west/side elevation. Showing historic wood siding and historic sign. Current condition. Photo by HDC staff, 10/27/205.

- Staff notes that the presence of an historic sign for "Bashor Confectioner Homemade Candy" at the first story of the newly revealed wood siding at the building's west façade (see above photos). Historic District Commission's "Signs and Awning" guidelines [Microsoft Word - Signs & Awning Guidelines FINAL](#) recommend that property owners "preserve historic signage when possible." Similarly, the National Park Service recommends that historic signs be retained whenever possible, particularly when they are "significant as reflecting the history of the building..." [Preservation Brief 25: The Preservation of Historic Signs](#). Research of historic newspapers (see below) revealed that the building housed businesses related to confectionary/candy making as early as 1927 through the 1960s.

- The painted sign at the building's west façade speaks to its historic use and therefore contributes to its historic character
- The application has not demonstrated that historic wood siding does not remain beneath the asphalt/Insulbrick at siding at the front façade's third-story gable end.

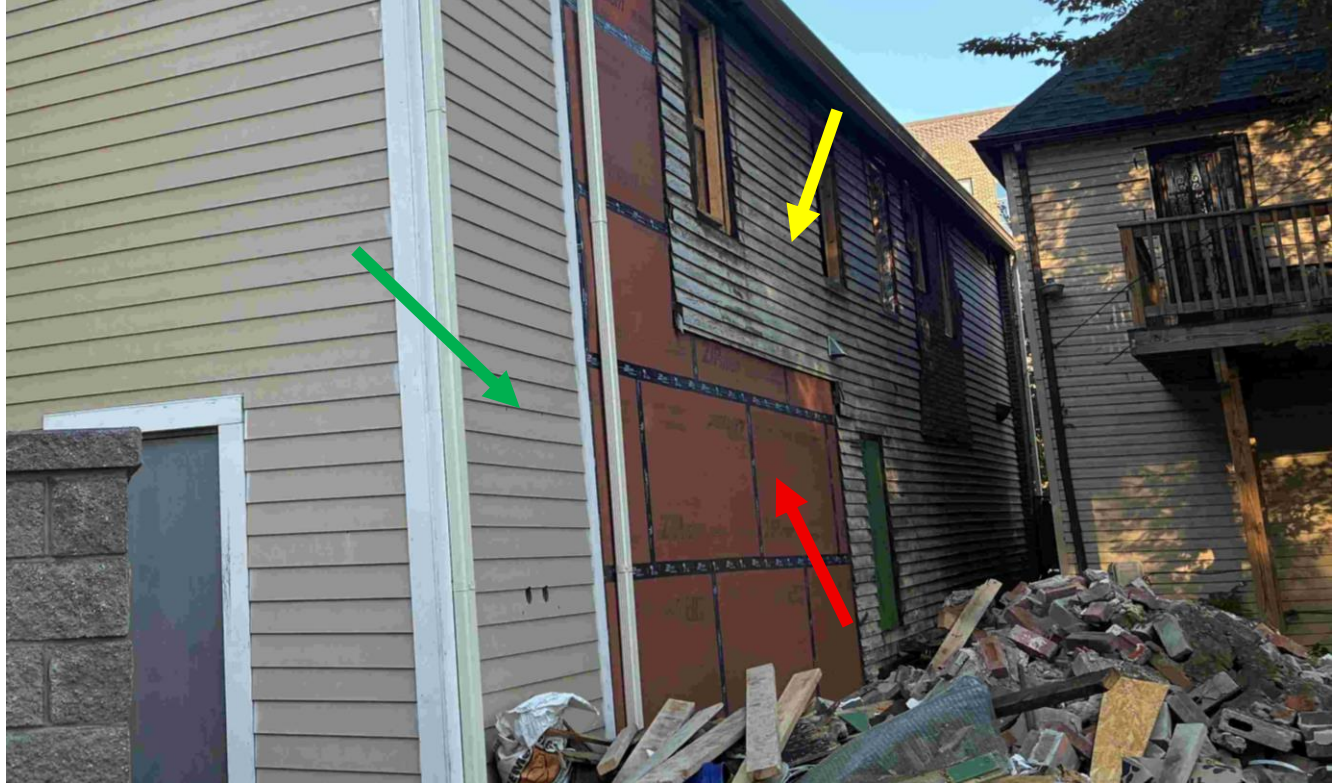
8002 Kercheval, east/side elevation. Showing historic wood siding (yellow arrow) which was revealed when Insulbrick/asphalt siding was removed ca. 2021; Zip sheathing, installed ca. 2021 (red arrow); and composite/Smartside LP siding installed ca. 2021 (green arrow) when rear addition was erected. Current condition. Photo by HDC staff, 10/27/2025.

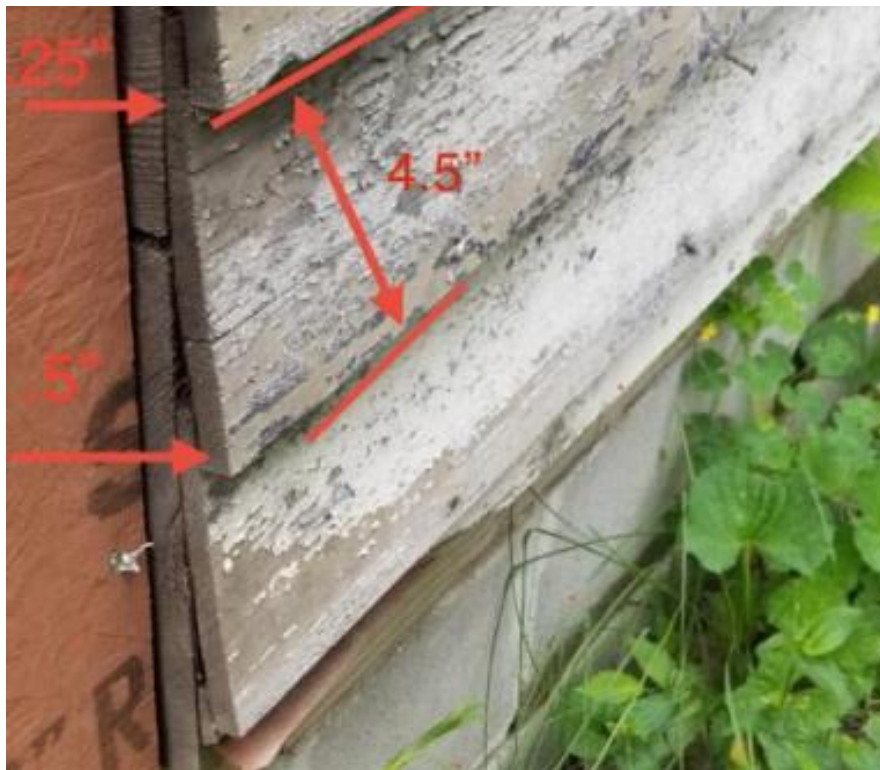
Detail, showing extant historic lapped wood siding at east/side wall. Dimensions noted in red. Image by applicant.

- The current historic wood siding displays a profile of 1/4"–1/2". As such, the proposed 5/16" thick siding provides an inadequate match to the building's historic wood siding.

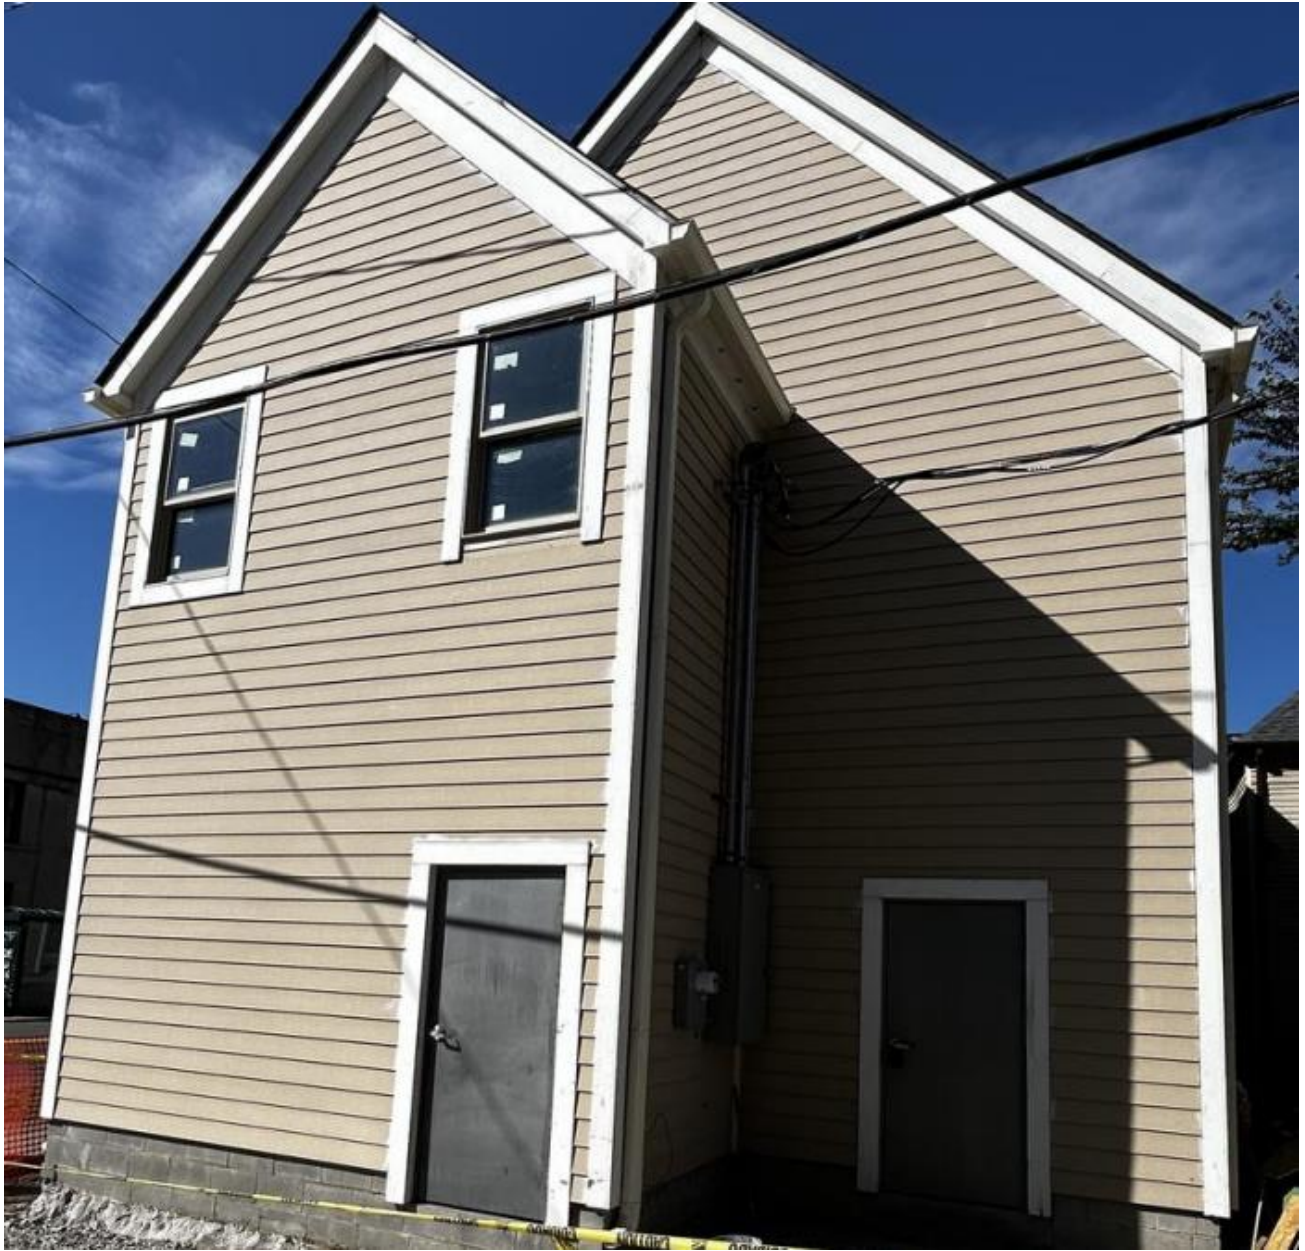
- In 2021, HDC staff was alerted that the new rear addition had been erected, but had been clad with a siding that did not conform to the approved permit drawings and or 2018 COA. Specifically, the new addition had been clad with **Smartside LP lapped siding (an "engineered" composite siding made of wood strands and fiber resins) which has a thickness/profile of 5/16", a 5 3/4" exposure, and faux wood-grain finish** instead of the approved smooth-finish cement fiber siding which has a **thickness/profile of 5/8"** ~~and an exposure of 2 1/2" to 2 3/4"~~. The property owner therefore submitted a proposal to the Commission for review at their 9/22/2021 Special Meeting in an effort to address the violation/unapproved work and obtain an "after -the-fact approval" of the Smartside LP lapped siding that had been installed at the newly constructed rear addition. The 2021 application also proposed to replace the brick veneer at the west façade with Smartside LP lapped siding, as well as installing with Smartside LP lapped siding at the front façade's third story gable end and the east side wall. Per the attached COA, note that the Commission approved the following at the 9/22/2021 meeting with respect to applicant's proposal to install new siding at the building's exterior walls:

Rear addition, erected ca. 2021 showing extant composite/Smartside LP siding, installed in violation and latter approved by the Commission. Photo by applicant.

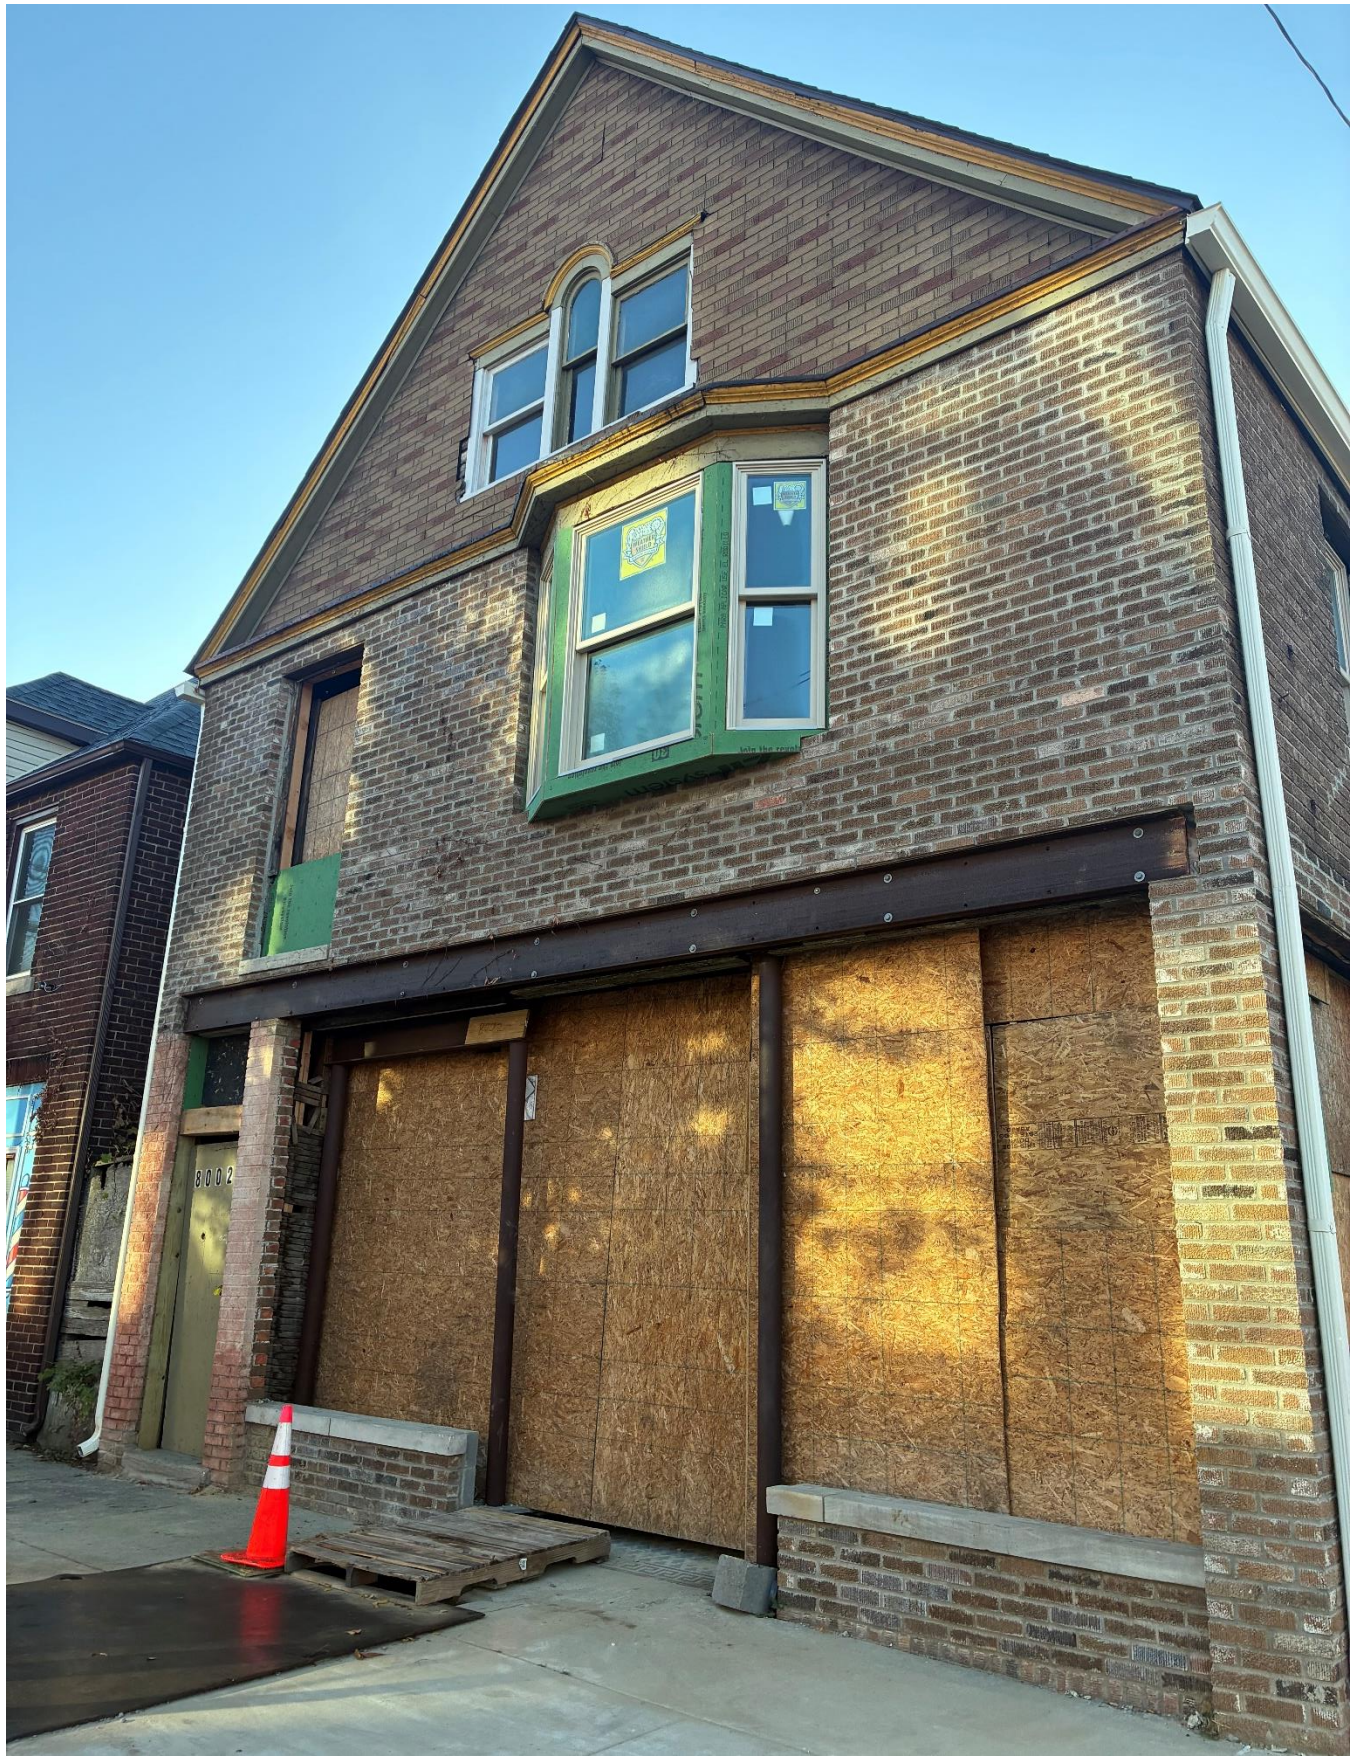
8002 Kercheval, front facade. Showing brick veneer at first and second stories. Asphalt/Insulbrick siding is present at the third-story gable end. Current condition. Photo by HDC staff, 10/27/2025.

- The application has not demonstrated that historic wood siding does not remain beneath the asphalt/Insulbrick at siding at the front façade's third-story gable end.
