**REVISED STAFF REPORT:** NOVEMBER 12, 2025 REGULAR MEETING    **PREPARED BY:** B. SALIE  
**APPLICATION NUMBER:** HDC2025-00584  
**ADDRESS:** 4224 CORTLAND  
**HISTORIC DISTRICT:** RUSSELL WOODS-SULLIVAN  
**APPLICANT/PROPERTY OWNER:** BRANDON JENKINS  
**DATE OF PROVISIONALLY COMPLETE APPLICATION:** 10/29/2025  
**DATE OF STAFF SITE VISIT:** 11/03/2025

**SCOPE:** REMOVE HISTORIC STEEL WINDOWS & INSTALL VINYL WINDOWS

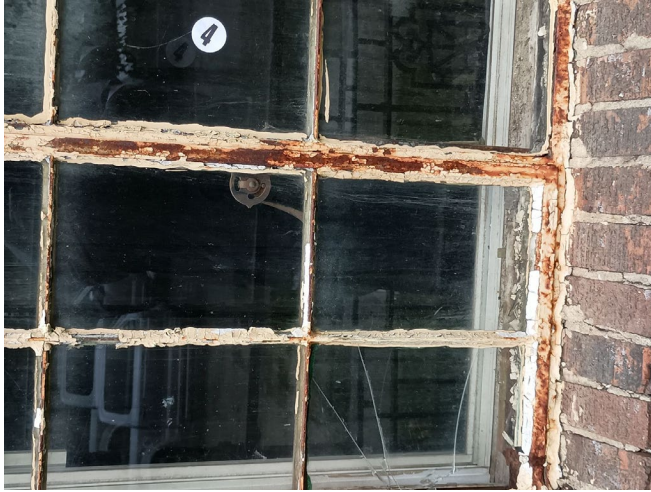
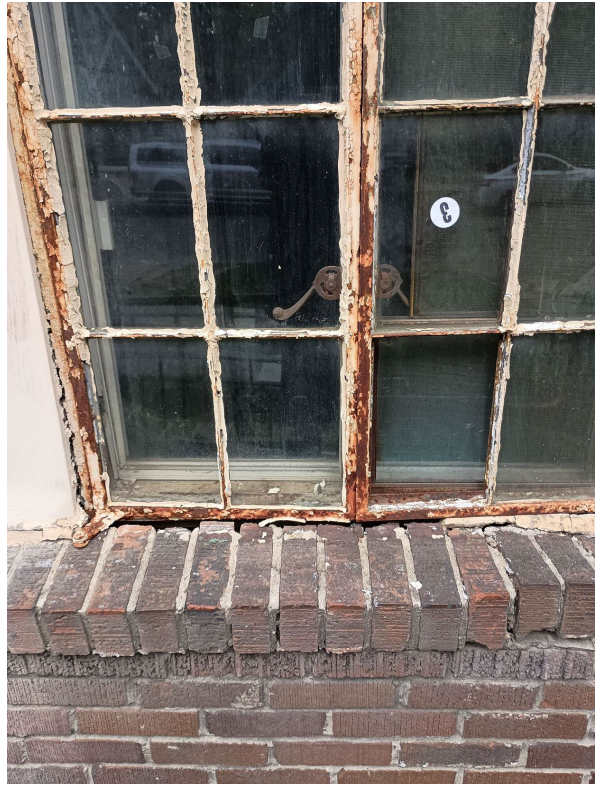
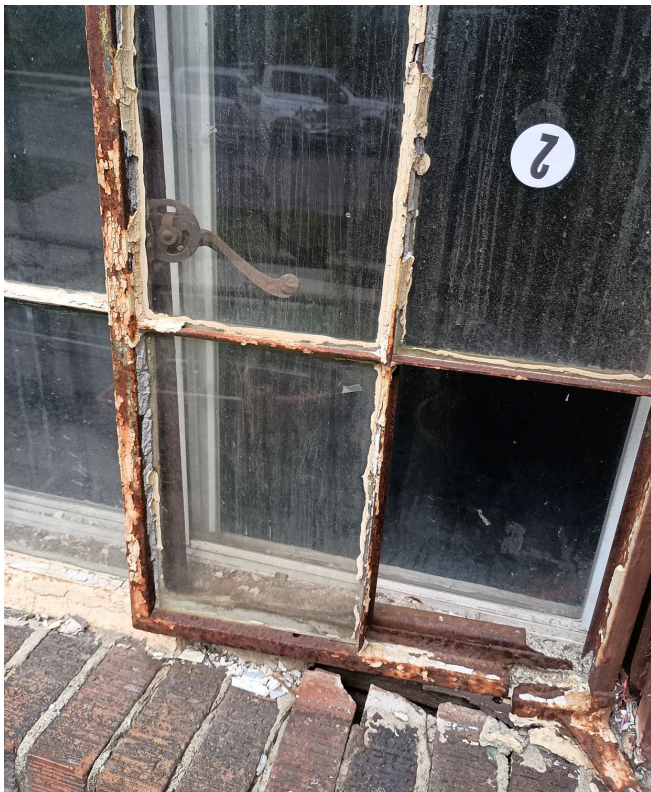
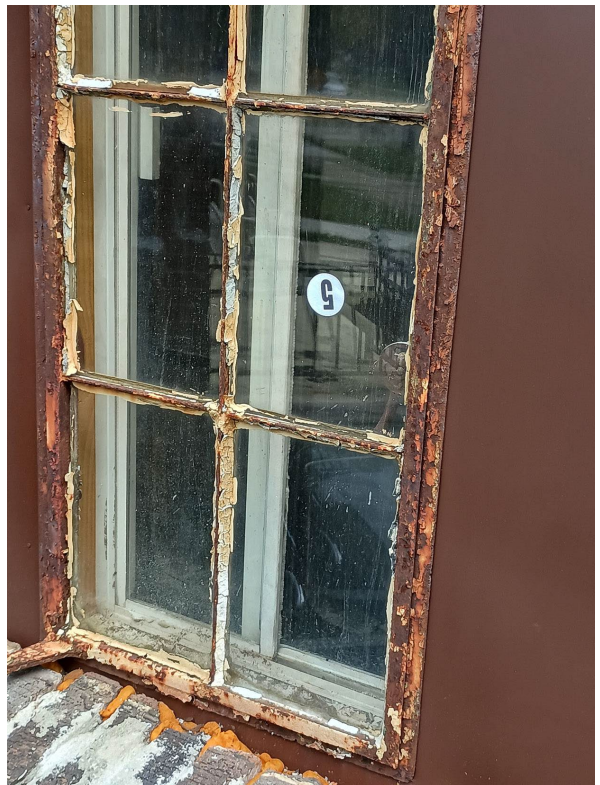
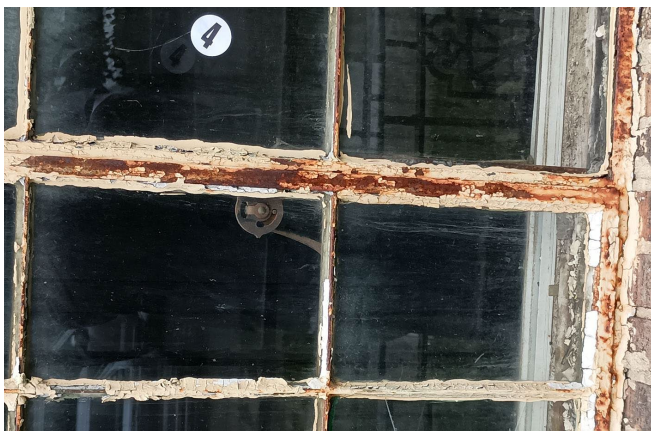
*Photos provided by applicant, show the historic steel casement window with significant rust and peeling paint on the trim and muntins*

- The front bay of the house has retained its historic aged windows. The windows at the front of the house are a distinctive, character-defining feature for this property. Since time of designation, the window frame and muntins were painted, which is now rusted and peeled.

- It is staff's opinion that the deterioration and the build-up of rust over the years show the windows to be beyond repair. However, vinyl is not an appropriate replacement window type for historic buildings, in particular for the thin profiles of steel casement windows:

- While the existing historic steel casement windows appear to be deteriorated beyond feasible repair, the proposed windows are not in-kind matches to the historic windows at this property. The historic steel windows, per NPS Standards (#6) and related Guidelines, may only be replaced by a window that "shall match the old in design, color, texture, and other visual qualities and, where possible, materials." Vinyl windows are not good matches for historic prototypes.

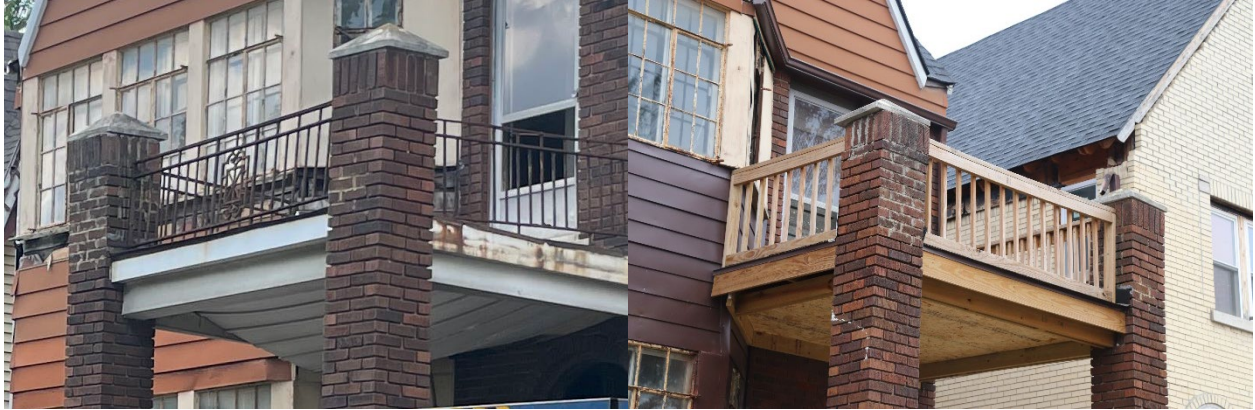
*Photo taken by staff on 06/24/24,  
for a violation for roof rehabilitation.*

- Upon site visit, staff identified other work being done (in violation). First, at the front porch where the porch ceiling has been reconstructed and adjusted. And second, at the second story balcony, where the wrought iron railing was removed and replaced with a wood railing (see next page).

- Prior to construction, the porch ceiling was caved in and in need of repair. It does not appear that the materials of the porch were not historically significant. Yet it is a concern to staff that the historic railing was removed without HDC staff approval. The second story balcony railing has been replaced with wood, which is not consistent with the house's original design and not consistent with the front porch railing, which retains its original wrought iron railing.

- The Commission was not given the opportunity to discern whether the balcony railing was beyond repair.
  - It is staff's opinion that the original wrought iron balcony railing is a distinctive, character-defining feature and was replaced without documentation confirming that they were beyond feasible repair, as required by Secretary of the Interior Standards #5 and #6. As such, it should be restored to its pre-violation condition, that of a wrought iron style railing.

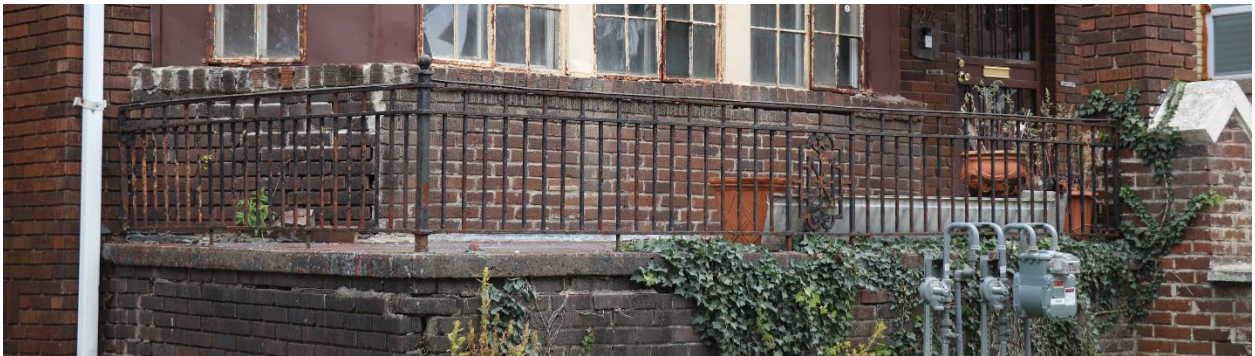
*Photo taken by staff on 11/03/24*

- The historic metal railing that was removed without HDC approval was a distinctive, character-defining feature to the building. Therefore, if the railing was deteriorated beyond repair, any new replacement railing should have matched the existing, per the Standards. As the current wood railing does not match the historic, it does not meet the Standards.

- The current application does not provide documentation that the historic, character-defining metal railing that was removed without HDC approval was deteriorated to an extent which merited its removal.
