**STAFF REPORT:** 11/12/2025 REGULAR MEETING

**APPLICATION NUMBER:** HDC2025-00638

**ADDRESS:** 3751 LESLIE

**SCOPE:** REPLACE WINDOWS (WORK COMPLETED WITHOUT APPROVAL) WITH ALUMINUM-CLAD WOOD WINDOWS

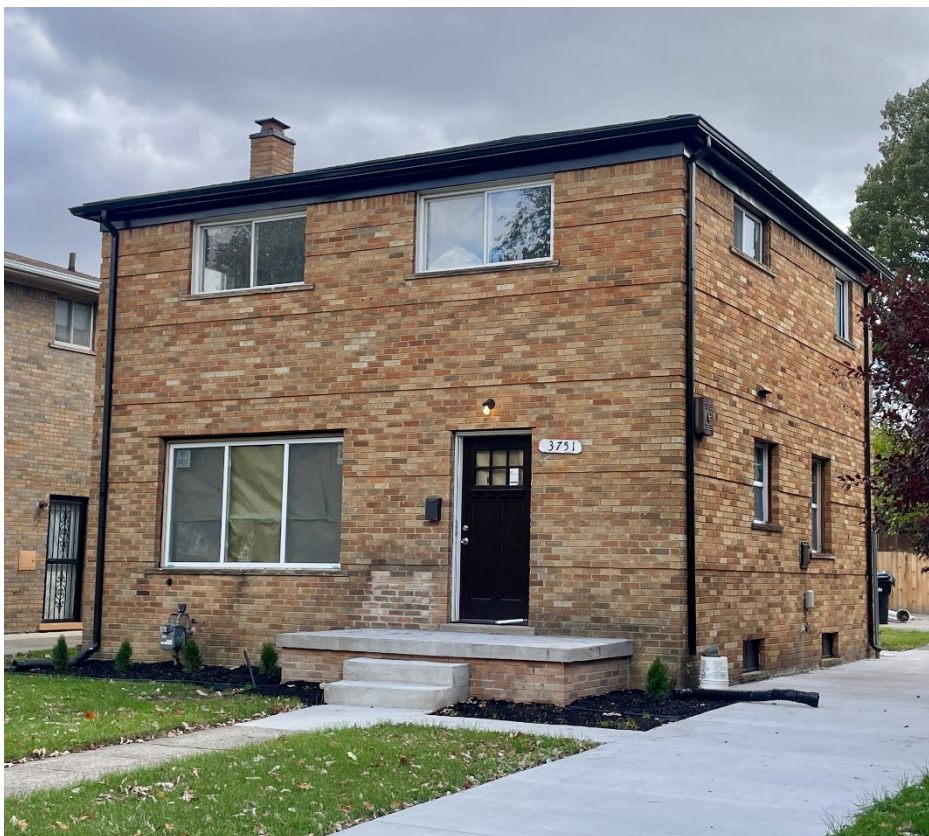
*Staff photo, 10/24/2025*

The installation of replacement vinyl windows were installed at the East and West elevations without the approval of the Historic District Commission, which has impacted the property's historic character.

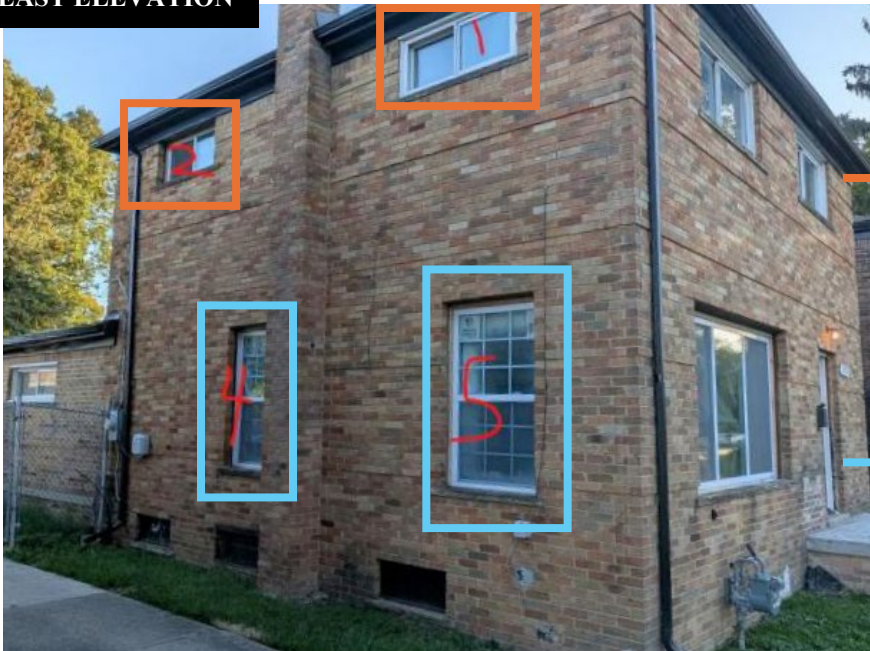
### EAST ELEVATION

- The historic steel windows were 3 panes across by 2 panes high

- The historic steel windows were likely 2 panes across by 5 panes high

- As the windows were removed without HDC approval, the scope of work that would meet the requirements of the historic ordinance (Section 21-2-59(e)) and state statute (MCL 399.205(12)), is the fabrication and installation of new steel-framed windows with an identical pattern and operation with dimensions that match the historic windows.
  - If the Commission considers the installation of aluminum-clad wood windows, the dimensions and details of the selected replacement windows should be reviewed.
  - Due to the difference in strength of steel and wood, the dimensions of the aluminum-clad wood frames and muntins/grilles will likely not match the thinness of the historic width and profile of the steel window frames, muntins, and mullions.

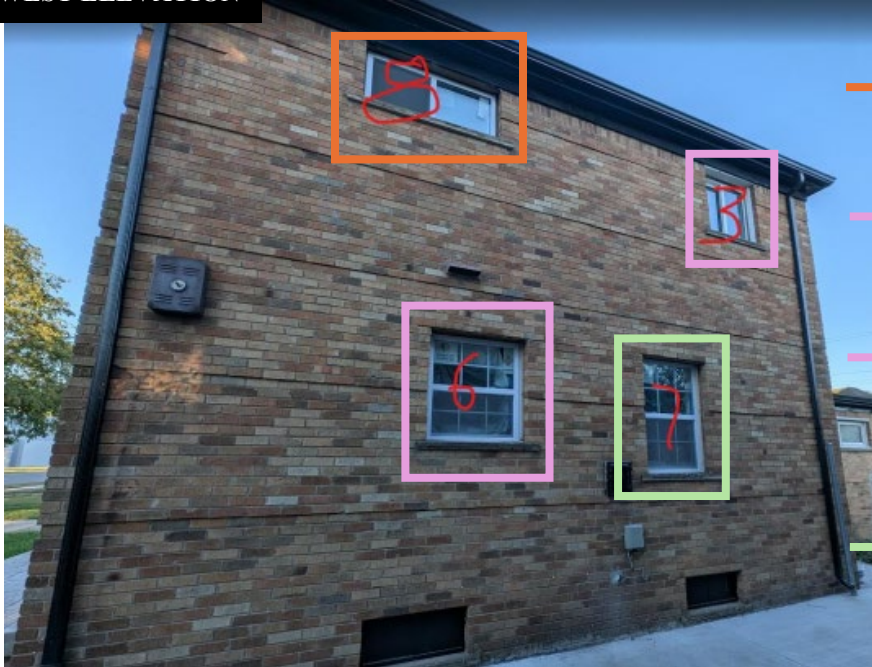
Photo from application

- The historic steel windows were likely 3 panes across by 2 panes high.

- The historic steel windows were likely 2 panes across by 2 to 3 panes high.

- The historic steel windows were likely 2 panes across by 5 panes high.
