**STAFF REPORT:** 11/12/2025 REGULAR MEETING

**APPLICATION NUMBER:** HDC2025-00639

**ADDRESS:** 949 CHICAGO

**SCOPE:** DEMOLISH TWO-STORY REAR WING, ERECT TWO-STORY REAR WING (WORK STARTED WITHOUT APPROVAL)

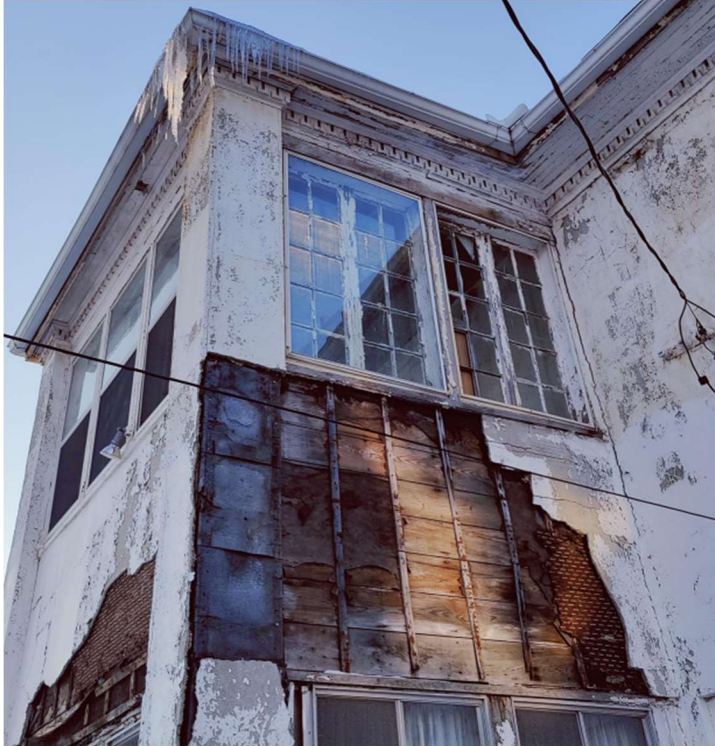
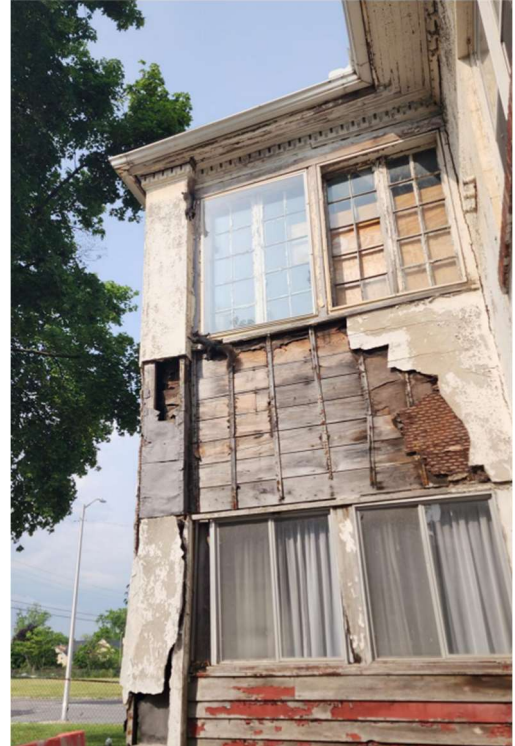
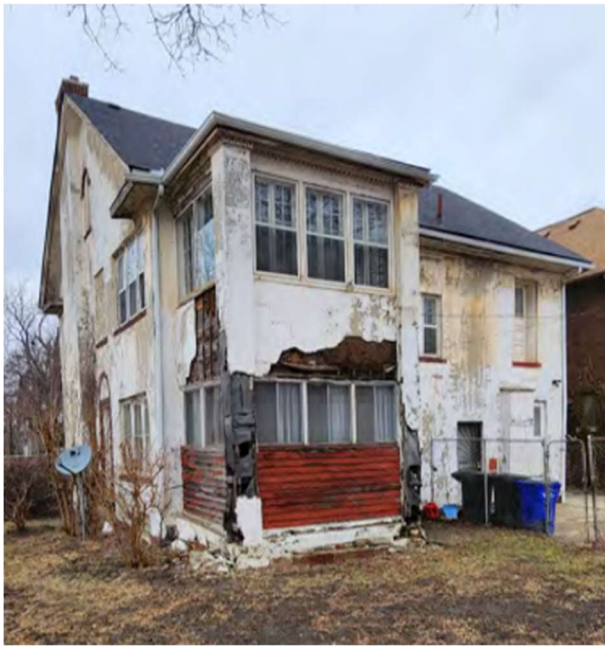
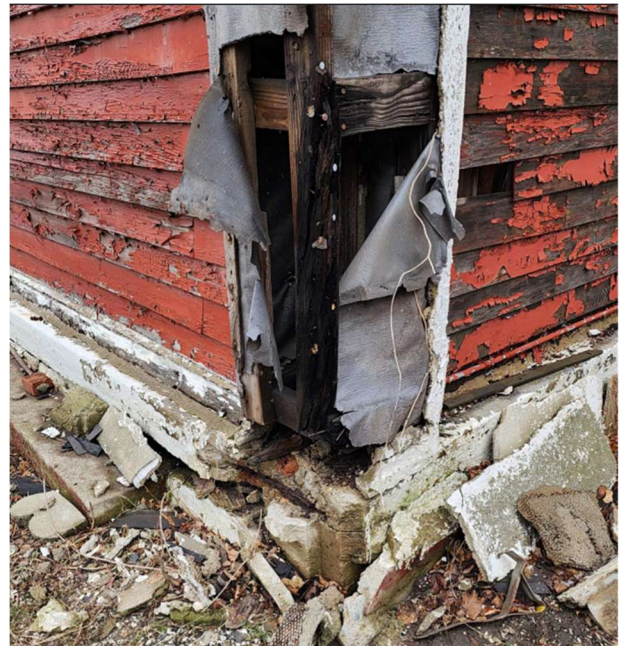
*Photos from application*

- Although the photos show that the rear wing obviously suffered water damage, it has not been proven to be unsalvageable, in staff’s opinion. Per the Secretary of Interior’s Standards for Rehabilitation:

- The applicant states “The structure has sustained significant water and weather-related deterioration, particularly in the lower wall framing, sheathing, and exterior finishes below the upper roof eave.”

- In the documentary photographs submitted by the applicant, there are obvious areas of decay that need renewal and repair. However, professional staff is not convinced from the evidence presented that the wing required wholesale demolition and reconstruction.

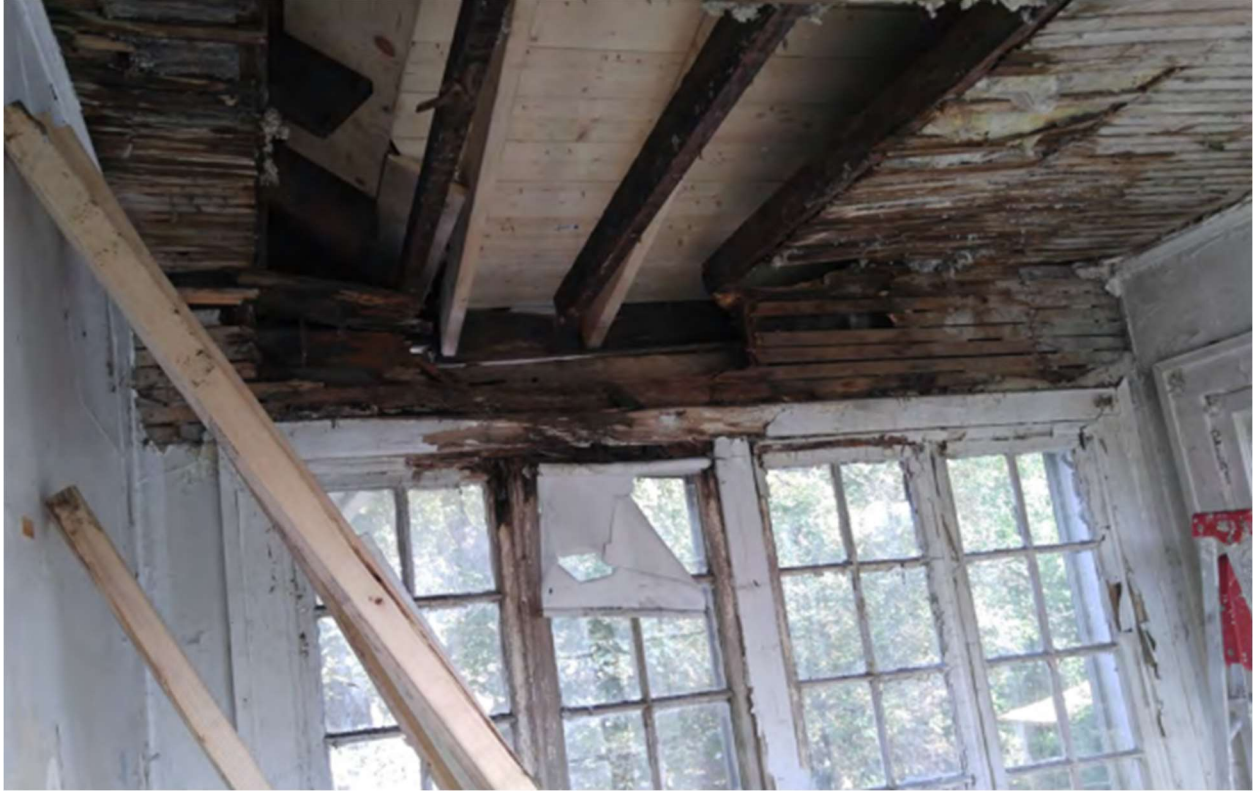
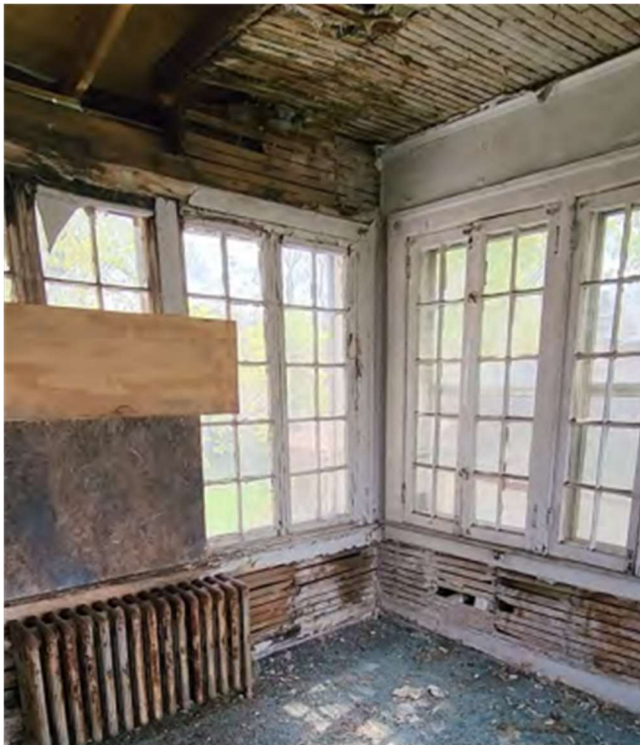
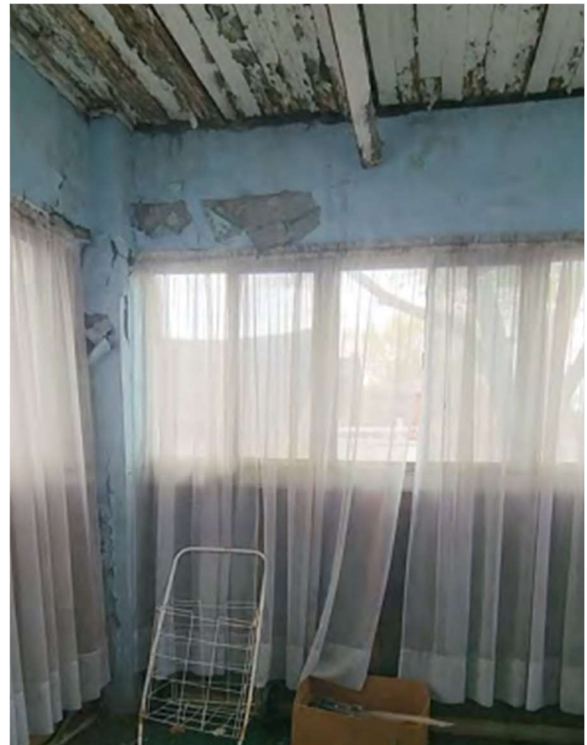
*Photos from applicant*

- Additional photos show deterioration, but not conditions compelling demolition/removal of all historic materials, including the historic windows.

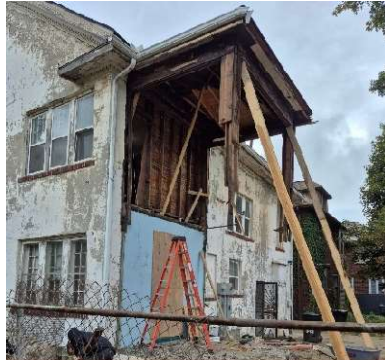
*BSEED staff photo, 10/07/2025*

- On 10/07/2025, the Buildings, Safety Engineering, and Environmental Department (BSEED) did an inspection and noted that the demolition of the rear wing was not permitted. The inspector spoke with the applicant and issued them a violation.

**Demolition already completed,  
BSEED staff spoke with applicant  
and issued a violation**

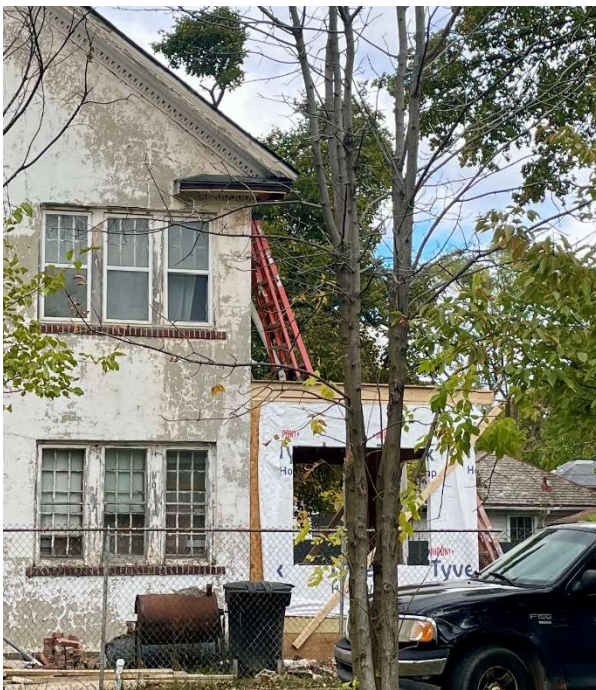
**10/24/2025**

**HDC staff informed applicant to stop work**

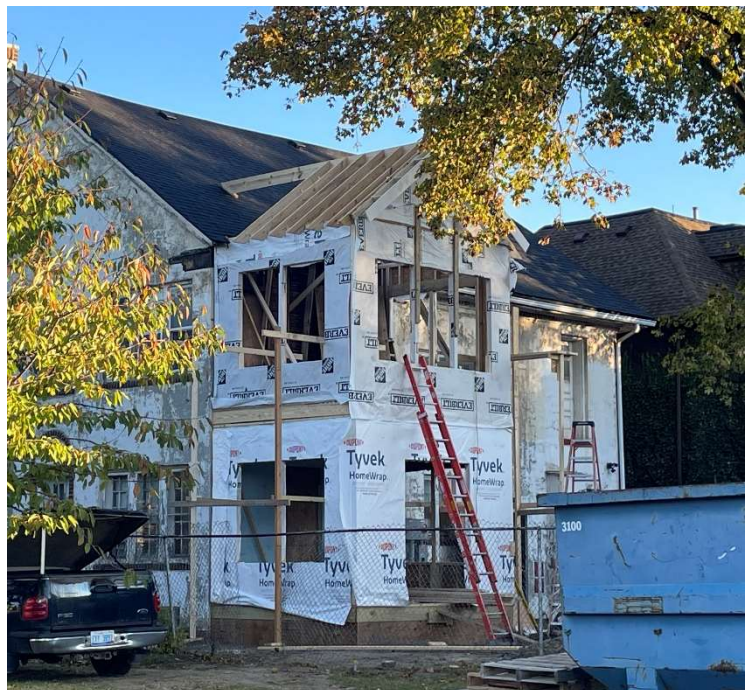
**10/29/2025**

**New construction continued**

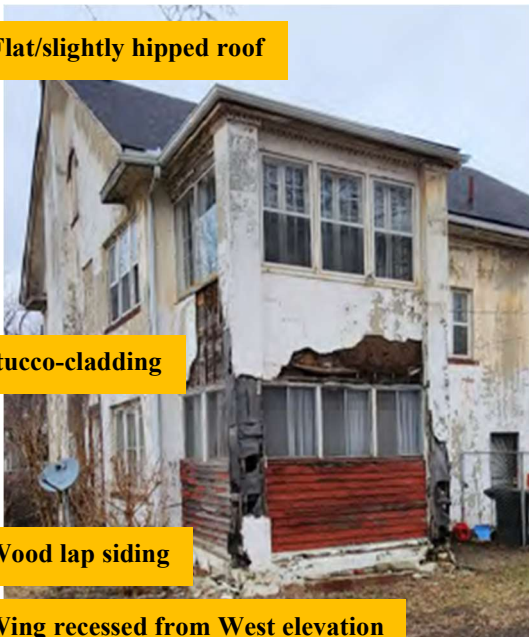
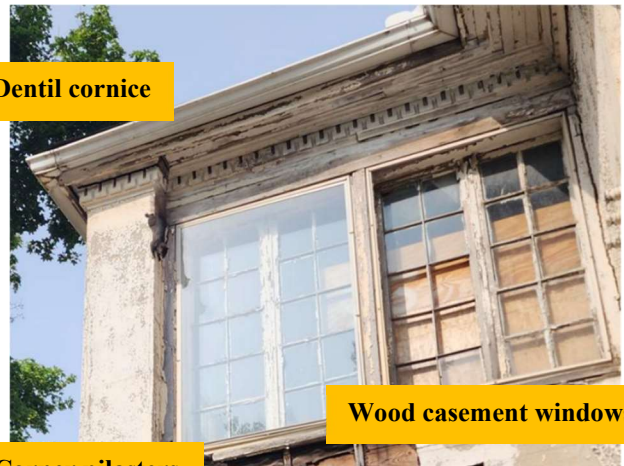
*Photos from application,  
staff notes added*

- The following photos illustrate the significant, character-defining elements which were demolished without approval:

- The existing house was a complete 360 degrees of authentic Colonial Revival expression; the two-story rear wing, including the recessed location, low-sloped roof, stucco-cladding, wood lap siding, dentil cornice, corner pilasters, and multi-lite wood casement windows, were distinctive character-defining features.
- The Elements of Design states that “sun porches, with a very high proportion of window openings subdivided by mullions and muntins, are common.” and that “porches and permanently enclosed sun porches are often placed at the side and, sometimes, at the rear of the building.” Additionally, “flat roofs are present only as subsidiary roofs on residential structures.”
