**STAFF REPORT: DECEMBER 10, 2025 MEETING**

**APPLICATION NUMBER: HDC2025-00616**

**ADDRESS: 4325 LESLIE**

**SCOPE: REPLACE HISTORIC WINDOWS, ALTER DWELLING**

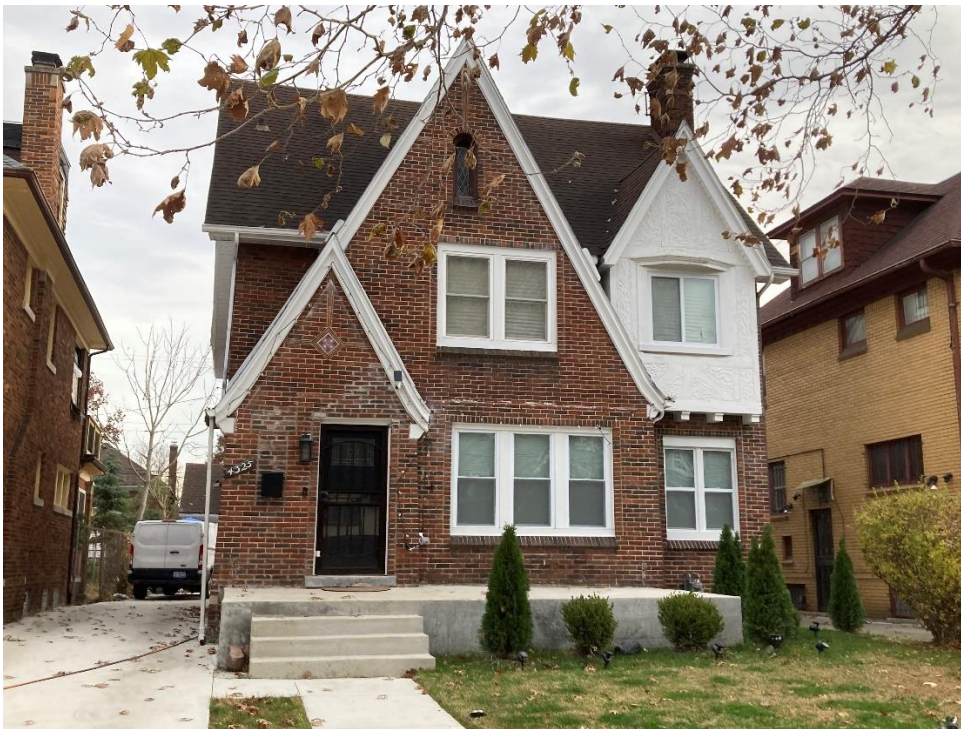
*4325 Leslie after extensive modifications. Staff photo, November 2025.*

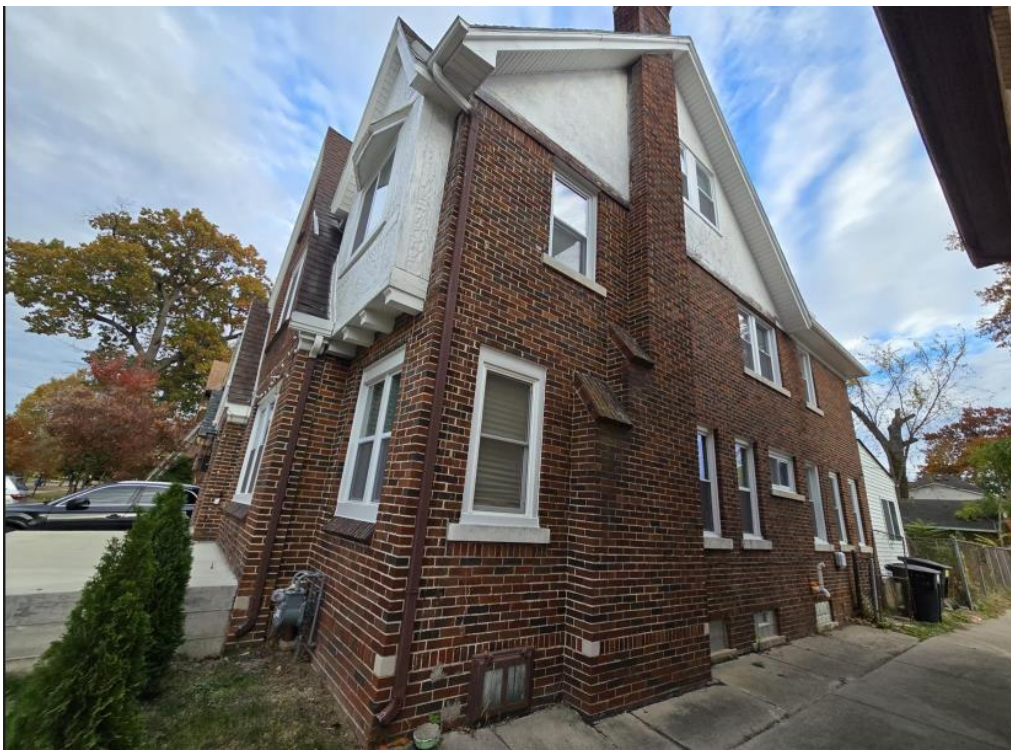
*4325 Leslie, west side of house. Vinyl windows on side of house and vinyl windows and vinyl siding on rear sunroom addition are shown. Also visible are the white-painted half-timbering details on the front of the house, near the northwest corner. (Applicant's photo from materials.).*

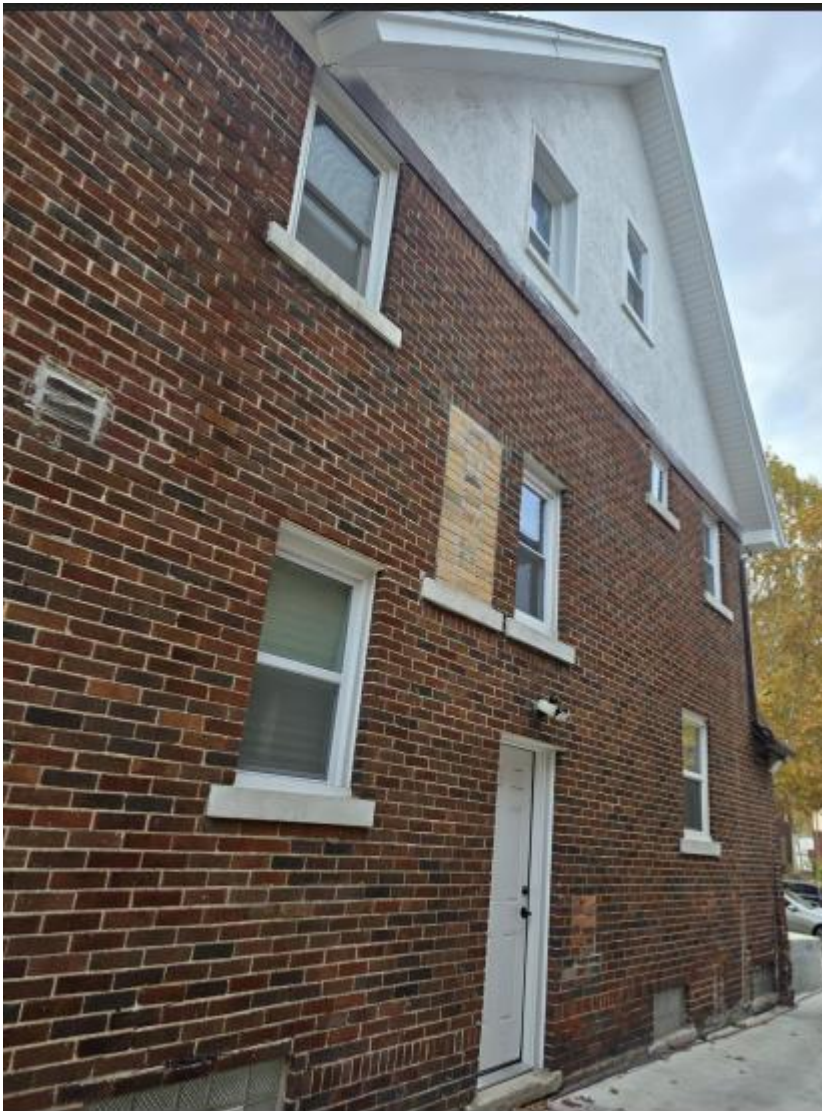
*4325 Leslie, east side, photo provided by applicant. Vinyl windows, infilled window opening, and new side door are all visible.*

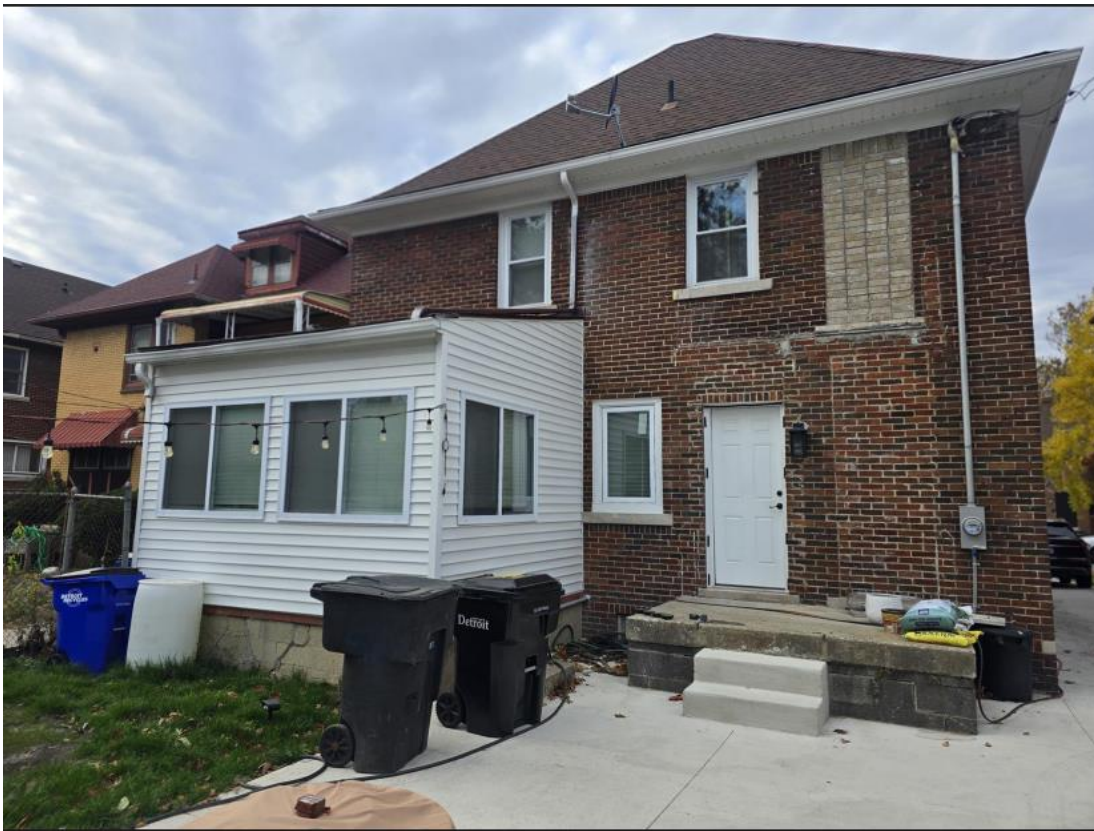
*4325 Leslie, photo provided by applicant. Rear sunroom addition with new vinyl siding and new vinyl windows, new vinyl windows on the historic house, brick-infilled opening at second floor, and new back door are all pictured. (The infilled opening next to the new back door with reddish bricks has been infilled since at least 2011, so it is not part of this proposal or the violations process.)*

- Although the non-historic rear sunroom is not of historic age and is not a distinctive, character-defining feature of the house, staff finds that the recently installed vinyl windows and vinyl siding are not compatible with the Tudor-style house. Replacement material in the historic district, even for non-historic materials like aluminum siding and aluminum storm windows, must be compatible with the historic house. The proportions, texture, sheen, and color of the vinyl siding are not compatible with this Tudor-style house.

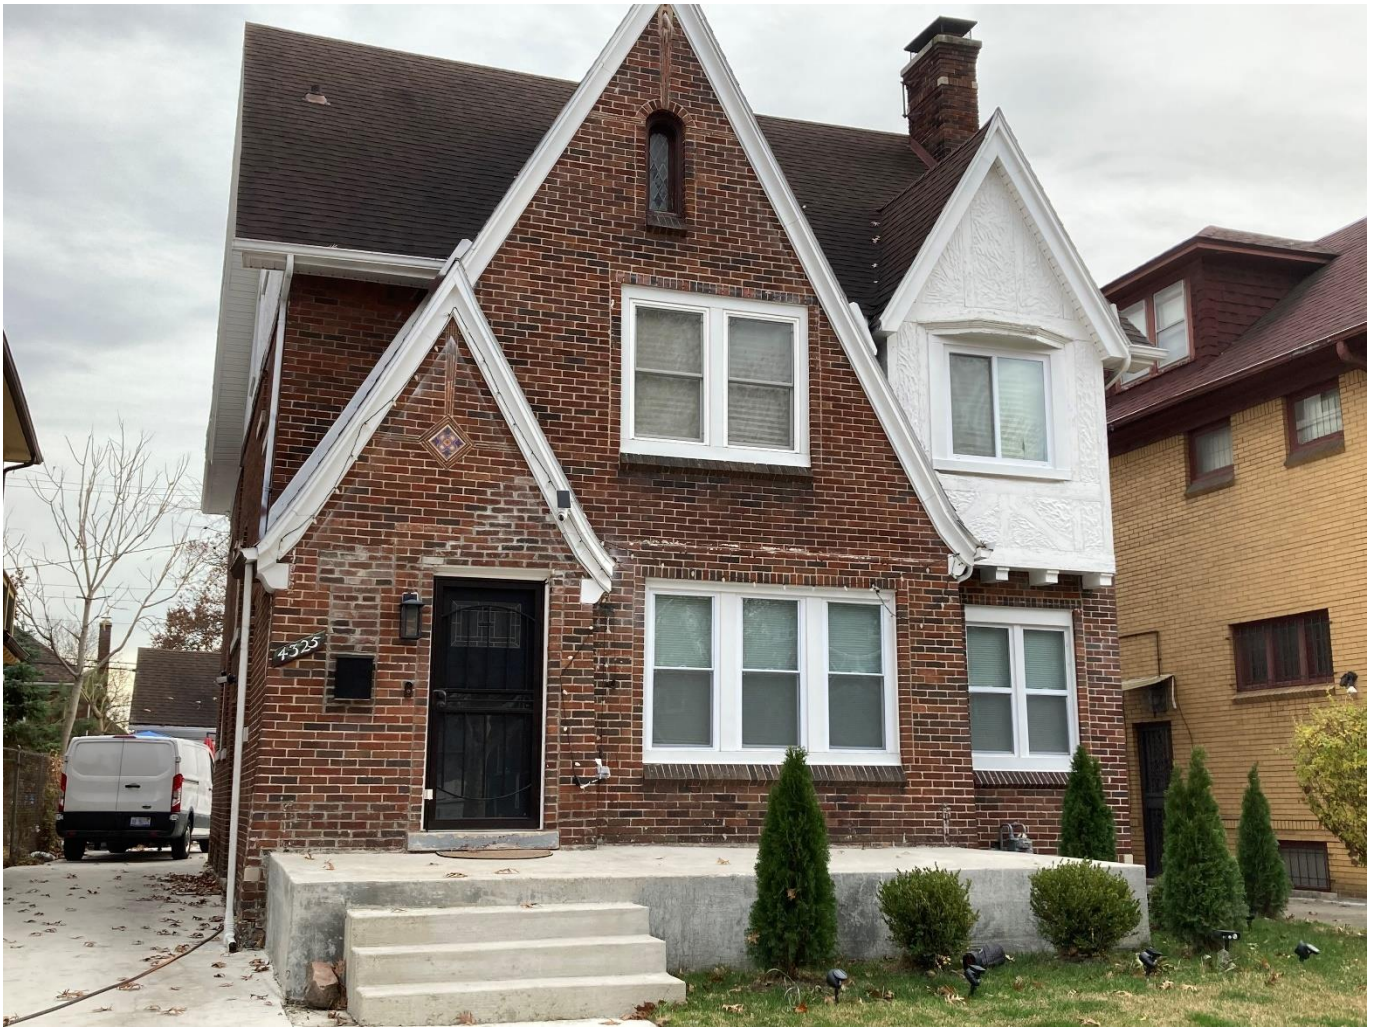
- The **historic, character-defining bowed bay window** with lattice-patterned leaded glass should have been preserved and repaired. If repair was not possible, Standard 6 requires that the new window should have matched the historic in design, color, texture, other visual qualities, and, where possible, materials. The bay window’s replacement does not replicate the historic window in any way—it lacks the dimensionality of the bay window, leaded glass, tall, narrow proportions, and the complementary color for the architectural details, and the vinyl introduced a plastic texture, detracting sheen, and blocky proportions. Where a projecting, detailed bay window with three tall, narrow, leaded sashes was, now is a flat window with two horizontal sliding sashes and wide rails and stiles in bright white vinyl.

*Current. Between 2022 and 2024, the bay window and its leaded glass on the house's upper right was removed, all of the rectangular leaded-glass windows on the front of the house were removed, the arched window next to the front door and its leaded glass were removed, the pointed-arch doorway and original door were removed, and the three brick piers, low guardrail, and the capped wing walls at the front porch were all removed. The narrow, arched window in the gable remains and retains its leaded glass. Painting the half-timbers white (like the stucco) neutralized this character-defining architectural feature. (Staff photo, November 2025)*

- The historic, character-defining second-floor bowed bay window (three sashes) that was near the house's northwest corner was removed and replaced with a flat window with two horizontal-sliding sashes, eliminating an important and dimensional historic feature and

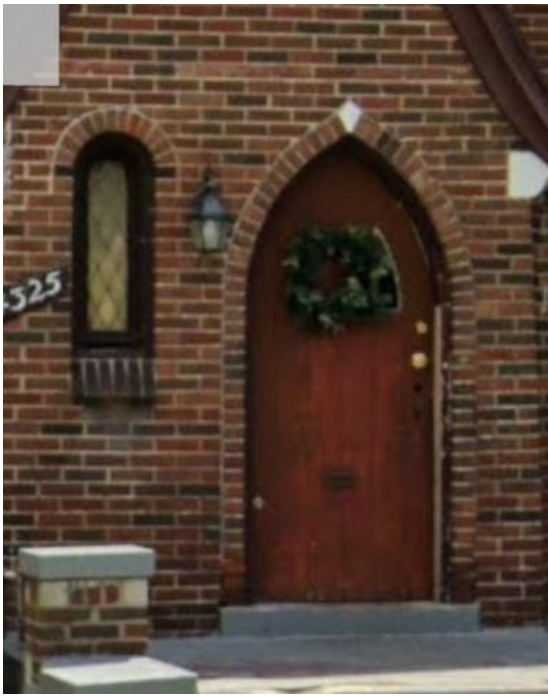
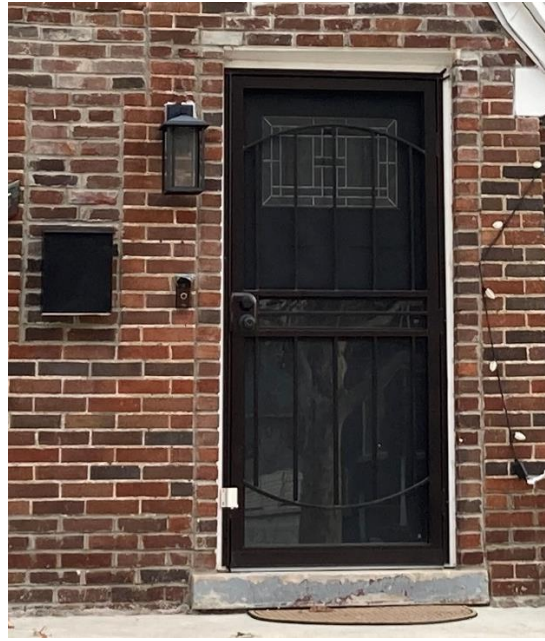
- The front, **arched doorway** was a historic, character-defining feature of the Tudor-style house, and its historic, wood door was a character-defining feature as well. Both features should have been preserved and repaired. If repair was not possible, Standard 6 requires that the new feature should have matched the old in design, color, texture, other visual qualities, and, where possible, materials. The historic, arched detail was infilled with brick and the new square door with rectangular glass window does not match the old. It is black, whereas the historic wood

door complemented the brown-painted details of the architecture. The replacement's material is unknown.

*Left, the historic, arched, wood front door at 4325 Leslie, compared with the squared-off, brick-infilled archway and modern door to the right. The new feature does not match the old in design, color, texture, or other visual qualities, as Standard 6 requires. Staff is not sure what material the new door is.*

- The historic, character-defining arched front entry and its front door were replaced with a squared-off front entry doorway and door. The arched decorative window next to the door was eliminated altogether. These changes diminish the house's historic character. Additionally, eliminating arched windows and doors on a Tudor-style house is in conflict with this district's Element of Design 10, which states, "Characteristic elements and details displayed on vernacular English-Revival-influenced buildings include arched windows and door openings, steeply pitched gables, towers, and sometimes half-timbering."

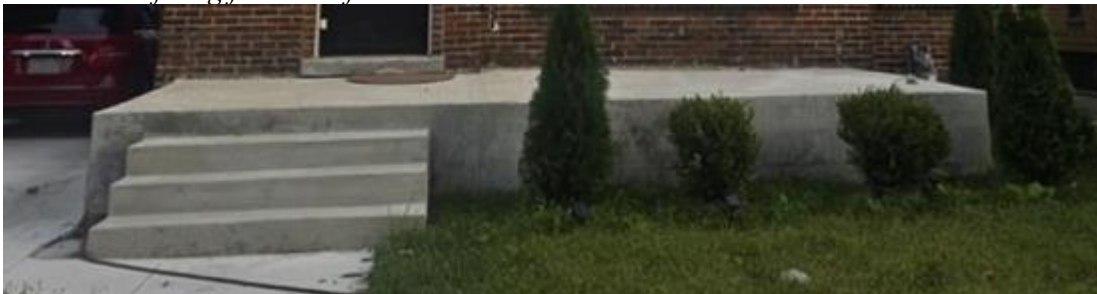
- The **historic front porch** was historically brick that matched the house, with a concrete cap. It had three brick piers that supported a low, black, iron guardrail. Two wing walls flanked the concrete steps, and concrete caps topped the piers and wing walls. Google Street View shows that between 2013 and 2018, either the brick below the cap was replaced with another material, like concrete block, or it was simply parged. Either way, the base of the porch was painted by 2018. The character-defining brick piers, brick wing walls, and low black iron guardrail all were still in place in April 2022. By March/April 2024, the front porch had been rebuilt with concrete and its brick piers, brick wing walls, and low black iron guardrail have all been removed. Those historic, character-defining features should have been retained and repaired, and if that was not possible, those details should have been replicated as per Standard 6. Instead, the new front porch lacks all of those details that the historic porch had.

*The porch that was erected by spring 2024 that does not replicate any of the missing historic features.*

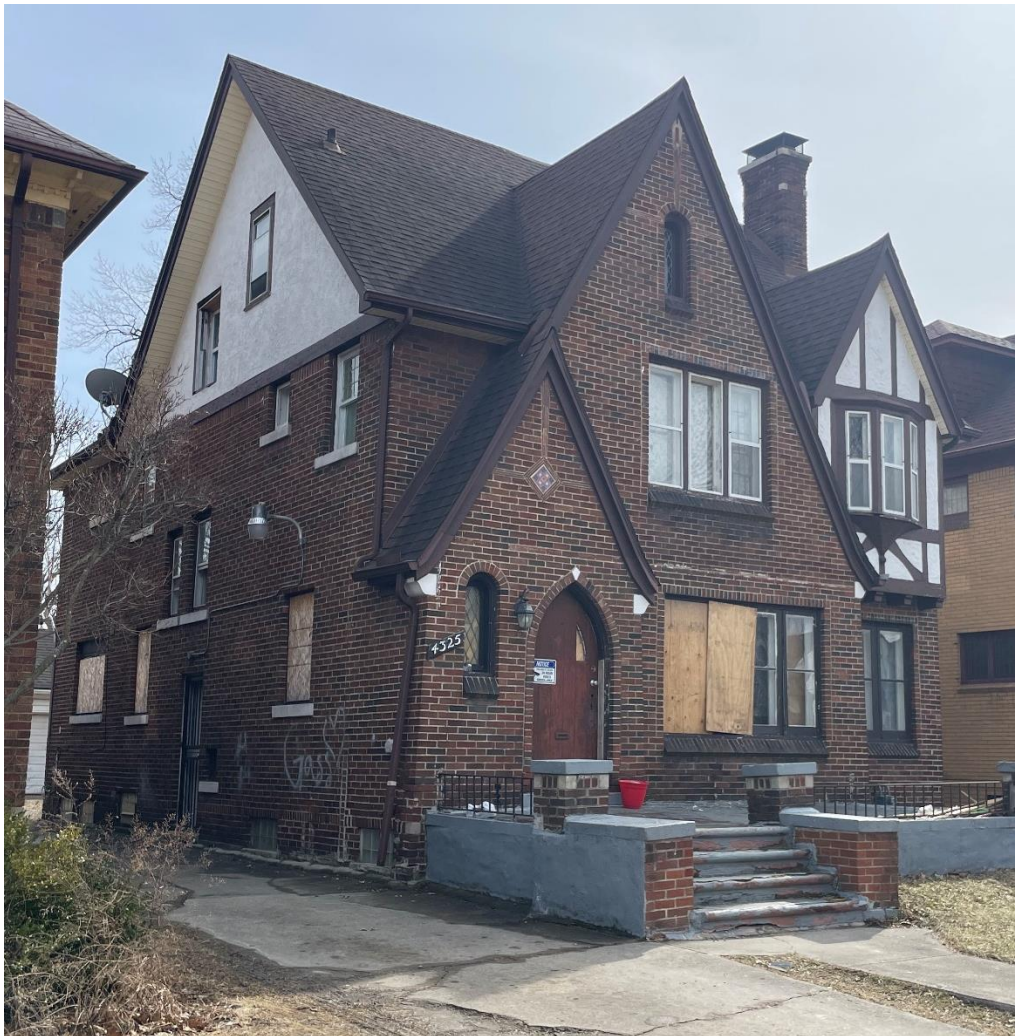
*Staff photo, violation-related site visit, March 2022, front and east-side windows*

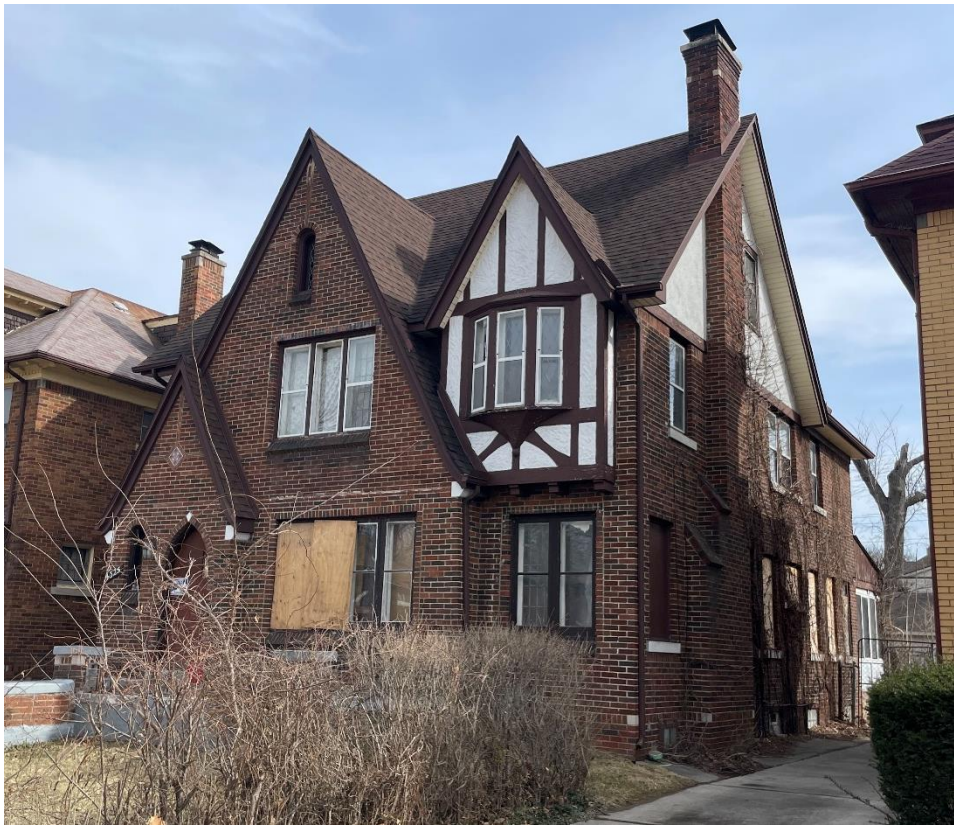
*Staff photo, violation-related site visit, March 2022, front and west-side windows*

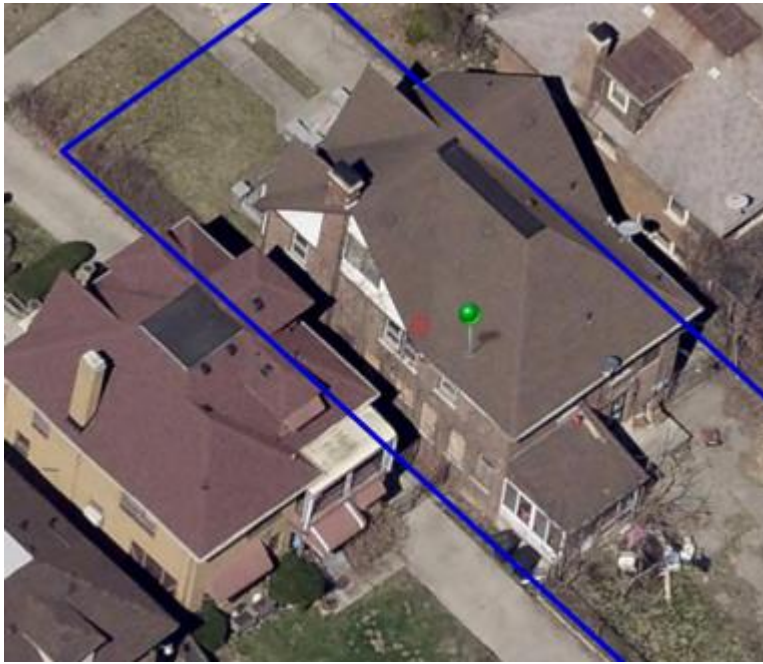
*Eagleview/ConnectExplorer, April 2022, west side of house with what appears to be boarded windows, and rear sunroom. Rear porch's appearance is consistent with similar photos from previous years. Also consistent with previous years, the second-floor window near the house's southeast corner appears to be boarded with a board painted dark brown.*

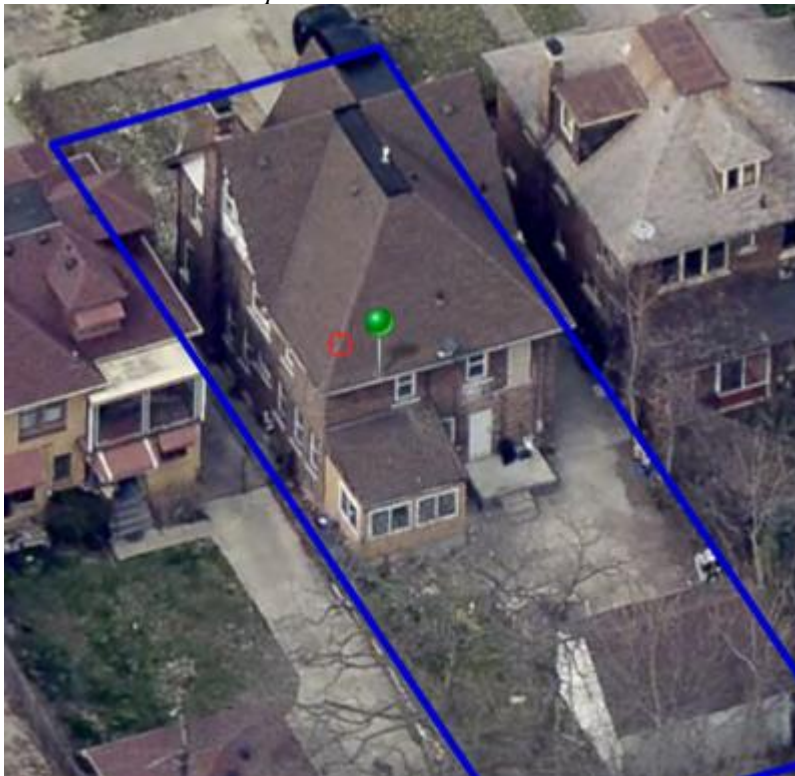
*Eagleview/ConnectExplorer, March-April 2024, house's west side showing white windows after having been boarded, and rear sunroom at the house's southwest corner showing that windows and siding have changed since 2022. The door leading onto the open porch near the house's southeast corner is new, as is the brick infill of the second-story window near the house's southeast corner.*

- Proposed with this application is the **replacement of two doors—the side door** on the house’s east side and the **rear door** as seen in the 2024 ConnectExplorer photo above. Both doors are steel panel-style doors. Neither have inappropriate windows in them, and staff does not find either to be incompatible for the house, especially for the side and rear doors, in design, texture, or other visual qualities, although both should be painted to match an appropriate trim color for this house.

- Also proposed with this application is the **brick infill of two window openings**—one on the east side of the house and one at the second story on the rear. The window opening on the rear of the house has been shown boarded and painted dark brown on Eagleview/ConnectExplorer images since at least 2014. (In 2005/2006 and 2011, it is hard to see that window clearly.) The infilled window on the east side is never shown in Eagleview or Google imagery. The *Guidelines for Rehabilitating Historic Buildings* recommend against blocking in windows. (They state, “*Not Recommended: Changing the number, location, size, or glazing pattern of windows through cutting new openings, blocking-in windows...*”) Staff does not find it appropriate to infill these window openings, especially with bricks that contrast sharply with the reddish-brown bricks of the house, and that are laid in a stacked bond pattern when the rest of the house has running bond bricks. The openings should be restored as windows, and if that isn’t possible, these openings should be infilled with bricks that match as closely as possible to the house’s existing bricks and should be laid in a running bond and slightly inset (from ½” to 1” in depth) to blend in with the existing materials while also indicating an alteration, instead of drawing attention to themselves as they do now.

Both doors are painted to match the trim once an appropriate color scheme has been selected, subject to HDC staff review and approval.

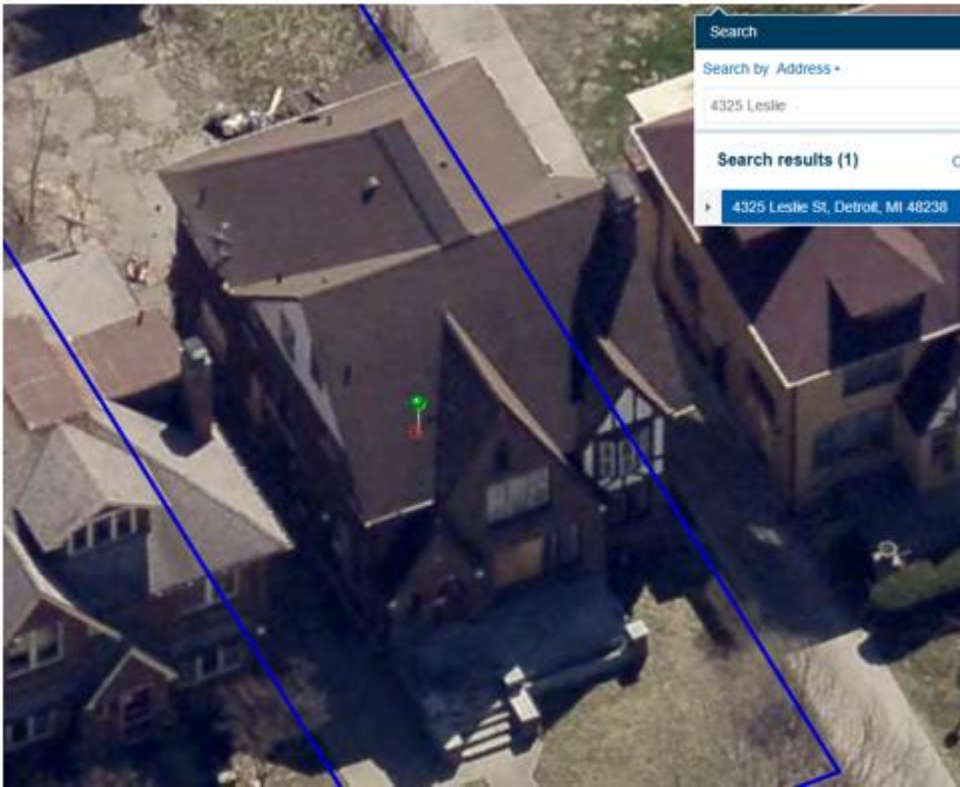
*Eagleview/ConnectExplorer, April 2022, shows front of house (north side) largely intact, but possibly with a board on some of the windows at the first floor.*

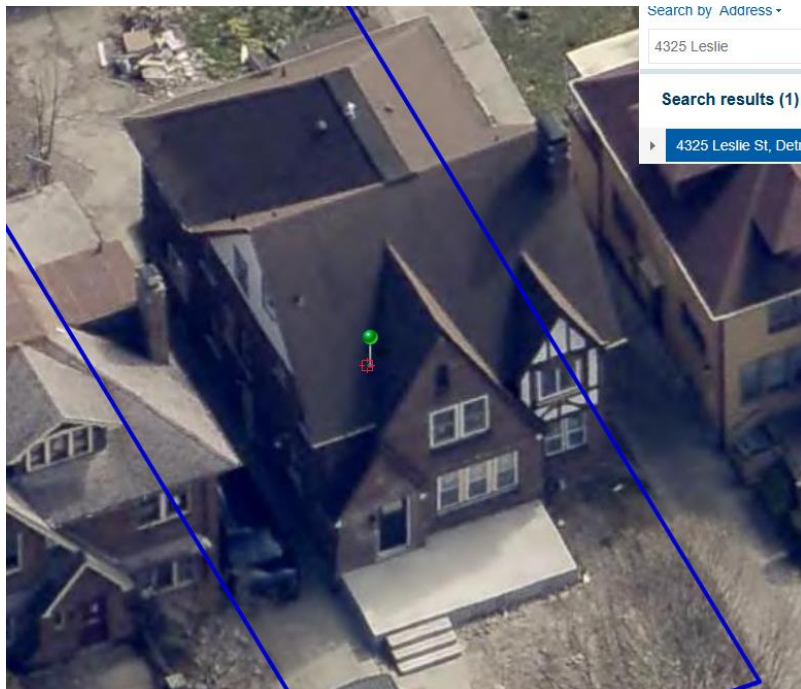
*Eagleview/ConnectExplorer, March-April 2024. Most of the historic character-defining features on the front of the house have been removed. Groups of three and four windows have become groups of two and three, the bay window was eliminated, and the front porch is altered.*
