STAFF REPORT: 02/11/2026 MEETING

ADDRESS: 1676 CHICAGO

APPLICATION NO: HDC2026-00021

SCOPE: REHABILITATE EXTERIOR (WORK COMPLETED WITHOUT APPROVAL)

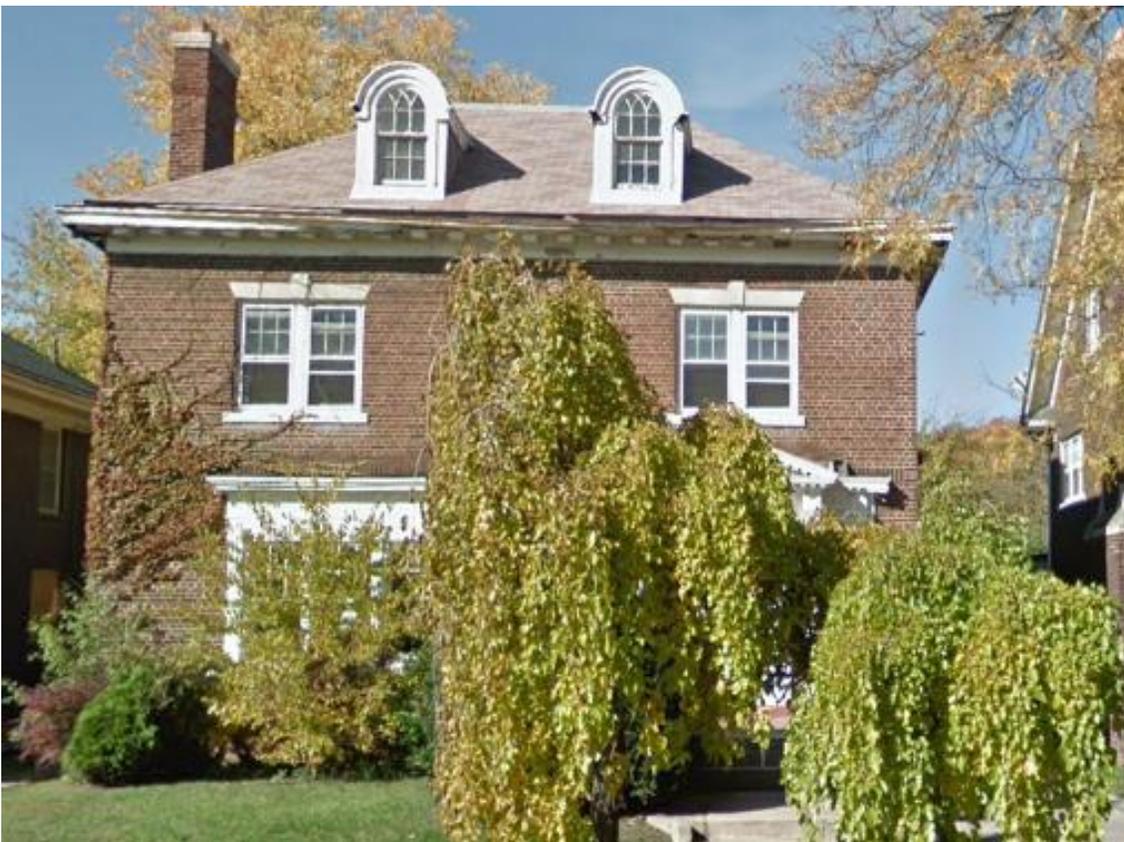
Google Streetview image, 2014. Note the poor conditions at the roof's fascia/soffit area. As noted above, the fascia/soffit area was repaired in 2002.

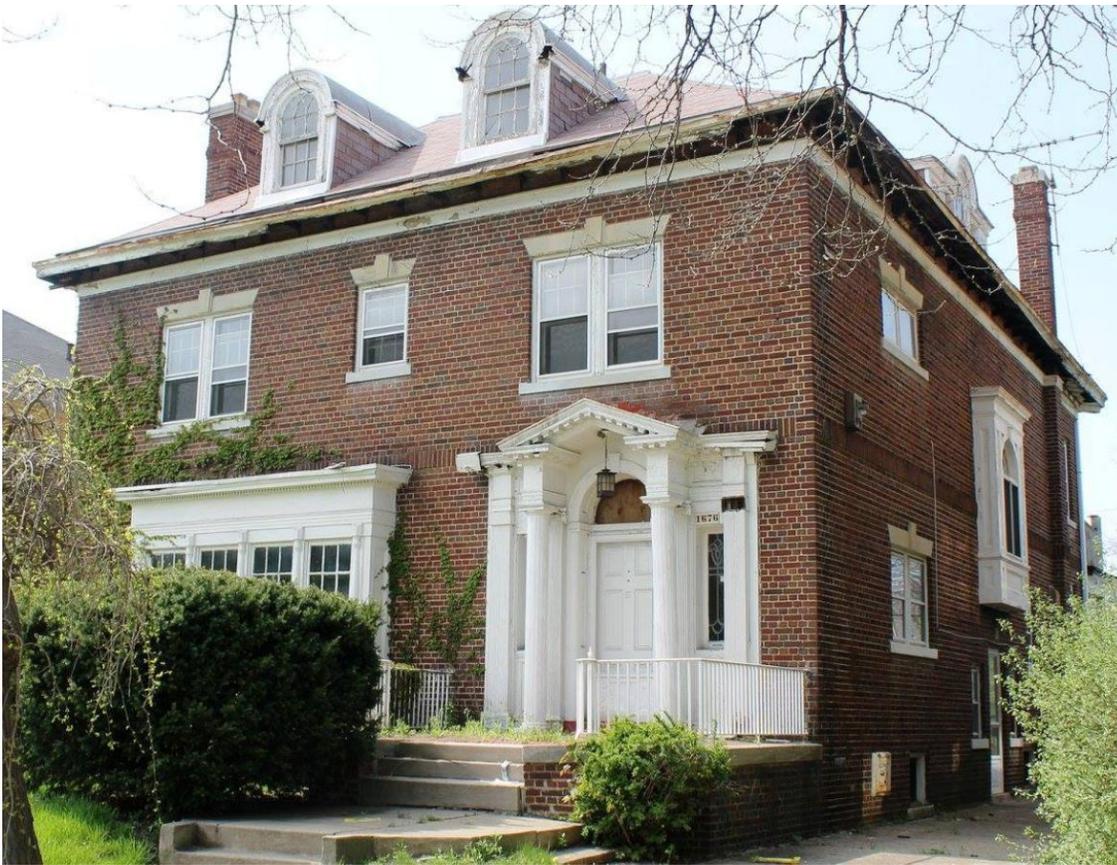
Conditions in 2015. Note the poor conditions at the roof's fascia/soffit area, ie the fascia is heavily rotted and the soffits area almost completely deteriorated

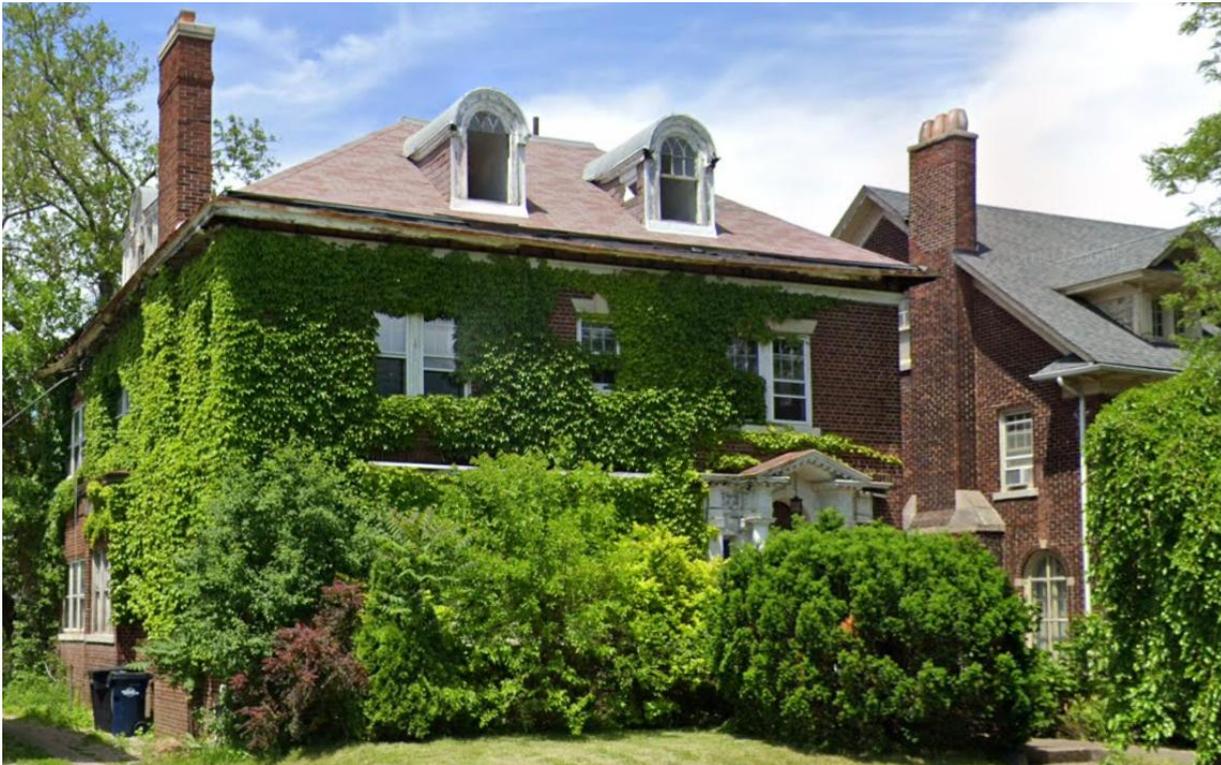
Google Streetview, 2019. The house appears vacant. Note rot/deterioration at roof dormer windows and worsening conditions at the eaves/fascia/soffit area

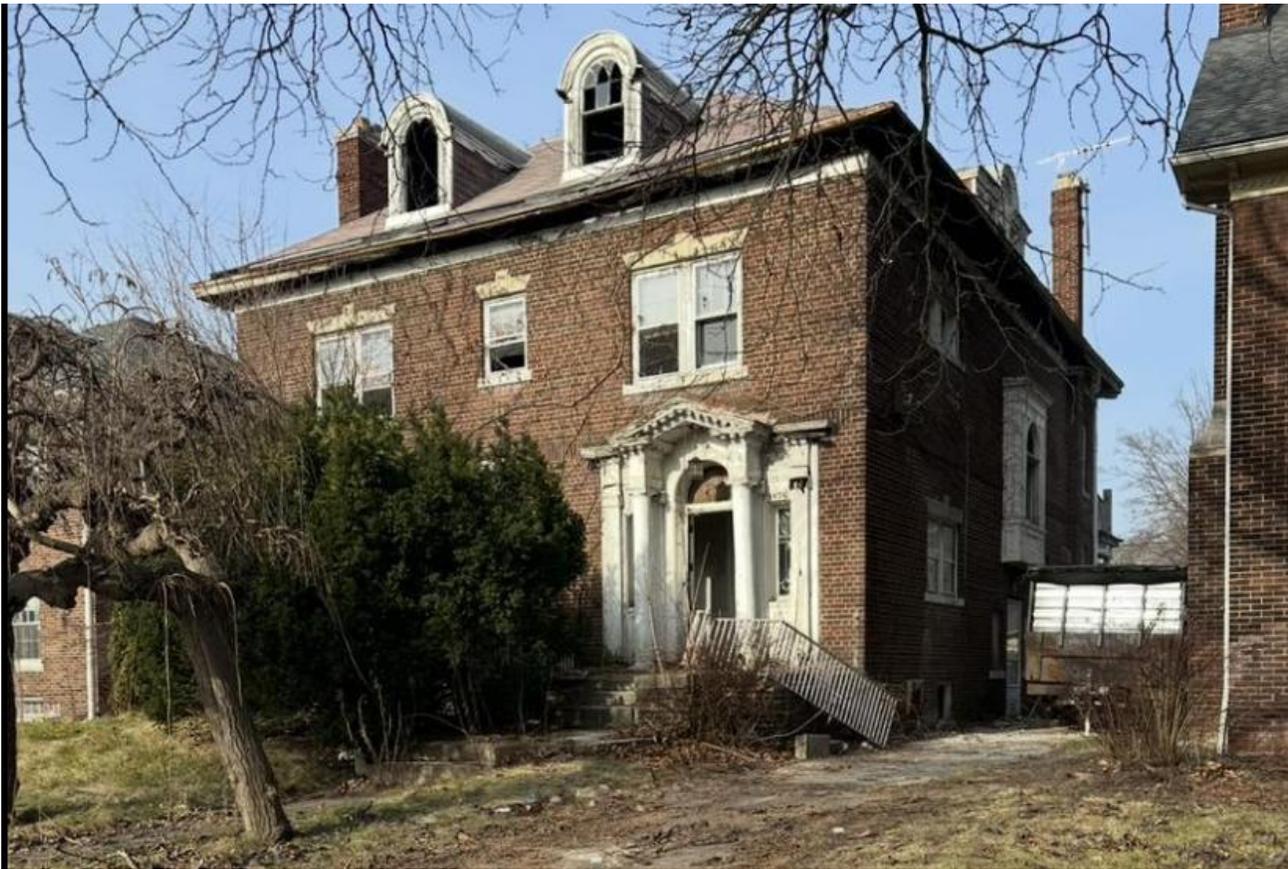
Conditions in 2023, prior to the current unapproved work. Vegetation has been removed from the façade. Note condition of the front porch railing, dormer windows, fascia/soffit/eaves, and the front door surround.

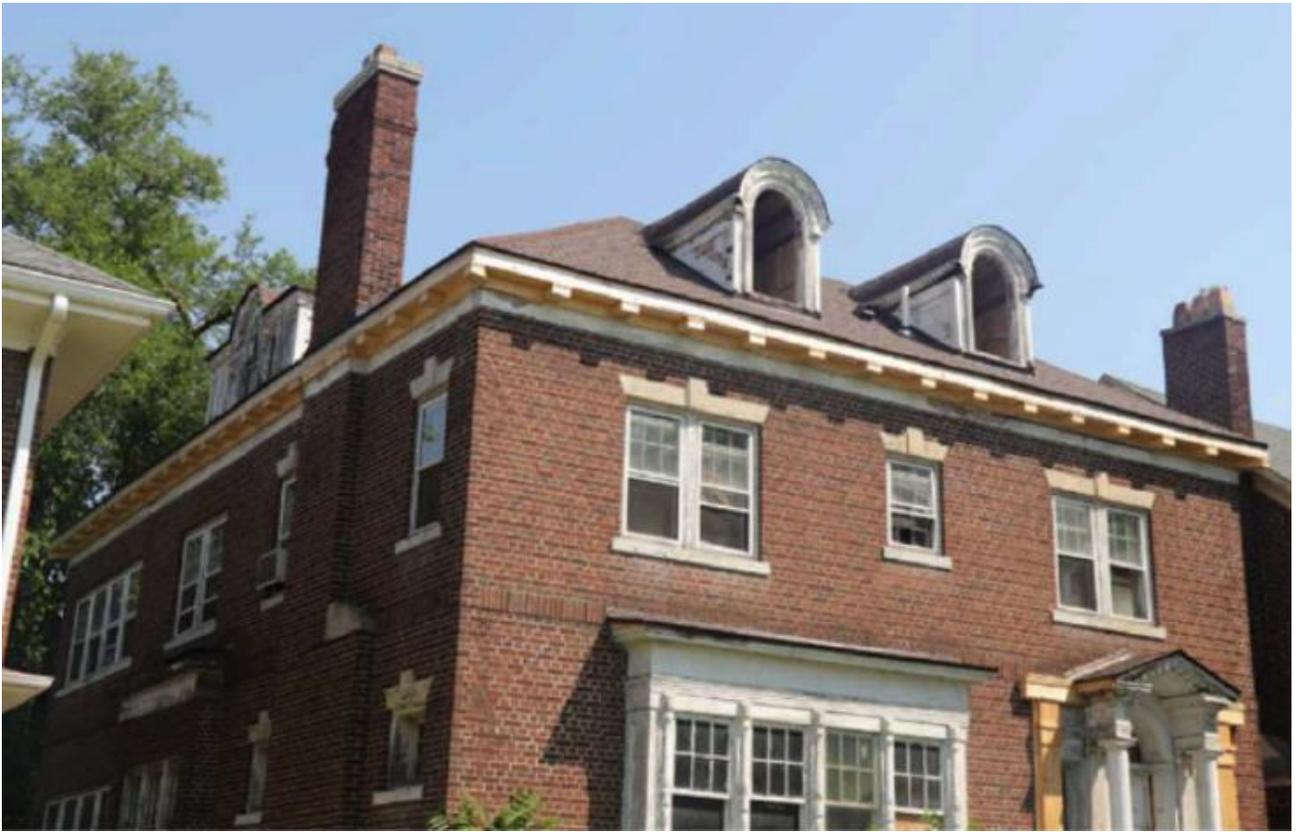
Staff photo taken in 2025, after the unapproved installation of new soffit/eaves

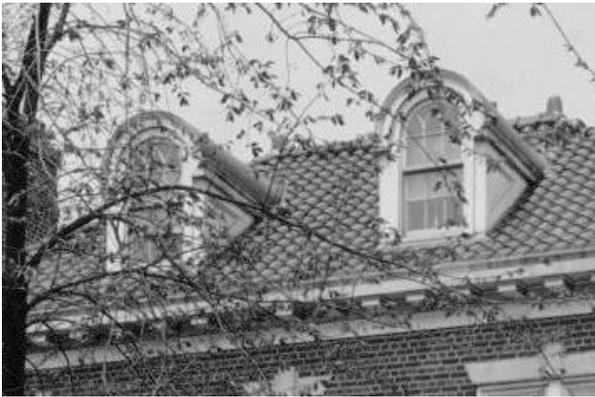
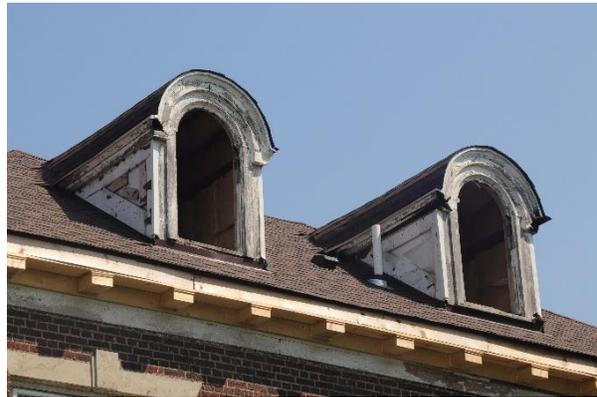
Eaves in 1922 (left) and 2025 (right). Note the different spacing and few number of dentils in 2025.

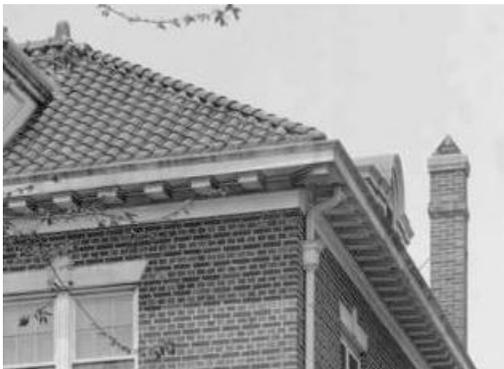
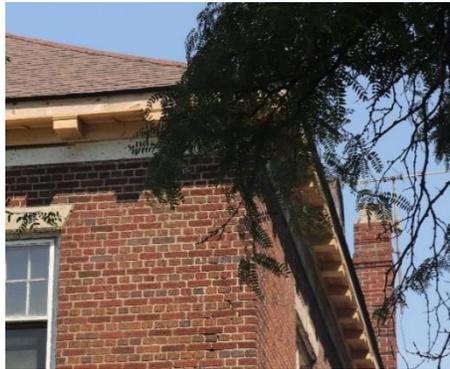
Eaves in 1922 (left) and 2025 (right). Note the different spacing and few number of dentils in 2025.

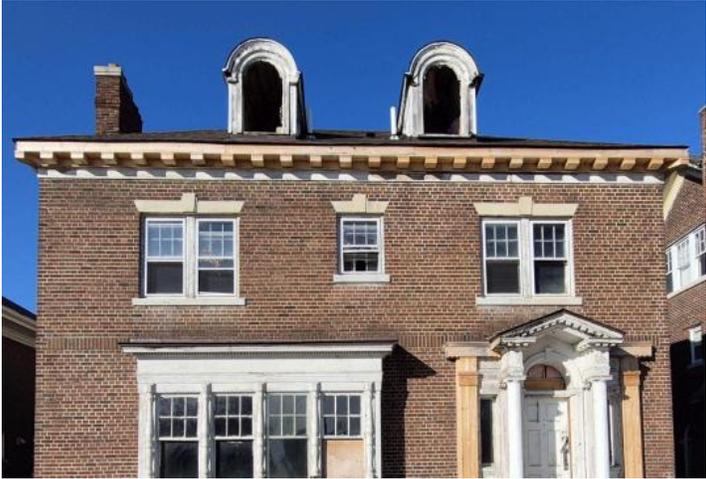
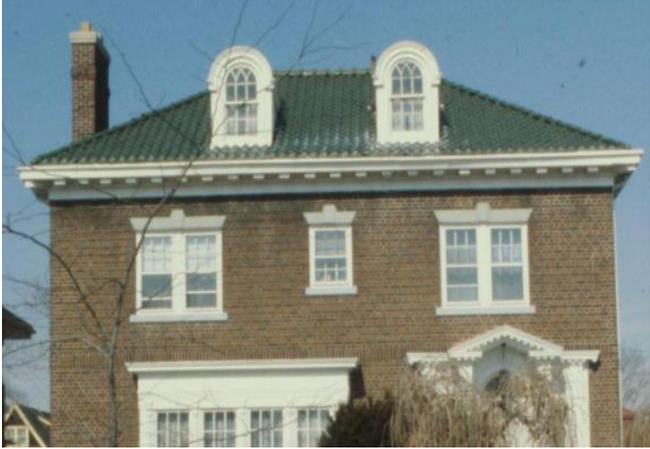
- In the interim between the July 2025 HDC meeting and the submission of the current application, the property owner undertook additional work at the roof's soffit to remove the dentils that had been installed without approval in 2005 and replace them with dentils which more closely approximate the dimensions, number and spacing of the original soffit dentils. The work was also undertaken without review and approval. The applicant is therefore seeking the Commission's "after the fact" approval of the work with the current submission. See below photos.

Showing condition of the soffit after dentils were installed without HDC approval sometime after the July 2025 meeting (left) and original soffit (right)

- With respect to the work which has been undertaken without HDC approval, it is staff's opinion that the items related to the soffit/eaves/fascia repair/replacement meets the Standards as they represent an adequate match to the original elements. However, the newly installed door surround does not adequately match the original, in staff's opinion. Specifically, the newly installed pilasters, pilaster capitals, and entablature do not match the original.

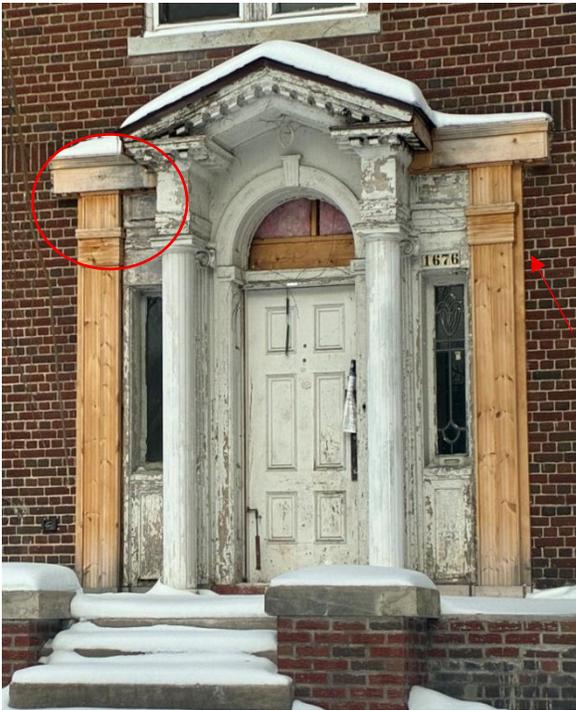
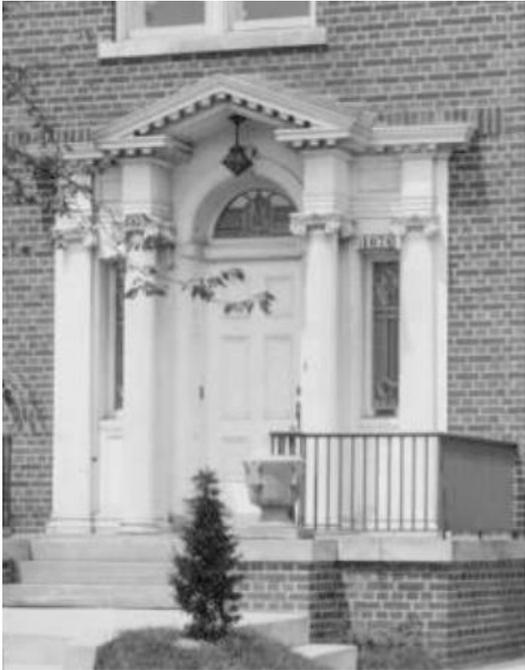
- The applicant is also seeking the Commission's approval to retain the existing door surround which was recently installed to replace the original without HDC approval. It is staff's opinion that the surround is a distinctive character-defining feature of the building. See the below photos which indicate that the newly installed surround is not an exact match to the original:

Appearance in 2026 (right) and 1922 (left). Note that original capital (see red arrows). Also, the entablature of the new do red).

- The newly installed elements at the distinctive character-defining front door surround do not adequately match the original
- The front porch replacement railing should be wrought iron or steel to match the original, not wood
- The two front yard trees flanking the walkway are significant landscape features that should not be removed,

- The newly installed front door surround shall be replaced with a new wood surround that better matches the original. The final design shall be reviewed and approved by staff prior to the issuance of the project's permit
- The front porch guardrails shall be made of wrought iron or steel to match to material of the original. Also, the height and design shall be consistent with the original railing. The final design shall be reviewed and approved by staff prior to the issuance of the project's permit
- The applicant shall provide staff documentation of the condition of the two front yard trees proposed for removal. Should the trees be in good condition, they shall be retained. If they are shown to be dead, diseased, or dying, they shall be replaced with two trees at the same location and of a similar species.

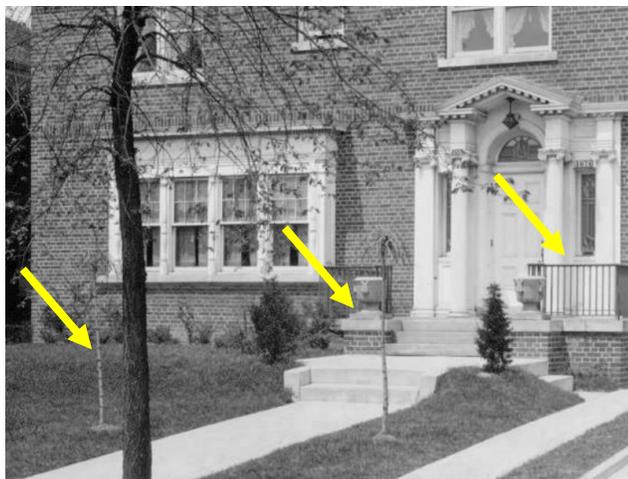
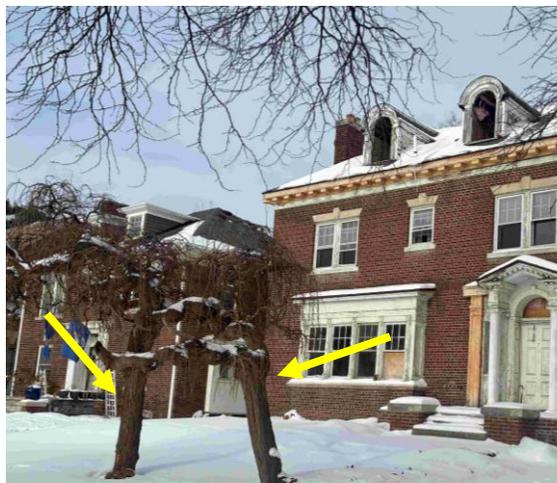
- The front porch guardrails were originally wrought iron (see below photos). The proposed replacement railing is wood.
 - The application proposes to remove two front yard trees that were present at the time of the house's original construction. It is not clear from the application that the two trees are dead, diseased, or dying. Also, these trees would not be replaced. Staff

considers the original landscape design to be a distinctive character-defining historic feature of the property.

Front yard trees in 1922 (right) and 2026 (left)
Also, see original metal railing.
