**STAFF REPORT:** 02/11/2026 MEETING  
**APPLICATION NUMBERS:** HDC2025-00741  
**VIOLATION NUMBER:** 1077  
**ADDRESS:** 2008 LONGFELLOW  
**HISTORIC DISTRICT:** BOSTON-EDISON  
**APPLICANT/PROPERTY OWNER:** NEVAR JAHWARY, STONEBRIDGE DEVELOPMENT  
**DATE OF PROVISIONALLY COMPLETE APPLICATION:** 01/20/2026  
**DATE OF STAFF SITE VISIT:** 01/28/2026

**SCOPE:** DEMOLISH AND REBUILD FRONT AND REAR PORCHES; DEMOLISH AND REBUILD UPPER WALLS AND WINDOW OPENINGS AT SIDE PORCH; REMOVE WOOD WINDOWS AND INSTALL NEW WOOD WINDOWS; INSTALL FOUR (4) ENTRY DOORS AT REAR; INSTALL ASPHALT SHINGLE ROOF AND REBUILD EAVES (WORK STARTED WITHOUT APPROVAL)

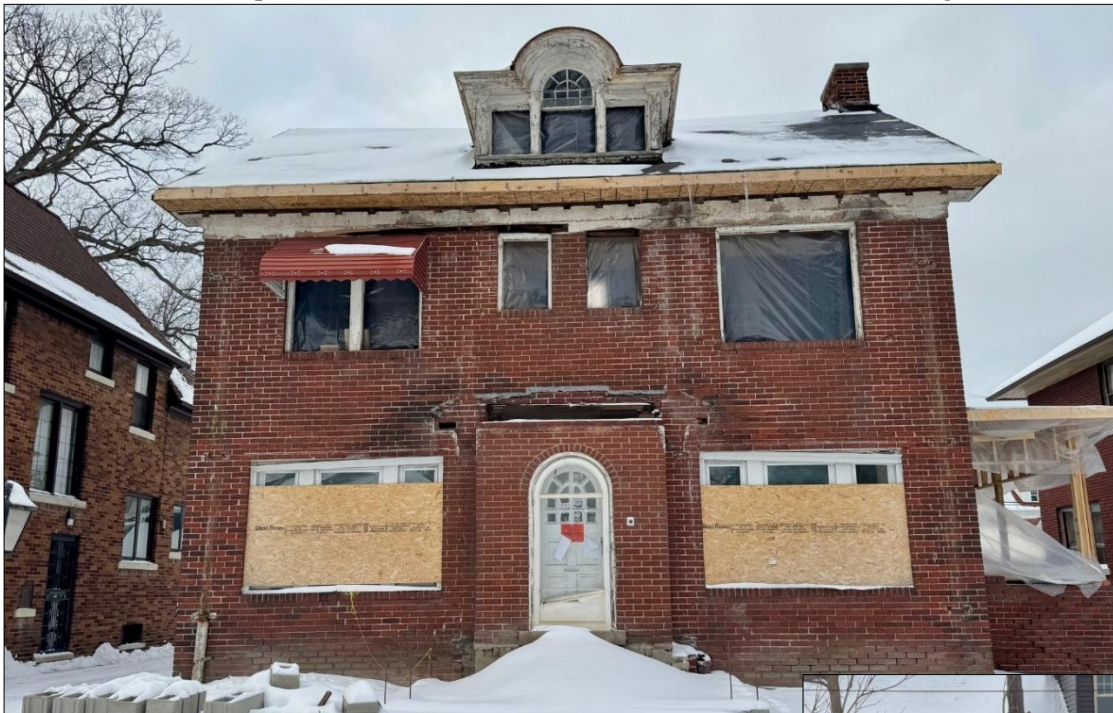
*Above: Front wall of the house facing Longfellow.*

Most of the original windows are missing and the roof and walls at the side and rear porches are in the process of being rebuilt. Outlines of removed cornice trim remains evident, and the eaves appear to be rebuilt. The front entrance’s covered porch has been removed, but the arched multi-light/paneled door remains in situ.

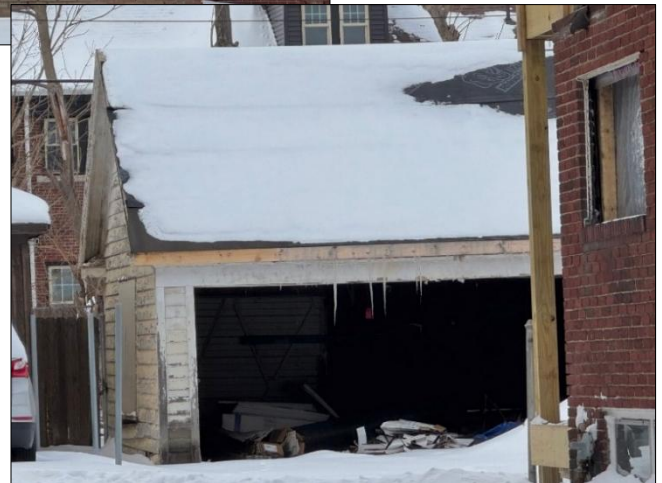
*Right: View of garage from sidewalk/end of driveway at Longfellow. Staff photos, January 28, 2026.*

A driveway on the west side of the property leads from Longfellow to a two-car garage at the northwest corner of the rear yard. The garage appears to be historic age and is clad with lap siding, has a side gable roof and a single overhead door.

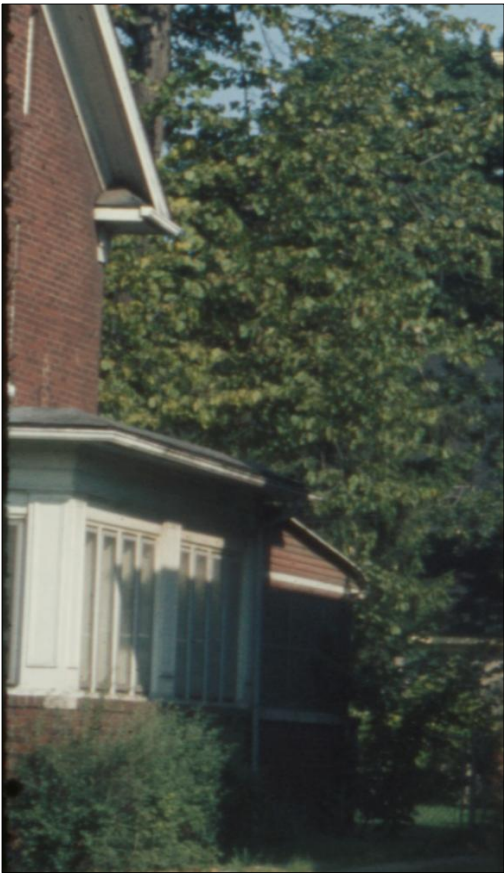
*1974 designation photos of the houses adjacent to 2008 Longfellow offer angled views of the side walls of 2008 Longfellow, including details to the side and rear enclosed porches. HDAB.*

*Left: Outer side wall of the one-story porch on the east side of the house. A metal shed/awning roof is visible and covered an open porch at the rear of the house. This awning has since been removed.*

*Right: Outer side wall of the rear porch and supporting wood column and railing at the first floor.*

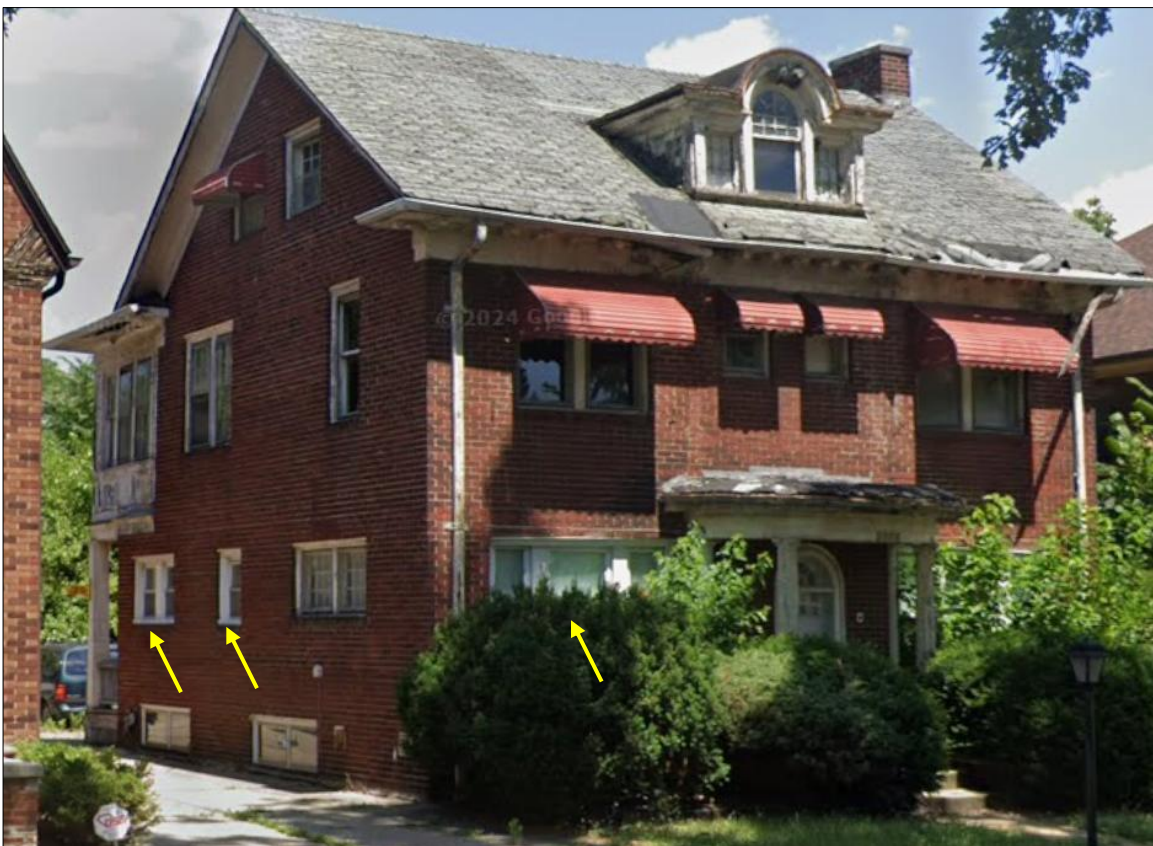
*The above Google street view image of the front and west-side walls shows that most of the architectural details were still intact, however some replacement windows appear at the first floor, identified by the brightness of the window frames/trim and lack of division of glass. July 2022.*

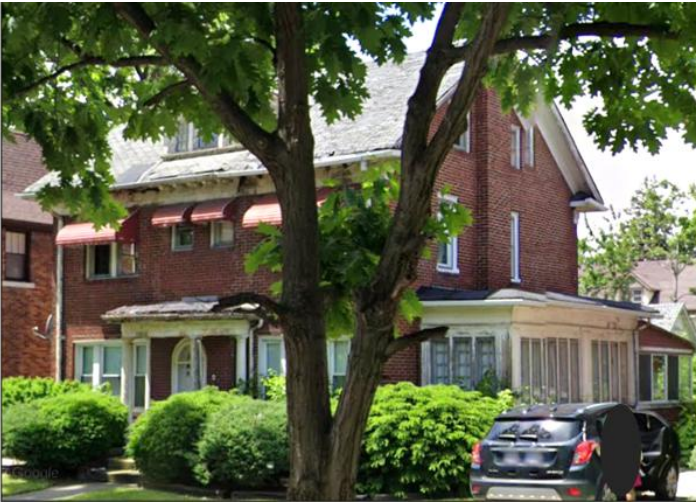
*This Google street view confirms replacement windows were in place at both grouped window openings at the first floor and that the original side porch walls and windows remained intact. June 2019.*

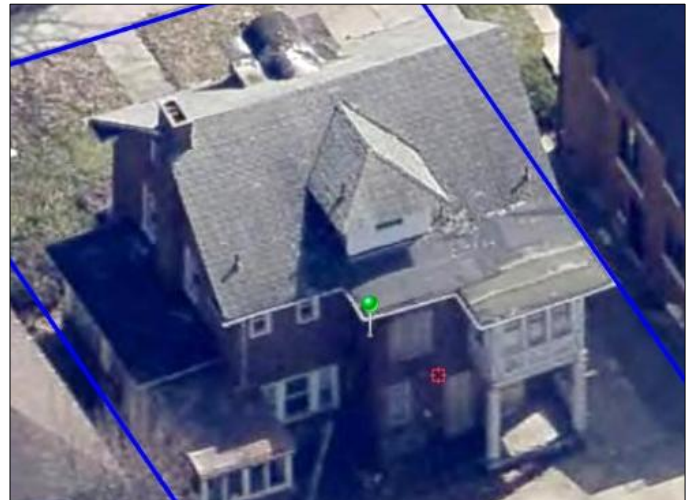
*This aerial view confirms the porches and windows at the enclosed second floor rear porch remained intact. ConnectExplorer, April 2024*

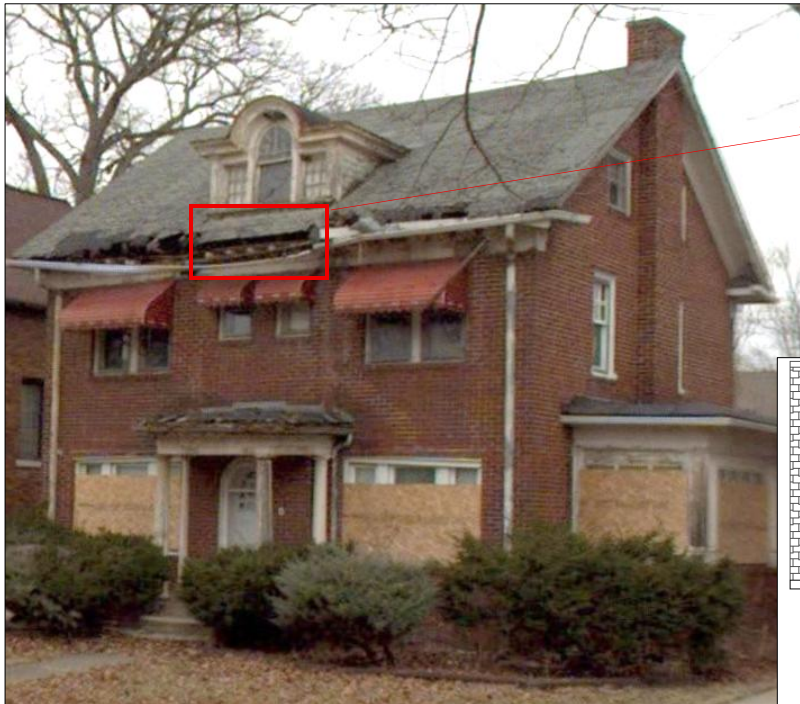
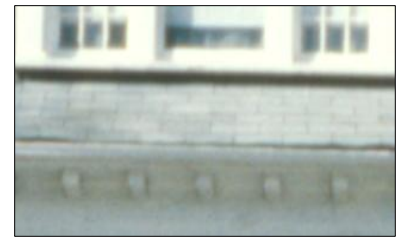
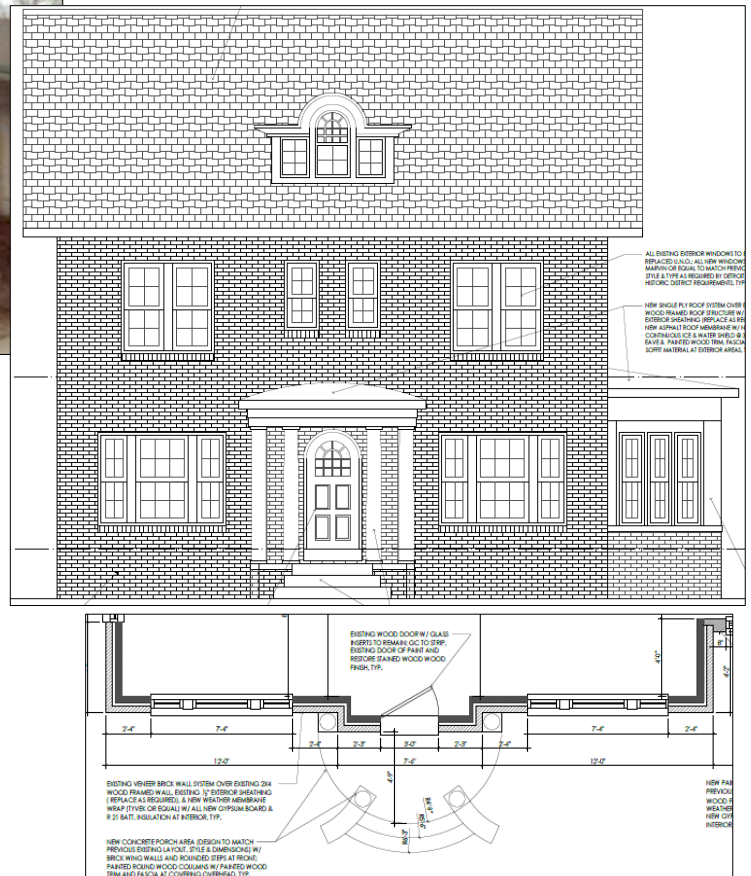
## Front wall/façade

Left: Conditions as of March, 7, 2025. Mapillary.  
 Above left: Staff photo of remaining dentil pattern. January 28, 2026.  
 Above right: 1980 photo of house, HDAB.  
 Below: Applicant drawings and photo of existing conditions.  
 Bottom: staff photo of ghost lines of dentil trim.

- Previous windows at Palladian dormer were casements with a nine-light pattern (now proposed as six-lights) and the central arched window had an undivided light bottom sash (staff believes that to be the original condition based on documented original casement windows on the side walls, which are discussed on following pages) and not a divided lower sash as proposed.

- Dentil trim at the soffit/eave was removed and its placement is noticeable on existing condition photos. It has not been included on the elevation; nor did the applicant reply to staff's inquiry; therefore, it is staff's assumption it will not be replicated.

- The triple window openings at the first floor were 4-over-1 with a central 8-over-1 pattern.
- Double window openings at second floor (mullered and single openings) were 6-over-1 double-hung windows.

- The drawings appear to show a close replication of the half-round raised and covered porch, except for the columns. The original columns were tapered, with a smooth finish and Tuscan capitals and bases. Staff doesn't know if the columns remain on site, nor their dimensions. The drawings do not replicate the original columns. Also, there is a square shaped concrete block foundation outline at grade, which doesn't match the previous curved porch, stairs and splayed side walls.

- Chimney is not depicted on elevation drawing.

- The soffit/eave/fascia repairs will be in-kind and new dentil trim, matching the old in material, dimension, profile, placement and finish will be installed at the façade/front wall. Dimensions and specifications of the proposed dentils, including visual/written confirmation that the new trim will be installed in the same location as the original dentils, will be submitted for staff review.

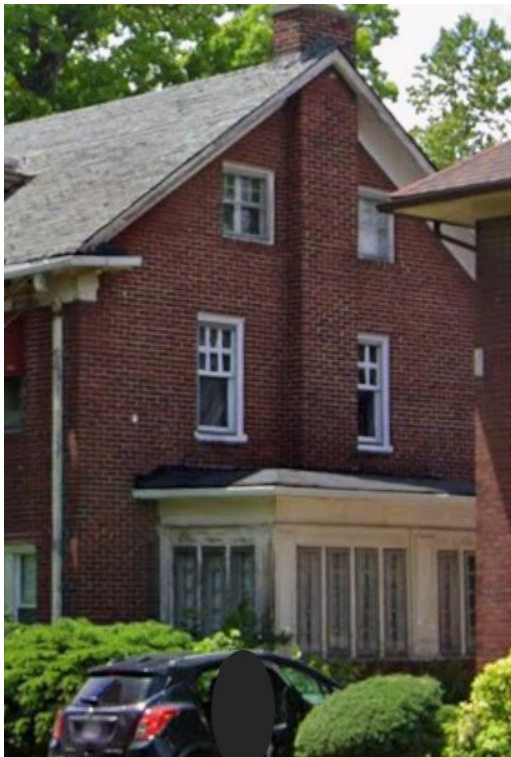
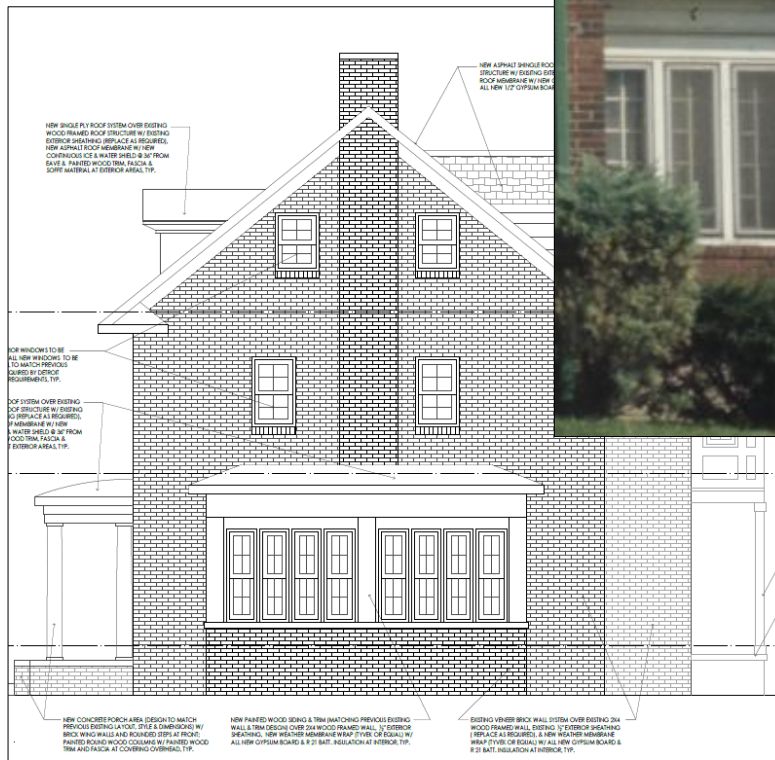
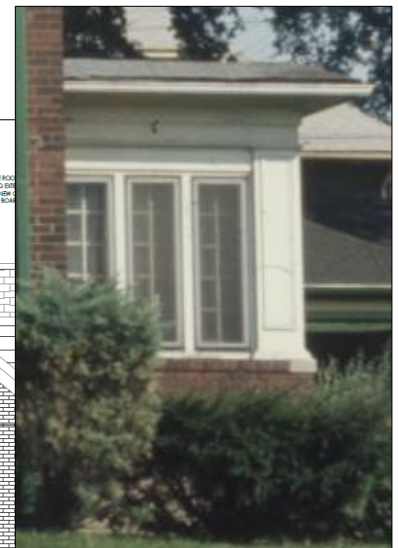
**East – Side Wall**

Top: 1974 designation photo showing column-like detailing at porch

- The rear single story masonry walled porch now retains its likely original open porch construction, however it is not included in the elevation drawing.

- Chimney height has increased (existing 6-7 brick courses vs. 11-12 courses on drawing).
- The window openings at the third floor are almost square in shape. 2019 photos show double-casements with a central mullion; each casement had a division of glass offering a 4-over-1 glass pattern. Single 4-over-4 double-hung windows are proposed for these openings. Staff also notes the dimensions of the openings on the elevation are rectangular, offering concern that the openings will be reduced in size/proportion.

- Window openings at second floor had double-hung sash with 6-over-1 pattern. Single, 4-over-4 double-hung windows are proposed here.
- Mullied casement windows were in place on all three walls of the enclosed porch and trim was detailed to offer the effect of columns and an entablature. Applicant proposes mullied, narrow 4-over-4 windows and no detailing is shown at the fascia and corners, although the drawings state “matching previous existing trim and wall design”.

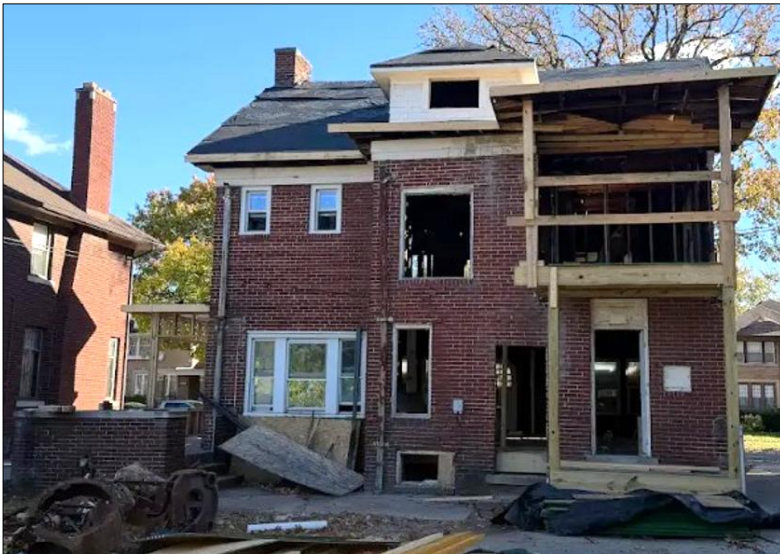
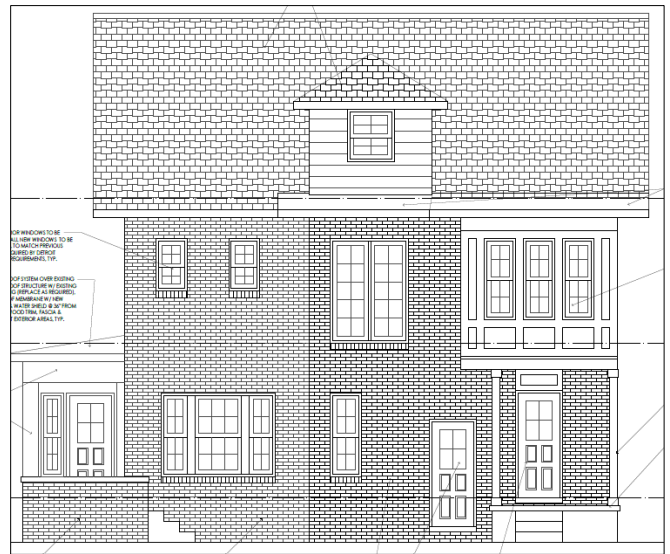
## Rear Wall

*Applicant photo and elevation drawing.*

- The massing and roof pitch for the central dormer is drawn differently than existing conditions.
- Detailing for the second floor enclosed porch walls appears to be similar to photo documentation of the area prior to its demolition. However, staff doesn't believe the proposed 4-over-4 double-hung is compatible for this property and location based on evidence of windows having a 4, 6, or 8-over-1 pattern.

- The proposed design of the lower porch and supporting posts do not match the footprint and massing of the original design, and the loss of symmetry and balance, integral to the overall classical revival design, is not a compatible design.

- Operation and dimensions of some window openings on the rear wall drawing (i.e., the central bay openings at the first and second floor) differ from existing conditions. The windows that remain in place at the first and second floor are replacement units similar to those at the front wall and west wall and were not approved by the HDC. Therefore, new double-hung windows at this location must match the original windows in design, operation and material (which likely would have matched the documented three-part window on the front wall that had two narrow 4-over-1 windows and a central 8-over-1 window).

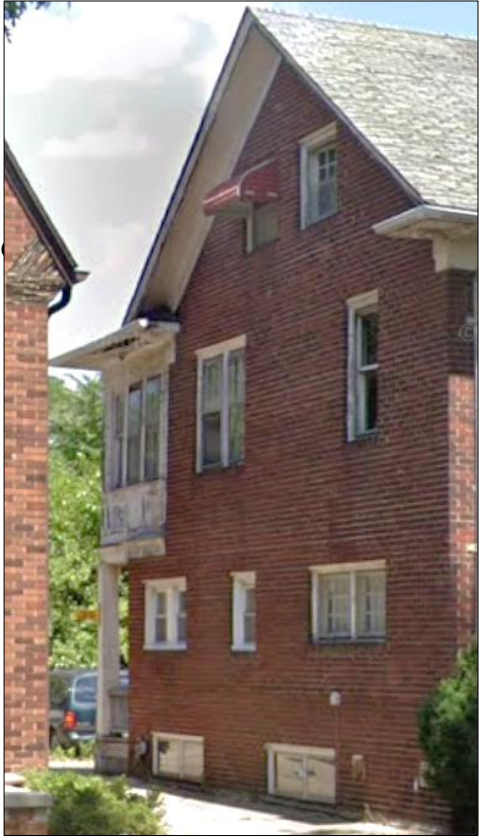
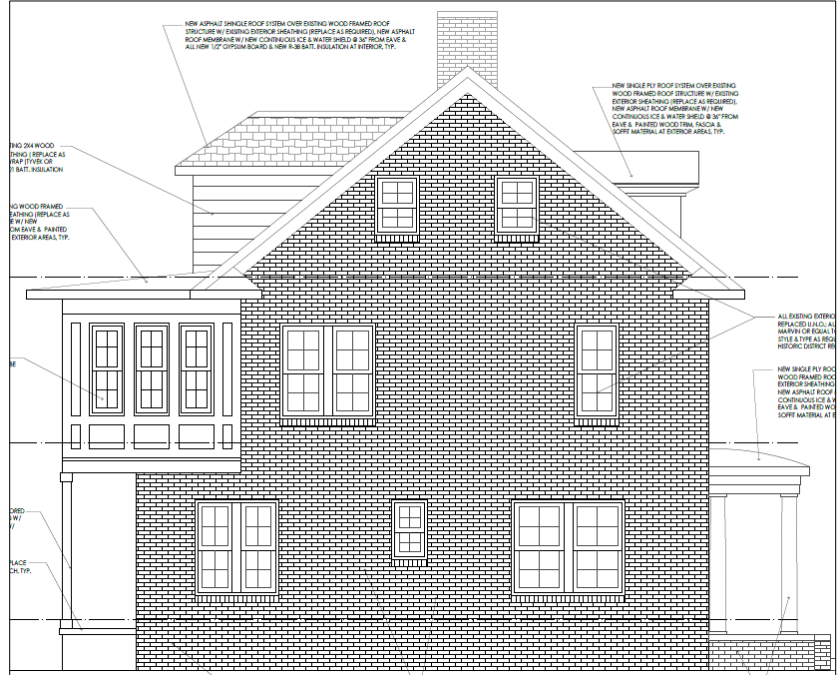
**West-Side wall**

Left: Google street view, July 2022. Above: Applicant elevation drawing. Below right: Applicant photo.

- Similar to the east side elevation drawing, this drawing shows differently sized windows at the third floor, change in operation and design for the opening.

- At the second floor, the single window opening appears to be narrower on the drawing than existing conditions and 4-over-4 double-hung windows proposed for all three windows; counter to the historic (and still existing in a few window openings) pattern.

- At the first floor, the window openings at center and near the rear had replacement windows in them recently (and the mullied opening may still have them), which staff confirmed were not approved by the HDC. Original windows are intact at the forward positioned windows, with 9 or 12-light casement (or fixed) windows.

- From the angled view of the applicant’s photo, it looks as though a butterfly roof has been constructed at the second floor rear porch, rather than a generally flat/low pitched roof.

- The elevation drawing shows the mullied openings at the first floor will be enlarged and window operation will change from casement to double-hung.
- Basement window openings are not drawn on the elevation, so staff assumes the openings will be removed. Details are needed on how this will be done (such as retain inset openings with new brick and retention of sills?).
