**SR-2 – STAFF ADVISORY REPORT (Rev. 03-11-2026)**

**ADDRESS:** 2050 ATKINSON

**APPLICATION NUMBER:** HDC2026-00729

**SCOPE:** REMOVE WOOD WINDOWS, INSTALL VINYL WINDOWS, REHABILITATE HOUSE  
(WORK STARTED WITHOUT APPROVAL)

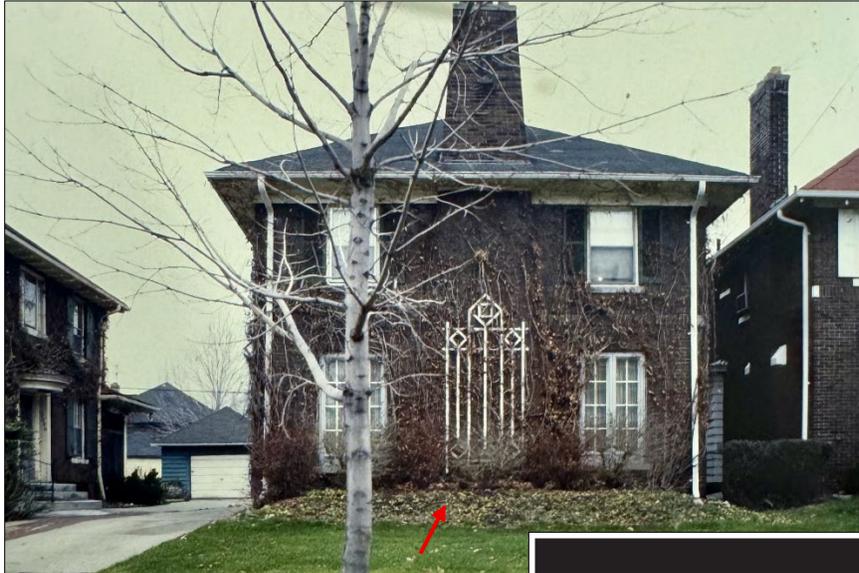
*Left: Designation photo, 1984. HDAB.*

- “20<sup>th</sup> Century Composite” is the style that describes the dwelling within this application, as the identified features called out on the architectural description page (with exception of arched openings and stone lintels) were components of the original design.
- The raised lawn visible in the designation photo remains intact and is also depicted at the bottom of the French doors in the house sketch at right (from the HDC Architectural Styles-Color Guide). This landscape element is a distinctive character-defining feature of the property, equal in importance to the house’s distinctive features.

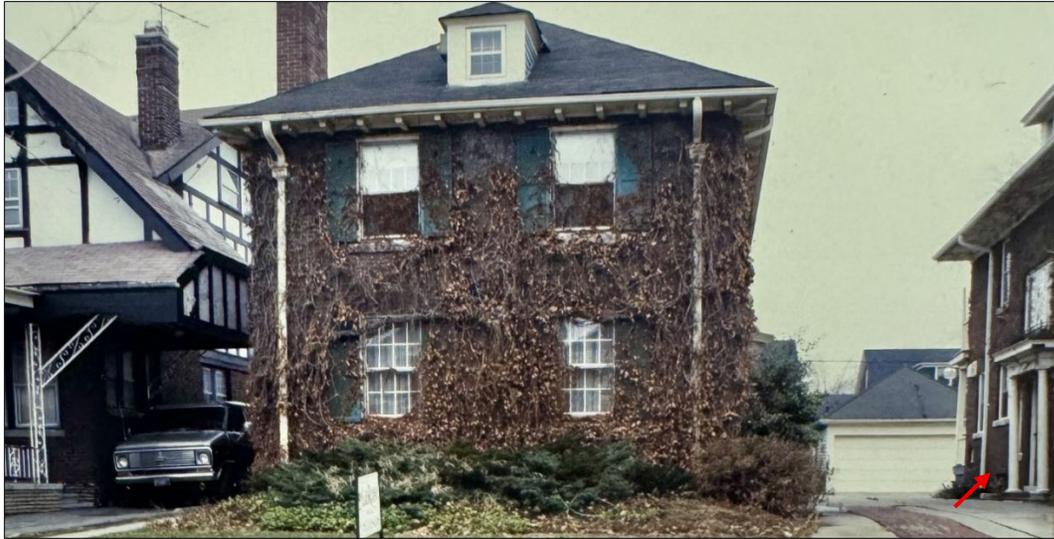
Above: The 1984 designation photo of the neighboring dwelling, 2056 Atkinson, offers a view of the portico (called a 'classical entry' on the 20<sup>th</sup> Century Composite drawing) at 2050 Atkinson. This distinctive character-defining feature was removed prior to 2007 without HDC approval. The outline and massing of the roof structure is visible on the masonry wall offering clear evidence as to the portico's location, width, and height.

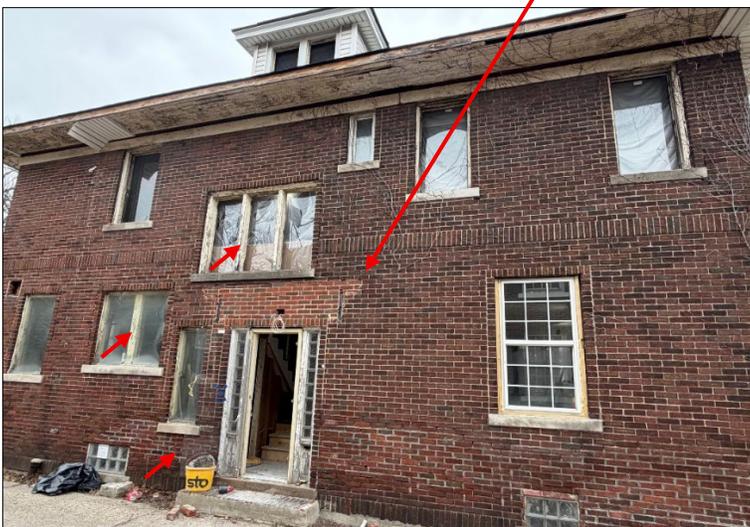
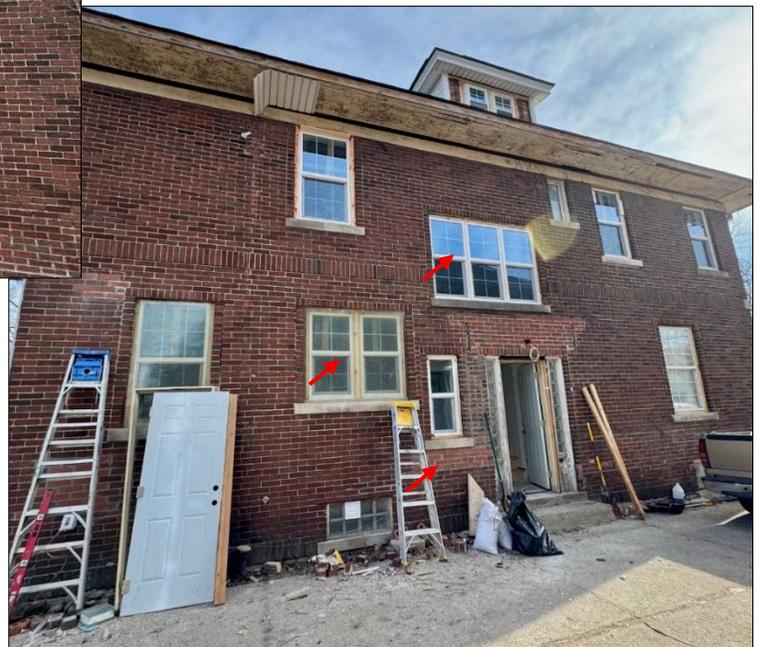
- Comparing the applicant's photo of the west wall and the photo staff took during the recent site visit, it is apparent that additional alterations were completed during the HDC review cycles and are not called out in the applicant's scope of work, specifically the reduction of the window opening adjacent to the front entrance, and removal of wood mullions in the 2- and 3-unit window openings.

The depth of the historic mullions created a distinct separation between the multiple windows, whereas the new mullions are narrow and in plane with the windows, contemporizing the openings. It appears similar mullion replacement has been completed at window openings on other walls of the dwelling.

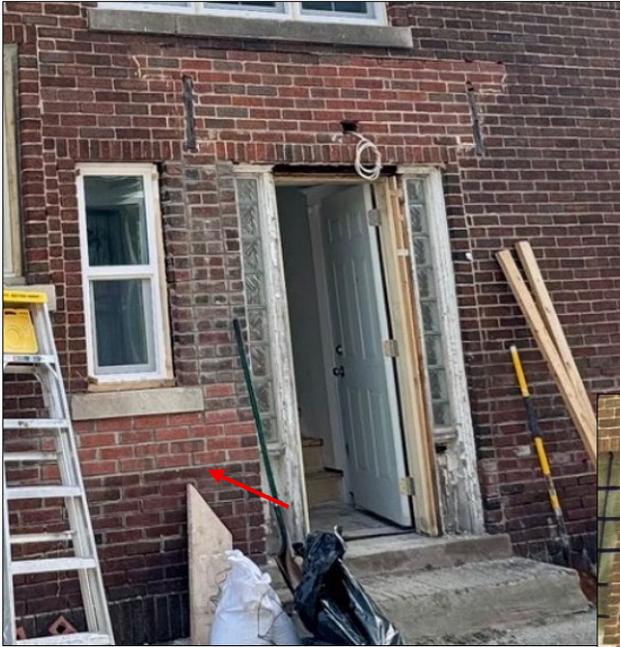
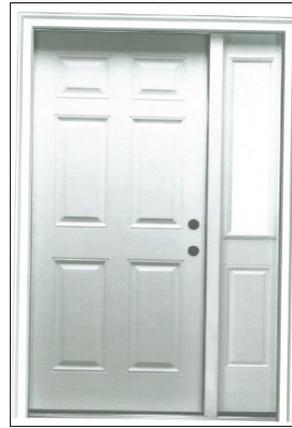
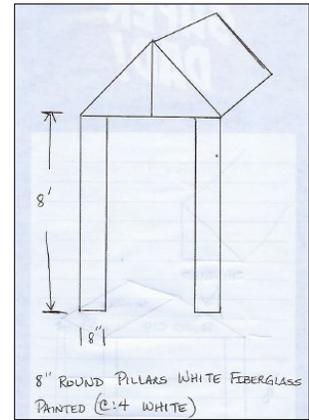
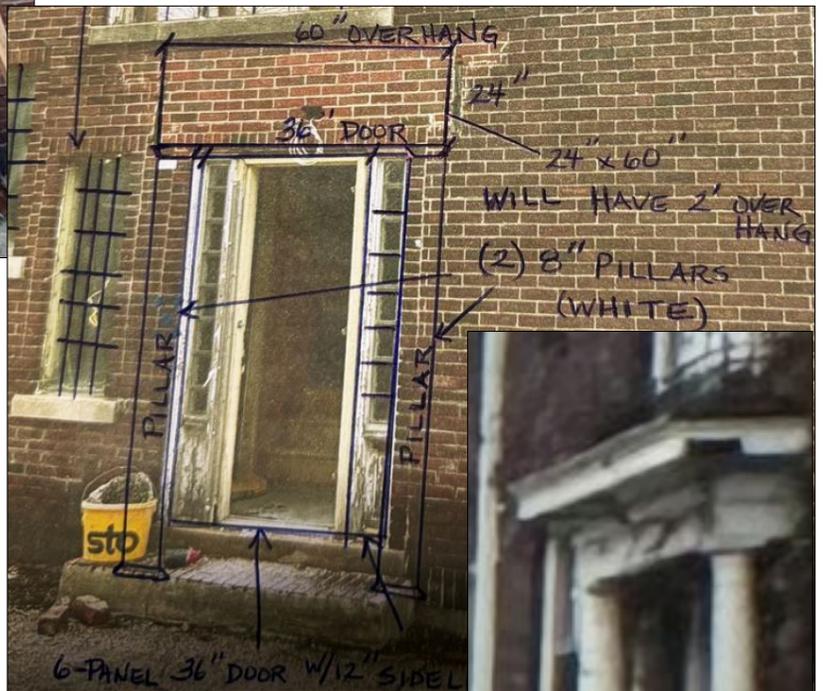
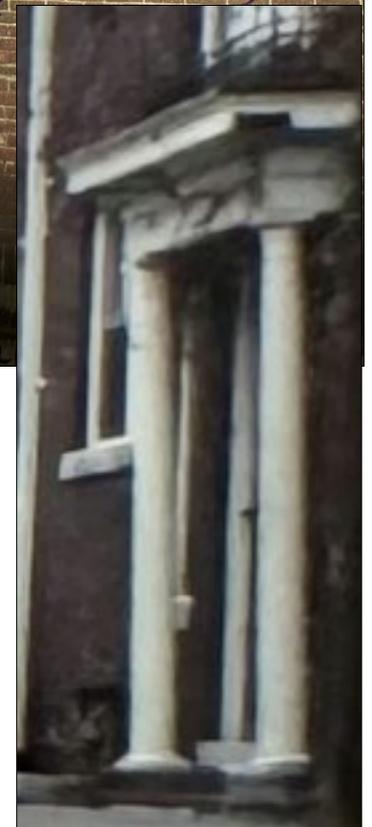
Above, Staff photo, 2/26/2026 showing current condition of entry door.

- Where the window was reduced in height, red brick was added to fill the remaining area of the original opening; the brick does not match the variegated brown and dark red colors of the historic brick. The original sidelights and panels of the main entry remain in place; however, the sidelight glass was replaced (at an unknown time) with glass block.

- The applicant's scope of work proposes replacing the non-historic door and historic sidelights with a factory mulled door and single sidelight.
- The roof structure for the portico is proposed to be a pitched roof (unspecified pitch), and the drawing suggests the columns will rest directly against the roof structure. This does not match the flat roof of the original design which replicated a Roman order, complete with frieze and cornice. Staff suggested the applicant use the designation photo and add dimensions for each component, as staff stated the requirement will likely be to match the components that were removed without approval.

- Cut sheets for DuraCast fiberglass round smooth columns were submitted (Cycle 4), including pages for tapered and nontapered columns. The drawing suggests nontapered columns and specify an eight-inch diameter and an eight-foot height.

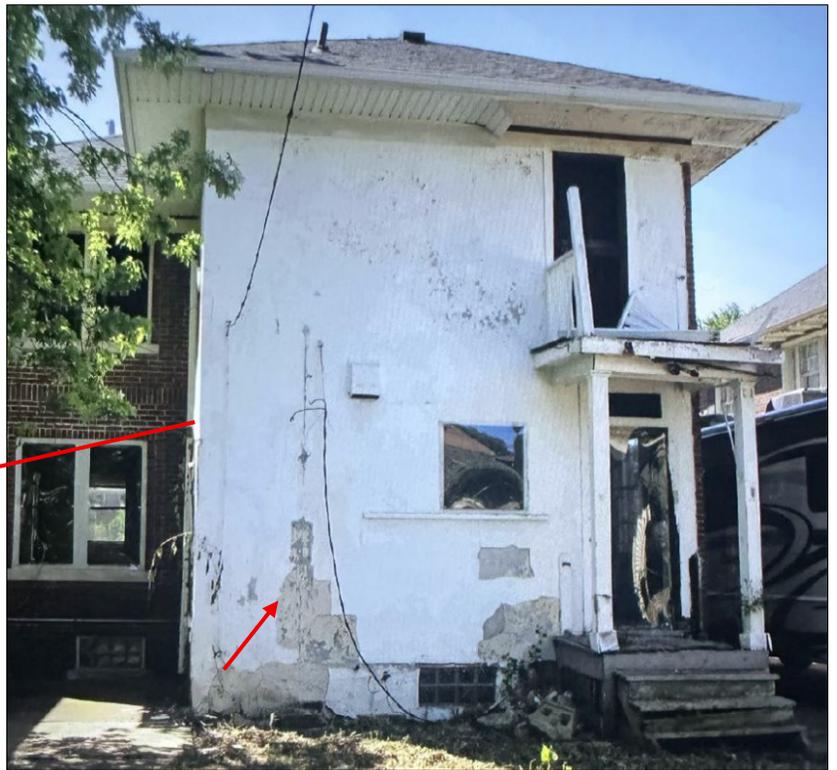
*Undated photo of rear wing submitted with the initial HDC application (received by staff on 11/26/25). The deteriorated later applied paint finish exposed the original stucco finish and color.*

- The applicant’s photo demonstrates repair of the stucco and rebuilding of the porches was needed and could have been completed to meet Standard 6.
- Rather, the applicant removed the second floor door and porch and installed a small window. The stucco was covered with EIFS (Exterior Insulation Finish System), which has a polymer-based exterior coating that contains plastic resin. It presents a contemporary expression of “stucco” which is not compatible with an early 20<sup>th</sup> century house. Additionally, EIFS is prone to moisture infiltration and is highly susceptible to impact damage.

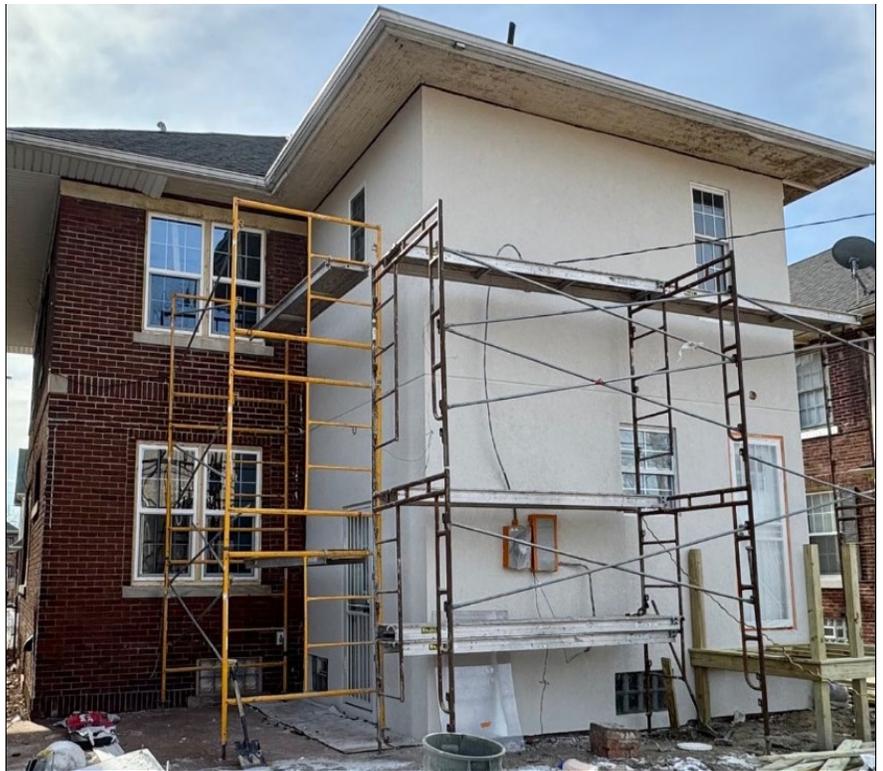
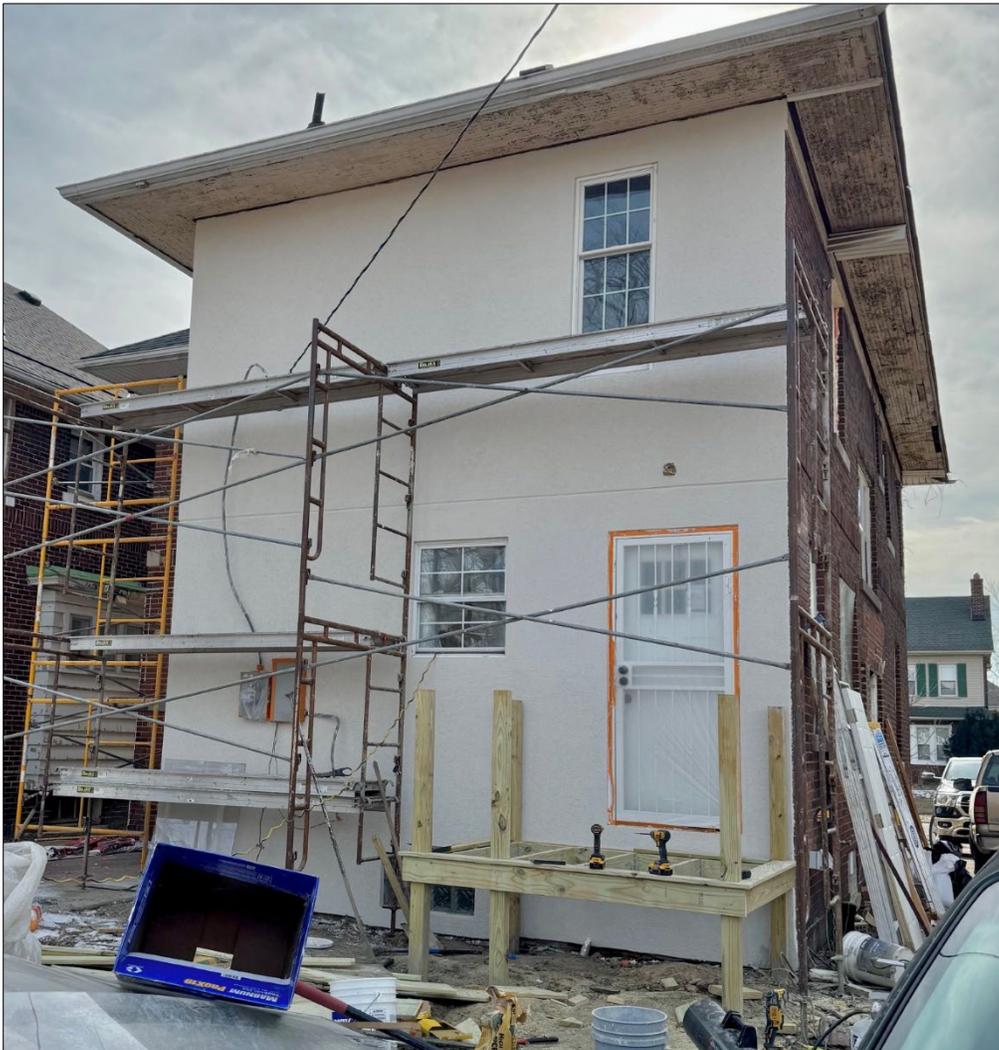
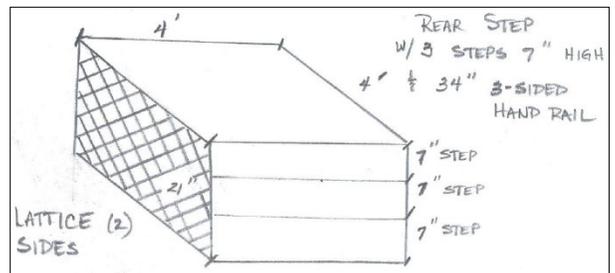
- The removal of the second story door and porch and replacement with a smaller window altered the features of this wing and removed the physical record of its time of construction and historic use.
- The drawing of a proposed first floor landing and stairs submitted by the applicant (Cycle 4) shows that it was to consist of a three step, 4'x4' landing and a “3-sided handrail”. Staff requested a drawing or photo of the proposed railing, but it has not been received. The landing under construction doesn't match the dimensions in the drawing, therefore a new

drawing must be submitted to reflect the current dimensions, design (including railing) and finishes – the applicant stated in one of the cycles the porch would be painted Yellowish-White (C:4). Additionally, diagonal lattice is a contemporary material and not compatible for use at a porch landing located at an entrance to an early 20<sup>th</sup>-century structure. Square lattice was used at this time, remains readily available, and would be a compatible material at this location.

1. The masonry cleaning will be comprised of a low-pressure hot water method (no chemicals), per the HDC's Masonry Cleaning Guidelines .
2. A photo of the selected design of the wood stair railing, along with a revised drawing of the porch and stairs accurate to the platform that is under construction, listing dimensions, materials and painted finish will be submitted for staff review.
3. Cut sheets for the gutters and downspouts, rear wing entry doors, and security doors will be submitted for staff review.

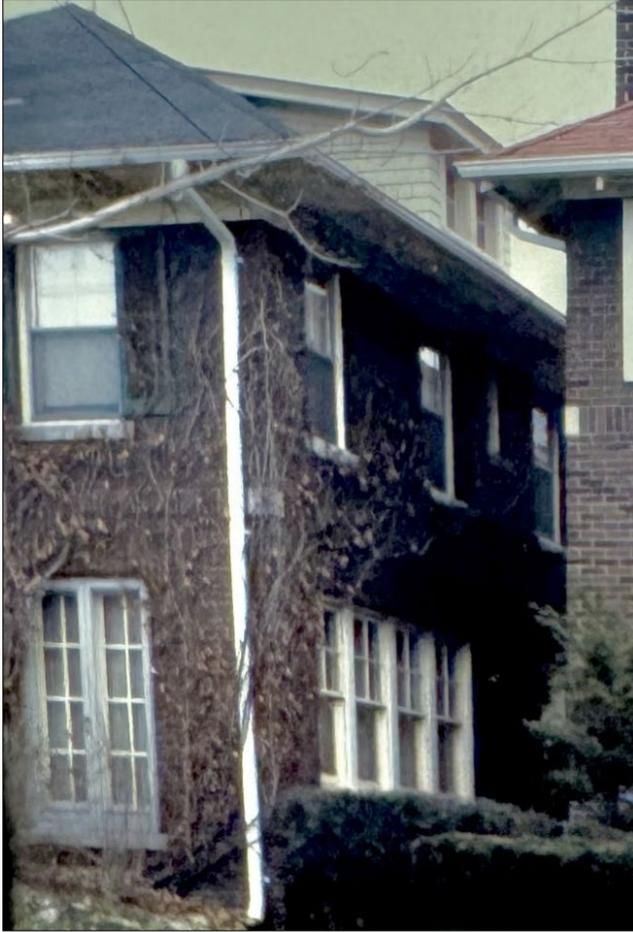
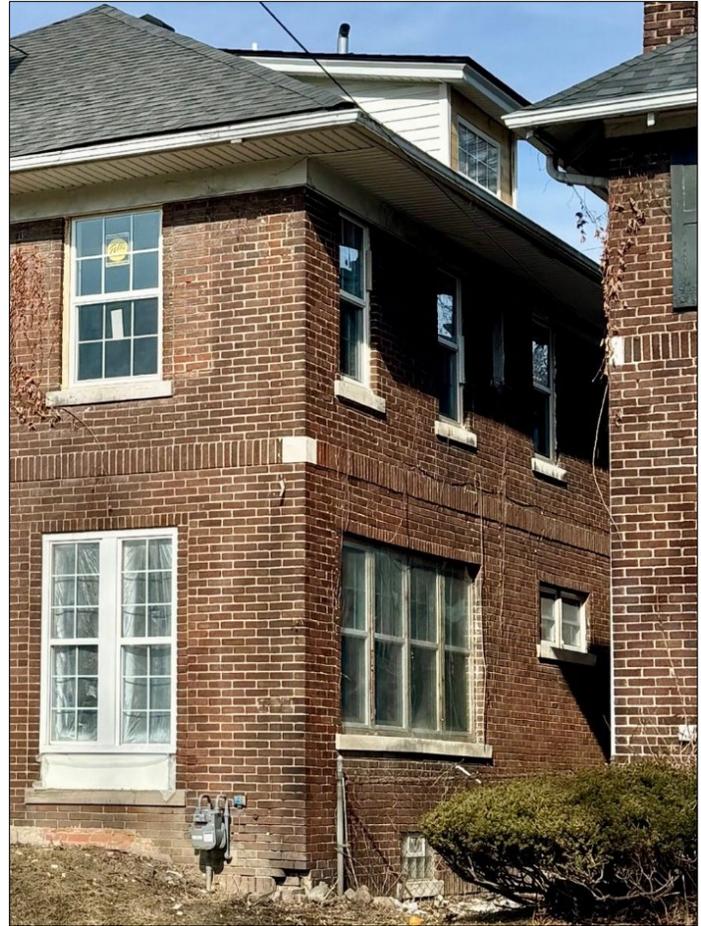
*Comparison of southeast corner of house*

- The angled view of this designation photo documents the original pattern of the double hung windows (4-over-1), depth of the original wood mullions, and design/operation of the French doors. At the dormer, wood shake siding covers the walls, and two square mullioned windows are in place.
- The 2026 photo shows the loss of depth/dimension at the mullioned window openings, altered pattern of window sashes (and between the glass grids), and double-hung windows in place of the French doors. At the dormer, wood shake siding was replaced with vinyl (although no siding appears at the front wall), and the mullioned windows have been replaced with a single wider than tall fixed or awning window.

- Vinyl siding has a reflectivity, curved edge profile and vertical joints that do not match the surface texture finish, pattern and edge details of the wood shake siding that was present and visible in the designation photo. Should the historic wood shake siding no longer be present below the vinyl siding, new wood shake siding is readily available and offers a matching texture, pattern exposure and edge profile to the historic wood siding.
