SR-2 – STAFF ADVISORY REPORT (03-06-2026)

ADDRESS: 2008 LONGFELLOW

APPLICATION NUMBER: HDC2025-00741

SCOPE: REHABILITATE HOUSE AND GARAGE (WORK STARTED WITHOUT APPROVAL)

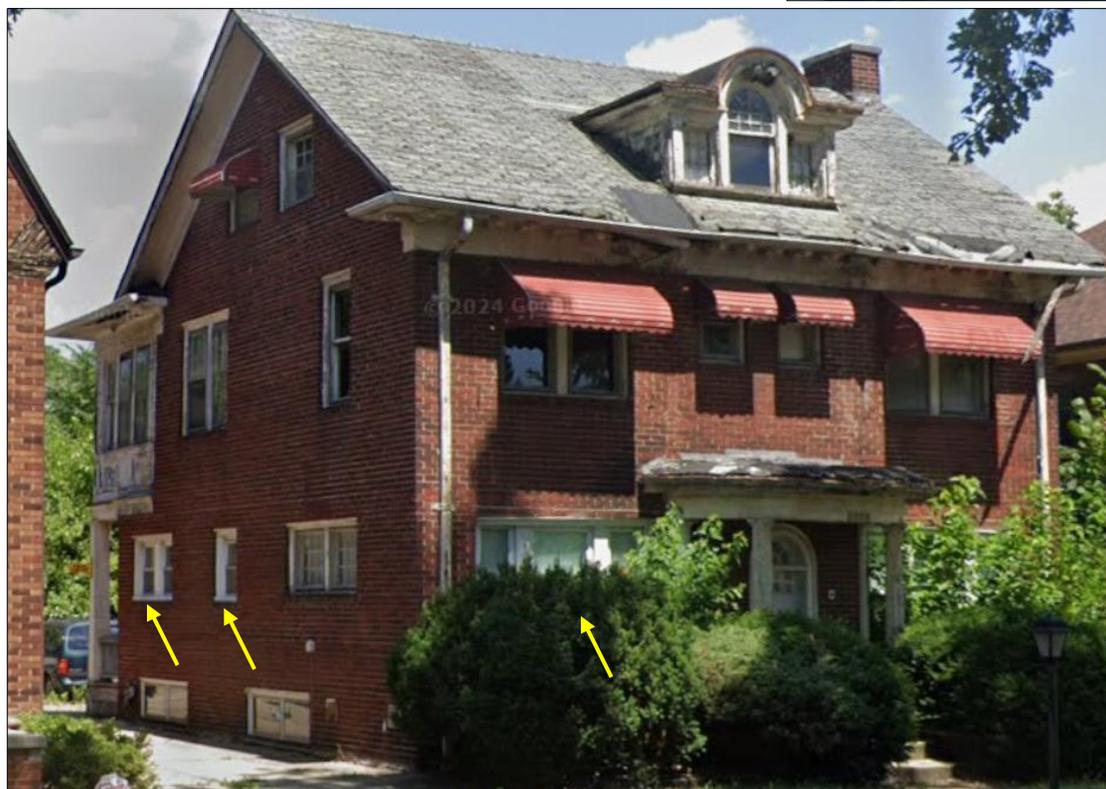
July 2022 - This Google street view image of the front and west-side walls shows that most of the architectural details were still intact. Some replacement windows appear at the first floor, identified by the brightness of the window frames and trim and lack of division of glass. Both 3-unit window openings at the front, two openings on the west wall (noted above) and window openings on the rear wall (one 3-window opening at the first floor and two windows at the second floor) contain vinyl replacement windows. There is no record of HDC approval for the vinyl windows.

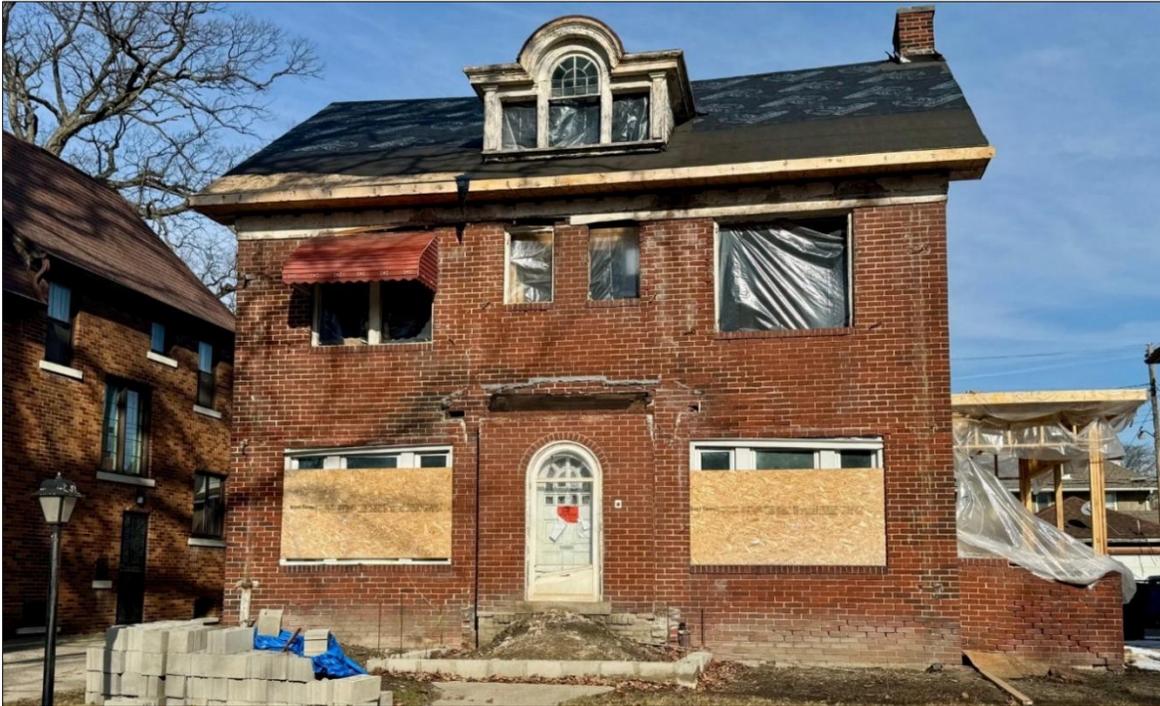
Staff photo of façade wall facing Longfellow. The only windows that remain on this elevation are the non-approved vinyl replacement units and the upper wood sash of the dormer Palladian window. The current owner/applicant removed the other historic-age wood windows. However, it appears that the wood mullions are intact at the first floor (wrapped in aluminum), second floor-west window opening and third floor dormer. 02/26/2026

- Intact historic wood windows will remain and be repaired as needed. Replacement windows will only be specified for openings in which vinyl windows have been installed and where historic windows were previously removed (i.e., empty window openings).

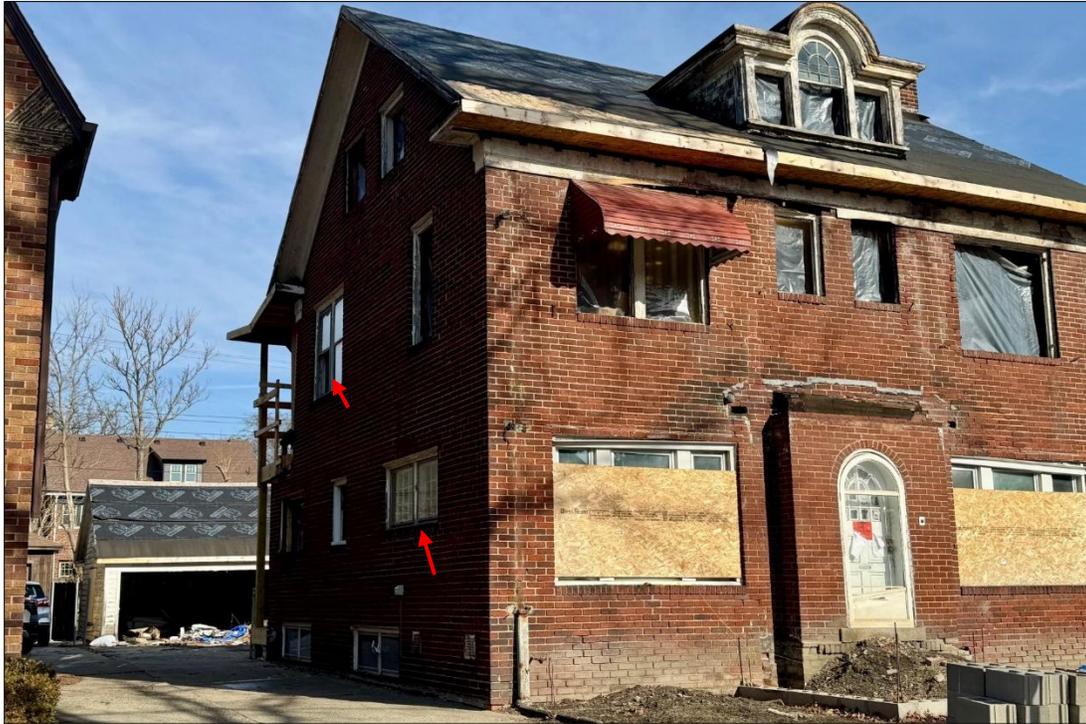
Looking northeast. There are two window openings on the west side wall that retain historic wood windows that could be repaired and should not be replaced. Staff photo, 02/26/2026

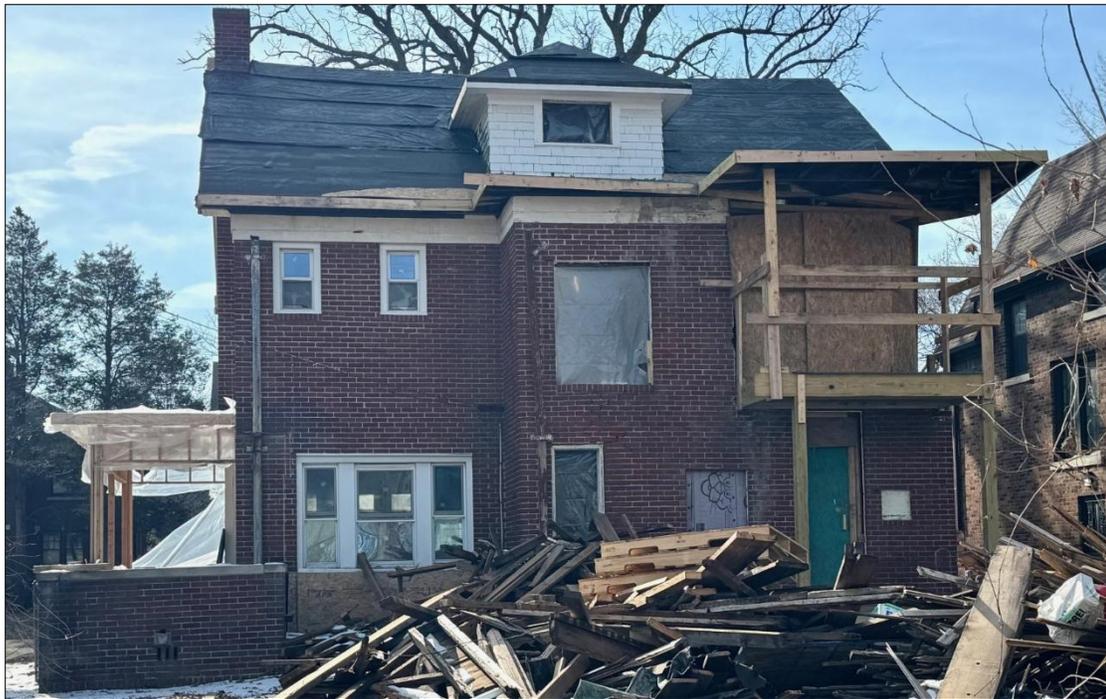
Rear of house, looking south from the alley. Vinyl replacement windows are easily identified. It appears that the wood brickmold remains in most of the openings on the four sides of the house; only a few openings would need new wood brickmold.

- Should staff determine the selected replacement window is not a match to the historic windows, another window line will be submitted for review.
- Existing wood brickmold will remain and be repaired. Where brickmold is missing, new wood brickmould, matching the dimension and profile will be installed and painted.

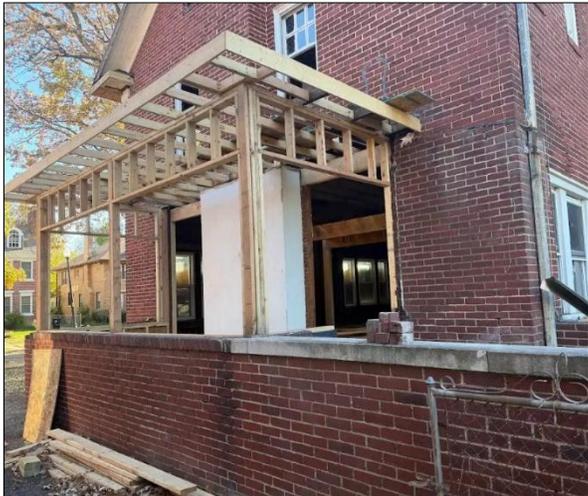
- The historic roof/wall/window structure that enclosed more than half of the side porch was demolished by the applicant, rather than repaired. The applicant proposes to rebuild this feature to match the historic design. Additional demolition work recently completed at the property was the removal of a non-historic enclosure of the remaining porch. Ghost lines remain of the now removed roof structure, showing how it wrapped around the side and rear walls, covering a portion of the downspout. This removal (unlike that of the historic porch enclosure) is an improvement to the property, restoring a historic and character-defining element.

Left: Applicant photo of side porch. Note the stone coping at the top of the masonry walls of the open porch, compared with the brick rowlock course on which the wall/window structure of the historically enclosed will sit.

Right: Applicant photo of the now open masonry porch and steps leading to the rear yard.

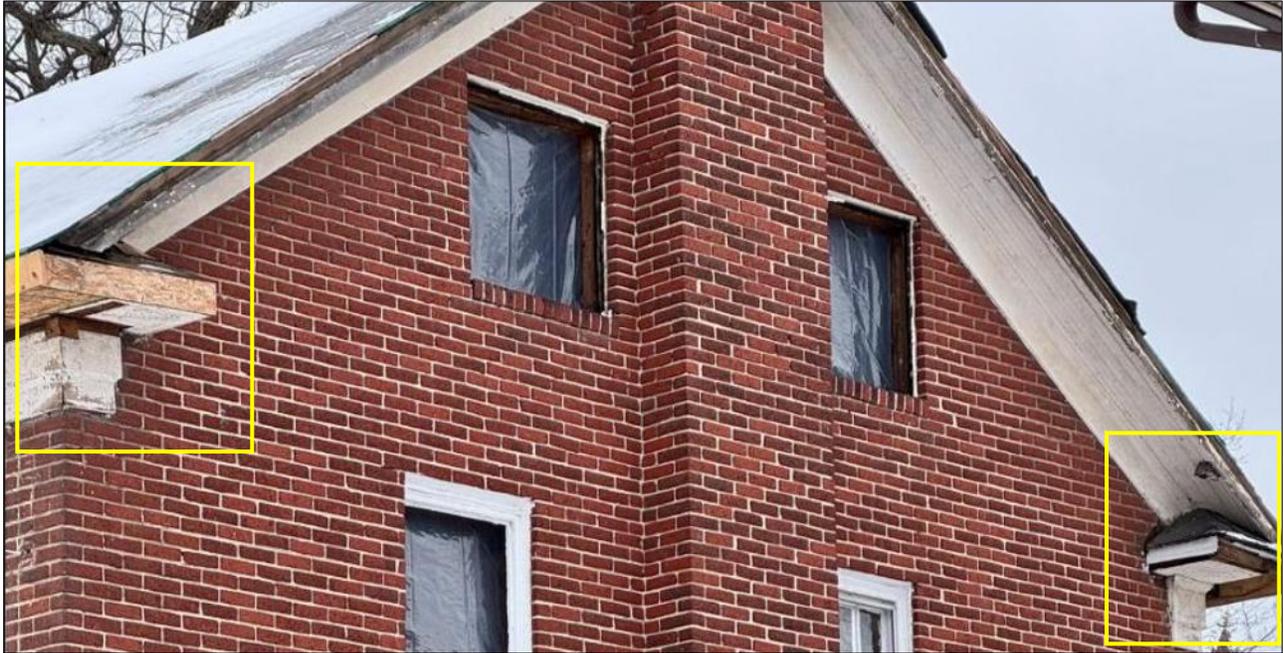
- One detail that staff questions on the drawings is the eave return. Boxed (closed) eaves are a distinctive feature of this house and are historically designed with eave returns to give the effect of a pediment, as seen here, on the east and west gable walls. The returns are covered with flashing to shed water and effectively “disappear” within the shadow of the overhanging eave.

Staff photo of east wall gable/rake. 01/28/26.

- The window/wall panel design at the second story rear porch will be revised to match the historic design and proportions.
- A section drawing or project notes will be added to the drawing set to clarify how the eave returns will be constructed and finished.

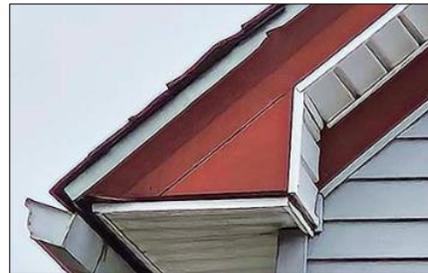
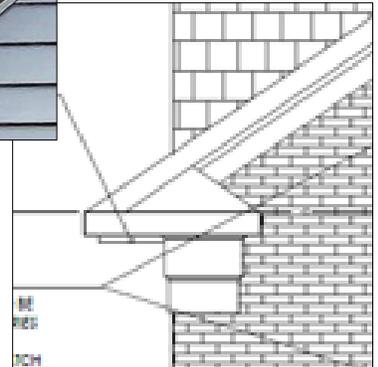
- A common occurrence in new construction, or in poor repair efforts at historic houses, is to build these returns out, i.e., capping them, thus creating a chunky and highly visible element.
- The eave return on the applicant’s drawing is confusing as it doesn’t identify a recessed or forward position as well as its finish/covering. Therefore, it is staff’s interpretation of the drawing that the intention may be to “box out” this detail, like the example provided, which would alter this highly visible, distinctive character-defining feature. The drawings should be amended to clearly note how this detail will be reconstructed, which could also be completed by the creation of a section drawing

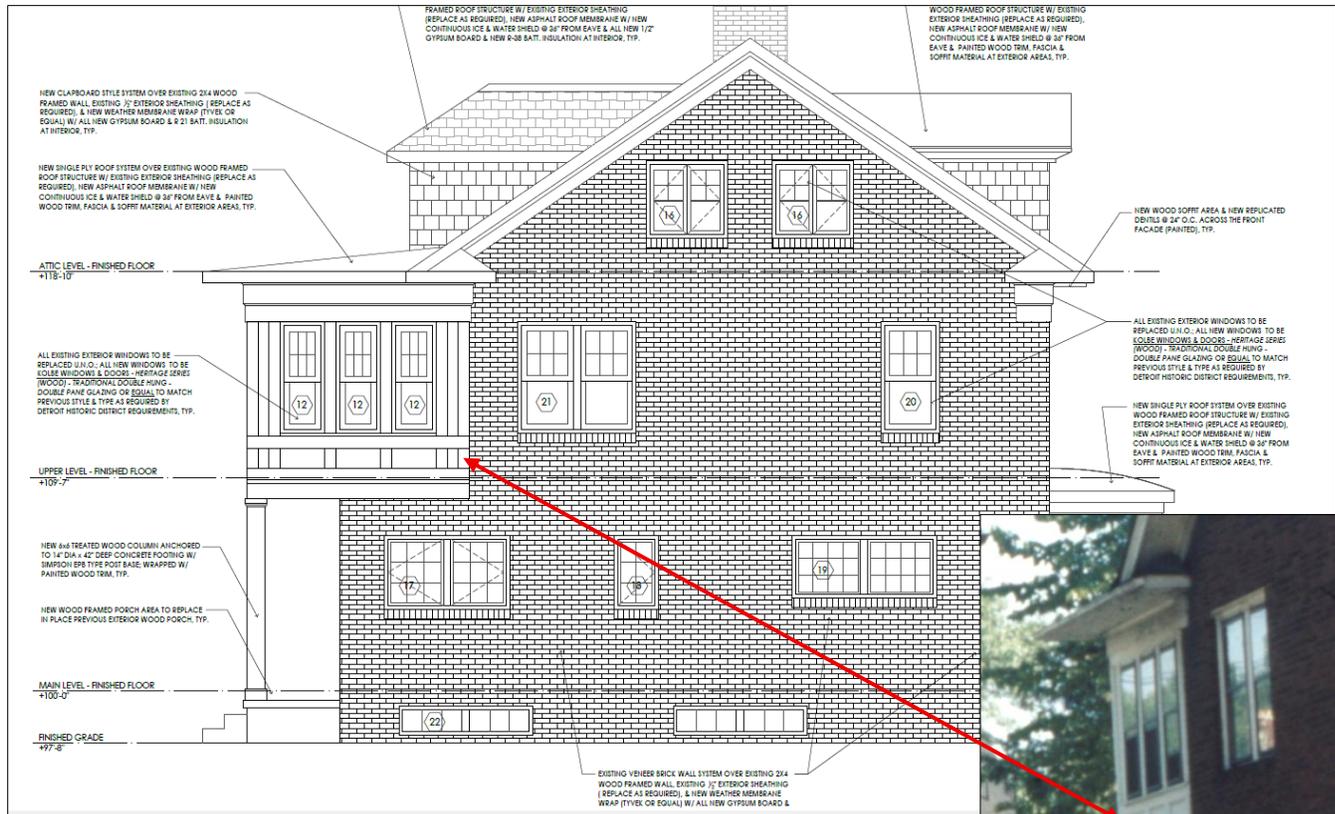
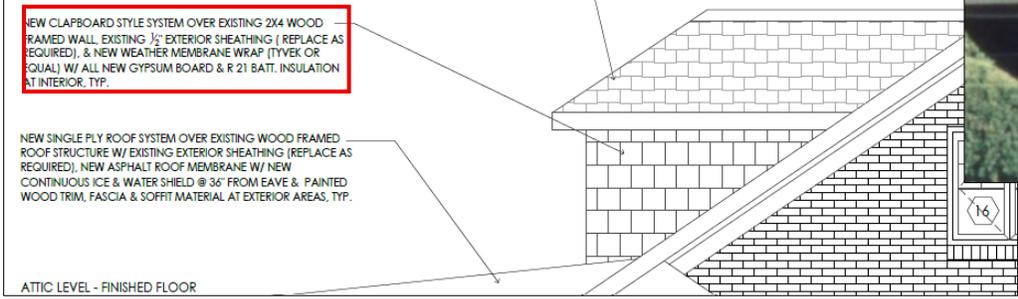
Applicant drawing of rear wall.

- The applicant's stated intent is to rebuild the rear porch to match the historic design. However, the proportions on the drawing, when compared to a 1974 designation photo, are not duplicative of the original condition.

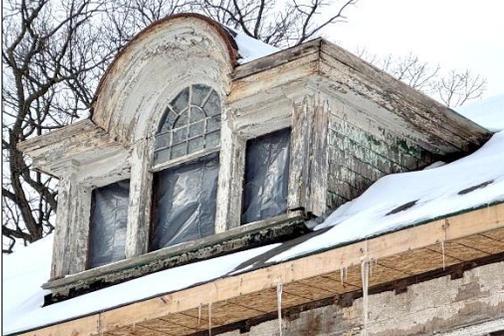
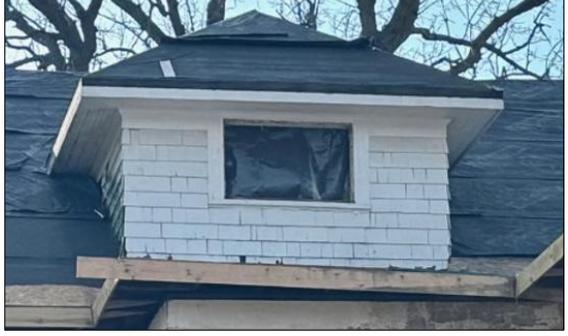
- The drawings state the wood shake shingle siding on the dormers will be replaced with a "new clapboard style system". The shake siding is a historic feature of the house and appears to be in repairable condition. The installation of a replacement siding material does not meet Standard 6.

Shake siding condition.
 Left: Front wall dormer. Staff photo, 01/28/26.
 Right: Rear wall dormer. Staff photo, 02/26/2026.

1. The wood siding at the house and garage date from the period of significance and are distinctive character-defining features of the property.
2. The wood shake and clapboard siding is intact and appears to be repairable. Wood siding is readily available and can be milled to match the exposure, profile and pattern of the historic wood siding and be painted to match the surface finish of the remaining historic wood siding/trim on the house and garage.

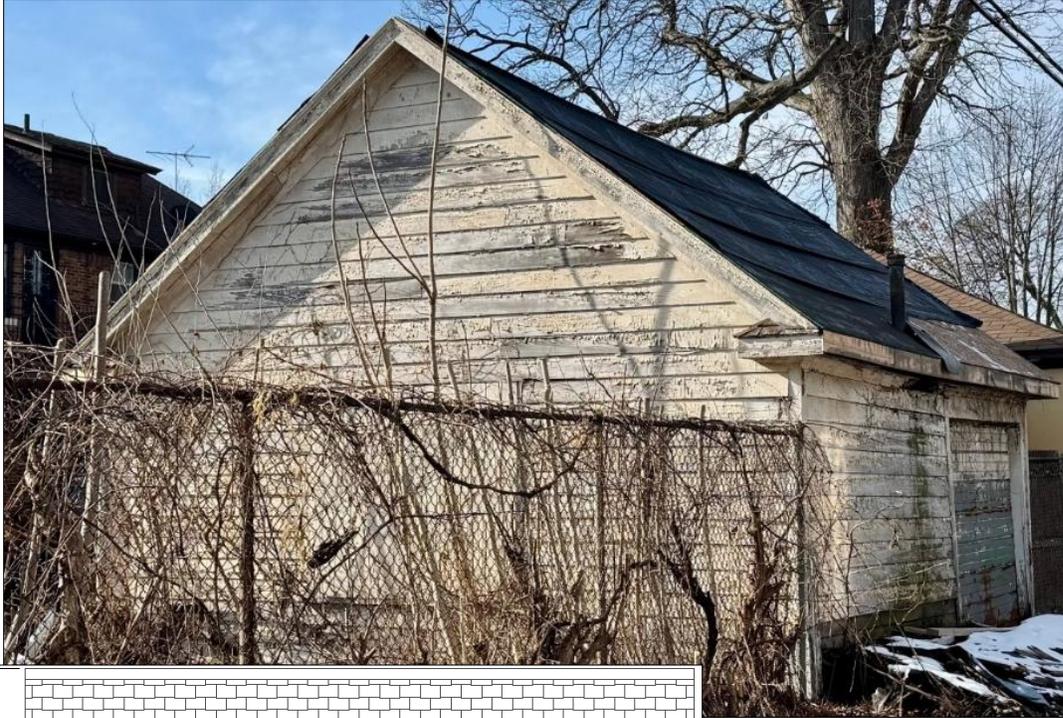
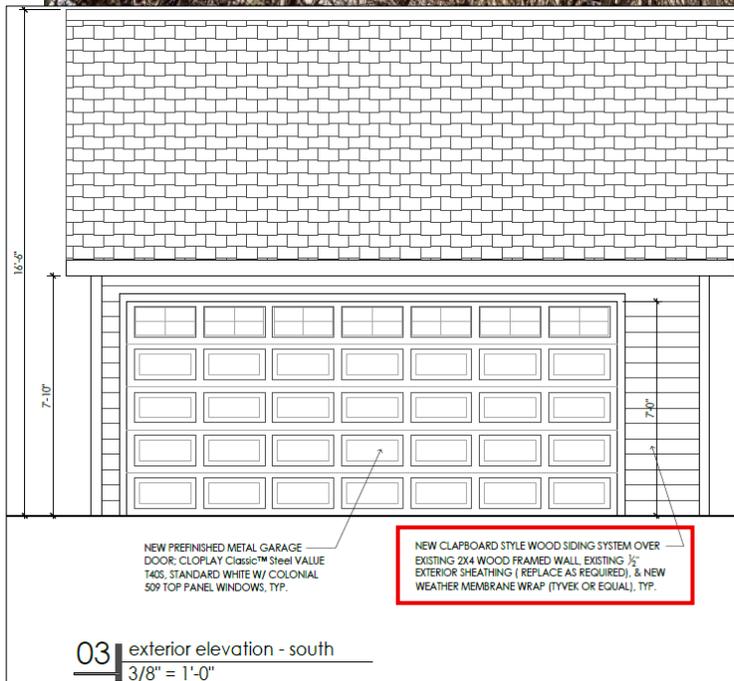
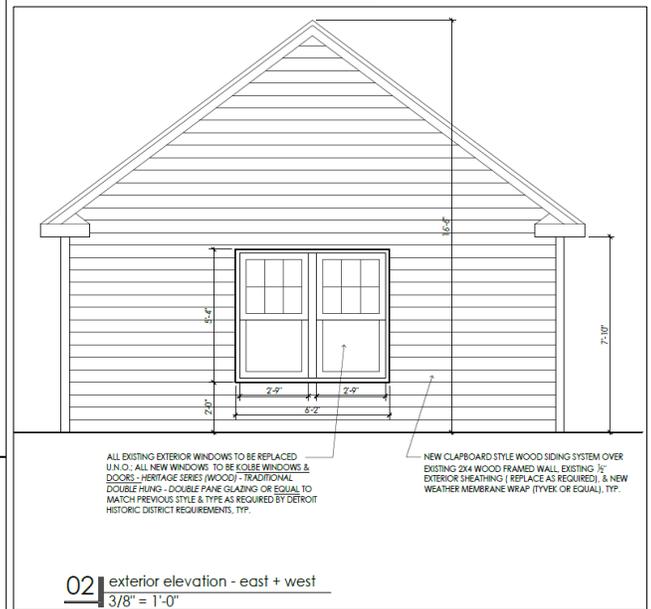
Left: Staff photo of east and rear walls of garage (taken from alley). 02/26/2026. Below: Applicant drawings.

- According to the building permit, the garage was erected the same year as the house (1919). The deep boxed eaves, mullied window openings, side gable roof and eave returns, match details found on the house and are distinctive character-defining features. Staff identifies the garage as a contributing structure within the historic district.
- Similar to the house’s dormers, a proposed work item specifies “new clapboard style wood siding system” to be installed on the garage walls. The historic wood siding and trim are intact and in repairable condition. Even if some replacement boards are necessary, wood siding is readily available and can be purchased/milled to match the exposure and profile of the historic wood siding.
- Staff offers similar concerns on the illustration of the eave returns, as discussed on the house’s gable walls.
