SR-1 – SUMMARY STAFF REPORT (05/01/2026)

ADDRESS: 470 MARTIN LUTHER KING JR. BOULEVARD

APPLICATION NUMBER: HDC2026-00162

HISTORIC DISTRICT: WILLIS-SELDEN

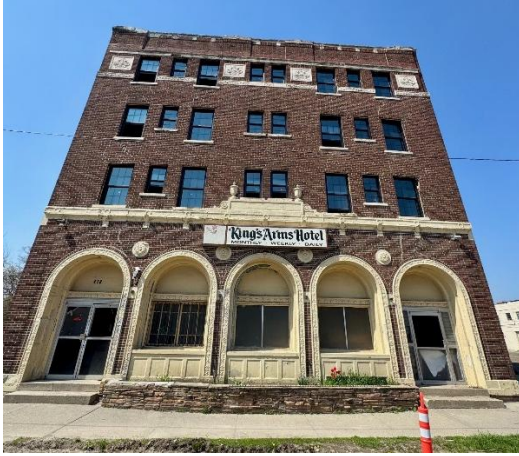
Staff photo, looking north, 04/22/2026

- Prior to the recent work, the window openings on the façade/front wall (floors 2 – 4) had wood double-hung windows (with a 4-over-4 or 6-over-6 pattern) and wood brickmold. The windows on the side and rear walls appeared to have had wood double-hung windows with a 1-over-1 pattern and wood brickmold.

- Between the time of local district designation (October 2011) and the latest Google street view (November 2024) wood windows remained in place on the façade, however some upper and/or lower divided light sash glass were replaced with undivided glass without HDC approval; the historic-age wood window frames and brickmold had remained intact.
