Appendix to Summary Staff Report, 15091 Penrod, 5/8/26

Staff has recompiled/ reformatted the applicant's submitted materials and photos for clarity and presents them in the following appendix.

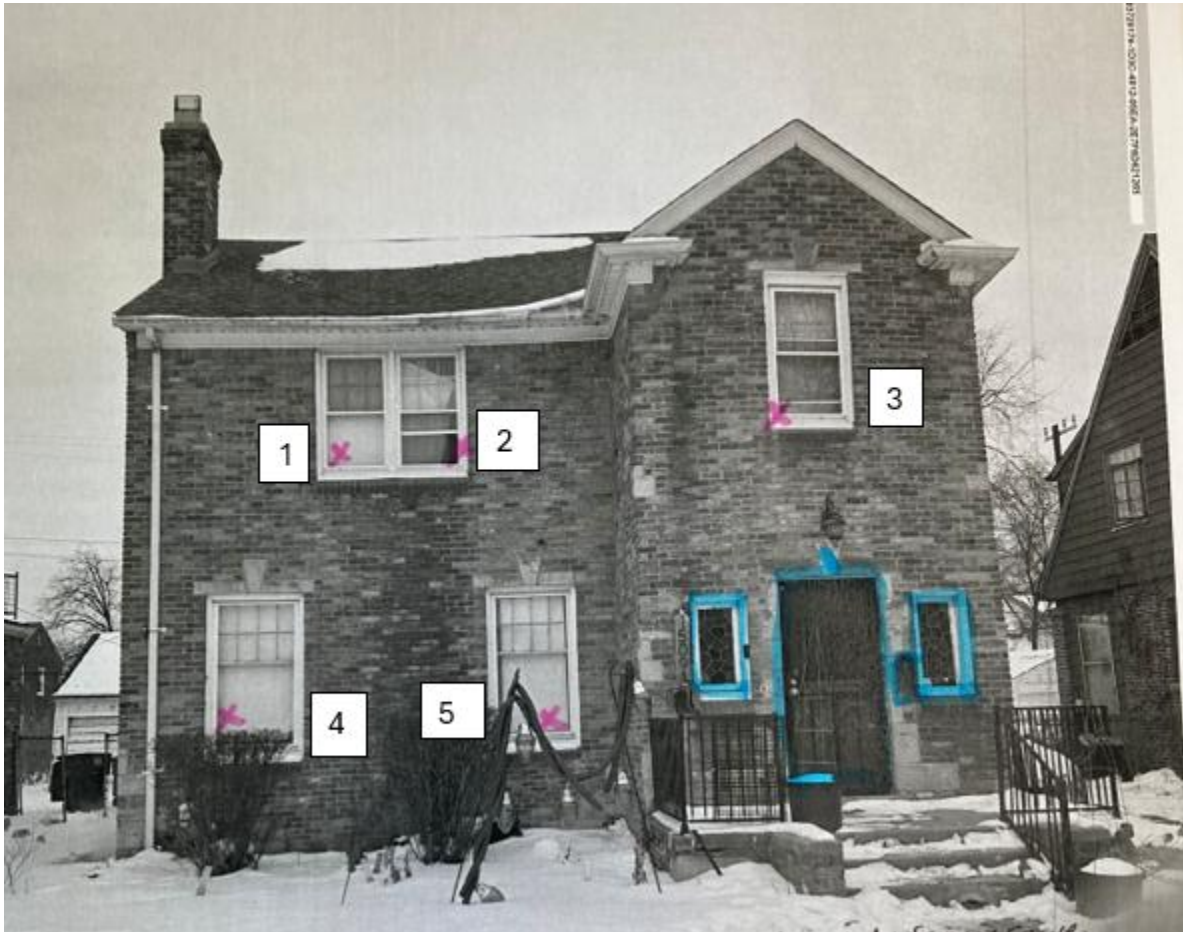
Applicant's Side A. Front of house, or east. Pink Xs mark features to be replaced. Blue outlines mark features to be preserved in place.

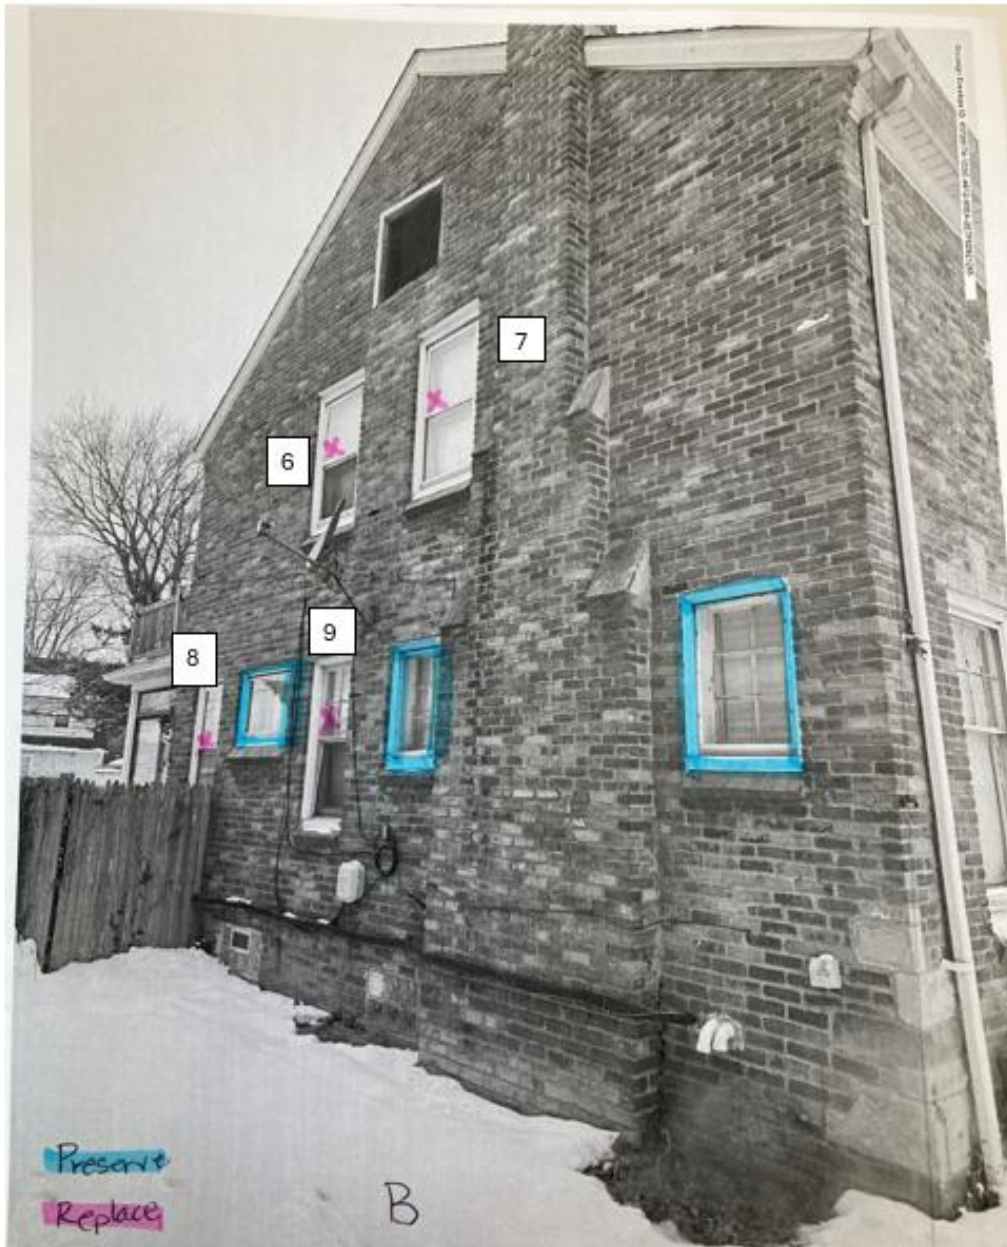
Applicant's side B, house's south side.

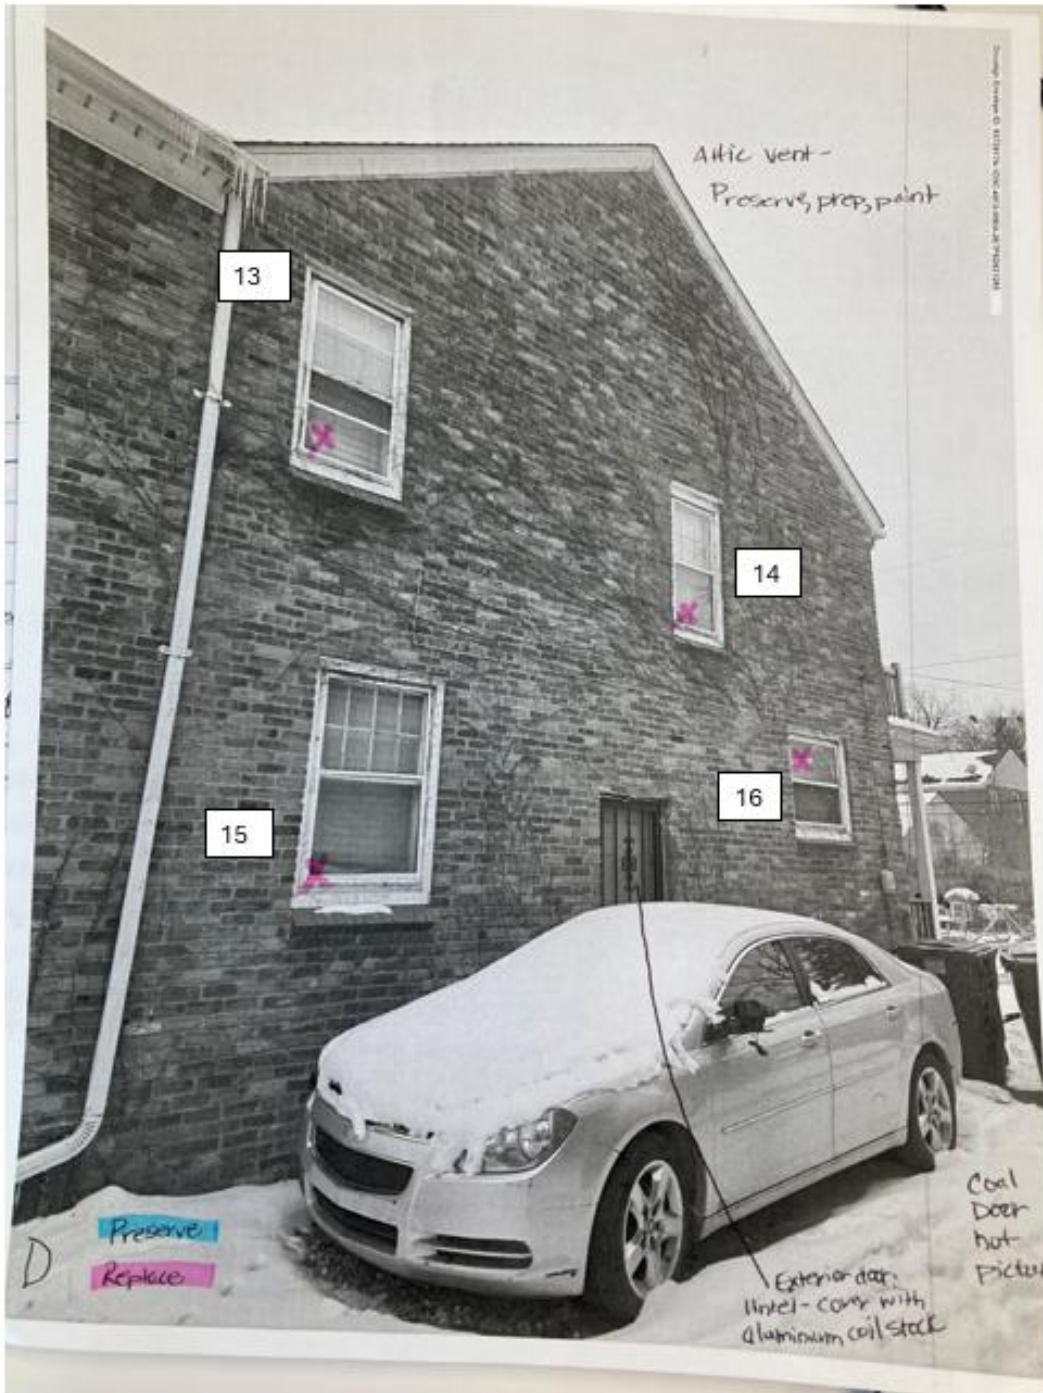
Applicant's side D, house's north side.

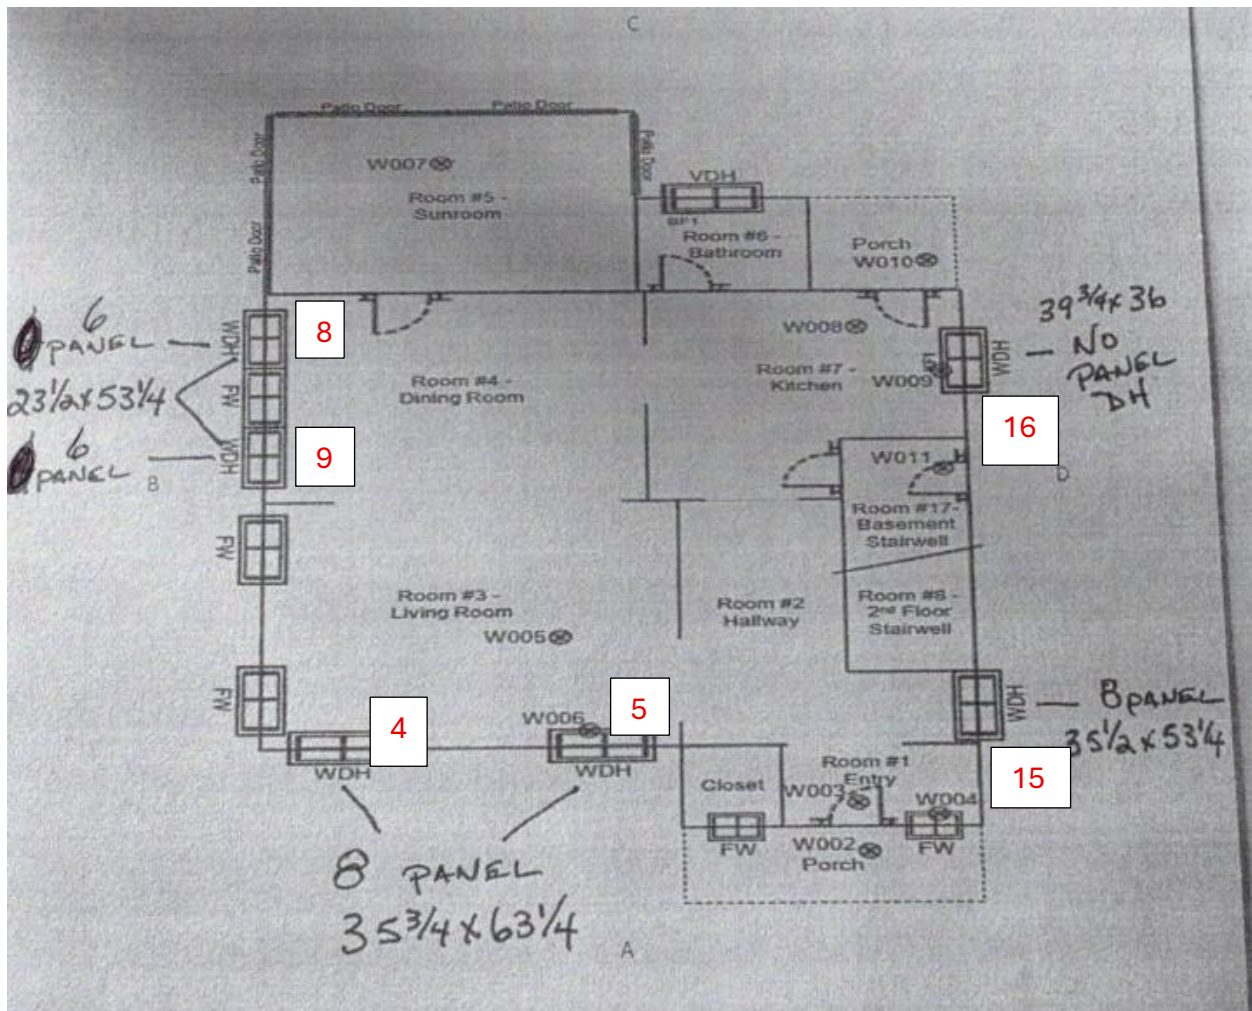
First-floor floor plan. Applicant provided this plan to accompany their draft window order. Both the floor plans and the window order were posted on the meeting webpage. Staff numbered the windows and door on the floor plans in red to correspond with the photos of the house staff marked up (above). (The symbols of the x in a circle scattered around the floor plan mark the locations where paint samples were taken.)

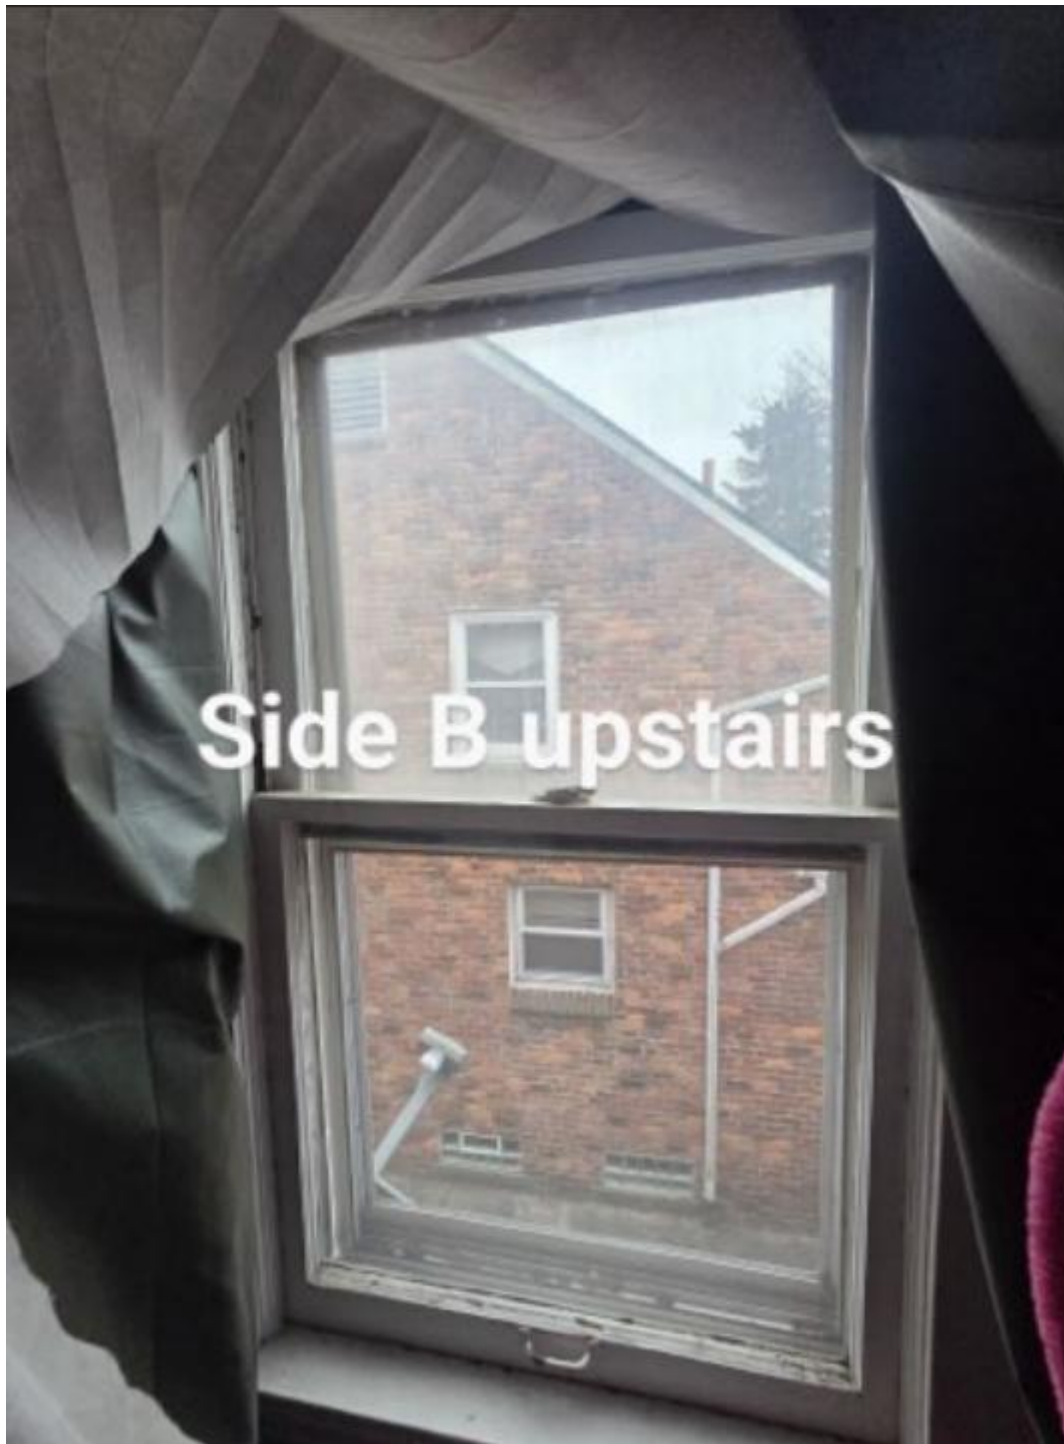
*Side B upstairs windows correspond to staff's Windows 6 or 7. Based on the arm of the satellite dish being visible here, staff believes this to be **Window 6**. It appears to be a wood replacement window.*

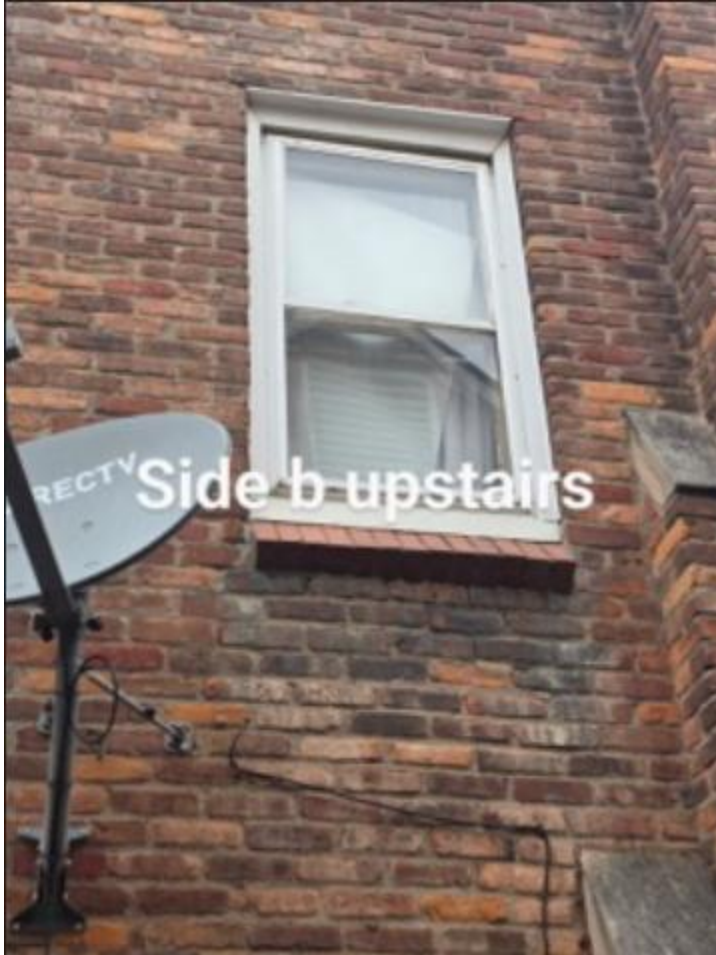
*In Cycle 3 application materials, the applicant further identified this window from the floor plan as “Bedroom 11 B2,” which would correspond to staff’s Window 6. However, based on the location of the satellite dish and chimney, staff believes this to be **Window 7**.*

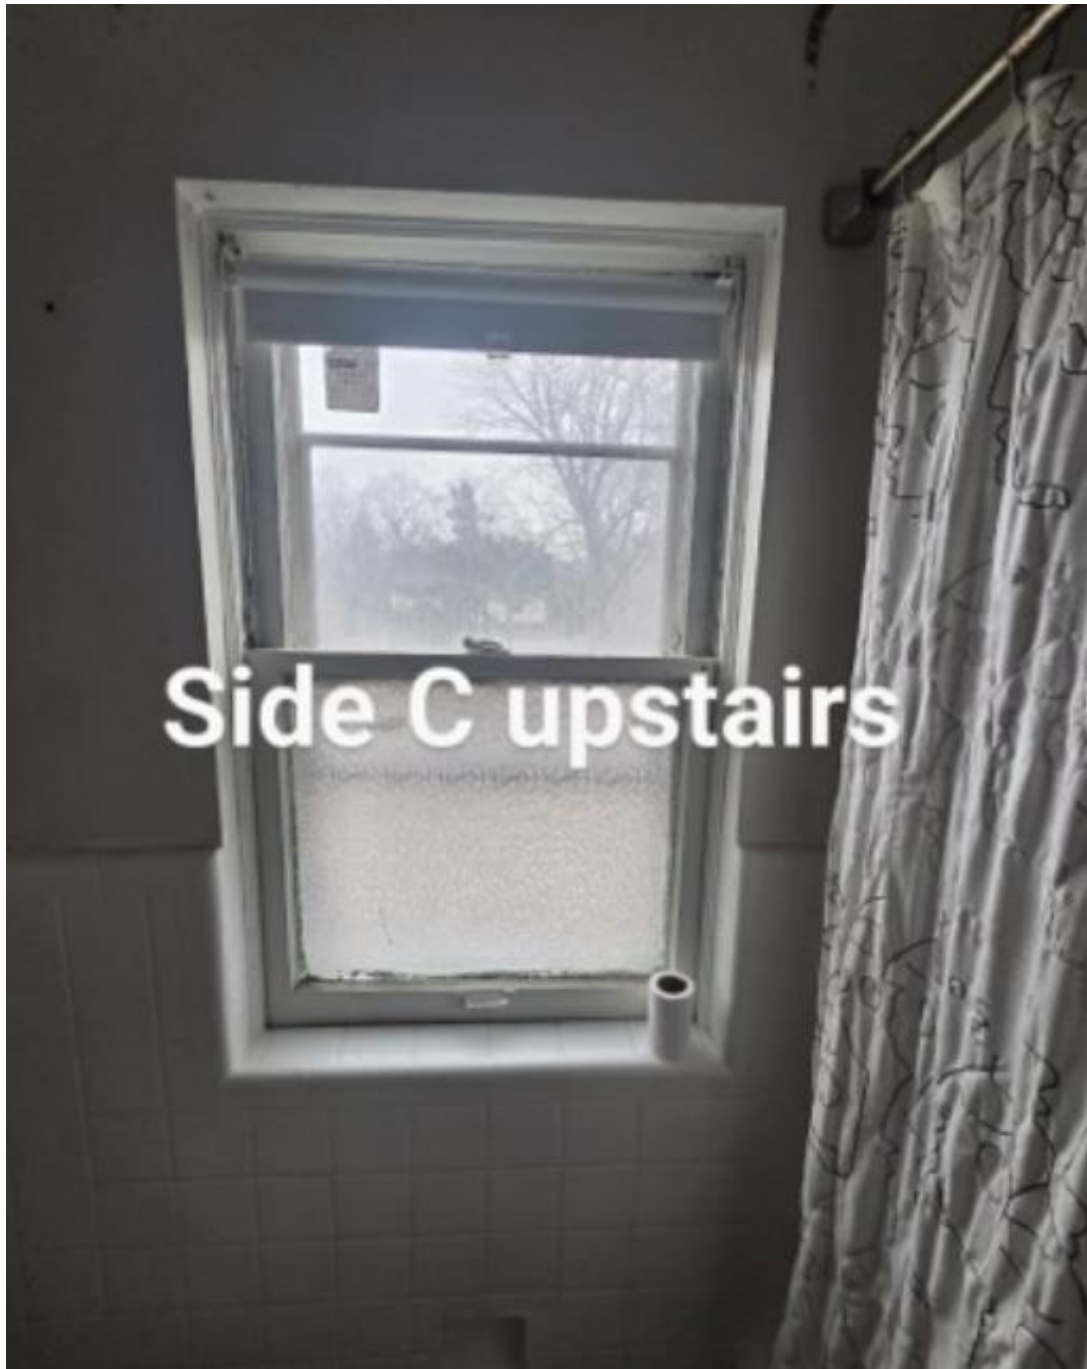
Window 10 by staff's identification. This window appears to staff to be a wood replacement window.

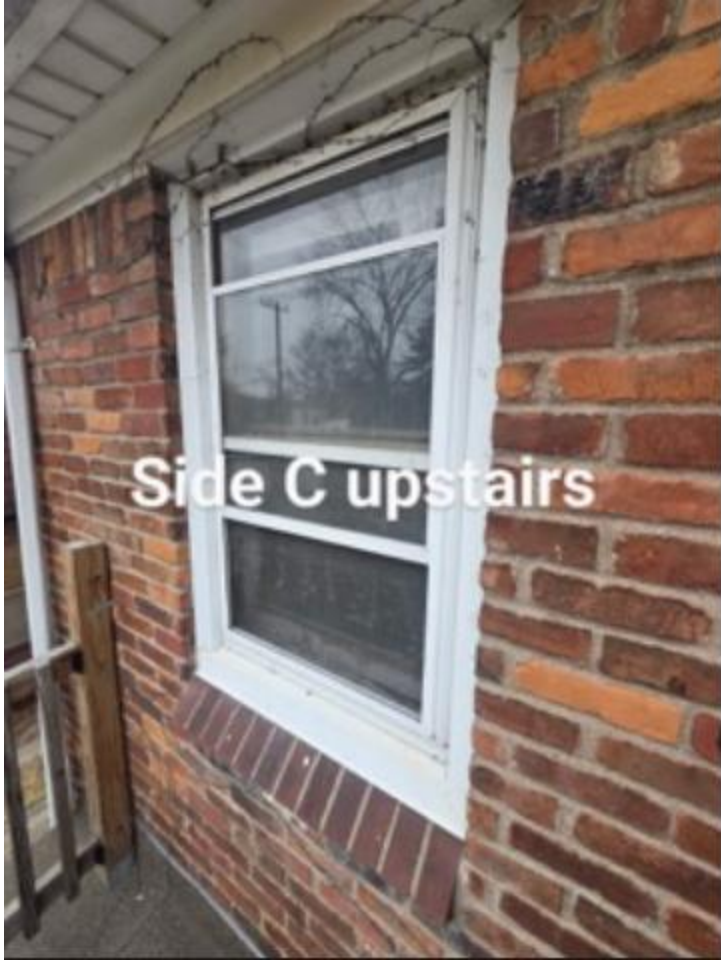
Window 10 by staff's identification. This appears to staff to be a replacement window.

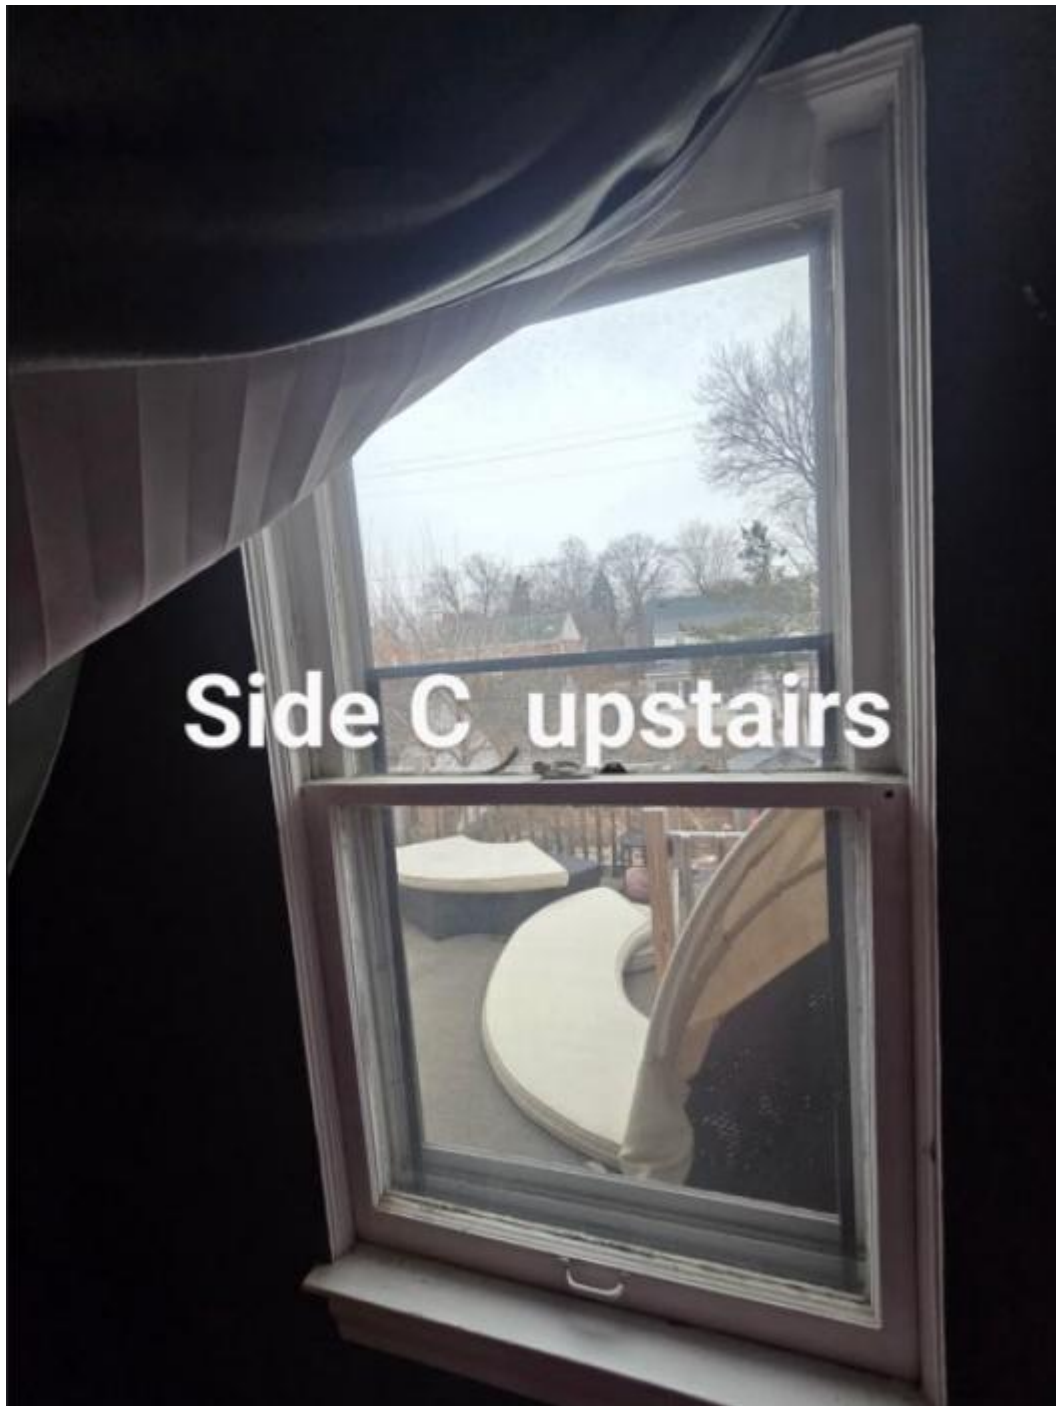
*Staff identified this window as **Window 12**. It appears to be a wood window without muntins. Staff believes this to be a wood replacement window.*

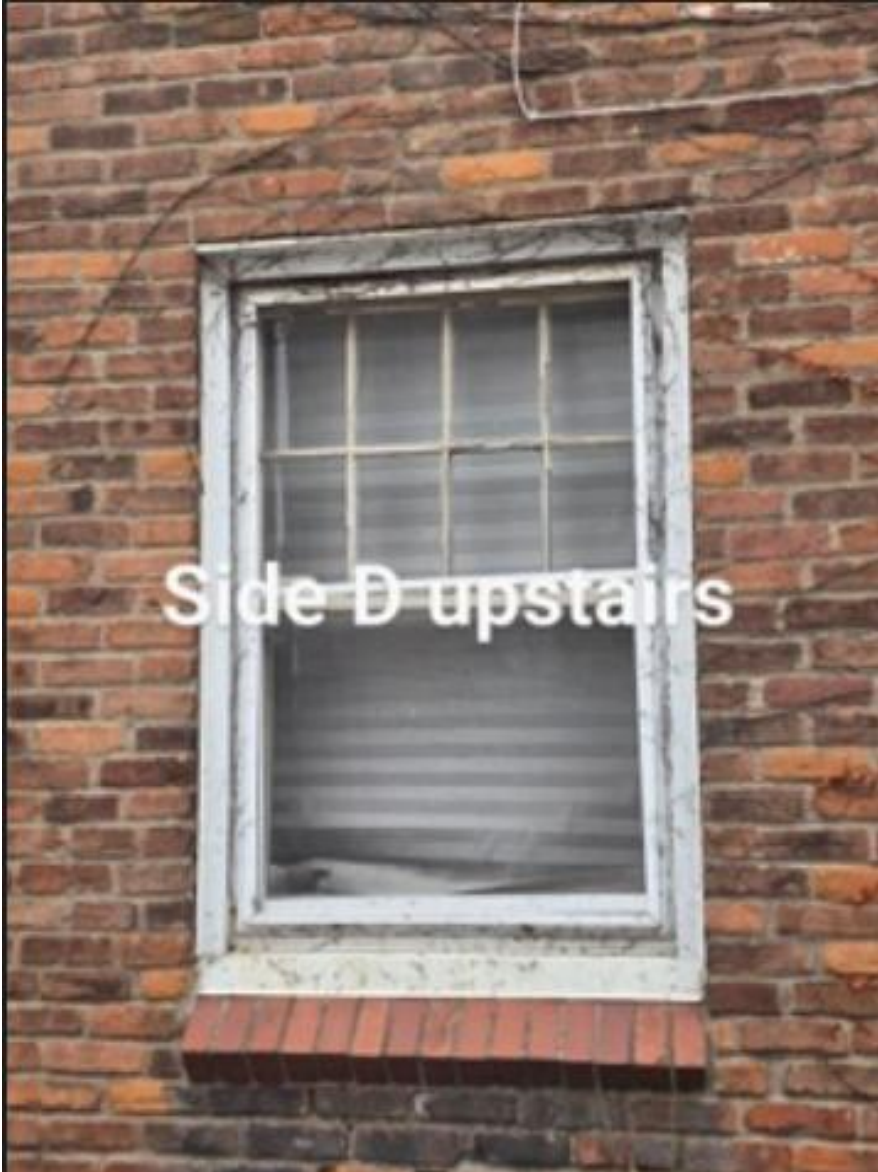
*According to staff's window identification, this is either **Window 13** or **14**.*

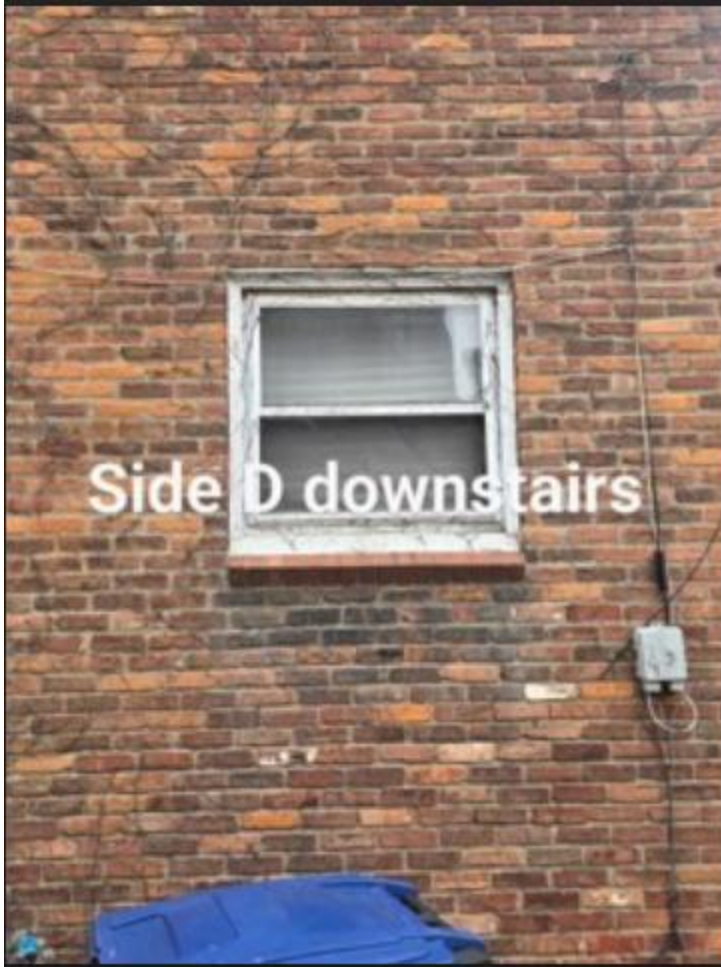
*In Cycle 3 application materials, this window is identified as "Kitchen." By staff's identification, this is **Window 16**. Staff believes this to be a replacement window.*

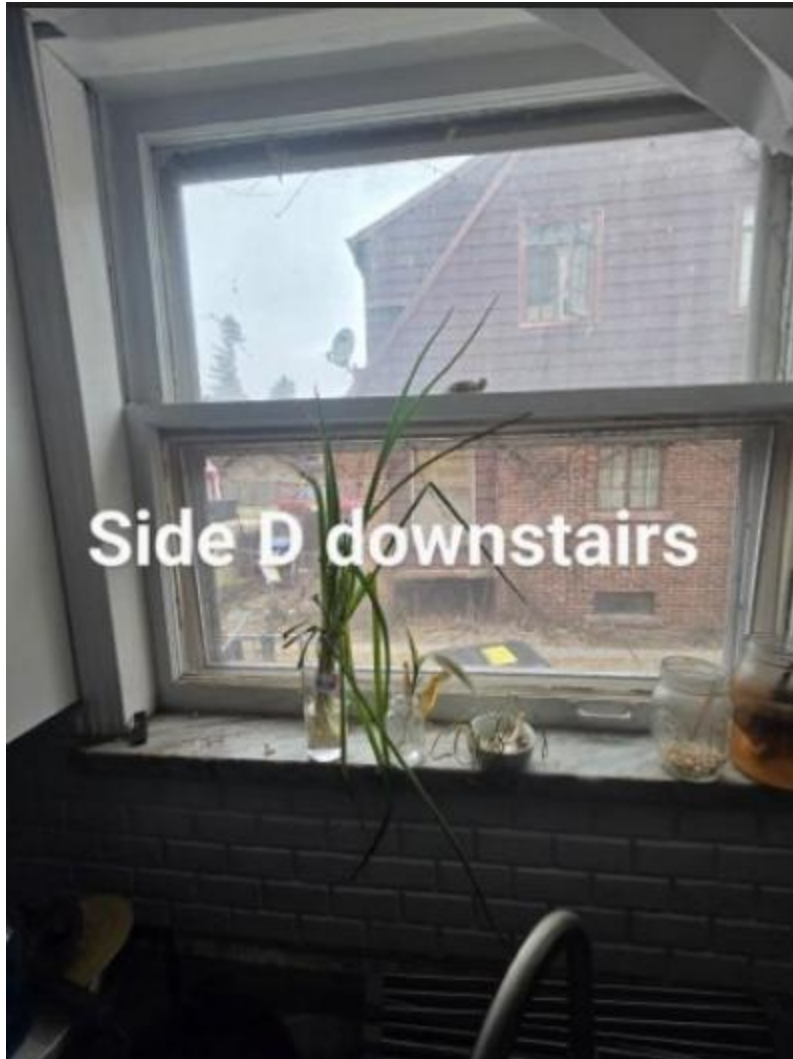
Window 16 by staff's identification. Staff believes this to be a replacement window.

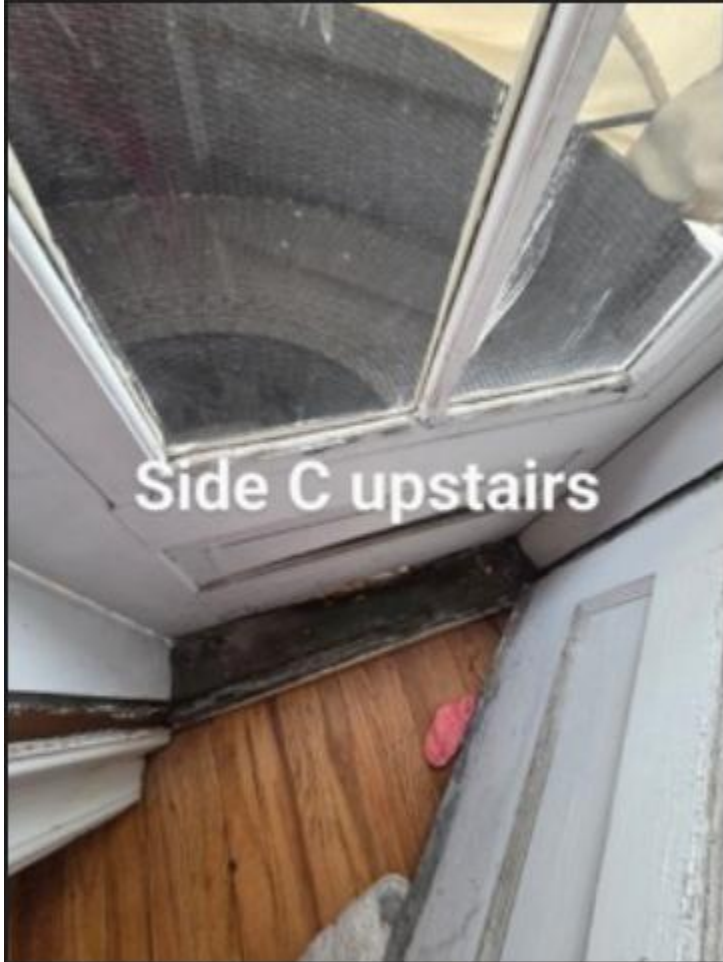
Rear balcony storm door interior and entry door exterior. Some deterioration can be seen in the wood below the glass on the storm door. Staff identified these doors as "11."

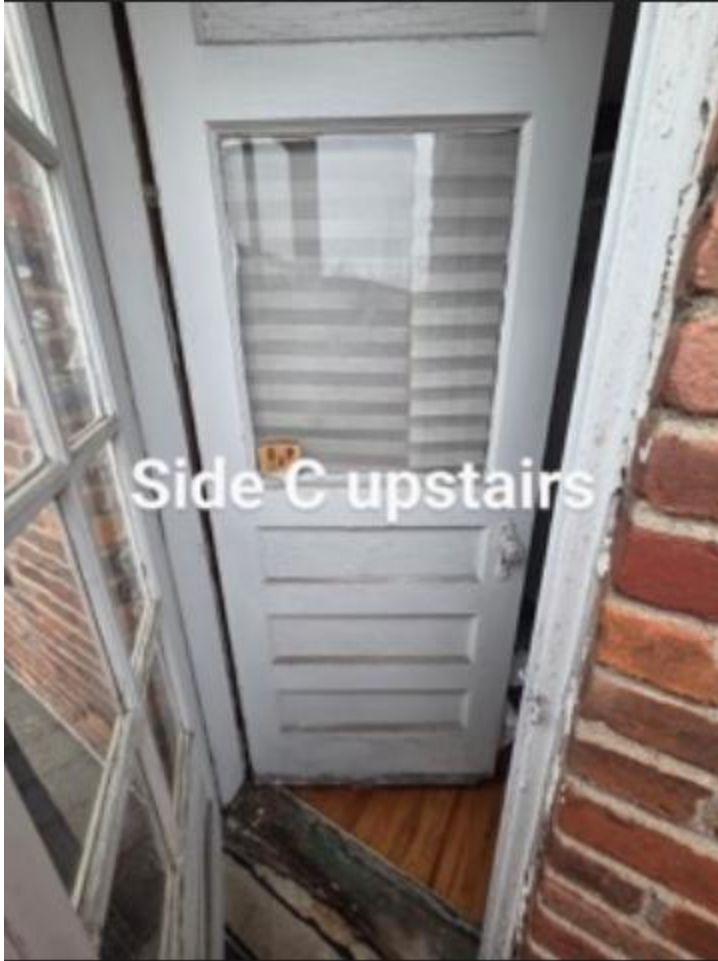
Rear balcony storm and entry doors. Staff identified these doors as “11.” A high-resolution version of this image was included in the Cycle 3 application materials, and staff included these details below.

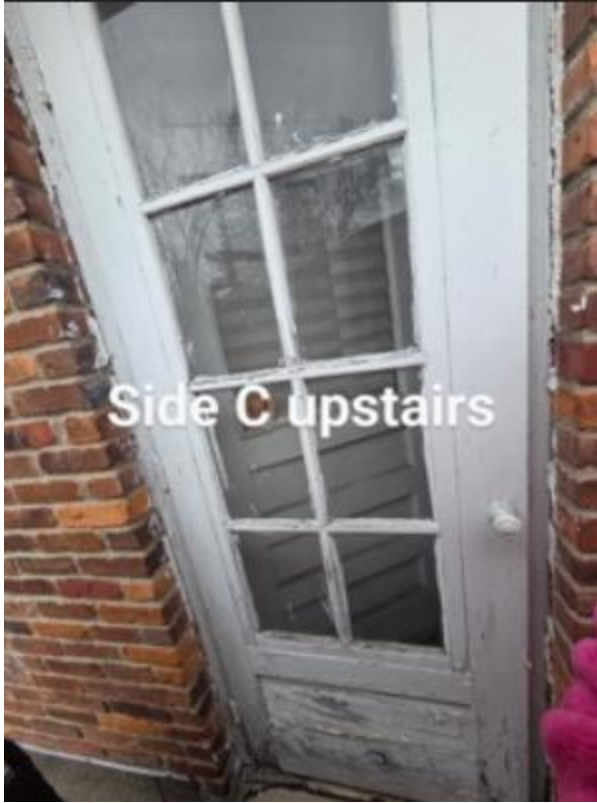
Exterior of the rear balcony's storm door. Some wood deterioration is evident below the glass. Staff identifies this door as "11."

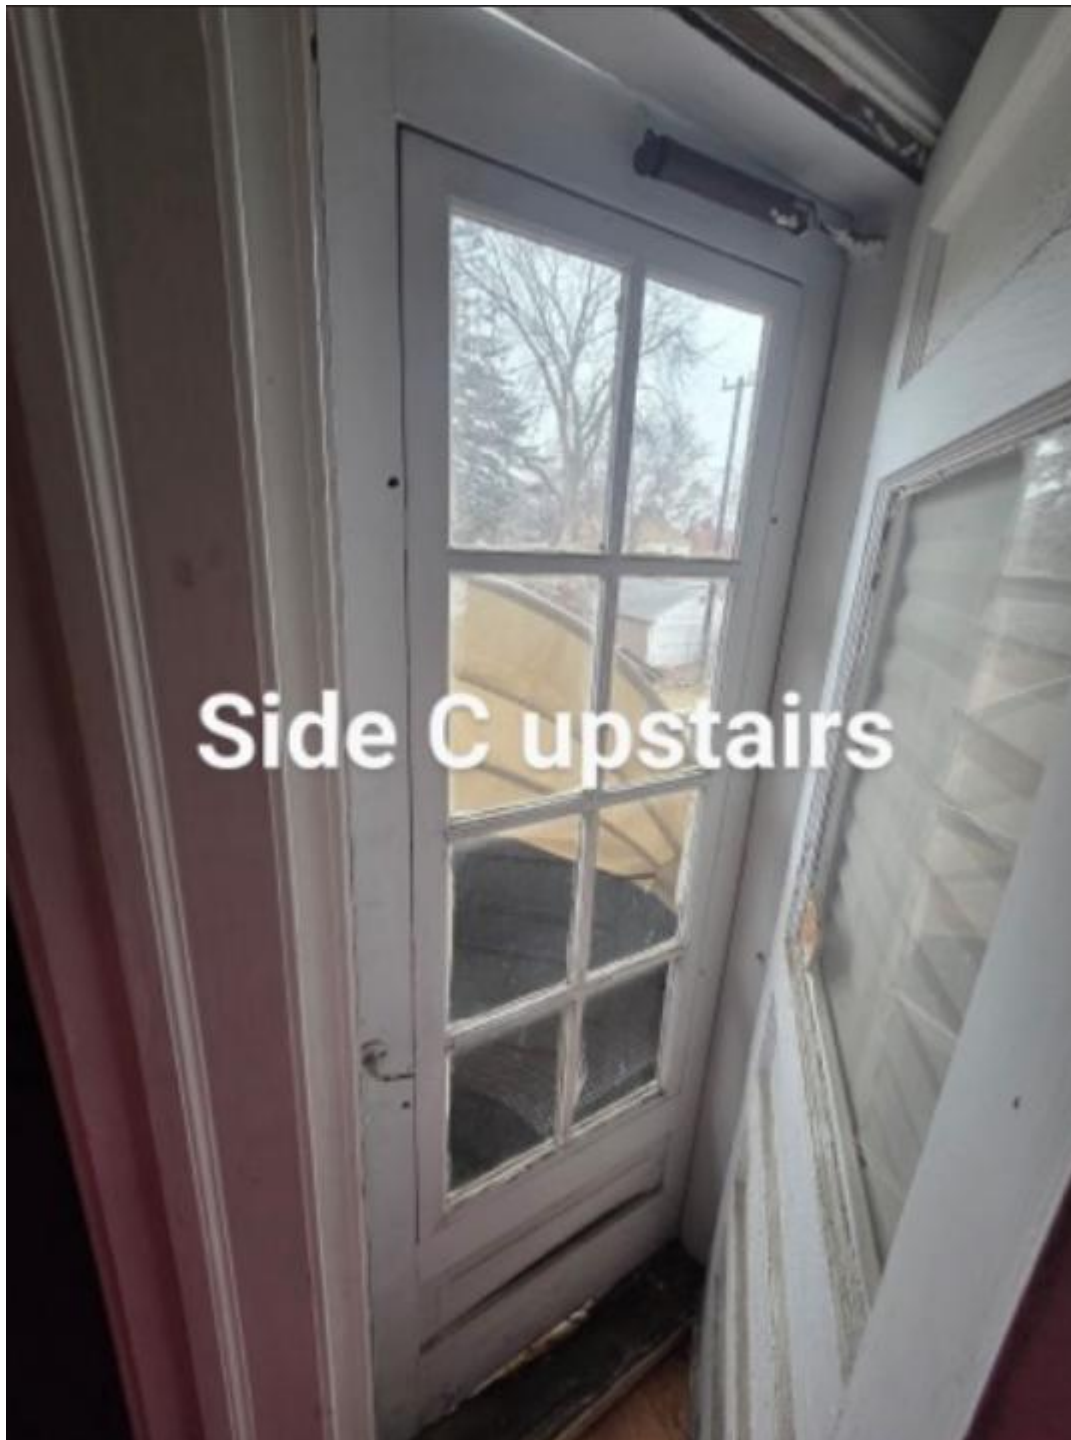
Interior of the rear balcony storm door and the exterior of the rear balcony entry door. Some wood deterioration can be observed below the glass on the storm door. These doors are identified as "11" by staff.

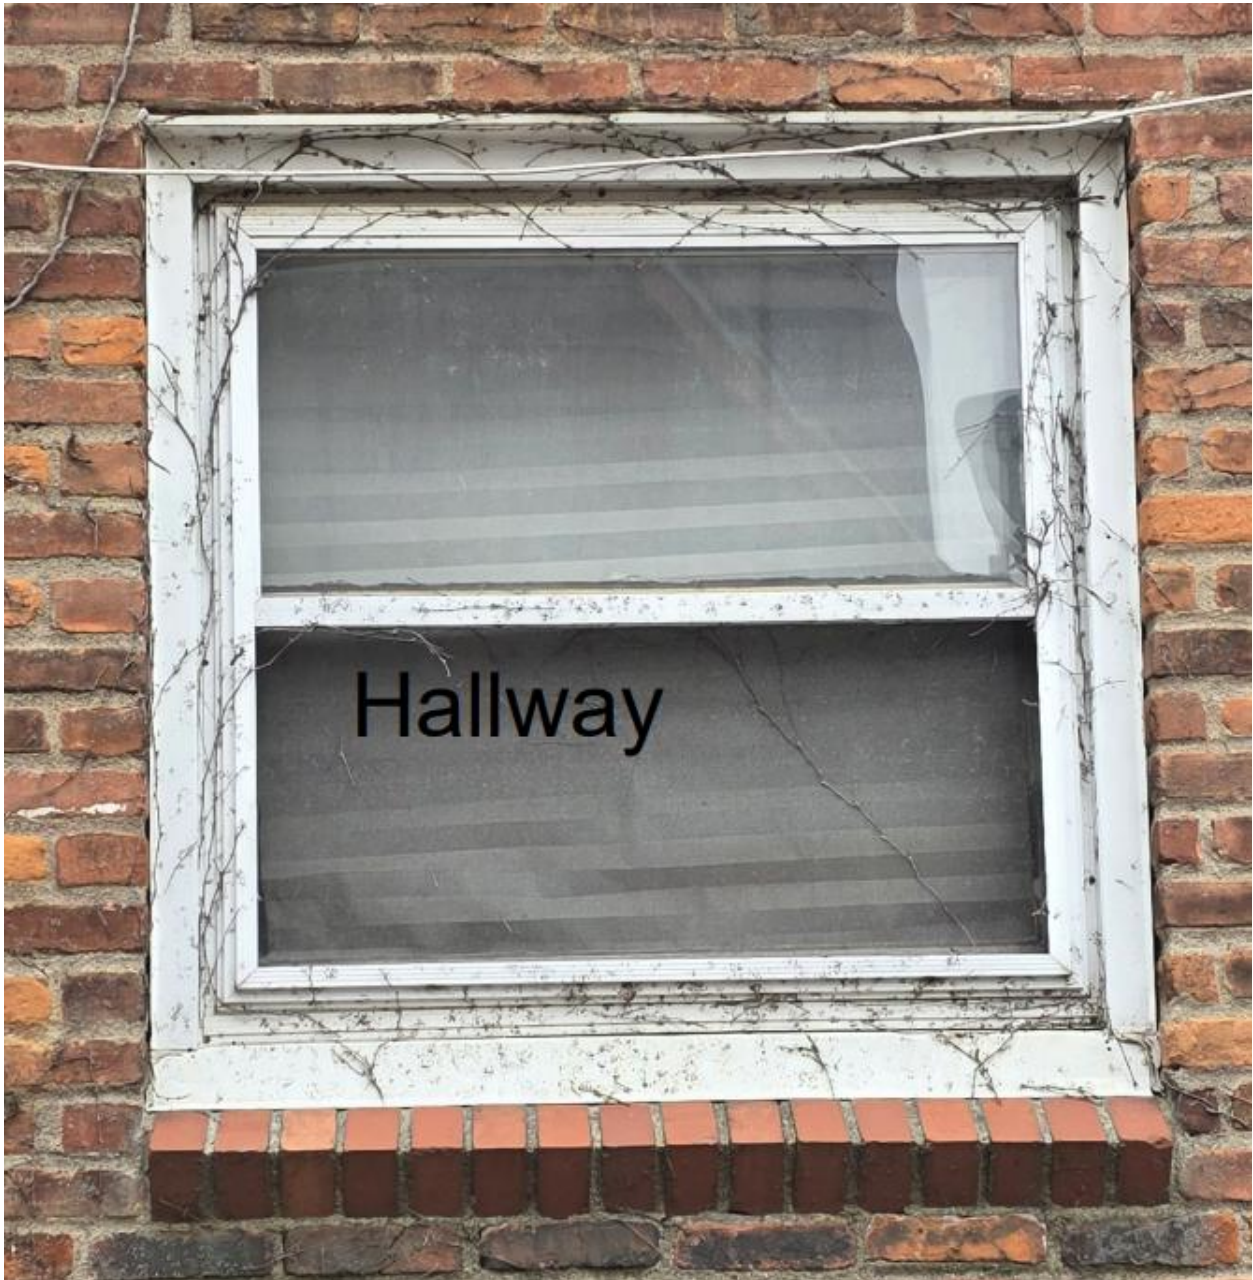
*The applicant identifies this window as “Hallway,” but according to the floor plan, “Hallway” would be staff's Window 15, but this does not have muntins. Because of the window's proportions and the white line above, staff believes this to be the kitchen window, staff's **Window 16**.*

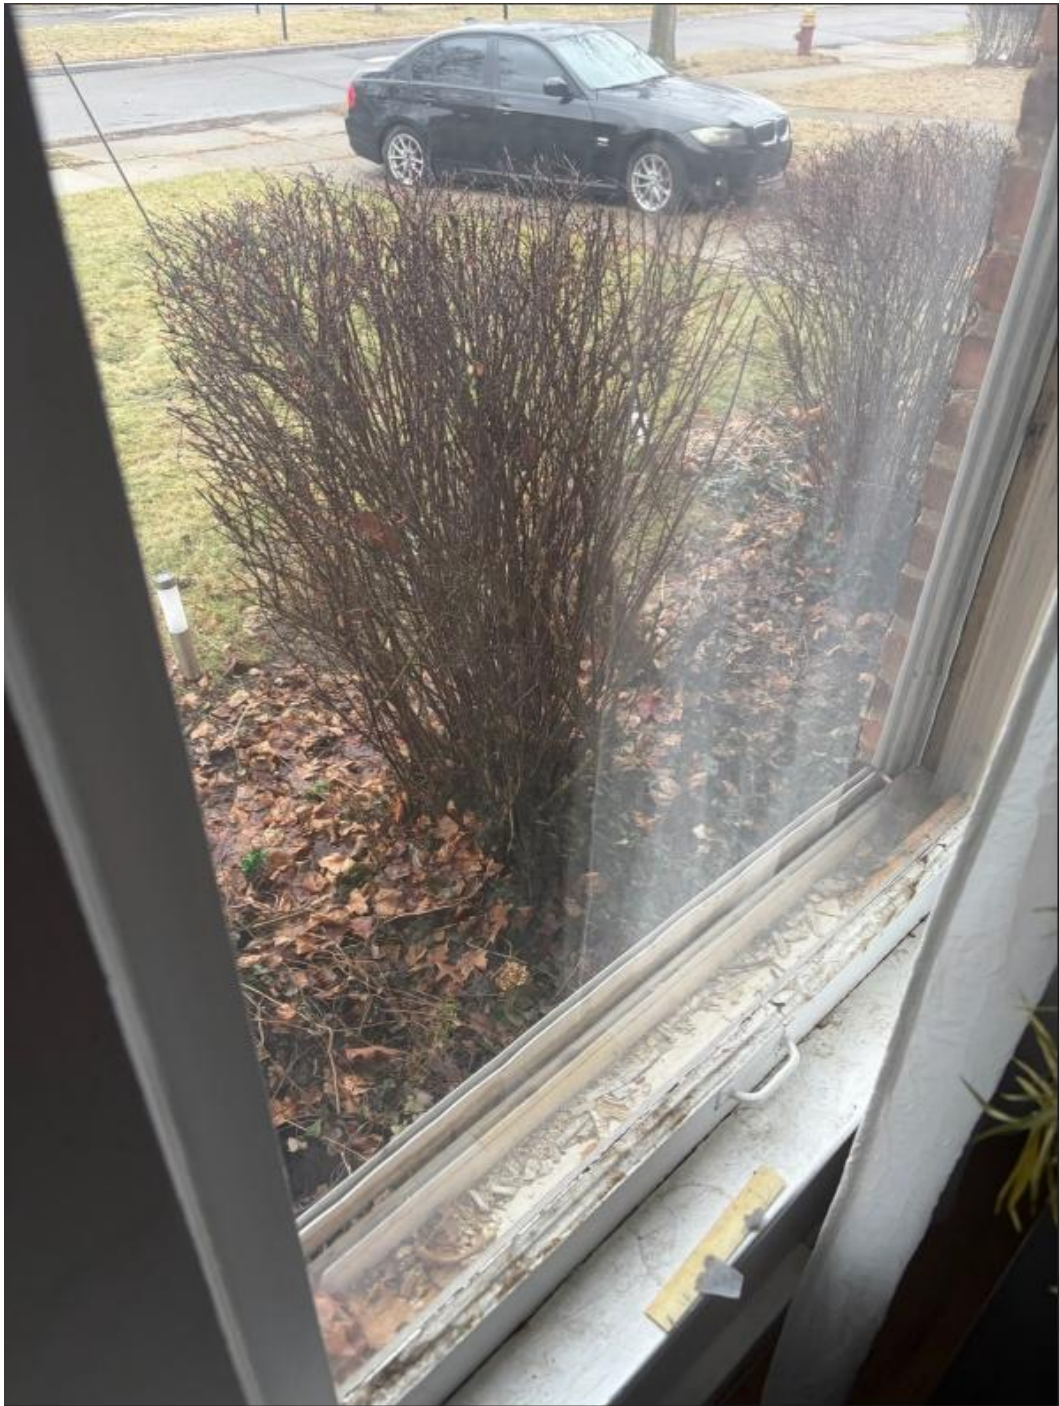
*Based on the location of the bushes, this appears to staff to be **Window 5**, one of the cottage-style windows. Some paint deterioration and paint flakes can be seen between the window and the storm window.*

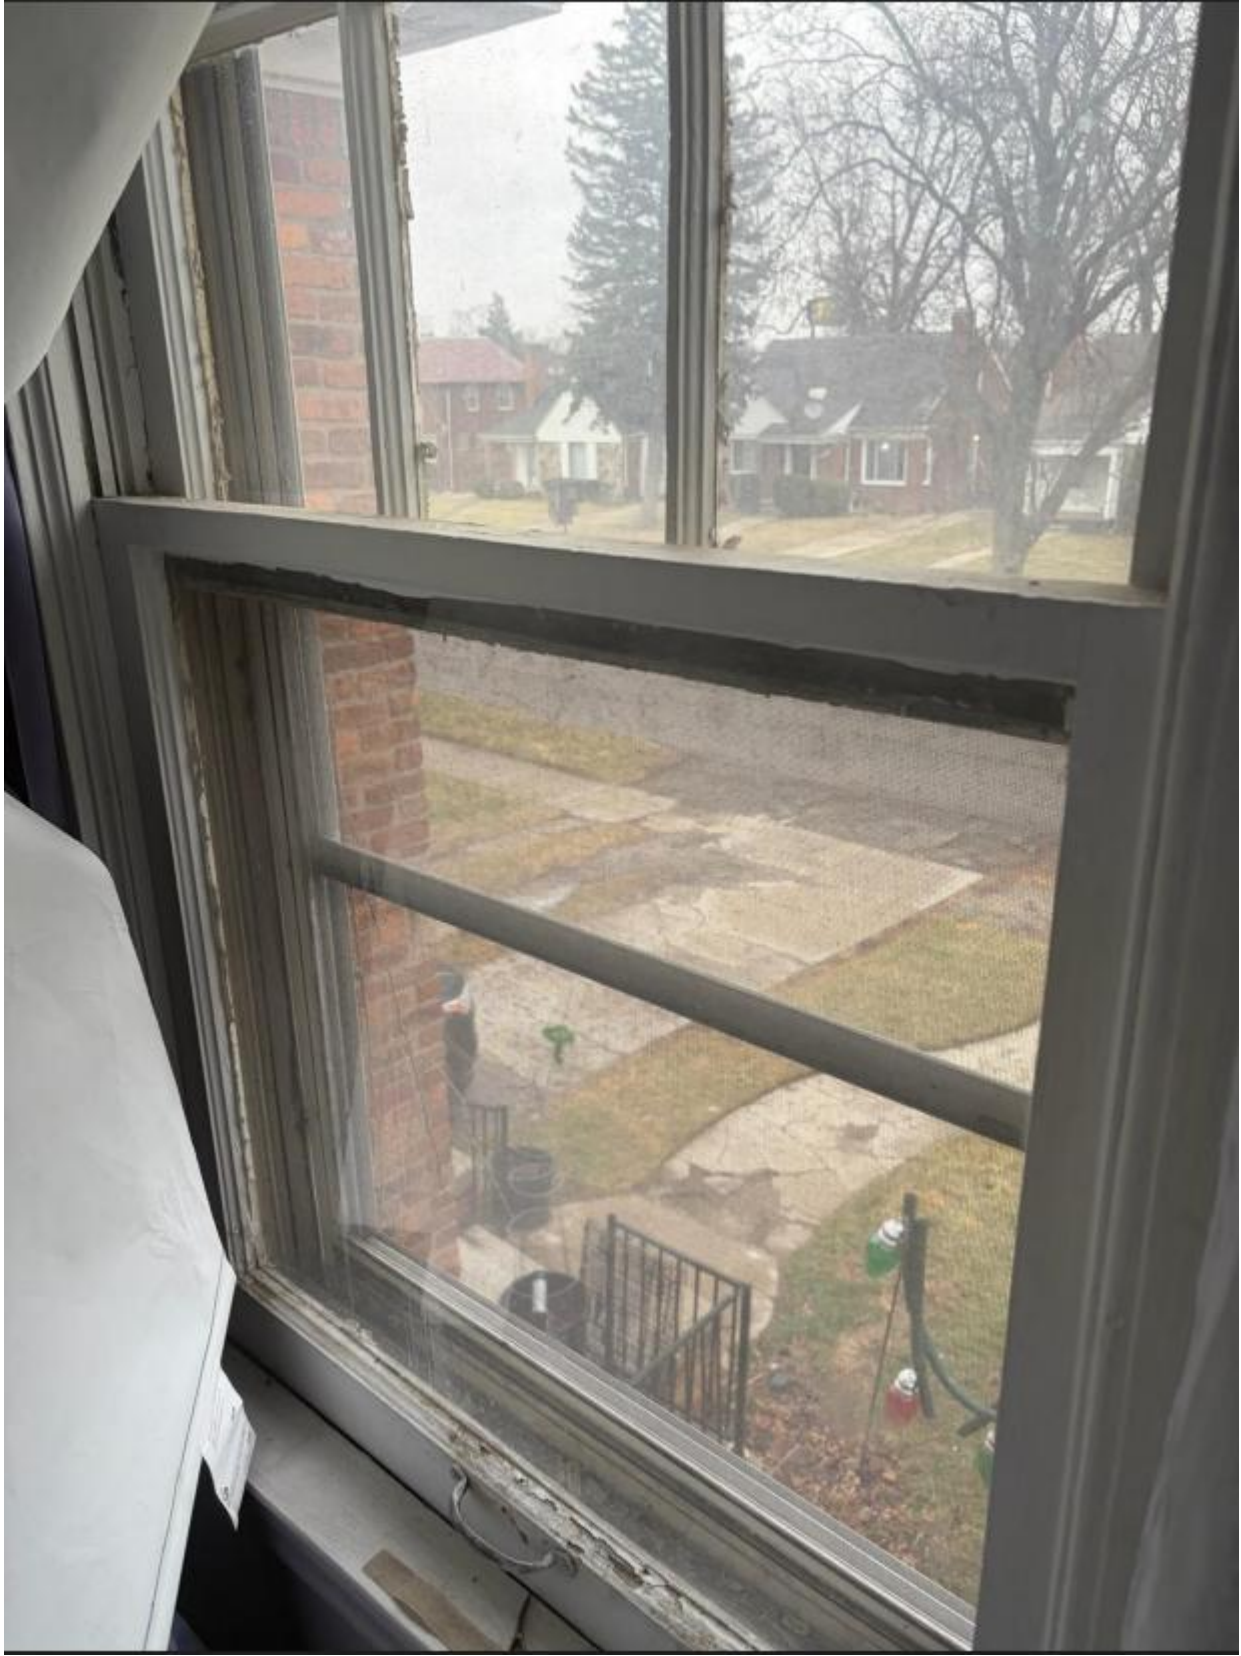
*This window appears to staff to be **Window 2**, interior. Some paint deterioration can be seen.*
