Terry Swafford Inc
716 Marlborough Street
Detroit, MI 48215
773-655-2951
terryswafford@gmail.com
www.swaffordbuildingworkshop.com

3333 Cambridge Estimate, 7/31/20:

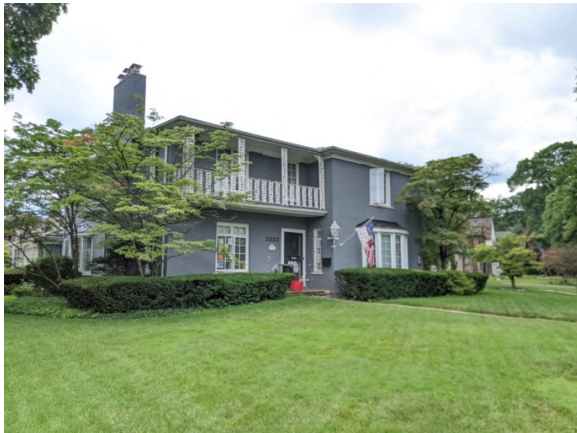
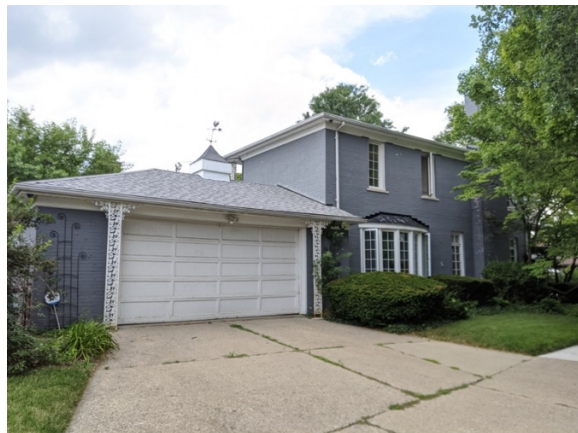
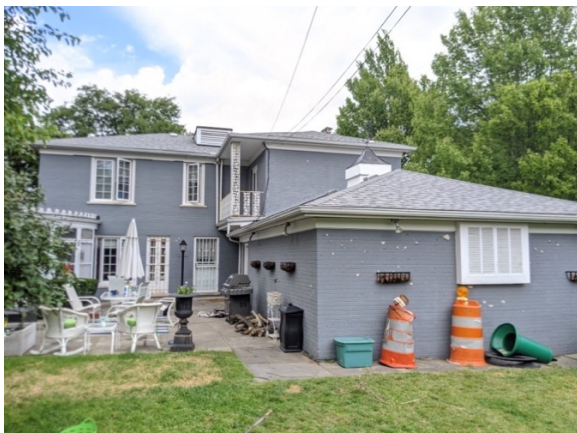
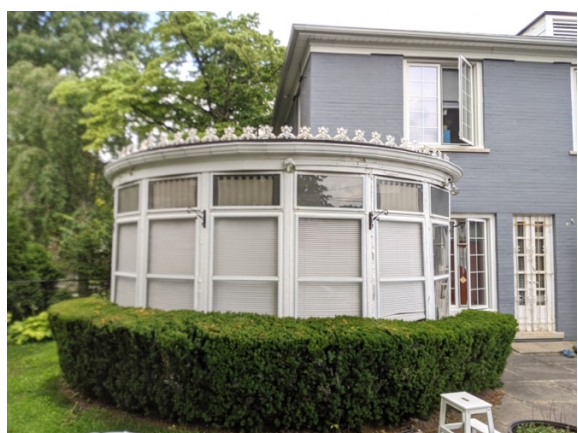
This house has an existing sun porch room that is attached to the back, NW corner. The condition is extensive rot and deterioration. The vinyl windows, painted plywood paneling, common pine trim, aluminum K style gutters, multiple outlets, and linoleum flooring were retrofitted during a previous remodel. The design and installation of these elements allows water to infiltrate from the behind the gutters, around the windows, through the paneling joints, and actually traps any water that gets in at the bottom.

The homeowners wish to restore this structure to its original intention as a screened porch. As so many remodeling projects turn out, this room doesn't function as an interior space and is an eye sore.

The original framework is made up of slab to ceiling posts, dotting the perimeter. The rotten ones will be replaced and the vertical spaces between them will be subdivided into small, then larger framed screens. The lowest sections will be cedar framed paneling.

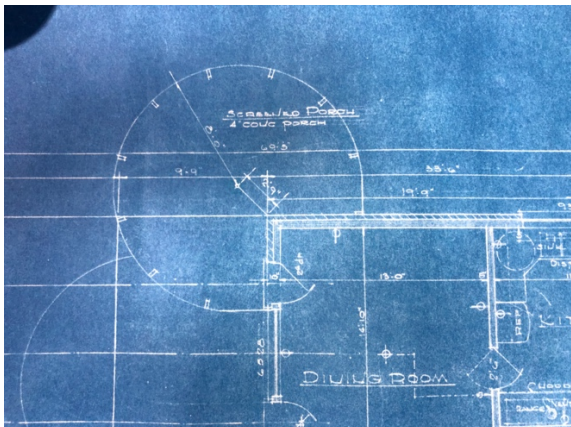
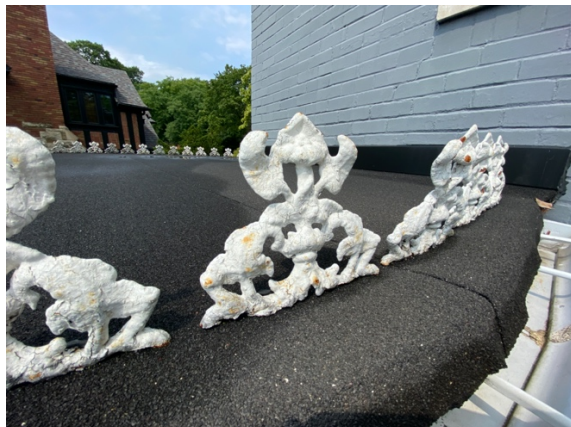
Here is the original blueprint of the house, showing the screen porch, and the roof perimeter filigree.

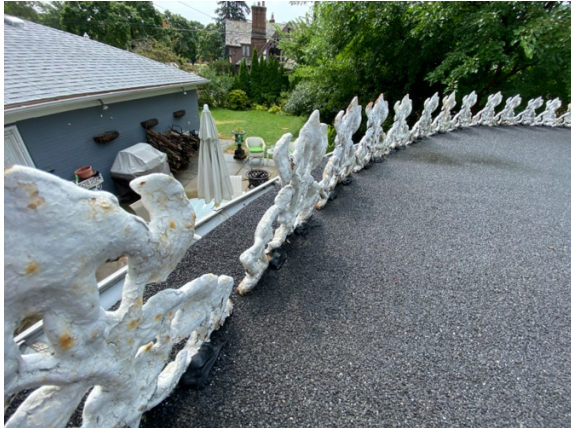
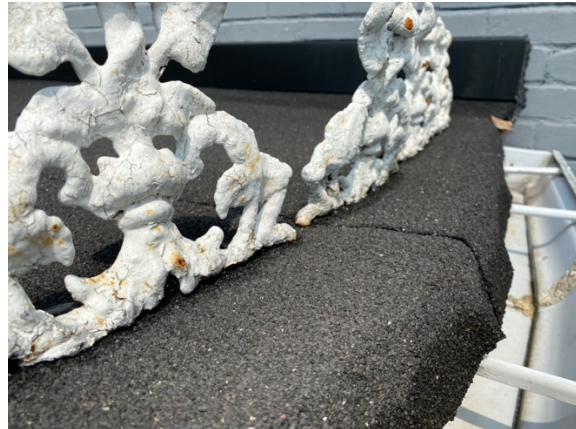
The ornamental iron work is a motif seen around the house and was installed around the roof perimeter. The roof was redone recently, and they remounted these pieces. They were mounted with surface screws, then sealed with roofing silicone. Some of the water damage below may have been tied to these and the previous failing roof. If water is present when we open things up, we can remove these, and better address their attachment points with proper sealing. They will be placed exactly where we found them.

Design, fabricate, and install white metal, extended drip edge system around upper perimeter, just under the roof edge, L + M: \$700.00
Option fabricate in copper (won't rust or need painting ever): \$950.00

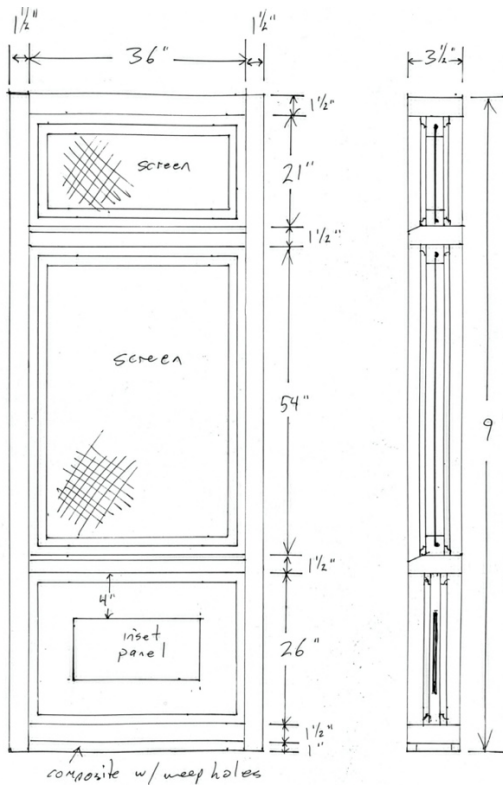
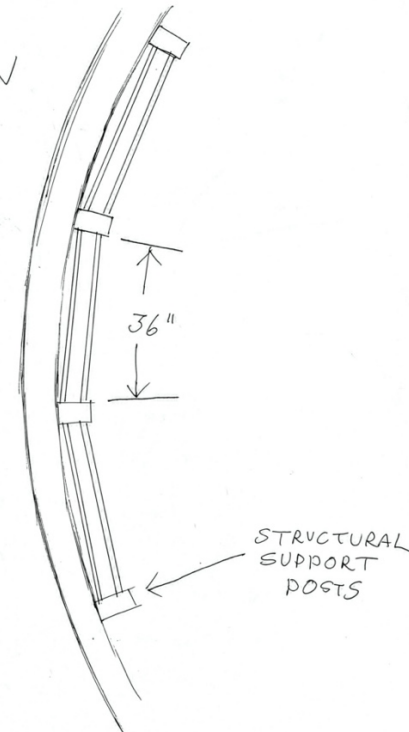
TOP VIEW
SCREEN
PORCH

These are the drawings detailing the panels and how they fit into the structure.

There are (15) open sections of 36" around the perimeter. One of these is a door. Each of the remaining (14) sections have (2) screens = (28) and (1) wooden panel = (14). There is a small screen above the door so the total for screens is (29) and (14) panels. All will be painted in the matching house white.
