687, 689, 691 W. ALEXANDRINE

REHABILITATION AND NEW CONSTRUCTION

THE CITY OF DETROIT HISTORIC
DISTRICT COMMISSION HEARING

DECEMBER 9, 2020

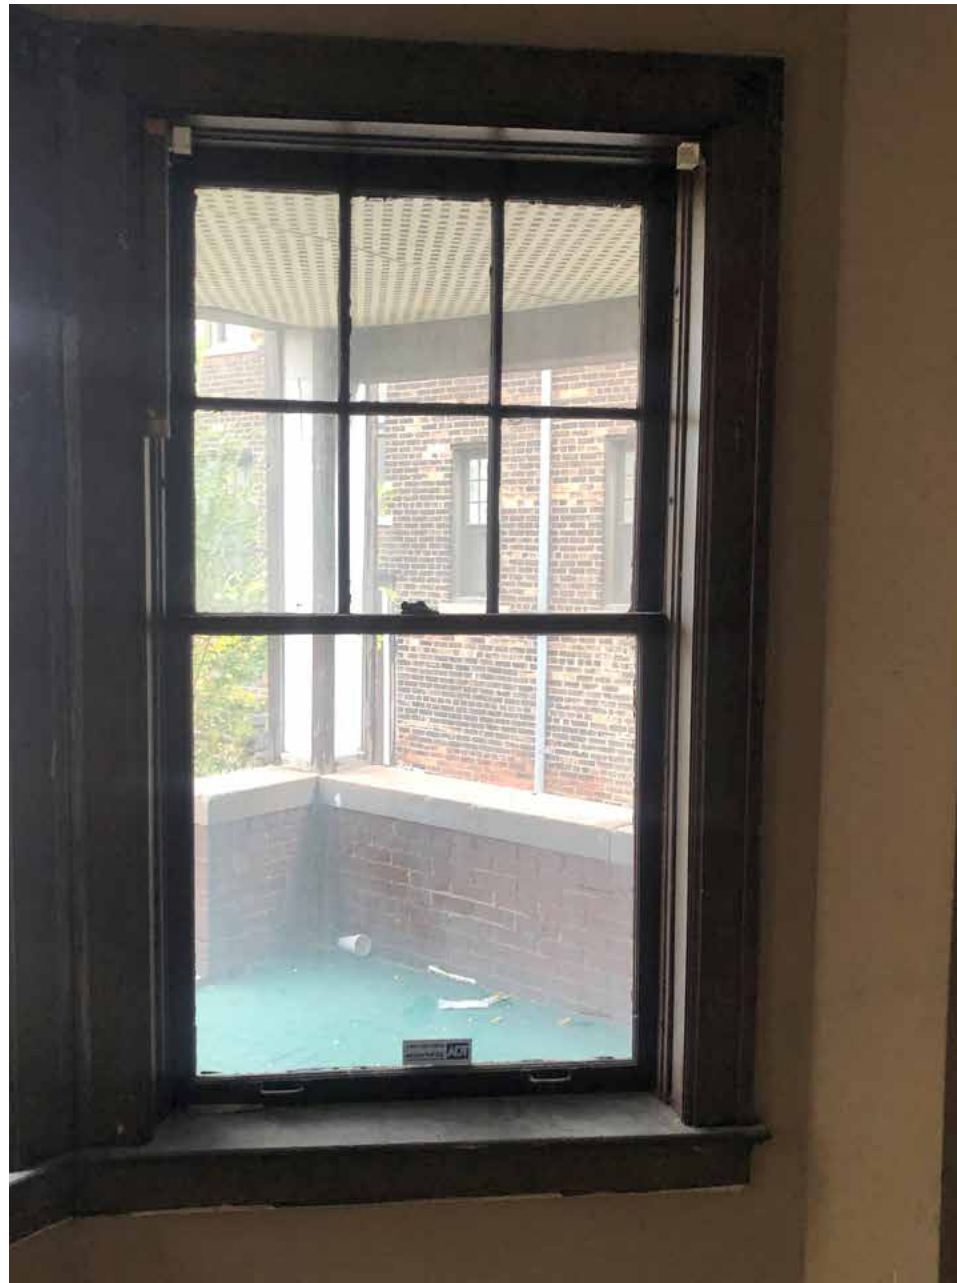
F-1

- WINDOW IS SEALED SHOUT
- EXTERIOR WINDOWSILL HAS SOME ROT
- ONE OF THE LEAD WEIGHTS IS MISSING
- WINDOW IS COCKED IN OPENING
- WINDOW WILL NOT LOCK
- WINDOW NEEDS TO BE RE-PUTTED
- WEATHER STRIPPING MISSING

We have inspected the windows at the property known as 687 / 689 Alexandrine, in Detroit Michigan. We have determined that the windows are beyond repair and should be replaced. They have several issues including rotten wood, missing wood, windows that have been replaced with noncompliant or nonhistorical windows, missing sashes, cracked and/or missing glass, poor insulating value (single pane) and damaged hardware that cannot be replaced. I have provided a detail report with photos for your review. Please see attached

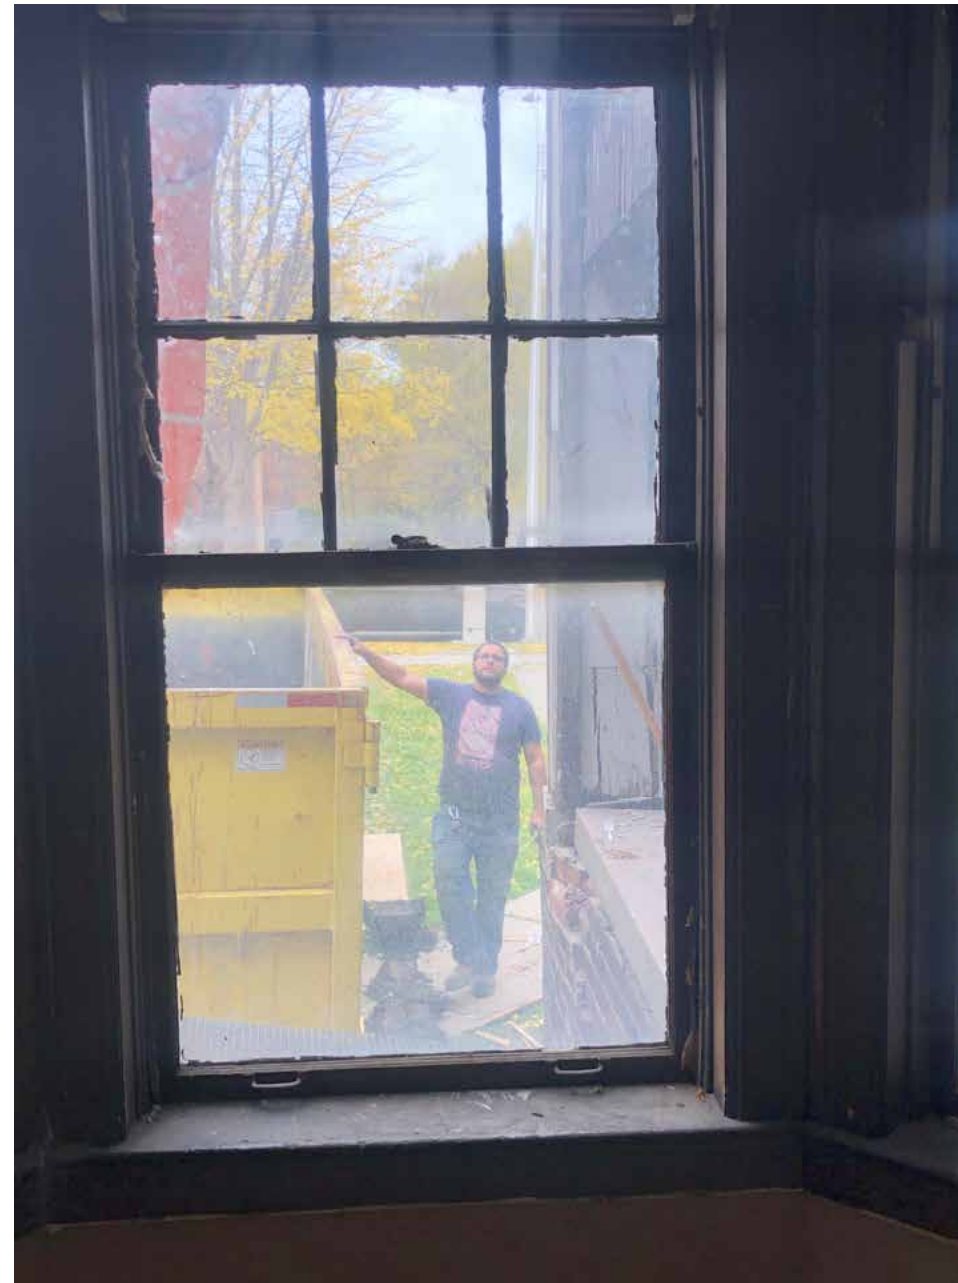
F-2

- WINDOW OPENS BUT THE LEAD COUNTERWEIGHTS ARE MISSING
- INTERIOR SILL IS ROTTEN
- ONE STOP IS MISSING, AND THE OTHER STOP IS MISSING ALL BUT ONE OF THE SCREWS
- WINDOW NEEDS TO BE RE-PUTTED
- WEATHER STRIPPING MISSING
- JAMB ON RIGHT SIDE HAS ROT

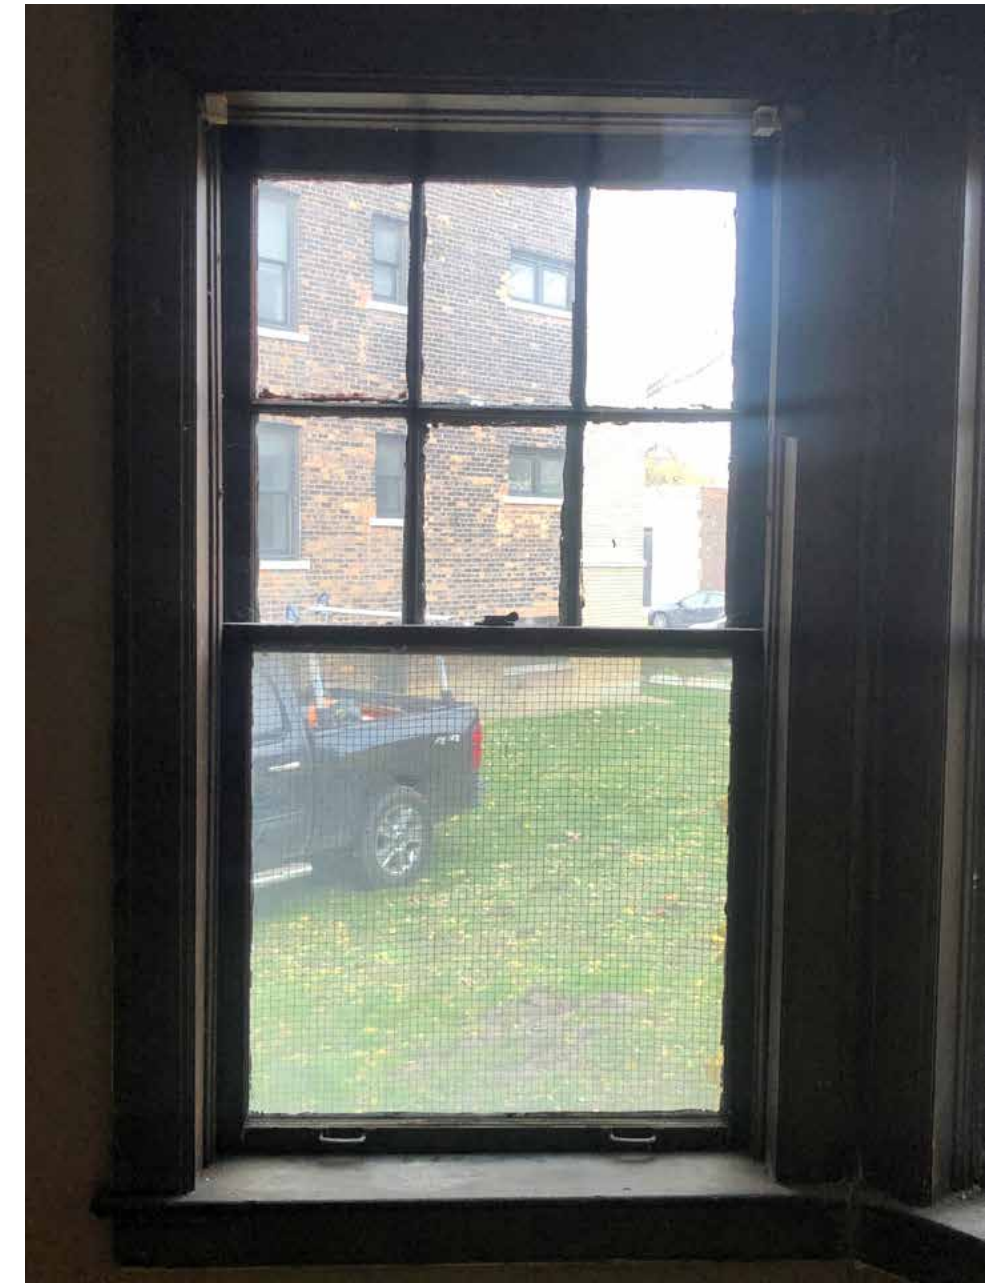
F-3

- WINDOW IS SEALED SHOUT
- EXTERIOR WINDOWSILL AND JAMB HAVE SOME ROT
- GLASS IS BROKEN IN BOTTOM SASH
- BOTH LEAD WEIGHTS ARE MISSING
- BOTTOM SASH HAS ROT RIGHT SIDE
- TRIM AT BOTTOM OF WINDOW HAS ROT
- WEATHER STRIPPING MISSING
- WINDOW NEEDS TO BE RE-PUTTED

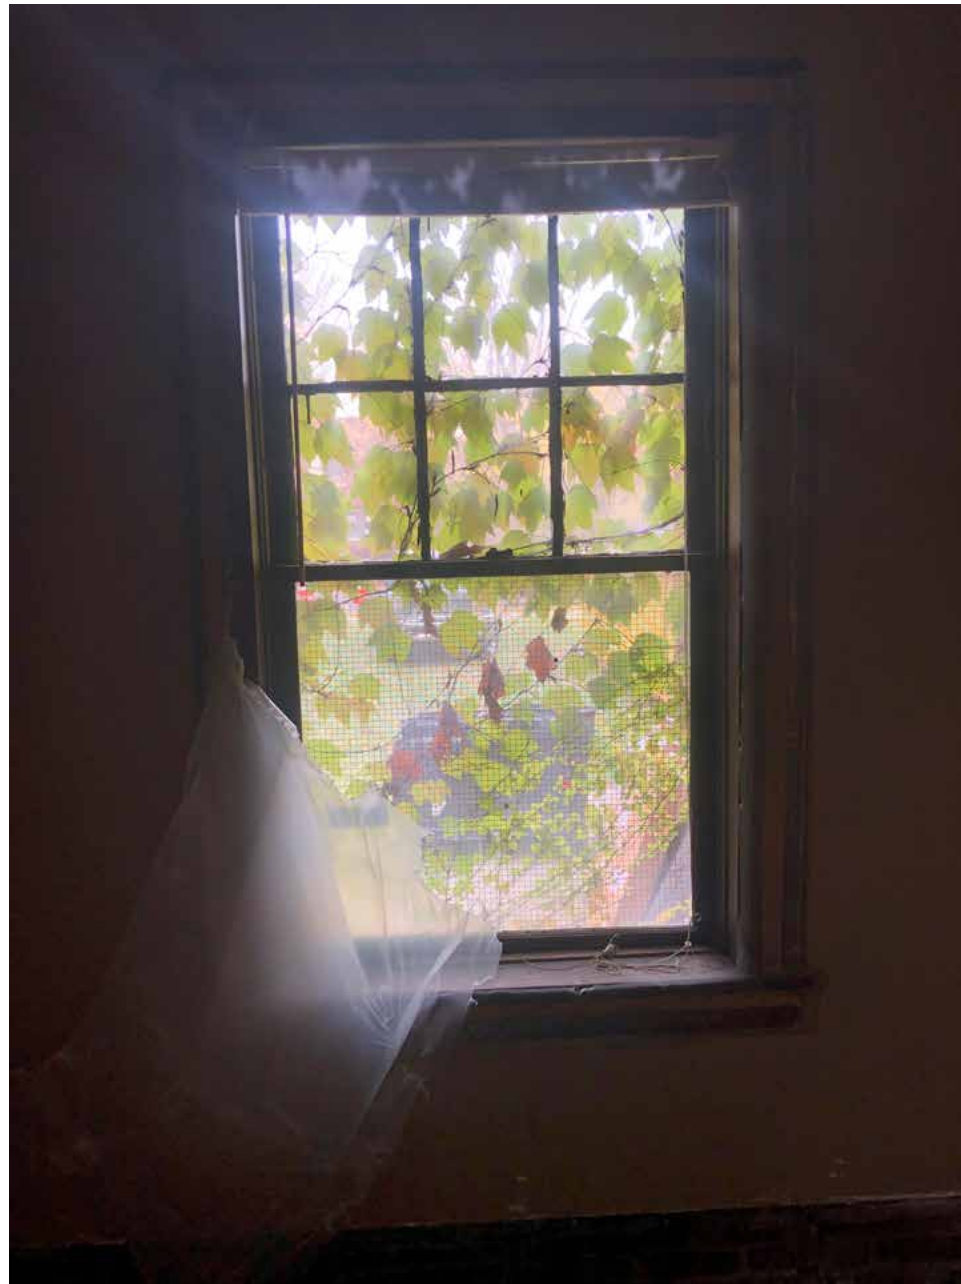
F-4

- WINDOW WILL NOT OPEN
- MISSING HANDLES
- BOTH OF THE LEAD WEIGHTS ARE MISSING
- UPPER SASH HAS EXTENSIVE ROT ON BOTTOM
- WINDOW INTERIOR SILL HAD SOME REPLACEMENT
- EXTERIOR BRICKMOLD EXTENSIVE ROT ON BOTTOM
- EXTERIOR SILL HAS EXTENSIVE ROT
- WEATHER STRIPPING MISSING
- WINDOW NEEDS TO BE RE-PUTTED
- WINDOW WILL NOT LOCK

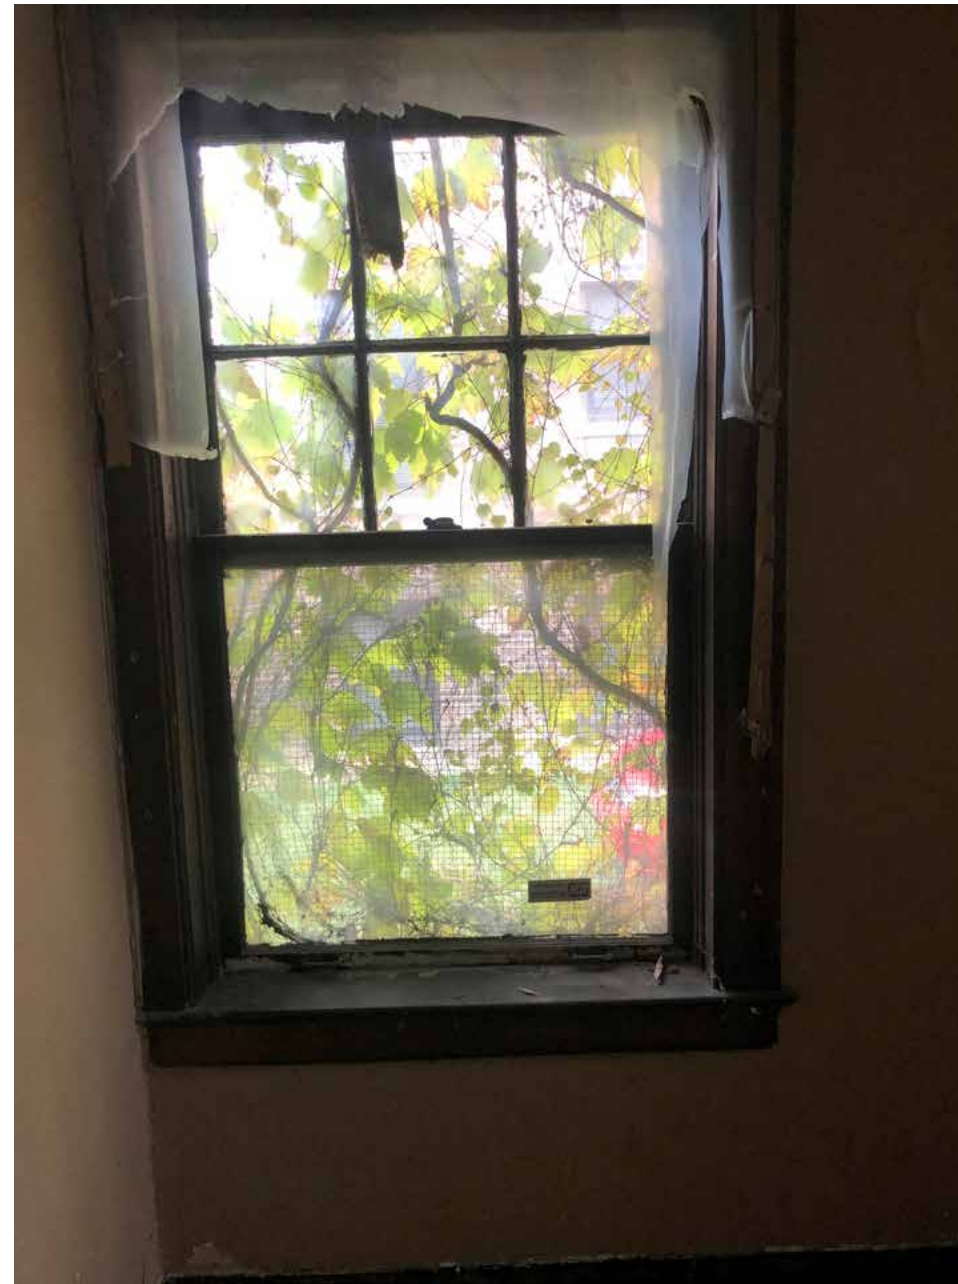
F-5

- UPPER SASH HAS FALLEN AND WILL NOT MOVE. OLD NEWSPAPER HAS BEEN STUFFED IN GAP
- WINDOW NEEDS TO BE RE-PUTTED
- BOTH LEAD WEIGHTS ARE MISSING
- INTERIOR SILL IS ROTTEN
- BOTTOM SASH HAS EXTENSIVE ROT
- STOPS HAVE ROT
- EXTERIOR LEFT BRICKMOLD HAS EXTENSIVE ROT
- EXTERIOR SILL HAS EXTENSIVE ROT

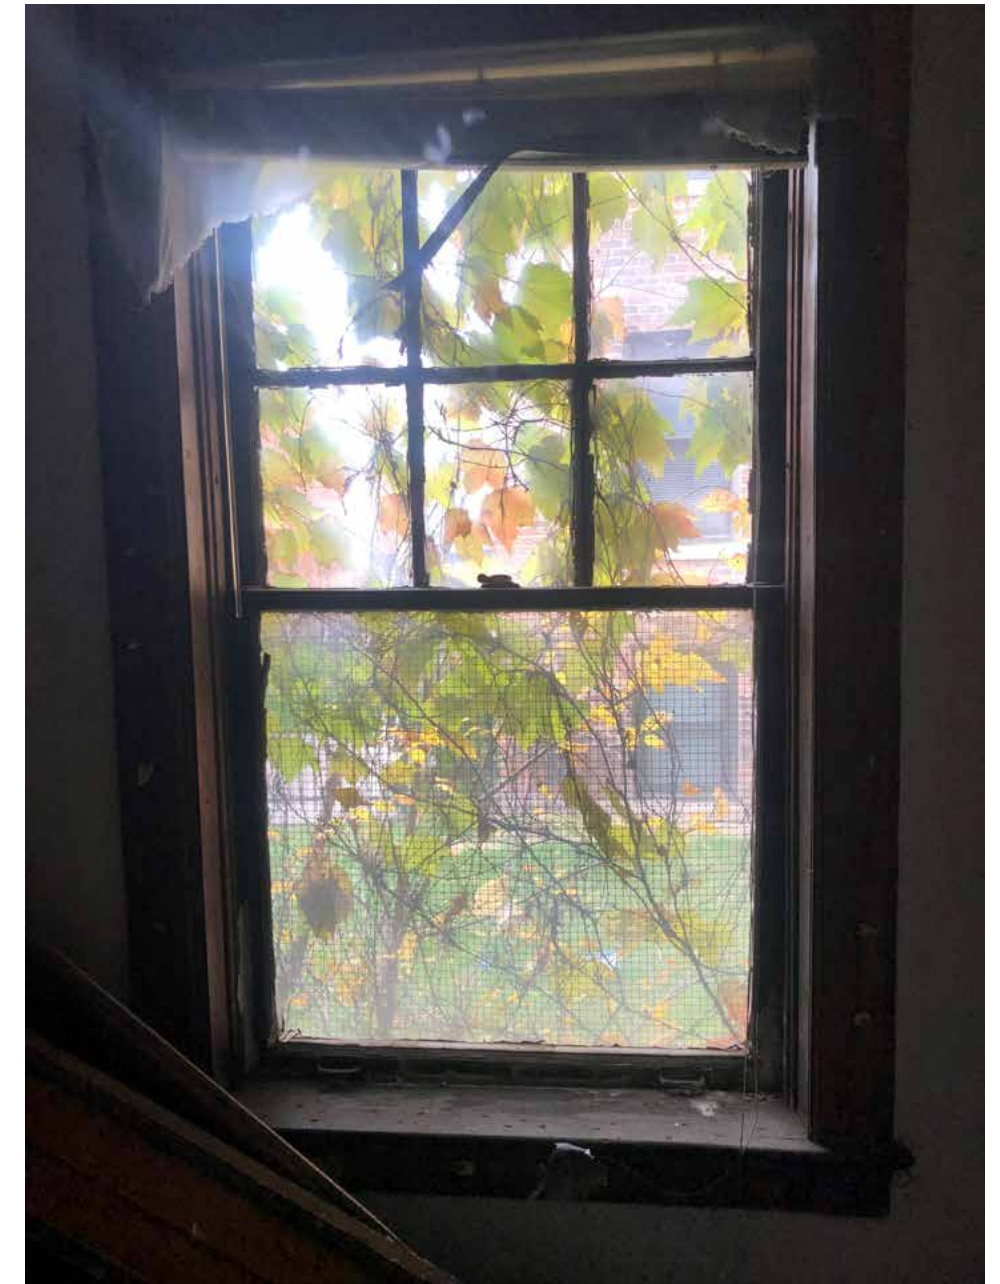
F-6

- WINDOW WILL NOT OPEN
- BOTTOM SASH HAS EXTENSIVE ROT
- WINDOW NEEDS TO BE RE-PUTTED
- BOTH LEAD WEIGHTS ARE MISSING
- INTERIOR SILL IS ROTTEN AND BROKEN
- EXTERIOR SILL HAS EXTENSIVE ROT, AND THE SASH IS PUSHED OUT
- STOPS ARE MISSING
- WEATHER STRIPPING MISSING

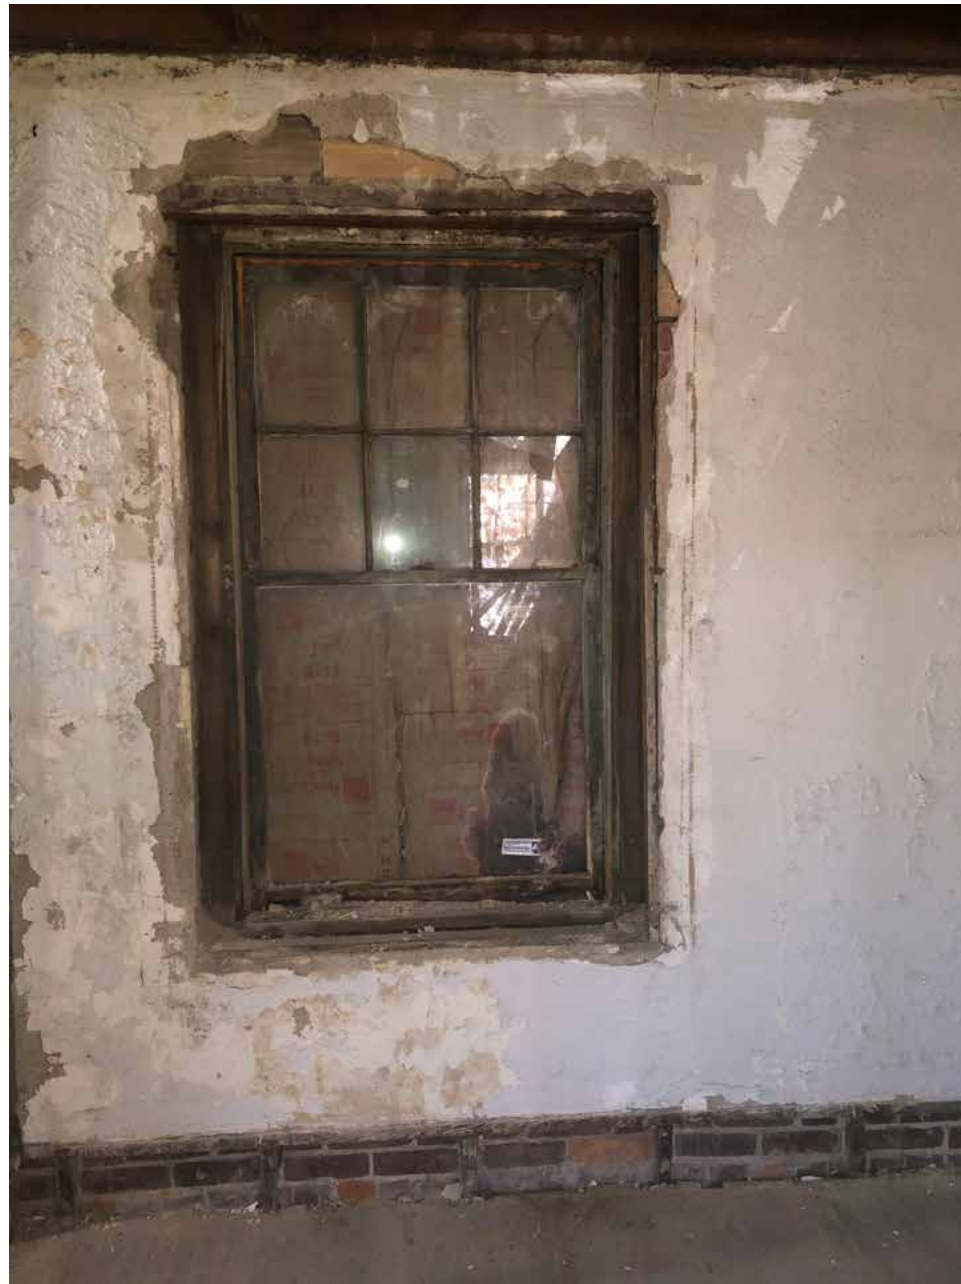
F-7

- INTERNAL SILL IS MISSING
- WINDOW WAS BOARDED UP ON THE OUTSIDE AND SEALERS WAS USE AROUND THE SASHES
- STOPS ARE BROKEN ON BOTH SIDES
- SEVER ROT ON WHAT IS LEFT OF THE JAMBS
- STOPS ARE MISSING
- UPPER SASH GLASS IS BROKEN
- LEAD WEIGHTS ARE MISSING
- TRIM IS MISSING

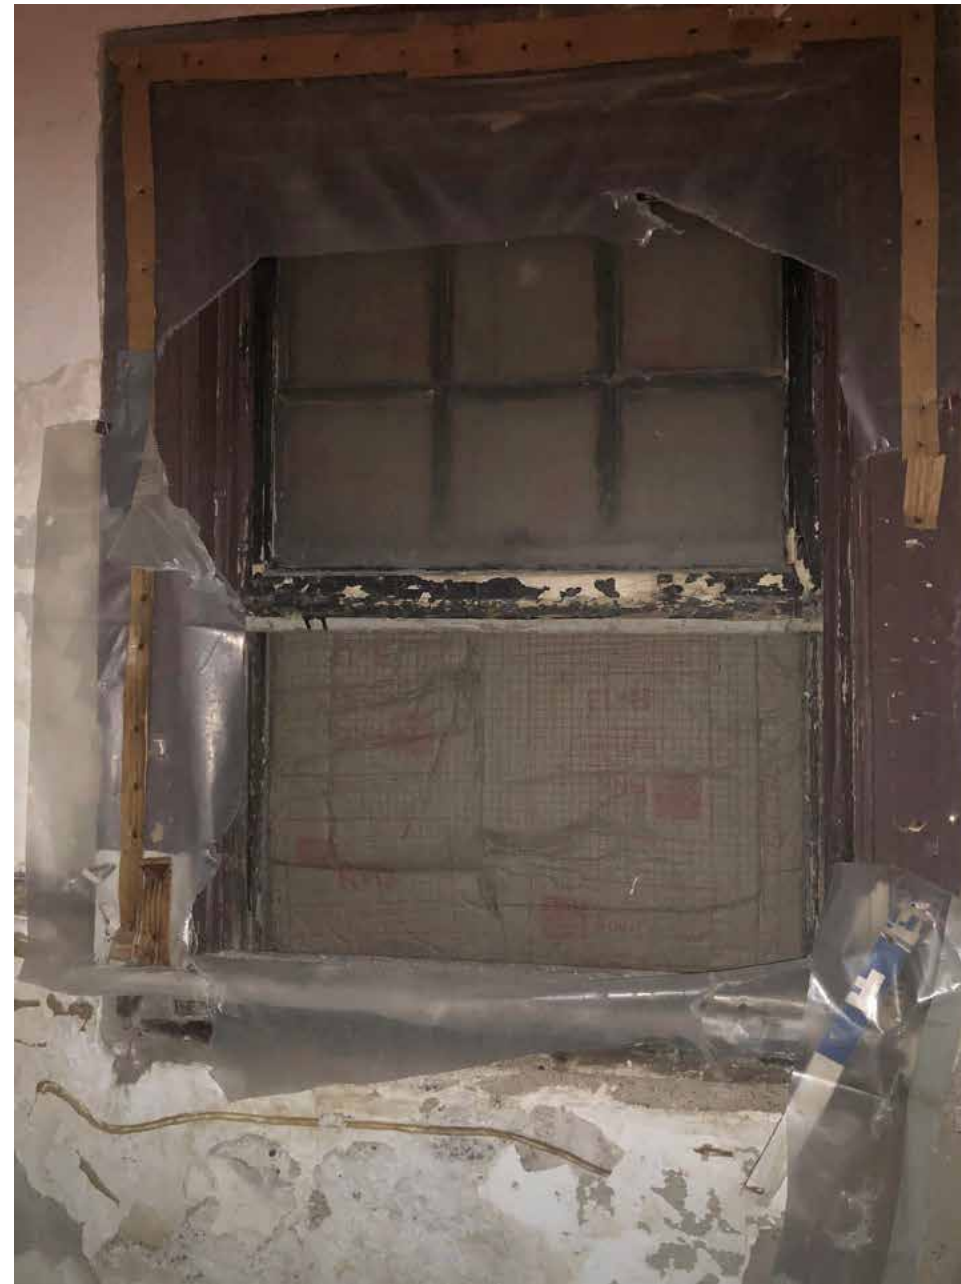
F-8

- INTERNAL SILL IS MISSING
- WINDOW WAS BOARDED UP ON THE OUTSIDE
- BOTTOM SASH MISSING
- STOPS ARE BROKEN ON BOTH SIDES
- SEVER ROT ON JAMBS

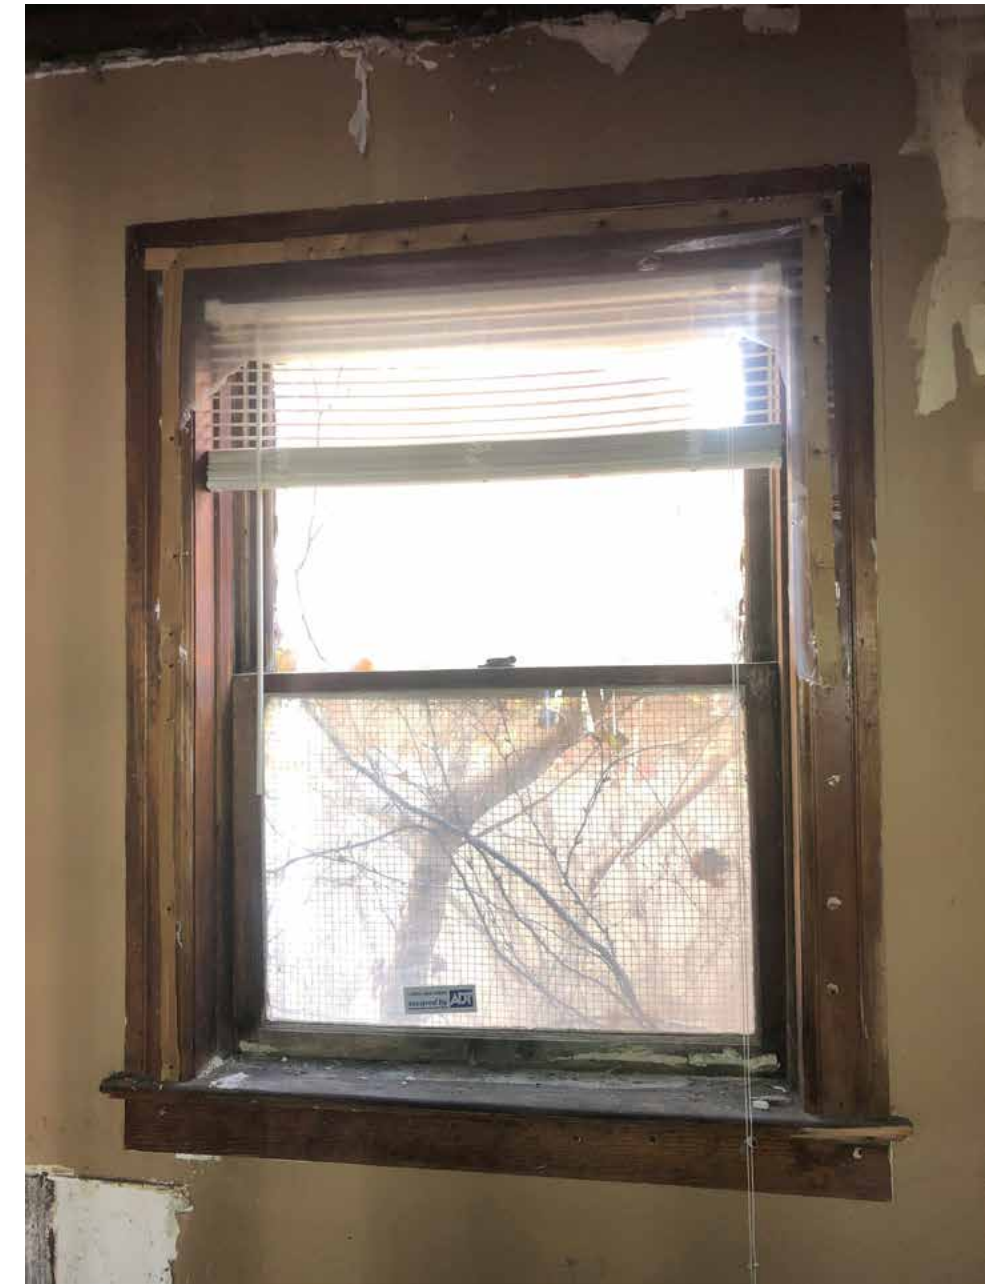
F-9

- BOTH SASHES' HAVE SEVERE ROT
- MISSING BOTH HANDLES
- WINDOW NEEDS TO BE RE-PUTTED
- BOTH LEAD WEIGHTS ARE MISSING
- WINDOW WILL NOT OPEN
- WEATHER STRIPPING MISSING
- JAMB ON RIGHT SIDE HAS WATER DAMAGE
- BRICK MOLDING ON BOTH SIDES HAVE SEVERE ROT
- EXTERIOR SILL HAS EXTENSIVE ROT
- STOPS HAVE BEEN REPLACED AND DO NOT MATCH

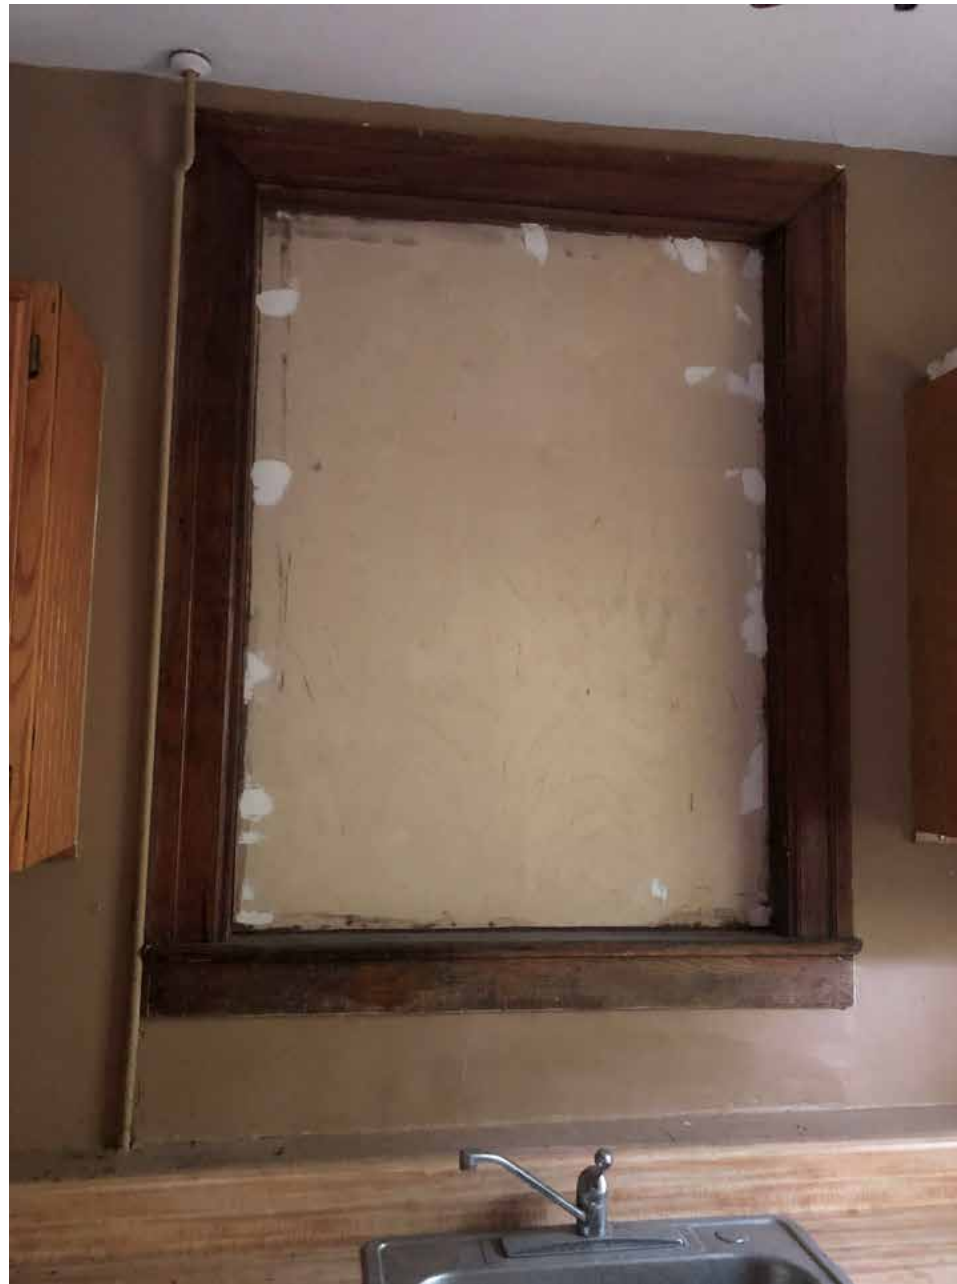
F-10

- SASHES' AND STOPE HAVE BEEN REMOVED AND THE WINDOW IS BOARDED UP INSIDE AND ON THE OUTSIDE.

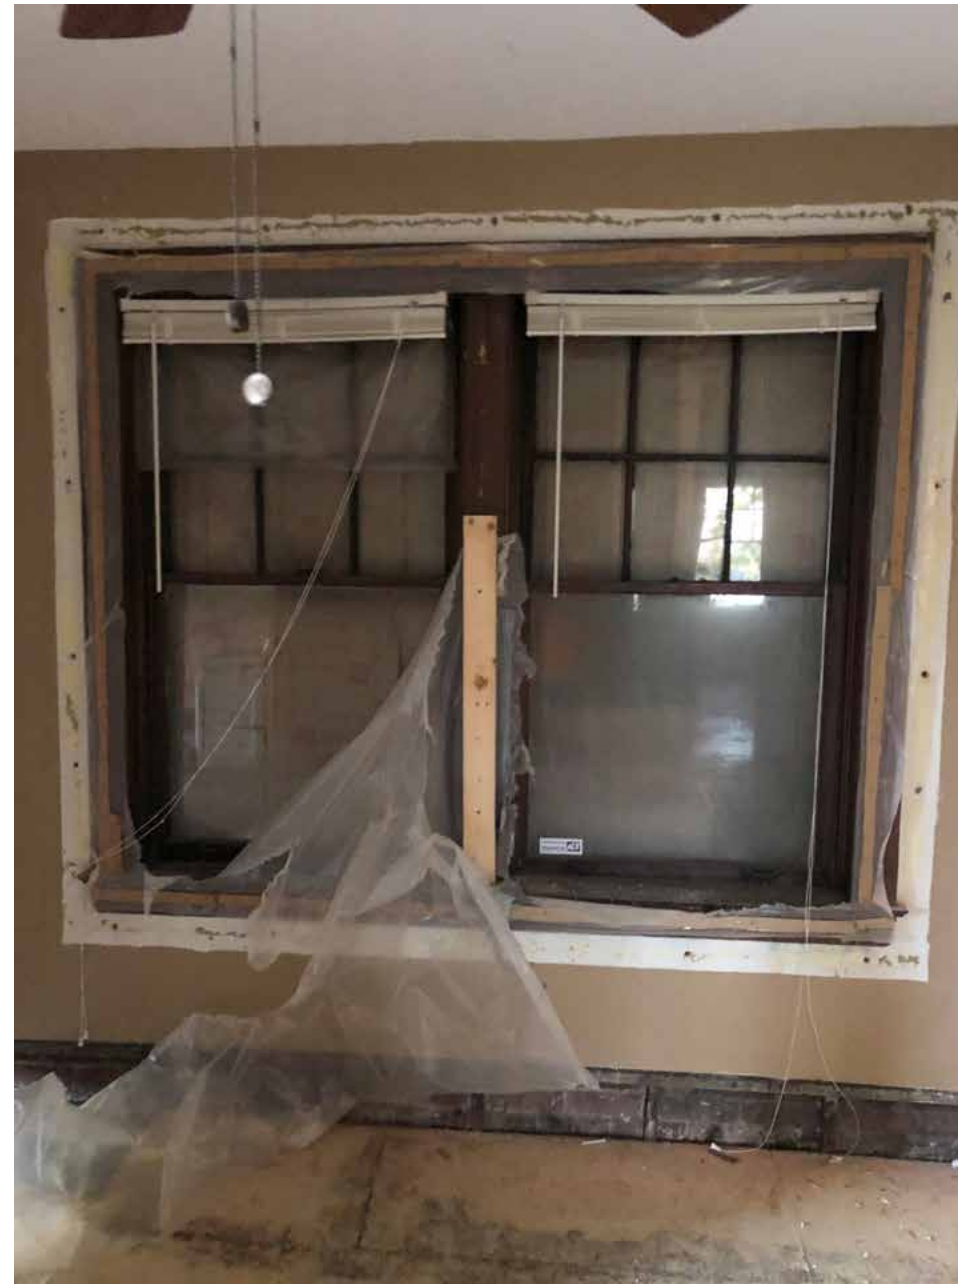
F-11 & F-12

- THE WINDOW IS BOARDED UP ON THE OUTSIDE.
- EXTERIOR SILL HAS EXTENSIVE ROT
- BOTH SASHES' HAVE SEVERE ROT
- WINDOWS NEED TO BE RE-PUTTED
- WEATHER STRIPPING MISSING
- LEAD WEIGHTS ARE MISSING IN BOTH WINDOWS

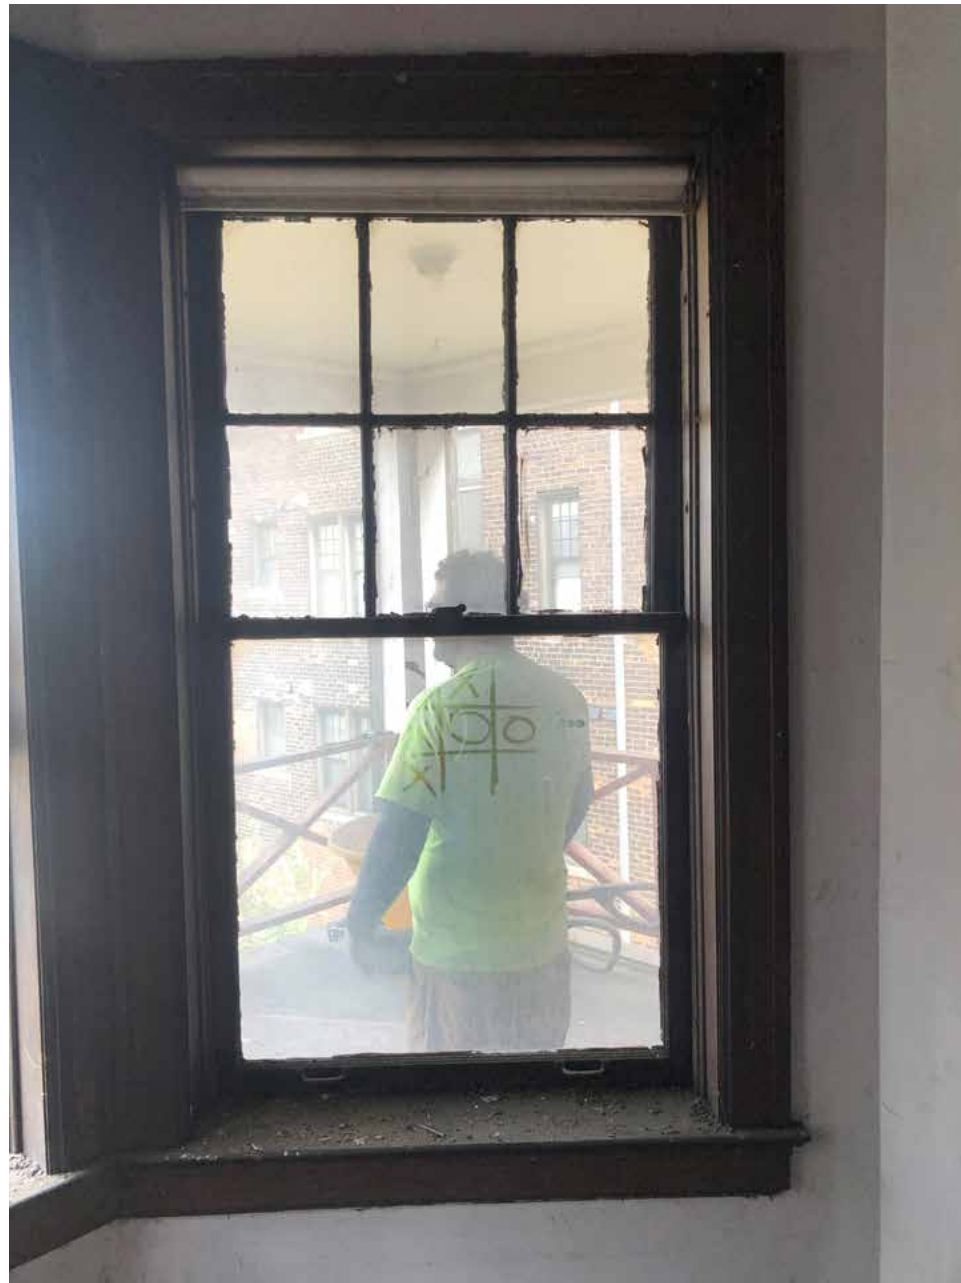
S-1

- WINDOW WILL OPEN
- EXTERIOR SILL HAS ROT
- SASHES WILL NOT LINE UP OR LOCK
- WEATHER STRIPPING MISSING
- INTERIOR SILL IS ROTTEN
- WINDOW NEEDS TO BE RE-PUTTED
- LEAD WEIGHTS ARE IN PLACE, BUT CORDS NEED REPLACING

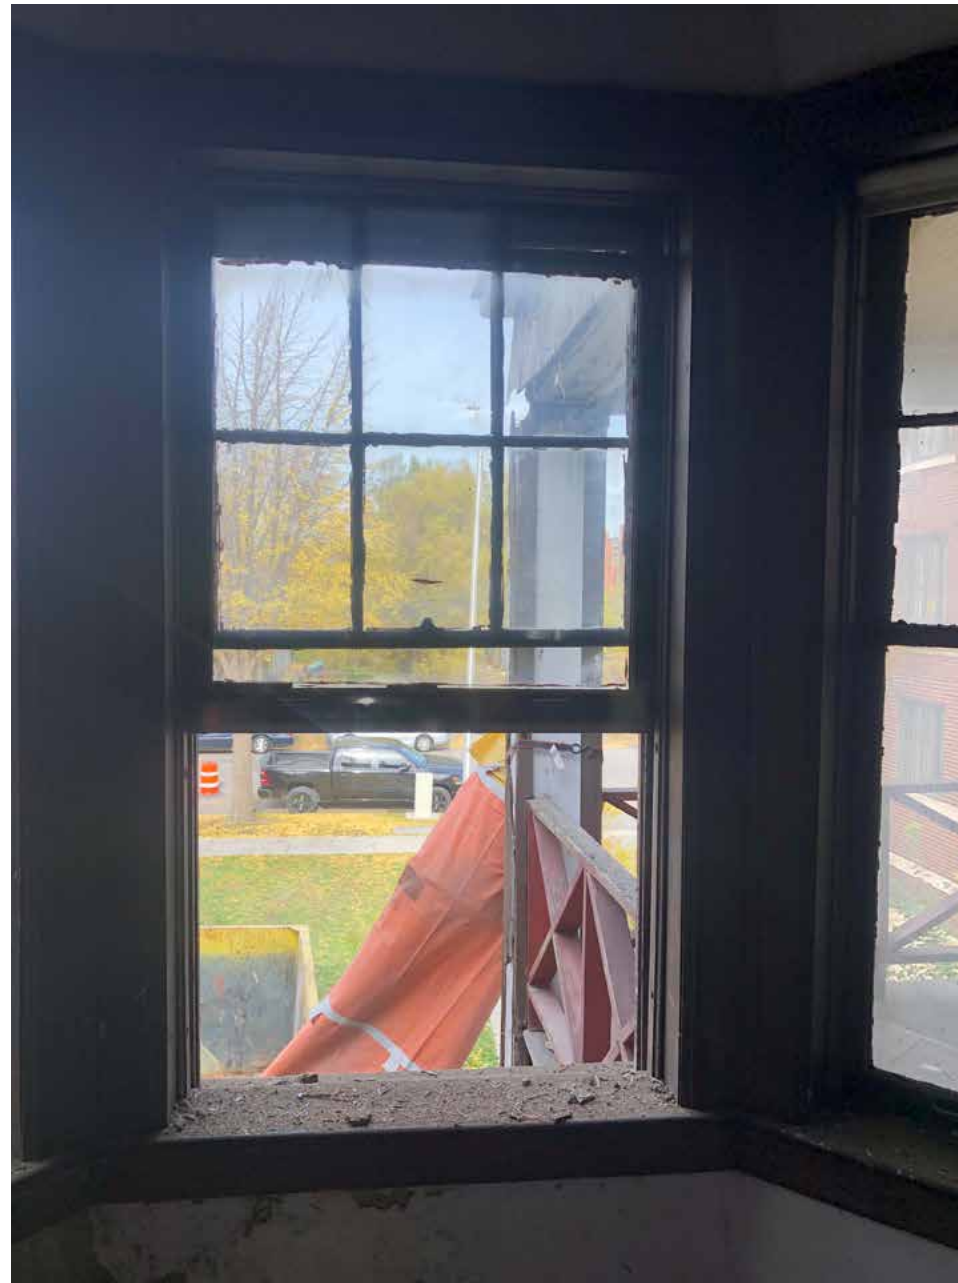
S-2

- WINDOW WILL OPEN
- LEAD WEIGHTS ARE IN PLACE, BUT CORDS NEED REPLACING
- BOTTOM SASH HAS SOME ROT
- STOPES ARE MISSING SCREWS
- SASHES WILL NOT LINE UP OR LOCK
- WEATHER STRIPPING MISSING
- WINDOW NEEDS TO BE RE-PUTTED
- INTERIOR SILL IS ROTTEN AND LOOSE
- BRICK MOLDING ON RIGHT SIDE HAVE SOME ROT

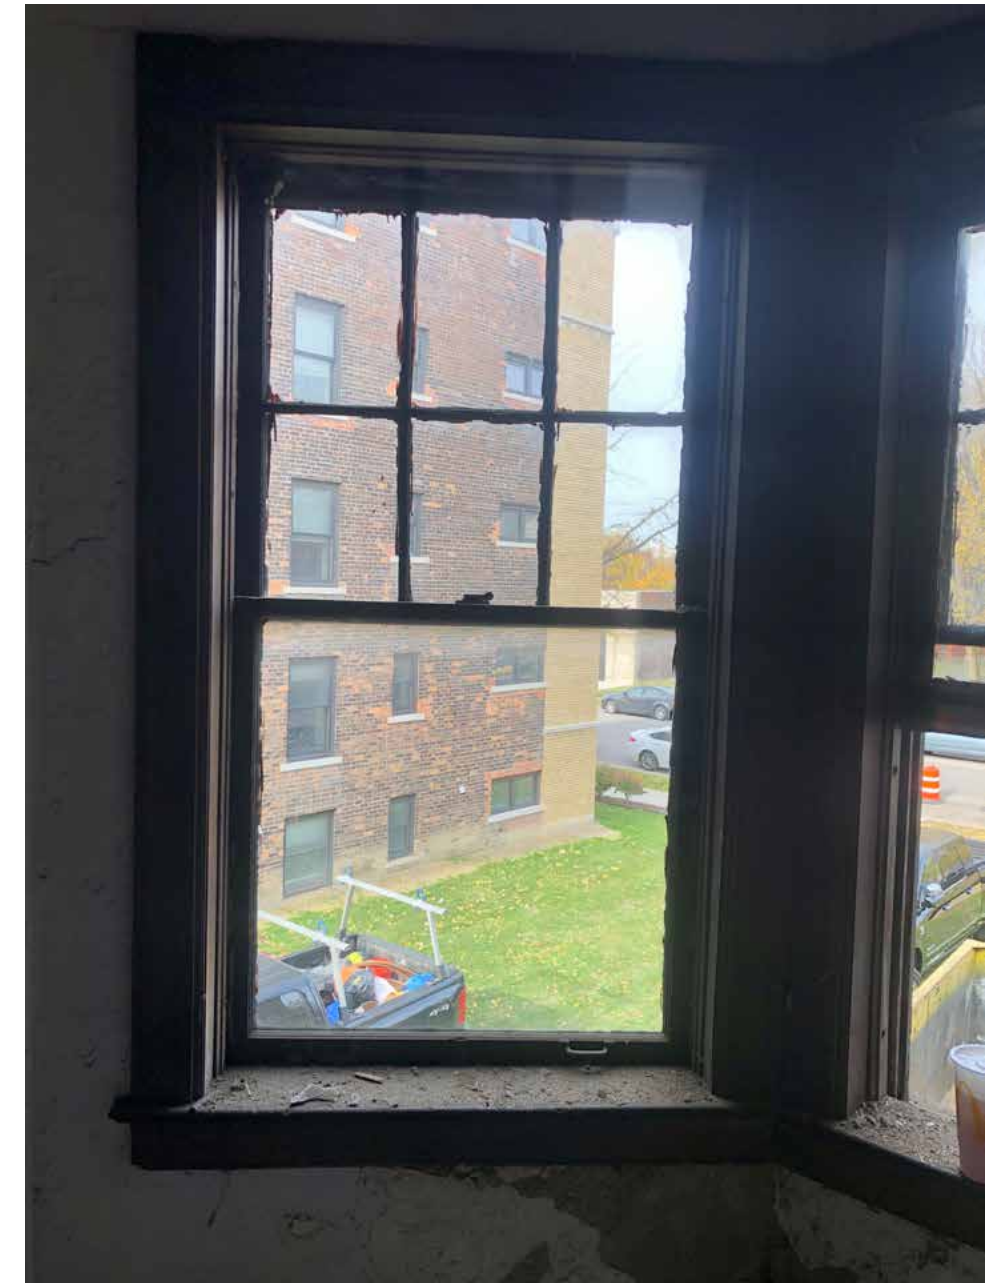
S-3

- RIGHT LEAD WEIGHT IS MISSING
- EXTERIOR SILL IS BROKEN
- BRICK MOLDING ON LEFT SIDE HAS SEVERE ROT
- WINDOW WILL ONLY OPEN HALFWAY
- MISSING ONE HANDLE
- WEATHER STRIPPING MISSING
- BOTTOM SASH HAS ROT AT BOTTOM

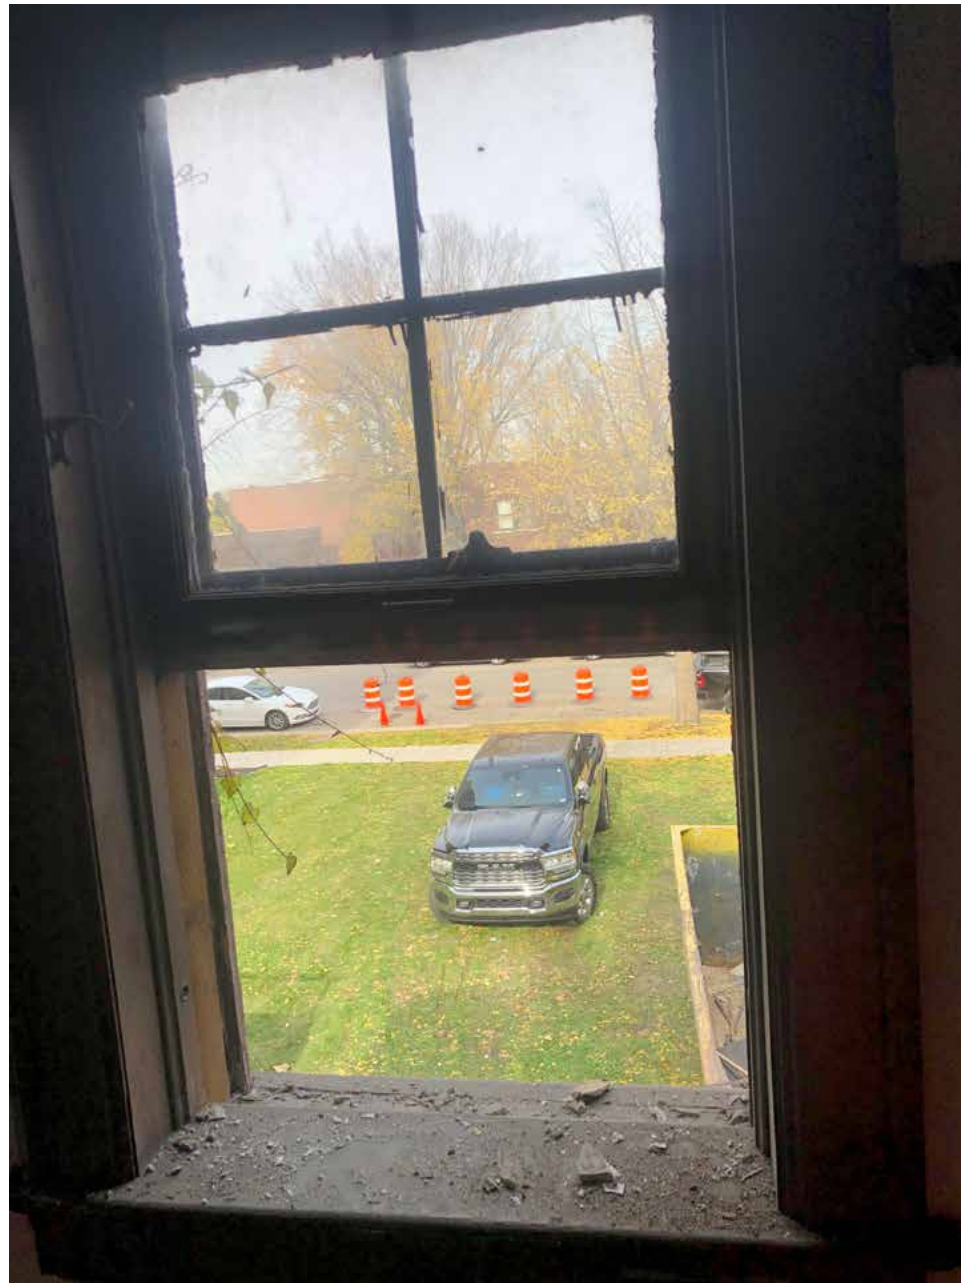
S-4

- WINDOW WILL OPEN
- LEAD WEIGHTS ARE MISSING IN BOTH SIDES
- EXTERIOR SILL IS BROKEN AND HAS ROT
- INTERIOR JAMB HAS WATER DAMAGE
- WINDOW NEEDS TO BE RE-PUTTED
- WEATHER STRIPPING MISSING

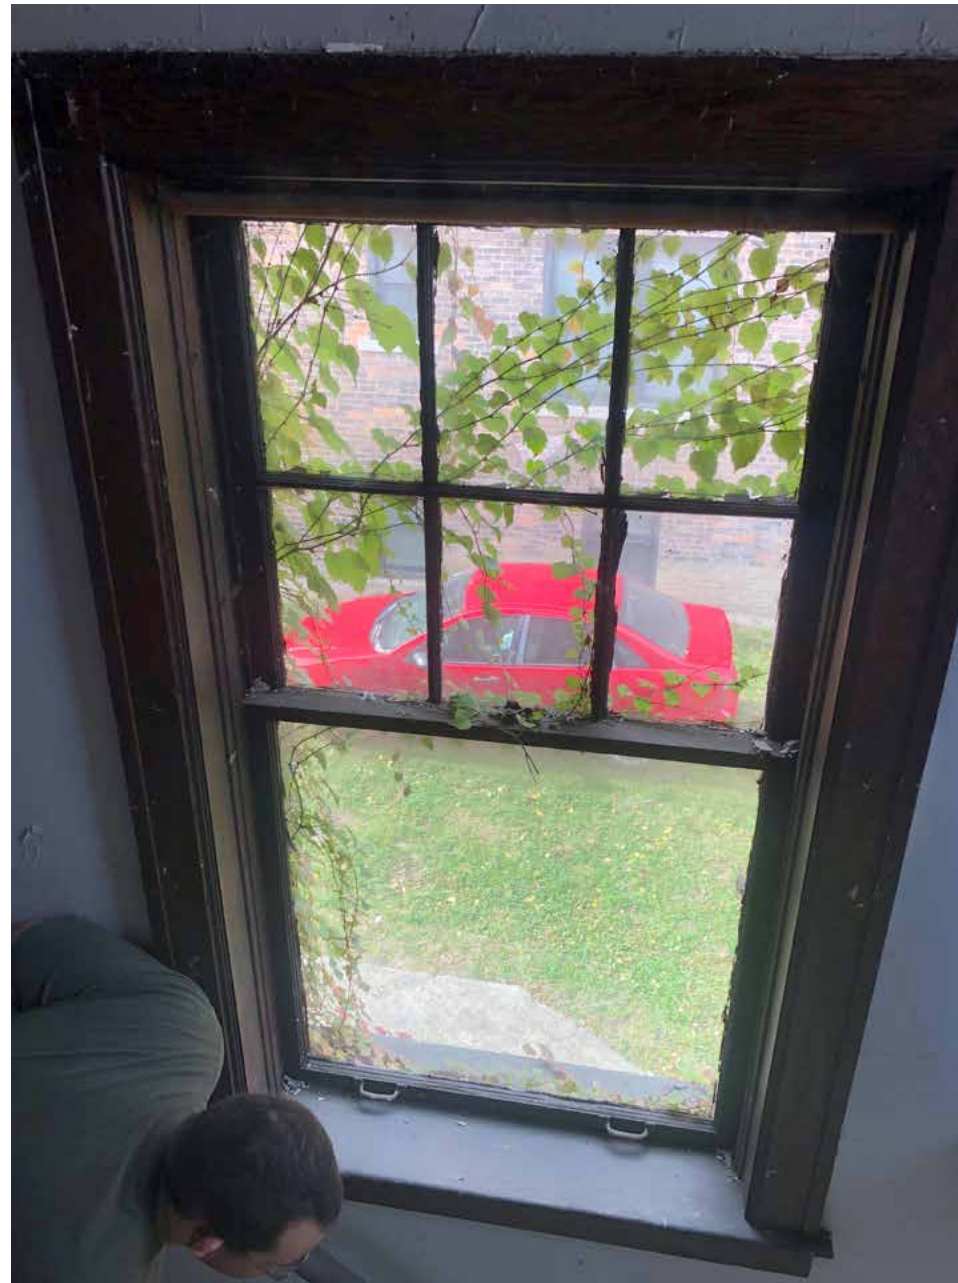
S-5

- MISSING BOTH WEIGHTS
- EXTERIOR SILL HAS EXTENSIVE ROT
- WINDOW WILL NOT OPEN
- WEATHER STRIPPING MISSING
- WINDOW NEEDS TO BE RE-PUTTED

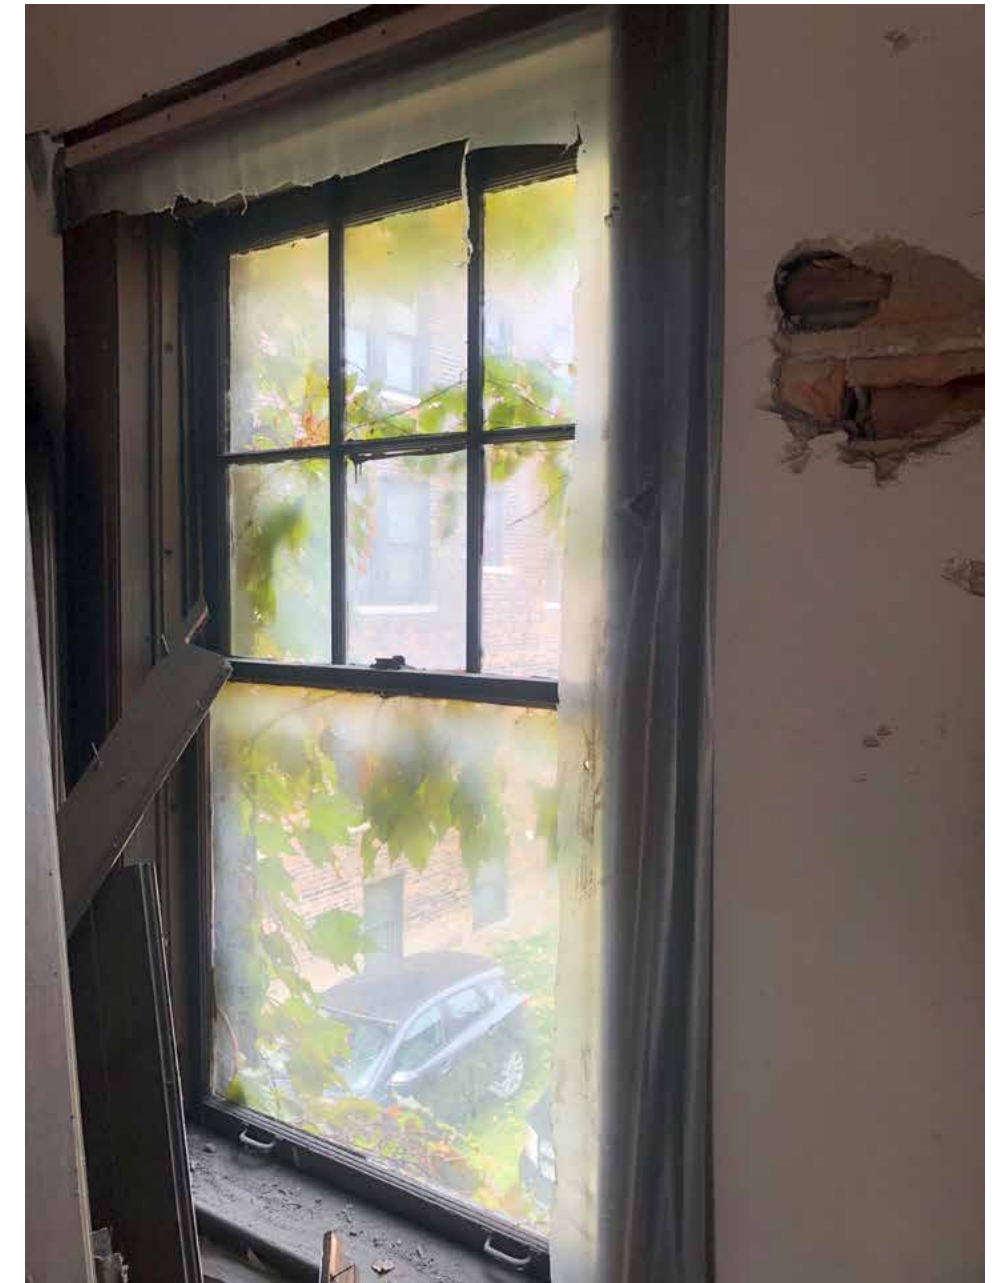
S-6

- GLASS IS BROKEN IN UPPER SASH
- WINDOW WILL NOT OPEN
- MISSING BOTH WEIGHTS
- EXTERIOR SILL HAS EXTENSIVE ROT
- WINDOW NEEDS TO BE RE-PUTTED
- MISSING SCREWS IN STOPS
- WEATHER STRIPPING MISSING
- TOP SASH HAS ROT ON RIGHT SIDE
- VINES ARE GROWING THRU WINDOW
