687, 689, 691 W. ALEXANDRINE

REHABILITATION AND NEW CONSTRUCTION

THE CITY OF DETROIT HISTORIC
DISTRICT COMMISSION HEARING

DECEMBER 9, 2020

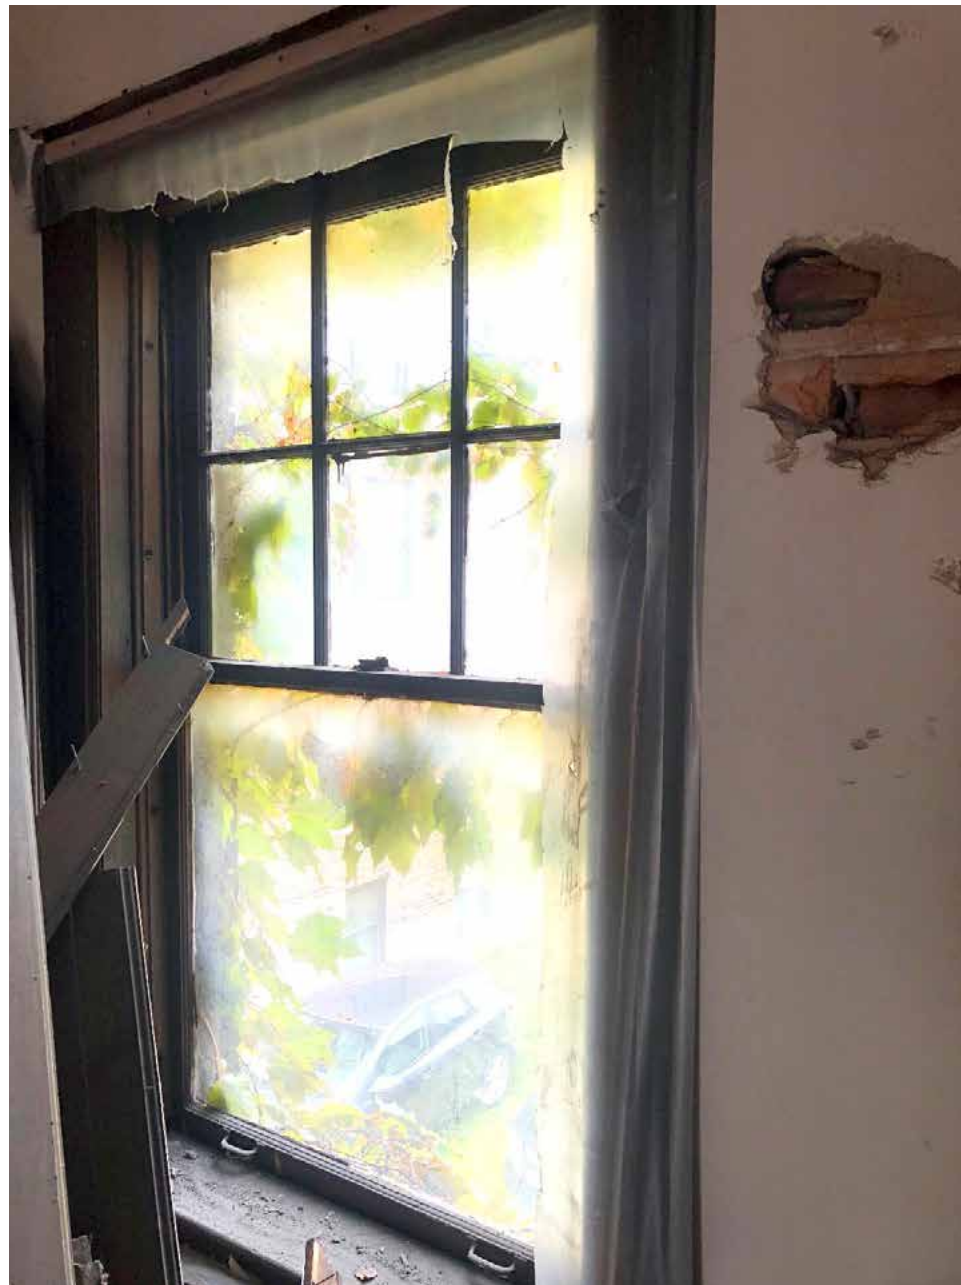
S-7

- WINDOW WILL NOT OPEN
- MISSING ONE LEAD WEIGHT
- VINES ARE GROWING THRU WINDOW
- BOTTOM SASH IS ROTTEN
- INTERIOR SILL HAS DAMAGE
- WEATHER STRIPPING MISSING
- WINDOW NEEDS TO BE RE-PUTTED

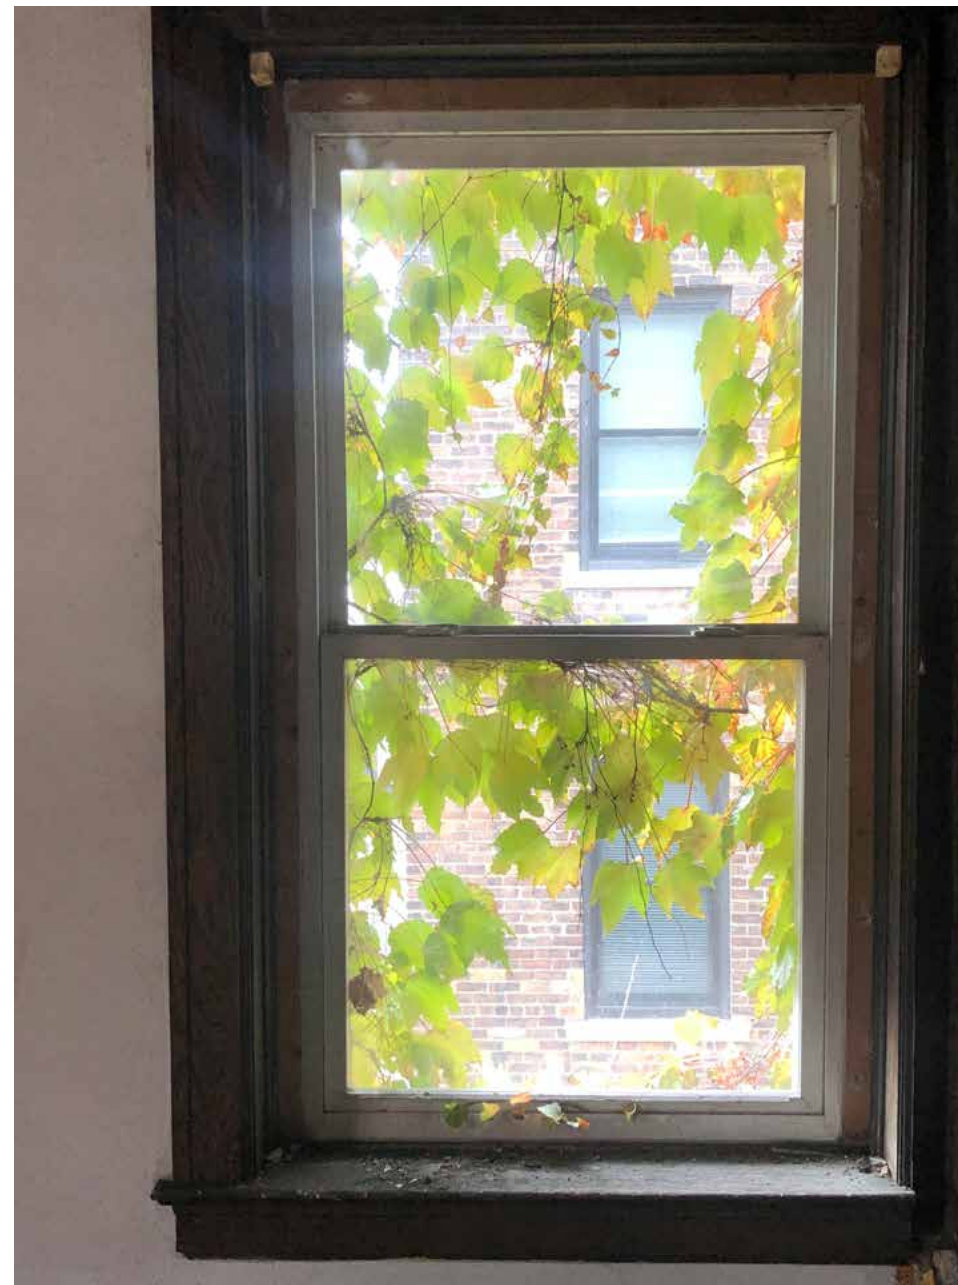
S-8

- WINDOW HAS BEEN REPLACED WITH A VINYL REPLACEMENT THAT DOES NOT FIT IN OPENING
- WOOD WAS USED TO INFILL THE GAPES
- STOPS ARE MISSING
- SASHES ARE MISSING
- LEAD WEIGHTS ARE MISSING
- EXTERIOR SILL IS ROTTEN

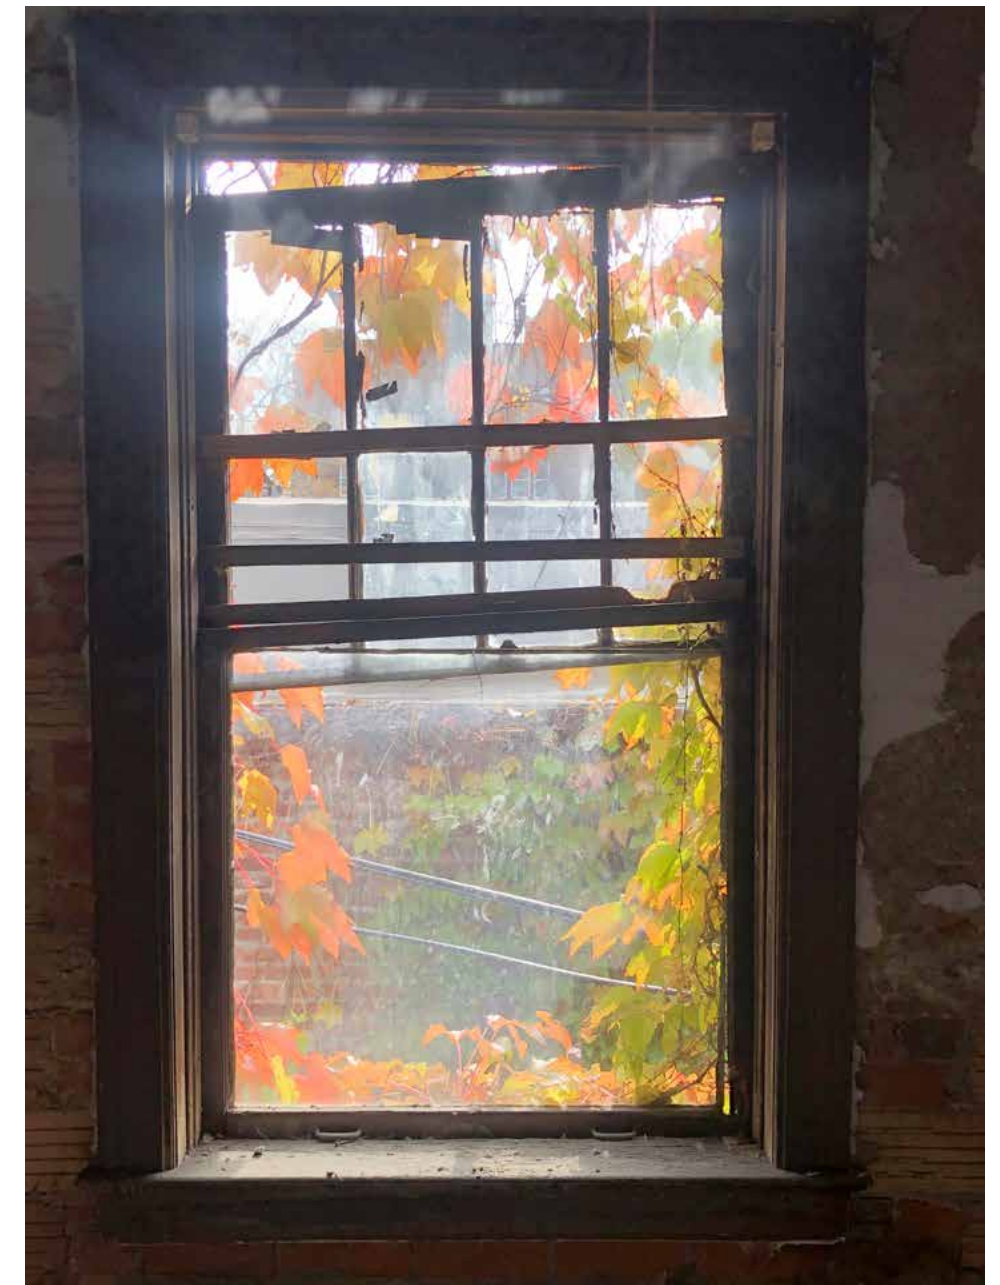
S-9

- WINDOWS HAS BEEN REPLACED WITH A VINYL REPLACEMENT THAT DOES NOT FIT IN OPENING
- WOOD WAS USED TO INFILL THE GAPES
- STOPS ARE MISSING
- SASHES ARE MISSING
- LEAD WEIGHTS ARE MISSING
- EXTERIOR SILL IS ROTTEN
- ONE WINDOW IS MISSING TRIM ON RIGHT SIDE

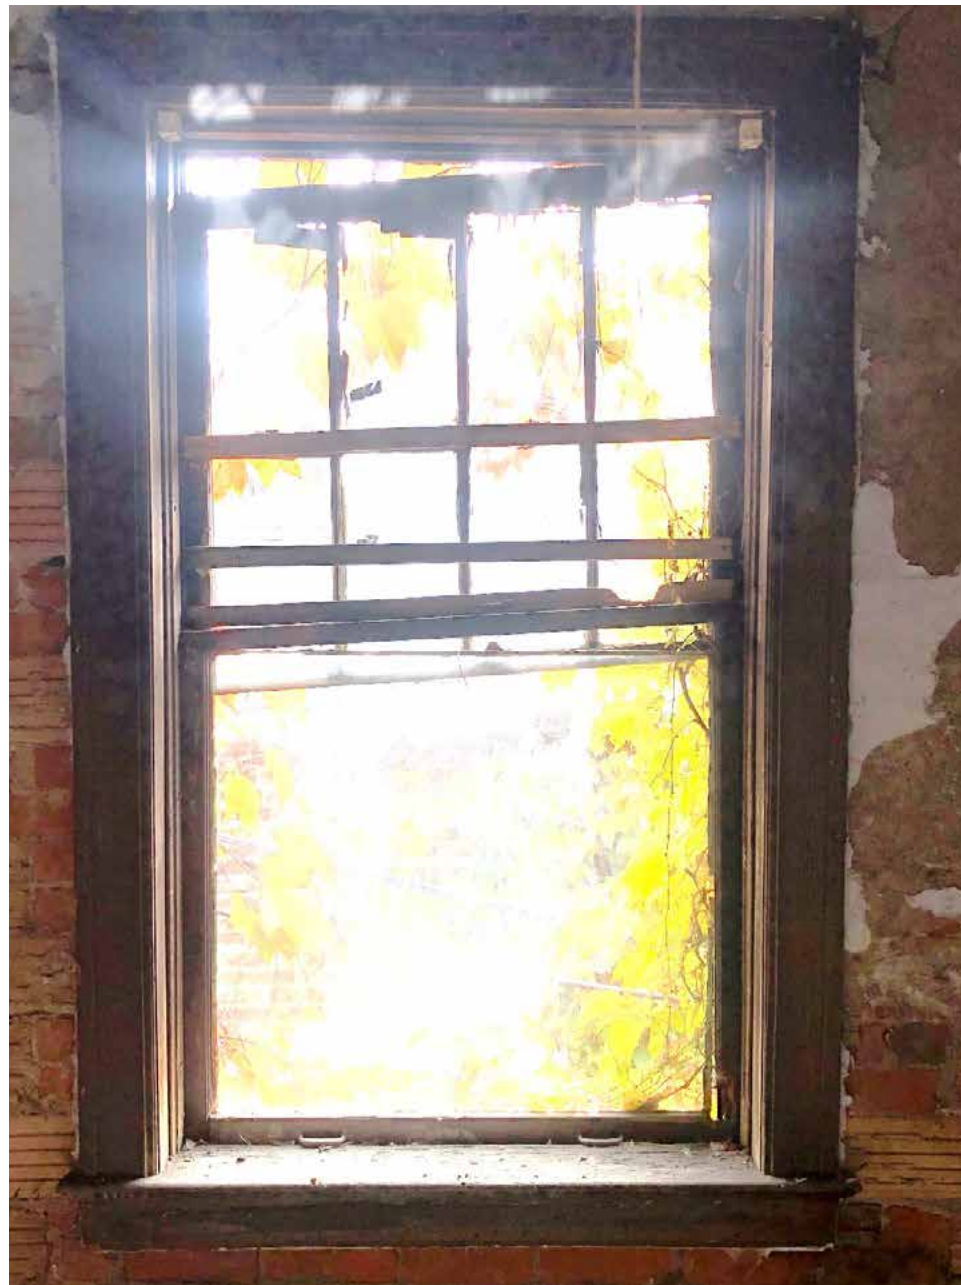
S-10

- UPPER AND LOWER SASHES HAVE MASSIVE ROT
- BOTH SASHES ARE FALLING APART
- MISSING GLASS IN UPPER SASH
- INTERIOR SILL HAS MASSIVE ROT
- EXTERIOR SILL HAS MASSIVE ROT
- WEATHER STRIPPING MISSING
- STOPS & JAMBS HAVE MASSIVE ROT AND ARE FALLING APART
- TRIM AROUND WINDOW HAS WATER DAMAGE
- LEAD WEIGHTS ARE IN PLACE, BUT CORDS NEED REPLACING

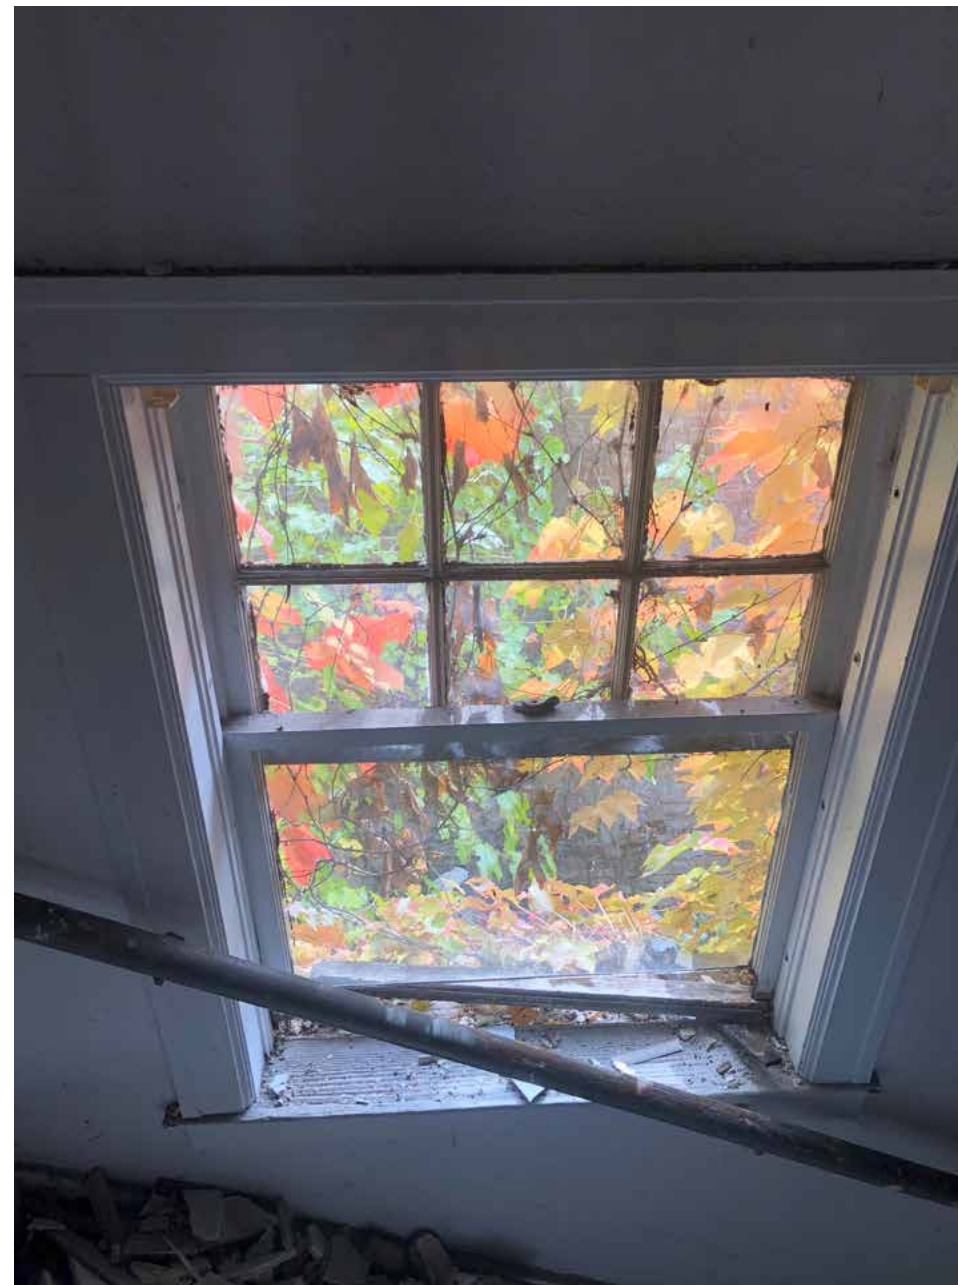
S-11

- WINDOW WILL NOT OPEN
- LEAD WEIGHTS ARE IN PLACE, BUT CORDS NEED REPLACING
- EXTERIOR SILL HAS MASSIVE ROT
- INTERIOR SILL IS ROTTEN AND LOOSE
- WEATHER STRIPPING MISSING
- WINDOW NEEDS TO BE RE PUTTED
- BOTTOM SASH HAS EXTENSIVE ROT

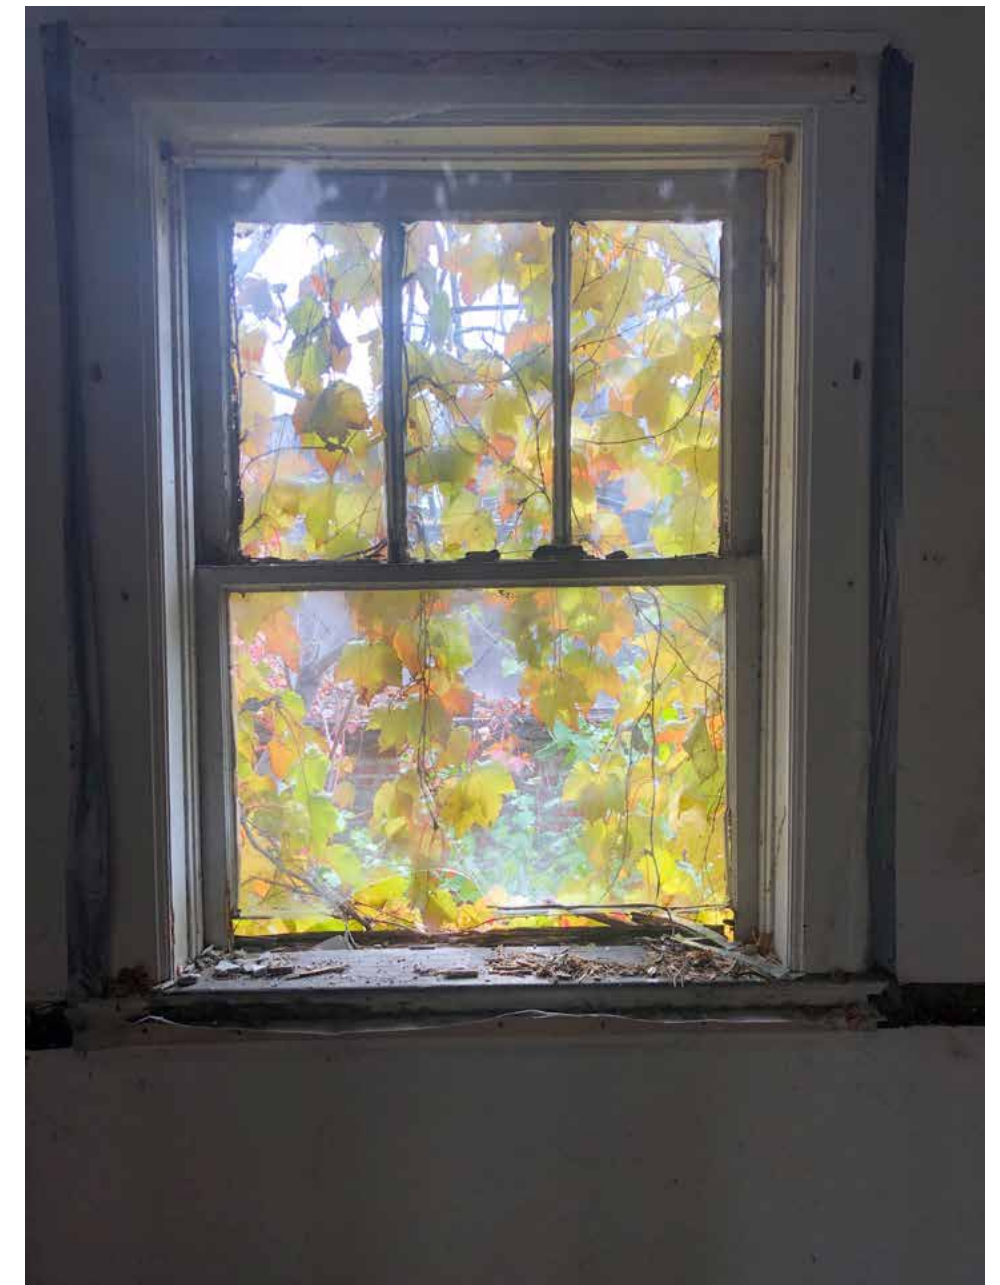
S-12

- WINDOW WILL NOT OPEN
- WINDOW IS THREE OVER ONE
- BOTTOM SASH HAS EXTENSIVE ROT AND IS BROKEN
- GLASS IN UPPER SASH IS BROKEN ON RIGHT SIDE
- INTERIOR SILL HAS MASSIVE ROT
- WEATHER STRIPPING MISSING
- WINDOW NEEDS TO BE RE PUTTED
- EXTERIOR SILL HAS MASSIVE ROT
- LEAD WEIGHTS ARE MISSING

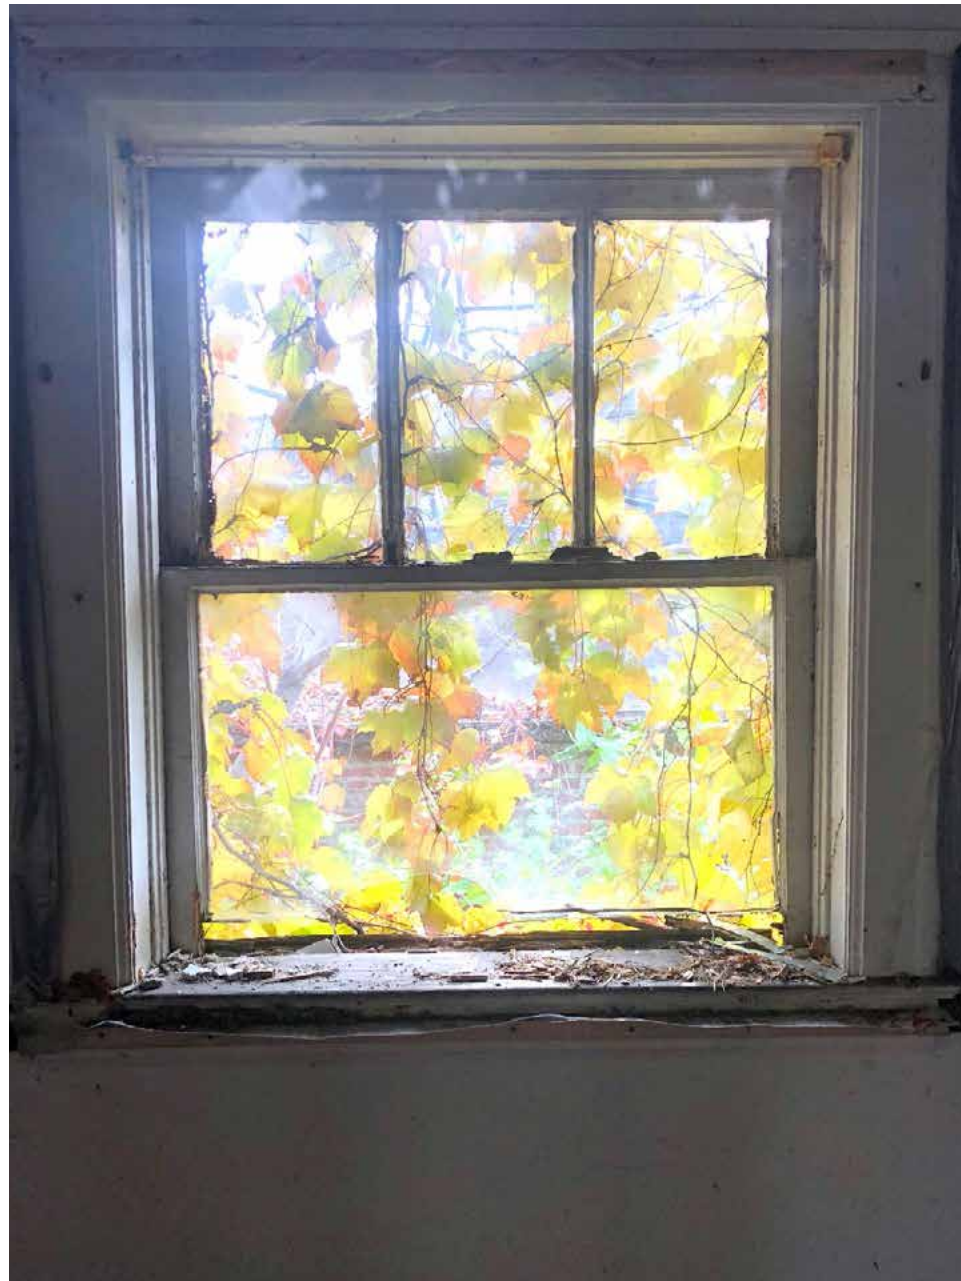
S-13

- WINDOW WILL NOT OPEN
- WINDOW IS THREE OVER ONE
- BOTTOM SASH HAS EXTENSIVE ROT
- GLASS IN UPPER SASH IS BROKEN ON LEFT SIDE
- INTERIOR SILL HAS MASSIVE ROT
- EXTERIOR SILL HAS MASSIVE ROT
- WINDOW NEEDS TO BE RE PUTTED
- LEAD WEIGHTS ARE MISSING
- WEATHER STRIPPING MISSING
- BRICK MOLDING HAS EXTENSIVE ROT

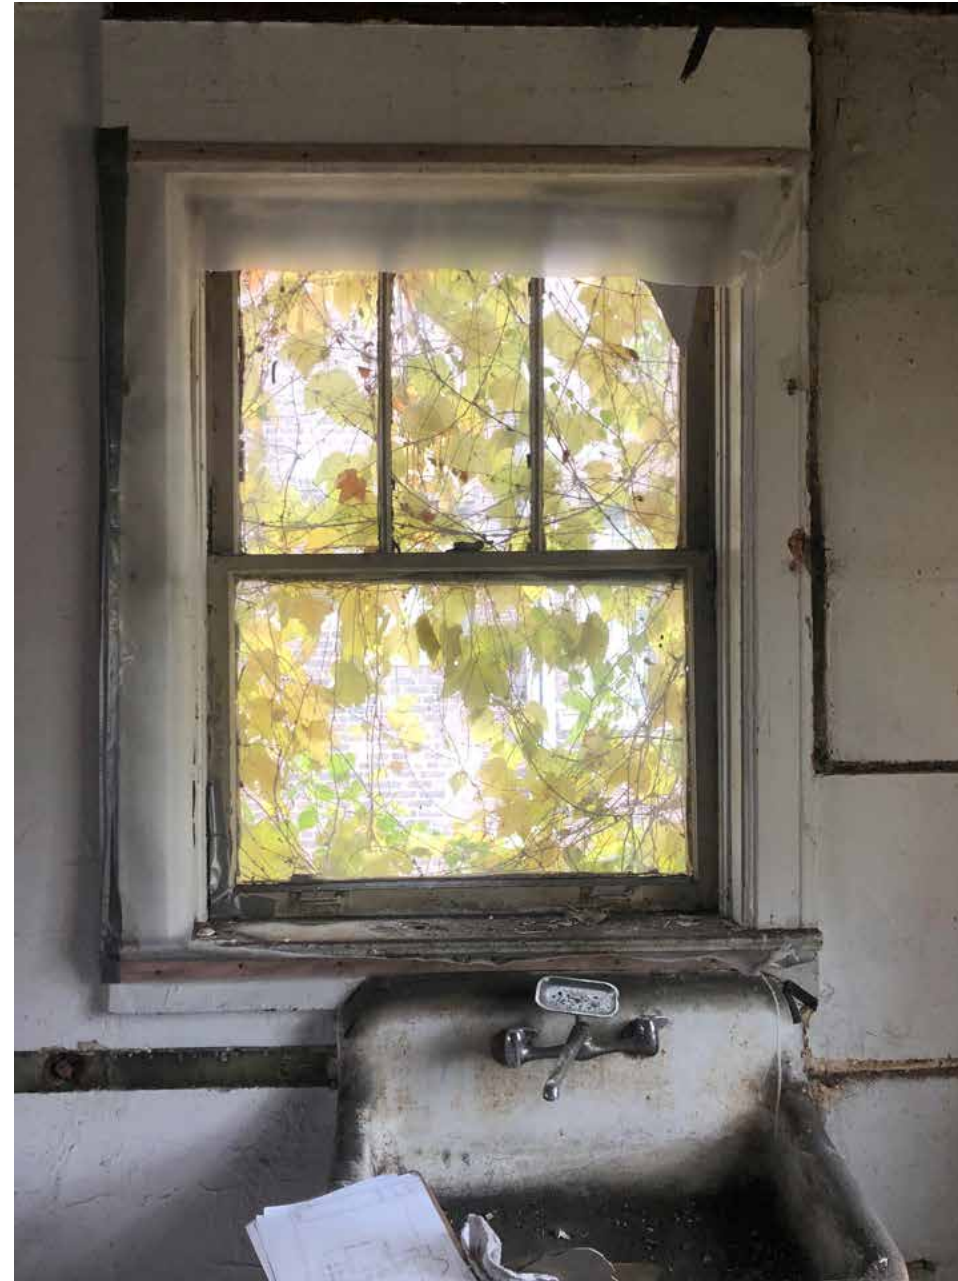
S-14

- WINDOW WILL NOT OPEN
- BOTH LEAD WEIGHTS ARE MISSING
- BOTTOM SASH HAS EXTENSIVE ROT
- WINDOW NEEDS TO BE RE PUTTED
- LOWER SASH GLASS IS FALLING OUT
- WEATHER STRIPPING MISSING
- INTERIOR SILL HAS MASSIVE ROT

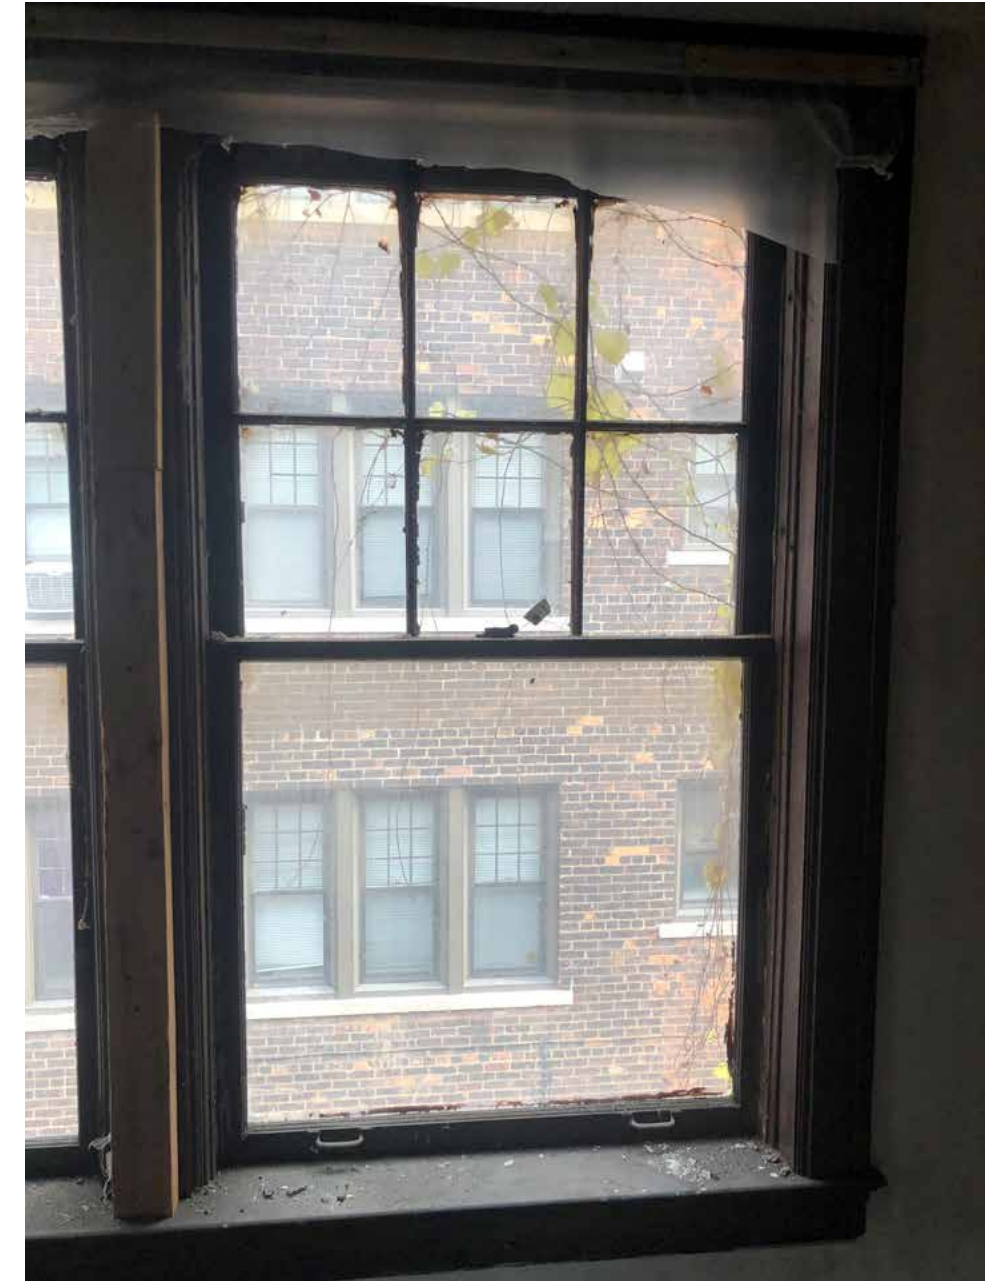
S-15

- WINDOW WILL NOT OPEN
- LEAD WEIGHTS ARE IN PLACE, BUT CORDS NEED REPLACING
- BOTTOM SASH HAS EXTENSIVE ROT
- WEATHER STRIPPING MISSING
- WINDOW IS BOARDED UP ON THE OUTSIDE
- WINDOW WILL NOT LOCK
- BRICK MOLDING HAS EXTENSIVE ROT
- GLASS IN UPPER SASH IS BROKEN
- UPPER SASH HAS EXTENSIVE ROT

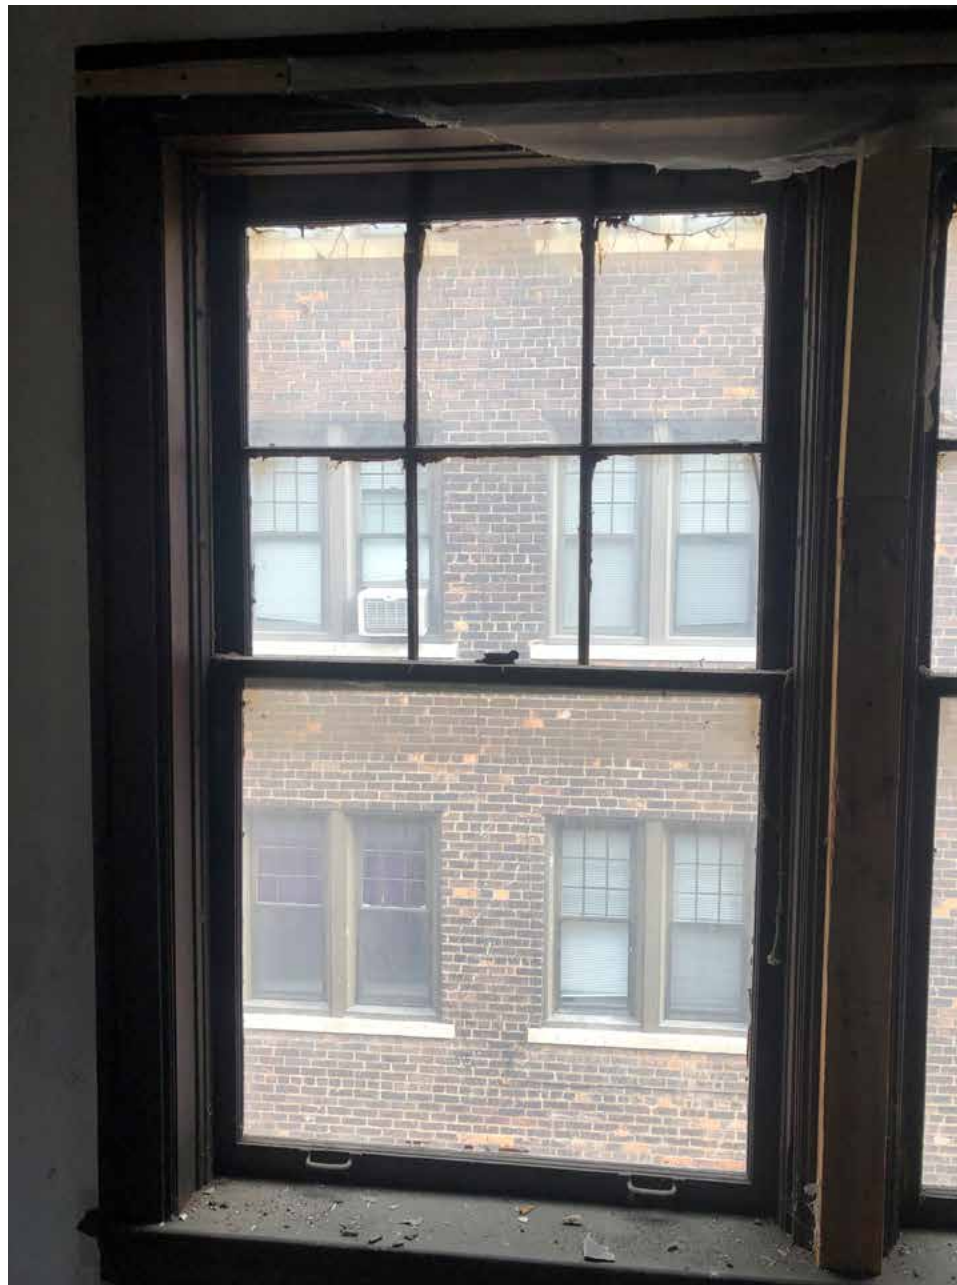
S-16

- WINDOW WILL NOT OPEN
- LEAD WEIGHTS ARE IN PLACE, BUT CORDS NEED REPLACING
- BOTTOM SASH HAS EXTENSIVE ROT
- WEATHER STRIPPING MISSING
- WINDOW IS BOARDED UP ON THE OUTSIDE
- WINDOW WILL NOT LOCK
- BRICK MOLDING HAS EXTENSIVE ROT
- TRIM BELOW WINDOW HAS WATER DAMAGE
- WINDOW WILL NOT LOCK

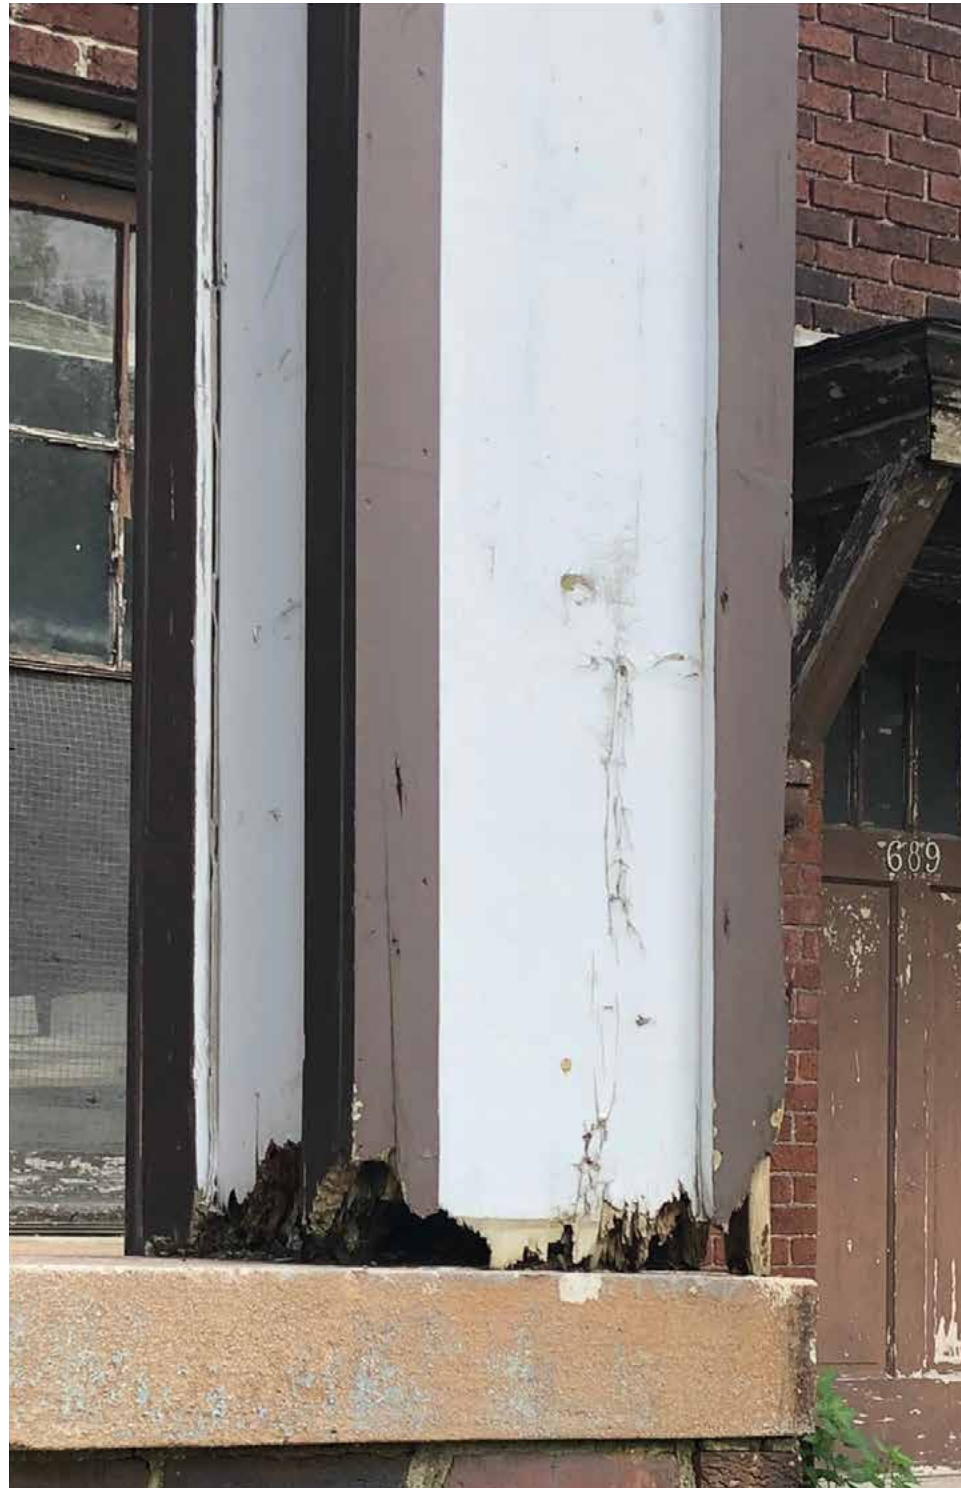
- COLUMNS HAVE SEVERE ROT AND DECAY
- TRIM BOARDS ARE MISSING

IT IS OUR OPINION THAT THE WOOD ON THE PORCH HAS SEVER ROT AND IS IN DISARRAY. THE UPPER PORCH IS DANGEROUS AND SHOULD NOT BE USE. THE WOOD ON THE PORCH NEEDS TO BE DISASSEMBLED WHILE SUPPORTING THE ROOF. THE PORCH TO BE REBUILT USING NEW WOOD AND SUPPORT COLUMNS. TRIM BOARD TO BE INSTALLED TO MATCH EXISTING AND PAINTED TO REDUCE THE CHANCE OF ROT.

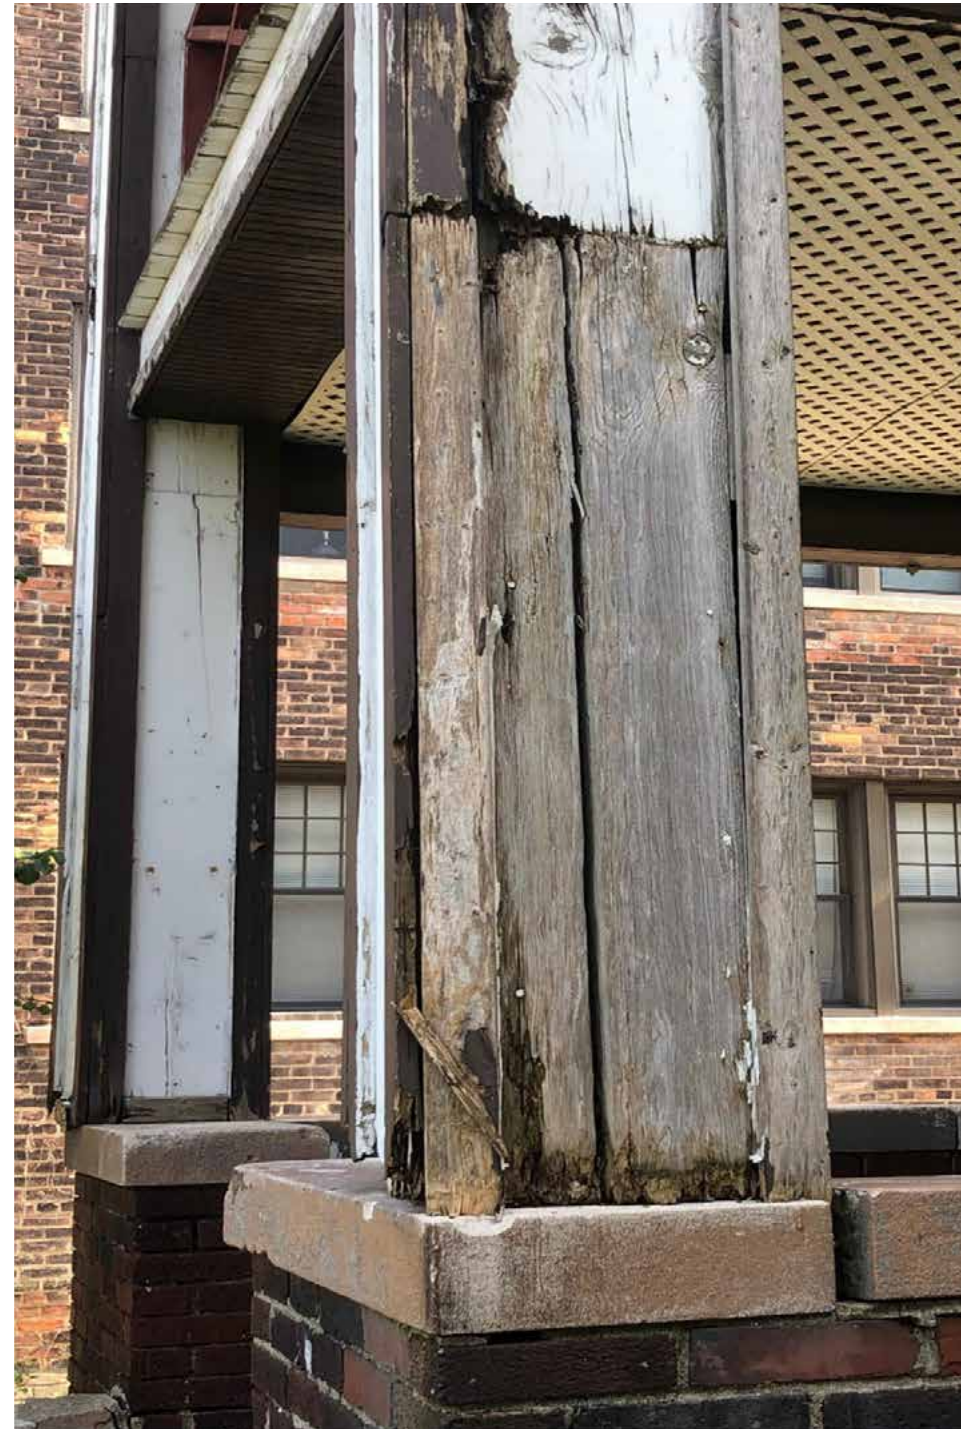
- BOARDS HAVE BEEN REPLACED
- COLUMNS HAVE SEVERE ROT AND DECAY
- SUPPORT FOR THE UPPER PORCH IS IN RISK

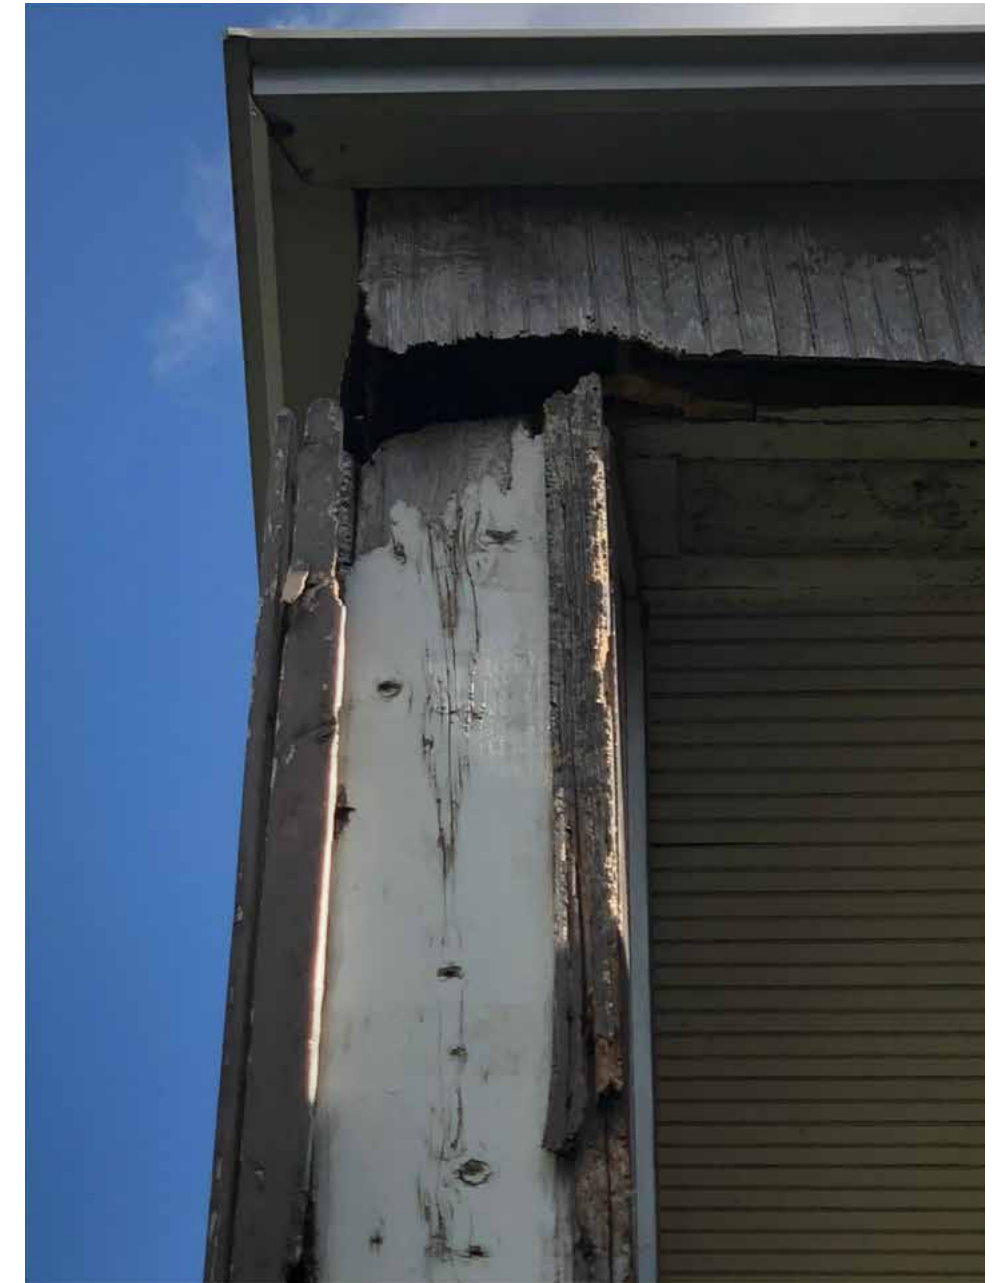
- BOARDS HAVE BEEN REPLACED
- TRIM BOARDS ARE MISSING
- COLUMNS HAVE SEVERE ROT AND DECAY COULD COLLAPSE CAUSING THE UPPER PORCH TO COLLAPSE.
- FACIA BOARDS HAVE ROTTED AWAY

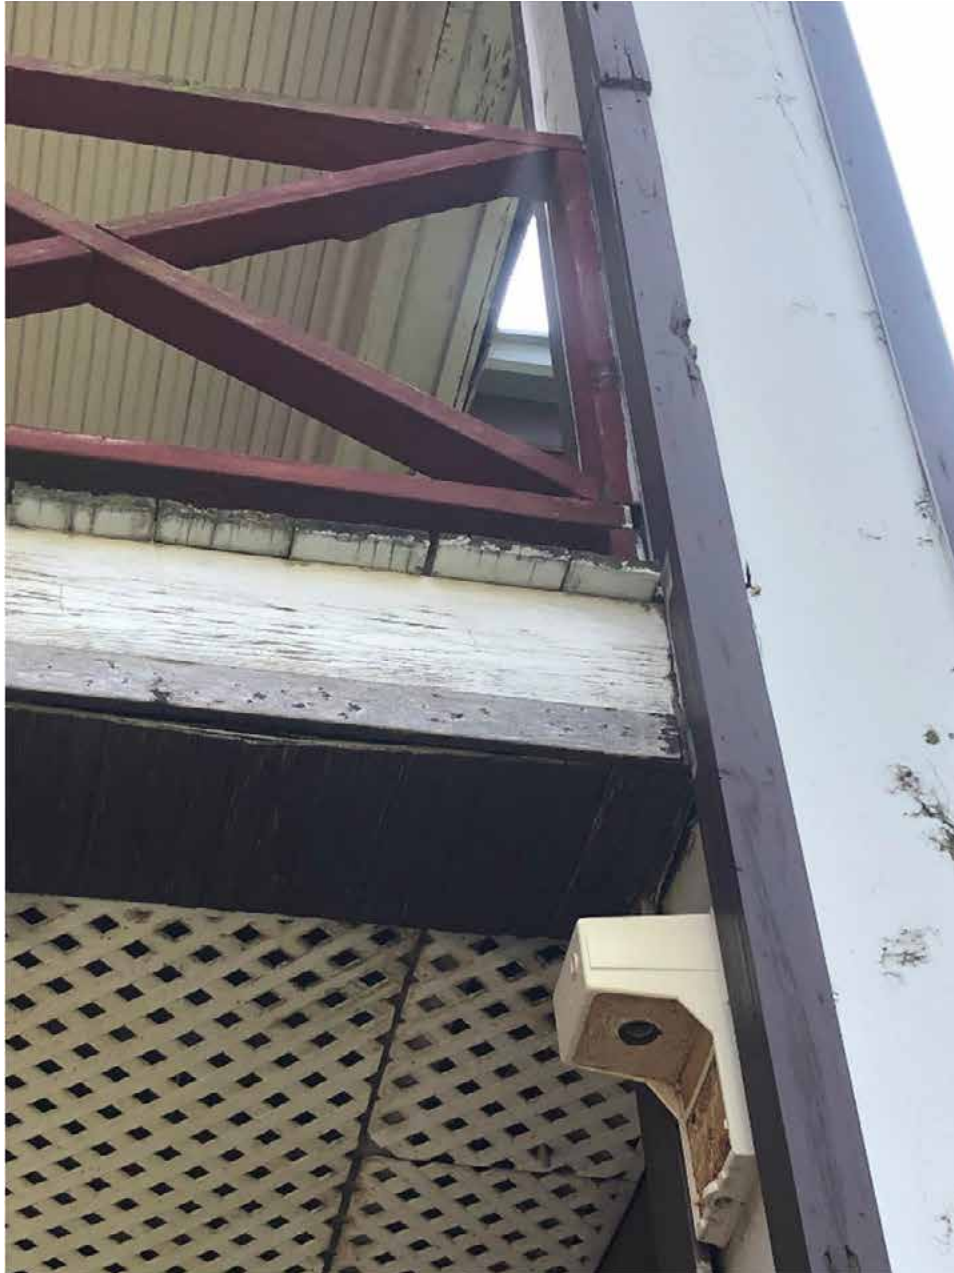
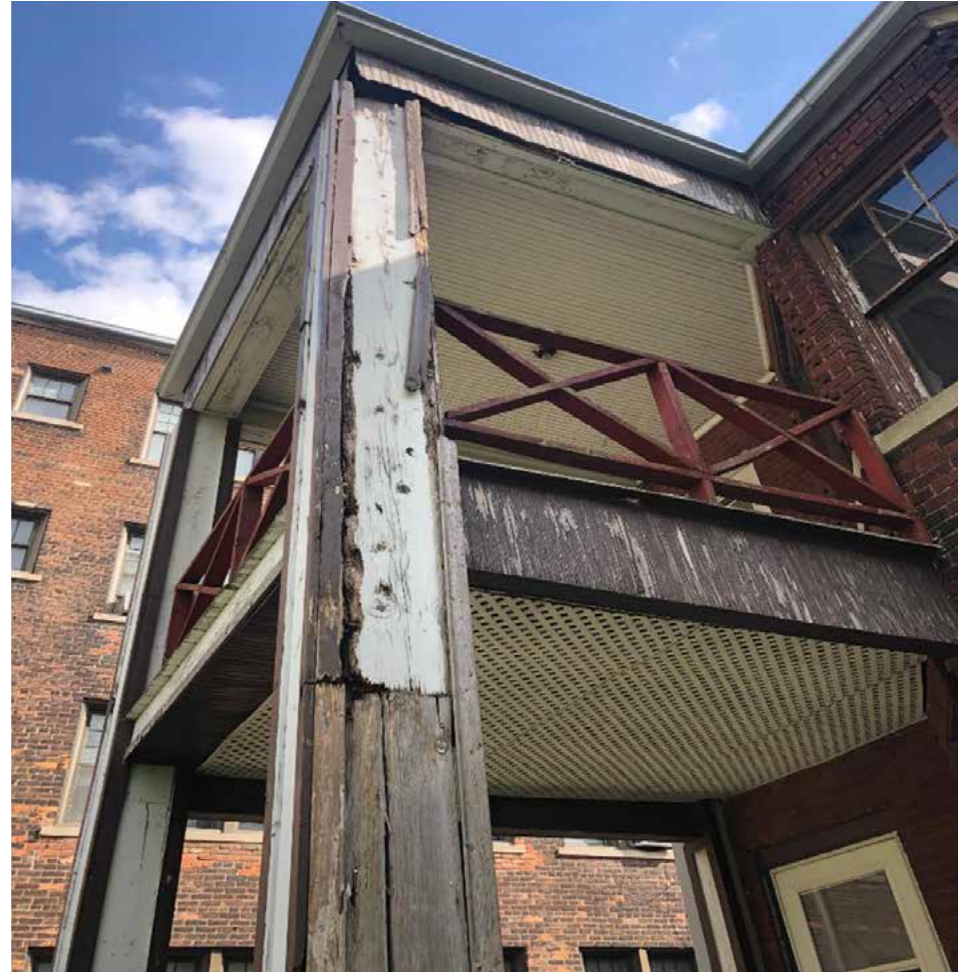
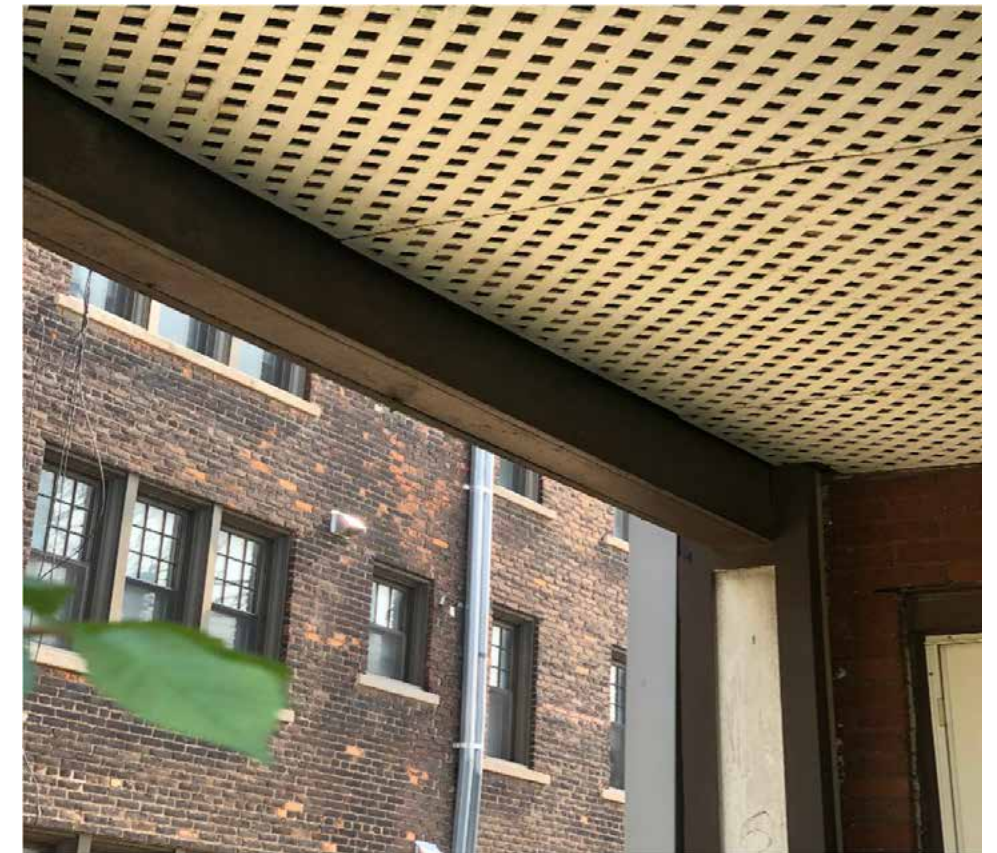
- UPPER PORCH HAS SOME ROT IN THE SUPPORTS
- THE FLOORING HAS A LOT OF ROT (WOULD NOT RECOMMEND ANYONE VENTURE ONTO THE PORCH)
- THE CEILING OF THE LOWER DECK HAS BEEN REPLACED WITH VINYL LATTICE.

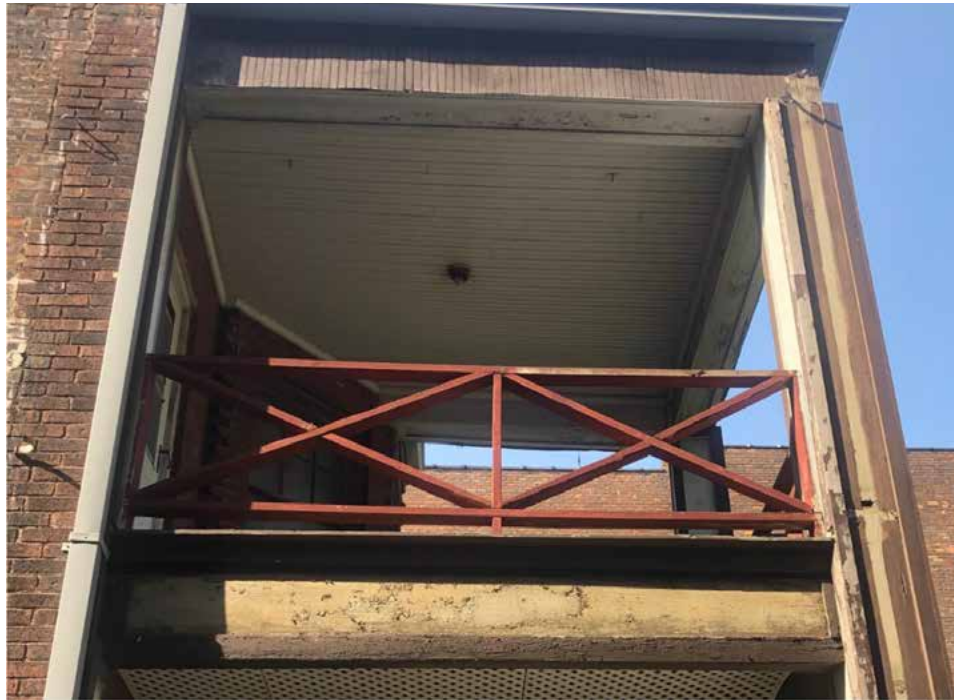
- UPPER PORCH CEILING IS BEADBOARD AND IN GOOD CONDITION. WOULD SUGGEST REMOVING AND REINSTALL ON REBUILT PORCH.
