687, 689, 691 W. ALEXANDRINE

REHABILITATION AND NEW CONSTRUCTION

THE CITY OF DETROIT HISTORIC
DISTRICT COMMISSION HEARING

DECEMBER 9, 2020

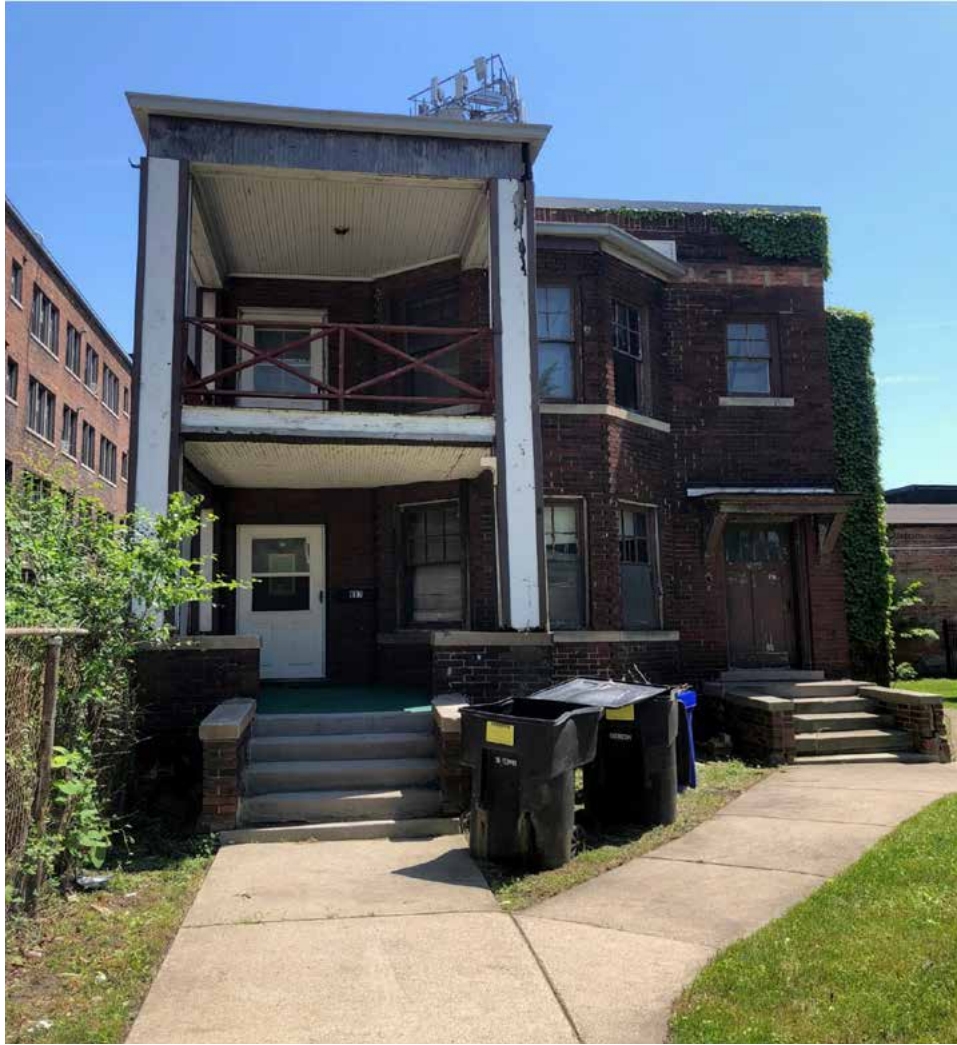
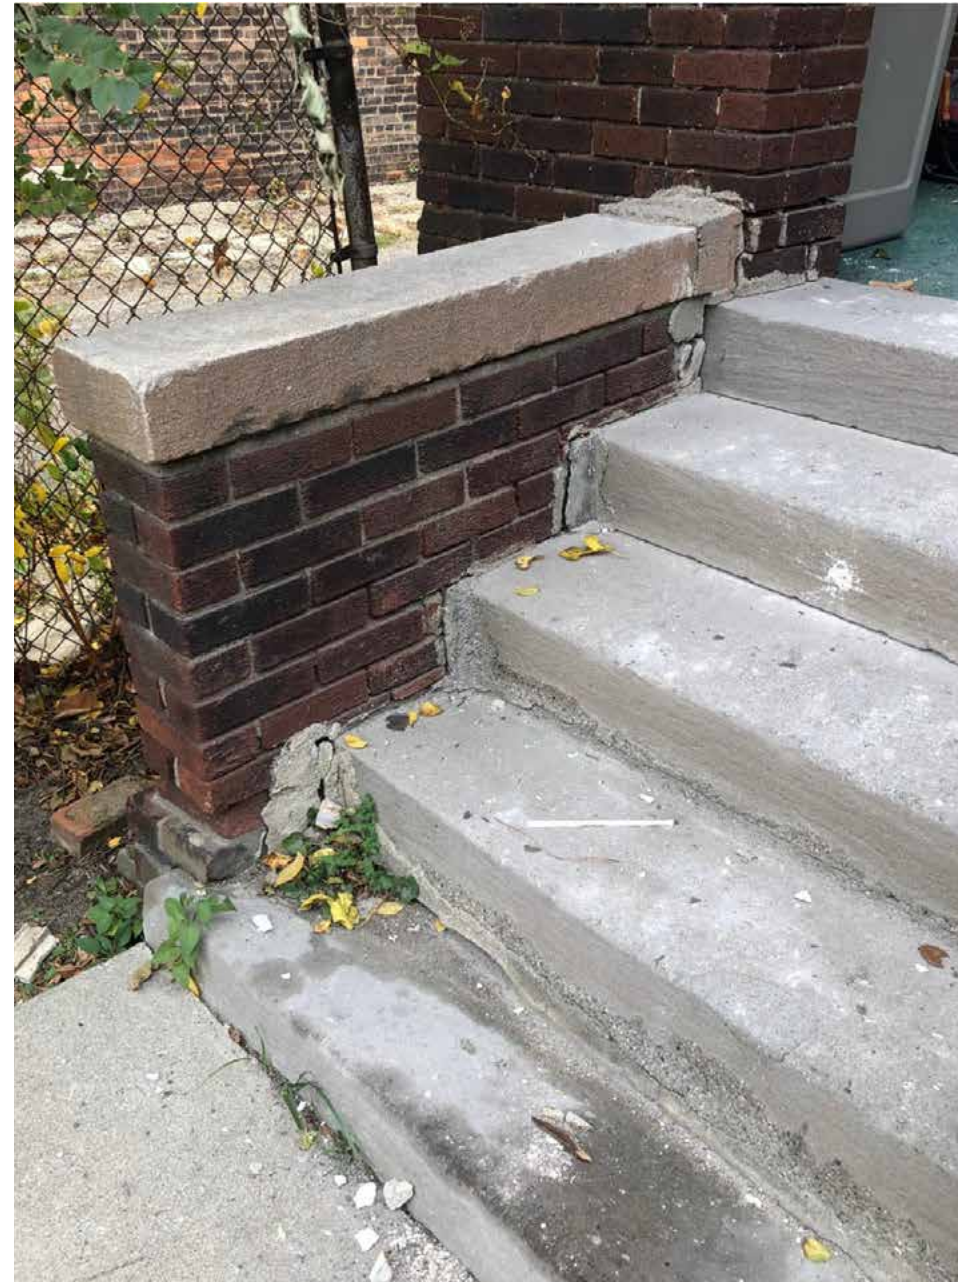
- STEPS HAVE PULLED AWAY FROM THE PORCH AND WAS IMPROPERLY FILLED
- WALL HAS PULLED AWAY FROM THE PORCH AND WAS IMPROPERLY FILLED
- STEPS ARE NOT TO CODE OR ADA COMPLIANCE.
- THERE ARE GAPS BETWEEN THE STEPS AND HAVE BEEN FILLED

IT IS OUR OPINION THAT THE PORCHES ARE IN SERVER DISARRAY. THE PORCHES ARE DANGEROUS AND NEEDS TO BE DISASSEMBLED, AND THE BRICK BE CLEANED OF OLD MORTAR, THE LIMESTONE STEPS, AND CAPS TO BE REMOVED AND CLEANED. THE PORCH TO HAVE A CONCRETE FOOTING AND THE PORCH TO BE REBUILT USING THE EXISTING BRICK AND LIMESTONE STEPS AND CAPS.

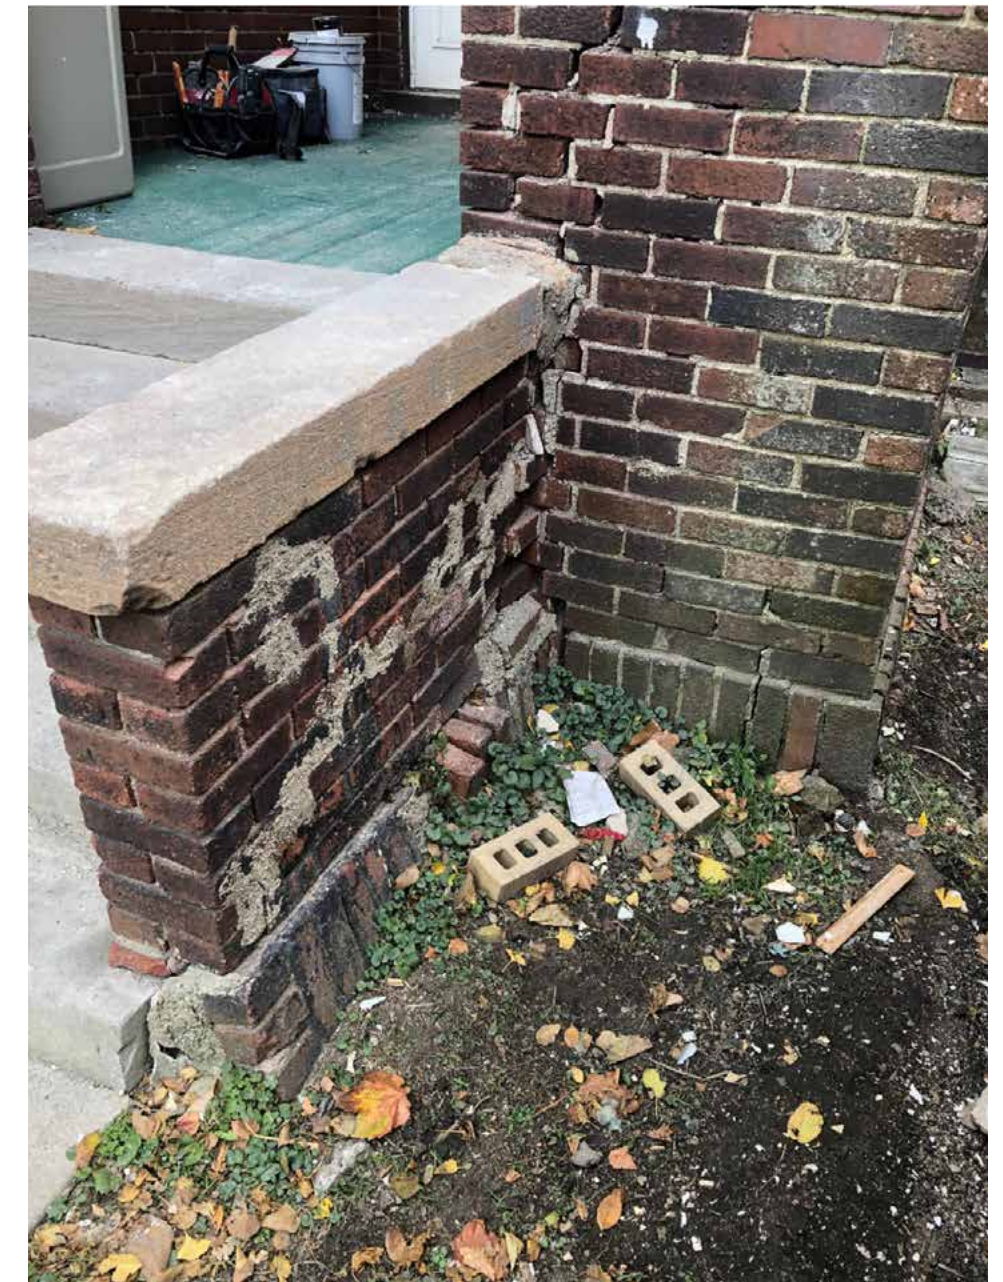
- WALL IS 2 LAYERS OF BRICK
- WALL HAS PULLED AWAY FROM THE PORCH AND WAS IMPROPERLY FILLED
- WALL IS FALLING APART. WILL NEED TO BE TORN DOWN AND REBUILT TO MAKE RIGHT.
- THE GAPS IN THE BRICK HAVE BEEN IMPROPERLY FILLED AND LOOK BAD.
- BRICKS ARE LOOSE AND FALLING OUT

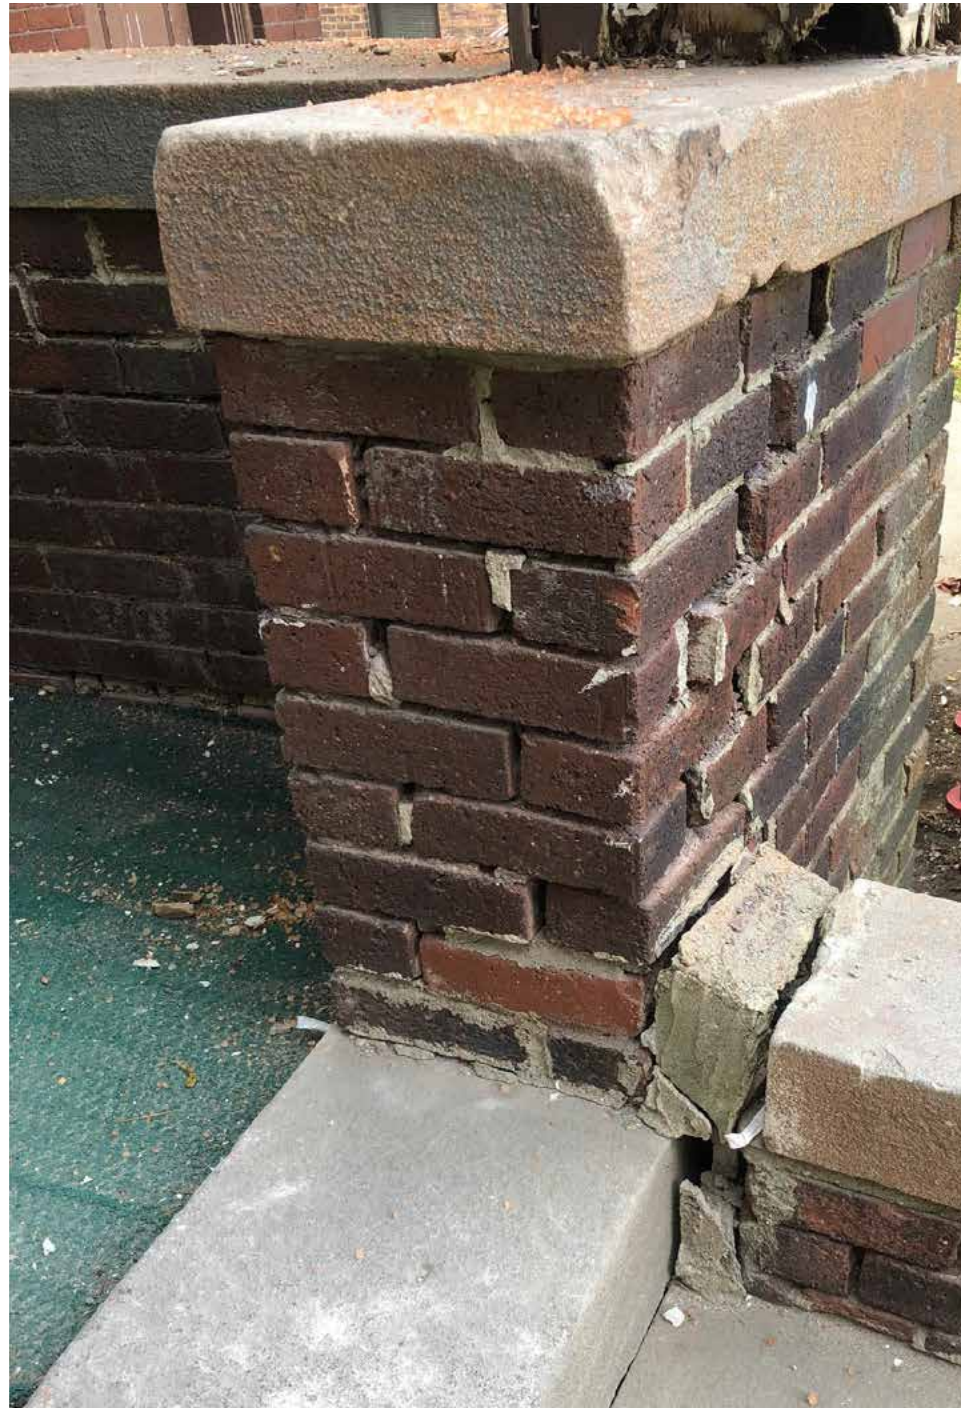
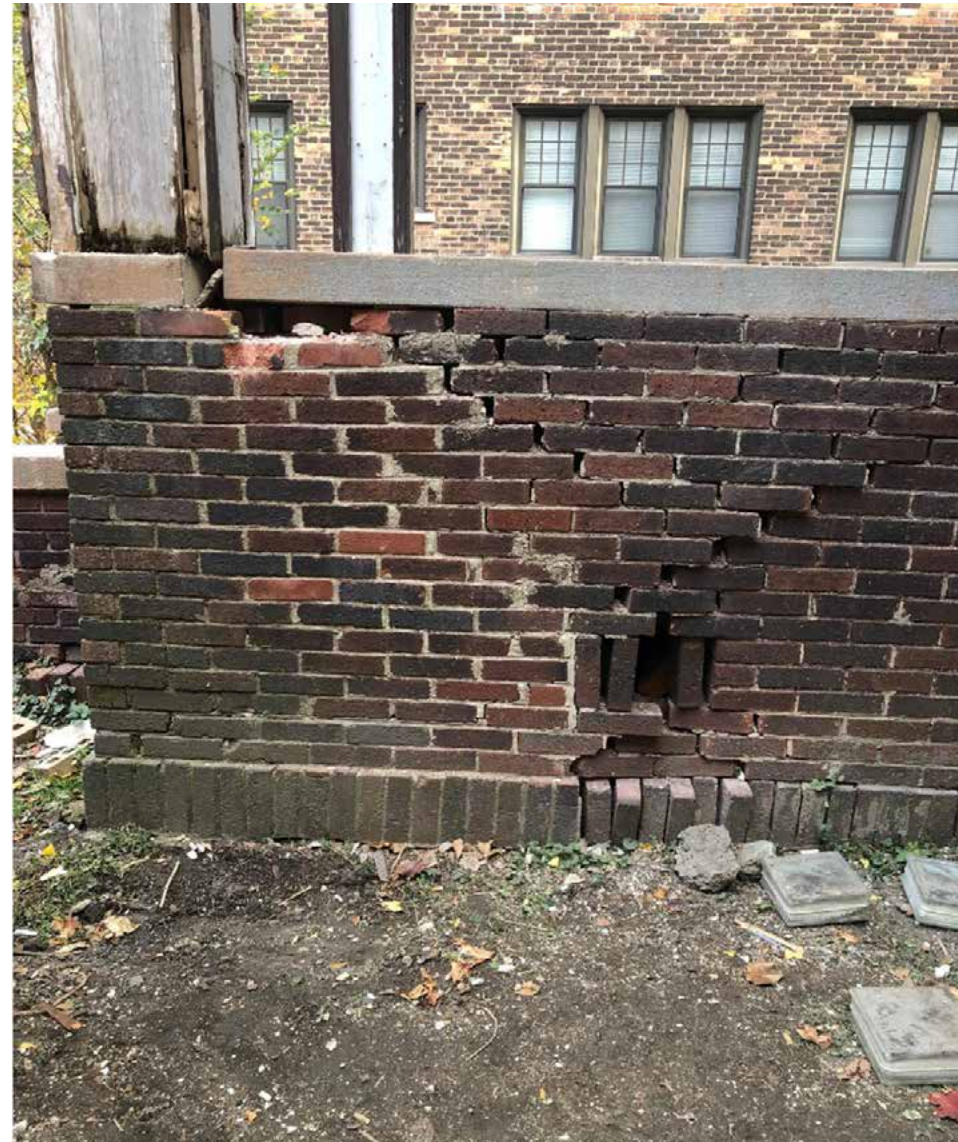
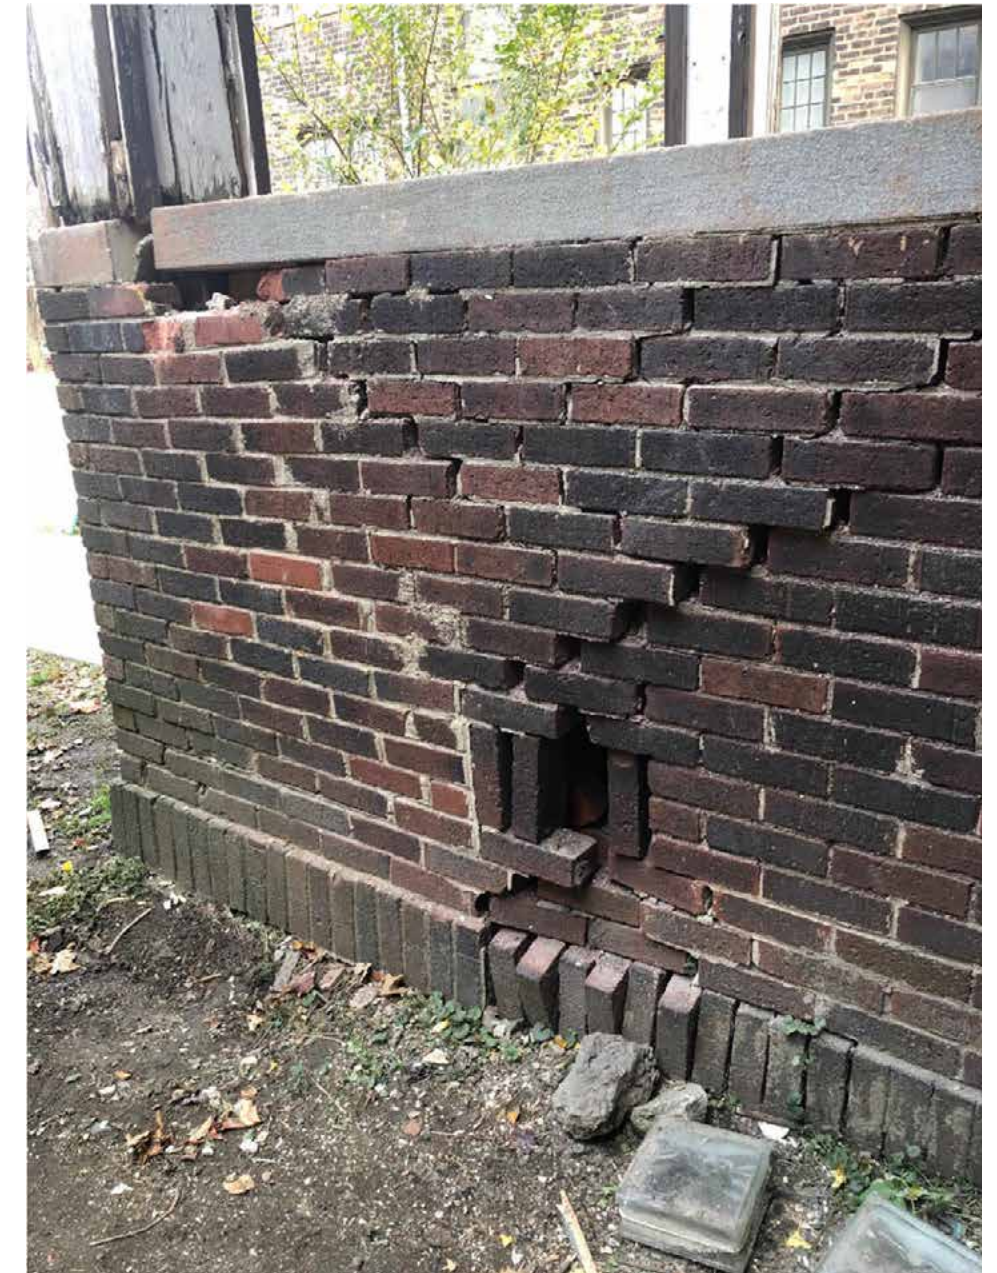
- WALL IS 4 LAYERS OF BRICKS
- THE GAPS IN THE BRICK HAVE BEEN IMPROPERLY FILLED AND LOOK BAD.
- BRICKS ARE LOOSE AND FALLING OUT
- WALL IS FALLING APART. WILL NEED TO BE TORN DOWN AND REBUILT TO MAKE RIGHT.
- SOME BRICKS HAVE BEEN REPLACED WITH NON-MATCHING BRICKS.

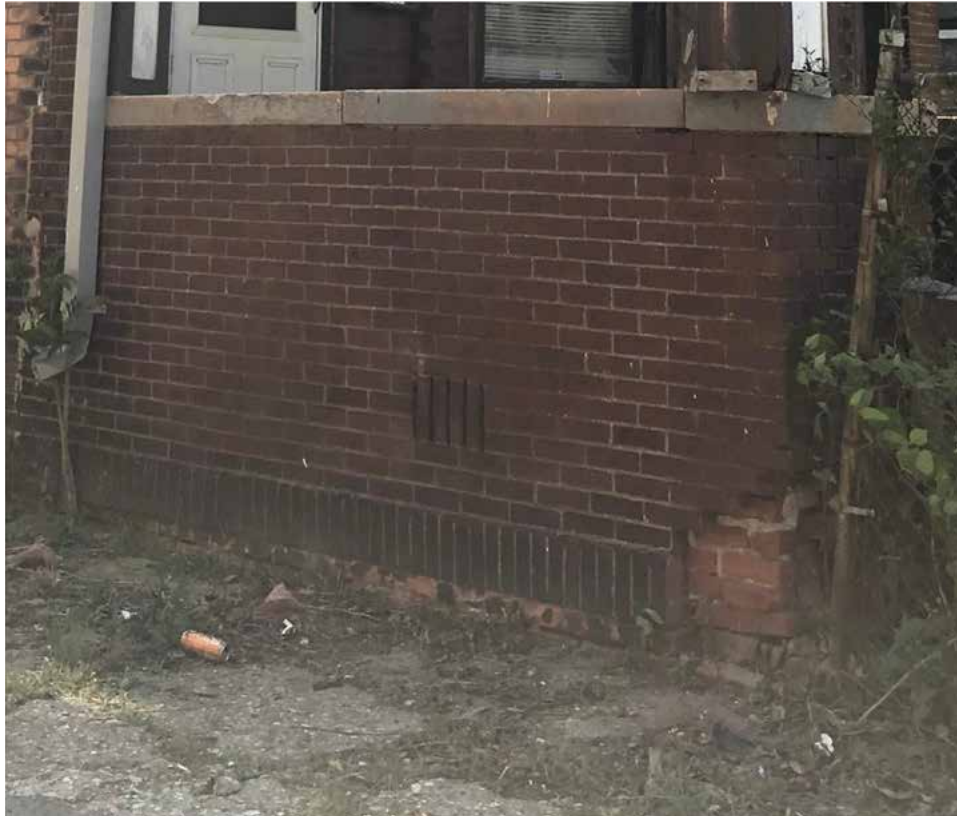
- WALL IS 4 LAYERS OF BRICKS
- THERE ARE SEVERE CRACKS IN THE PORCH WALL
- THE GAPS IN THE BRICK HAVE BEEN IMPROPERLY FILLED AND LOOK BAD.
- BRICKS ARE LOOSE AND FALLING OUT
- WALL IS FALLING APART AND IS UNSAFE. WILL NEED TO BE TORN DOWN AND REBUILT TO BE CORRECTED.
- SOME BRICKS HAVE BEEN REPLACED WITH NON-MATCHING BRICKS.
- WALL SUPPORTS THE UPPER PORCH AND IS LEANING OUT AND COULD COLLAPSE CAUSING THE UPPER PORCH TO COLLAPSE ALSO.
- BRICKS ON CORNER ARE MISSING.
- THE REST OF THE PORCH WALLS IS IN GOOD CONDITION. BRICKS NEED TO BE CLEANED.

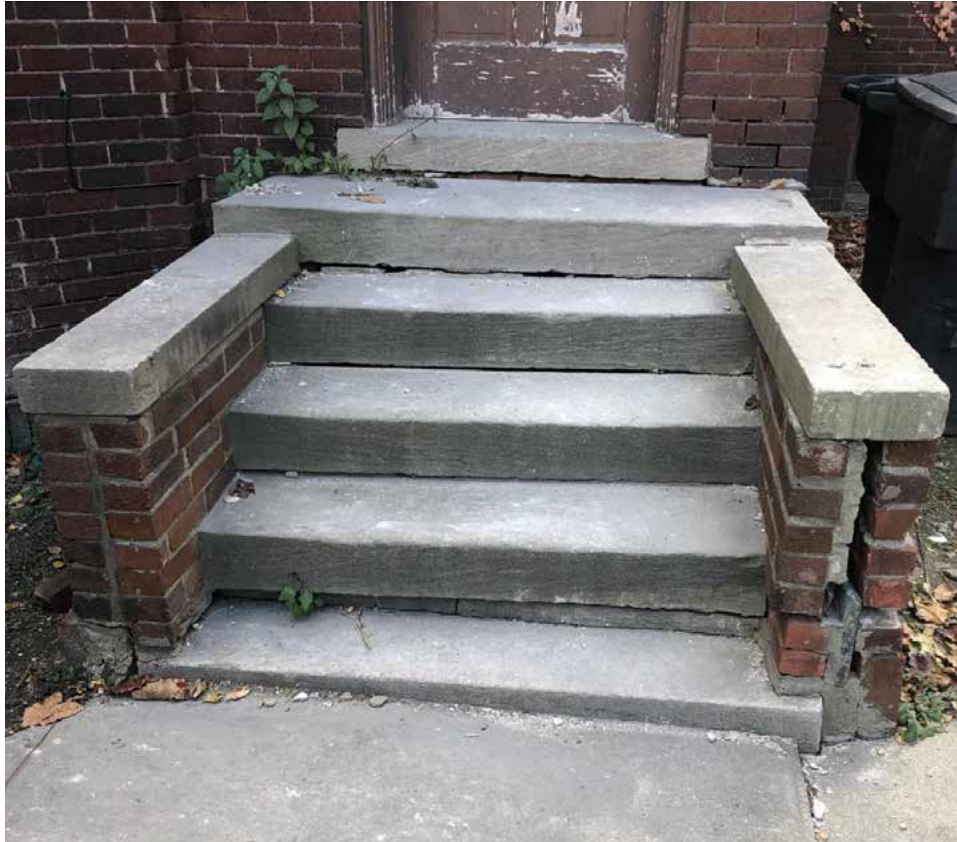
- STEPS HAVE PULLED AWAY FROM THE PORCH AND WAS IMPROPERLY FILLED
- STEP WALL HAS PULLED AWAY FROM ITSELF AND WAS IMPROPERLY FILLED
- STEPS ARE NOT TO CODE OR ADA COMPLIANCE.
- THERE ARE GAPS BETWEEN THE STEPS AND HAVE BEEN FILLED

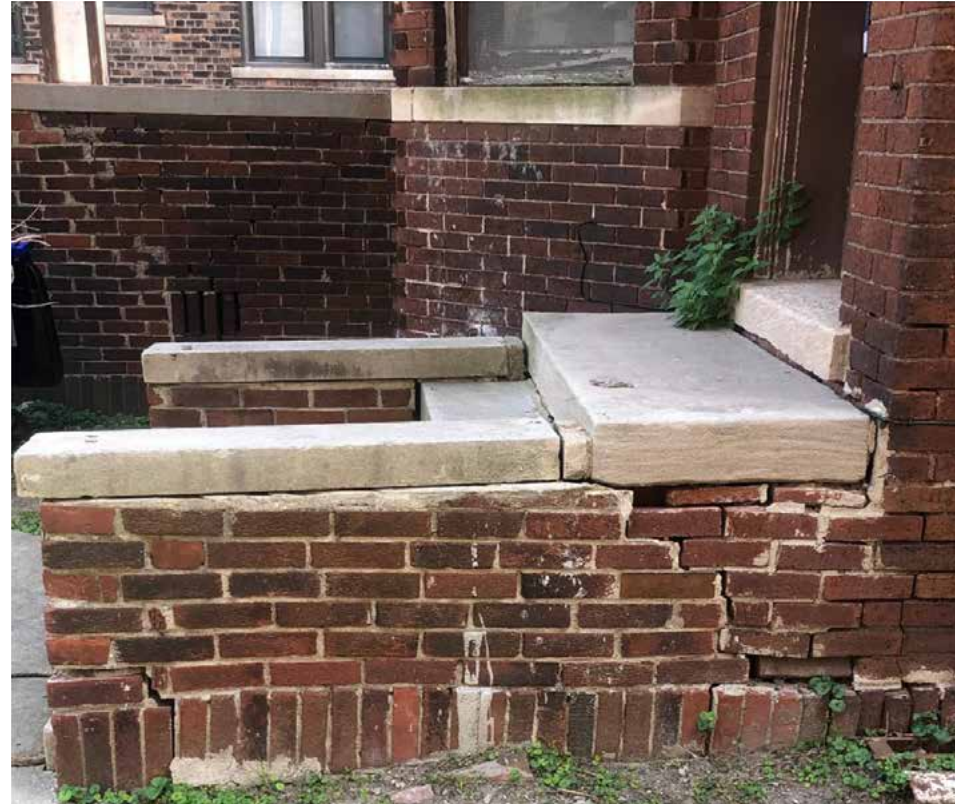
- THE GAPS IN THE BRICK HAVE BEEN IMPROPERLY FILLED AND LOOK BAD.
- BRICKS ARE LOOSE AND FALLING OUT
- THERE ARE SEVERE CRACKS IN THE PORCH WALL
- WALL IS FALLING APART AND IS UNSAFE. WILL NEED TO BE TORN DOWN AND REBUILT TO BE CORRECTED.
- SOME BRICKS HAVE BEEN REPLACED WITH NON-MATCHING BRICKS

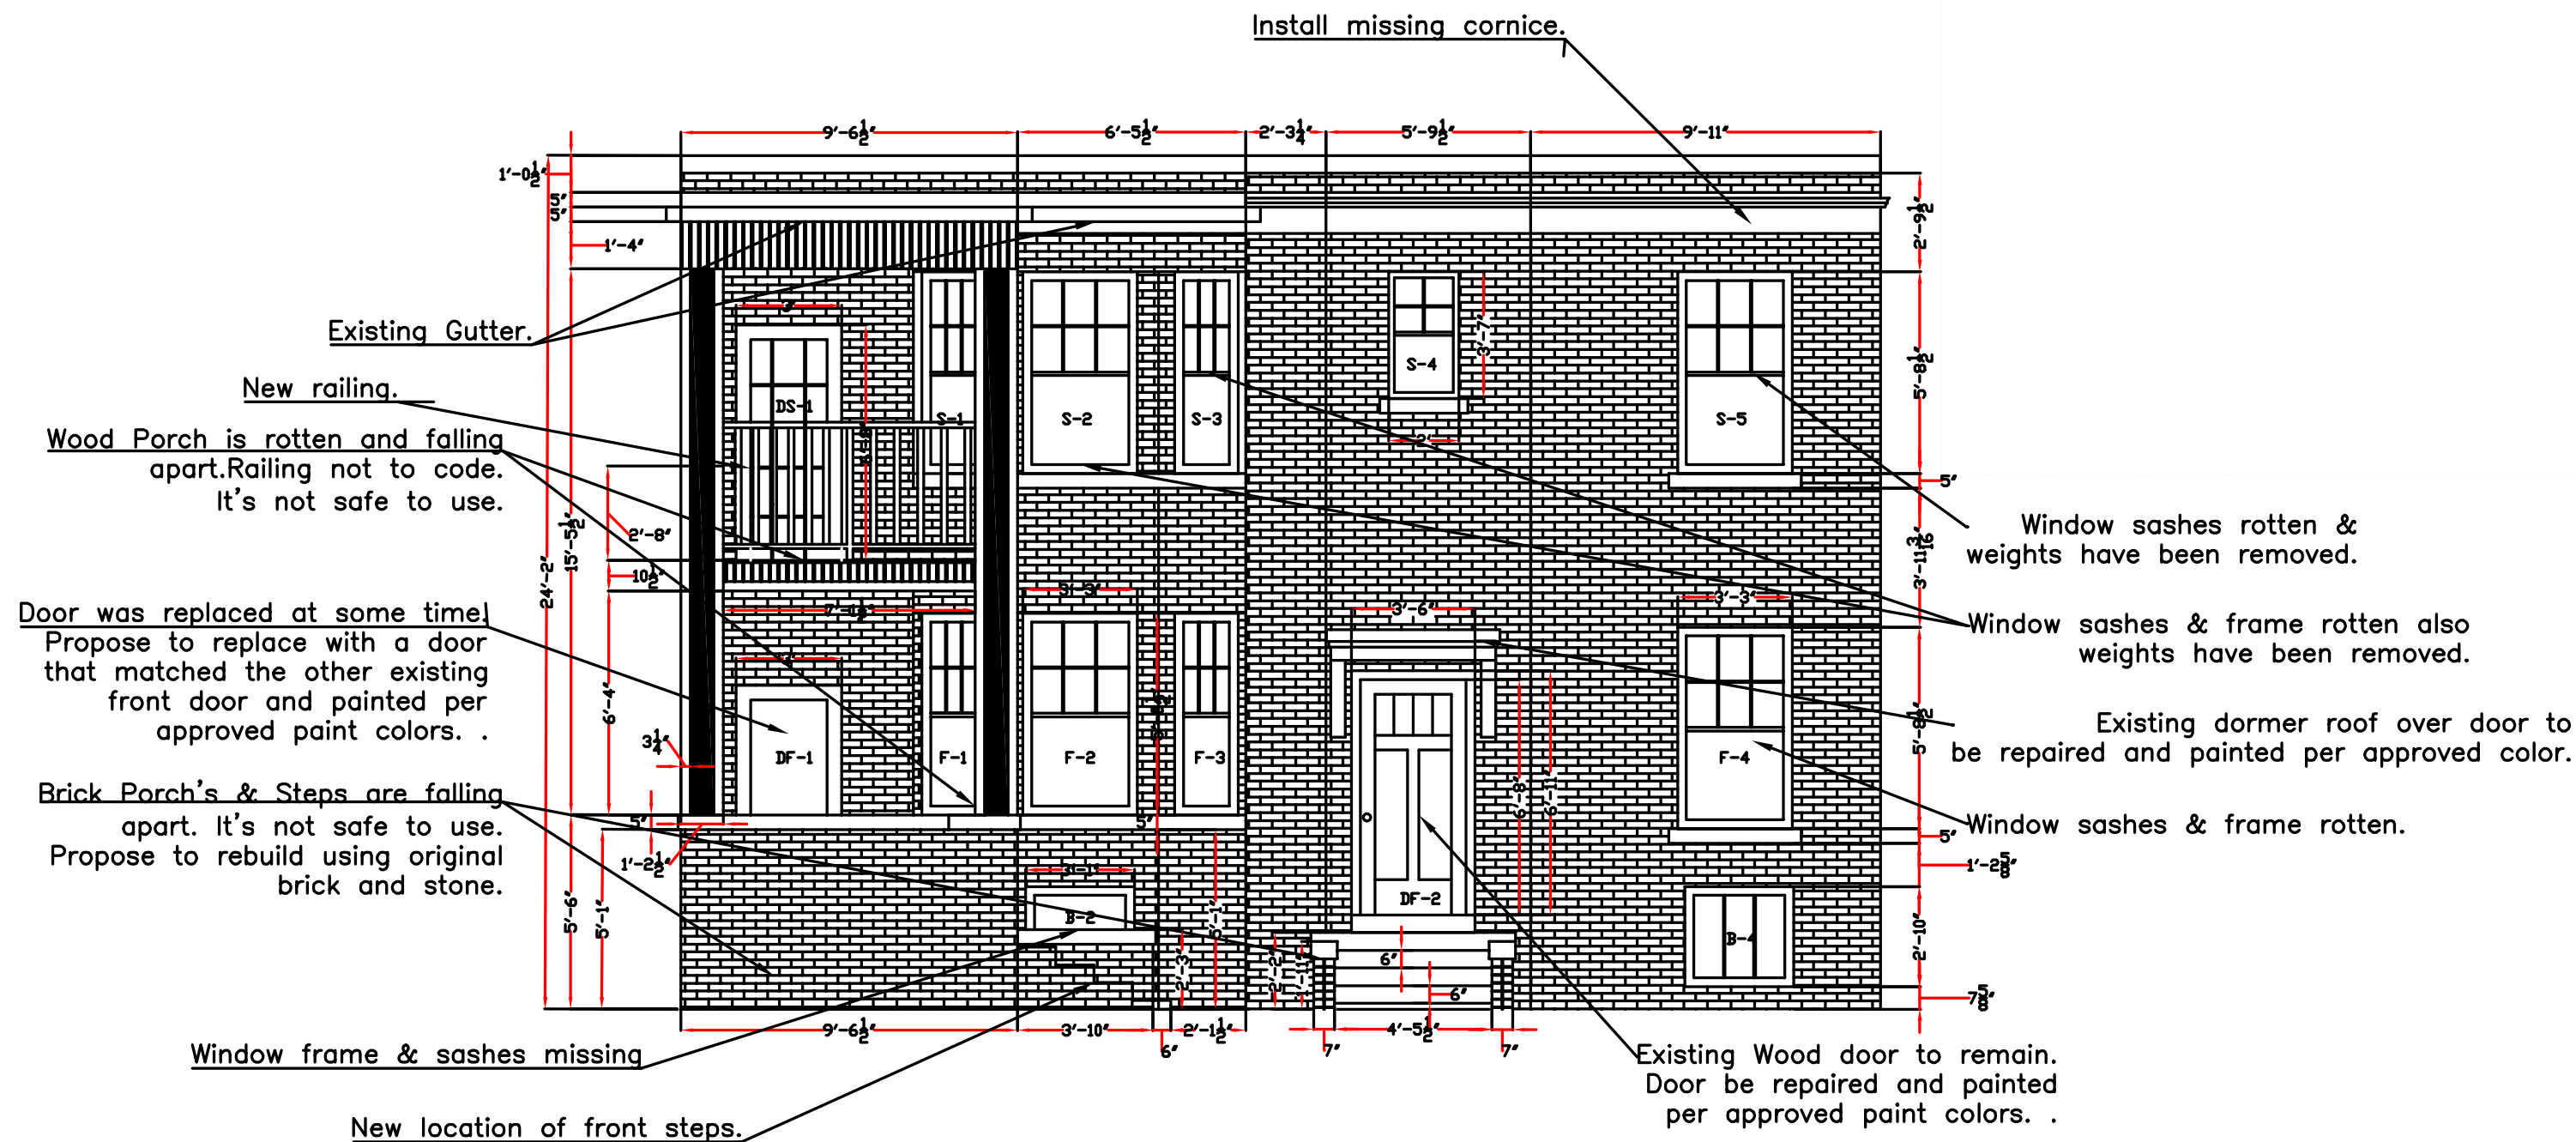
SOUTH ELEVATION (EXISTING)

The existing cornice has fallen off the building and was demolished. A new wood cornice will be installed with replicated profiles found on other historic buildings in the district, however in a modest interpretation.

Install missing cornice.
