MEMO

Re: Supplemental Photos, Marlboro Apartments, 1031 Marlborough, Detroit, MI

Marlboro Apartments Photo Log
1031 Marlborough, Detroit, MI
February 2019

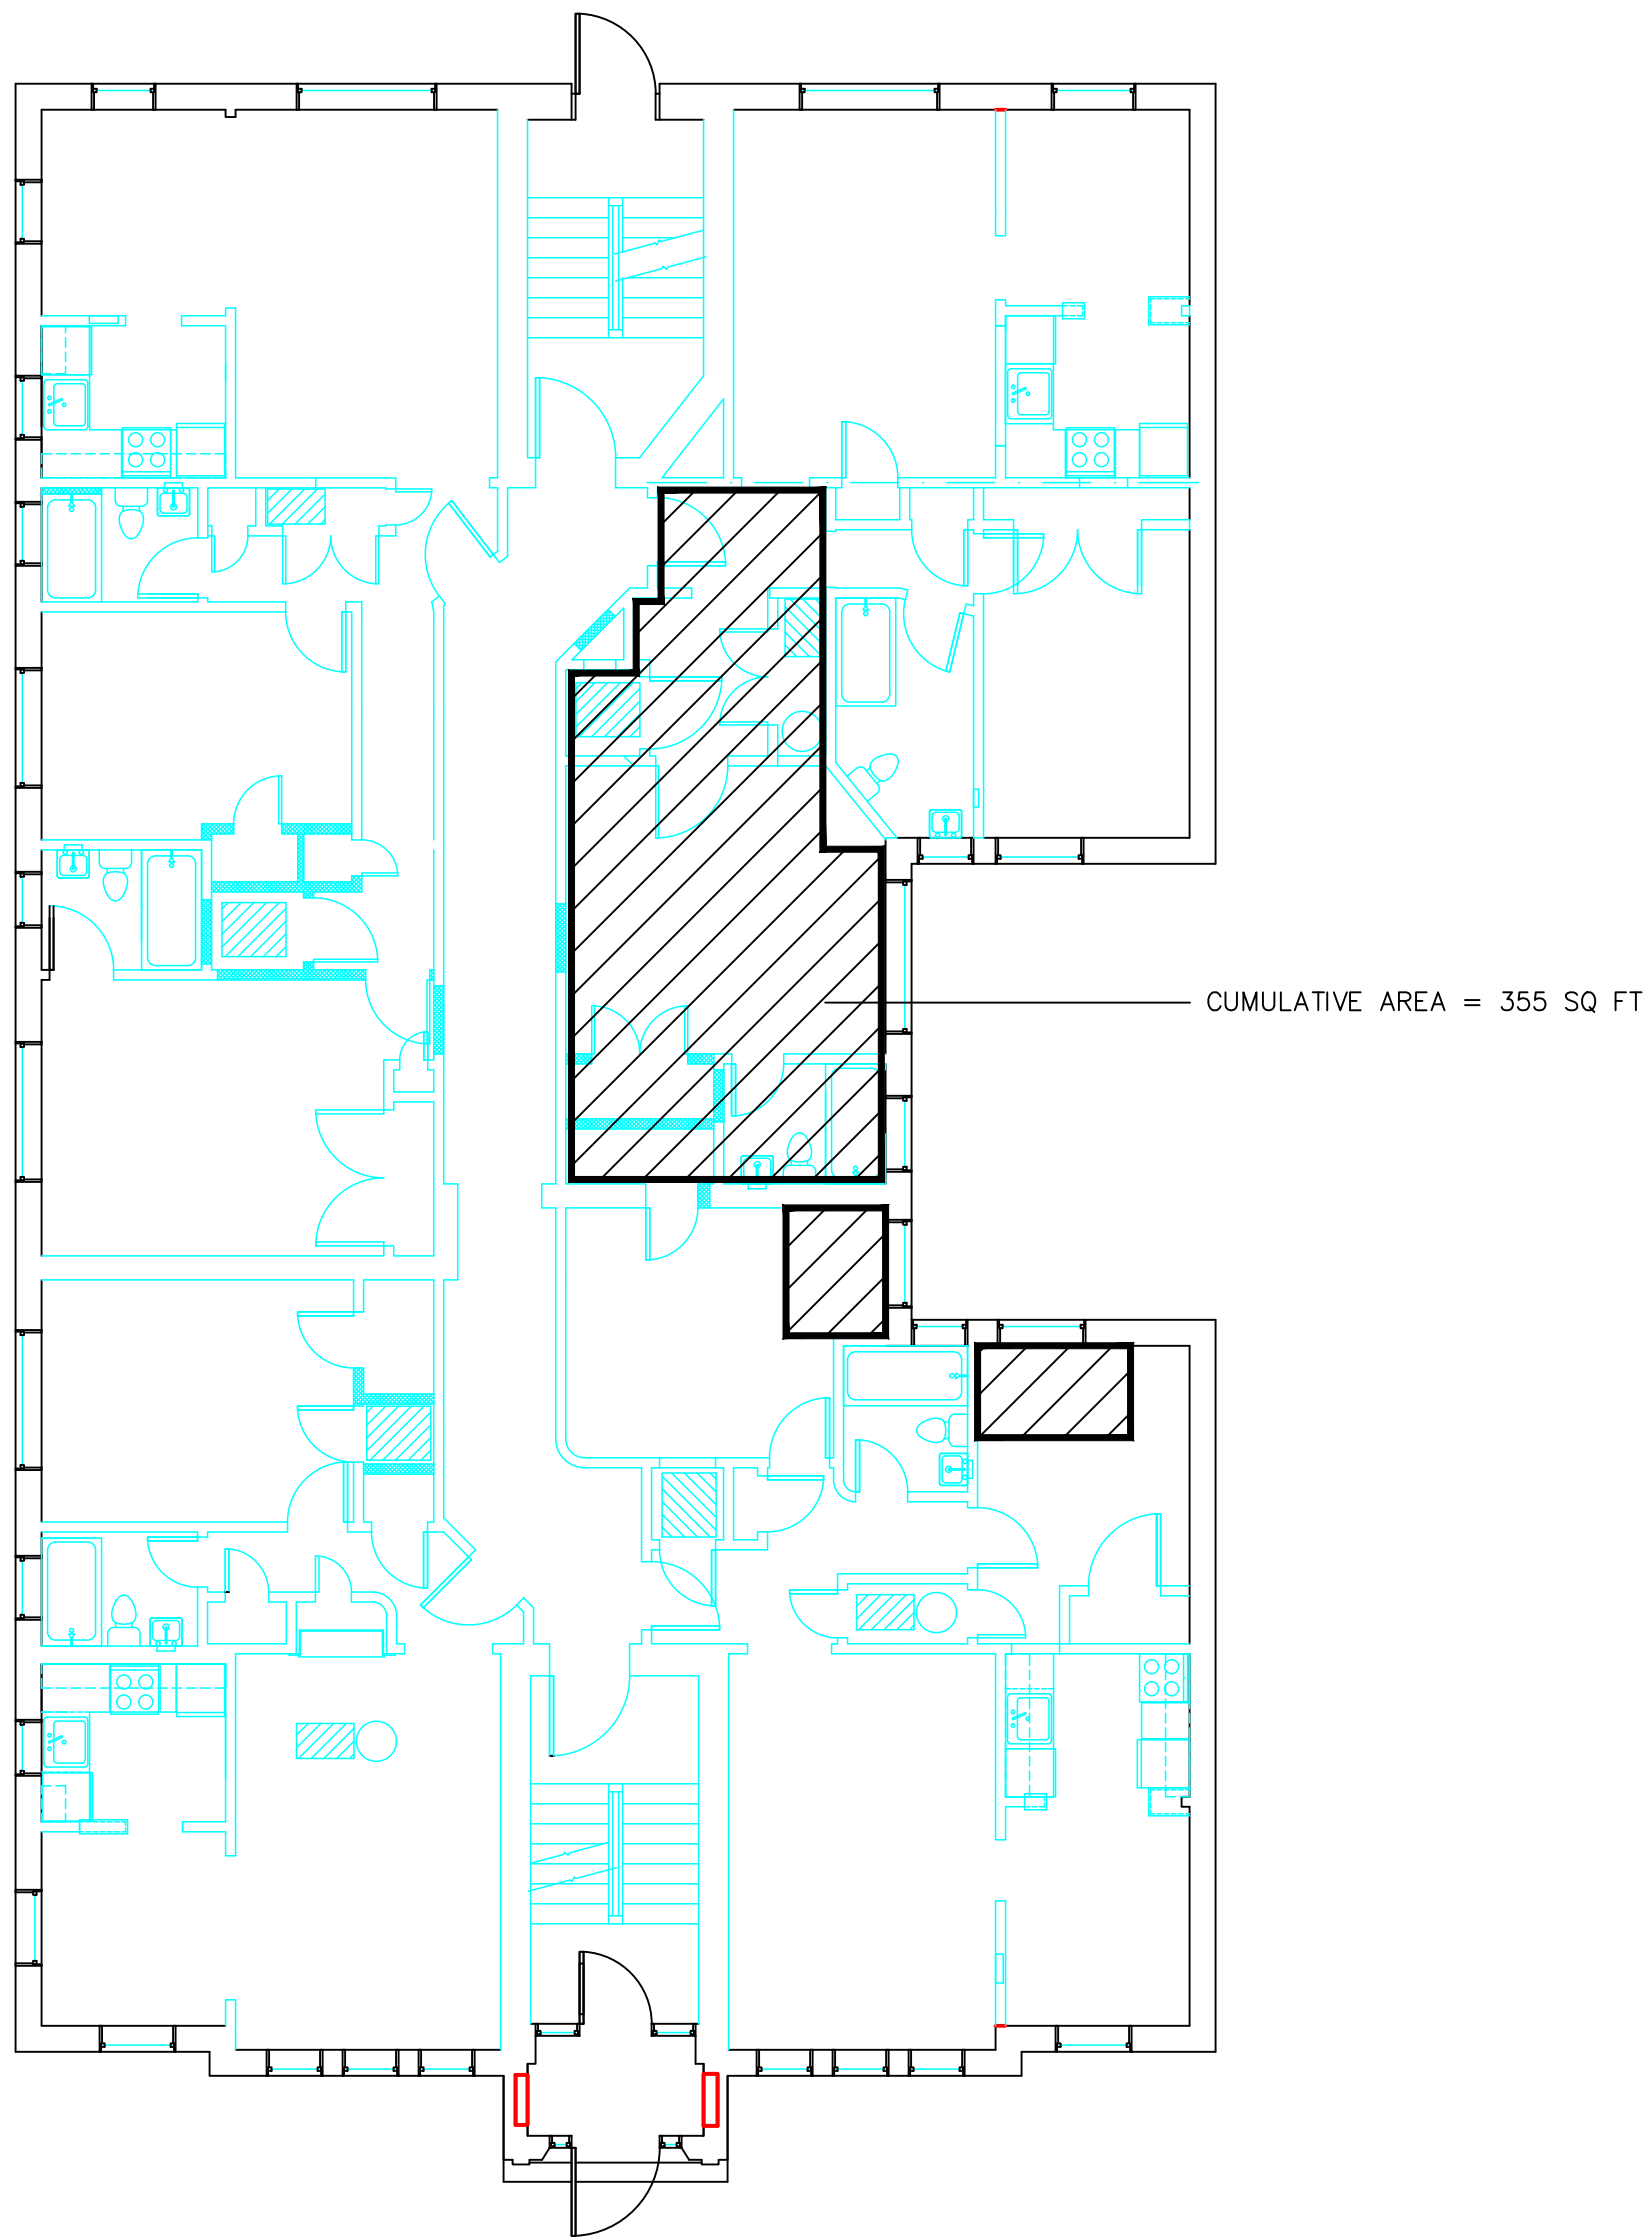
1st FLOOR, HARDWOOD FLOORING PATCH LOCATIONS
1/4" = 1'-0"

AREAS OF EXISTING HARDWOOD FLOORING TO BE REMOVED AND PATCHED WITH PLYWOOD OR OSB FLUSH WITH EXISTING ADJACENT FLOORING SURFACE. PRESERVE EXISTING HARDWOOD FLOORING TO REMAIN, PROTECT FROM DAMAGE.
