14111 & 14131 East Jefferson Buildings
EXISTING CONDITIONS AND RESTORATION PROPOSAL REPORT

Fenelon Diaz, CPBD

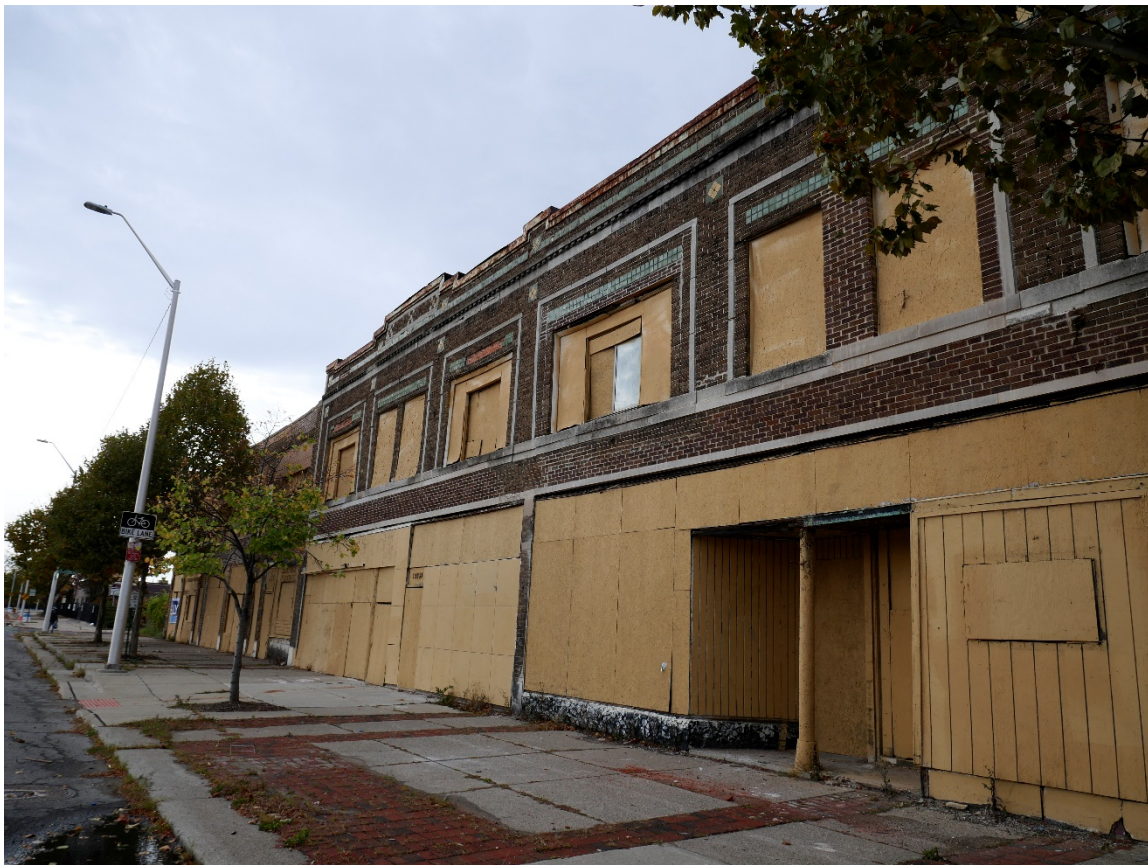
South Facade 14131 (East Jefferson Ave. side)

Both buildings, 14111 & 14131, keep same original materials on South Facade, 2nd Floor: Old Chicago Rosse Brick color and gray stone for trimming.

The first floor is currently covered with wood panels and plywood as a prevention measure for weather or irruption.

South facade brick wall is planned to be restored and repaired as original, adding new framing to the 1st floor and finishing it with exterior composite siding.

Windows for both floors are missing and will be provided, keeping as much as possible the look from the first half of the 20th Century, according the Final Report from the History Designation Advisory Board for the Jefferson-Chalmers Historic Business District. (May 11, 2007)
