## CITY OF DETROIT SIGNAGE WALL REPORT

Date:	Mon., Nov. 17, 2020	Date on site:	Nov. 13, 2020
Attention:	Michael Richards	Project name:	277 Gratiot Ave
Company:	Total Outdoor	Silman project #:	19837
Report:	City of Detroit Signage Wall Report	Location:	277 Gratiot Ave Detroit, MI
Owner:	Broadway Detroit Development LLC	Present at site:	Chris Kelley, Silman Ariana Sabbat, Silman
Submitted by:	Jenna Bresler, PE	cc:	Broadway Detroit Development LLC

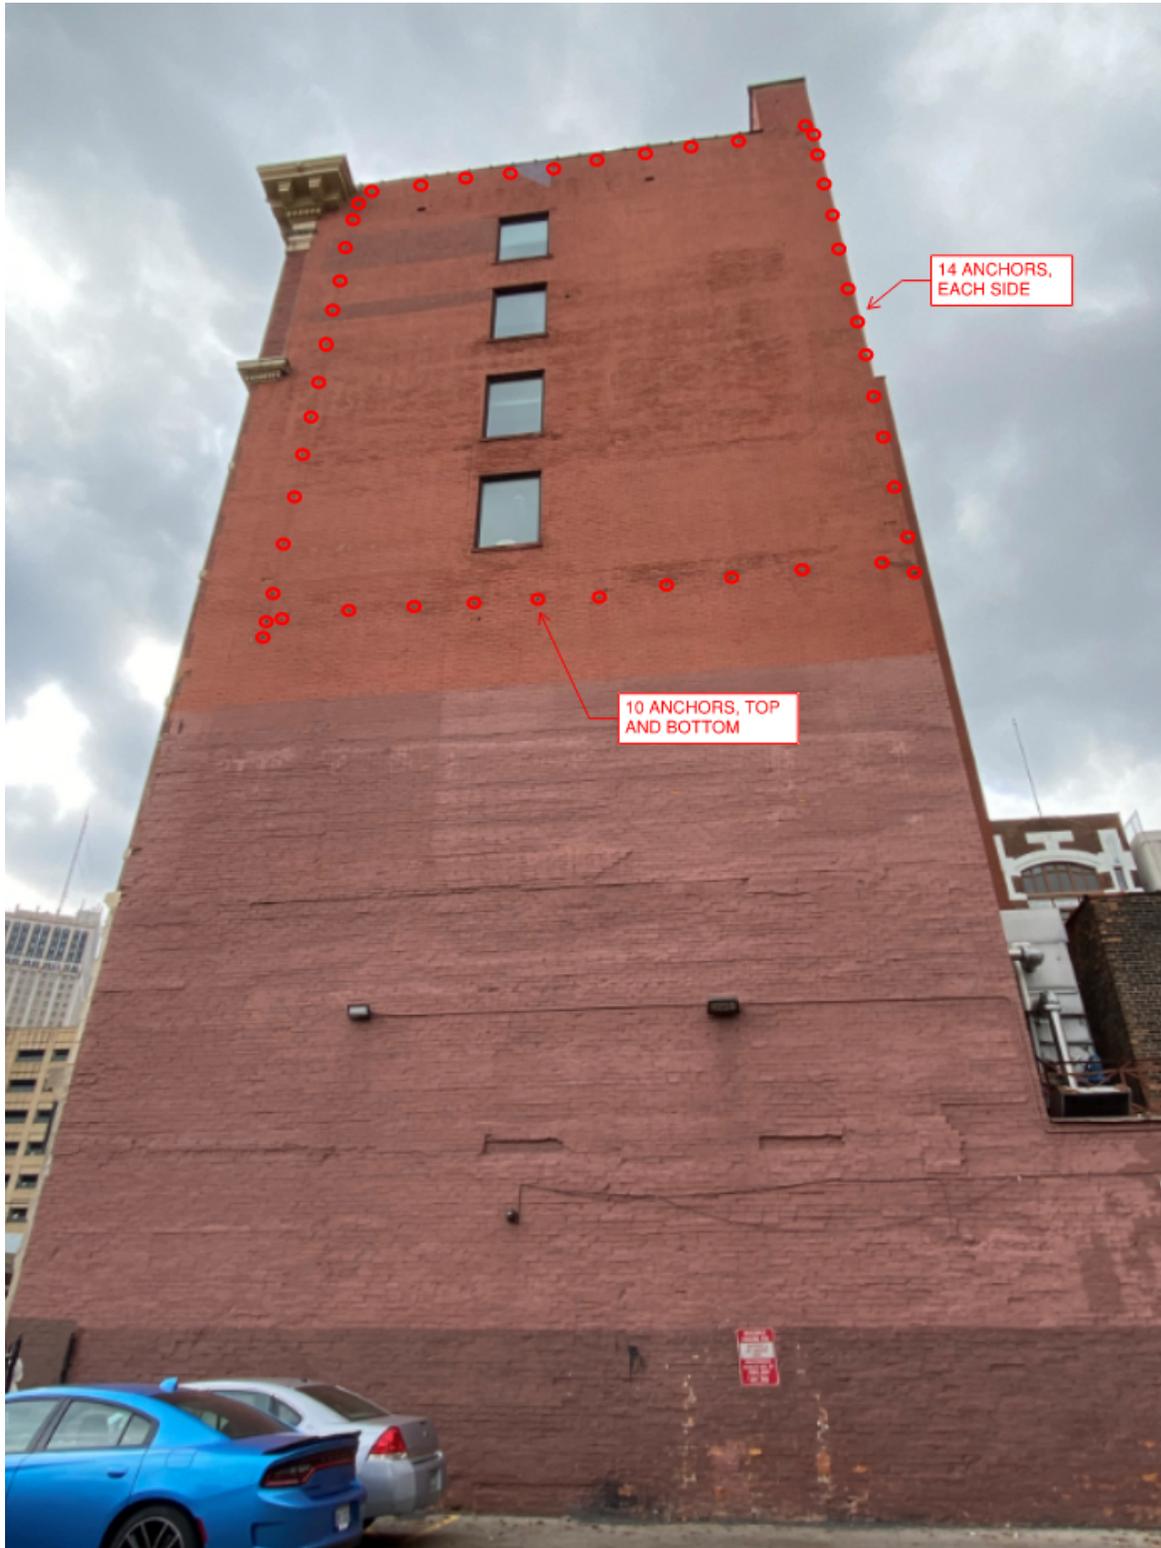
**Figure 2** Wall Elevation *(Photo by Silman)*

As requested, Silman performed a visual assessment of the exterior north façade wall (facing the parking lot on Gratiot Ave); review of the façade was conducted at grade via binoculars and completed on November 13, 2020. The building appears to be eight stories. It could not be determined at this time whether the structure of this wall is multi-wythe load-bearing masonry, or beam-column framing. Portions of the cornice terminate on the upper levels of the east end of the façade (Figure 2). Most of the brick on this façade was observed to be in fair condition. Assessment of the bottom four stories was limited due to the recent coating of paint.

While the signage is currently not attached to the building, the signage anchors are connected to the brick as shown in Figure 2. It does not appear that the conditions observed during the review are caused by the sign anchorage nor impact these sign anchors.

Based on the findings of Silman's review, the building façade that is to support the signage is in fair condition. There are no signs of distress in the wall where the anchors are secured. Given the approximate load of the sign, the wall can support the signage as designed by Total Outdoor.
