Property Address: 14831 Warwick, Detroit, MI 48223

I am looking to replace the front entry door on my property at 14831 Warwick St. Detroit, MI 48223:

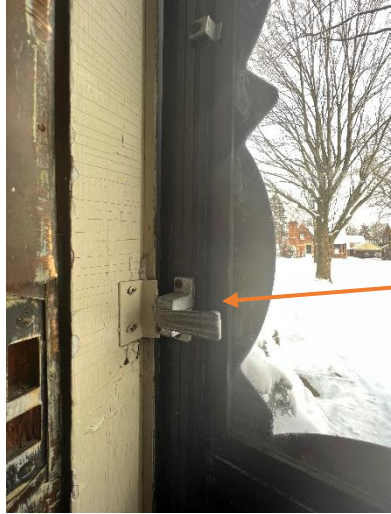
Screen door doesn't lock

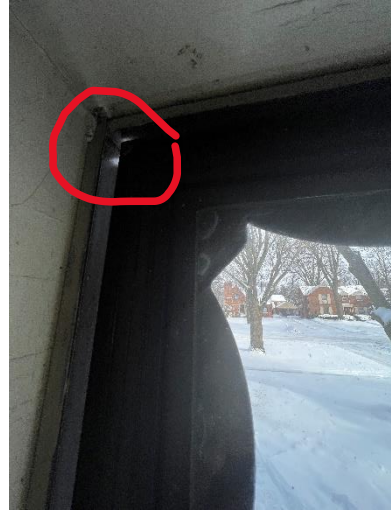
Screen door doesn't close all the way,

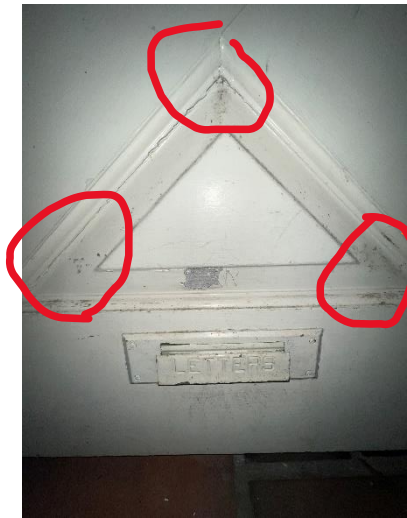
Mold on door

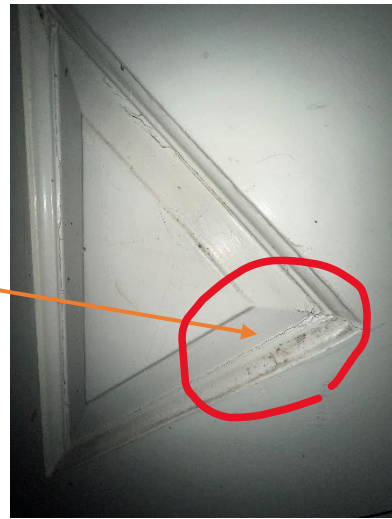
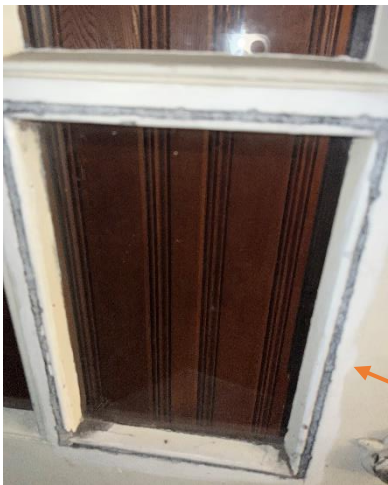
Mold growing around window pane that was replaced

After the glass pane and shutter was broken by someone unlawfully attempting to enter the home, the broken pane was replaced. Mold developed on the replaced pane and the integrity of door still remains compromised.

The proposed new door would provide physical security for me and my family with a properly working lock system and decorative glass disallowing outsiders to see directly into the home or being able to easily break the glass. The new door system would also provide a wood looking material that is less susceptible to mold growth like the current door.

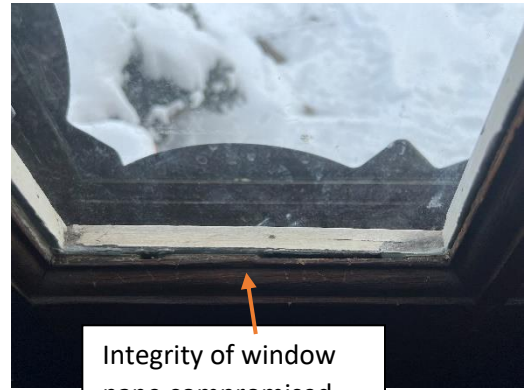
Integrity of window pane compromised after being replaced

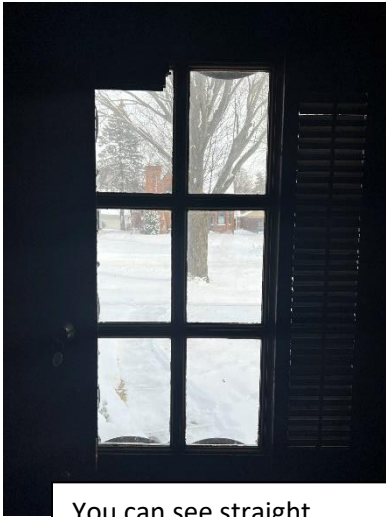
You can see straight through the house from outside, after someone tried to break-in and broke shutter and lower window

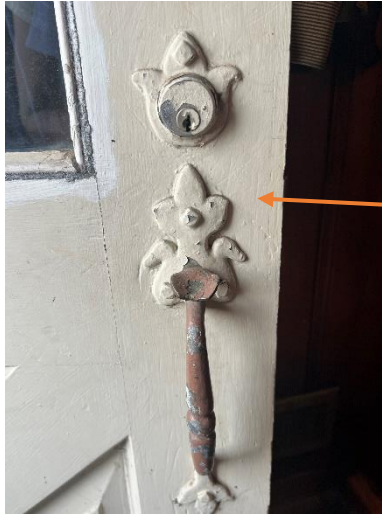
Lower lock does not work from exterior

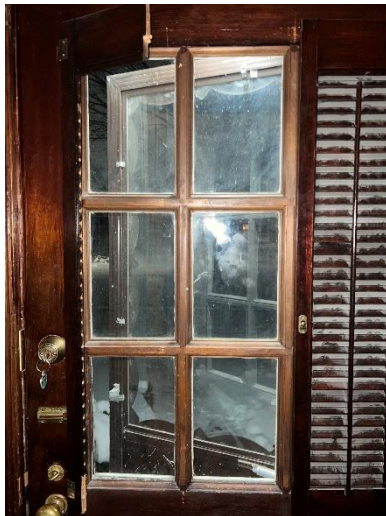
Broken shutter, key in door for easy exit during emergency
