1901 Chicago Proposed Window Project

July 13, 2022

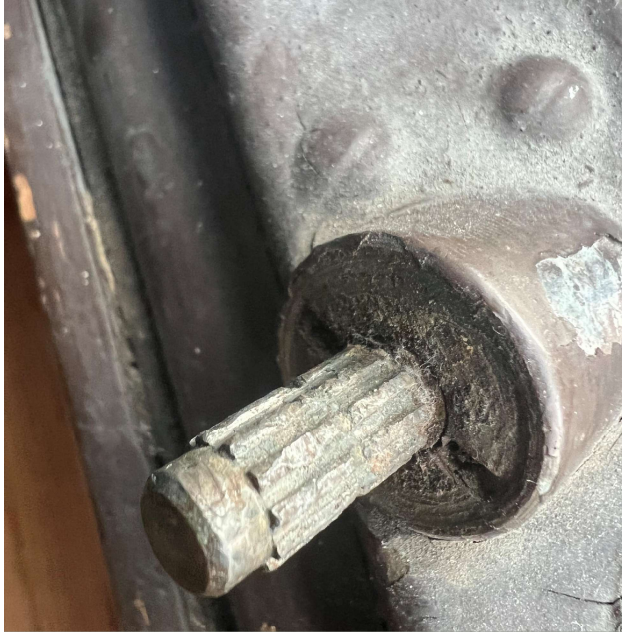
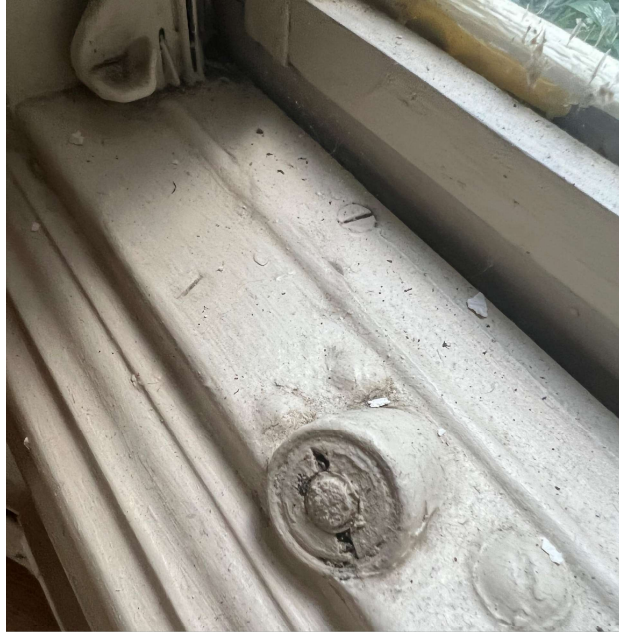
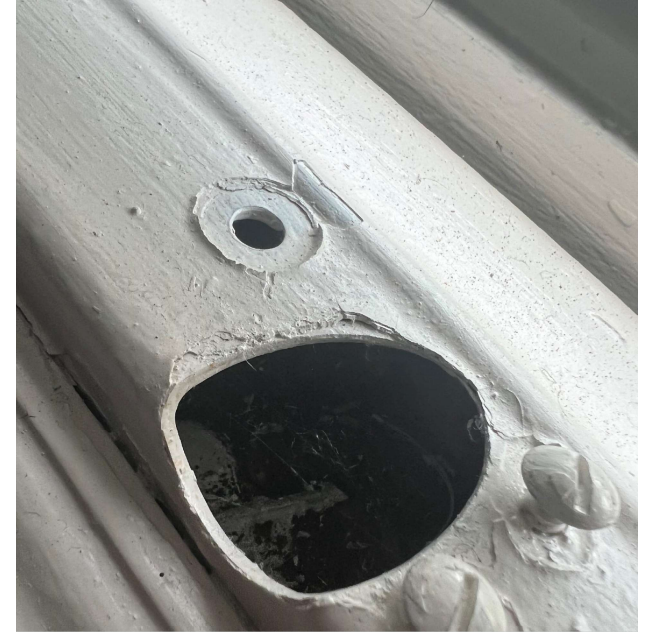
- Cranks are missing from majority of windows
- Splines are damaged or missing from several windows
- Entire mechanism missing in some cases
- Teeth inside of cranks and/or teeth on splines are worn beyond repair

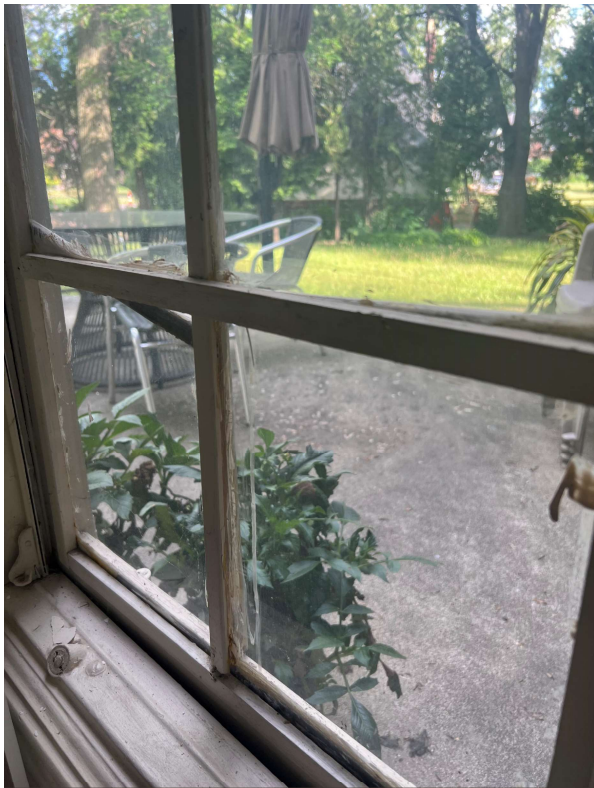
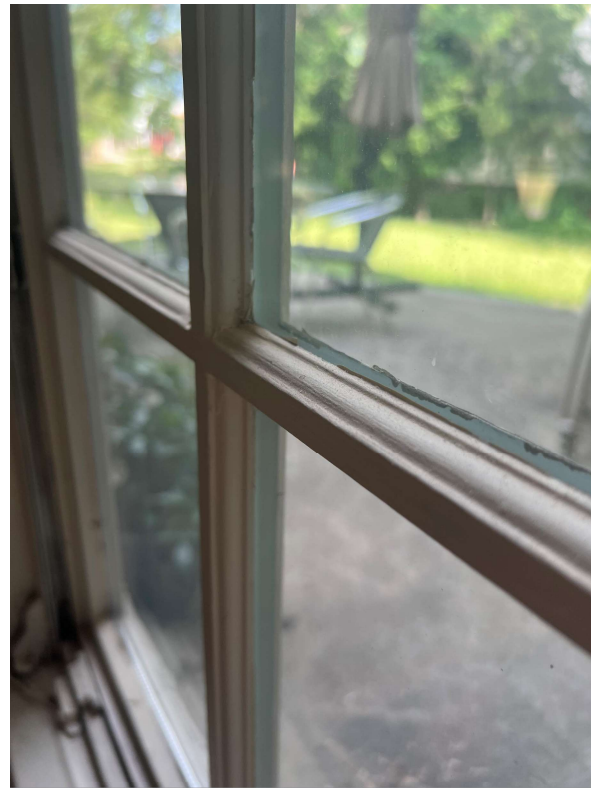
- One of the casements in the bay window has been presumably broken and replaced
- It is comprised of plexiglass in place of standard window glass and the “muntins” appear to be made of a strip of vinyl siding
- This casement is part of the 6-segment connected bay window
- *See pictures: left is the Plexiglas replacement; right is standard window w/ proper muntins*

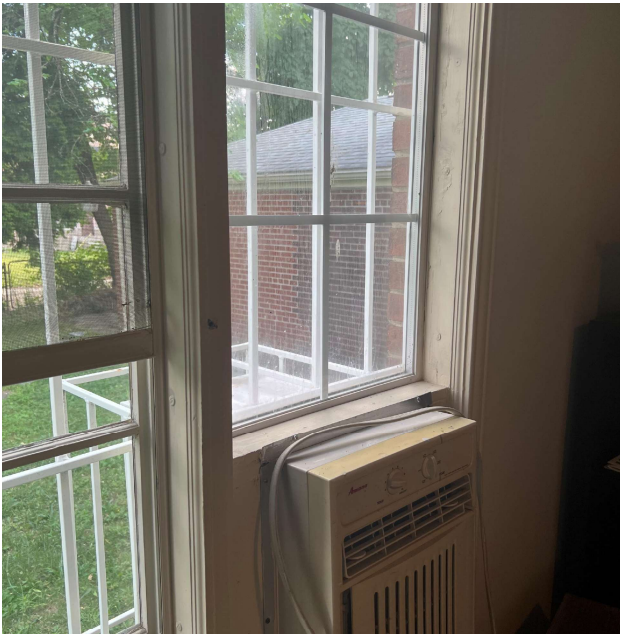
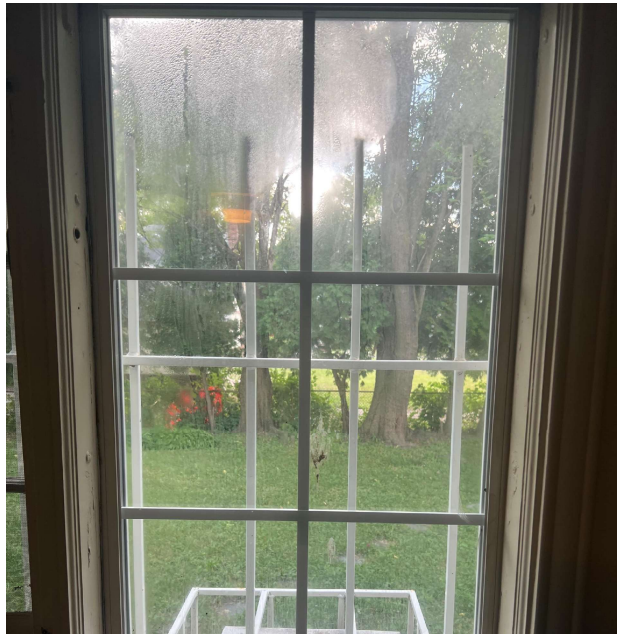
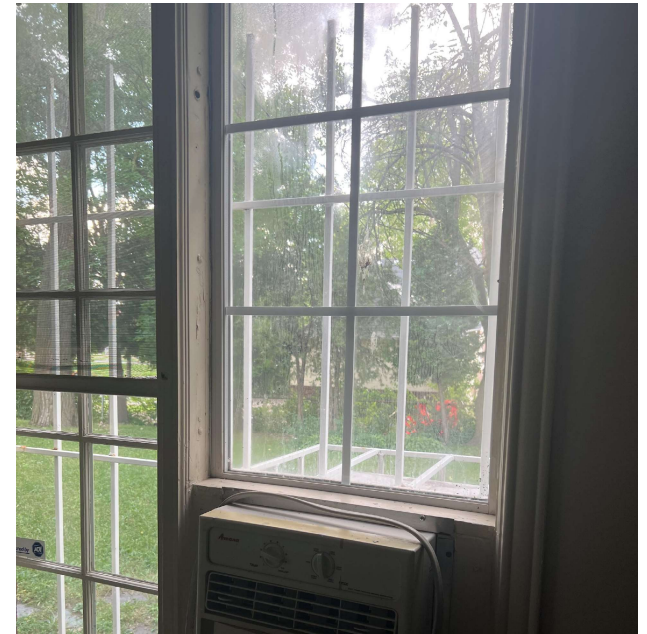
- The breakfast nook window is built to accommodate an A/C unit
 - It does not cover the full window opening – only the portion not consumed by the A/C unit
 - We would like to remove the antiquated A/C unit and would be left without a full covering in that case
- We are 100% certain that this replacement window is not original given that is white vinyl and has a blown seal

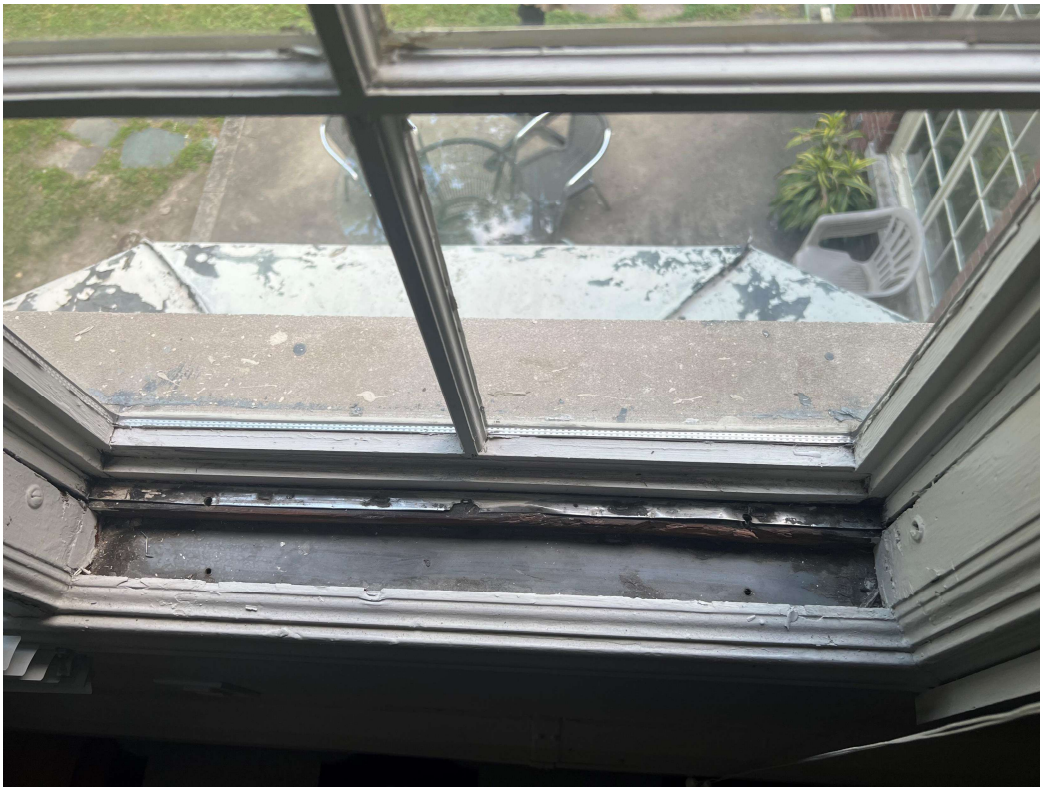
- The rear-facing upstairs window was added to this project for two reasons:
 - The window lacks a bottom stop and track/rail that should sit inside the sill, as well as all mechanical components necessary to operate the window
 - During rainstorms, we have water penetrating the main floor's ceiling due to improper sealing and missing window components, causing significant damage to the plaster and excess moisture throughout the house
