HISTORIC DISTRICT COMMISSION REVIEW

1620 ATKINSON – GARAGE DEMOLITION & REBUILD

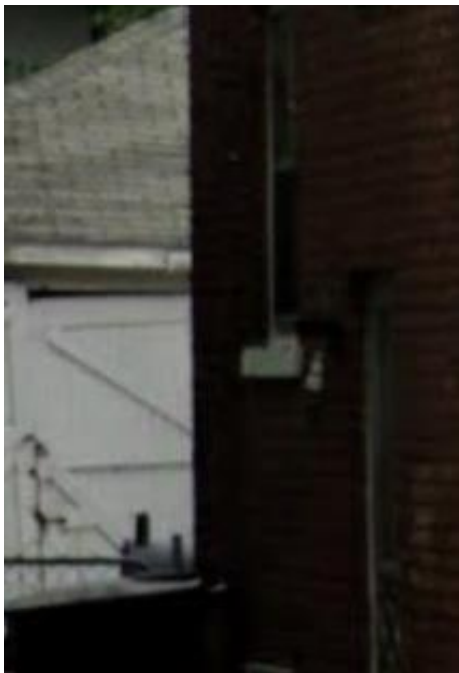
Figure 2 - Original Two-Car Garage, Left Side

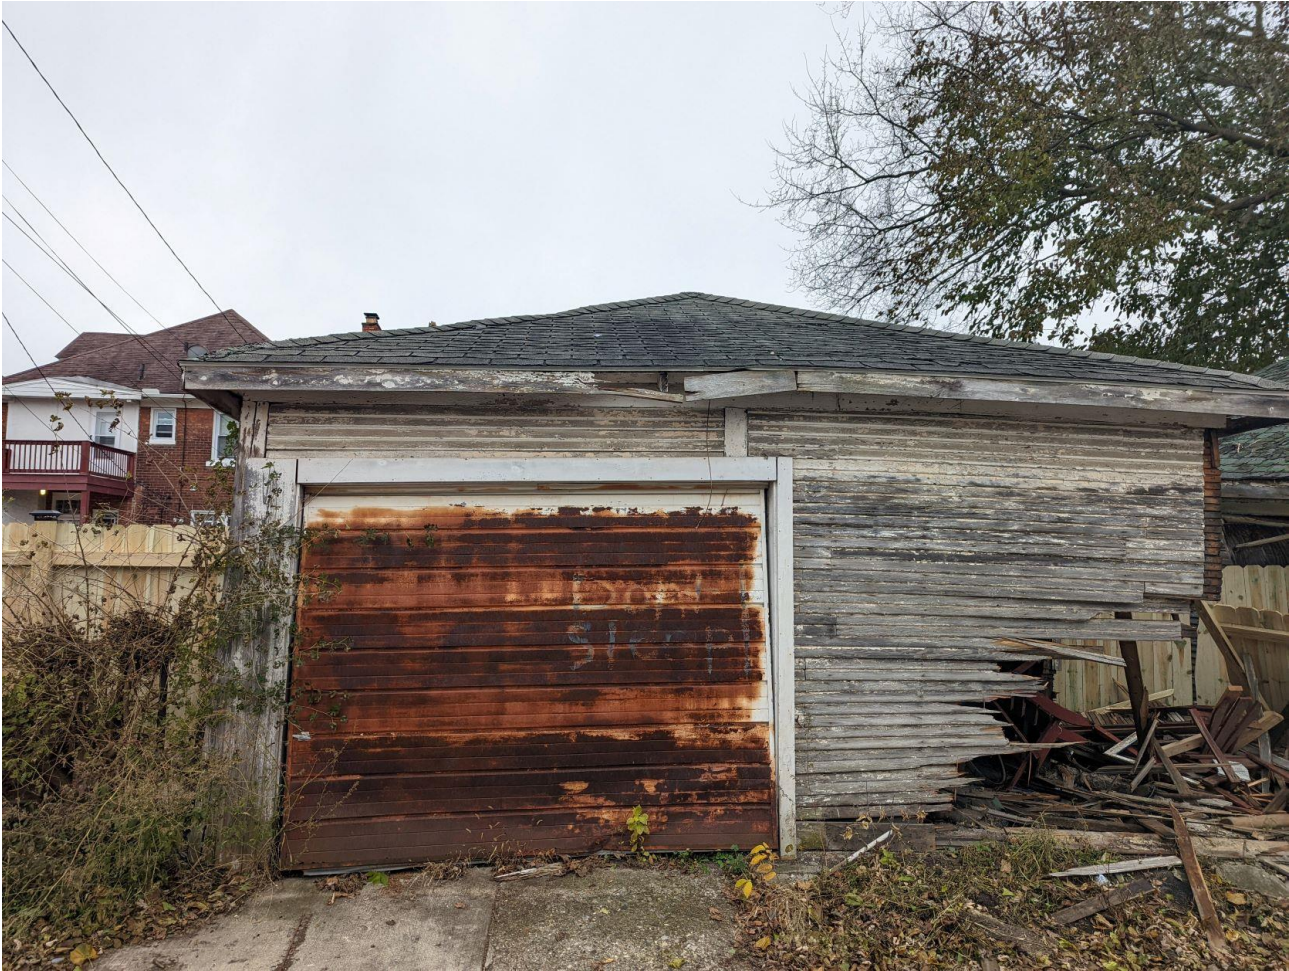
Figure 3 - Back of Garage (alley side) - see corner

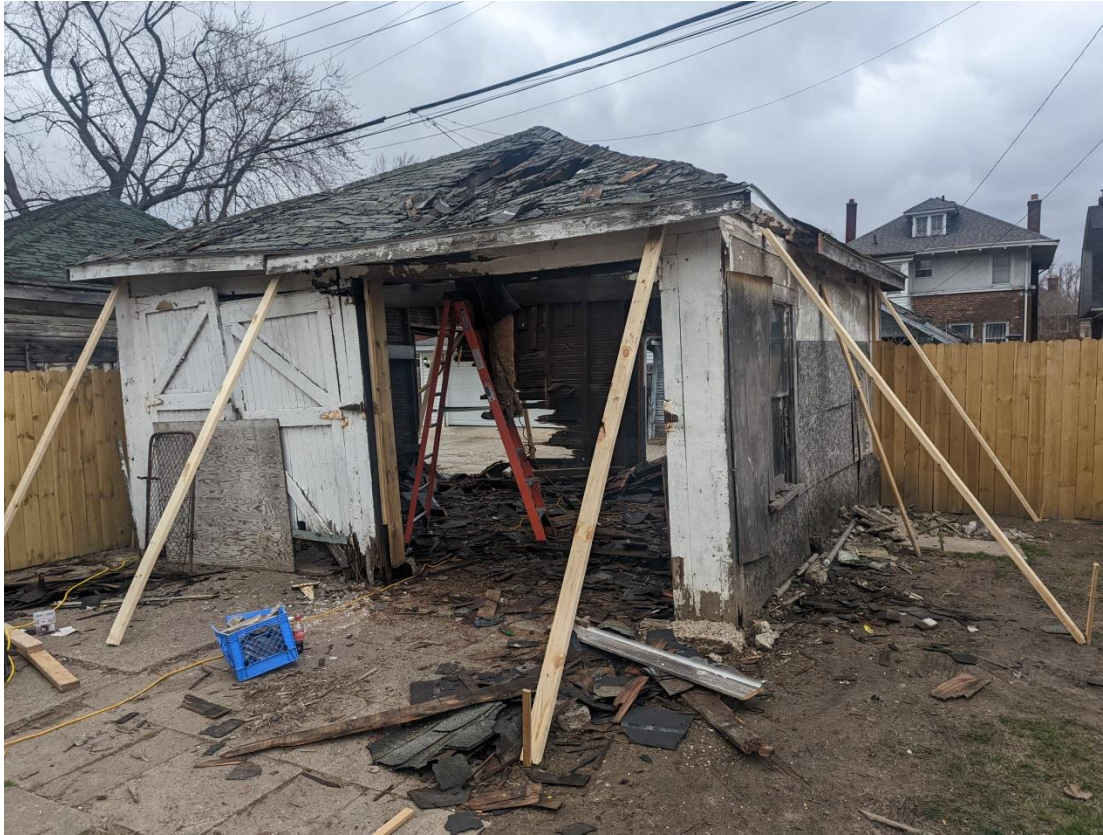
Figure 7 - Full through view (front, side, & through back) of damaged garage

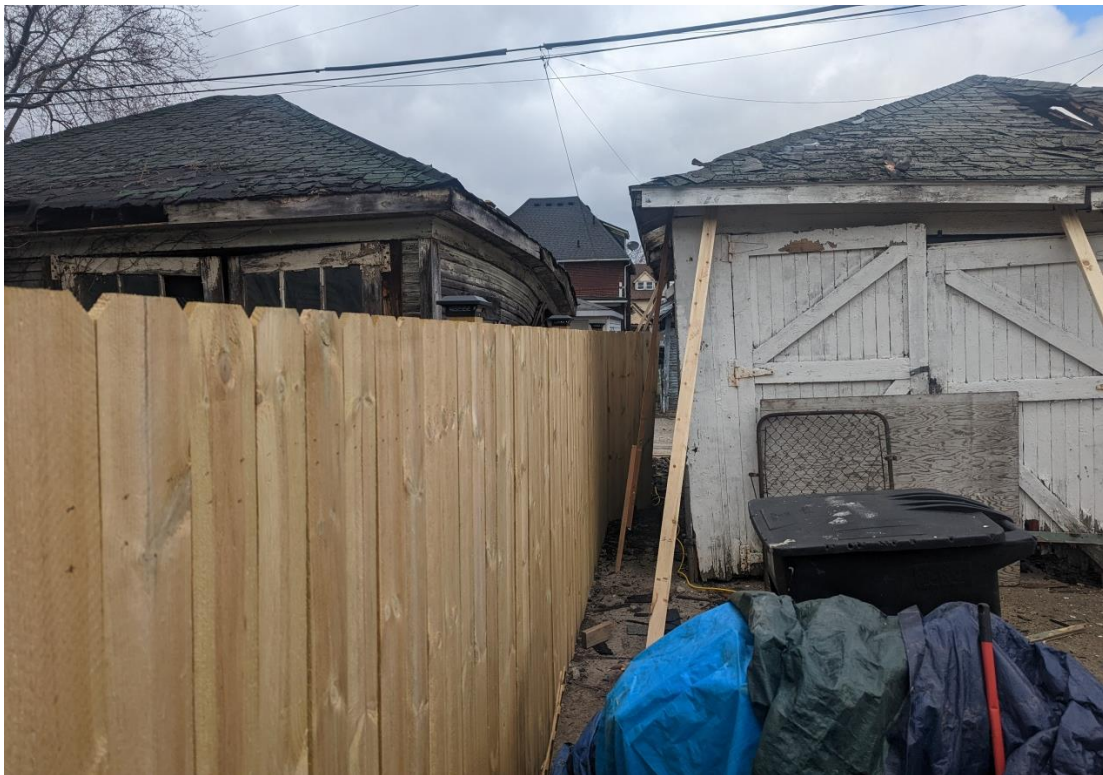
Figure 8 - Left side, near fence, of damaged garage

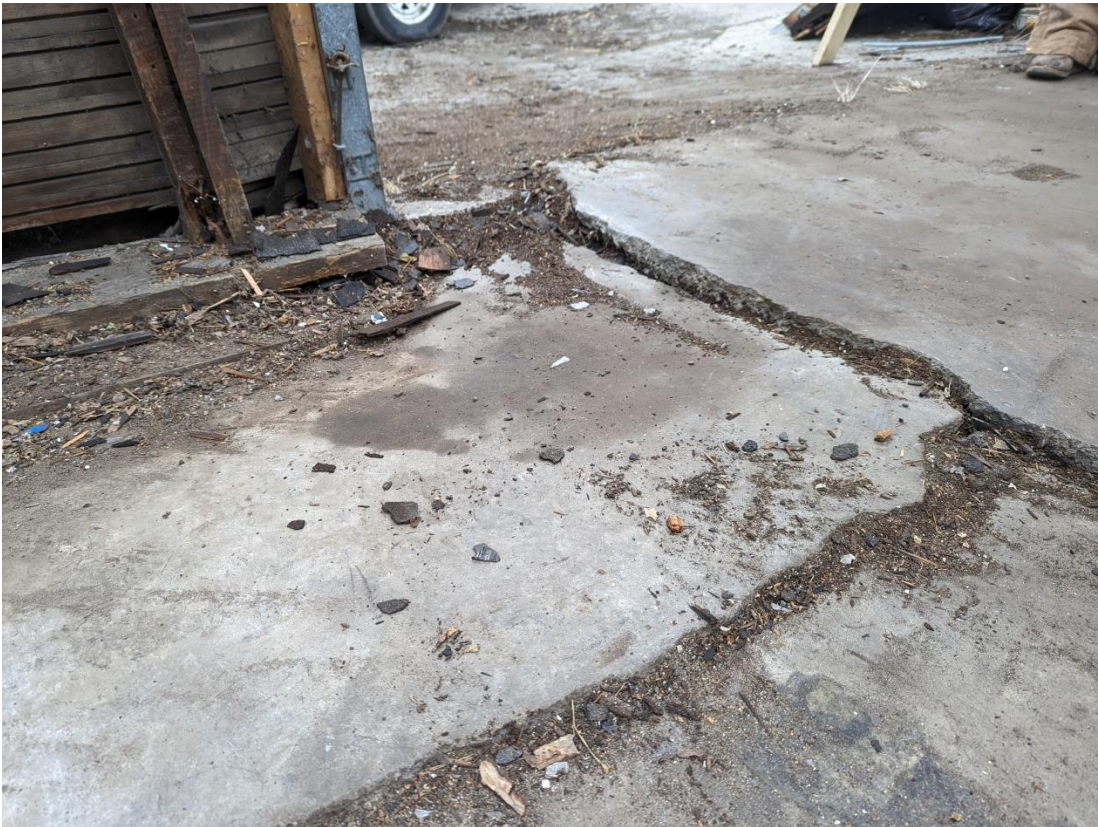
Figure 10 - Post Demolition, uneven concrete slab

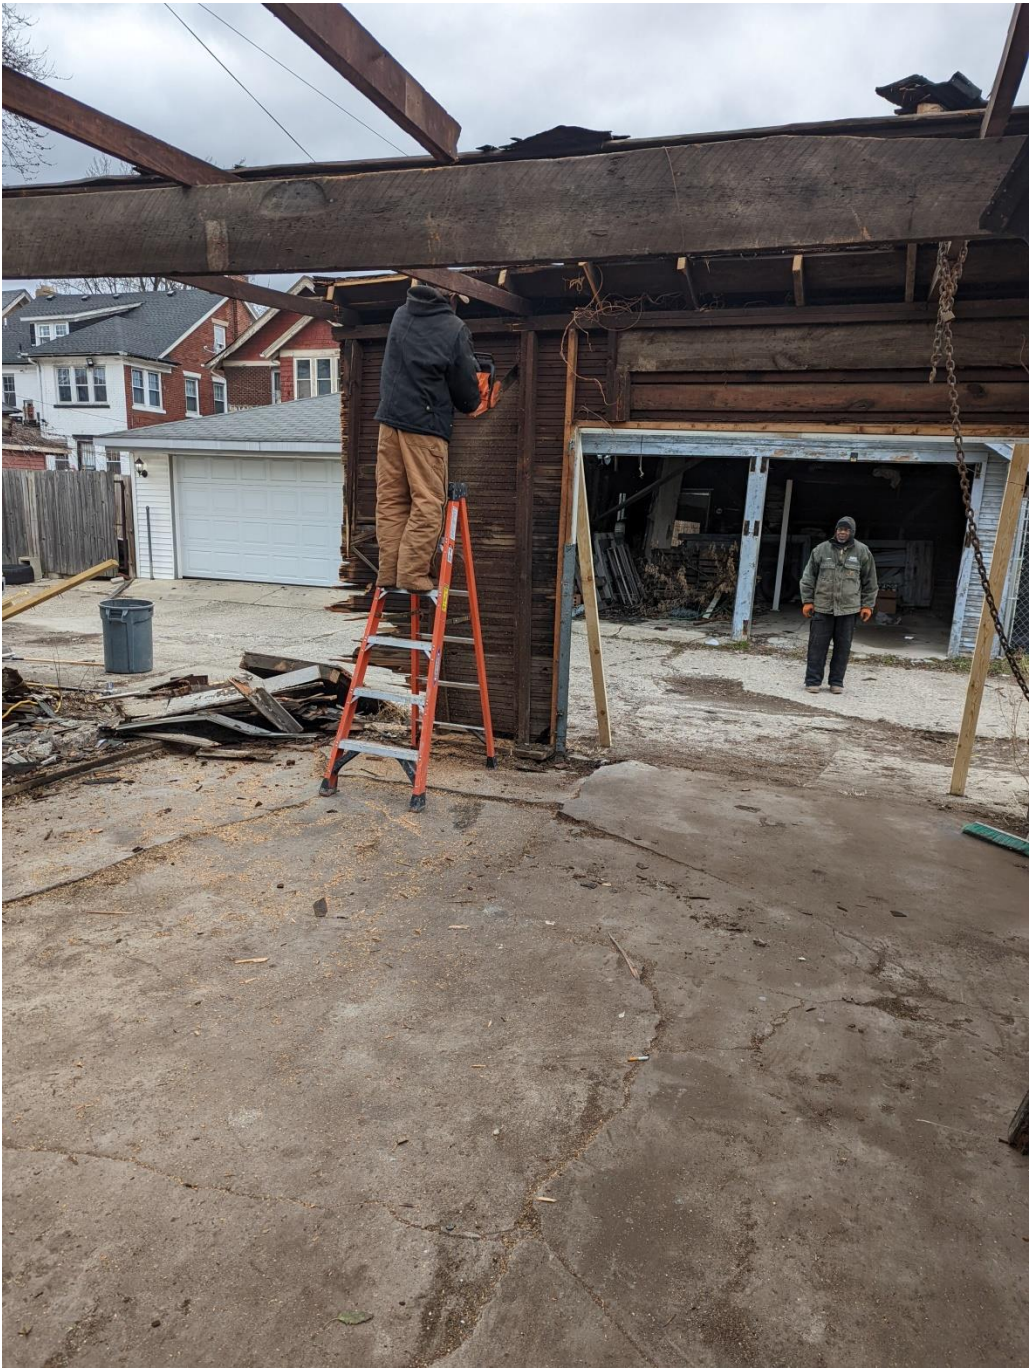
Figure 13 - Replacement garage to be erected as structure was a safety hazard and needed to be demolished

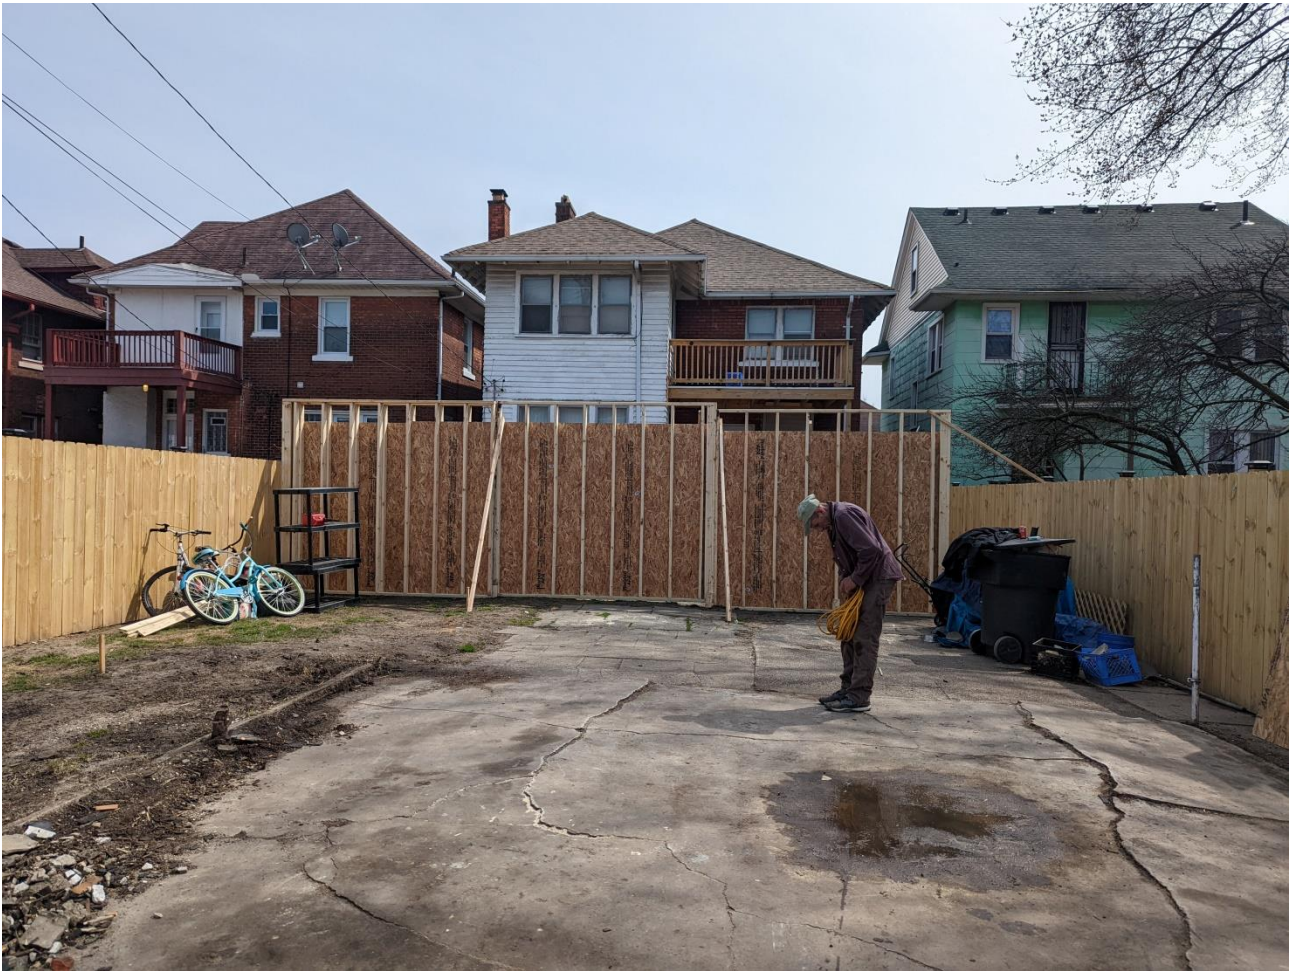
Figure 14 - Demolition completed. New garage to be erected in same area
