<u>Historic Roof Replacement Questions:</u> **913 CHICAGO BLVD – BOSTON EDISON DISTRICT**Information provided by current owner as well as on-site assessment conducted by Bruttell Roofing Co, Inc

Regarding: Building permit application for re-roof of **913 CHICAGO BLVD – BOSTON EDISON DISTRICT Exterior photos and condition report**

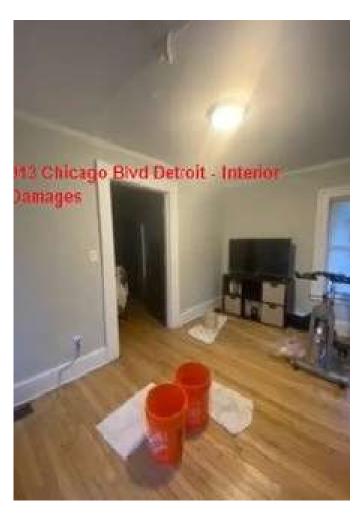
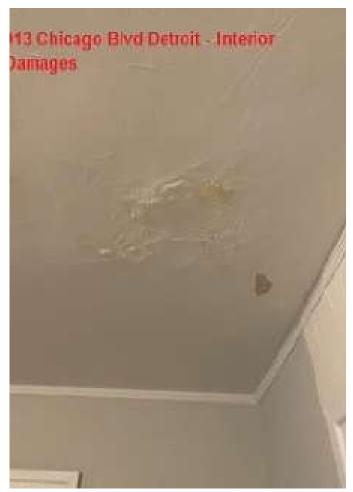
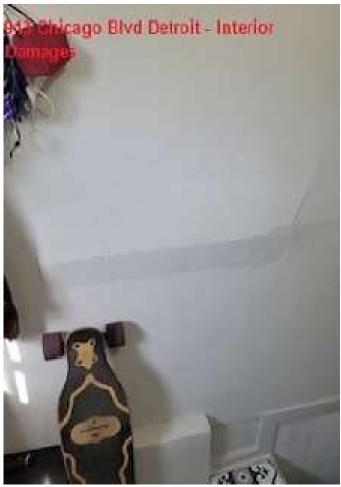
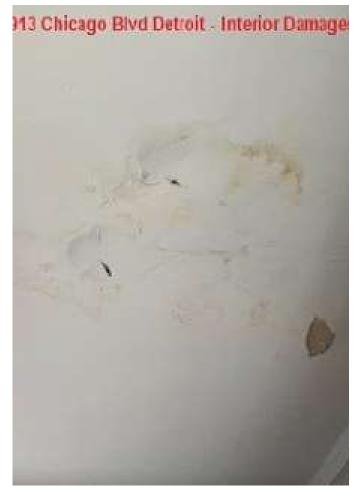
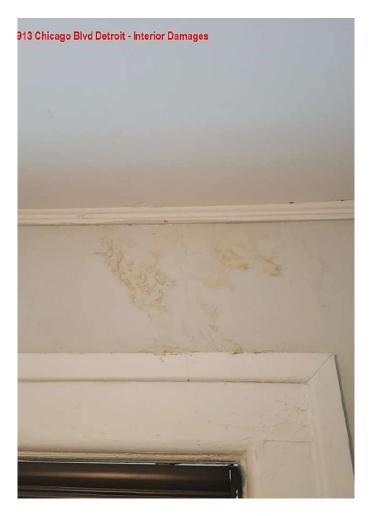
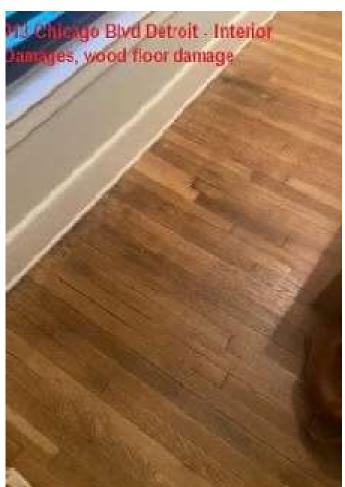
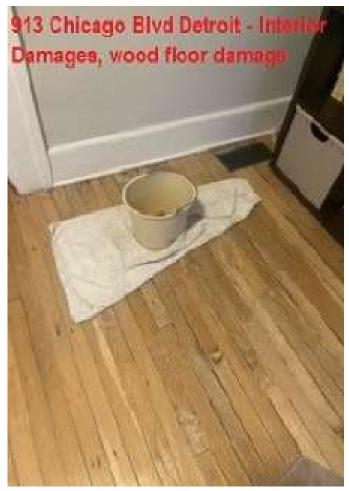
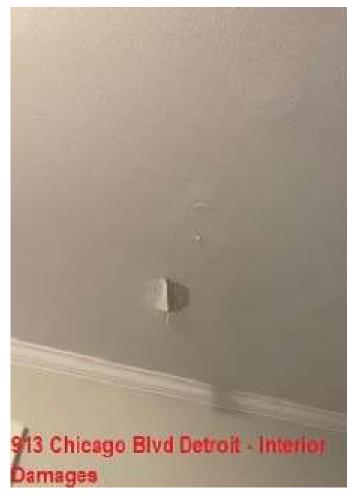
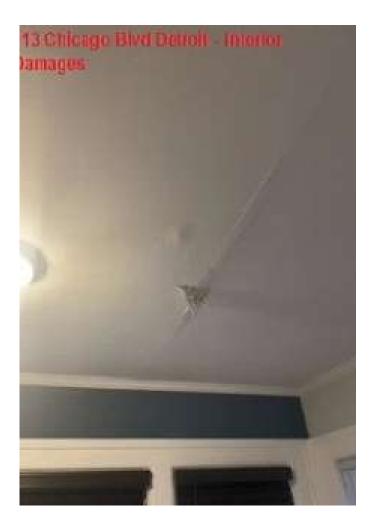
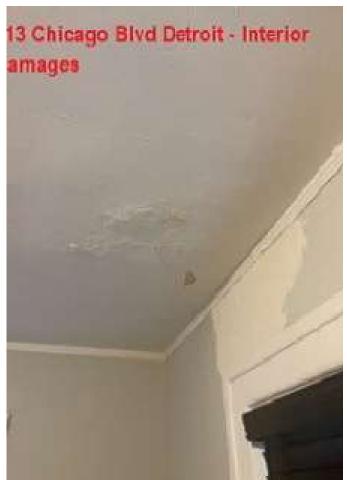
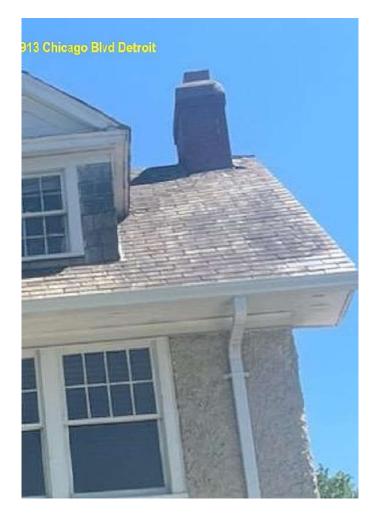
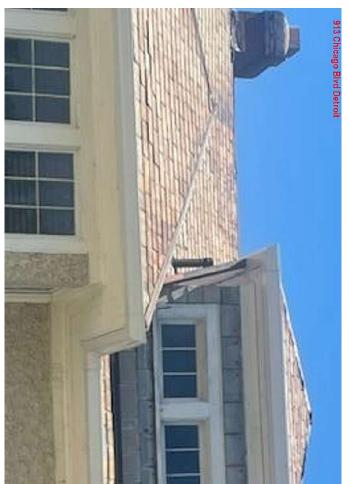
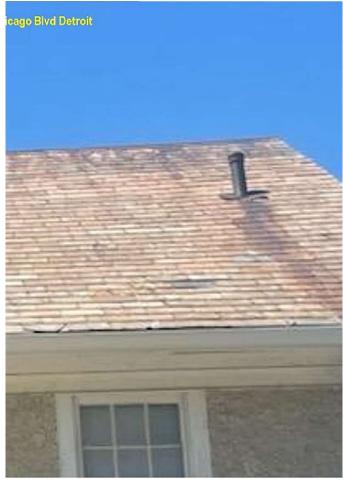
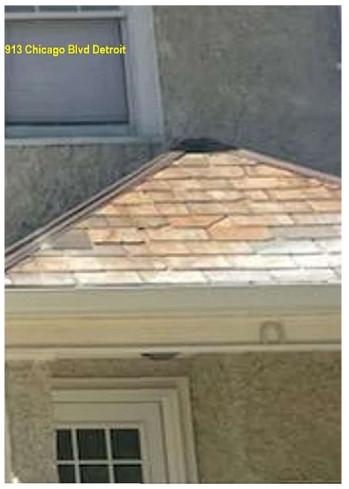
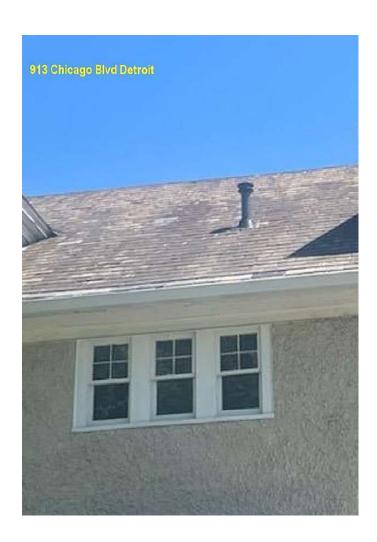
Please see attached photos of existing roofing conditions. Please note: We are not able to climb and walk the roof again until replacement for safety and condition reasons. There are cracked and uneven tiles with complete penetration failure throughout the entire roofing system. This roof is unrepairable with the condition being too far gone past its lifetime. This entire roofing system has failed, is unrepairable, and is causing damage to the home. This is considered an extremely high priority installation and each day spent waiting continues to cause additional damages to the home. Client would like us to consider this now an emergency situation and has asked that we replace this roof immediately.

Provide cost of an in-kind repair of the roof (2 estimates as required). Note the percentage of new tile that would need to be added in order to repair. Also, note the outcome of installing new tiles with the existing tiles Roof is being 100% replaced with CertainTeed Landmark PRO shingles and all appropriate accessories
