Property: 1062 Vinewood St Detroit MI 48216

Description of existing condition and project.

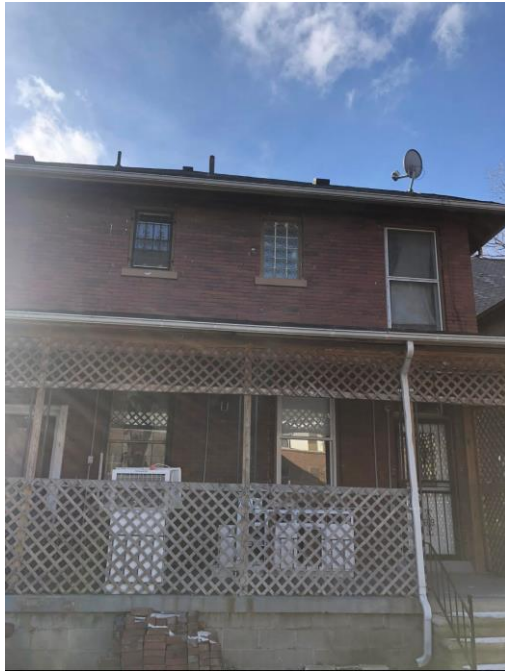
Before: Back wall bathroom window and room window.

Status: Both windows were falling apart; We want to patch those windows with Masonry work.

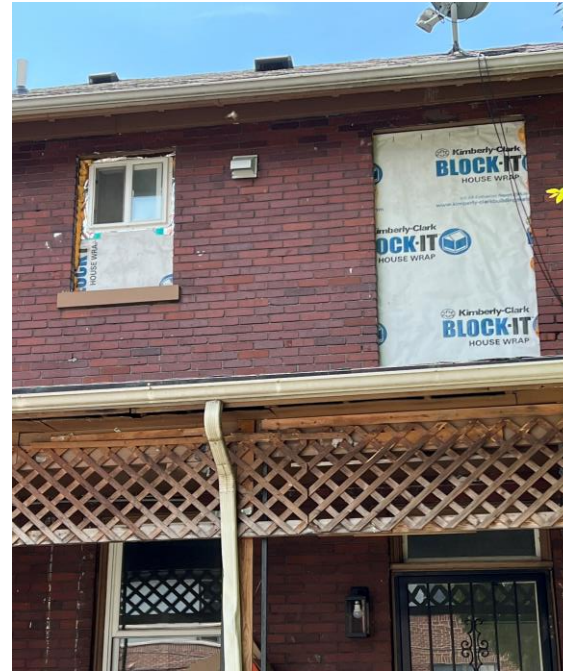
After: Back wall bathroom window replaced, and room window removed.

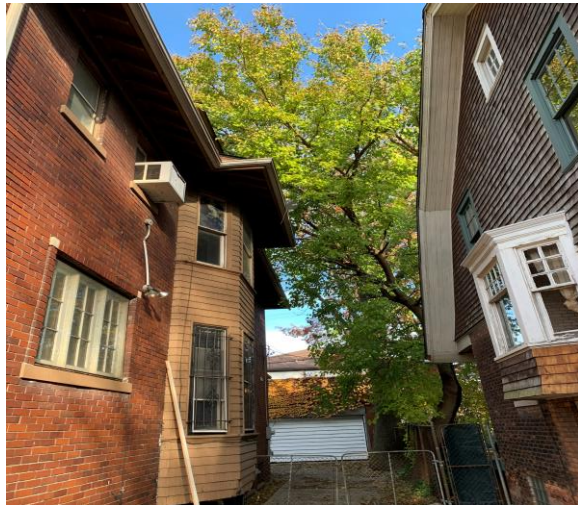
Before: South wall on the side of the house top two windows. They were cover from the inside by drywall and falling apart.

Status: Both windows were falling apart; We want to patch those windows with Masonry work.

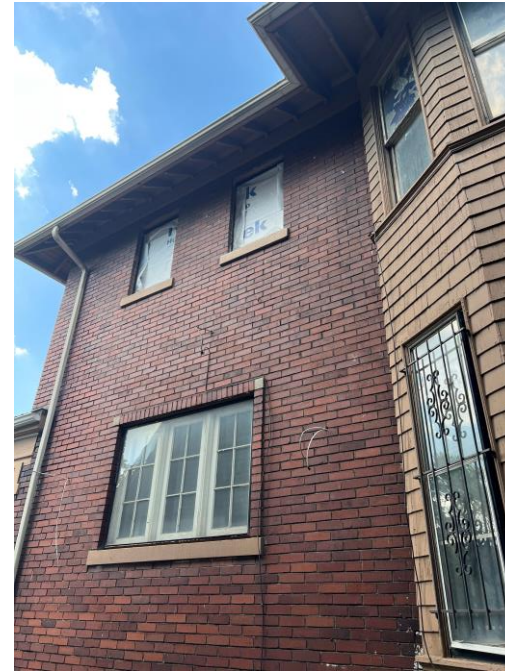
After: Both top windows removed.

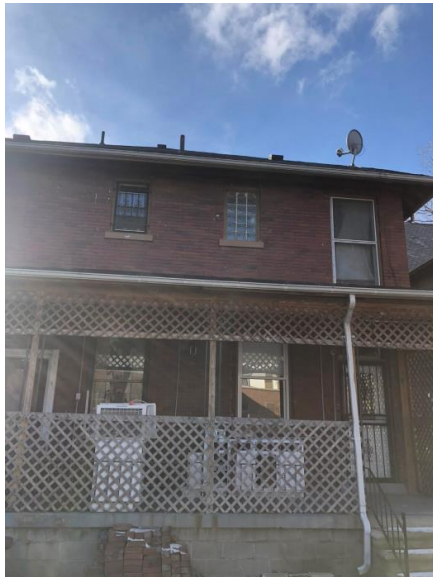
Before: first floor back left window.

Status: Windows were rotten and falling a part; We want to patch those windows with Masonry work.

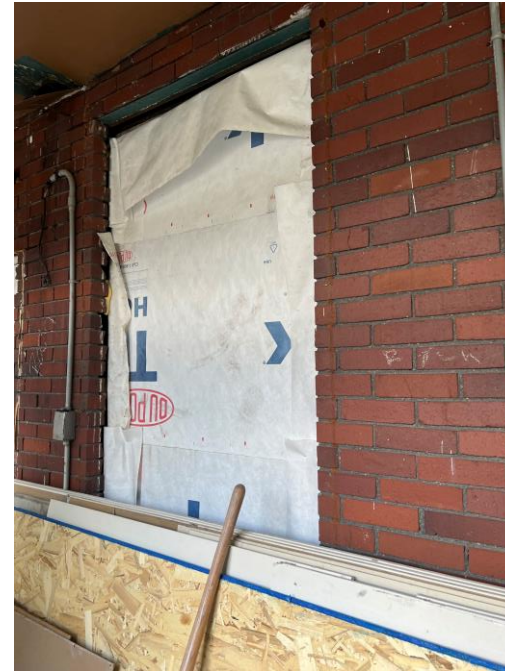
After: First floor back left window removed.

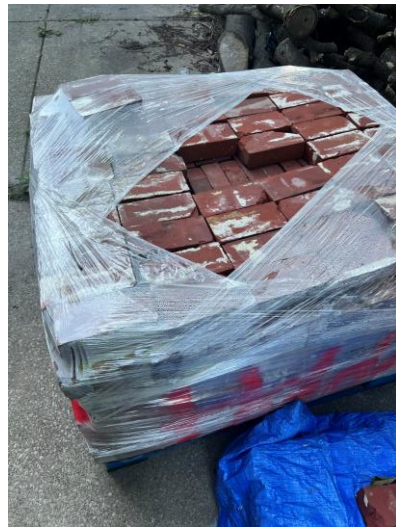
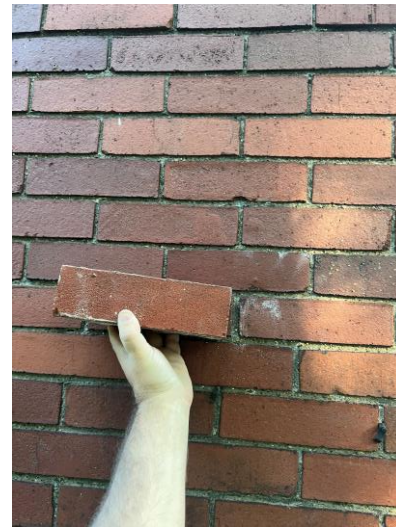
- All the windows are 100+ year old and are rotten and falling apart. We want to patch those windows with masonry work.
- Materials: Neusd face brick (see pictures below for match)

- General Contractor removed old windows and added weather insulation.
- Masonry contractor has been hired to do the work.
- Bricks were picked in a local store (neusd face brick) and matches current and existing brick.
