# 14894 Greenview Rd

## Window Replacement

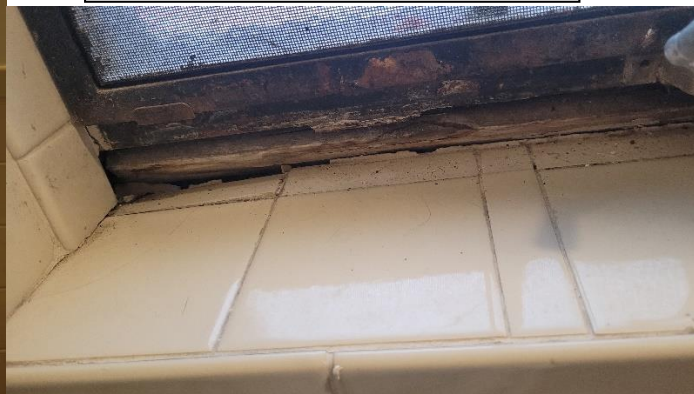
Rotting of trim around second story bathroom window
