Building Permit Application: **913 Chicago Blvd – Boston Edison District. ePLANS Permit number BLD2022-02869** Removal of Slate roof, installation of CertainTeed PRO Asphalt shingle roofing system.

Request: The planning division requires photos of the existing roof and specifications/details (color, material) of new roofing material to better understand the project scope and what additional applications (if any) may be required from the planning division.

Existing Conditions: Built in 1913, 2.5-story colonial home. The Gable roof featured dark-grey slate with open valleys, slate also featured on the sides of the two dormers. 5" k-style aluminum gutter system in place. The house roof replacement is the subject of this application.

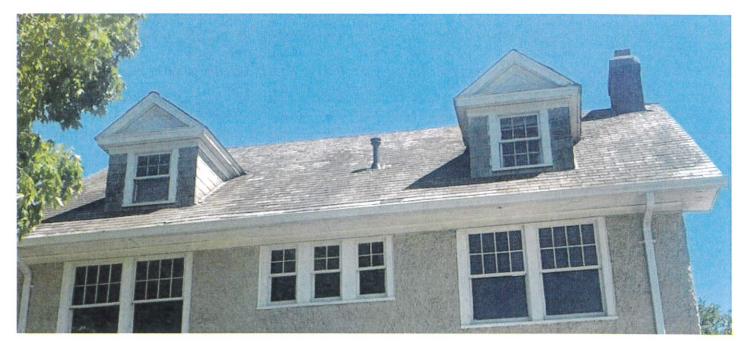
Rationale: The slate size was 12x12", age approximated at 108 years with a typical life expectancy of 80 years. The roof was not well maintained over time having been vacant for many years. The slate was cracked and uneven throughout the roof field with many signs of age and wear apparent including missing and broken tiles, staining, accelerated fade and overall penetration failure. Inside of the home there were damages throughout with some leakage making its way down to the first floor. Damages include but not limited to exterior stucco, window trim, wood floor, walls, and ceilings.

The photos were taken from the ground, the roof was considered too unsafe to climb. I requested close-up photographs from the project managers twice and was denied due to the slate condition and our inability to see the damage to the deck beneath. We could not see where the deck was missing or failed and this also posed huge safety concerns.

House Roof Replacement: Remove all slate roofing from the house. Install CertainTeed Pro dimensional asphalt shingle, Driftwood in color.

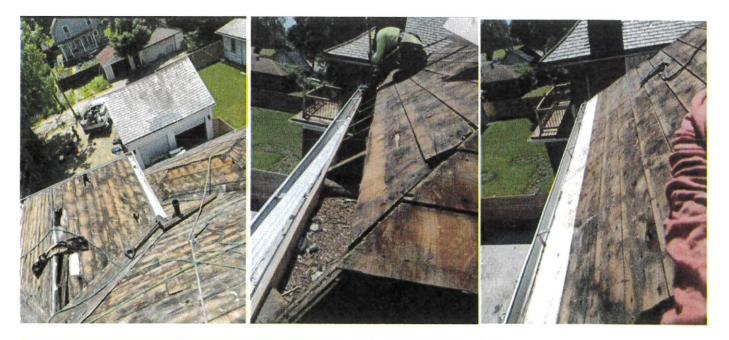
Please see below photos from the roofing installation showing the holes and general damage to the roofing deck. This was a concern when considering roof repairs as these issues would not have been properly addressed without full section removal and replacement, and could cause injury to workers who could not tell if they were stepping on a failed area in the deck:

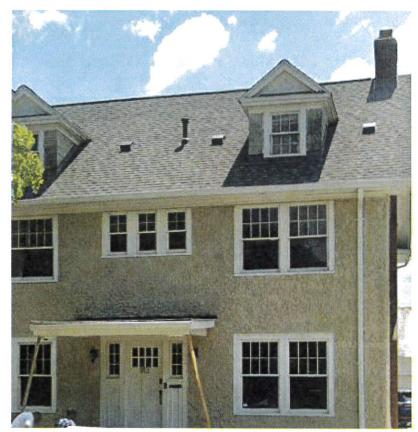
Please see below a few photos from the installation along with a photo featuring the completed roof:
