Restore & Revitalization
Of
345 Arden Park Blvd
Detroit, MI 48202

Items that have been completed

Reasons for Restoration

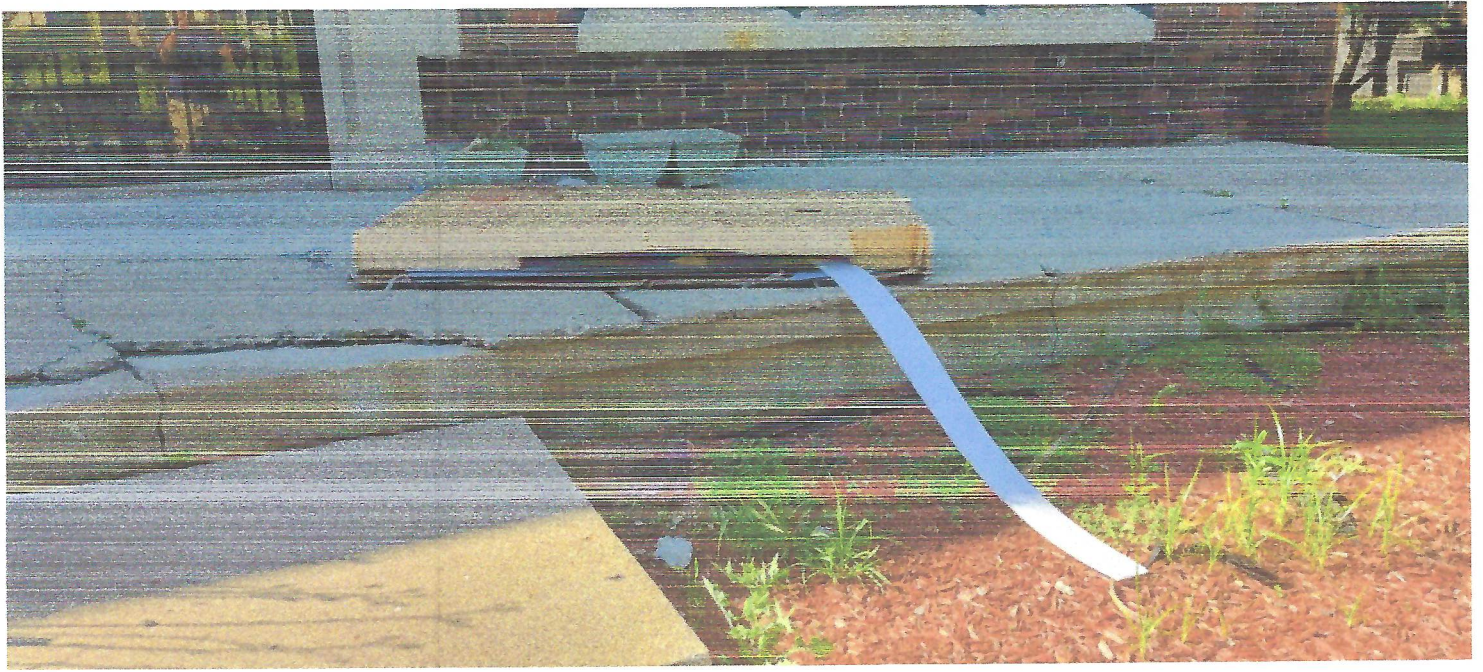
- 3. Front porch posed a safety hazard for anyone that would come onto the porch.**
 - a. Multiple cracks on cap of porch**
 - b. Missing large sections of concrete**

This photo shows the present tripping hazard to persons that may come onto porch

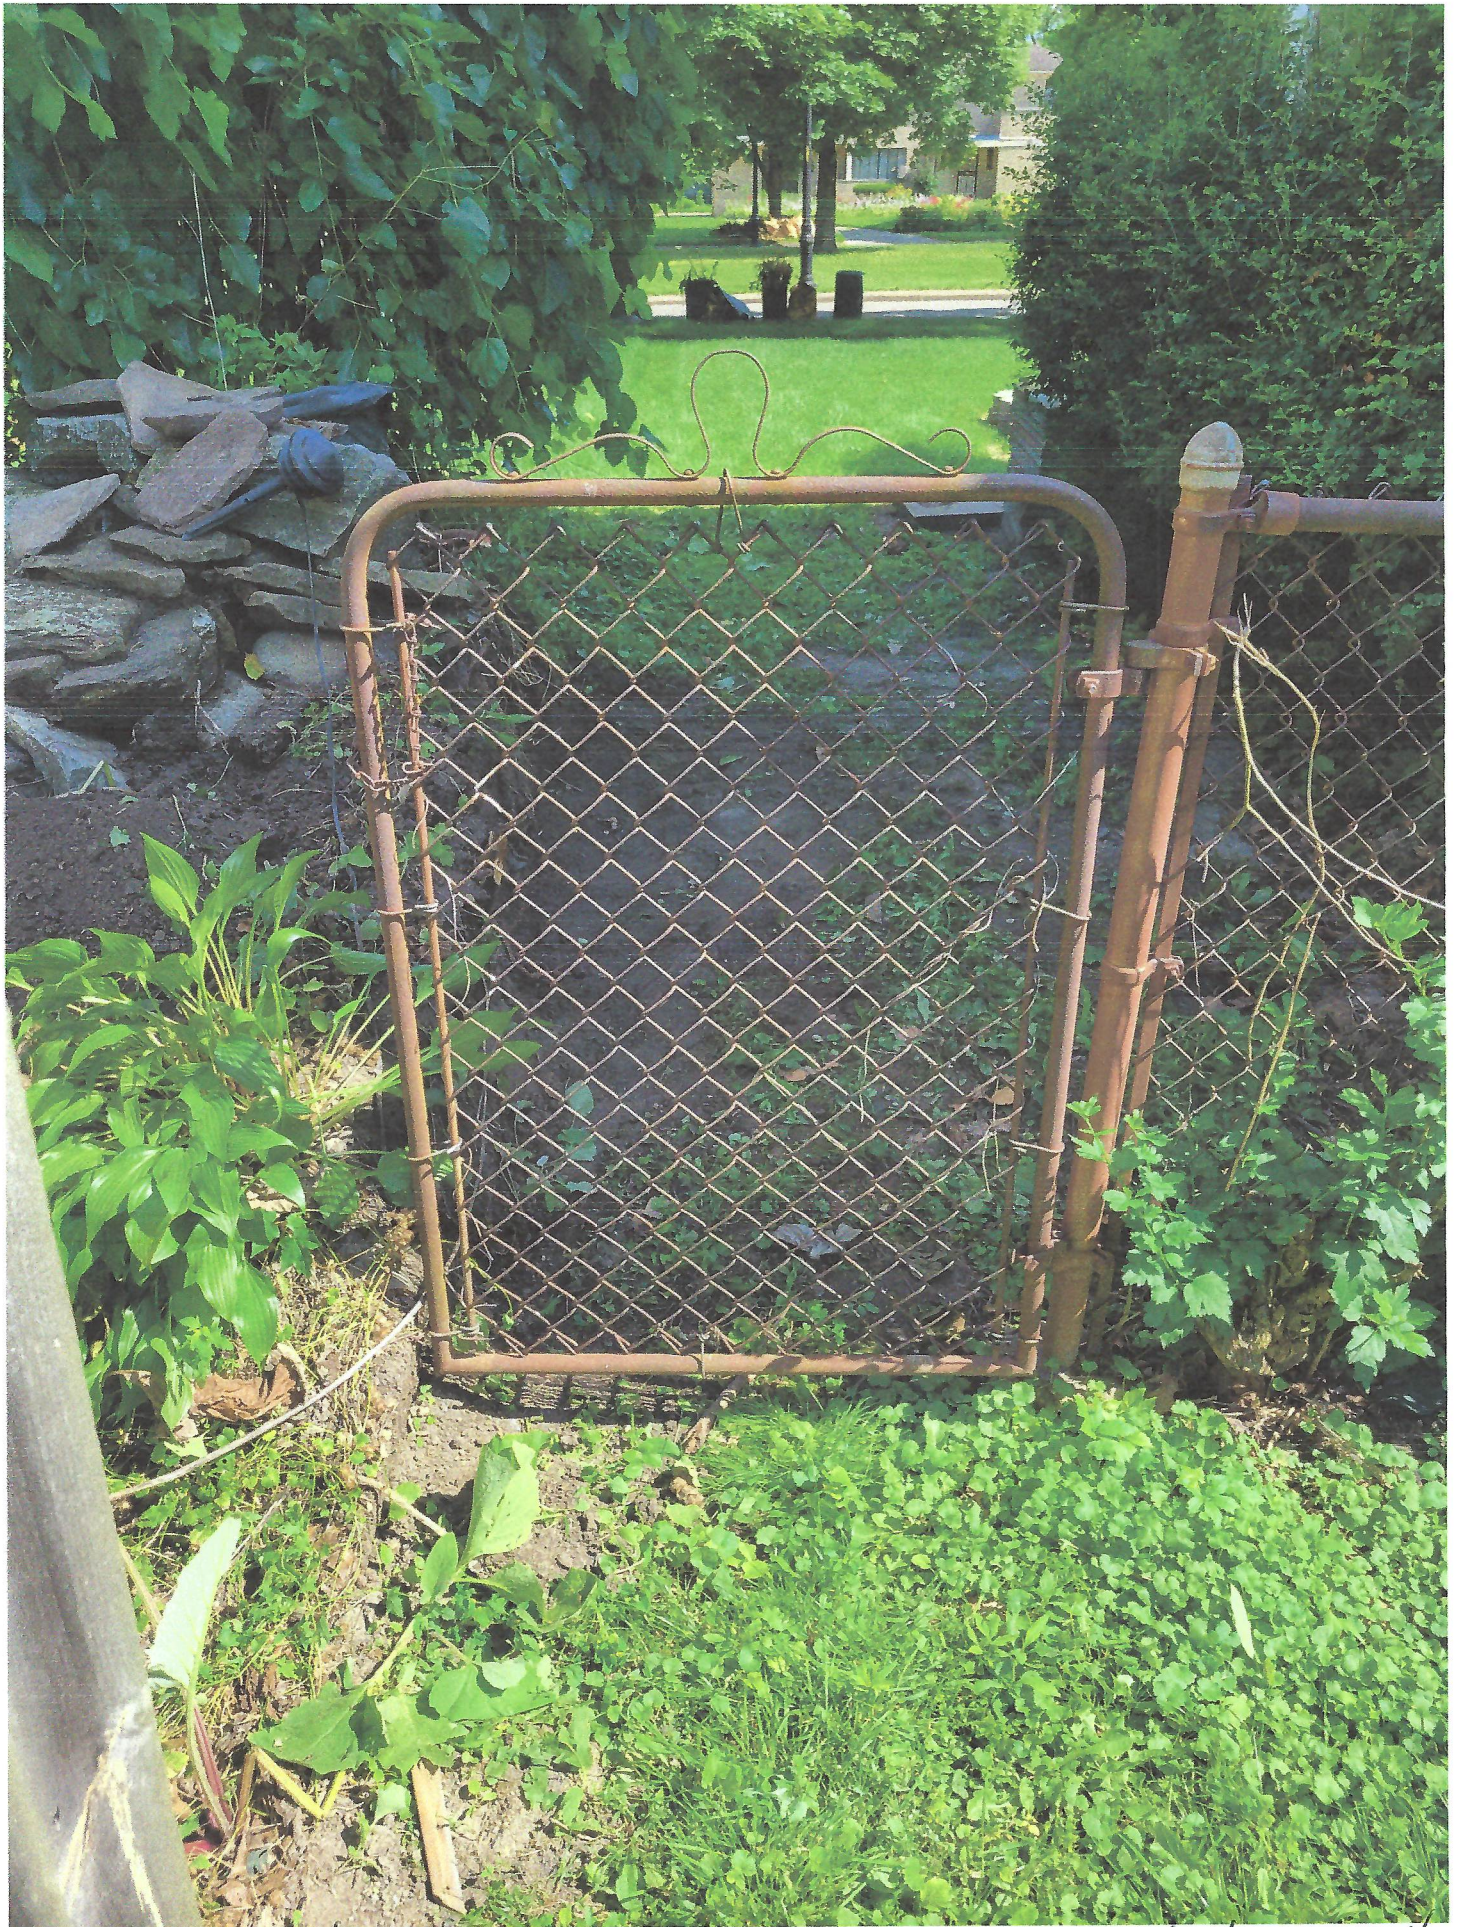
- 5. The fence that was installed is 6' tall and is Rod Iron and black in color. The choice of material was in keeping with this historical neighborhood. The need for the fence was on both sides of our home there was no real security where anyone could walk right into our backyard from the sides. We were victims of a home invasion. With the installation of the Rod Iron gate and fence it provides elegance to our home and some means of security.**

This photo shows the lack of security between home,

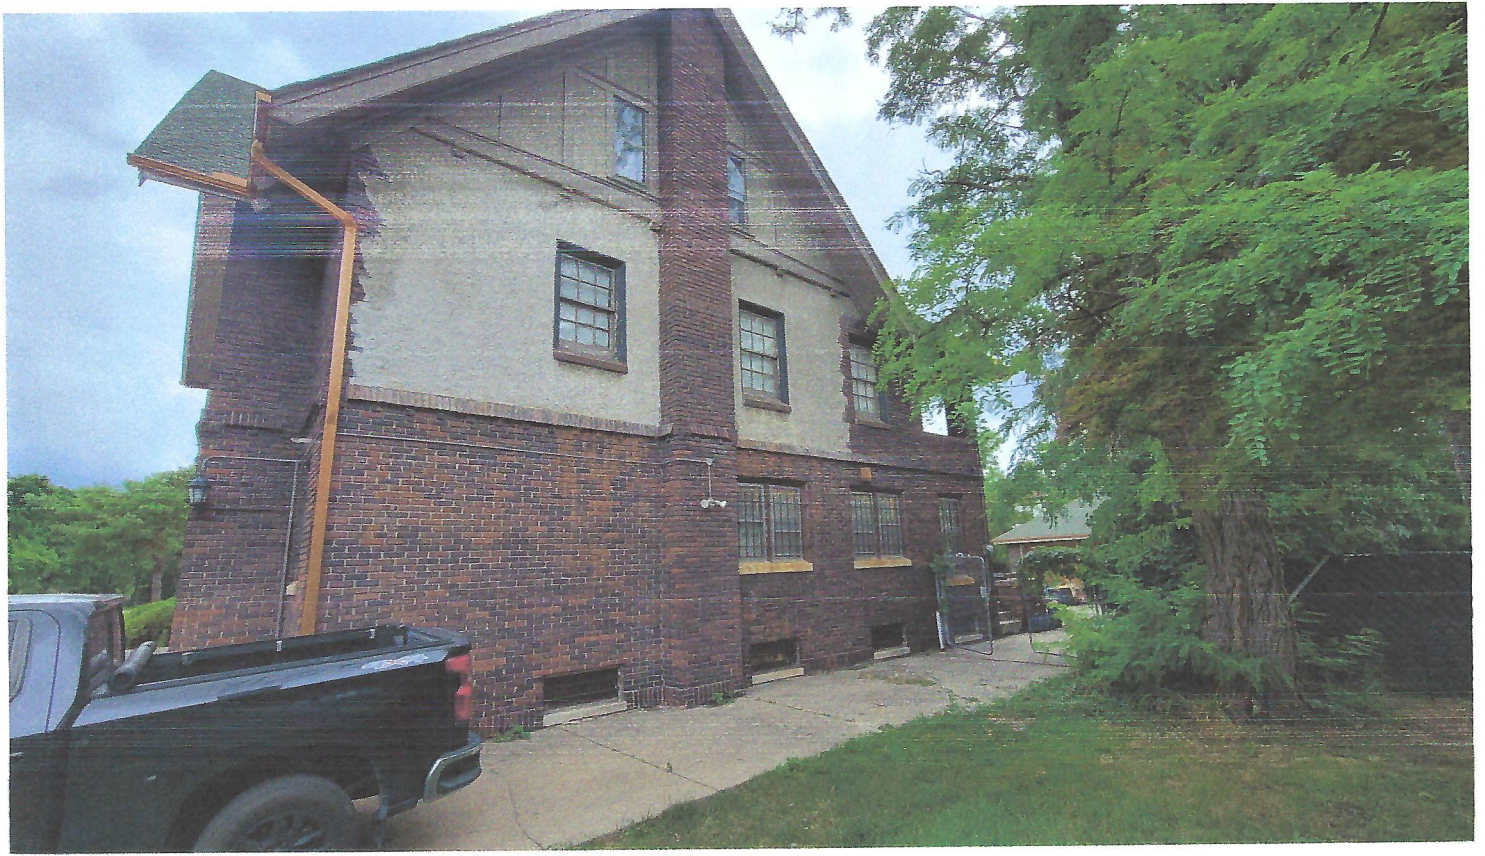
- 4. Driveway missing large sections of concrete, slabs of concrete cracked through which sank along the entire eastside of house foundation which rainwater or water in general would make its way into the basement. As far as the driveway by garage, the driveway was a mixture of patchwork over the years such as, asphalt and concrete patchwork.**

This photo shows the cracked concrete and sinking of concrete slabs along side of home that has led to water in basement. Photo also shows cracked and missing concrete.

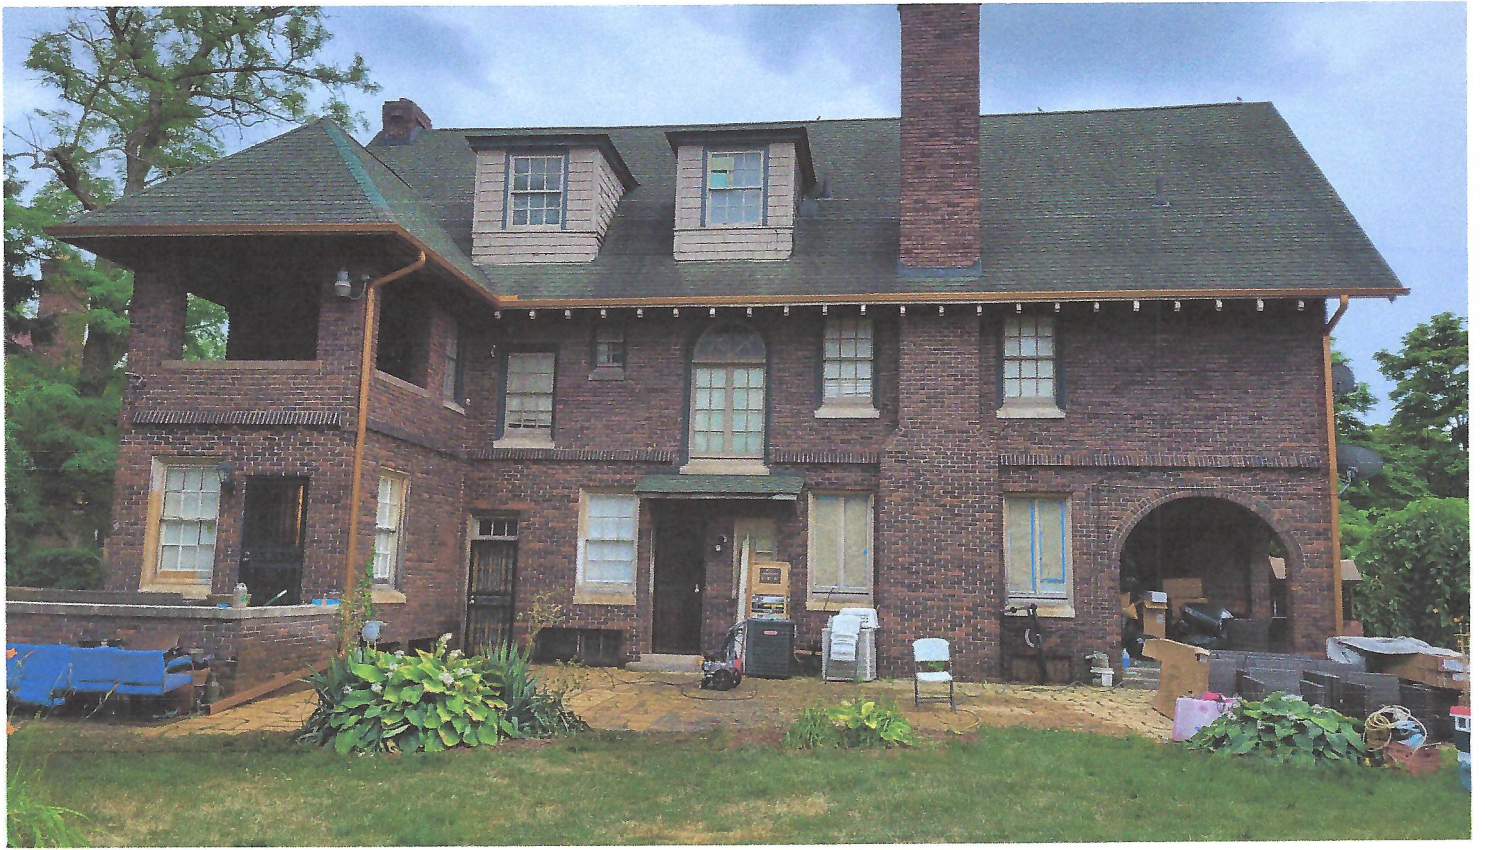
This photo shows the need to
refresh paint.

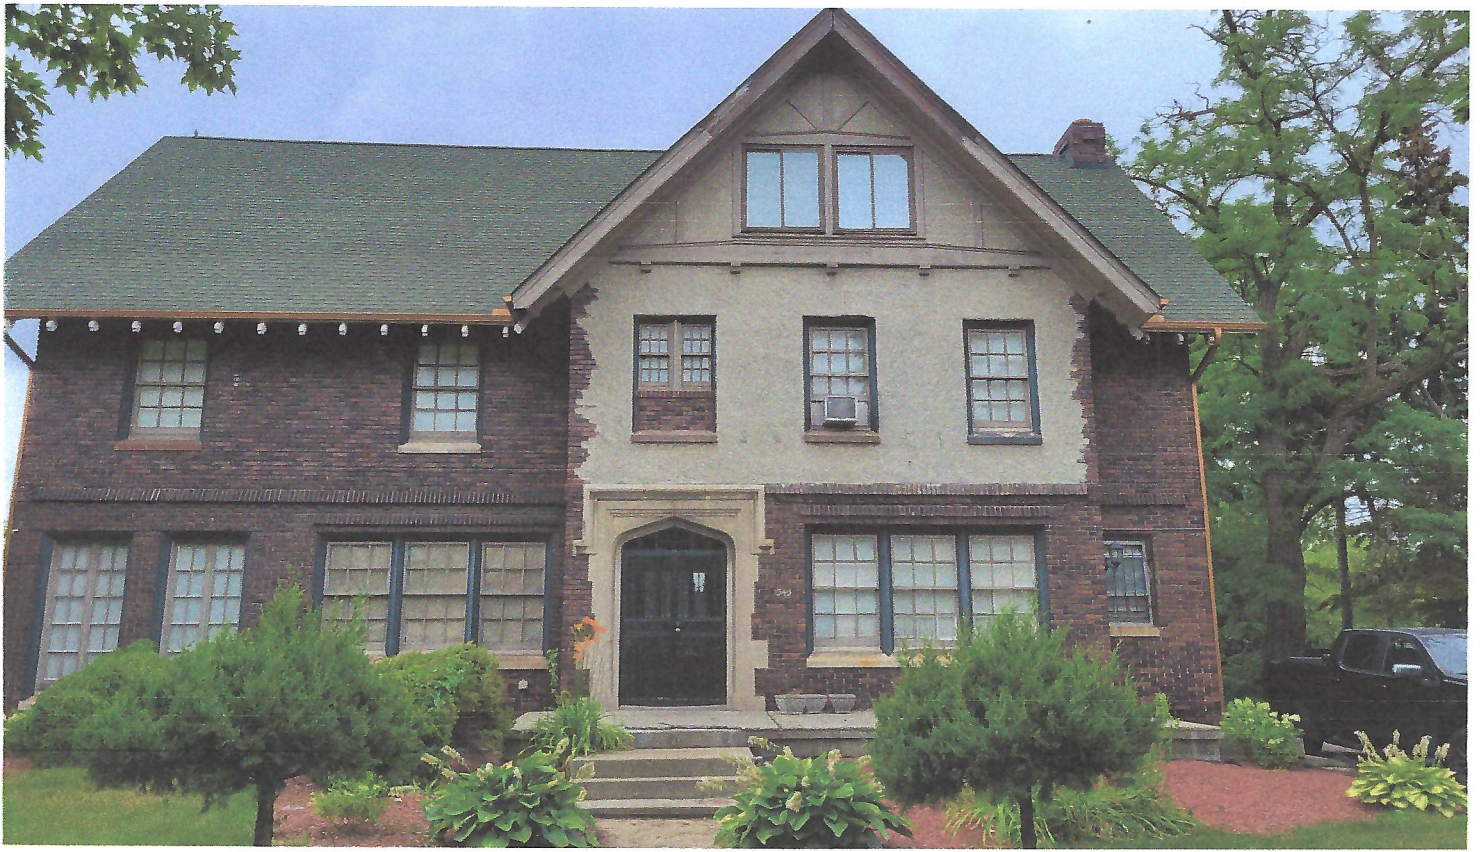
This photo shows the need to refresh paint and uniform.

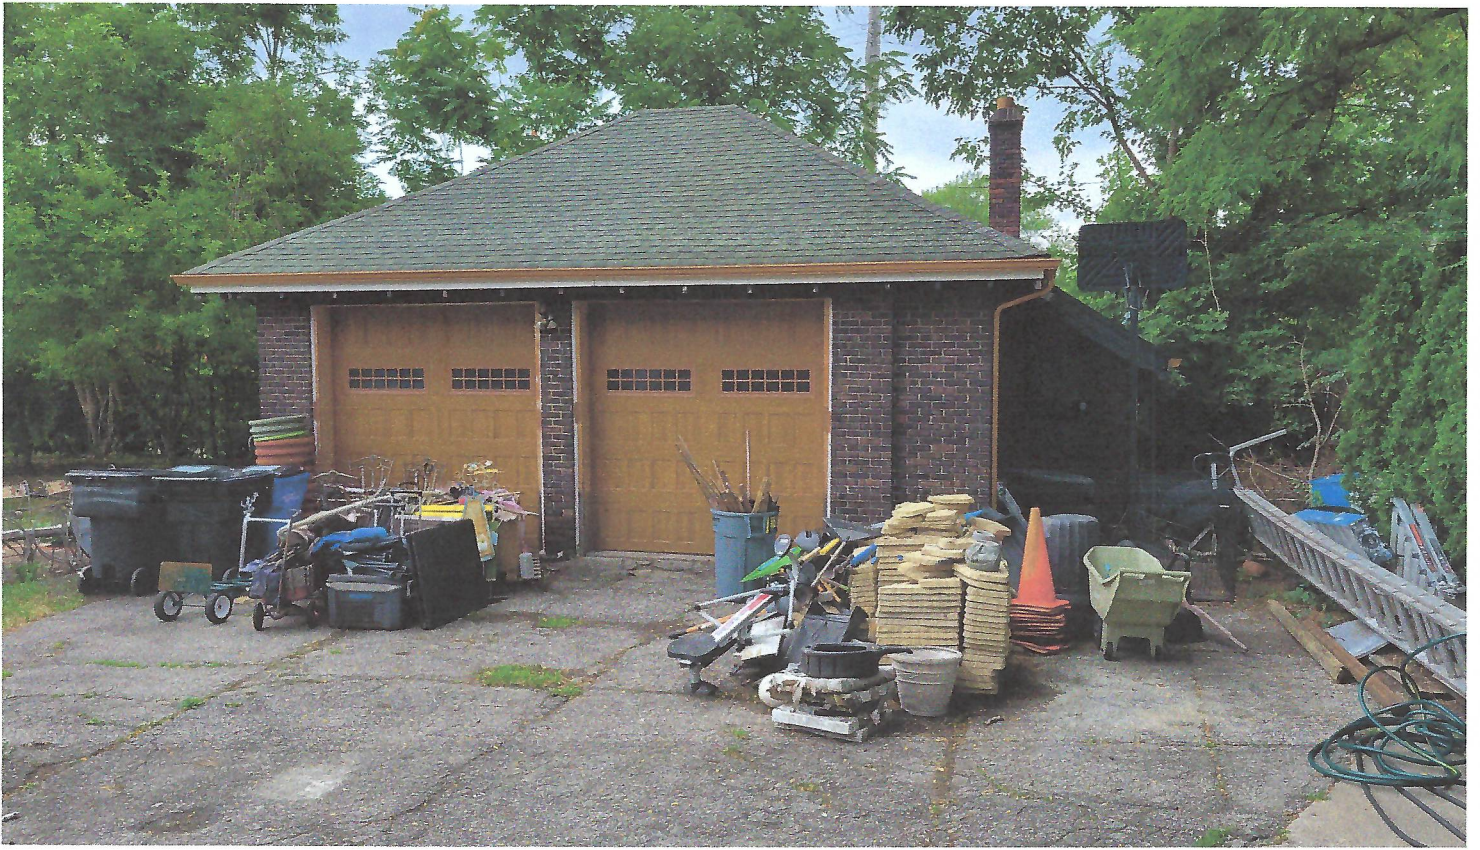
This photo shows the condition
of driveway as one would expect
garage.

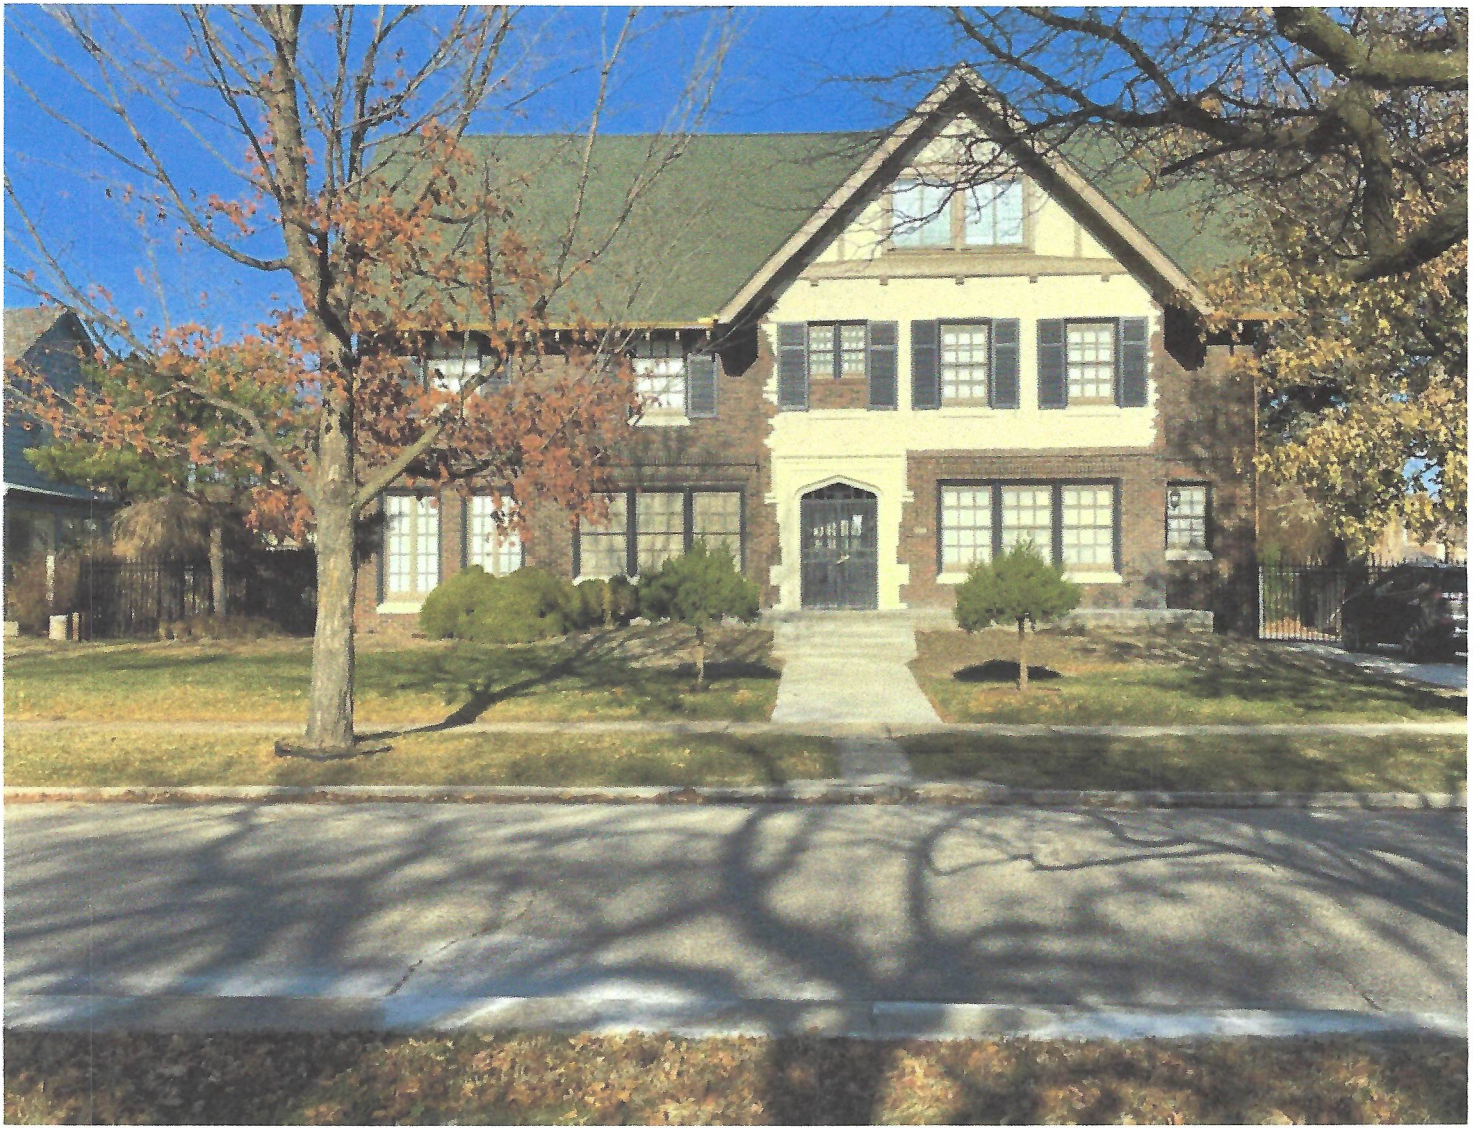
This photo shows AFTER ~~work~~ work
has been completed

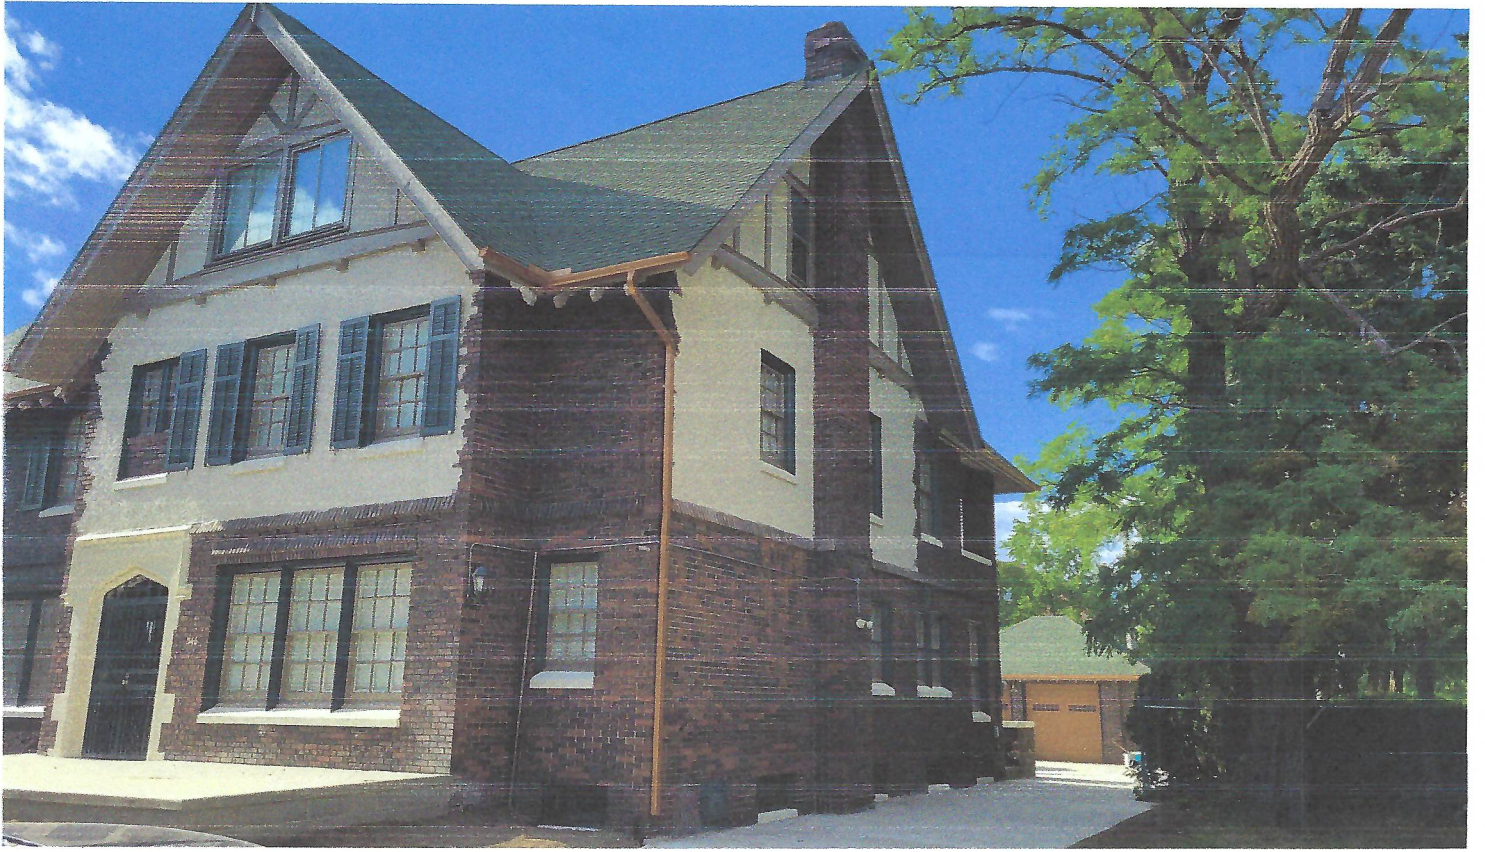
Photo of finished work

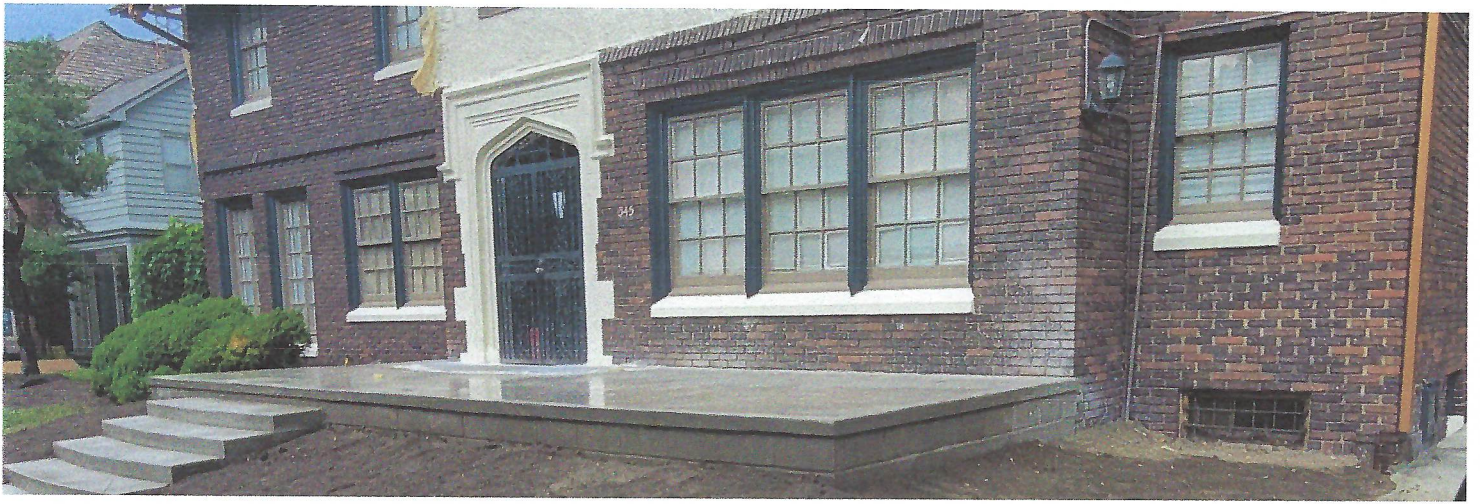
New Porch & Steps

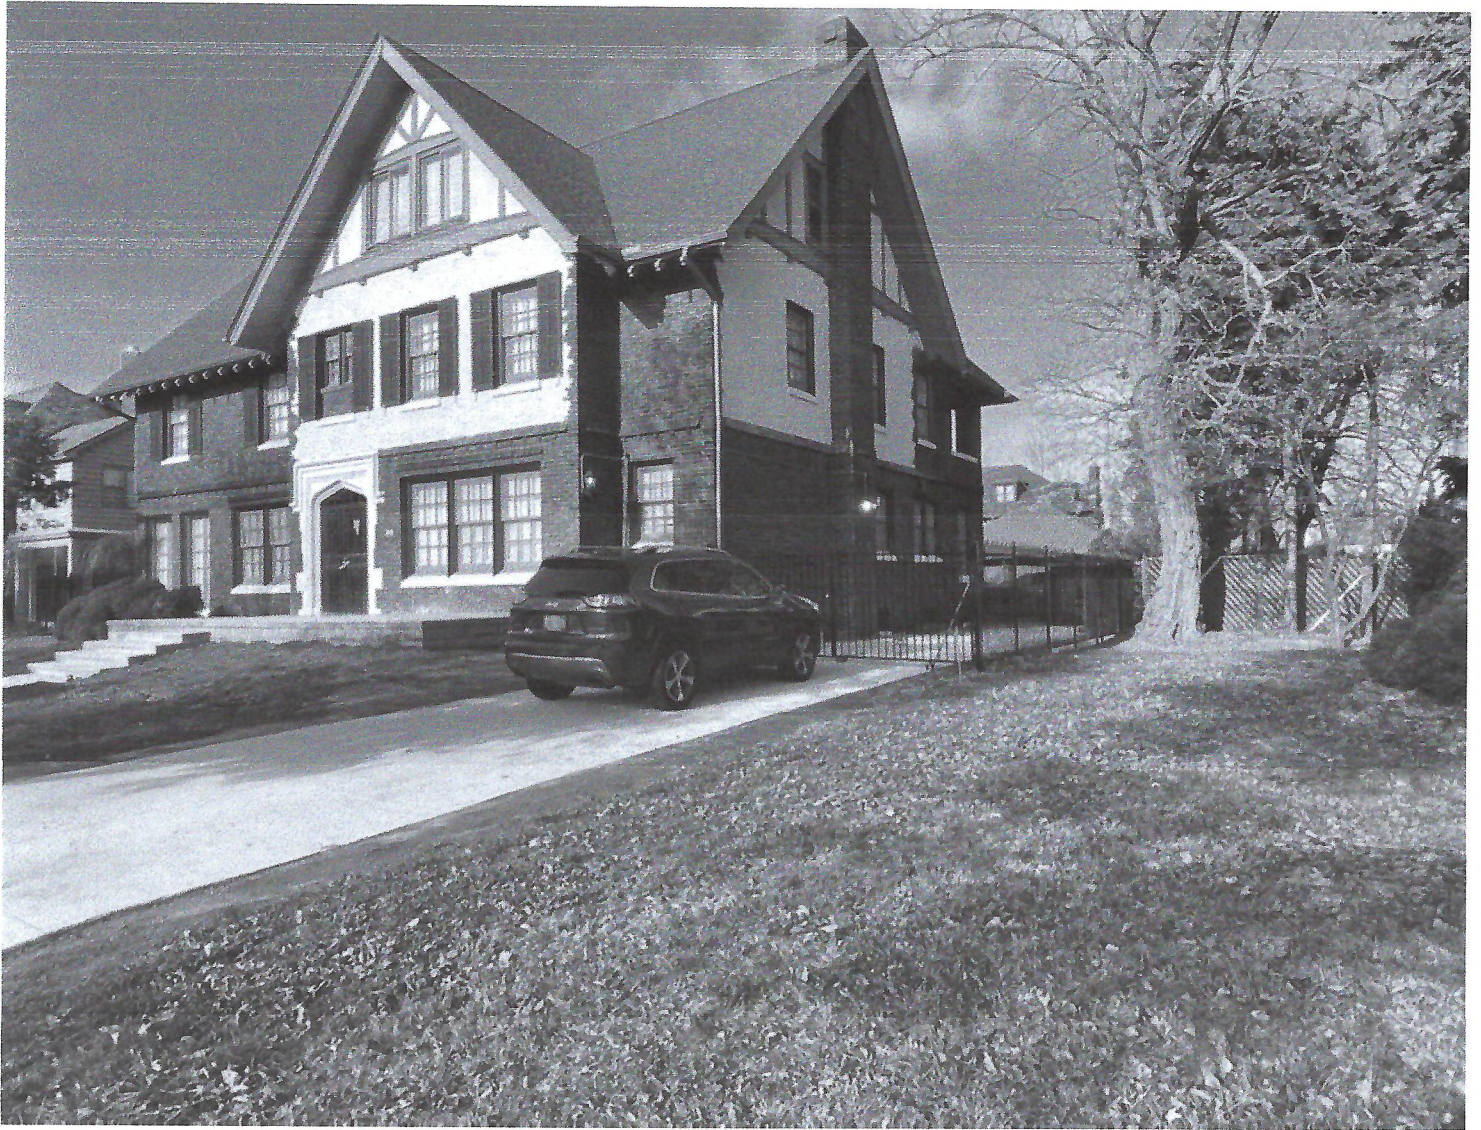
Rode Irons
FENCE

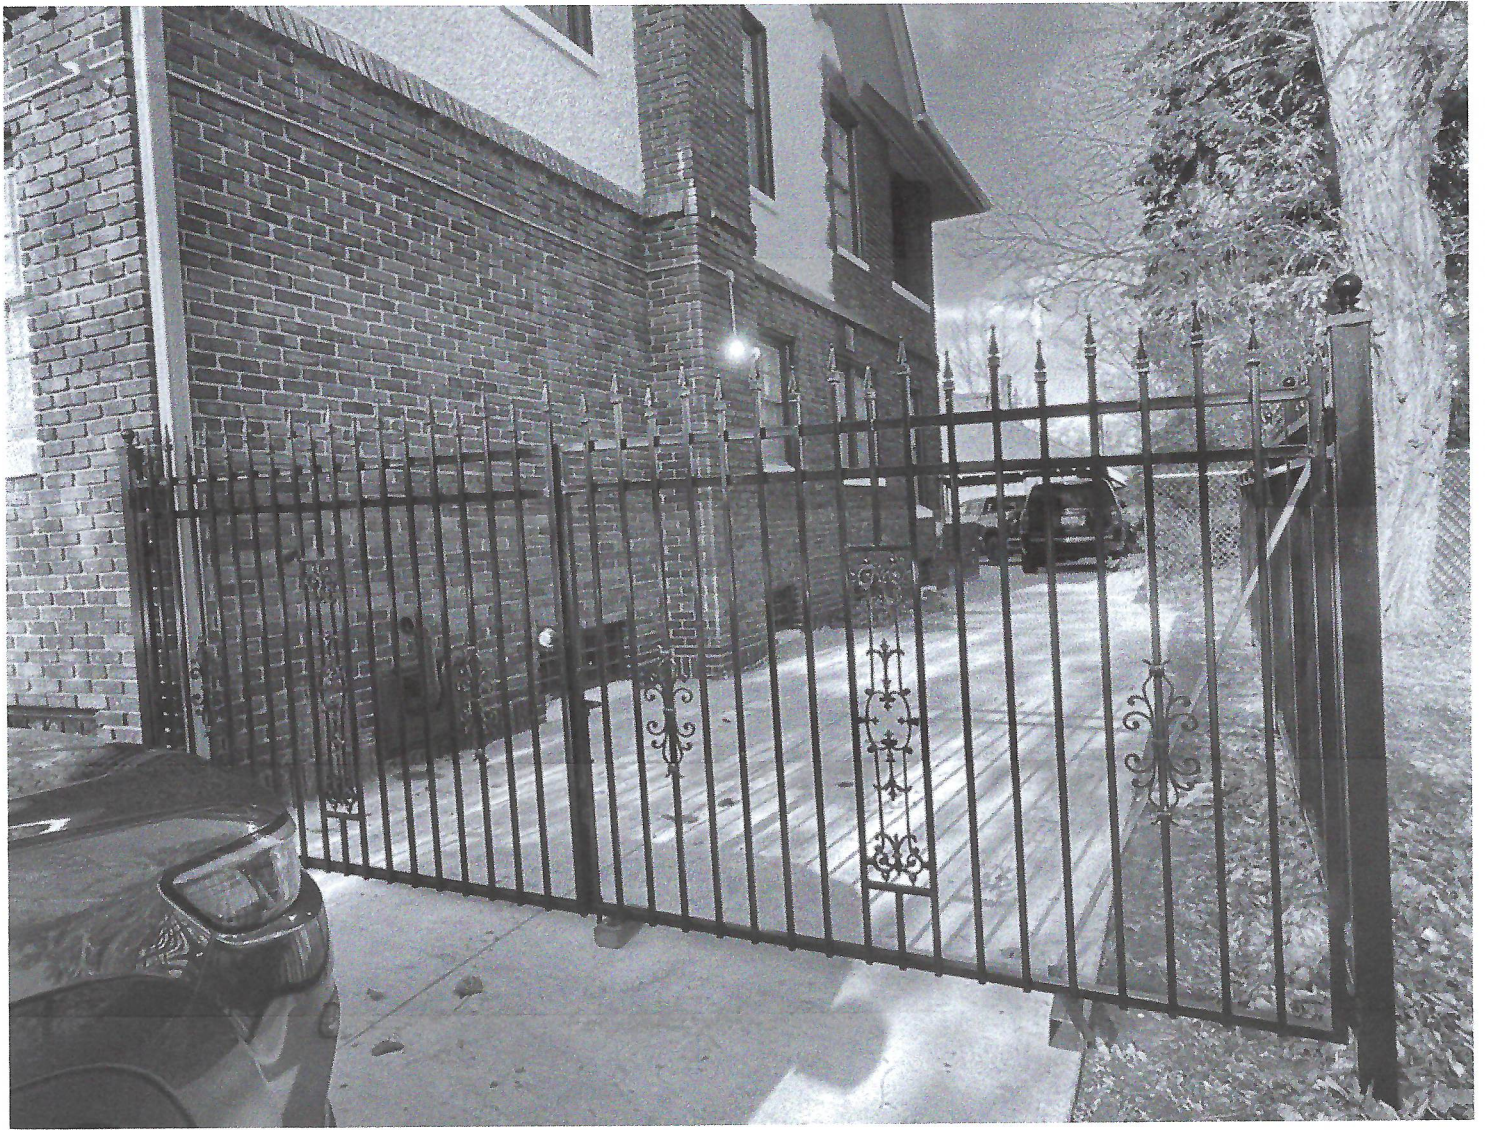
Rode Inow Gate

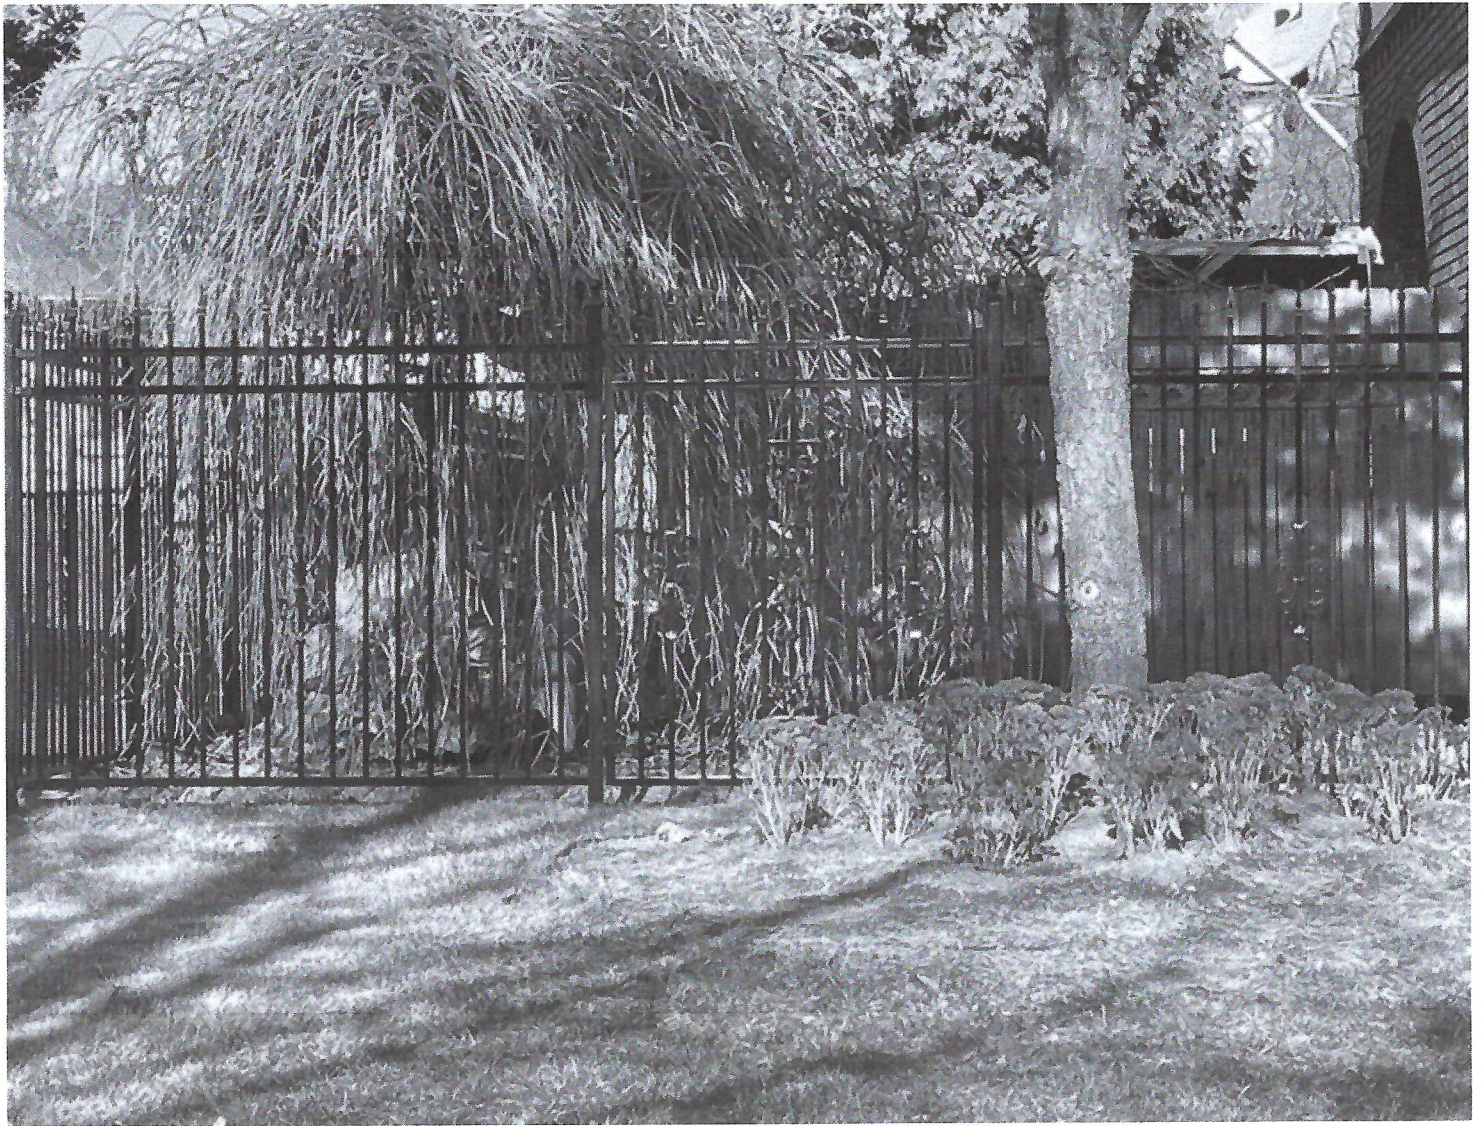
Rode Iron Fence between
property

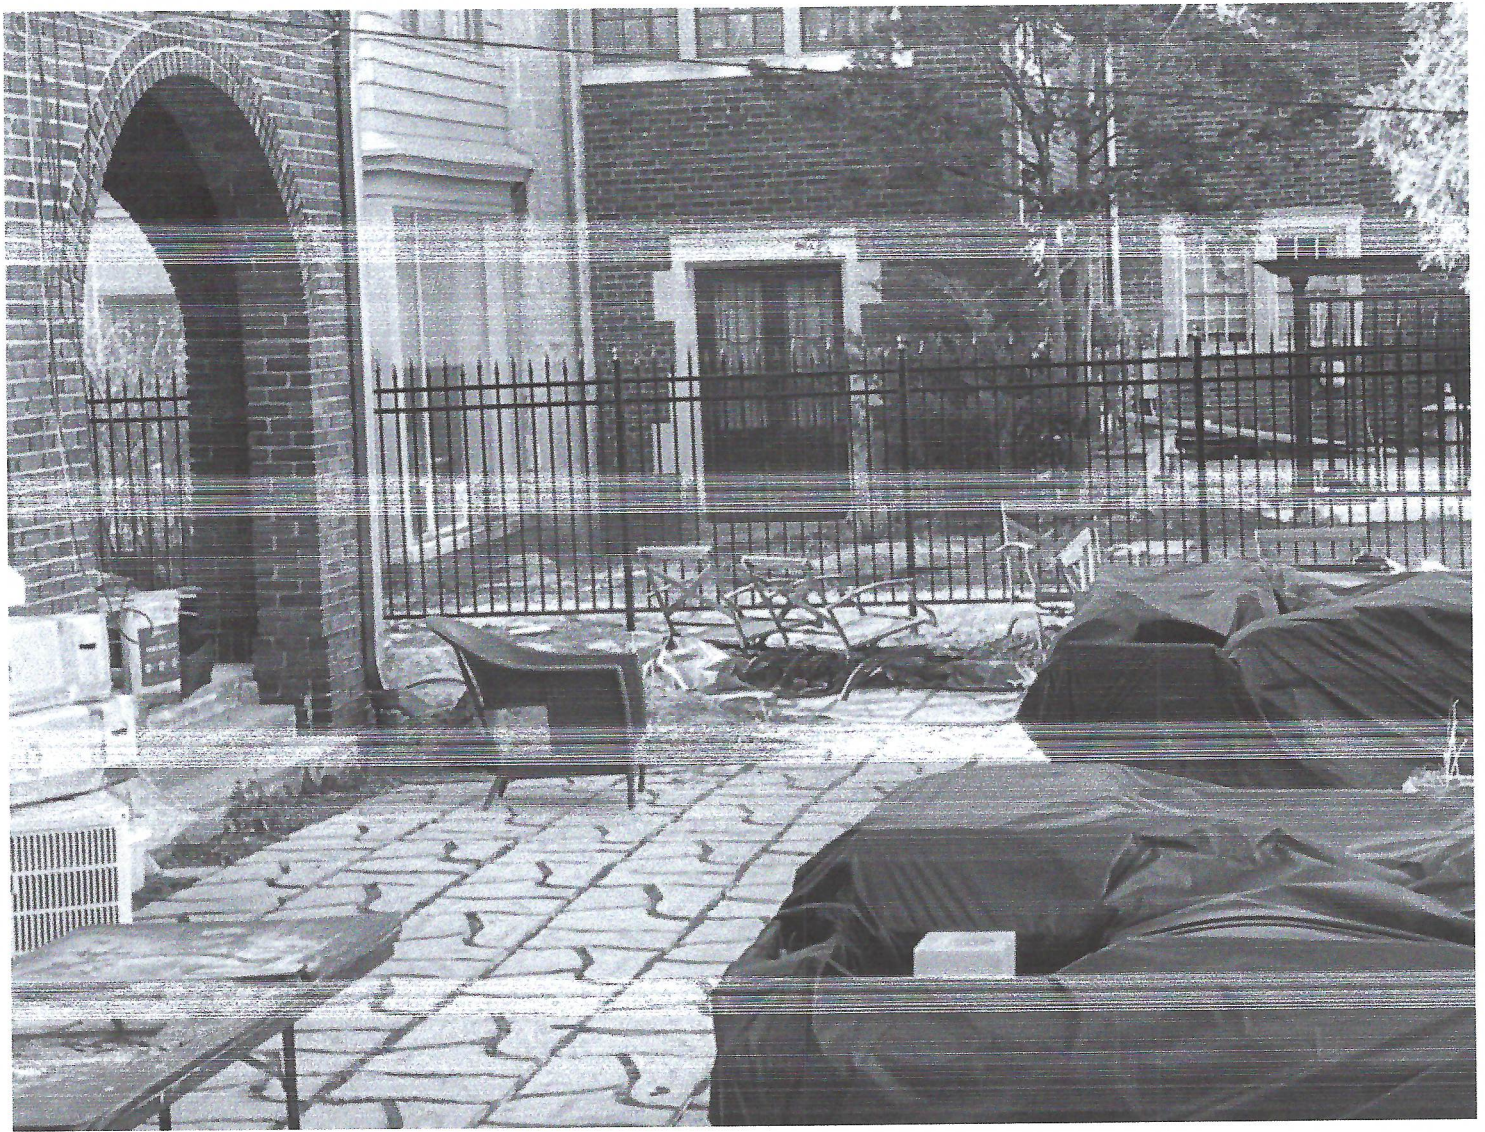
Rode Iron FENCE between
property
