CITY OF DETROIT HISTORIC DISTRICT COMMISSION

92 E. Forest. Detroit, MI

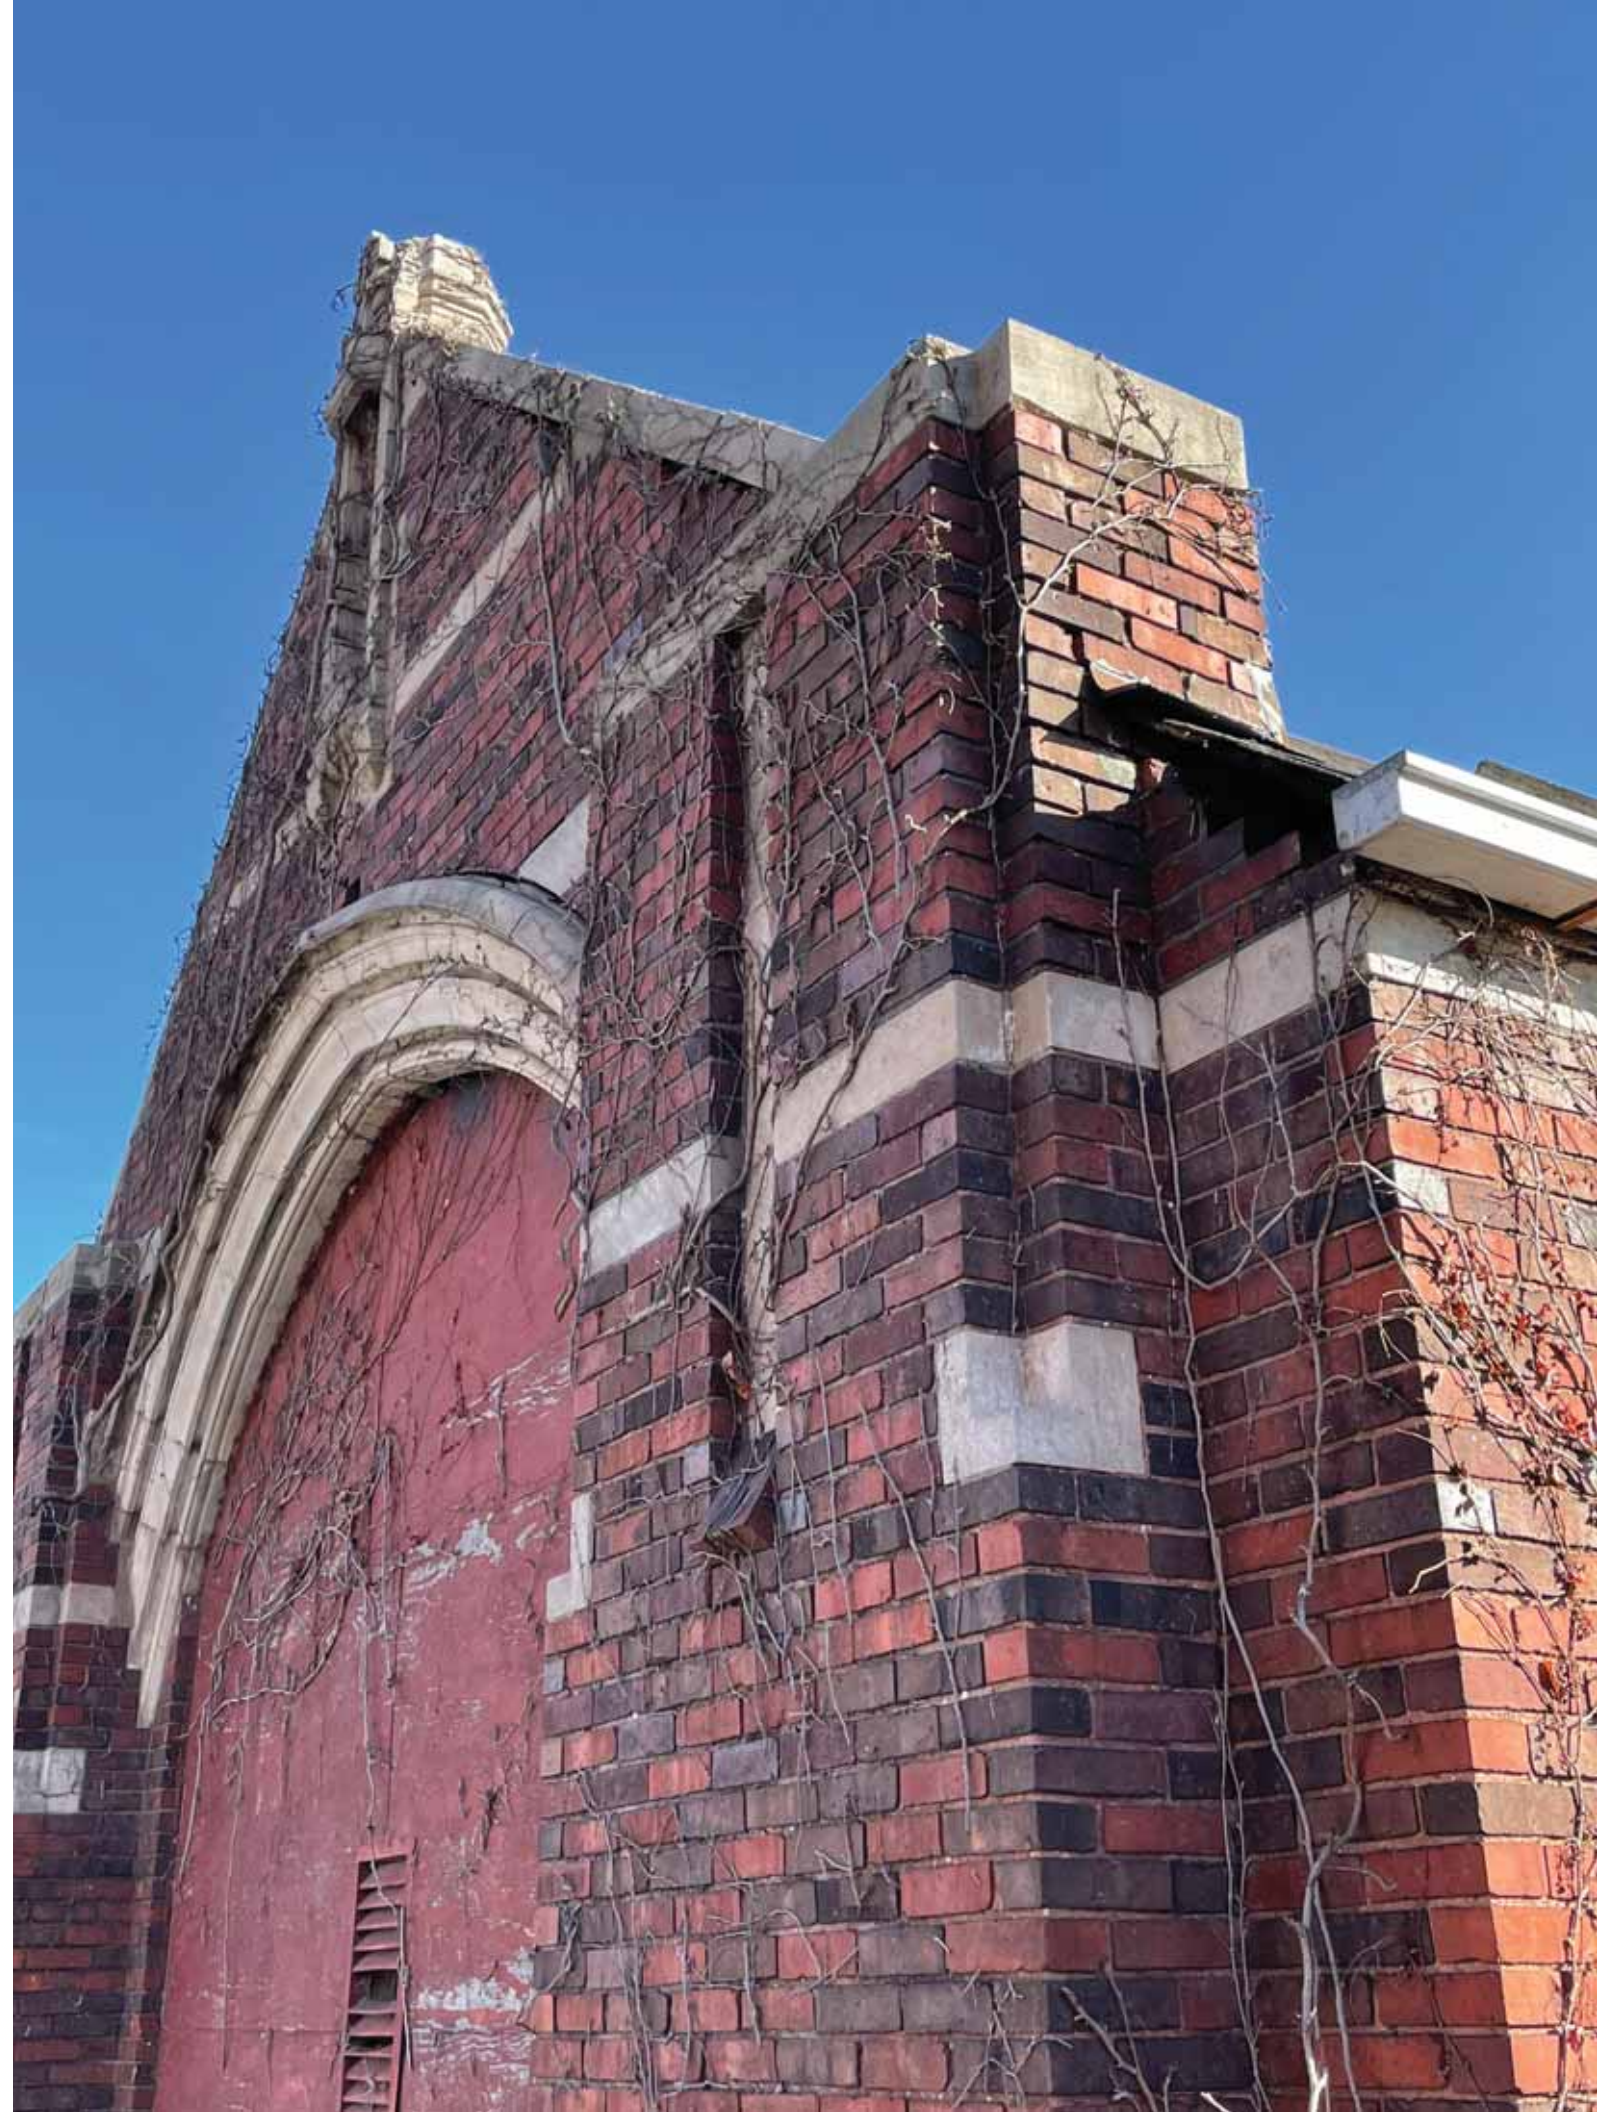
- An in-depth analysis of existing slate roof.
 - Esko roofing and Monahan Construction thoroughly examined the existing conditions using a lift
- Owner selected a new window restoration expert.
 - Peter Carrol or North Coast Window Works
- Thorough analysis of existing vinyl, wood 1/1 and Nave wood windows.
- Numerous site observations to accurately measure , photograph and assess conditions.
- Thorough analysis and selection of replacement windows.

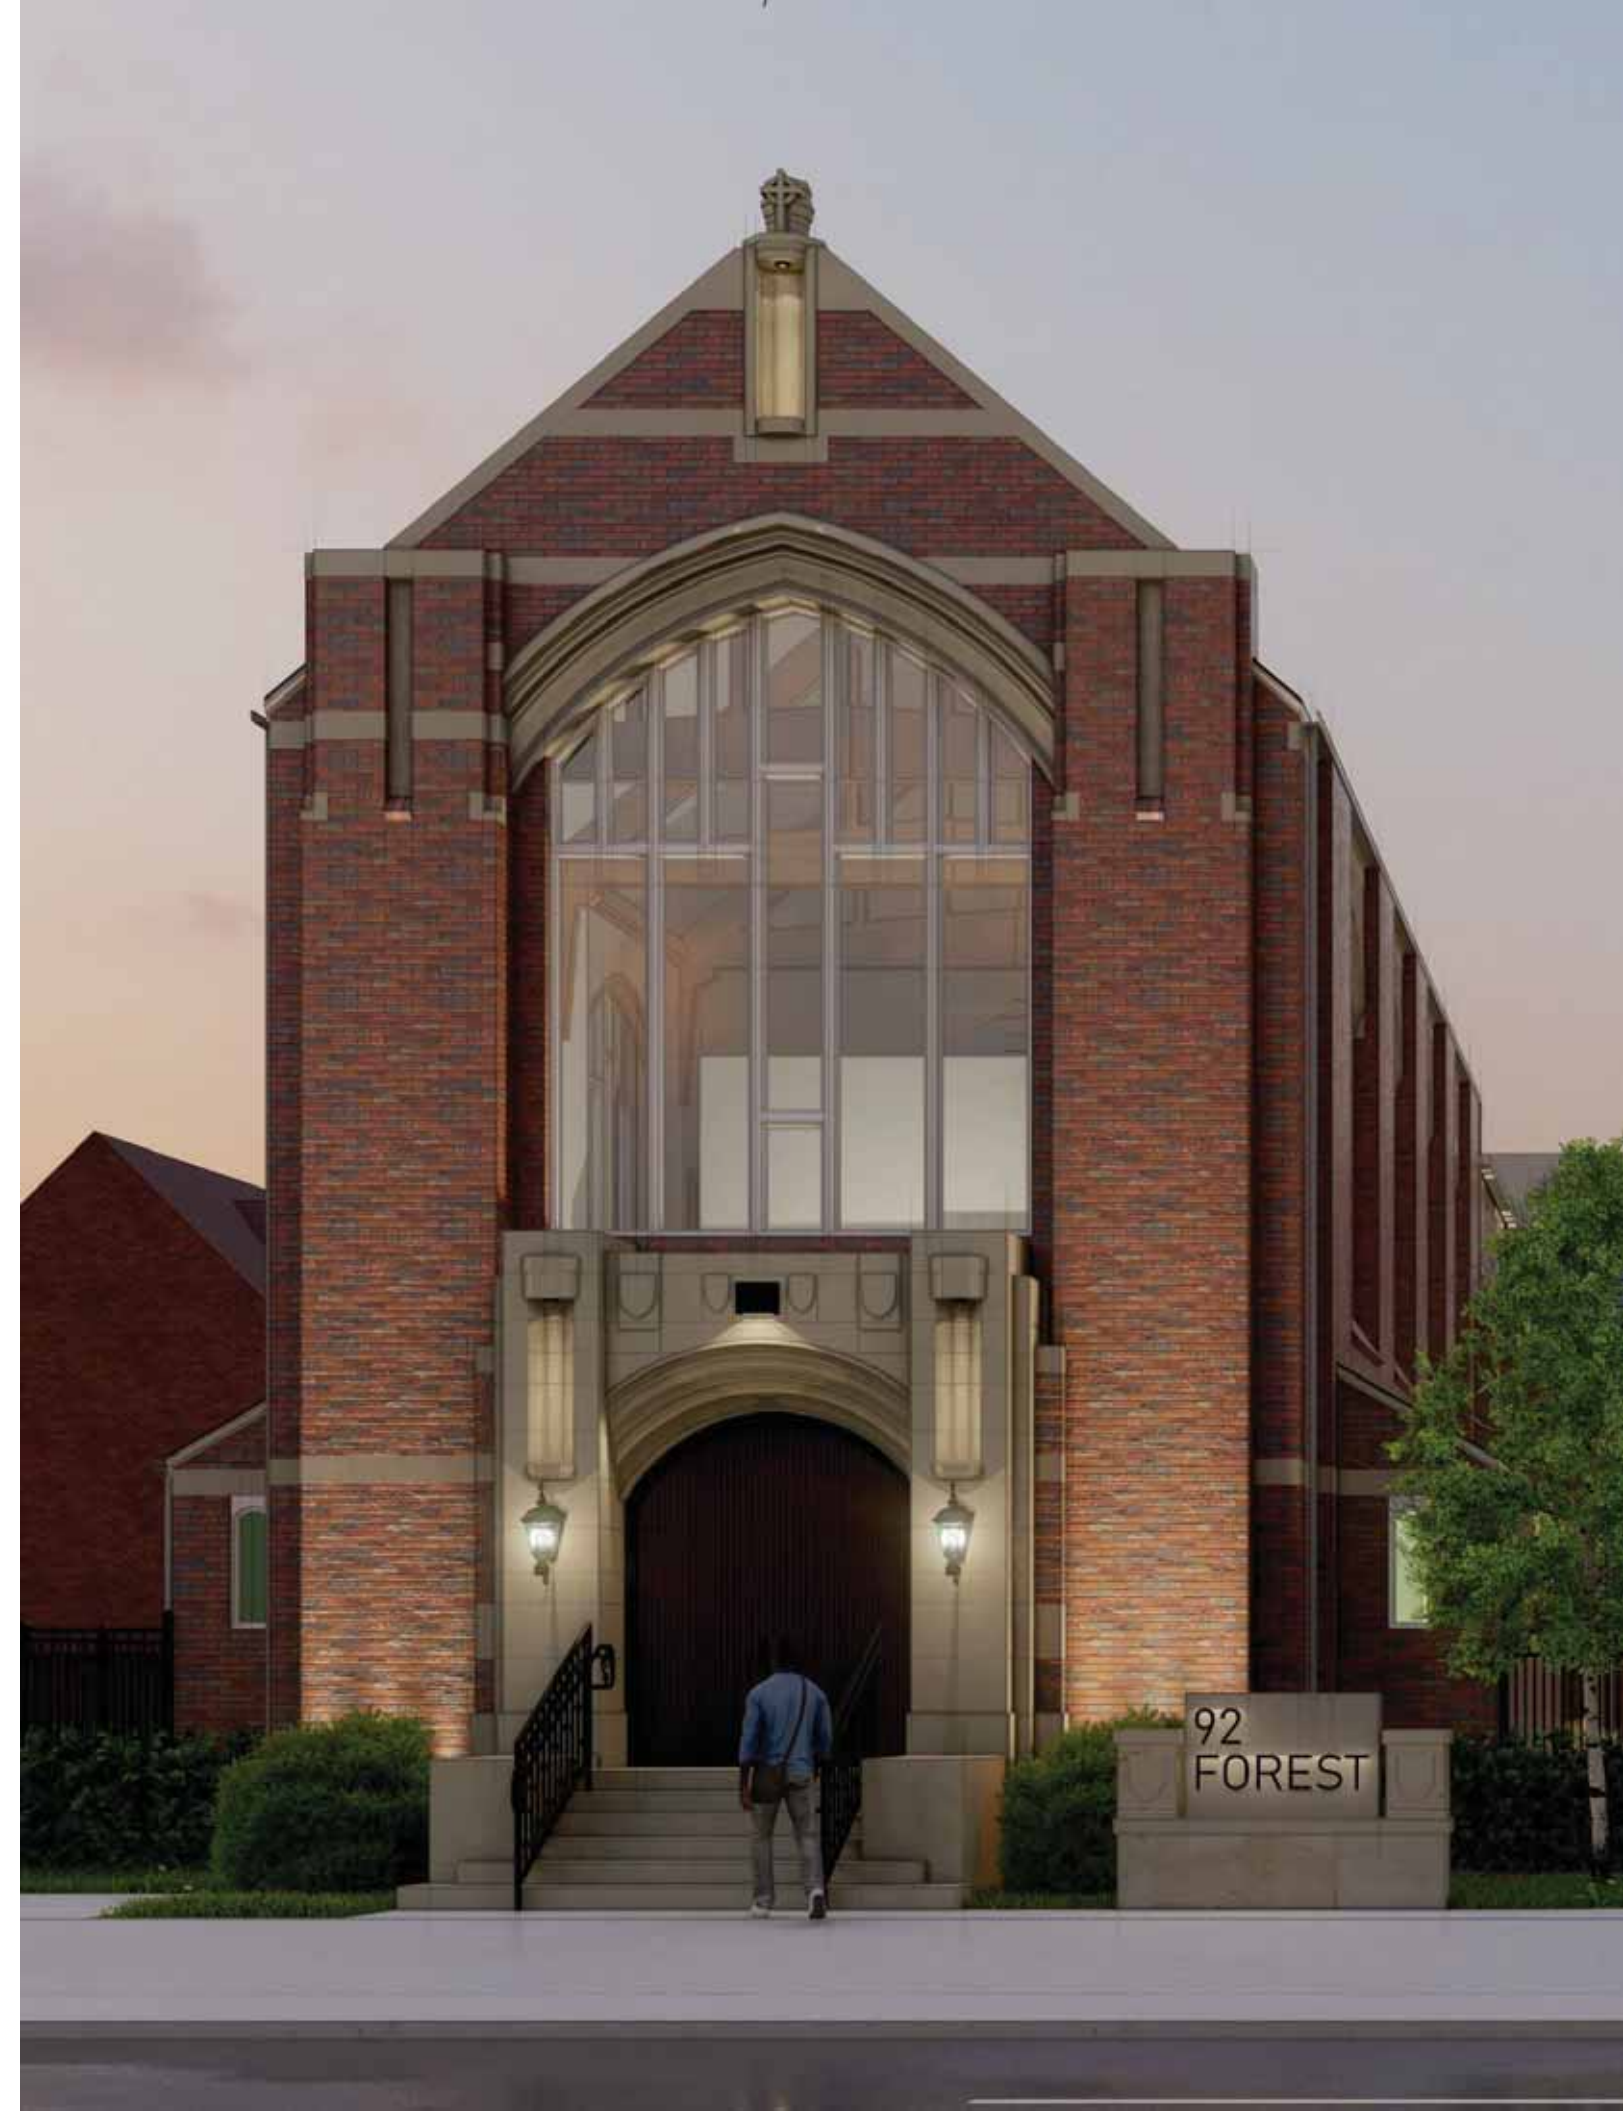
- In this presentation we aim to provide further clarity to support our approval requests for the following items addressed in the staff report:
- **Request 1:** Nave Gabled Roof Replacement
- **Request 2:** New Entry Doors
- **Request 3:** Replacement of existing vinyl windows
- **Request 4:** Replacement of Wood 1/1 Windows
- **Request 5:** Arched Window Restoration and Repairs

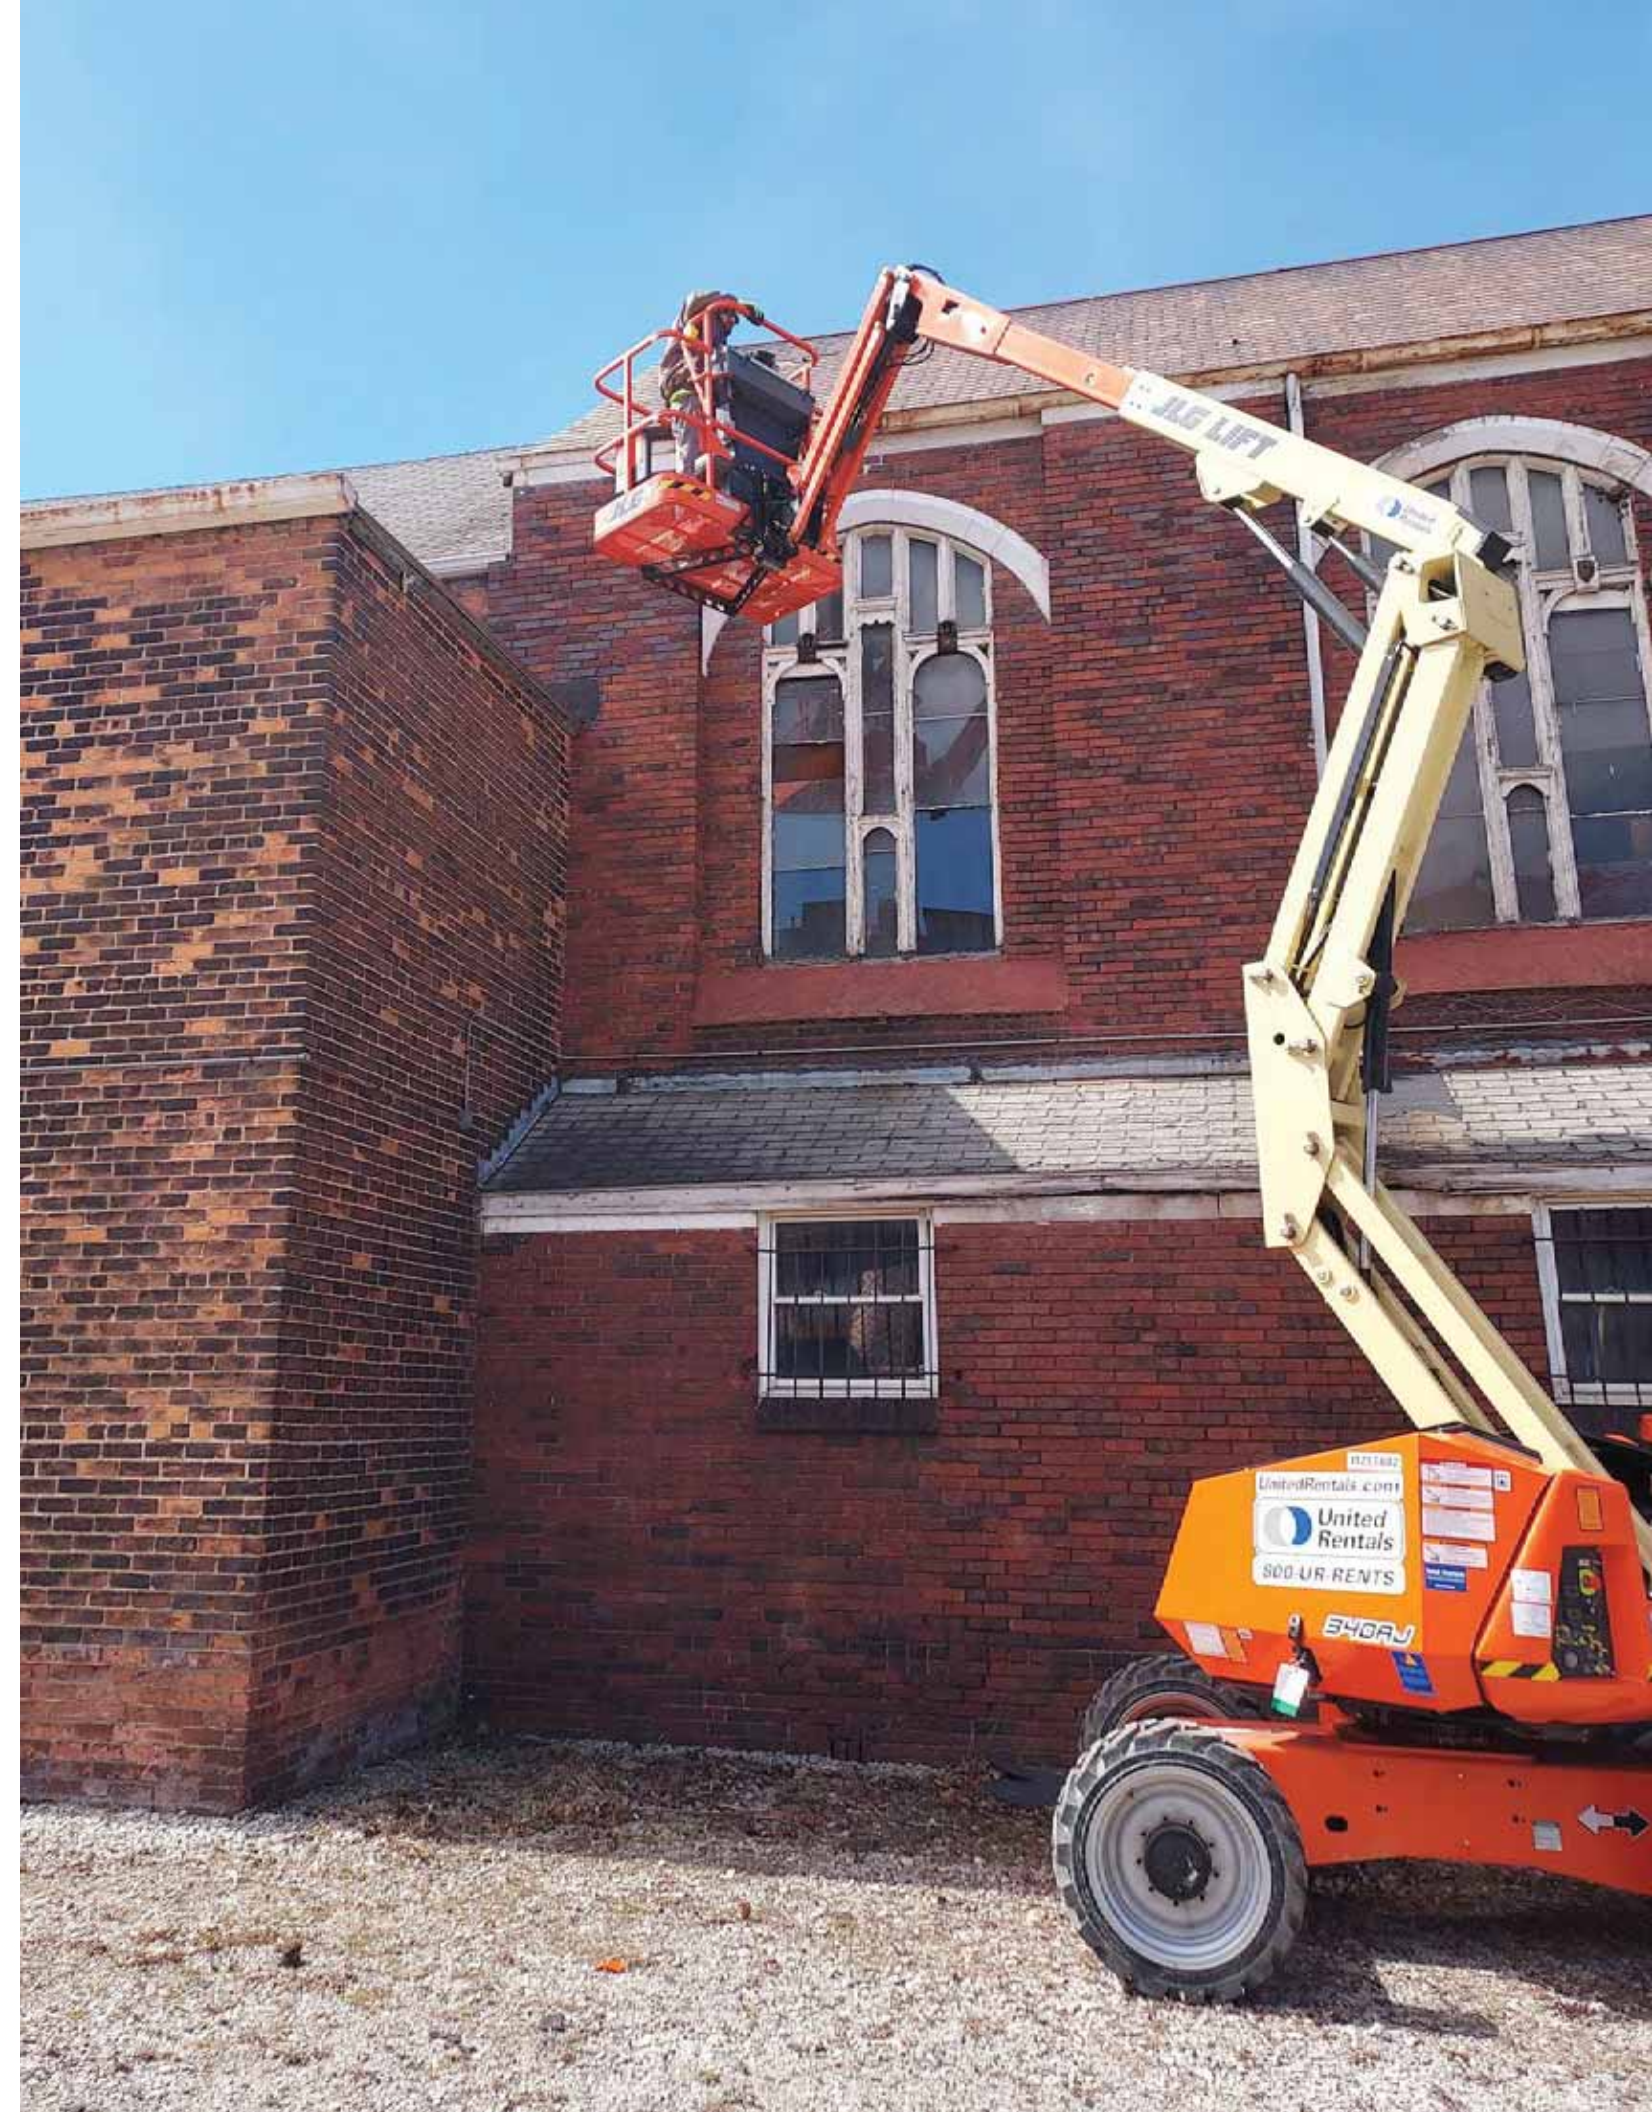
1. Existing slate is 1/6th of the nominal thickness that it should be (compared to new)
2. The tiles are “dead” using the industry standard sound test
3. The tiles have degraded to a brittle, delaminating, and sheering state which creates dangerous conditions
4. The change of use requires a layer of continuous insulation under the roofing and slate systems do not allow for insulation below in a manner that would keep the profile minimal as currently exists
5. Will match the shingles approved in Phase 1

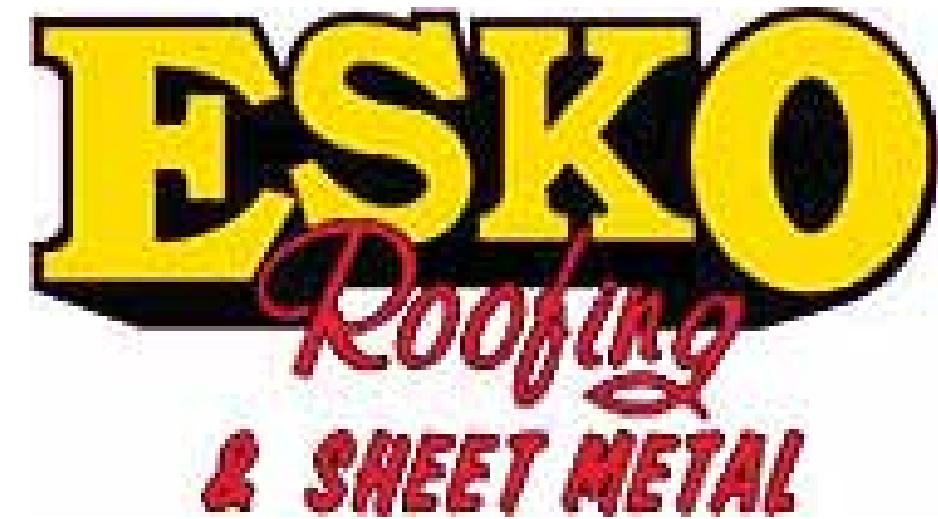
- 20+ Years of Experience in roofing with extensive experience in slate roofs and evaluations
- Justin, Kevin Monahan, and Jeff Klatt went up on a second lift to evaluate the slate roof. The following slides recap the findings

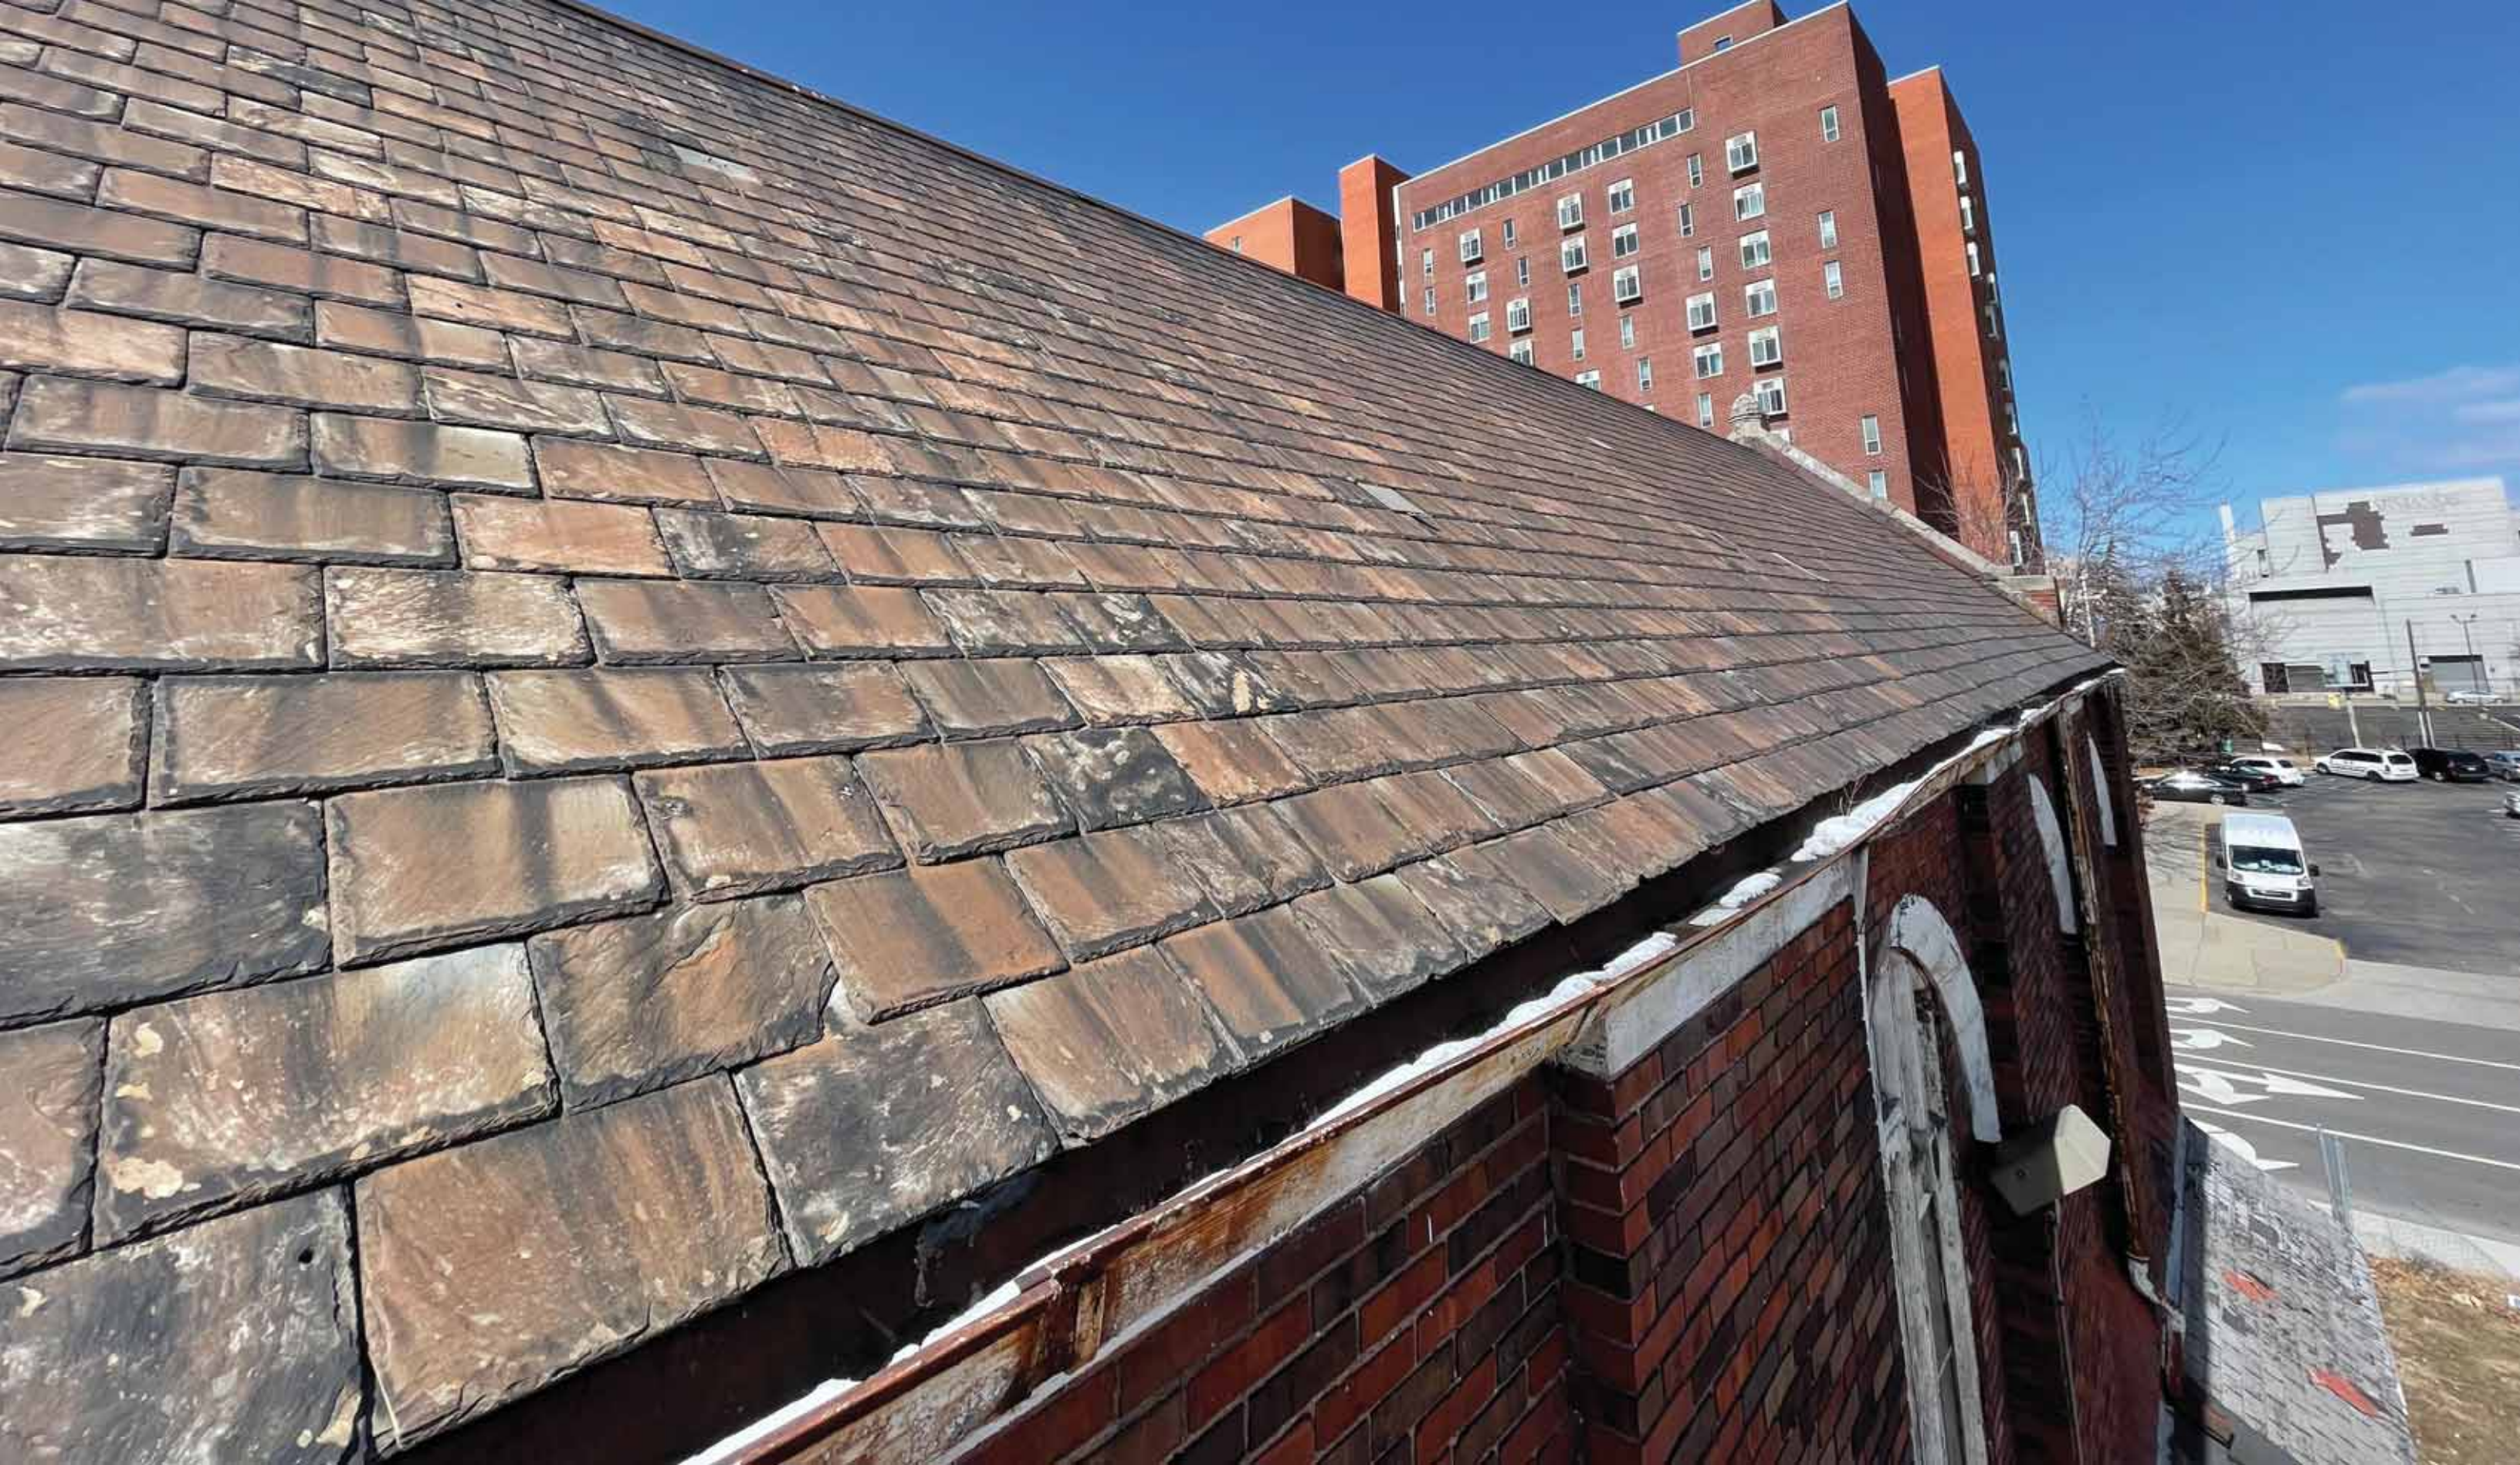
Existing Conditions, Slate is 1/6 of standard slate thickness, with delamination and sheering of tiles.

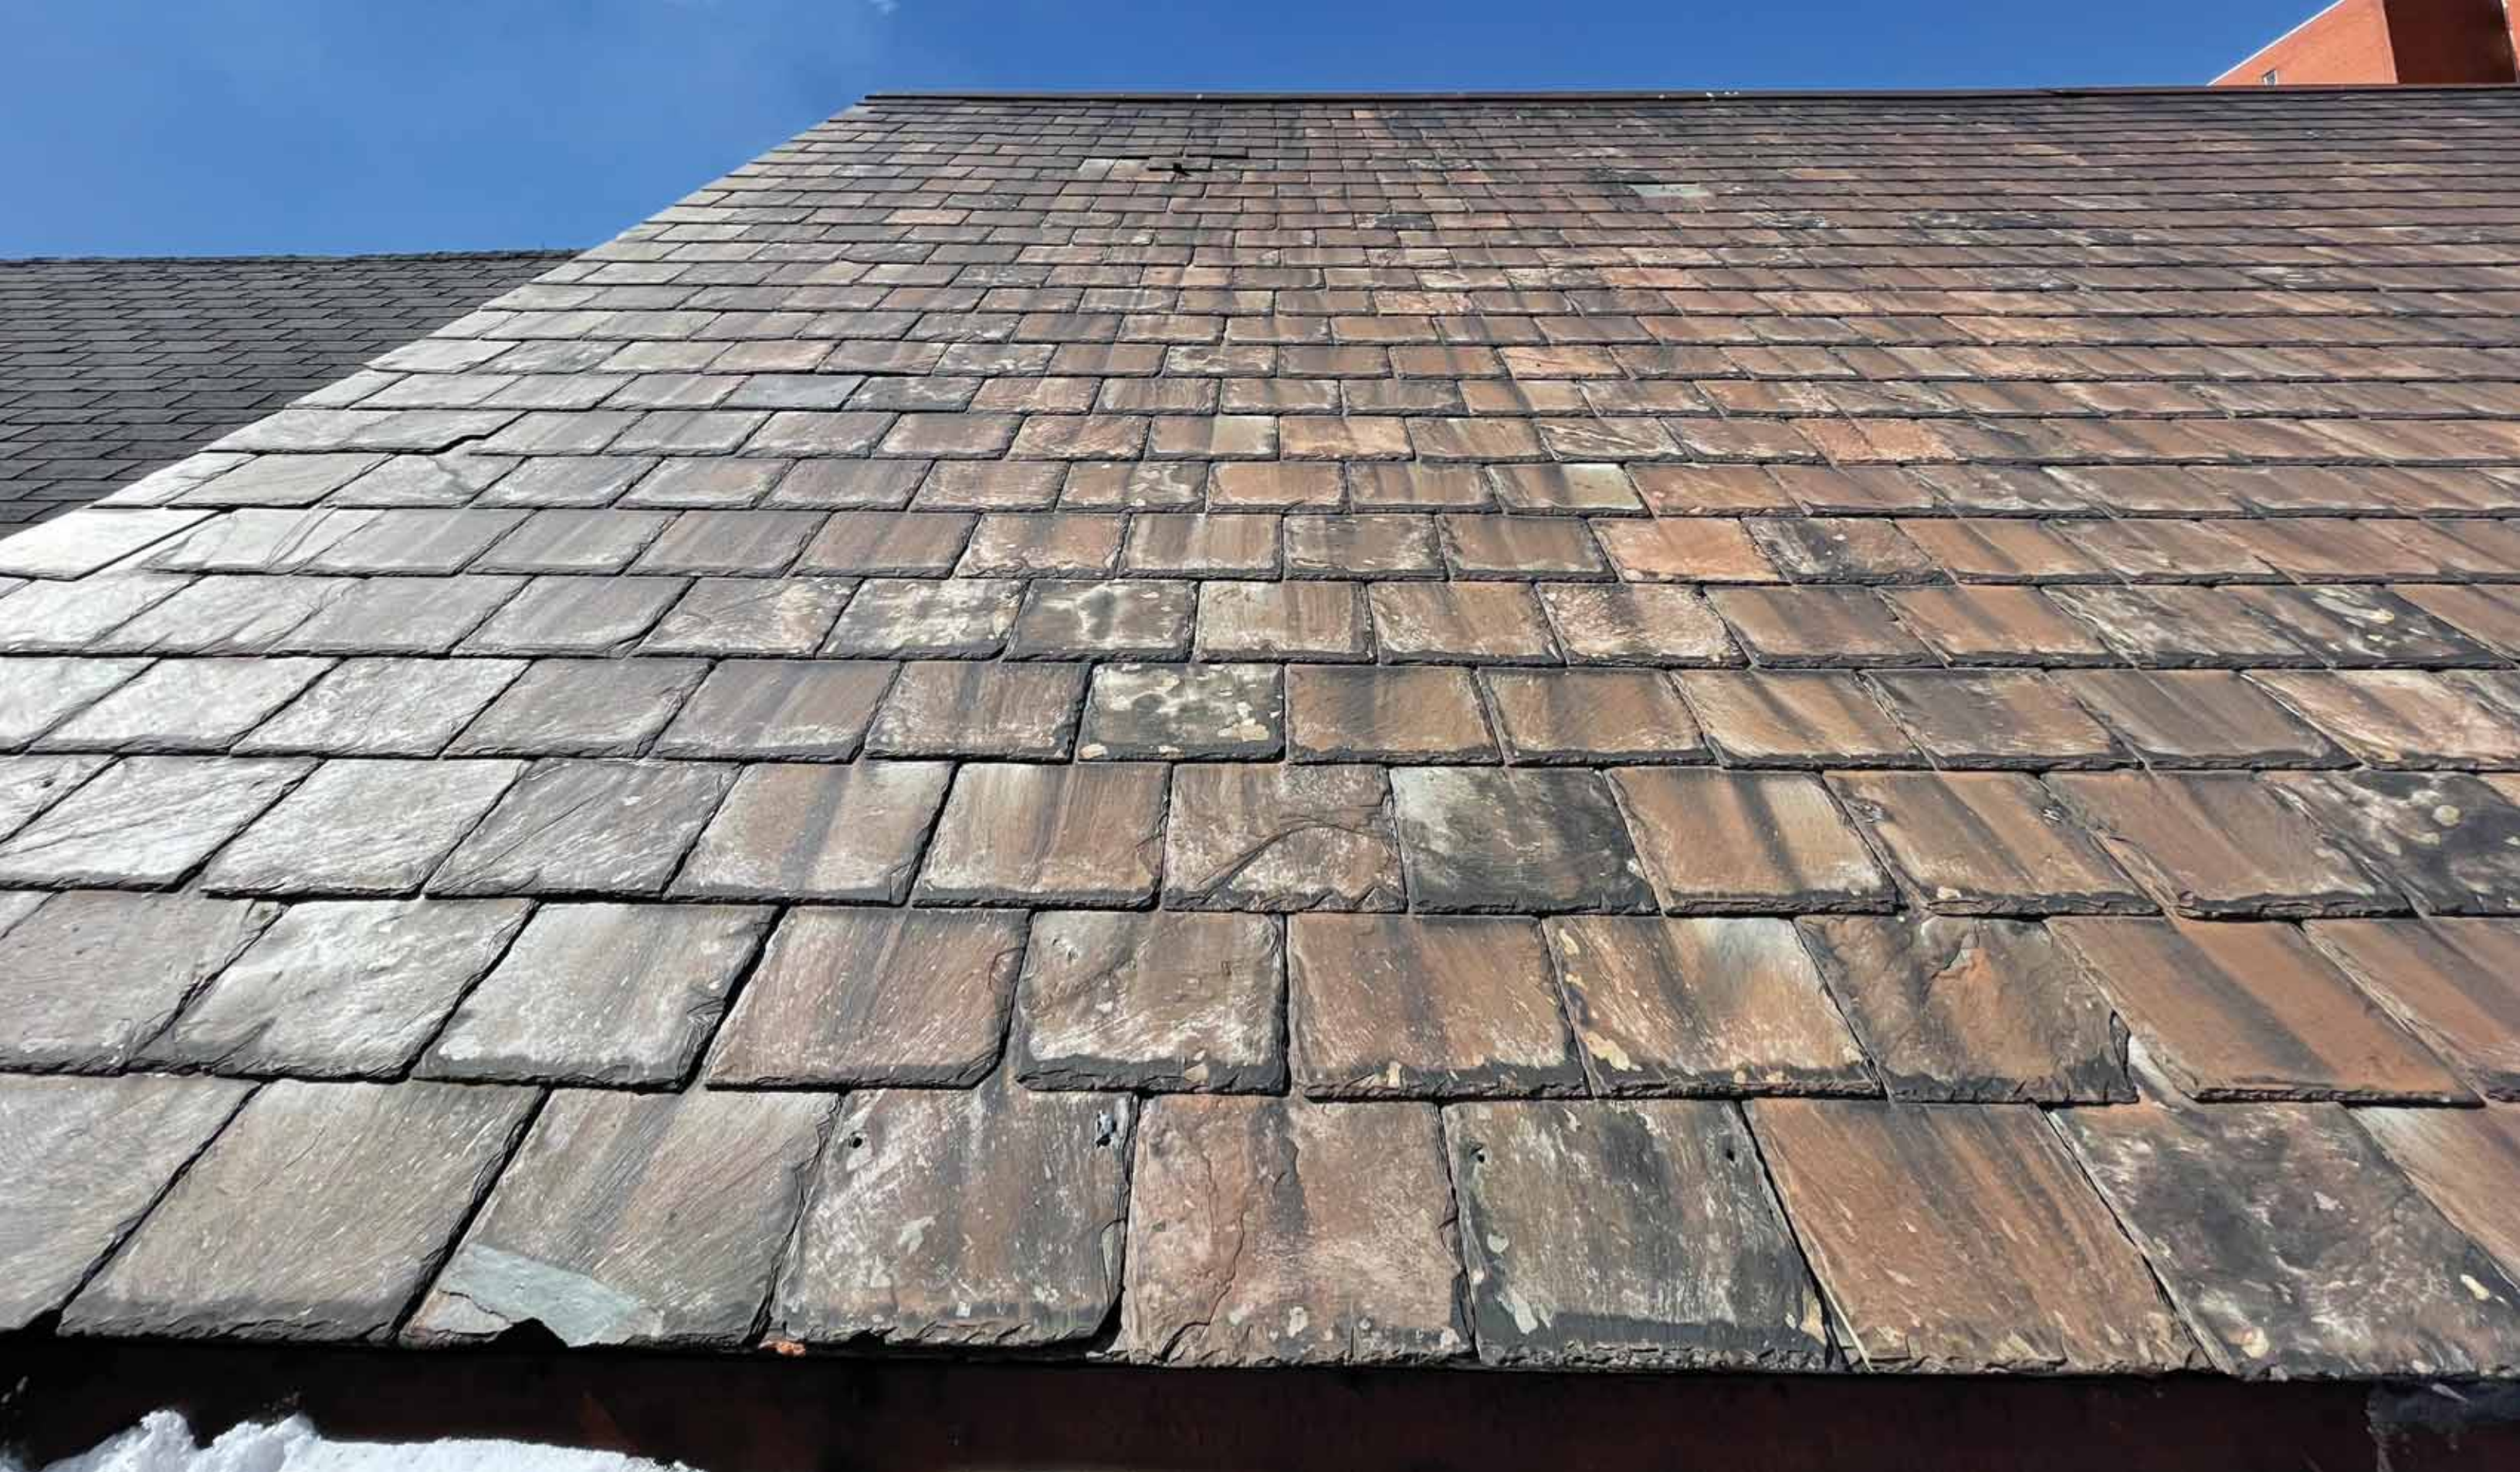
Existing Conditions : Slate is 1/6 standard thickness with visible delamination and sheering of tiles.

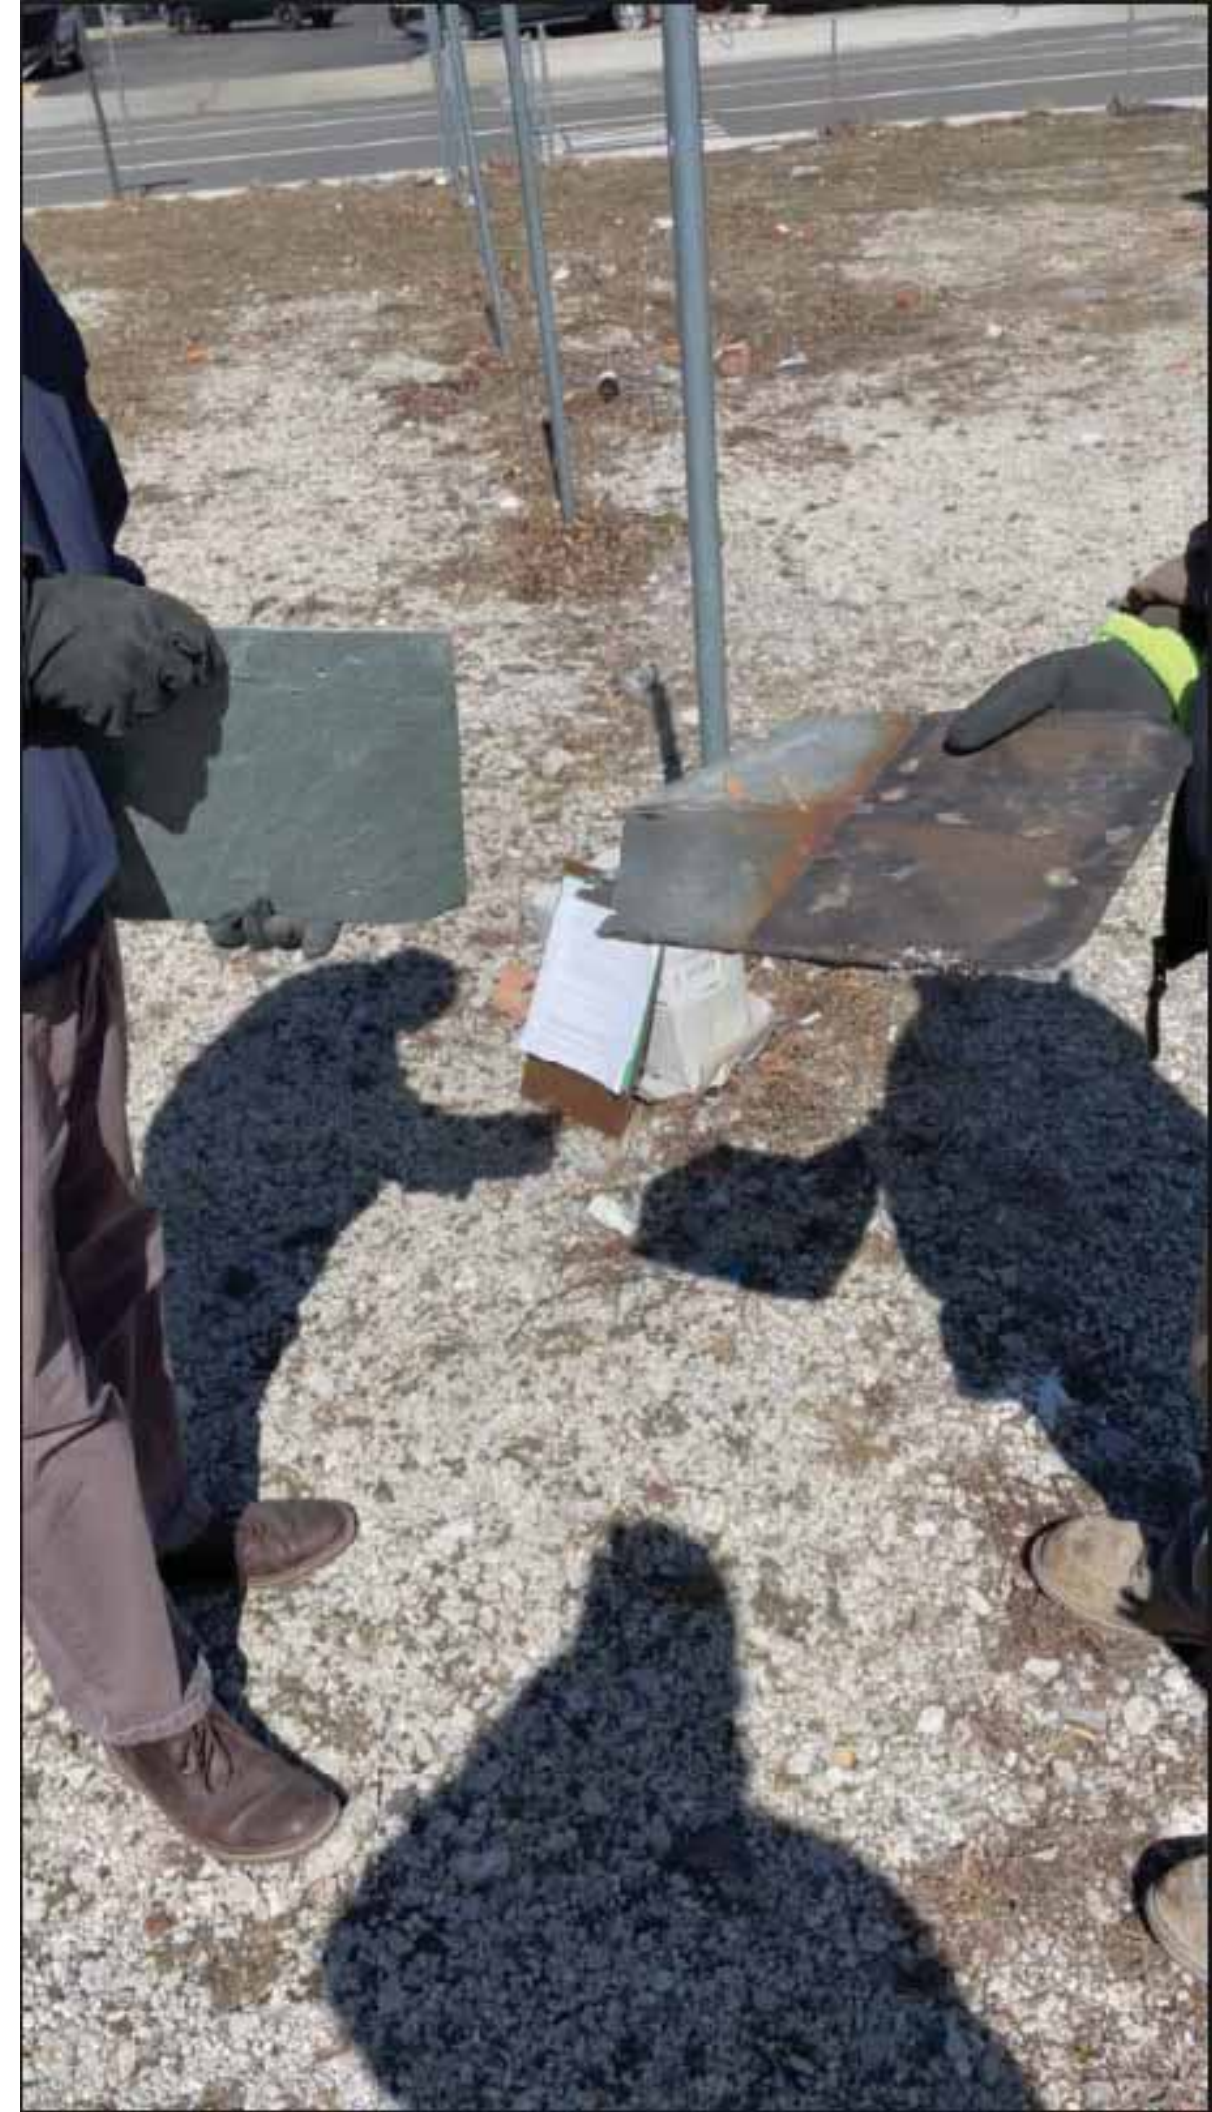
1. In this video from Exhibit B, you will be able to hear the difference between what the sample of new slate sounds like and what the existing slate sounds like.
2. This sound test is used in testing the life and condition of slate tiles within the industry.
3. The test results conclude that the current slate is **beyond salvageable life.**
