CITY OF DETROIT HISTORIC DISTRICT COMMISSION

92 E. Forest. Detroit, MI

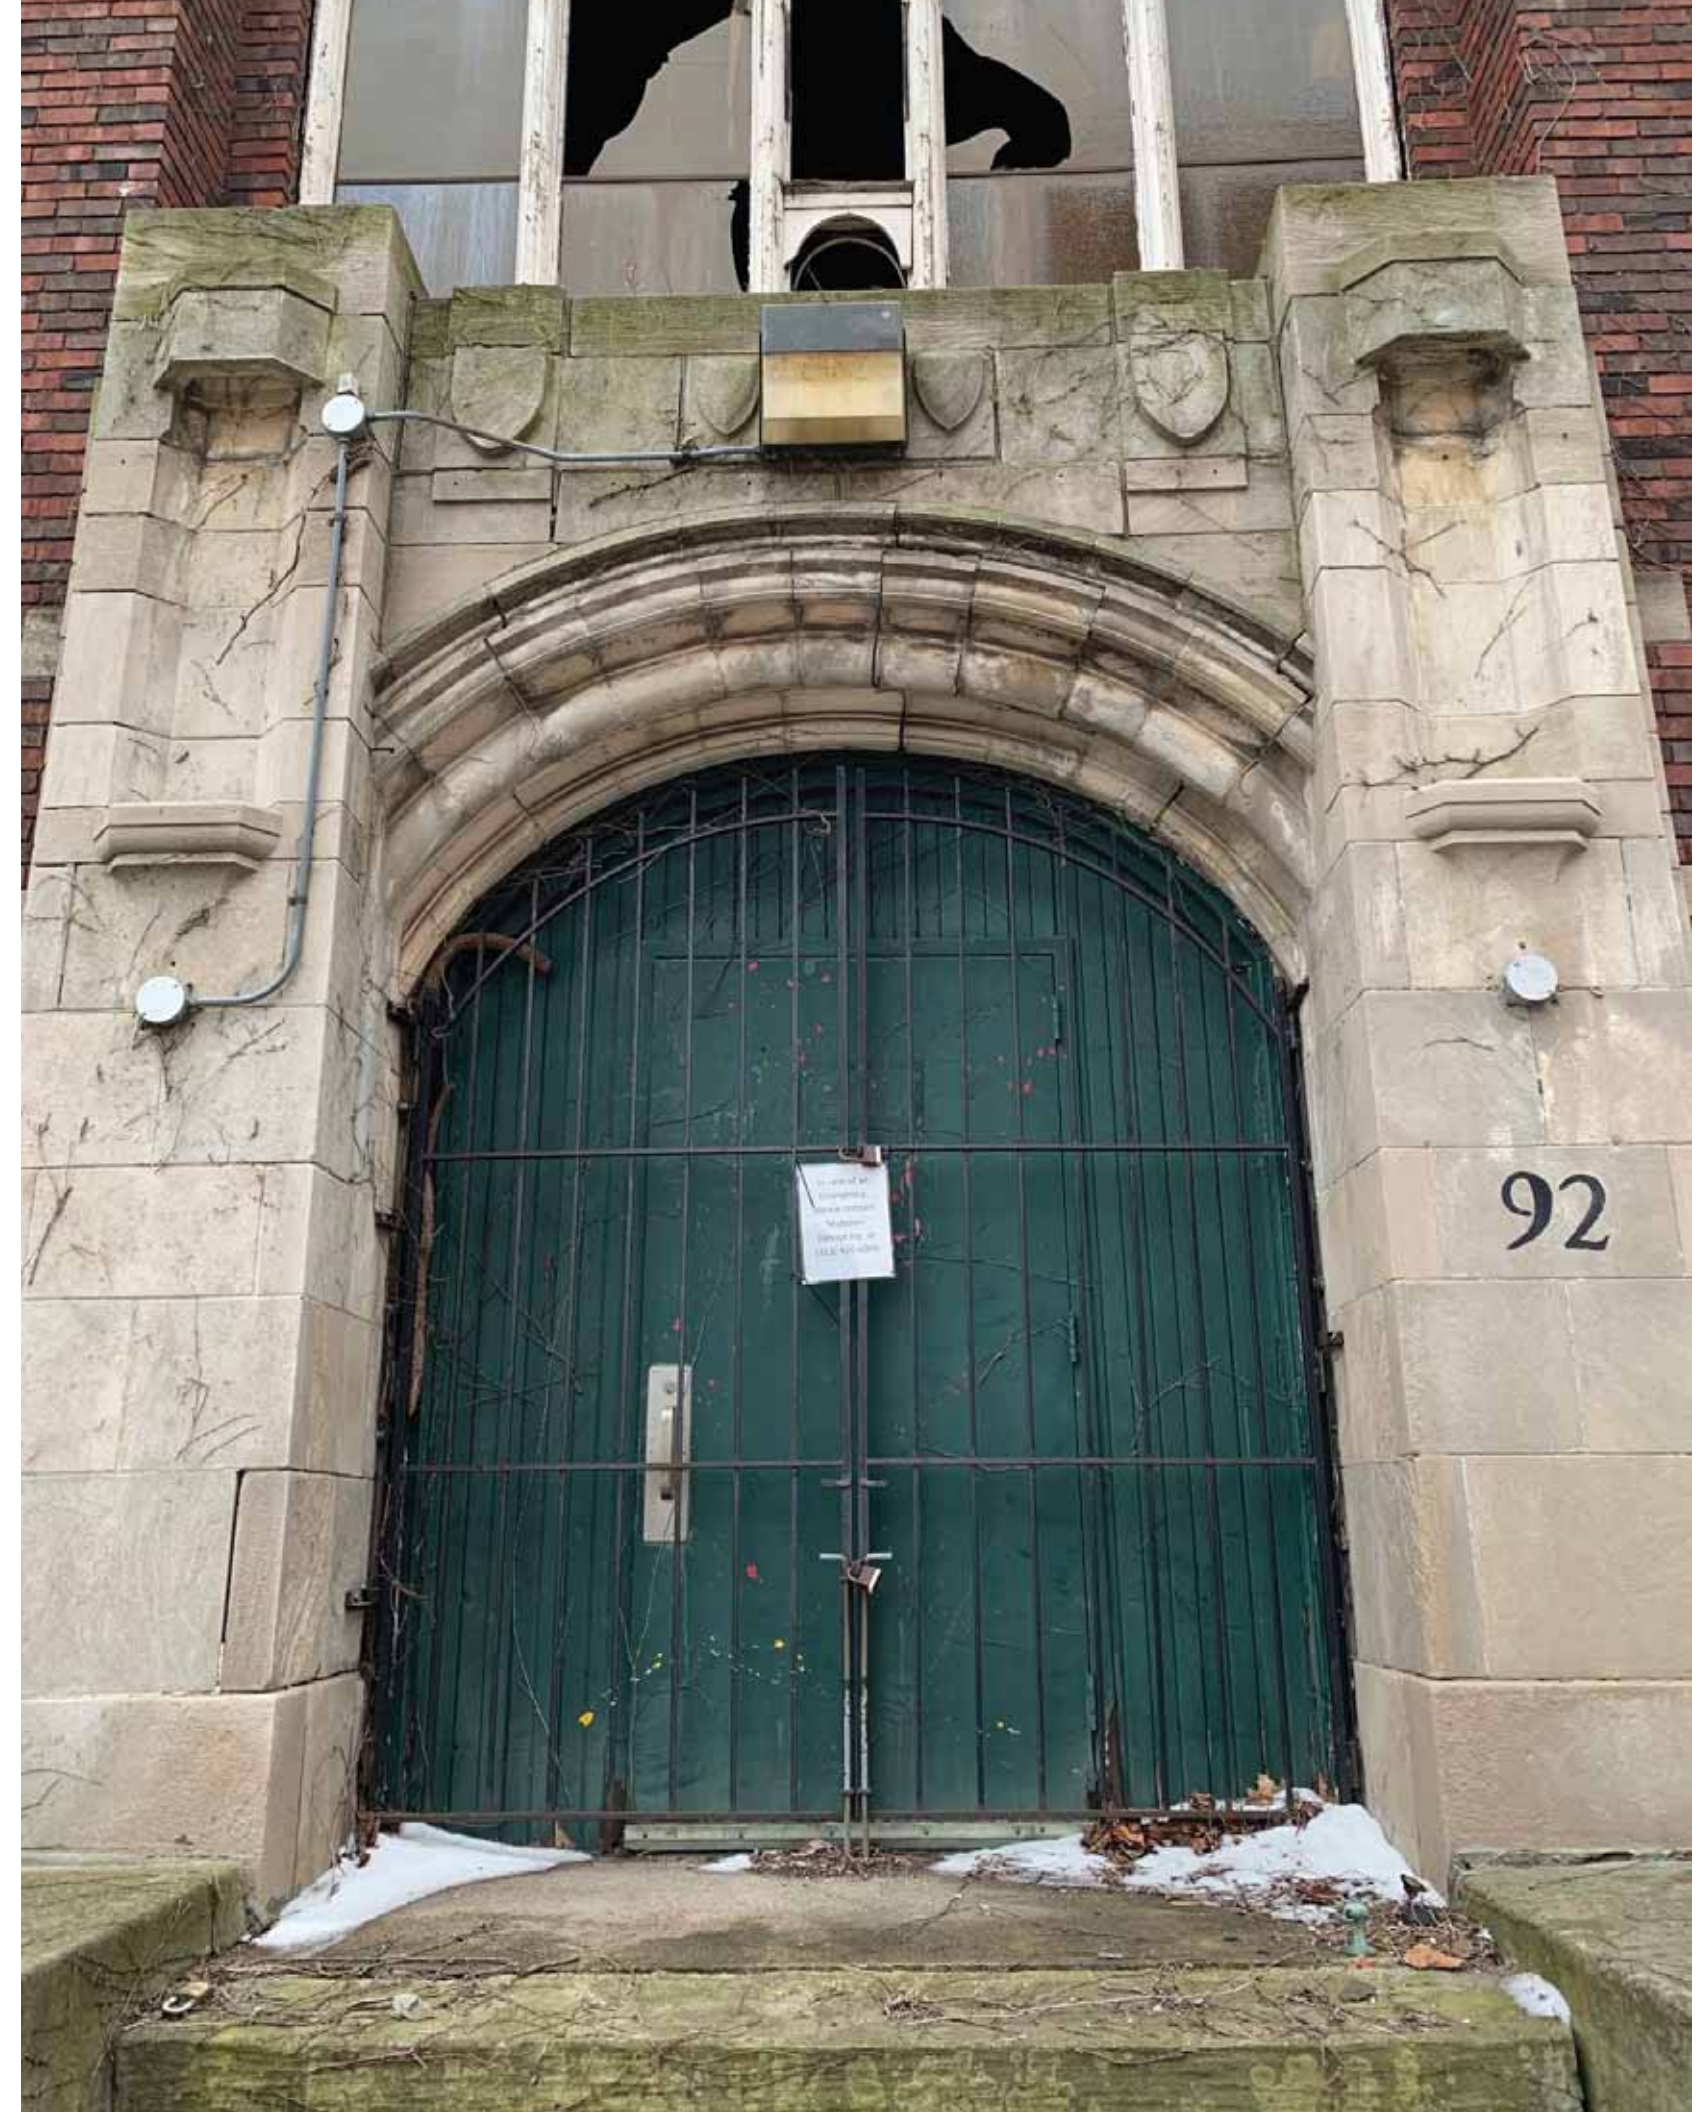
- The Current Entry Door is a plywood infill with a single swing door inset.
- The proposed doors are what would have likely been installed originally due to historical timing and style approximations.

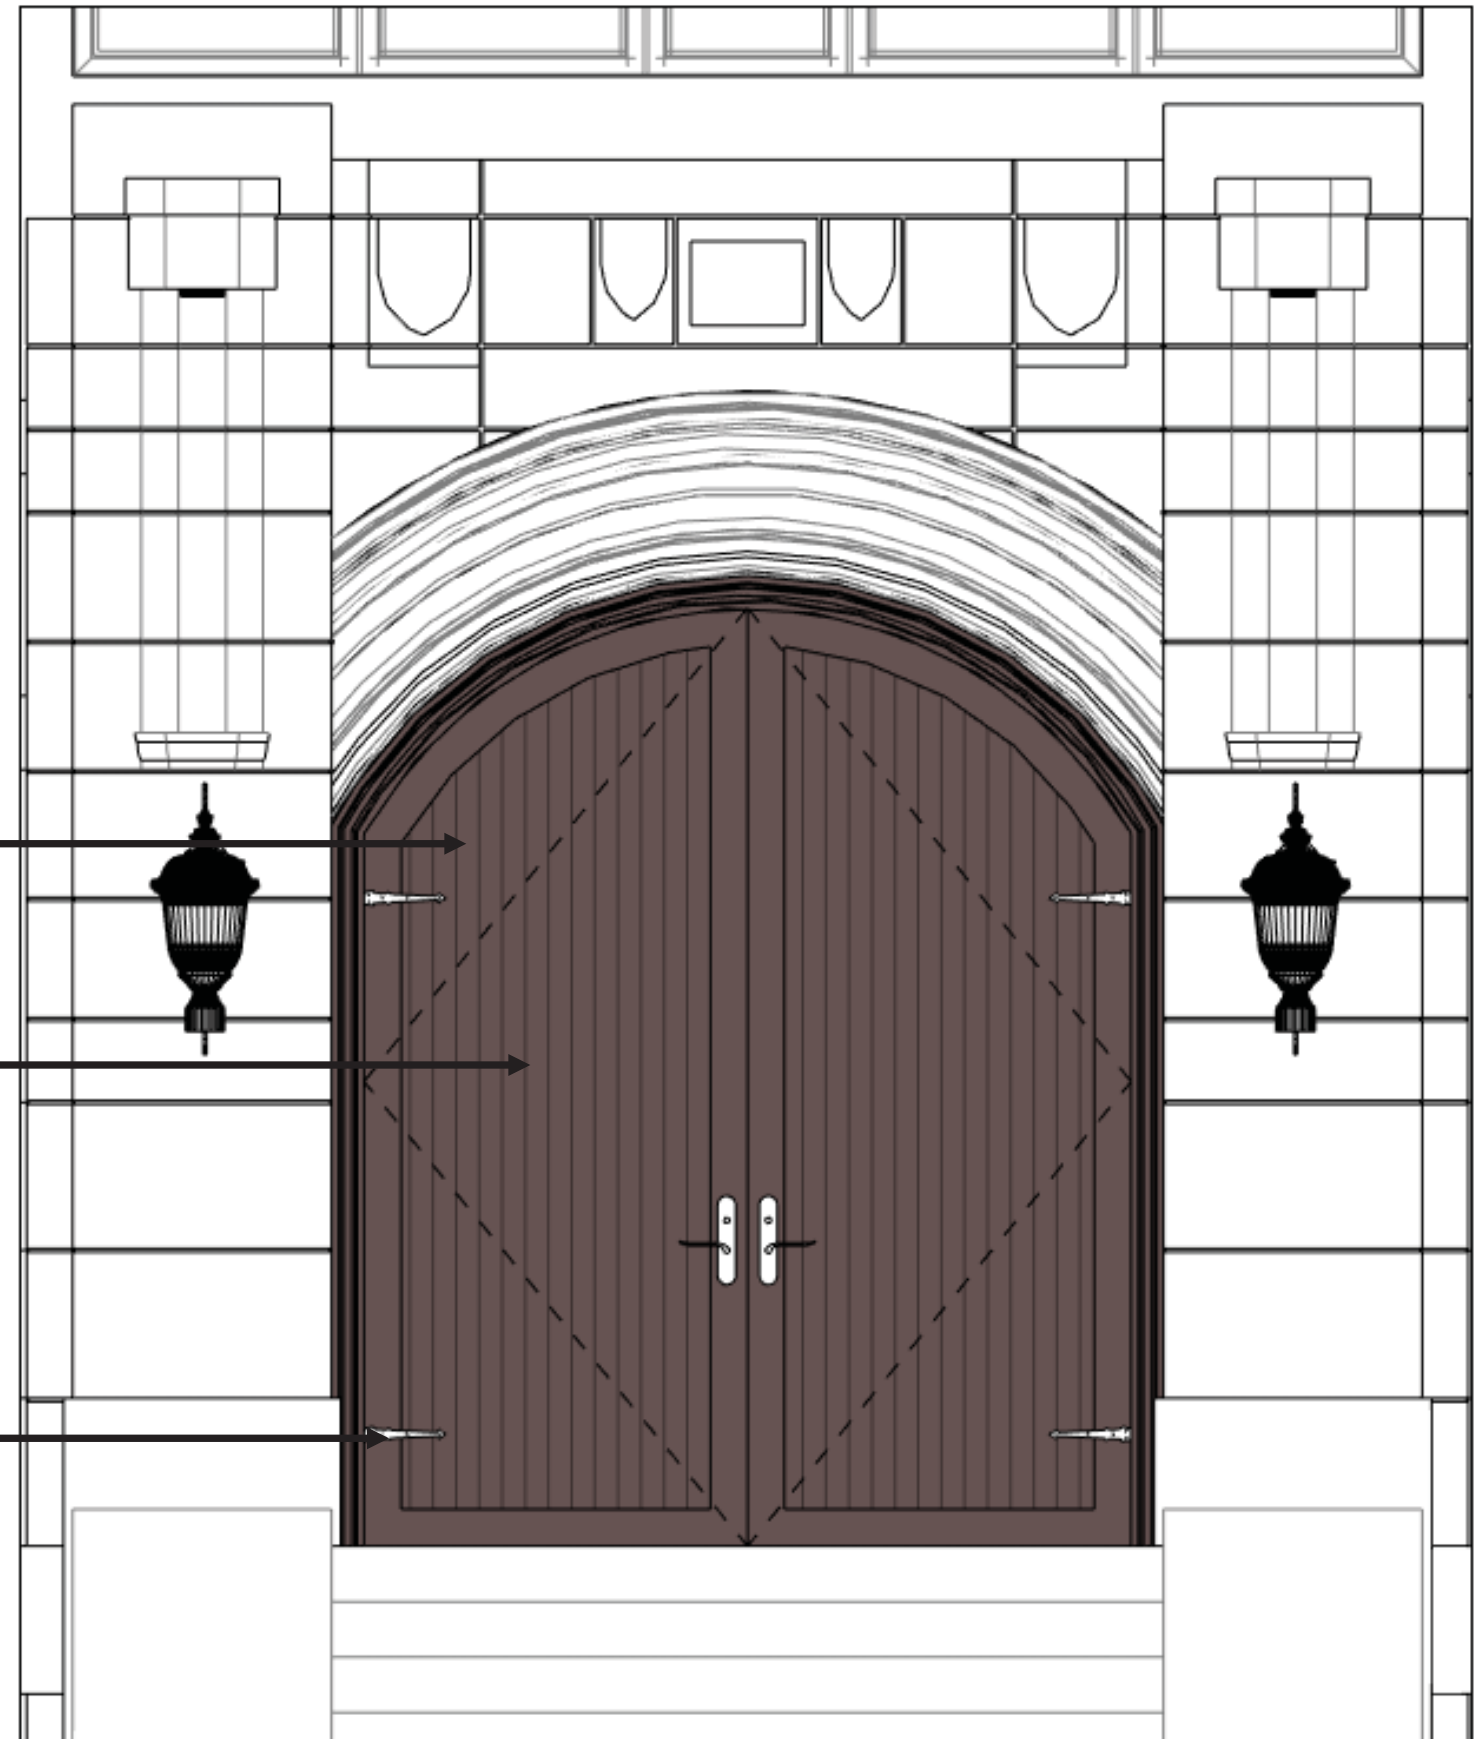
- The proposed doors are what would have likely been installed originally due to historical timing and style approximations.
- 1-3/4" solid wood doors with V-Groove panel finish.
- Stain to coordinate with structure - exact color to be submitted to staff for approval
- Exposed, decorative hinges
- New door hardware to be black in color to match new fixtures

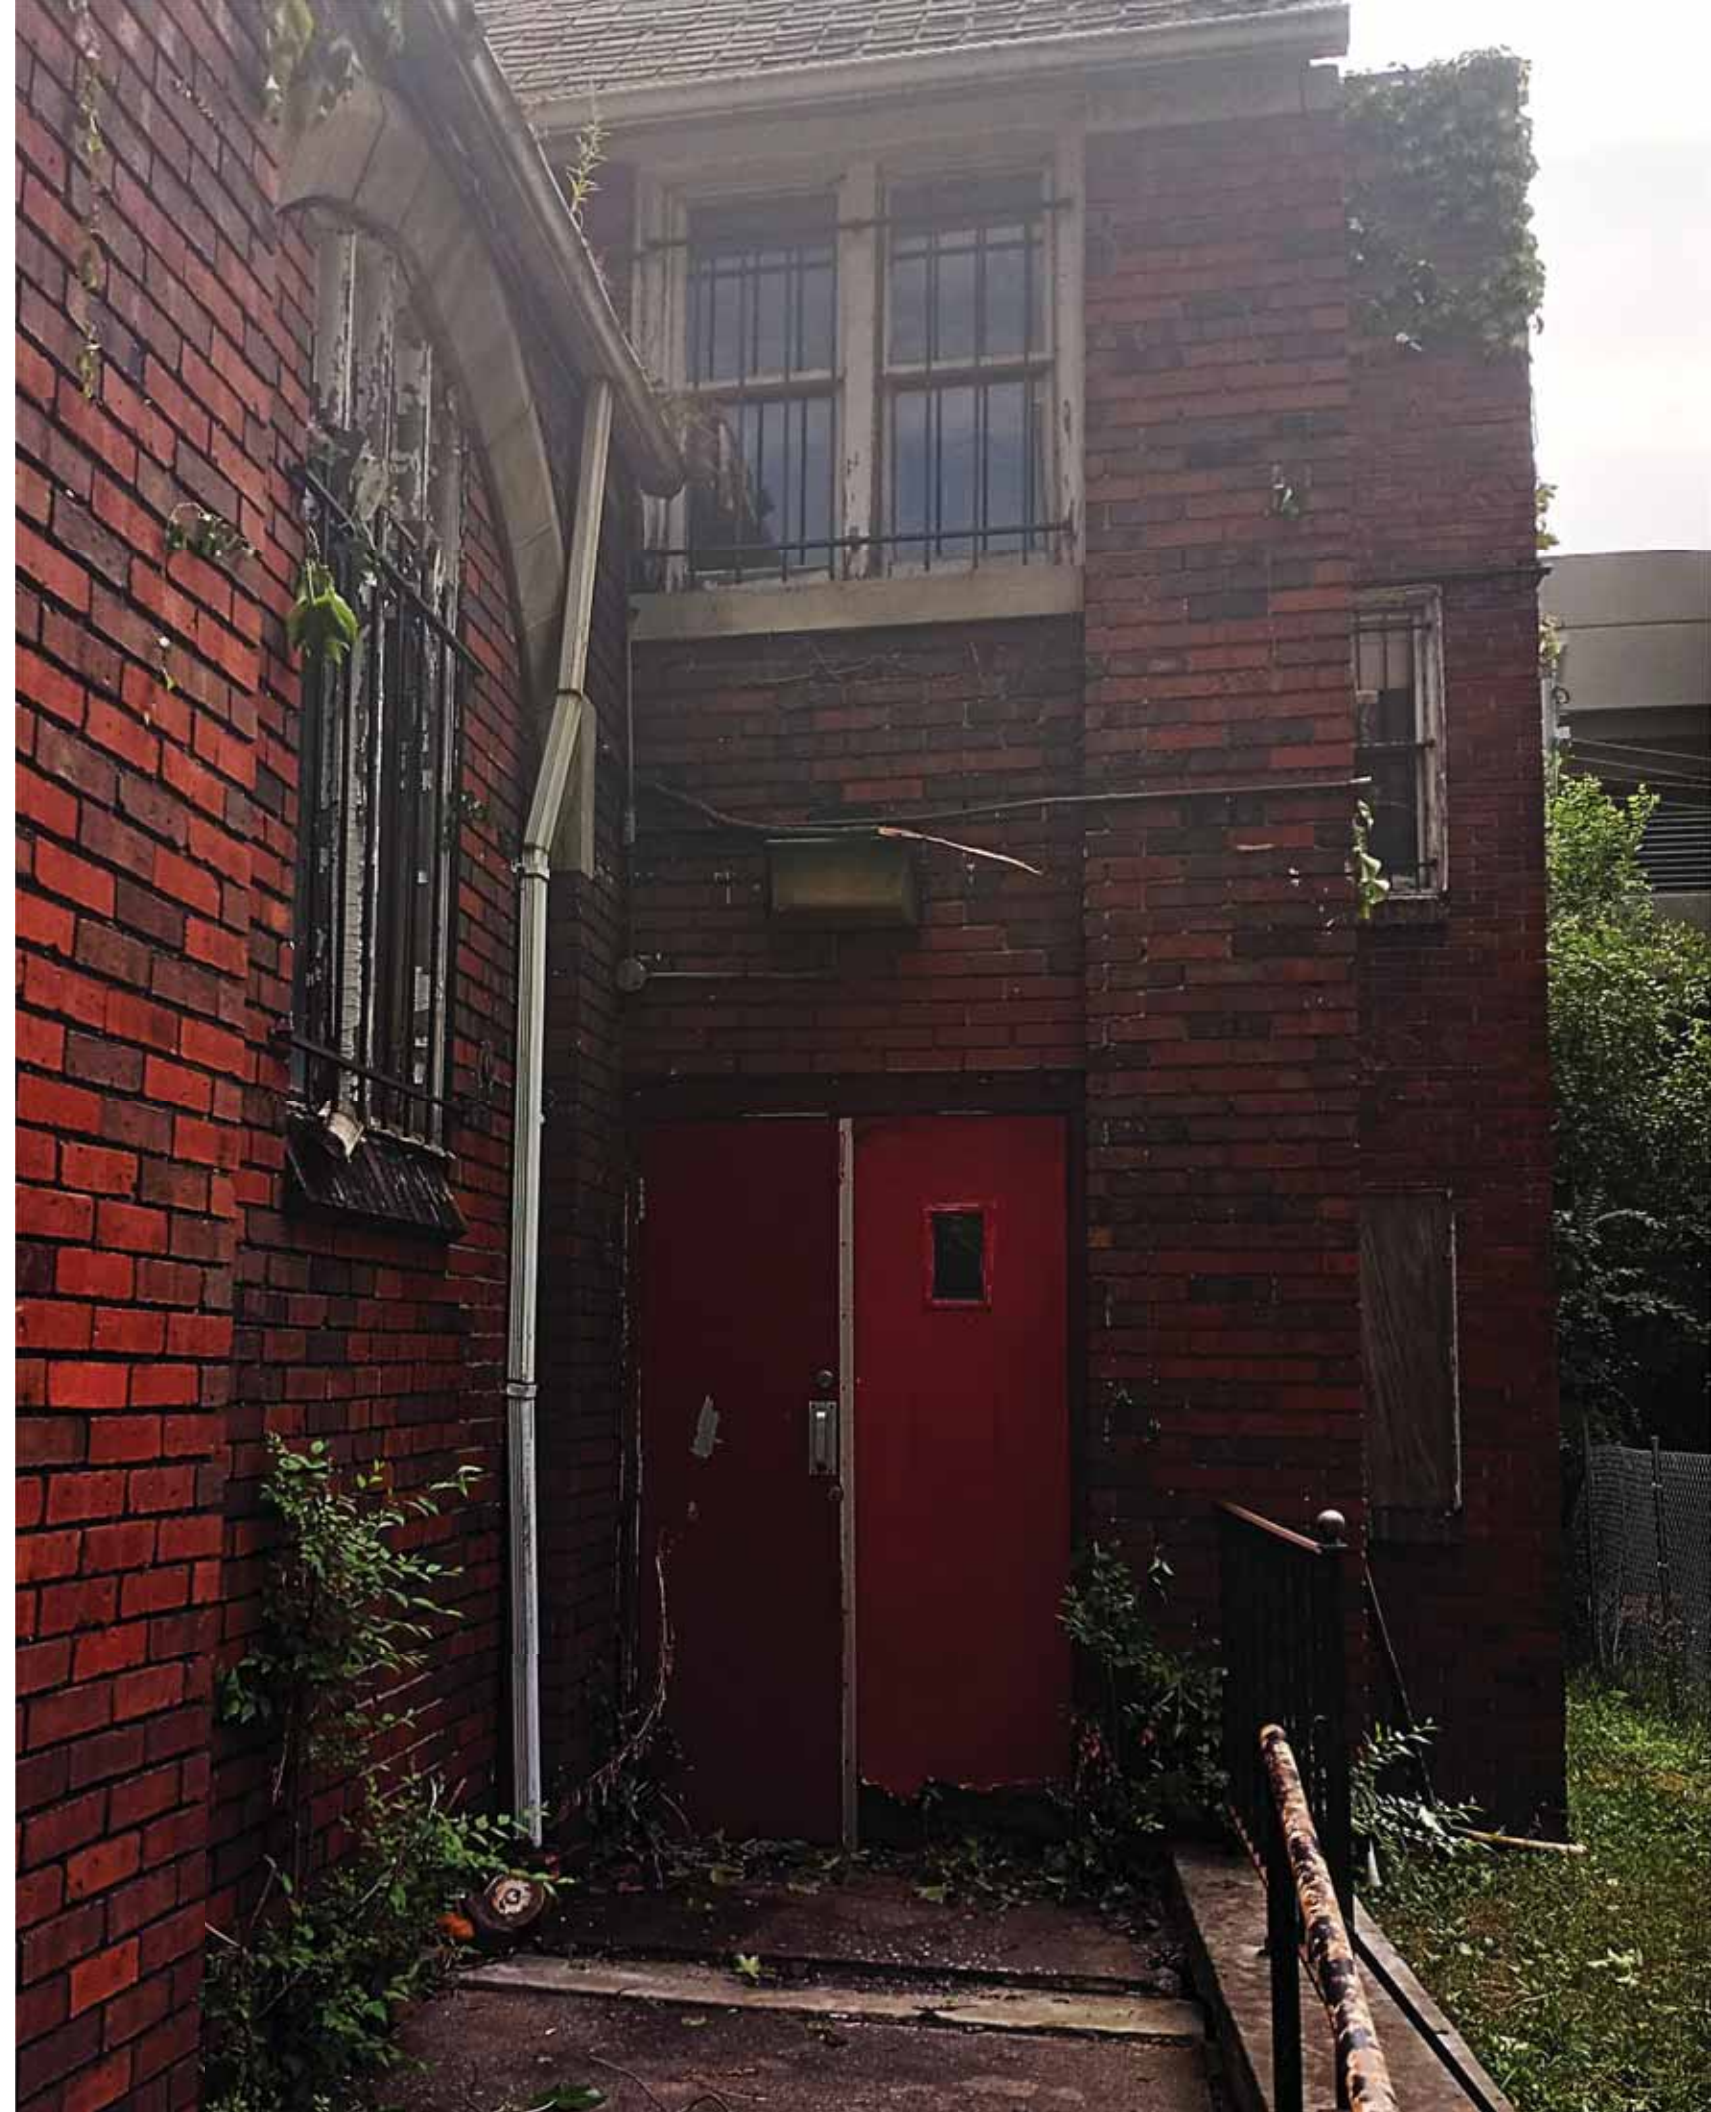
- The Current Entry Door is a wood, double swing door with sever delamination and portions of the finish missing.
- The proposed doors are in keeping with the style of the new front entry door, but with a vision panel at the side for users and security.

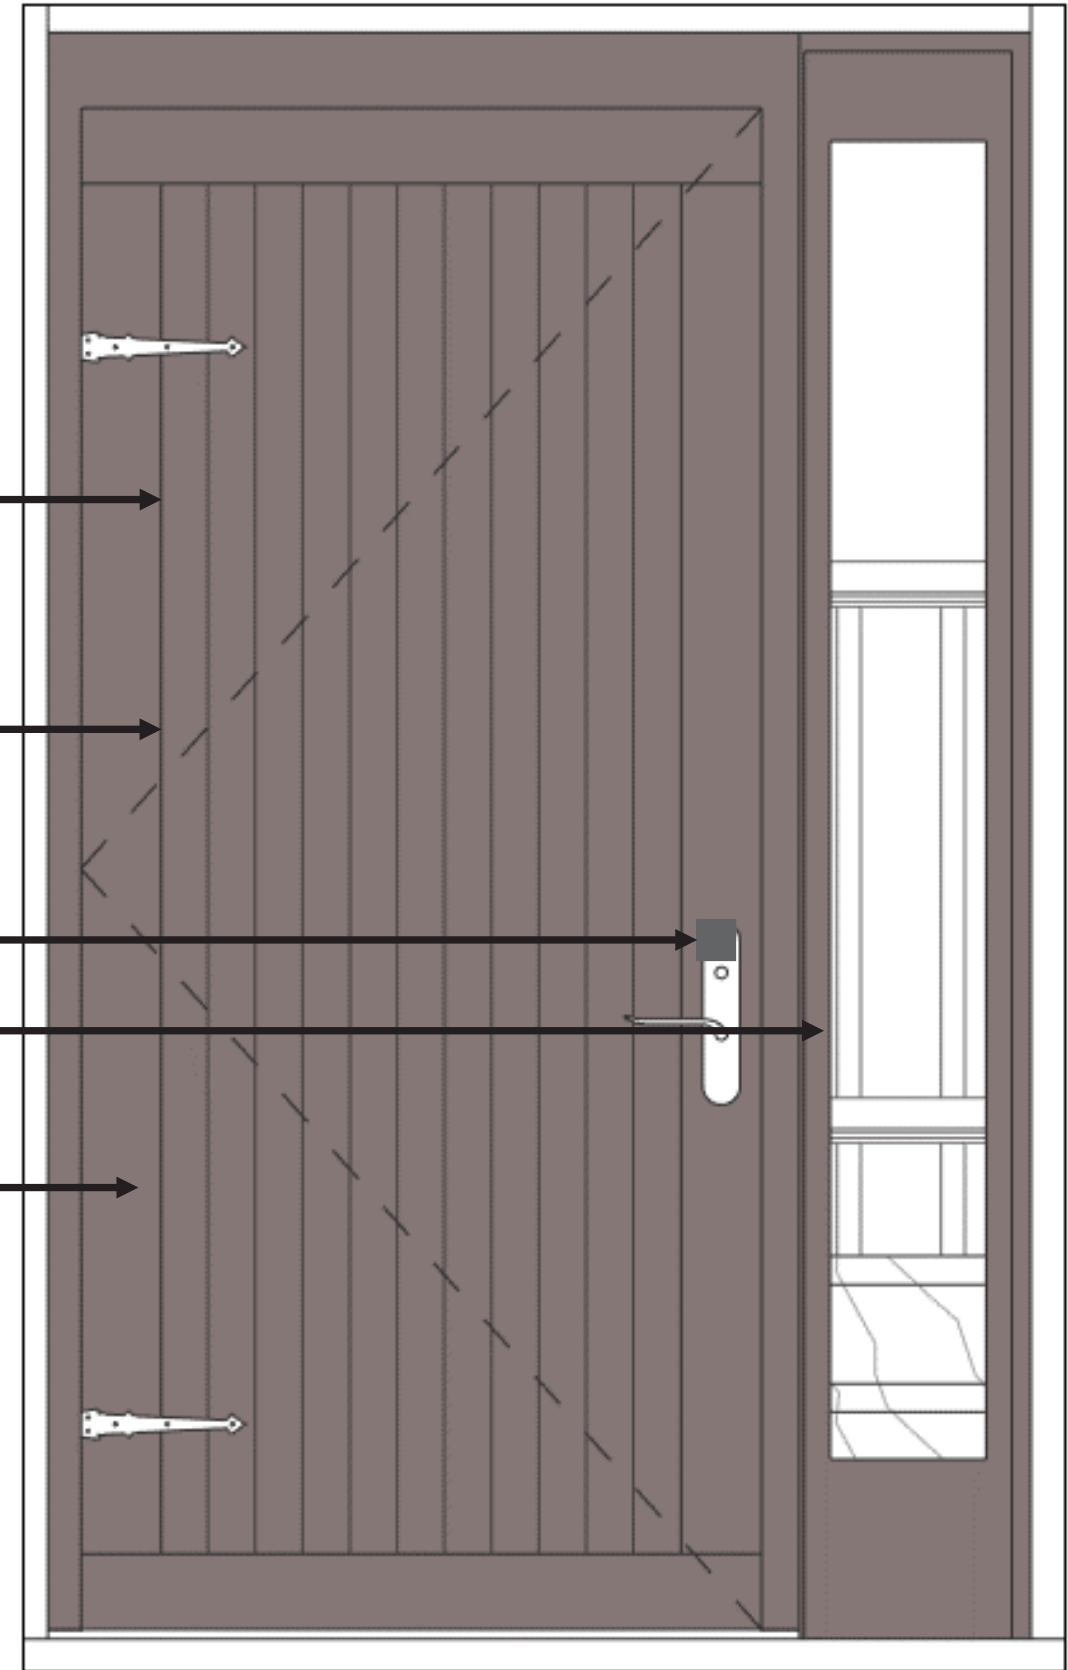
- The proposed doors are what would have likely been installed originally due to historical timing and style approximations.
- 1-3/4" solid wood doors with V - Groove panel finish.
- Electronic door hardware
- Side-lite in wood frame to match
- Stain to coordinate with structure-exact color to be submitted to staff for approval

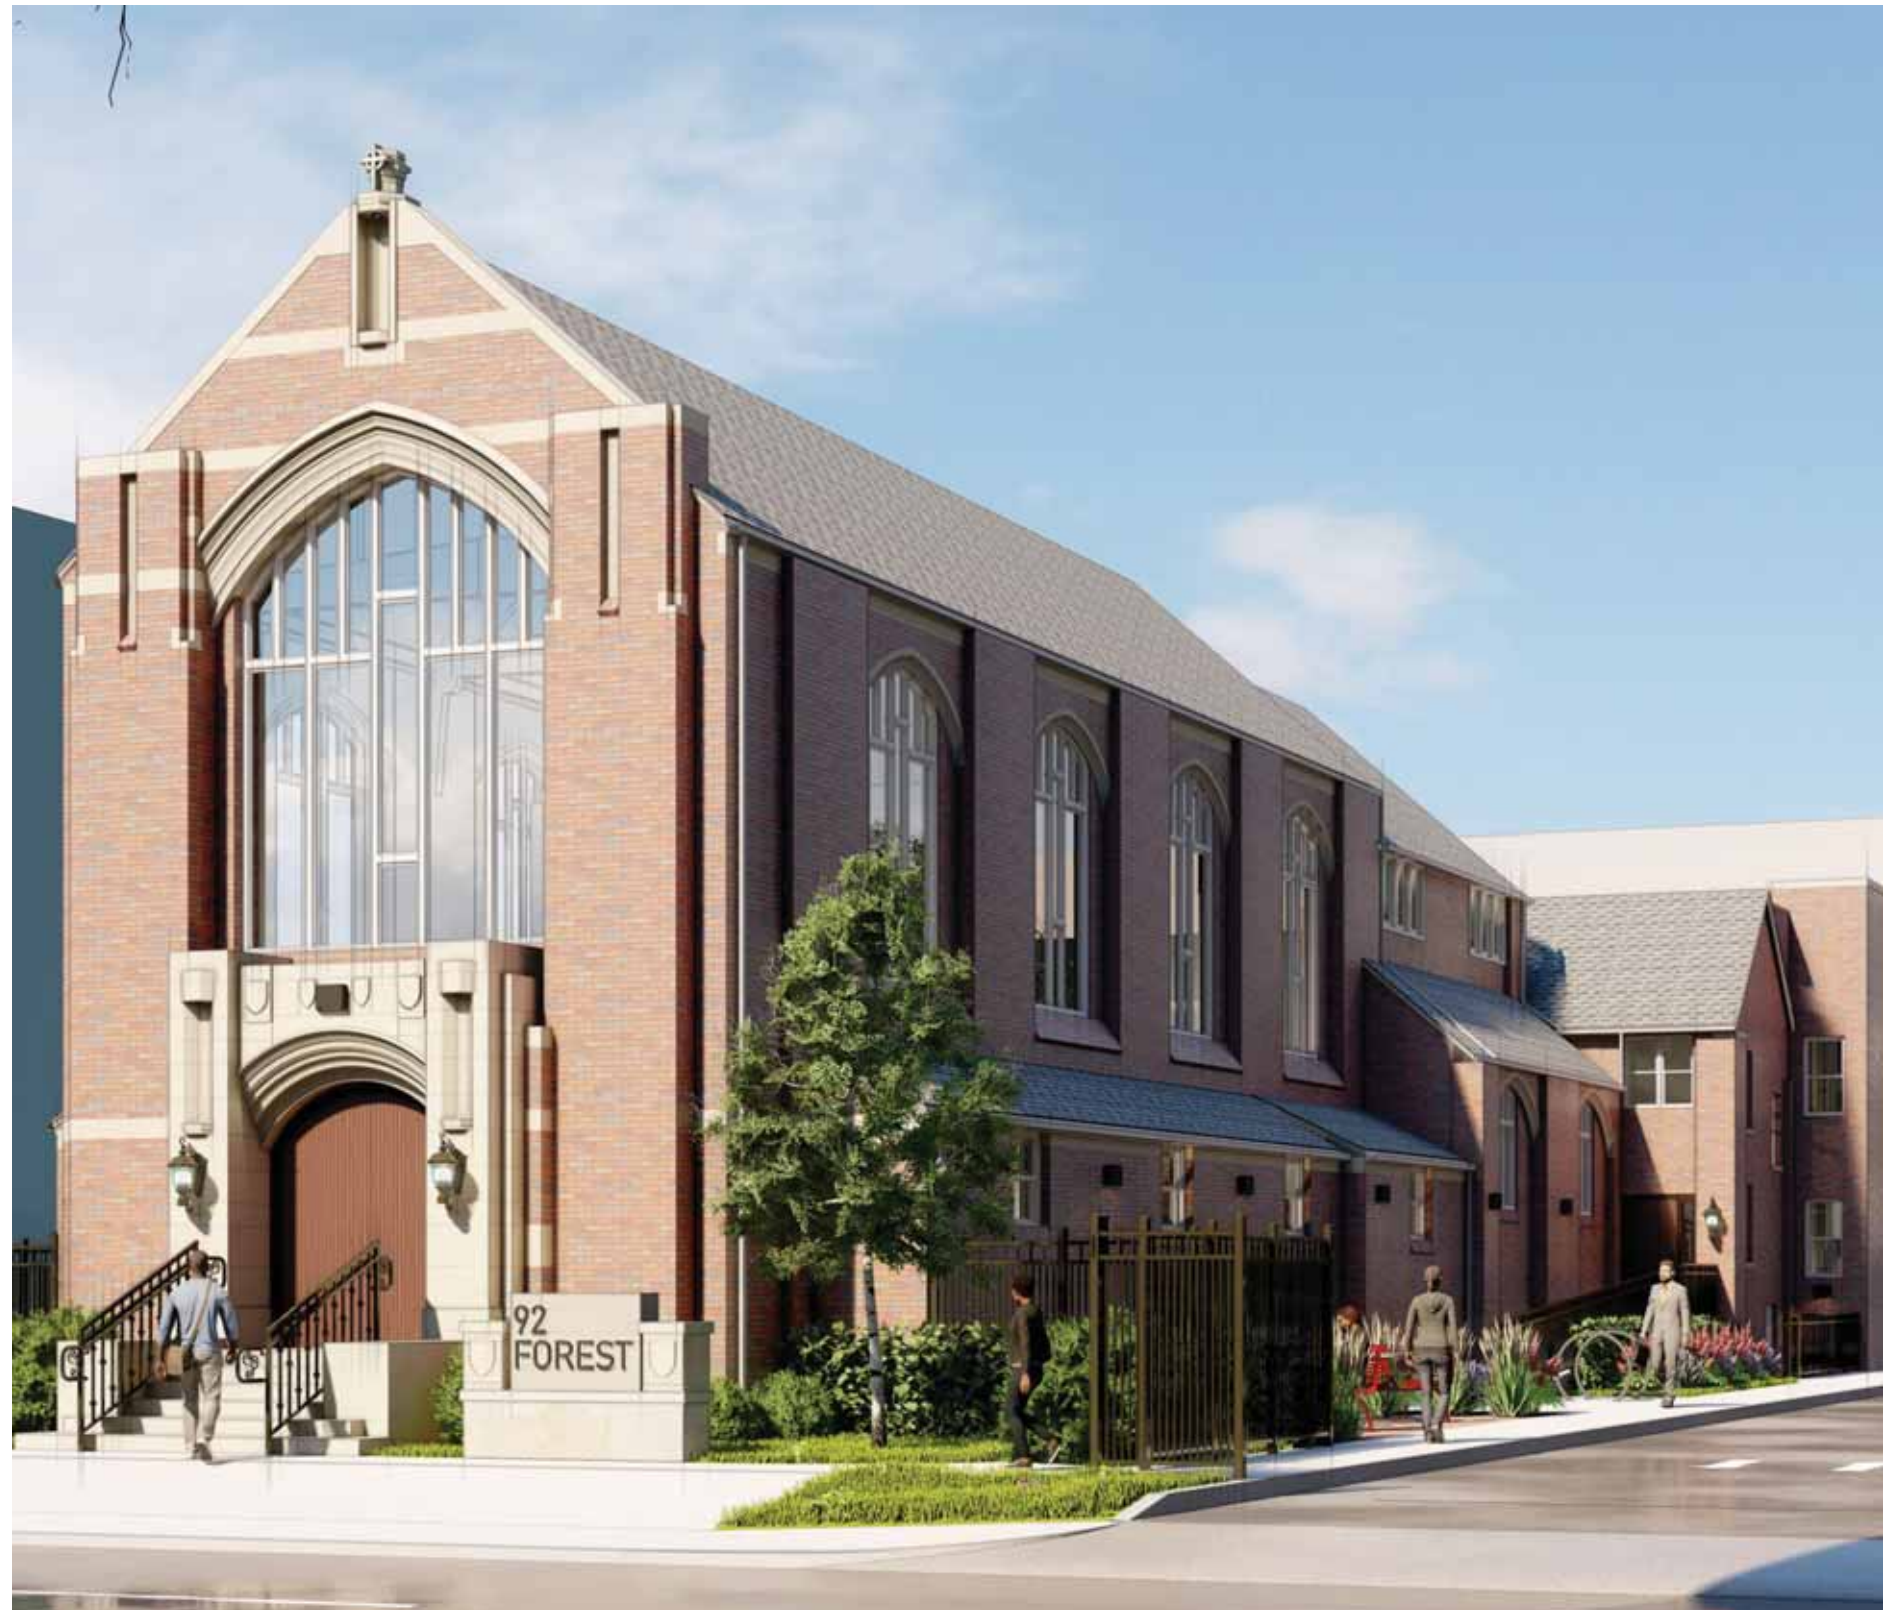
1. Current doors are “non original” / infill doors that do not fit the style of the building or the age
2. Proposed doors are consistent with what was likely initially installed as no photographic evidence of these doors exists in records
3. Entry Doors to be solid wood doors with V-Groove detailing
4. Meter Room Door to be wood-look steel door for durability

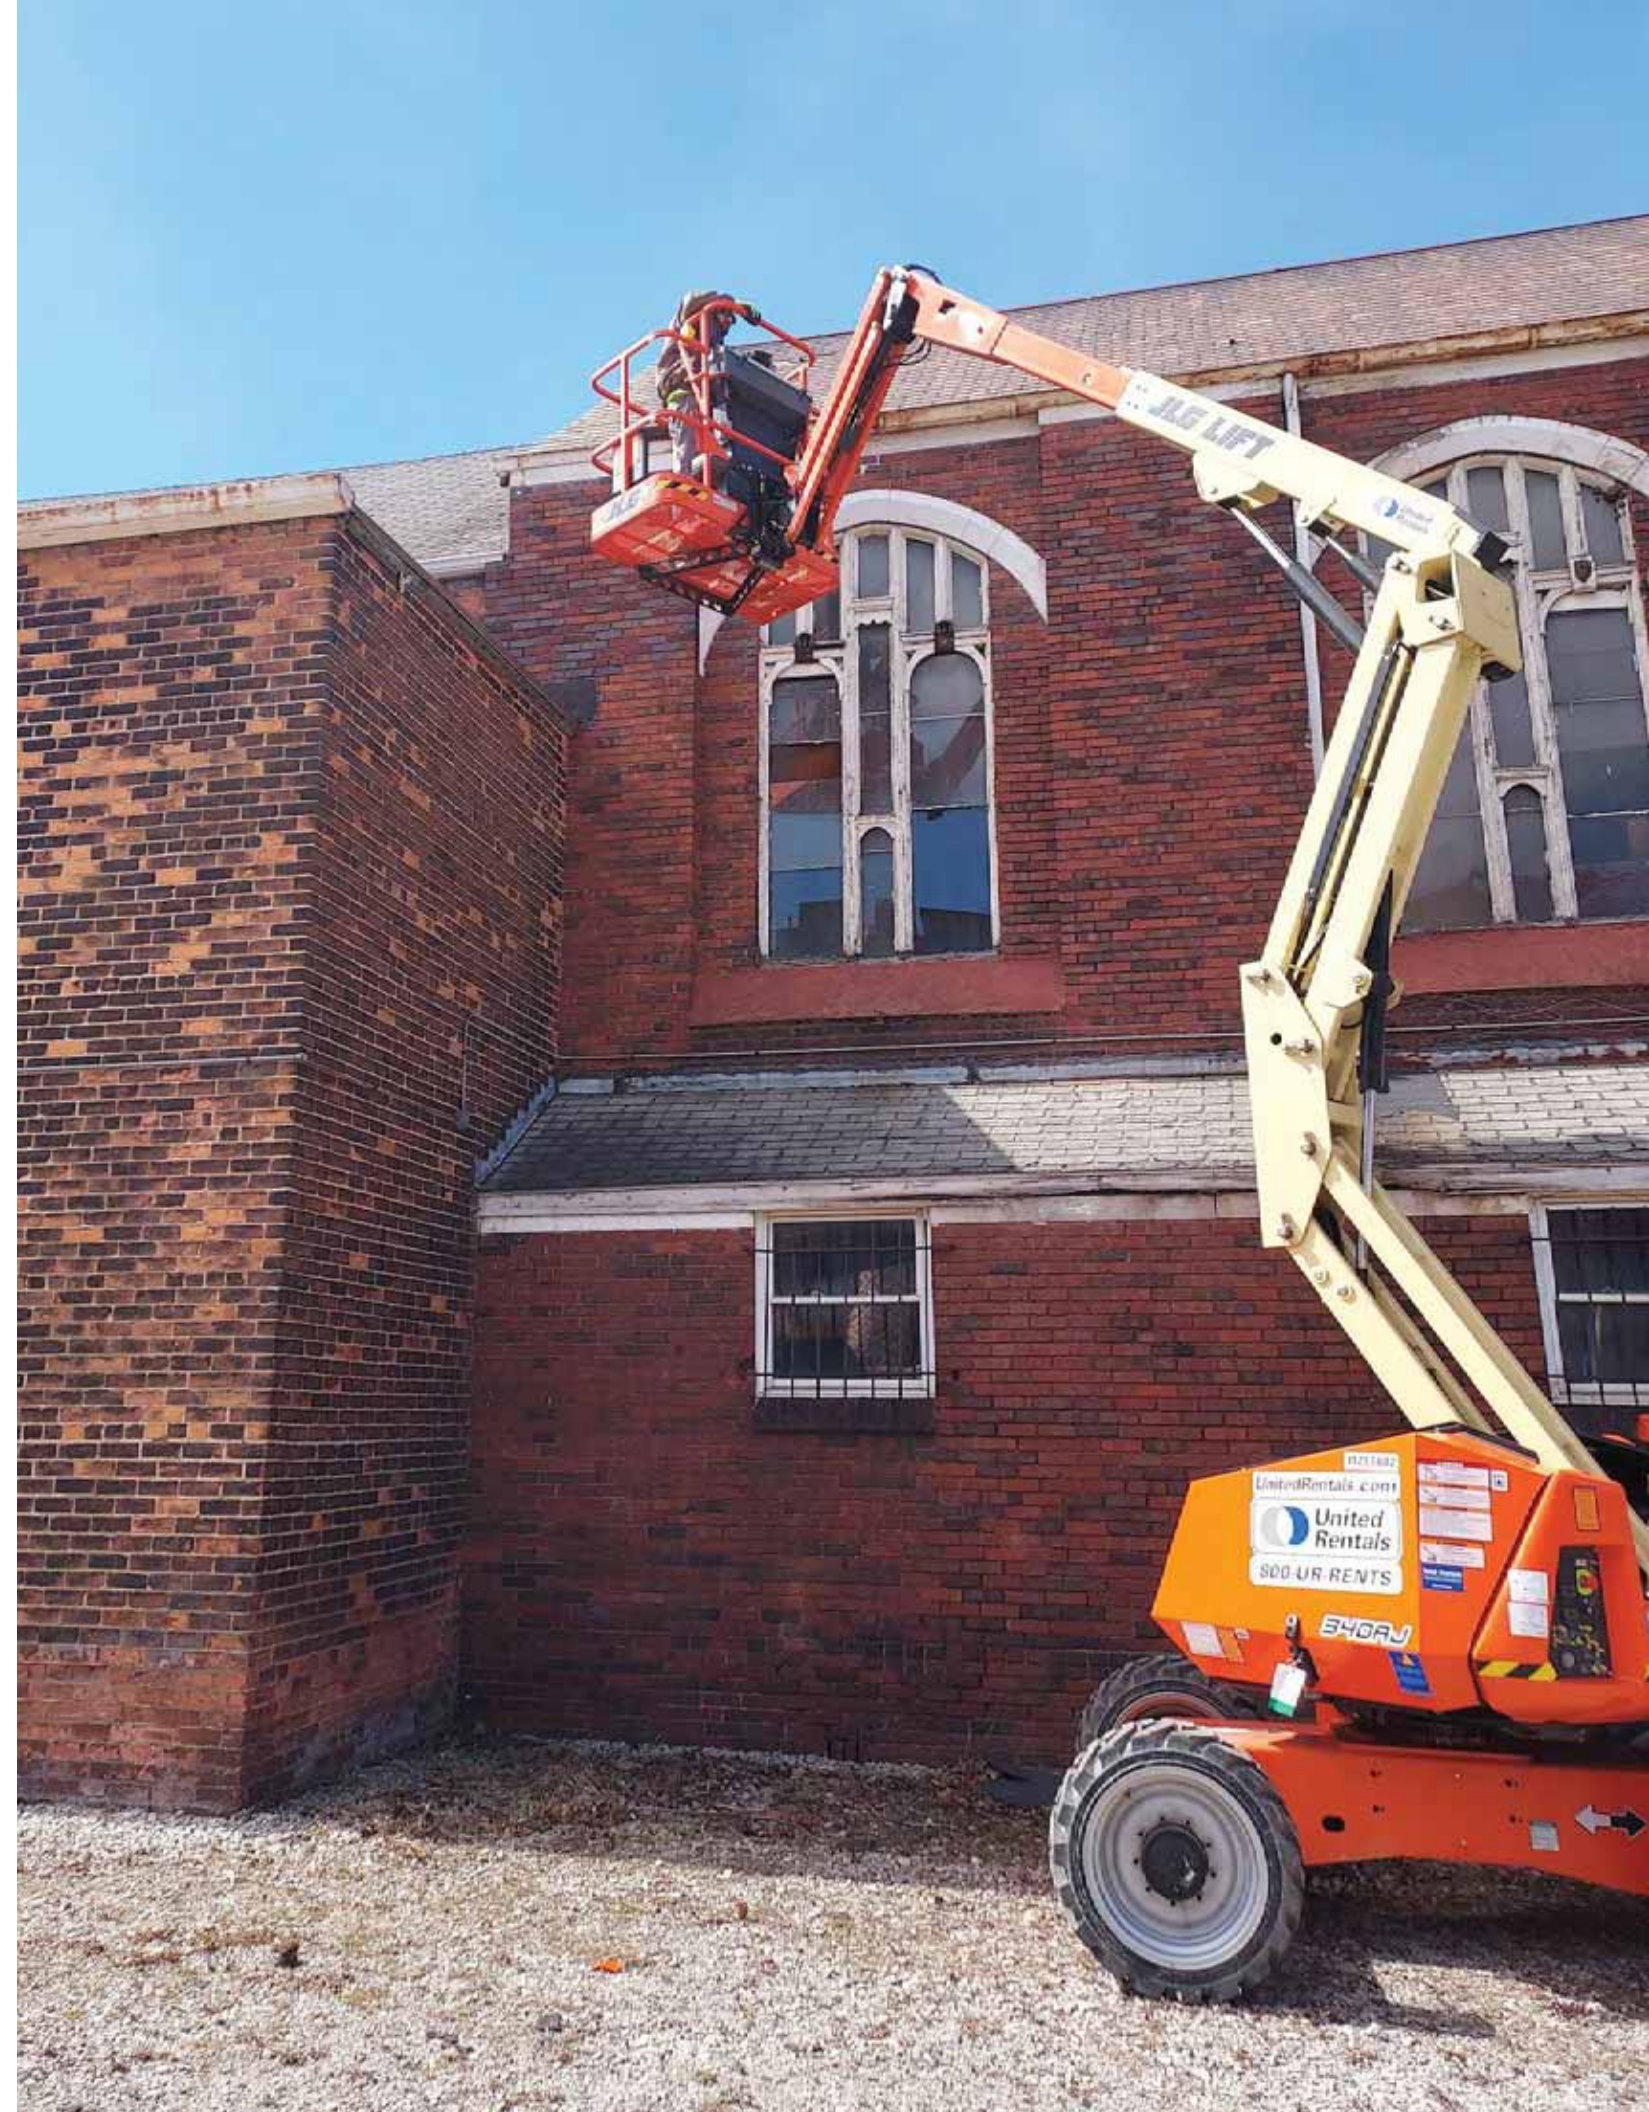
- Replace Vinyl Windows (#3) with Windsor Pinnacle Windows with new Replicated Brickmould and Trim
- Replace Wood Windows (#4) with Windsor Pinnacle Windows with New Replicated Trim and Brickmould
- Will Match The New Windows Approved In Phase 1
- Repair, Refinish, And Replicate In-kind Arched Window (#5) Pieces With New Energy Efficient Glazing

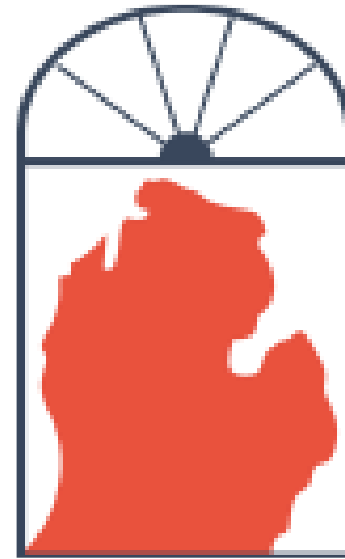
North Coast
Window Works
Rehab. Rebuild. Restore.

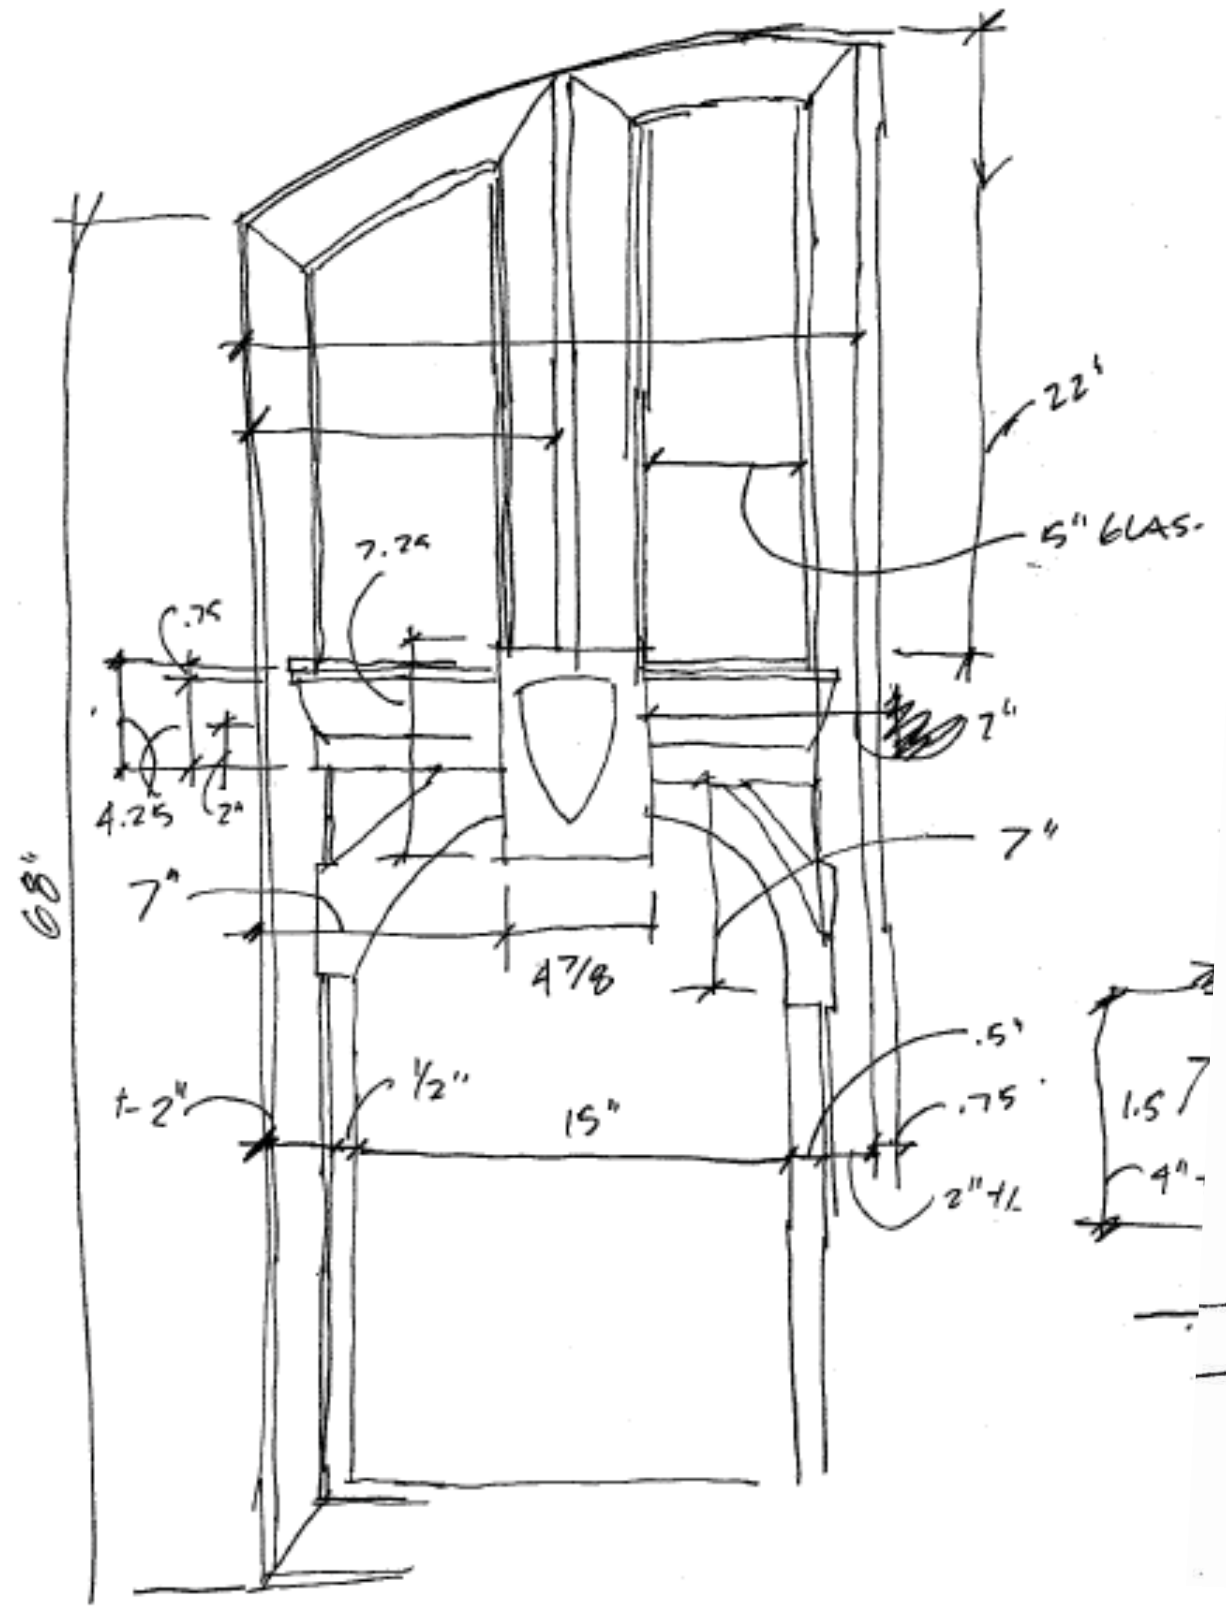
Measurement of nave windows
