CITY OF DETROIT HISTORIC DISTRICT COMMISSION

92 E. Forest. Detroit, MI

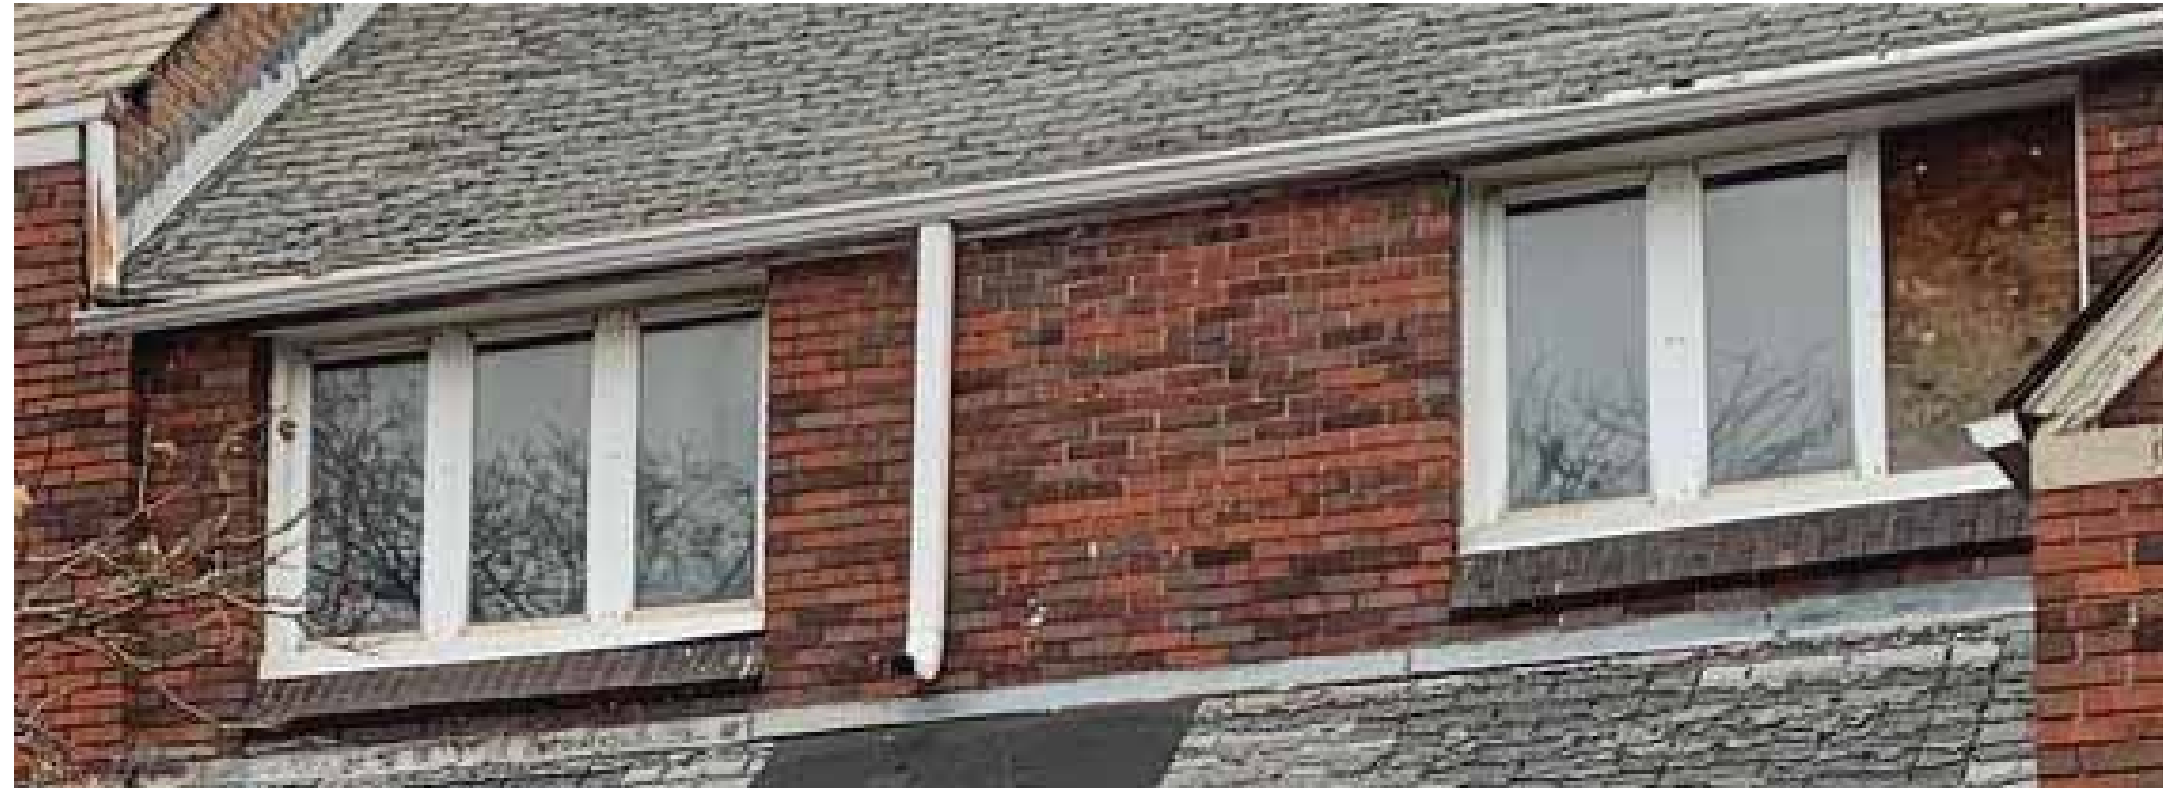
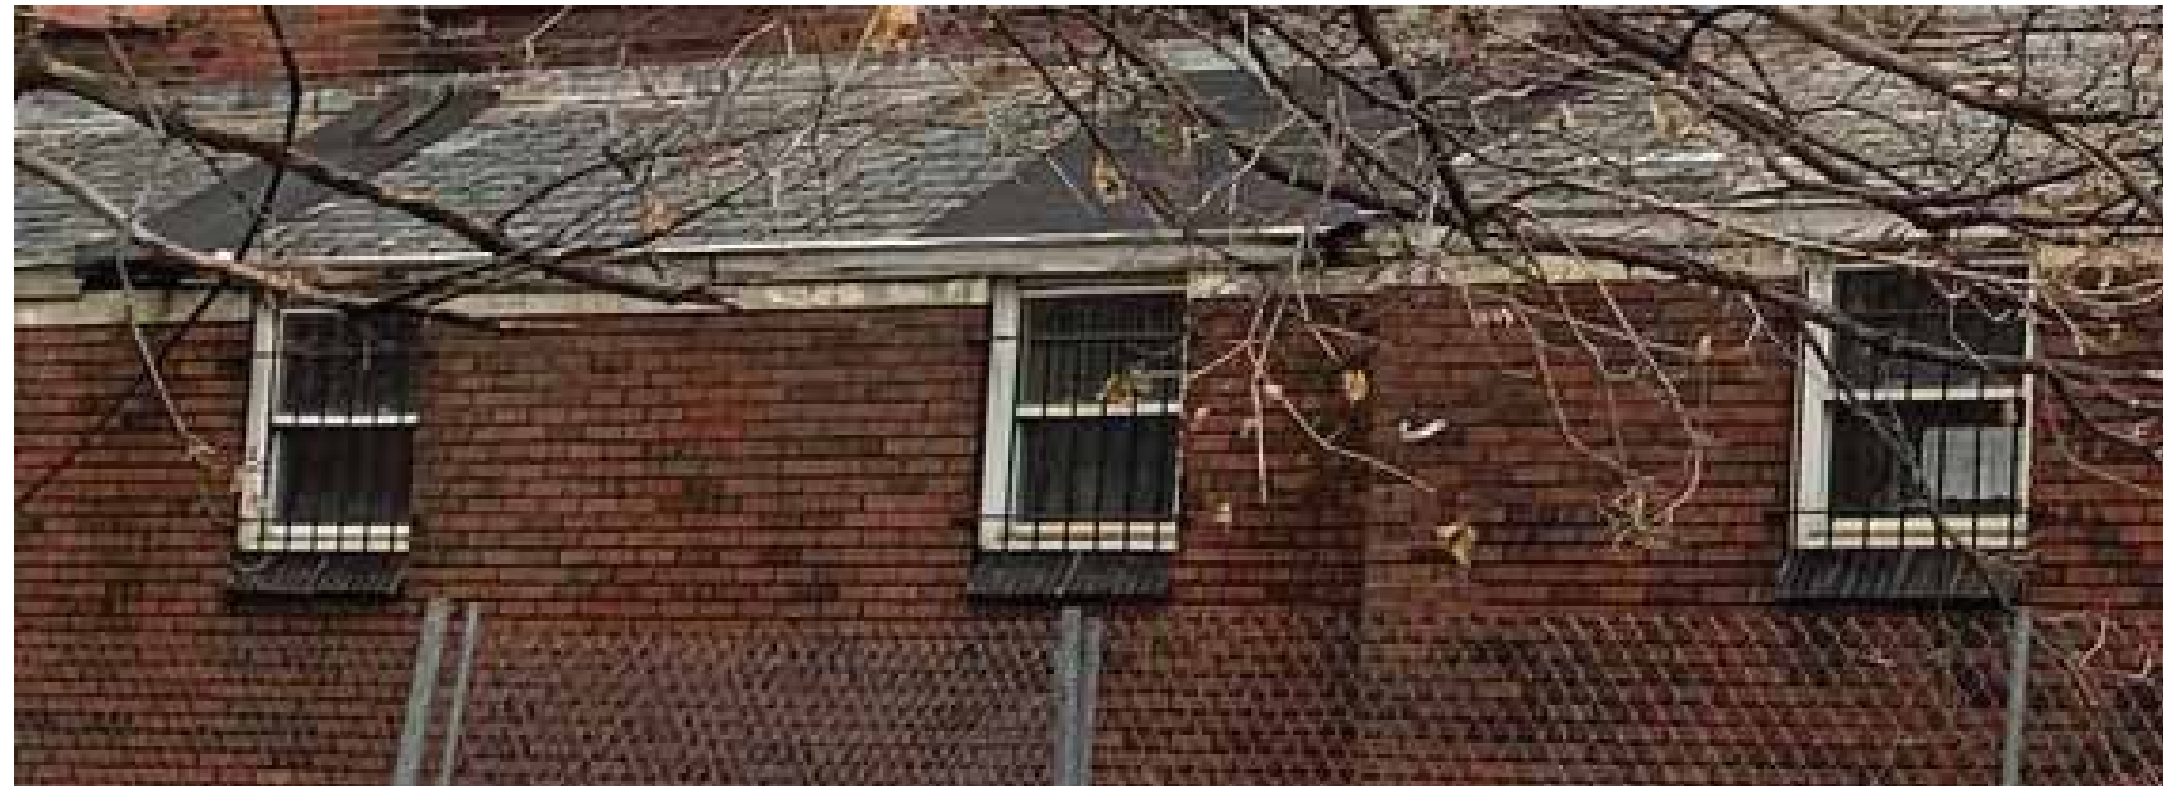
- The Current Vinyl Windows are cheap replacements installed when the prior wood windows failed.
- We propose to replace these with the previously approved **Windsor Pinnacle Windows**
- High quality wood windows with exterior aluminum cladding
- We will replicate the original brickmould and trim as found on the remaining wood windows.

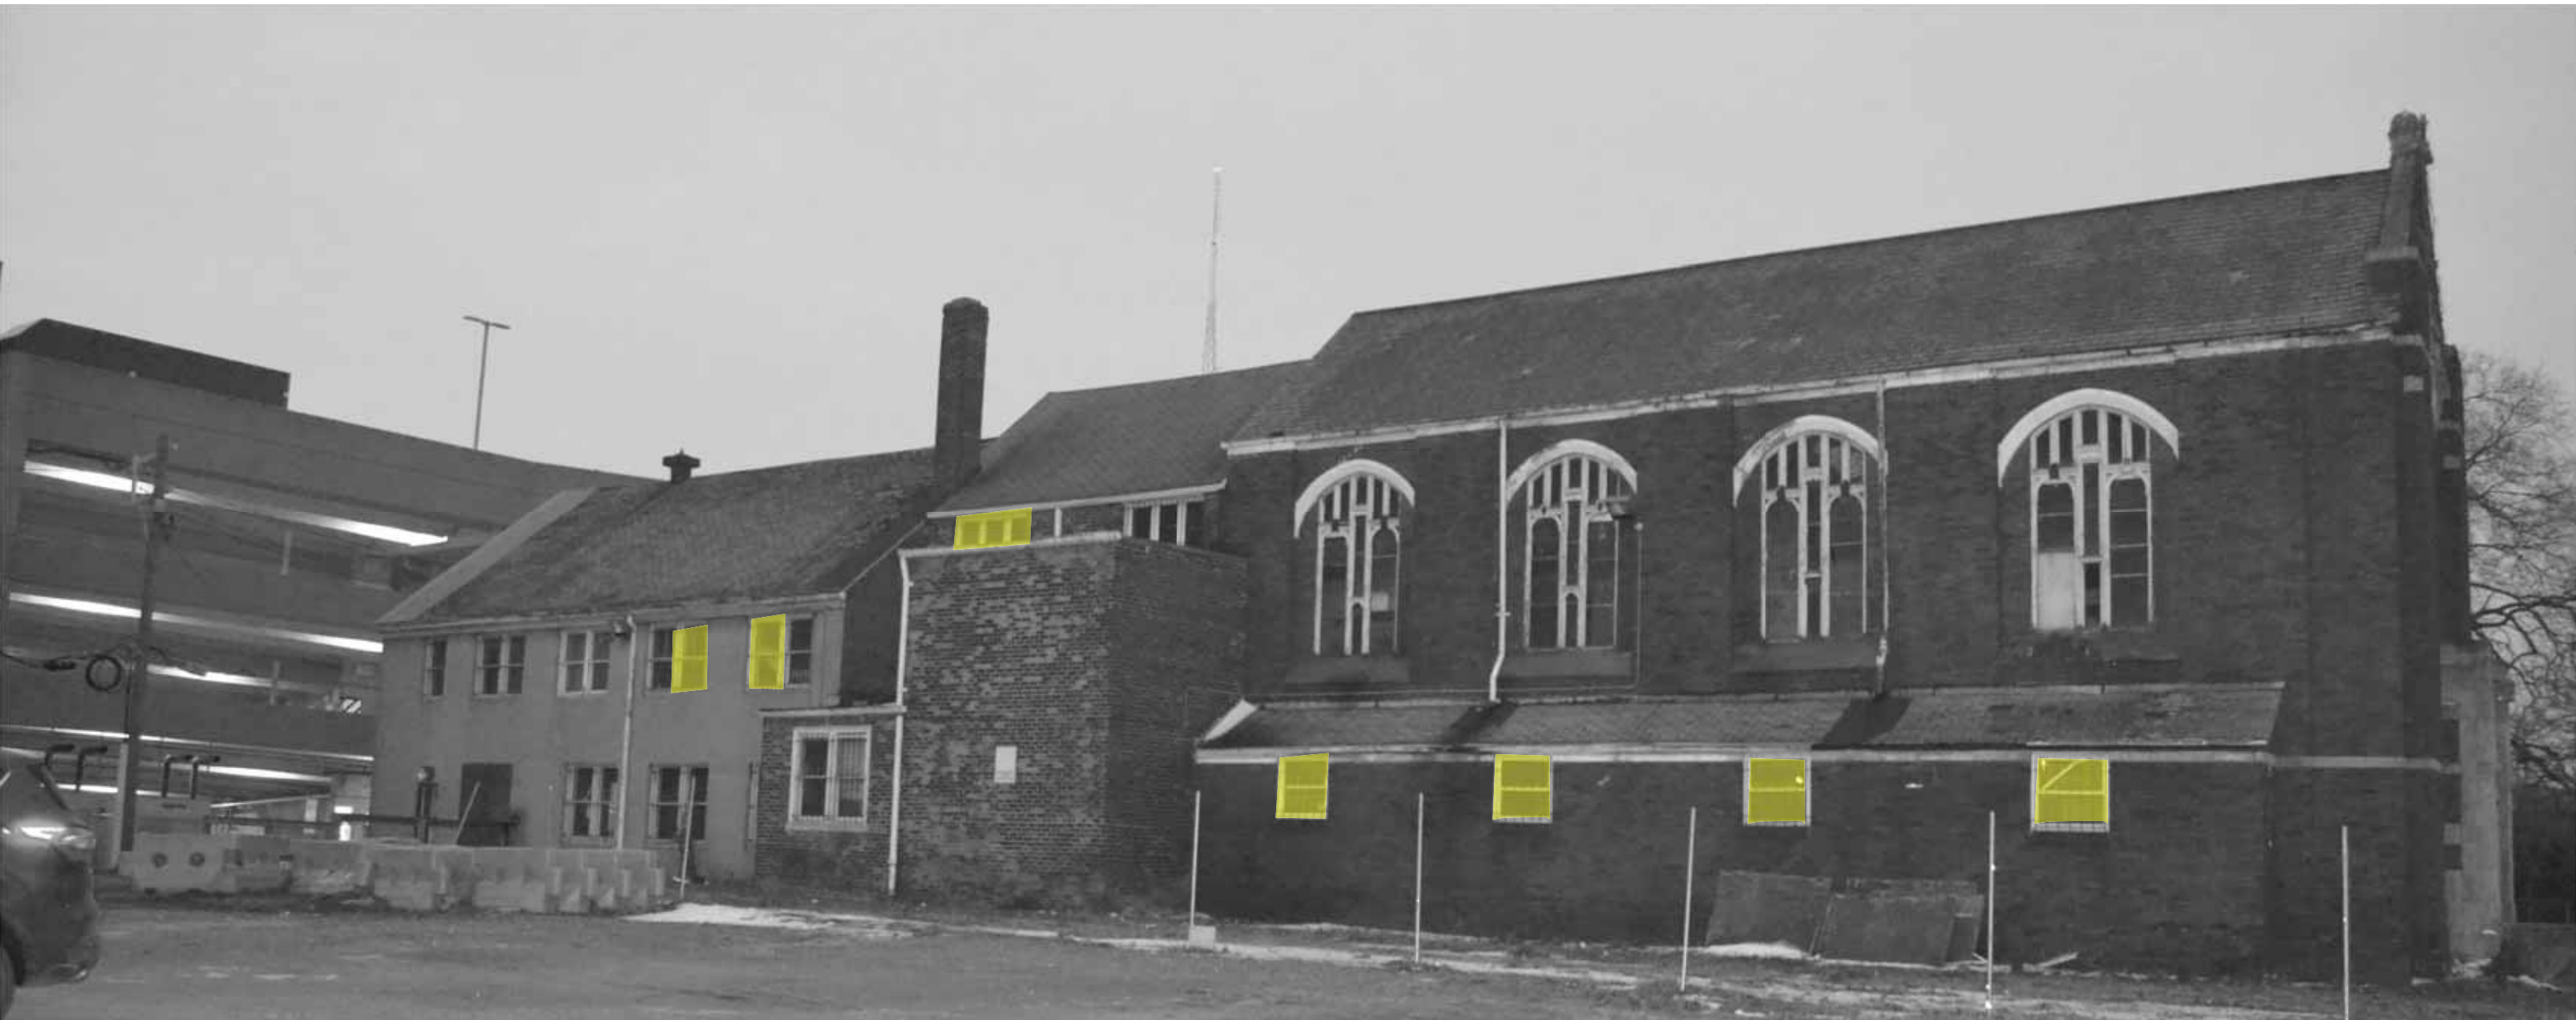
1/1 and Triple Vinyl Replacement Windows

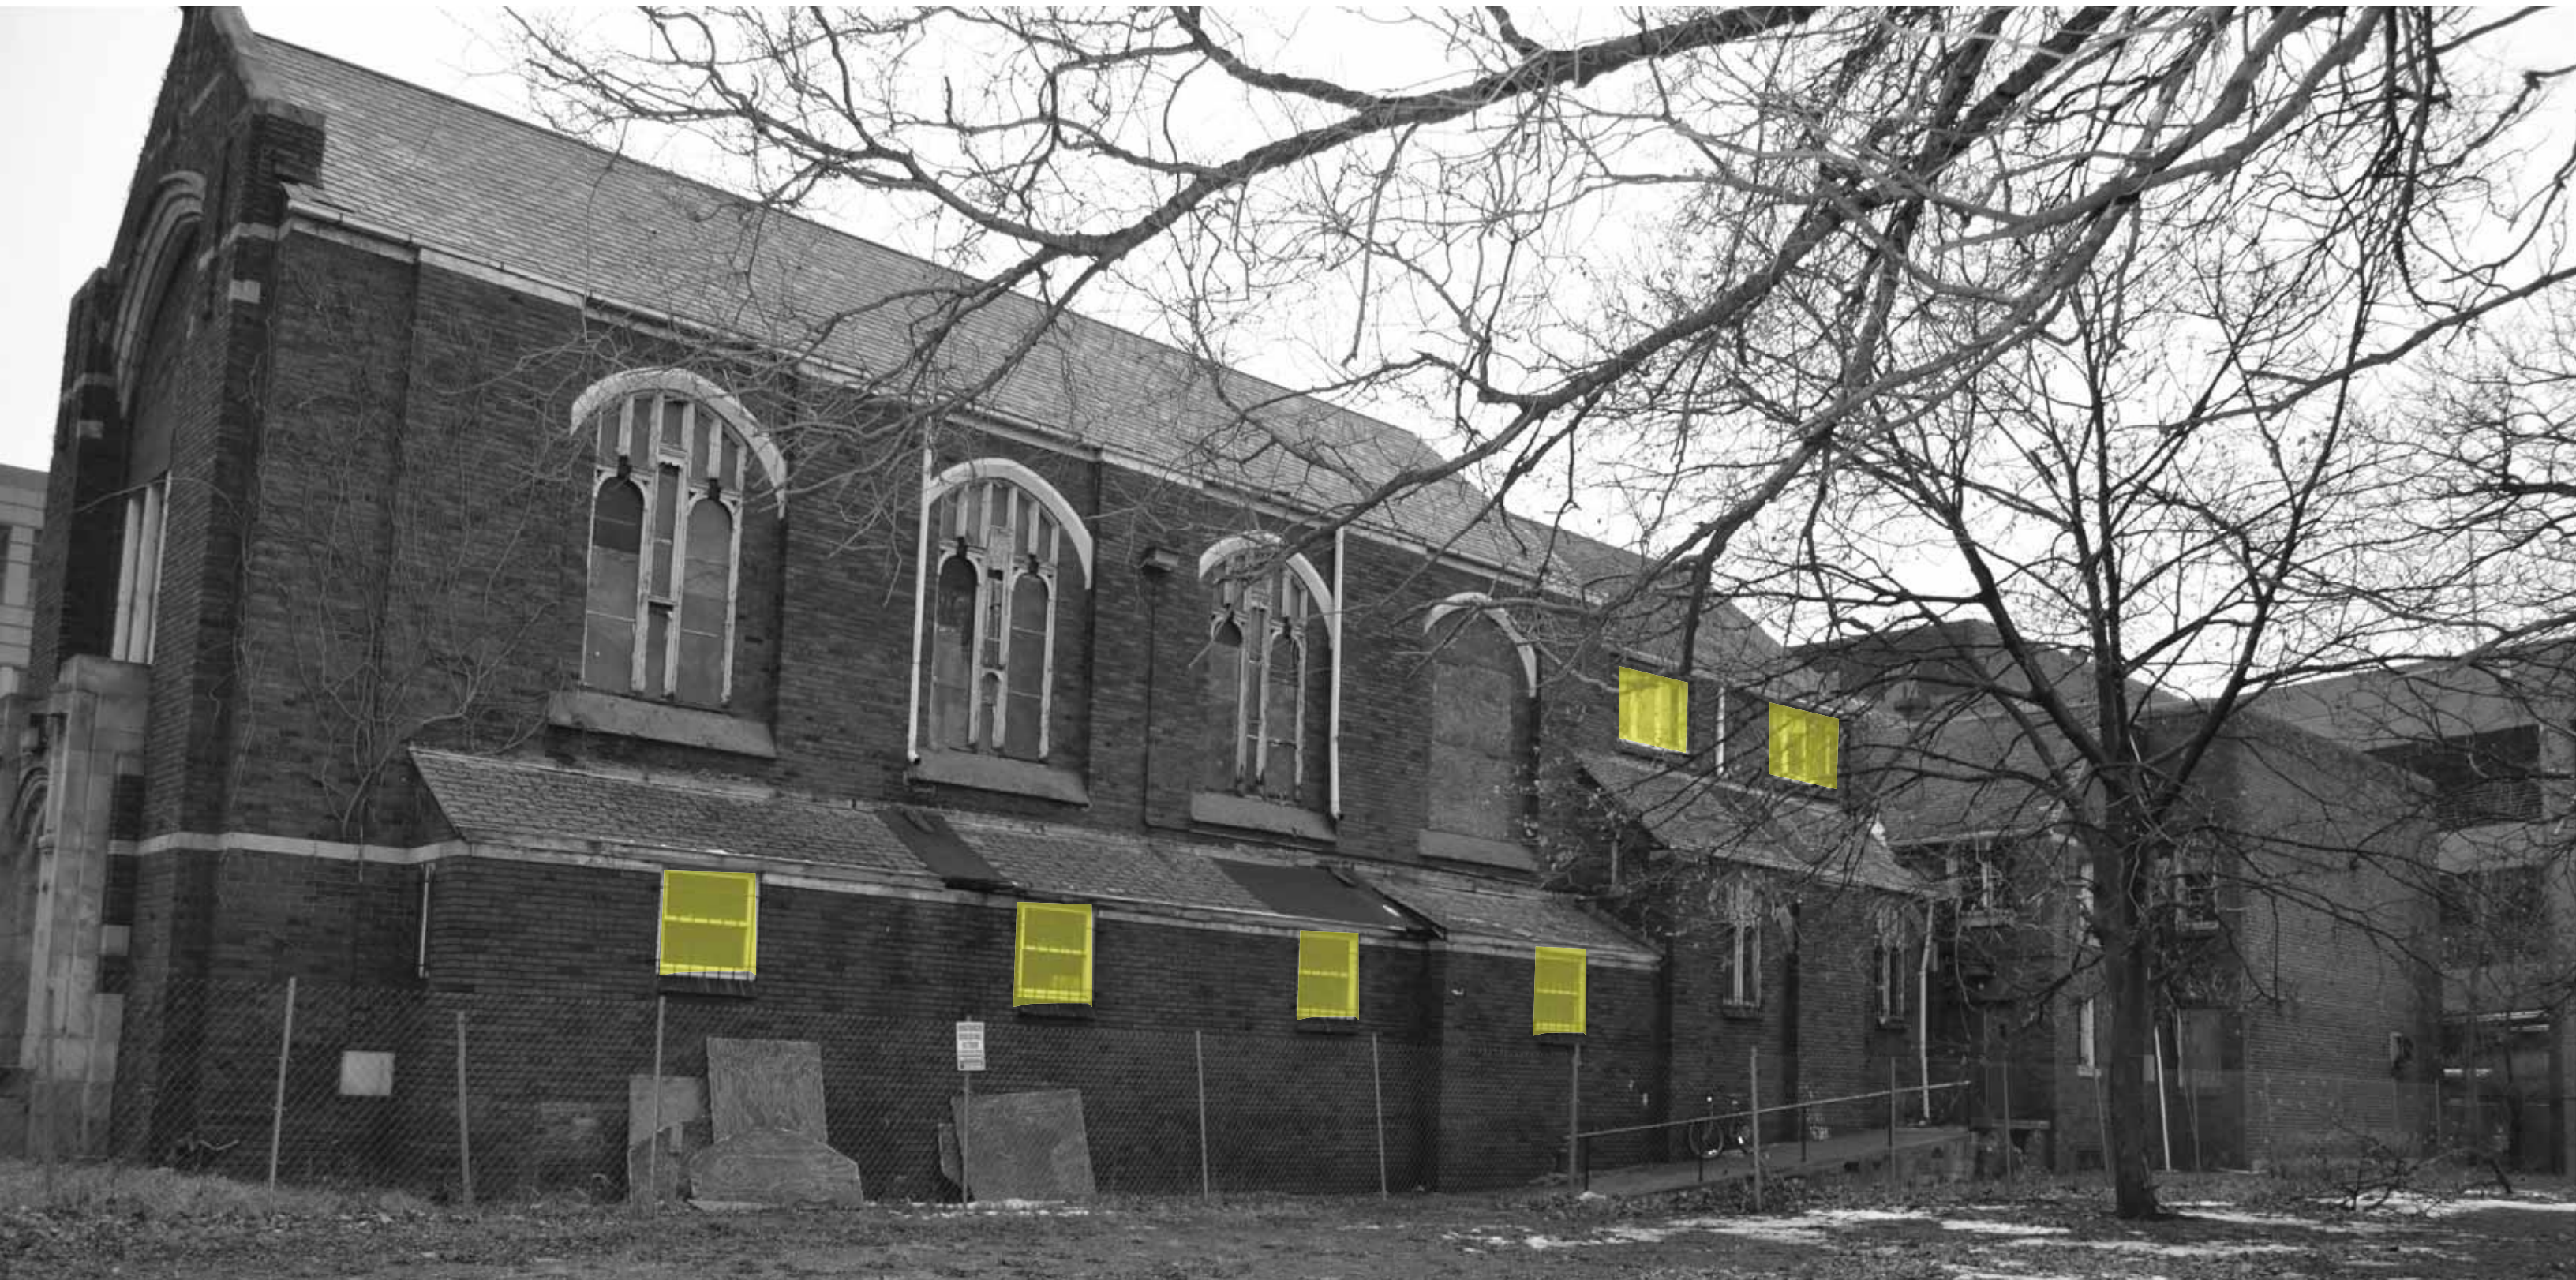
1/1 and Triple Vinyl Replacement Windows

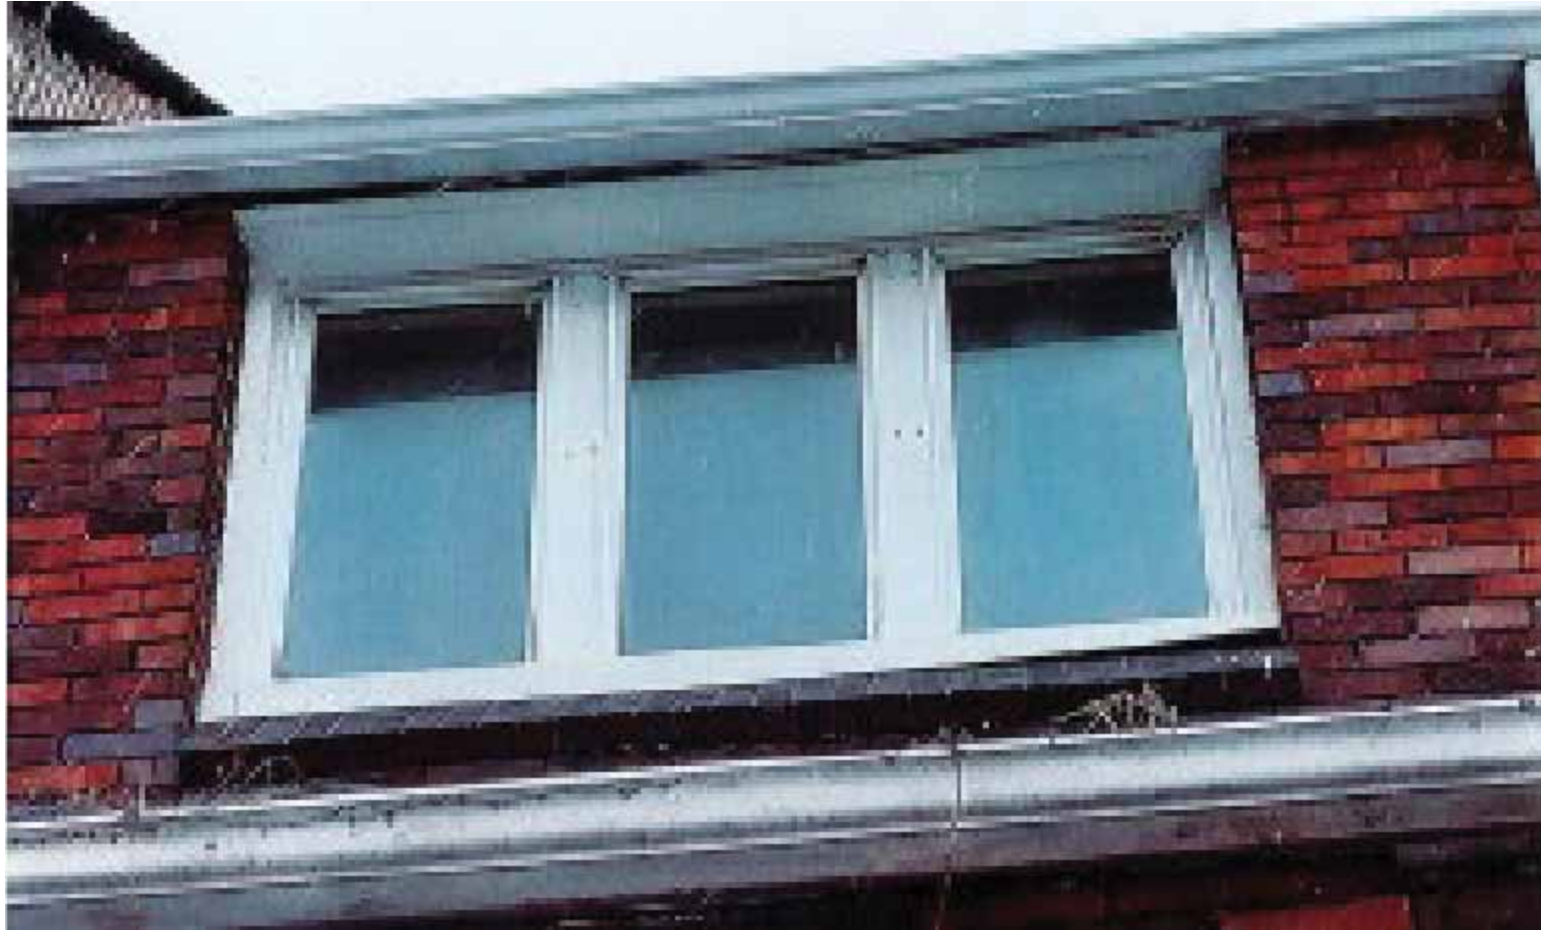
Image of window FW1, vinyl replacement in brick surround and center addition.

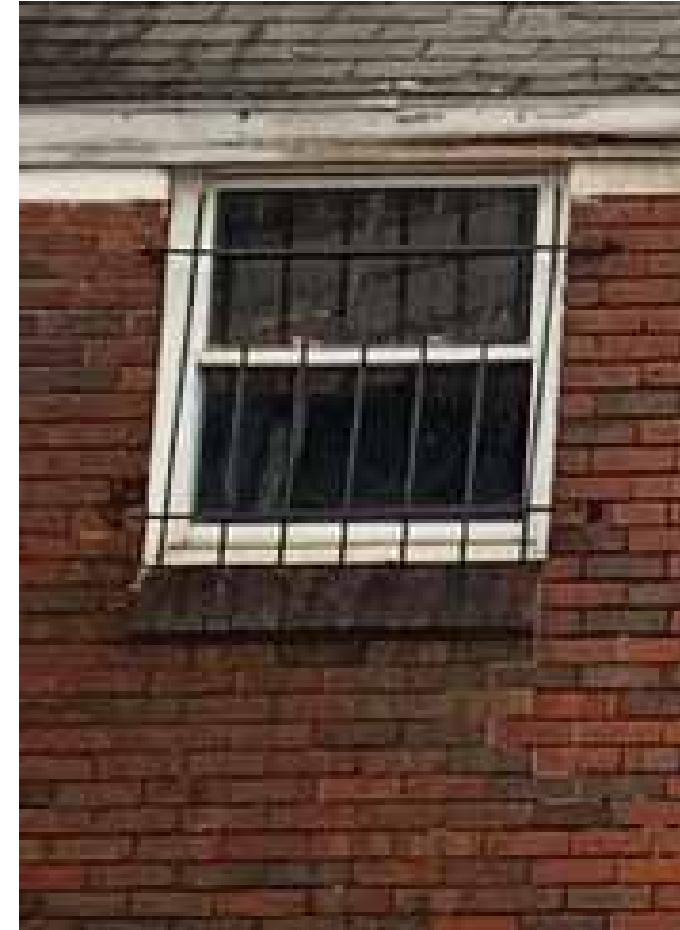
Images of vinyl replacement on in brick surround at Nave Sheds

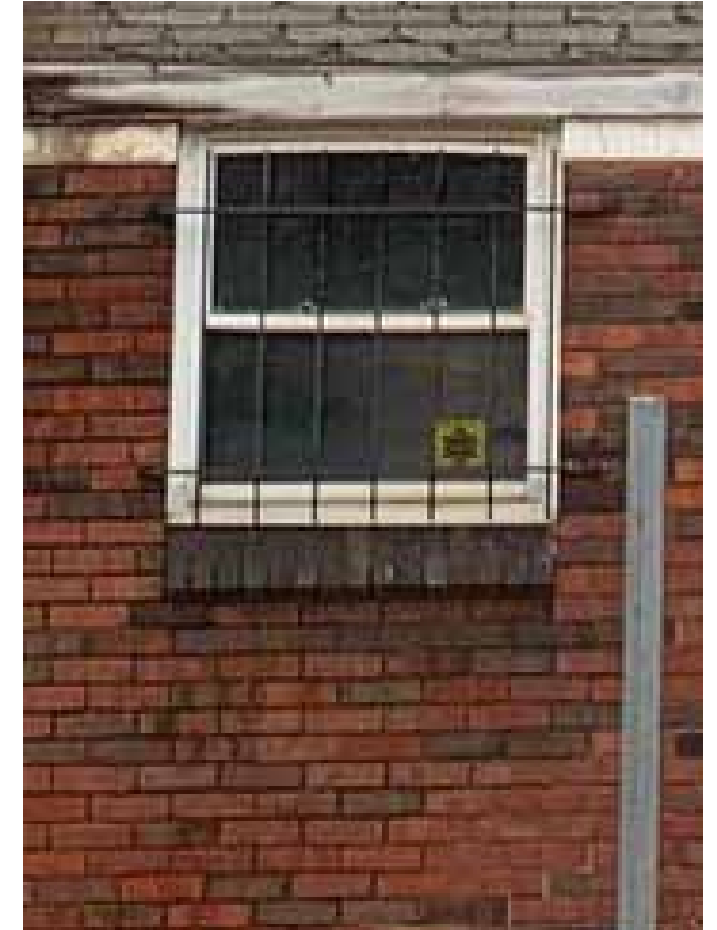
- By replicating the wood trim found on the existing wood windows and installing new, energy efficient windows, these three openings will be restored to their original intent.

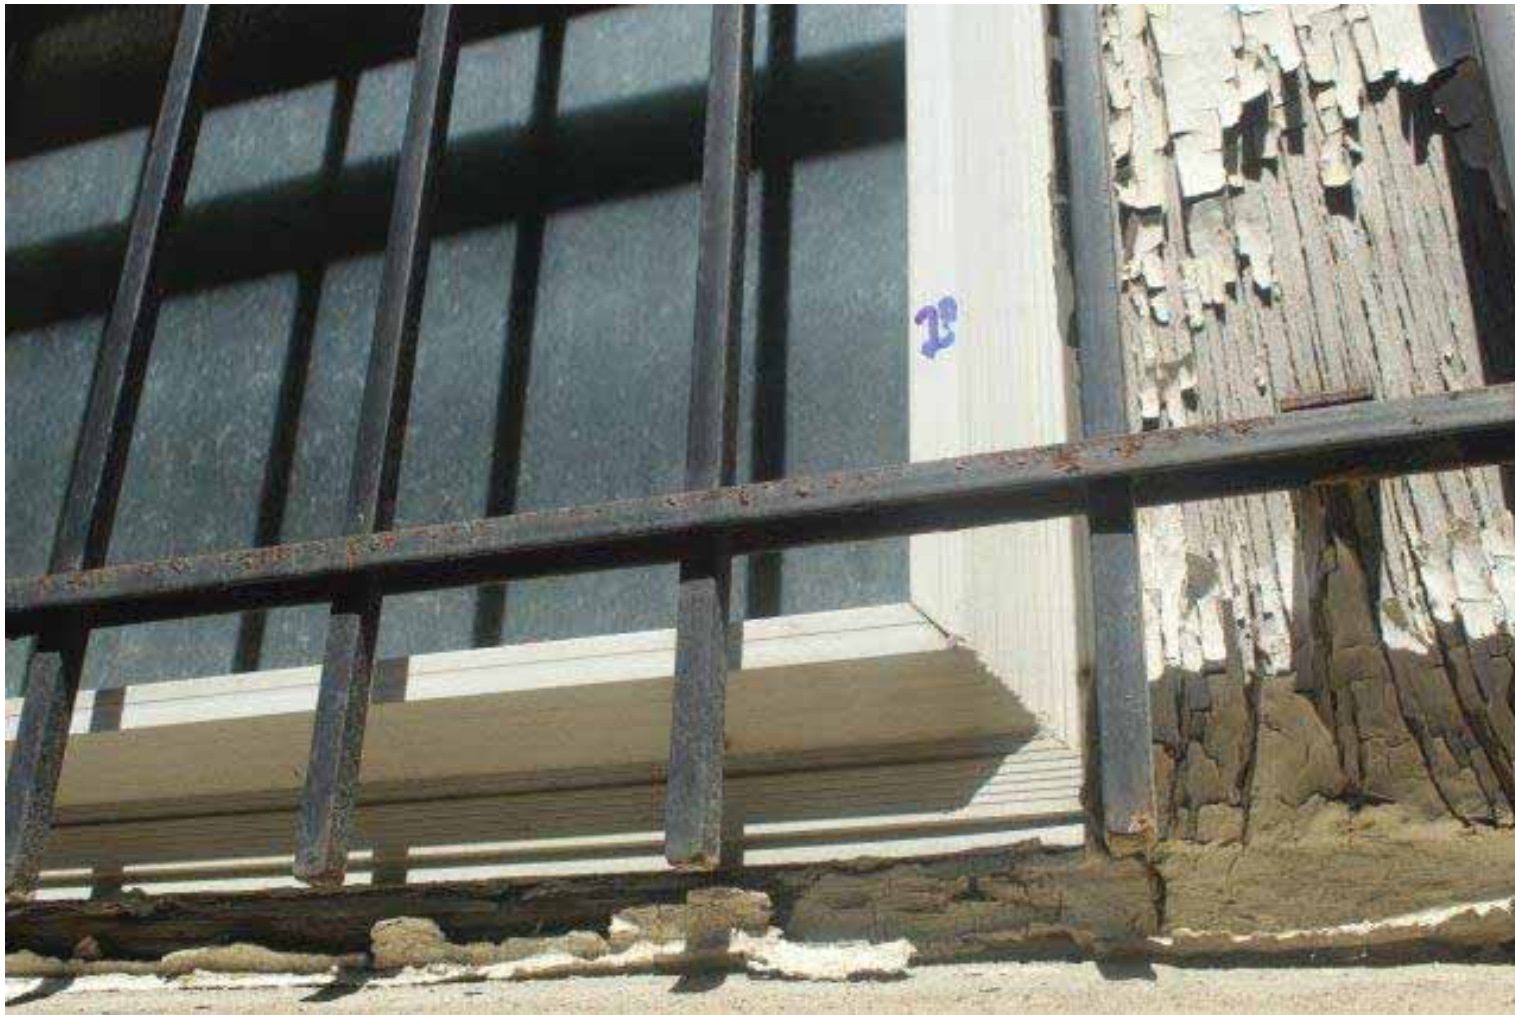
Image of window 28, vinyl replacement in wood trim. The trim is deteriorating and beginning to fail.

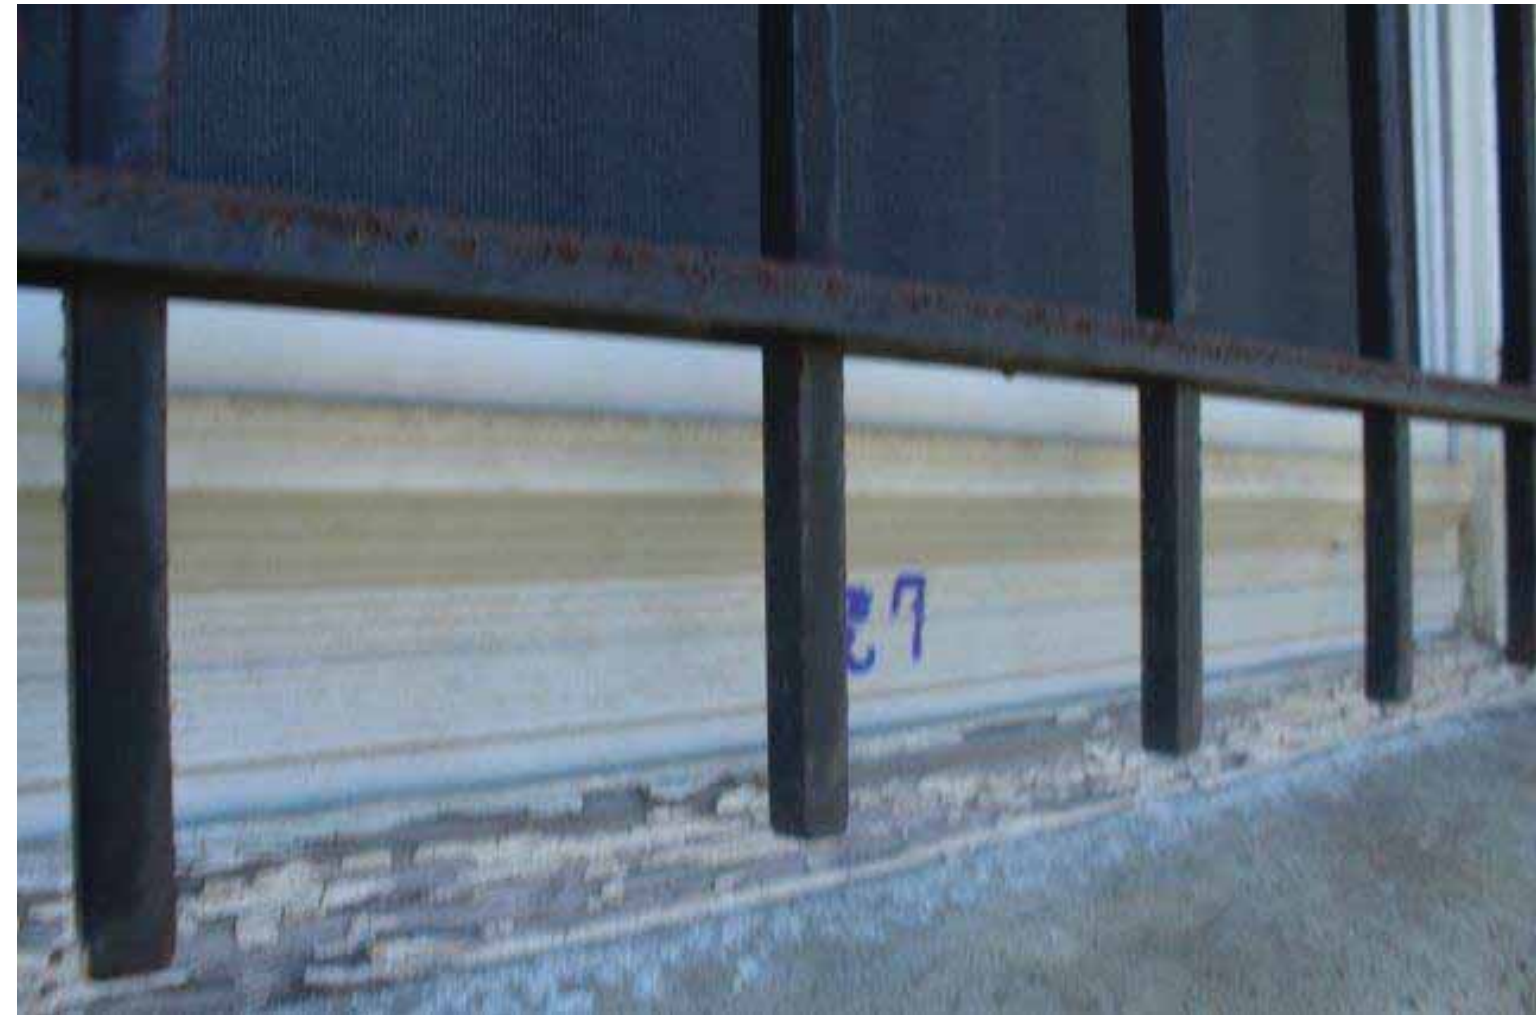
Image of window 27, vinyl replacement on wood sill. The sill is deteriorating and beginning to fail.

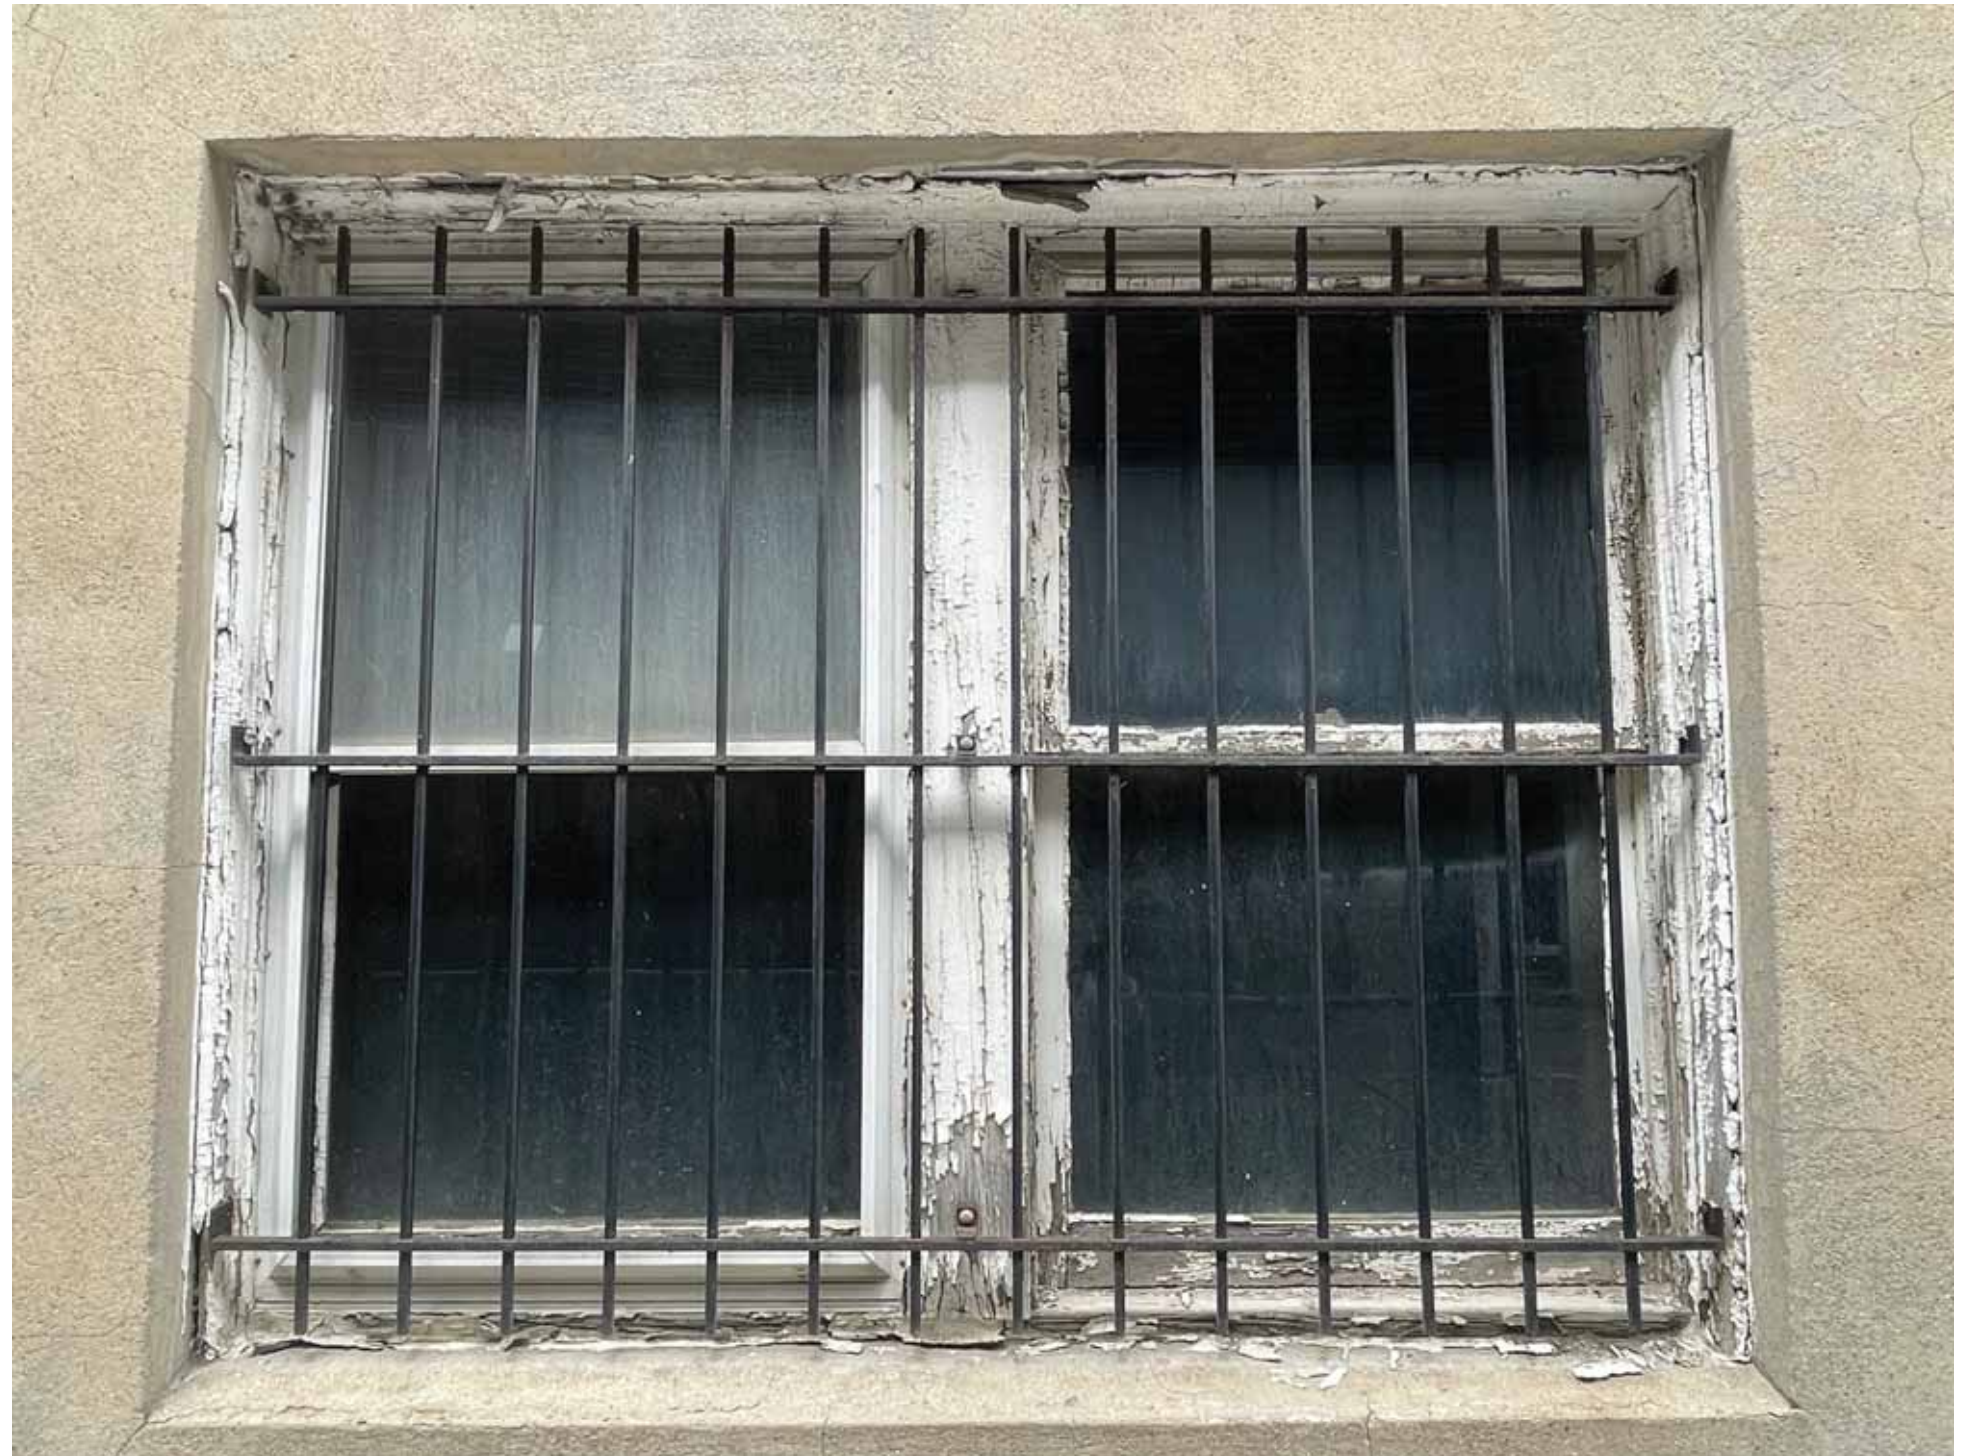
- The Current Wood 1/1 Windows were of poor quality when originally installed.
- Repair is not recommended or feasible.
- In replacing, these windows will last much longer than a repair of the current, poor-quality windows as well as meet new energy requirements.
- Will provide a consistent appearance with the replaced vinyl windows
- Windows exist in the non original, non historic portion of the building

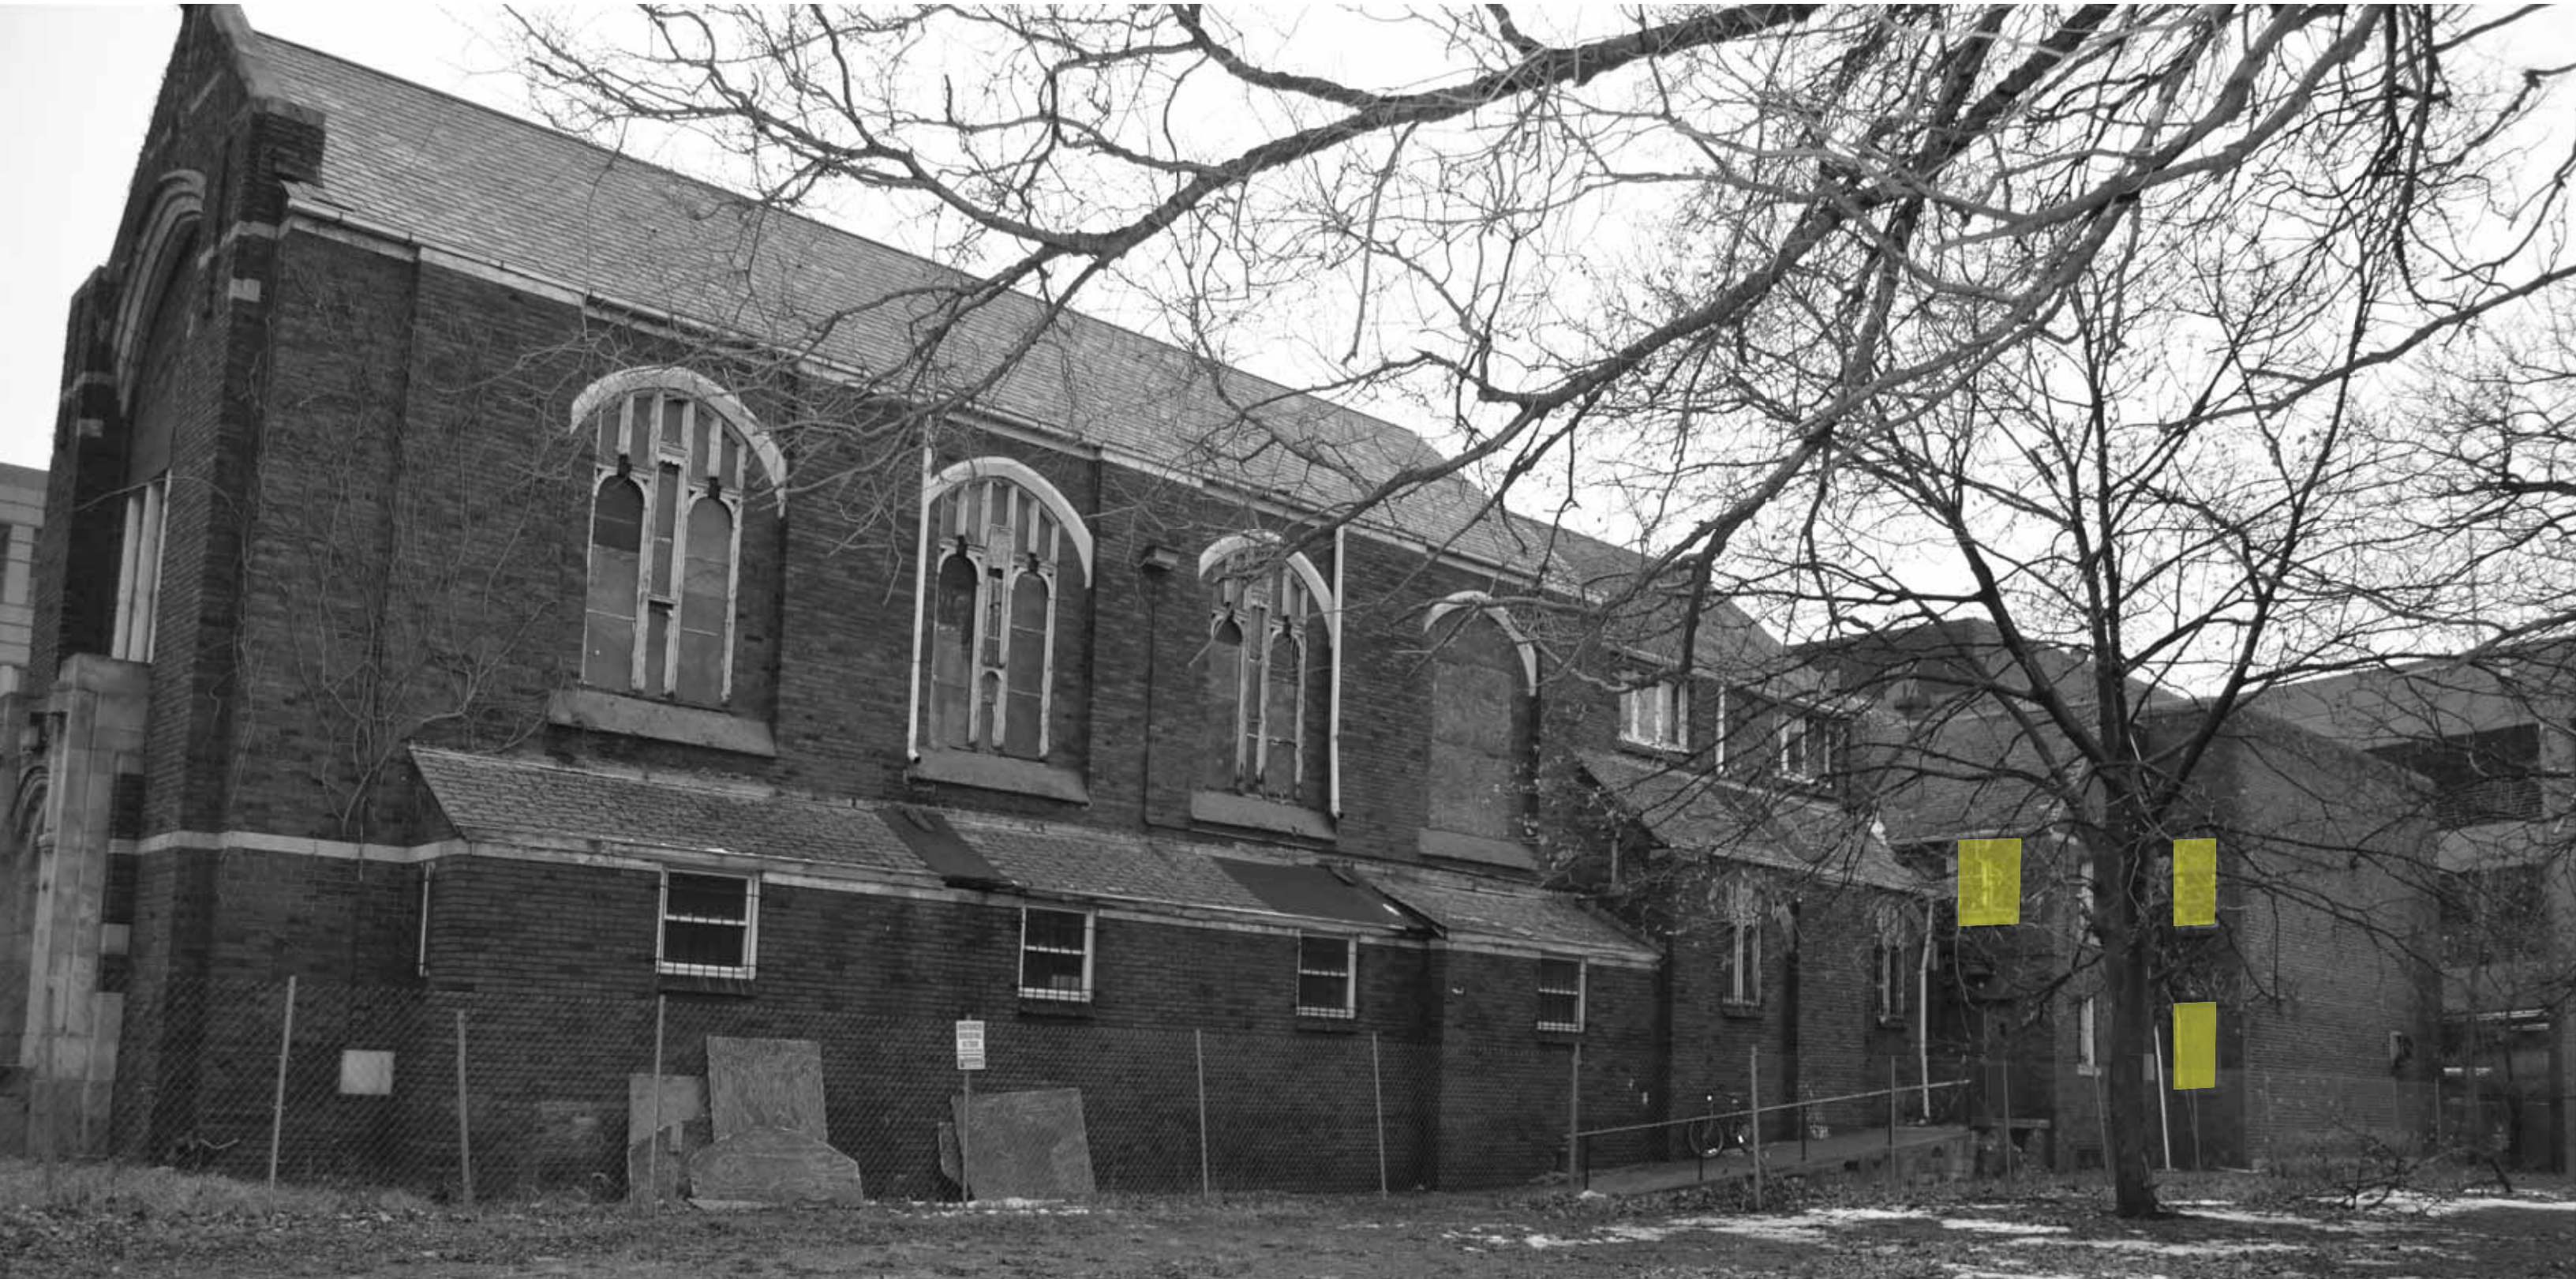
1/1 Wood Replacement Windows
