CITY OF DETROIT HISTORIC DISTRICT COMMISSION

92 E. Forest. Detroit, MI

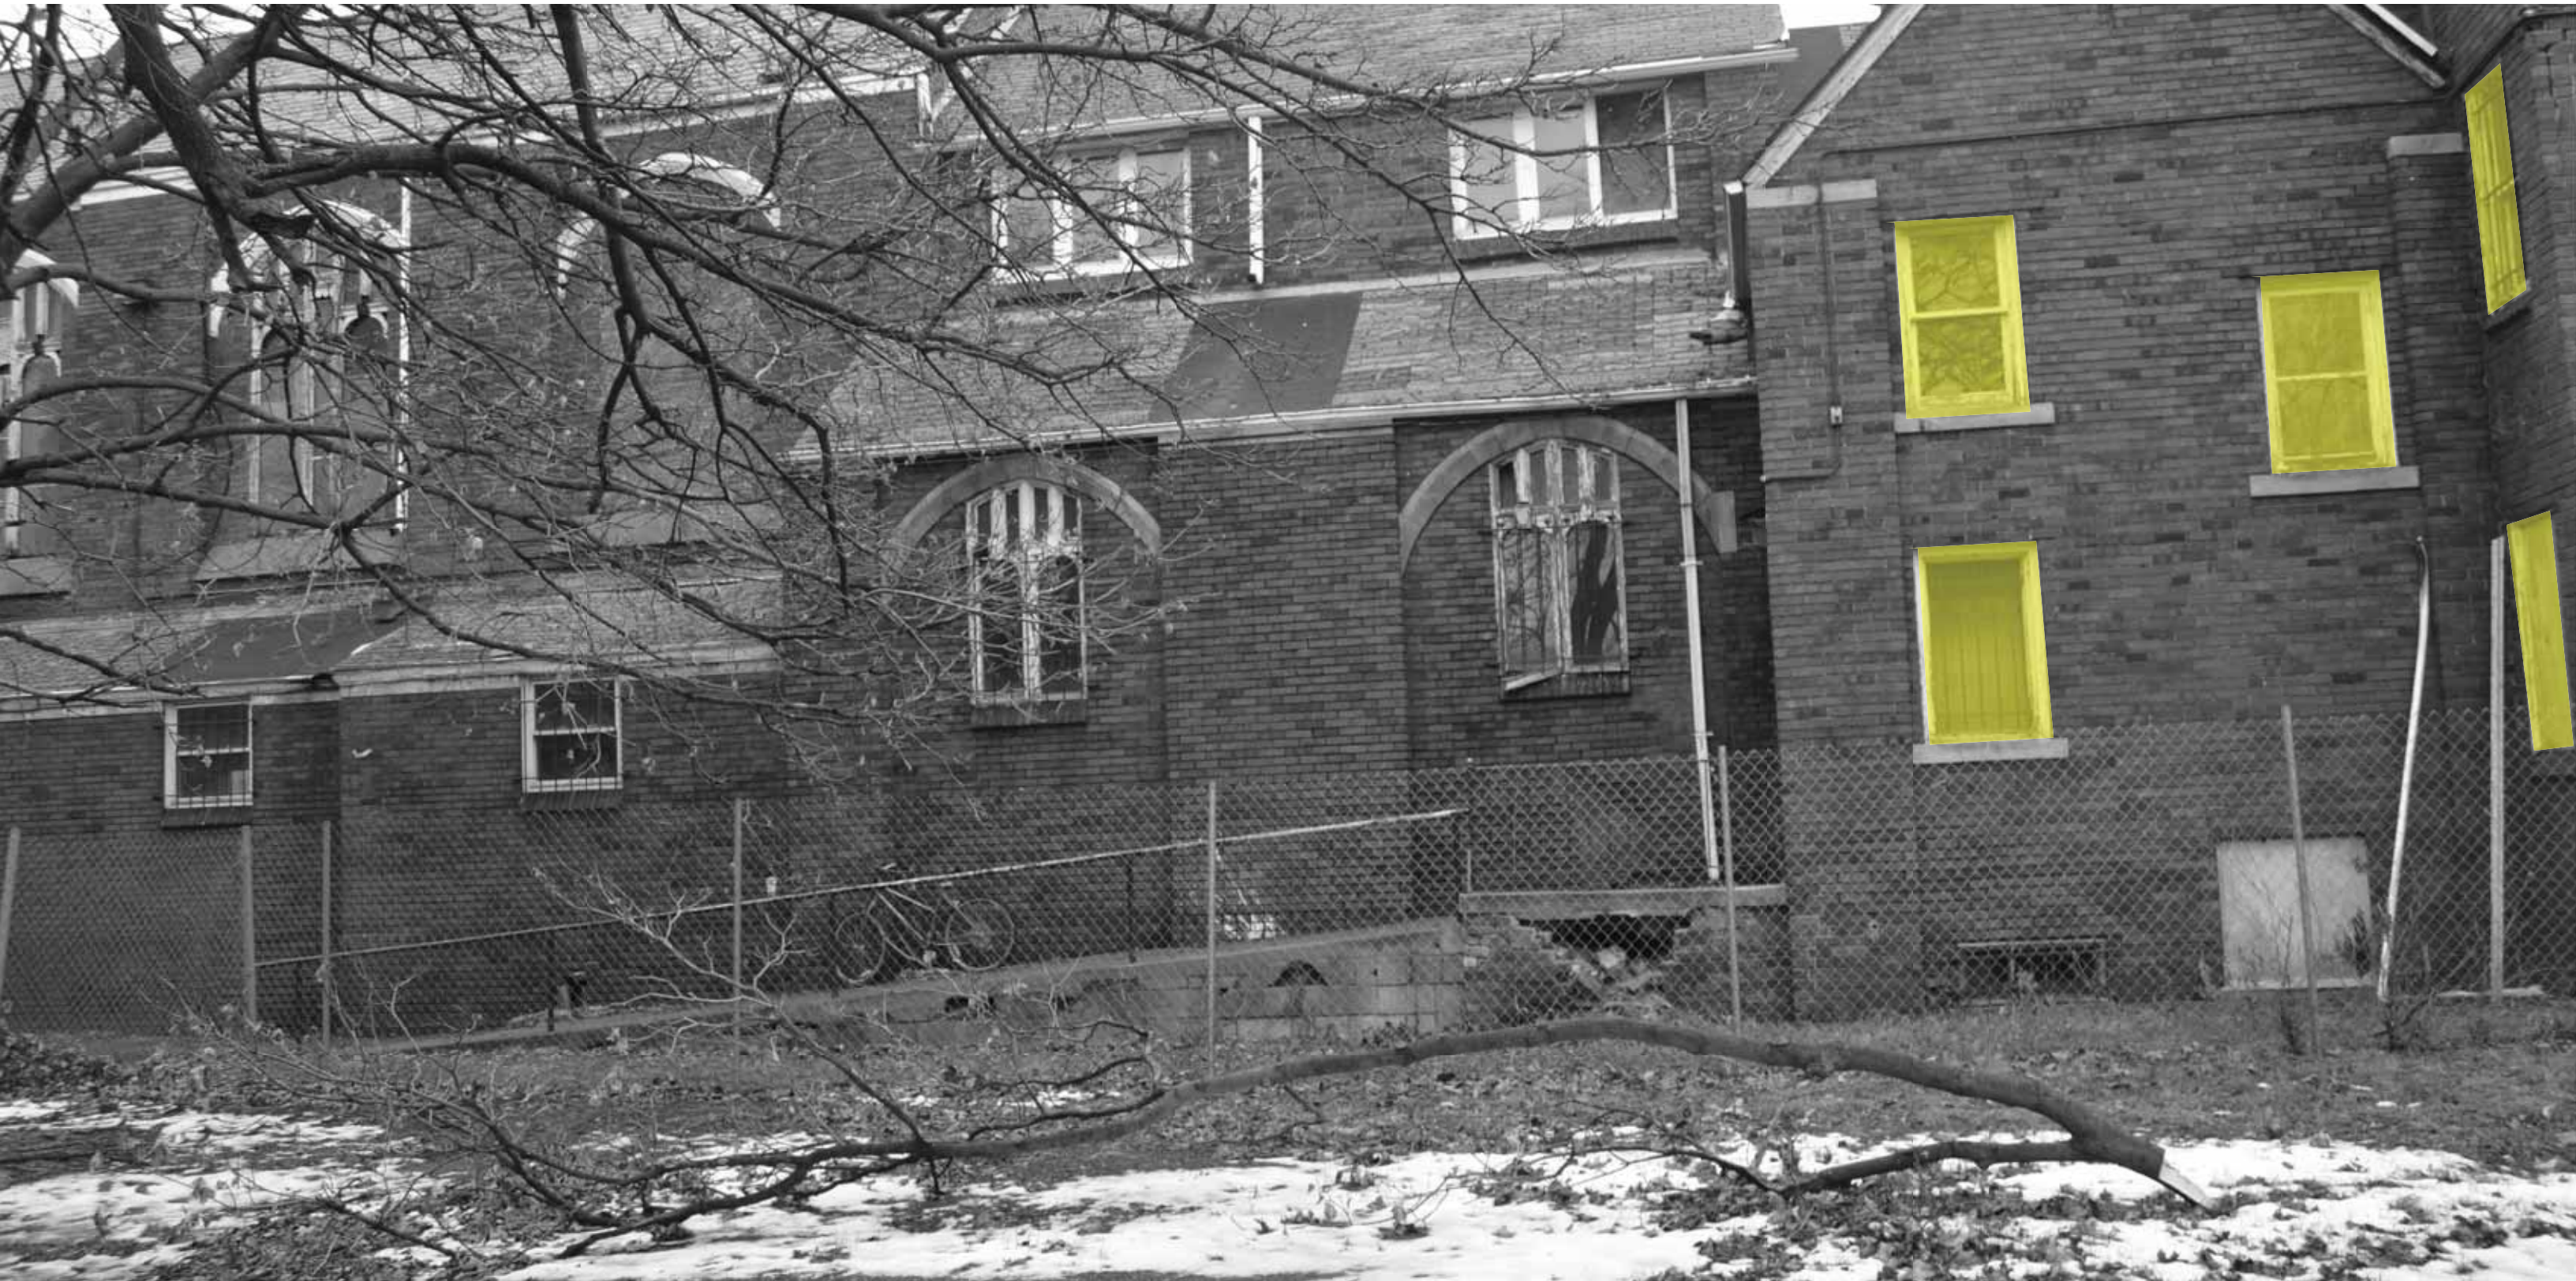
1/1 Wood Replacement Windows

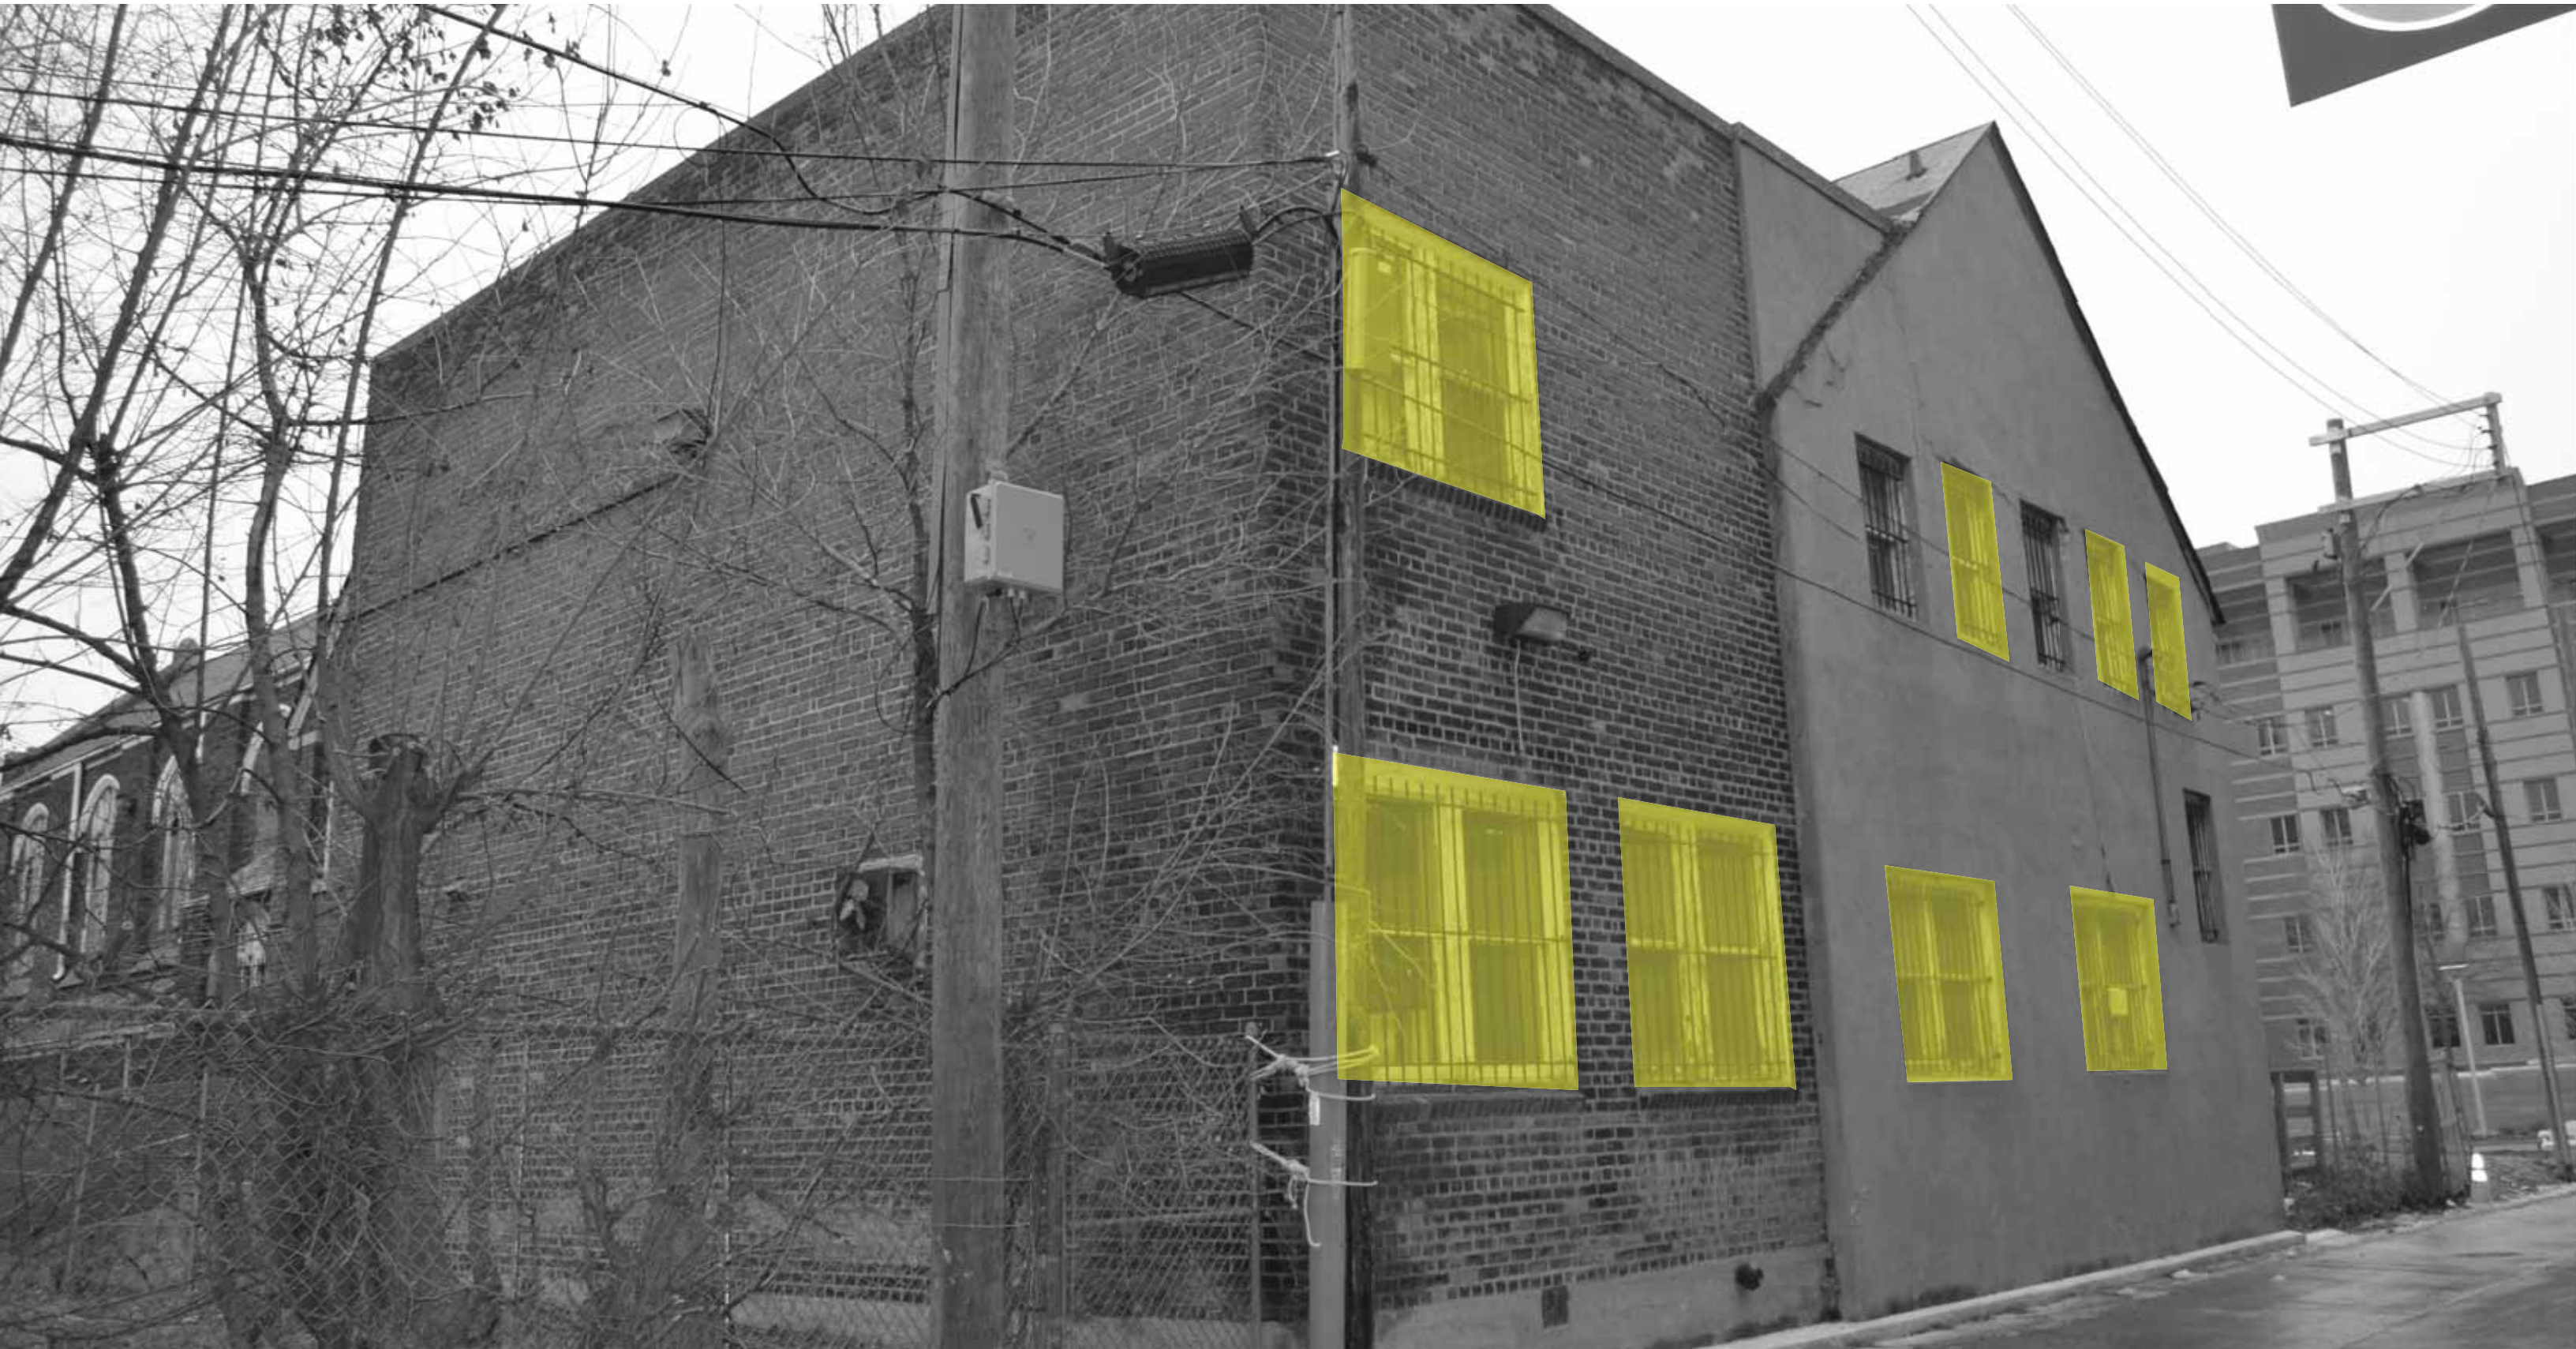
1/1 Wood Replacement Windows

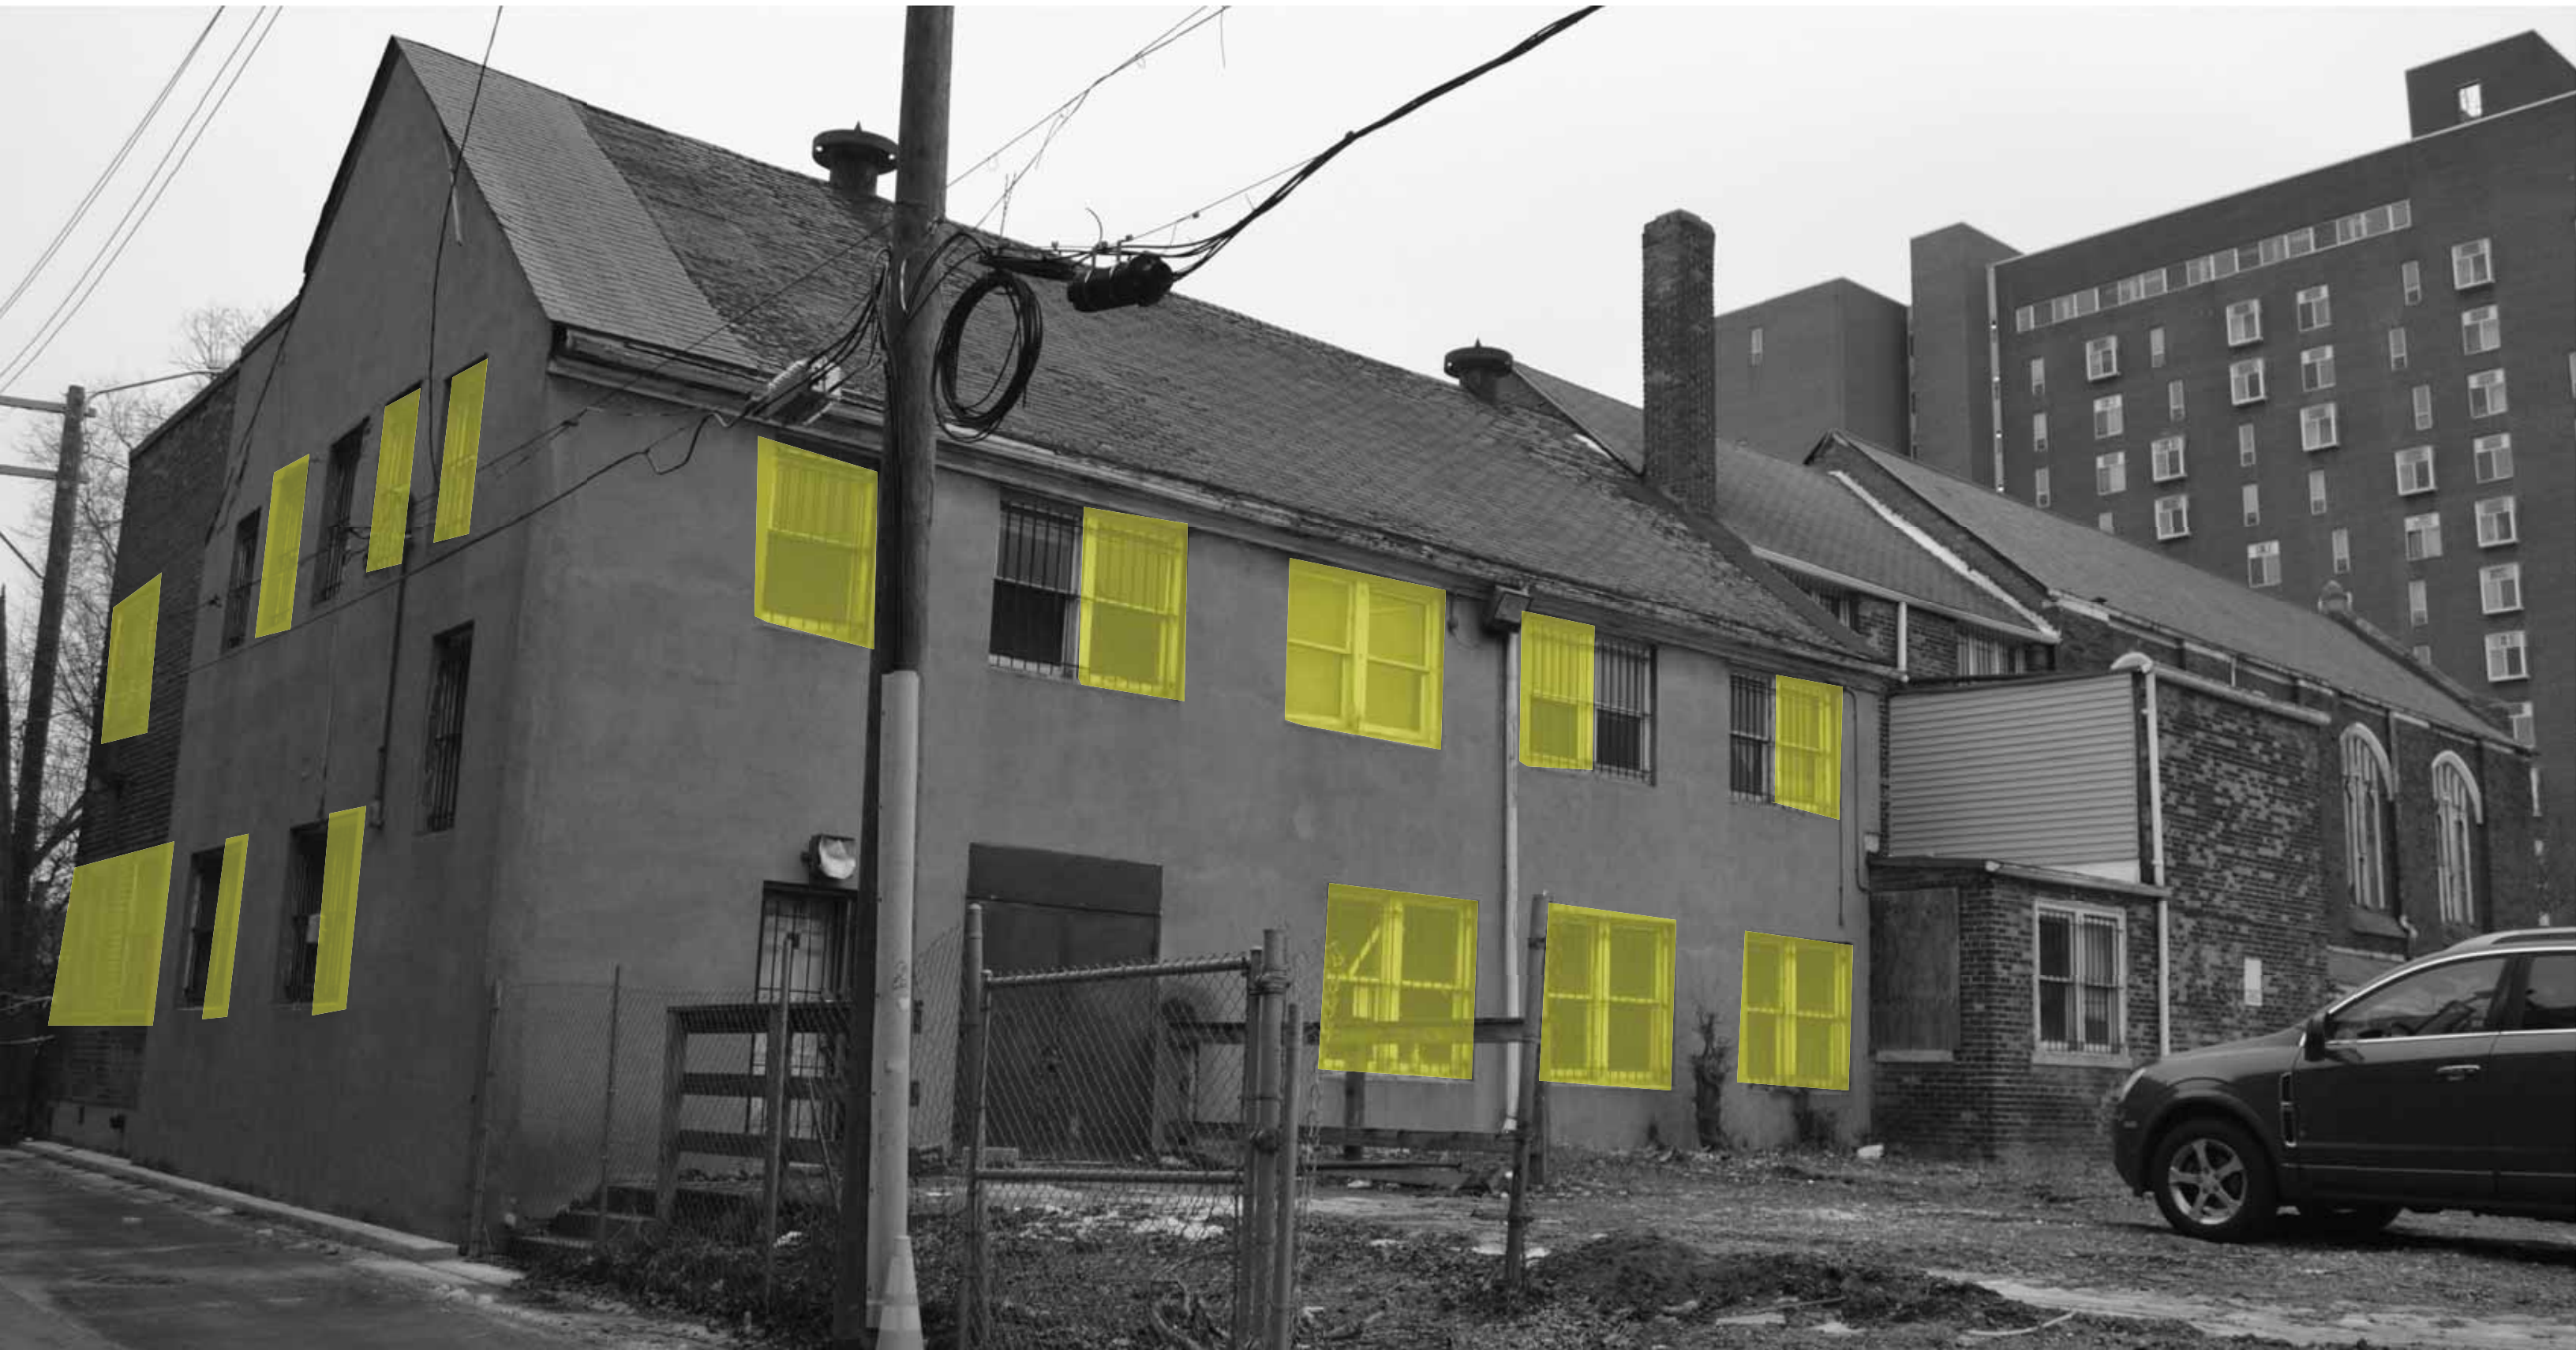
1/1 Wood Replacement Windows

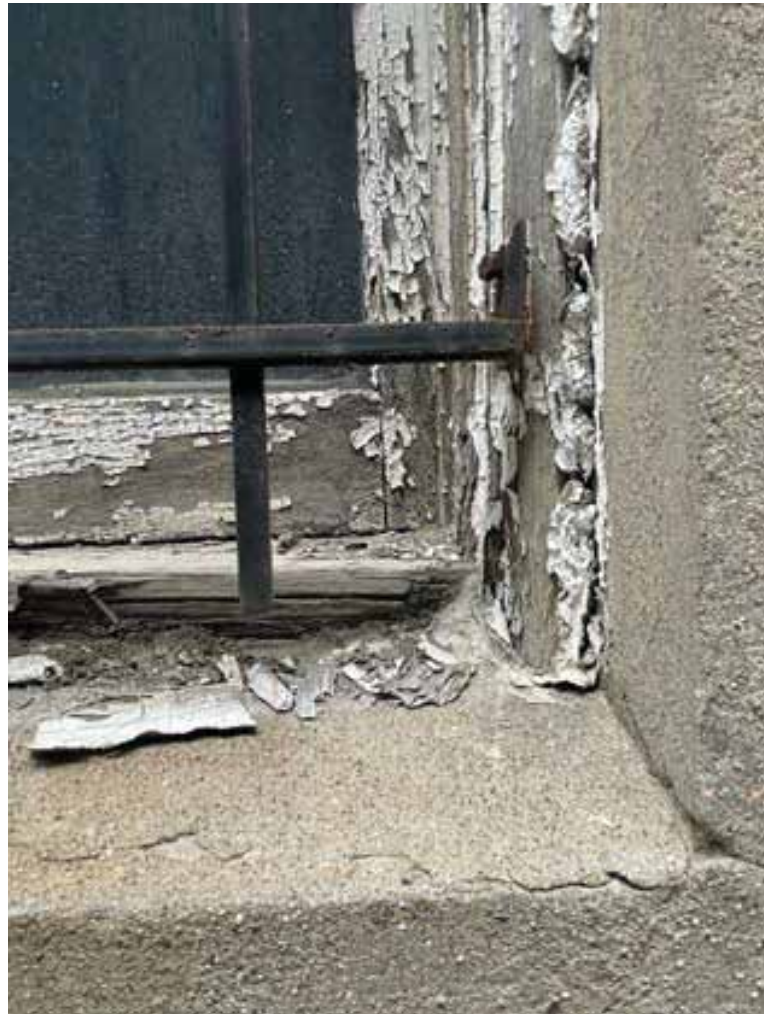
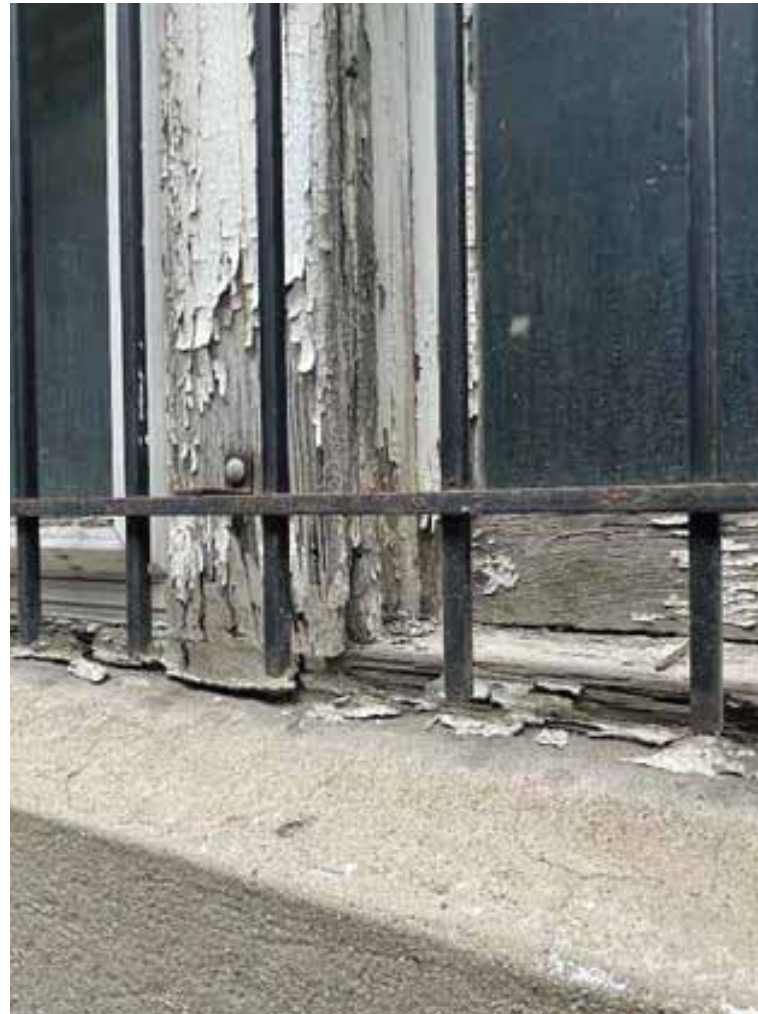
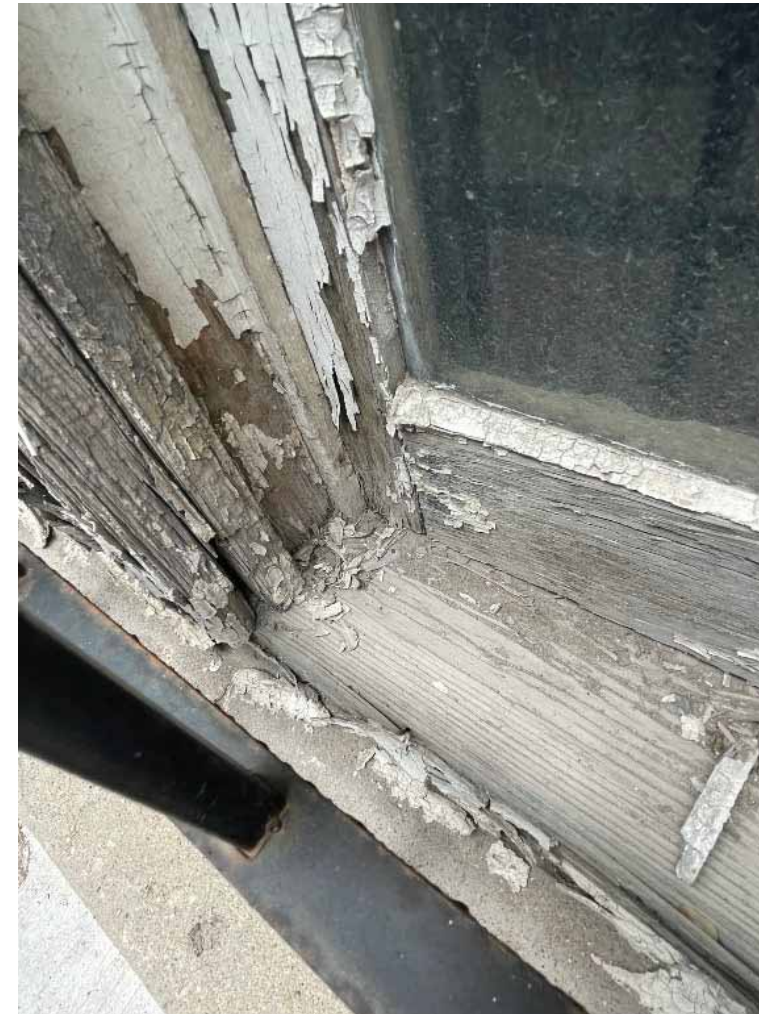
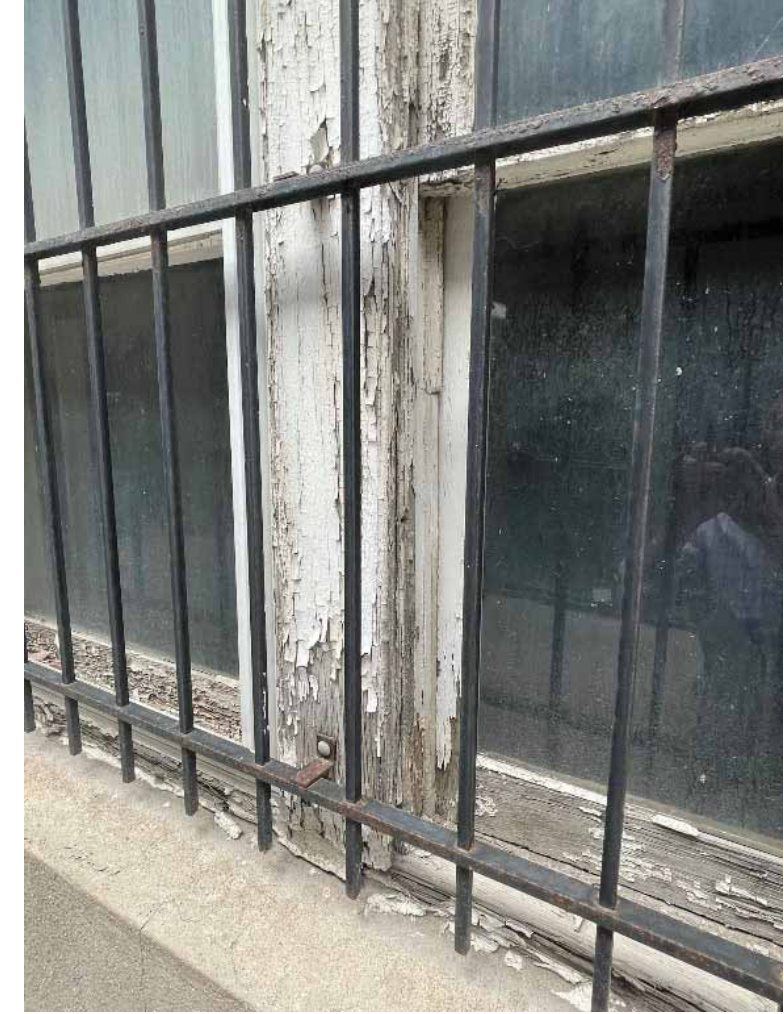
Images showing typical levels of damage to the wood windows at sill, side rail, and center rail conditions.

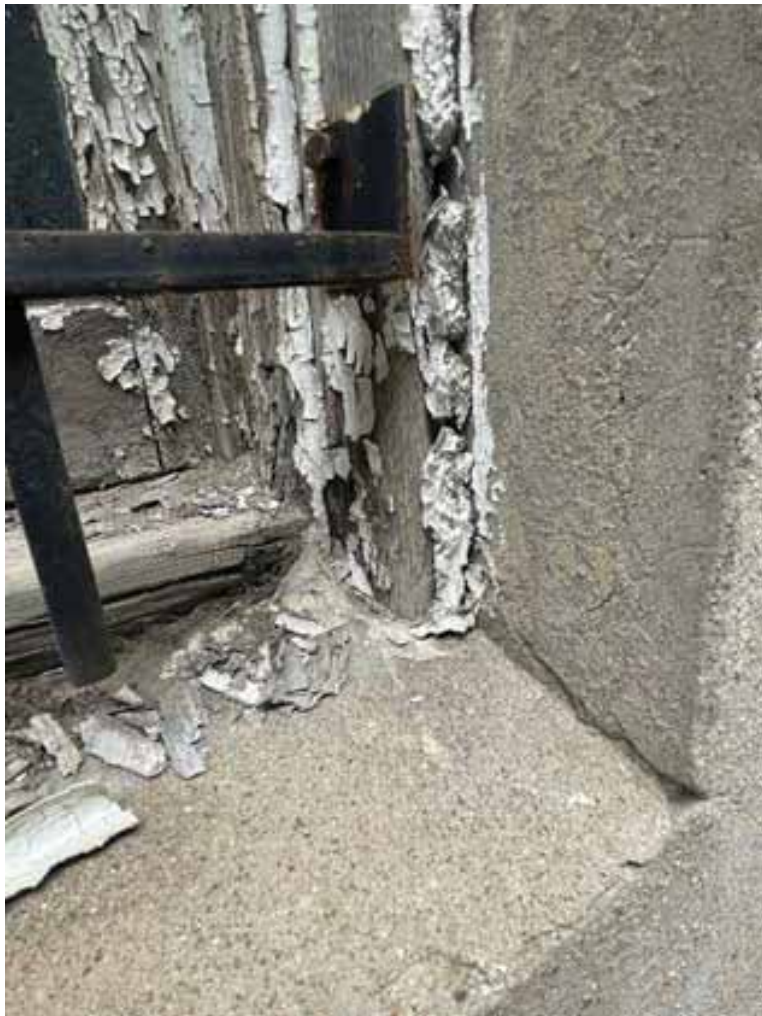
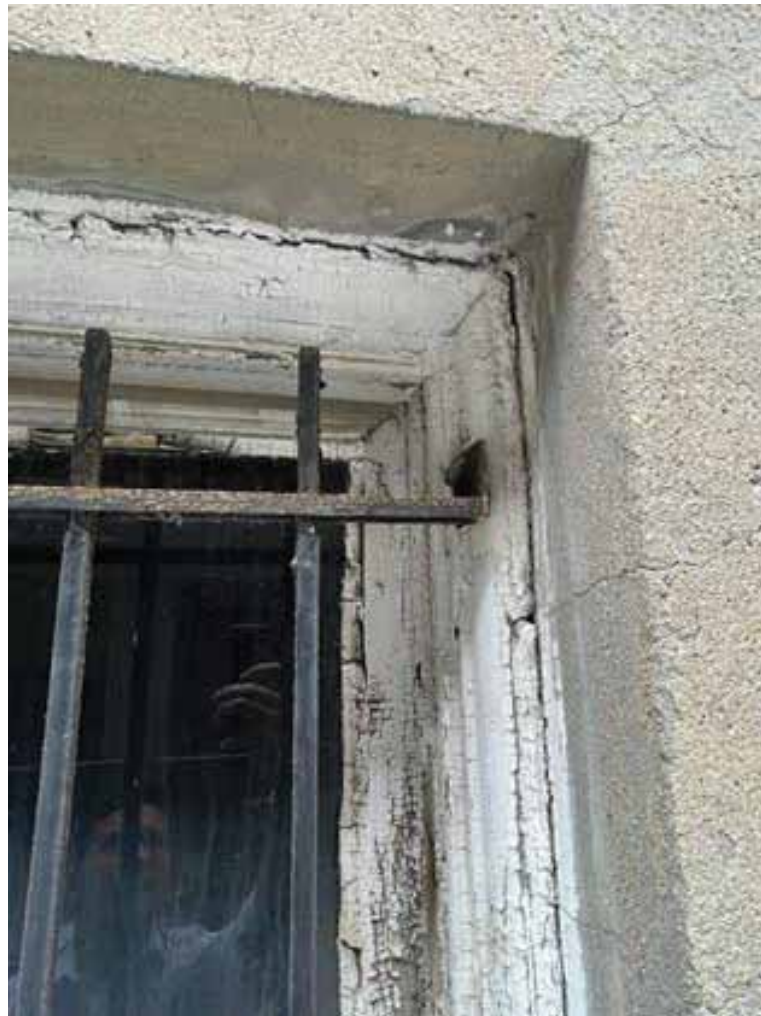
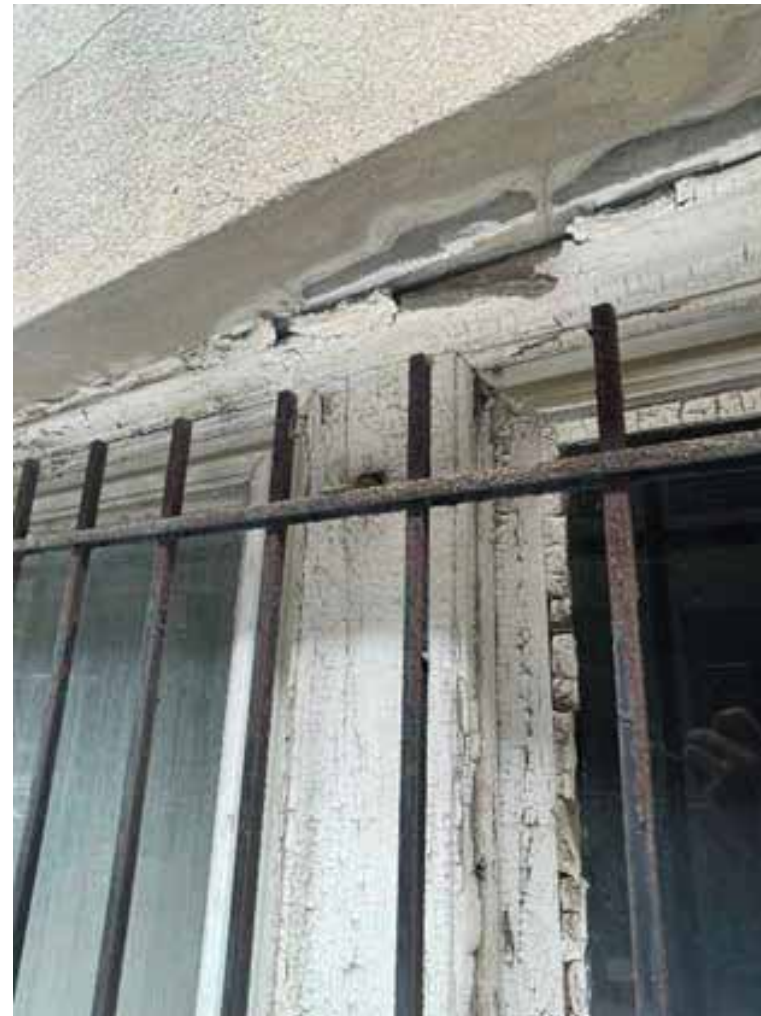
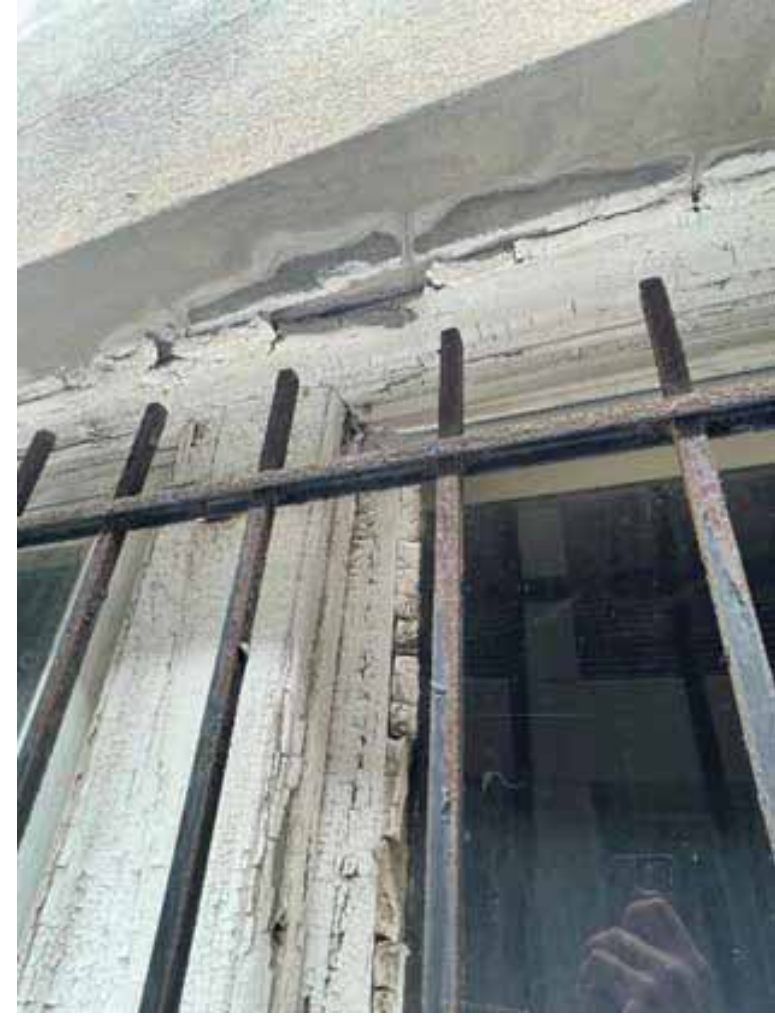
Images showing typical levels of damage to the wood windows at side rail, header, and brickmould connections.

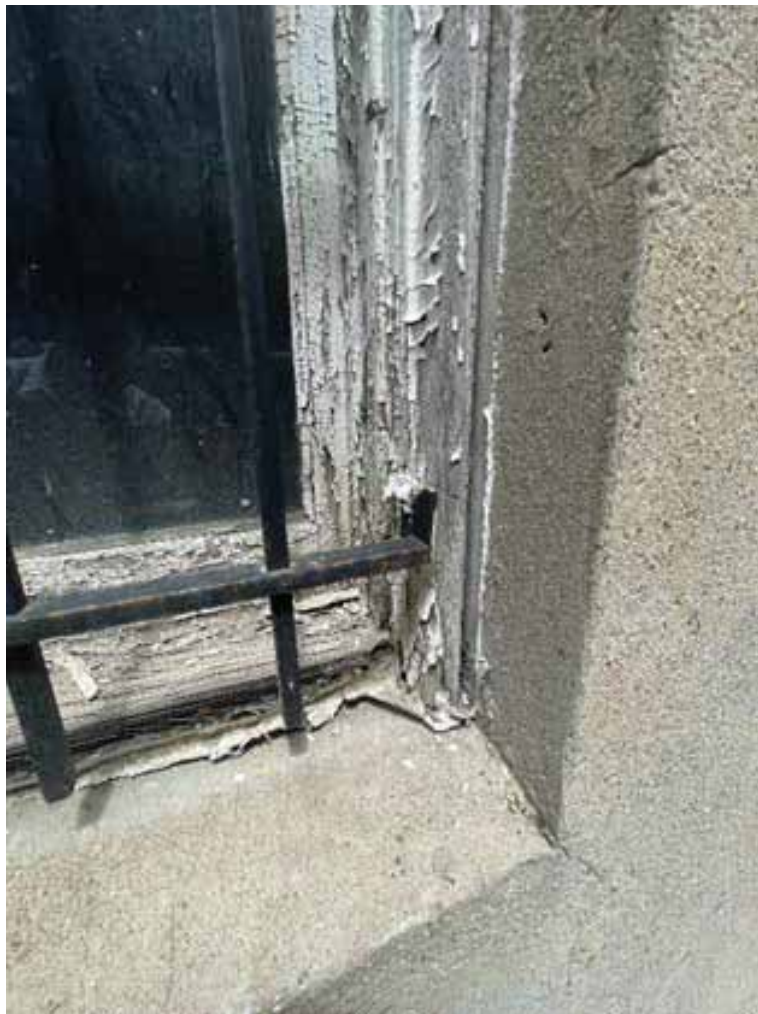
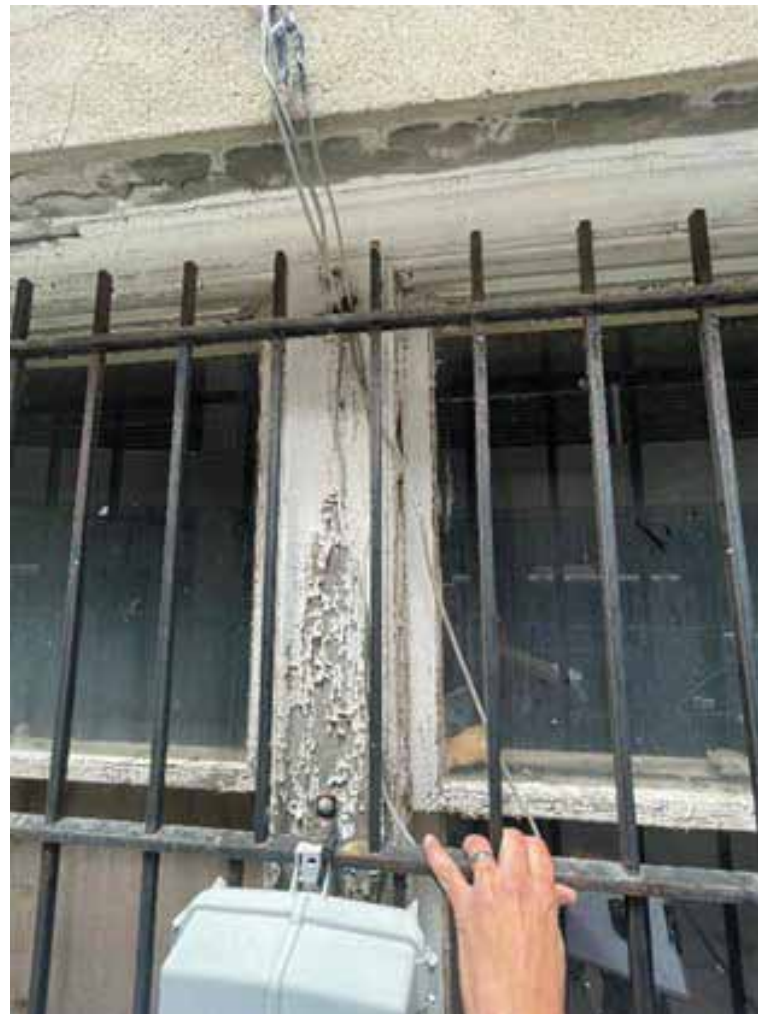
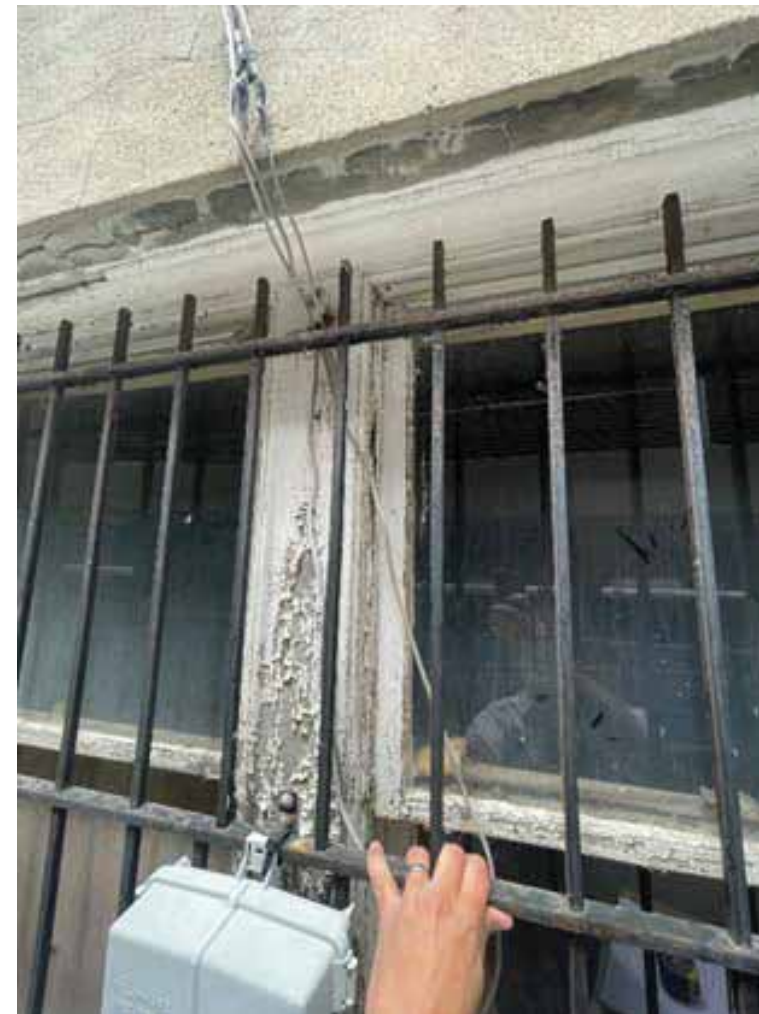
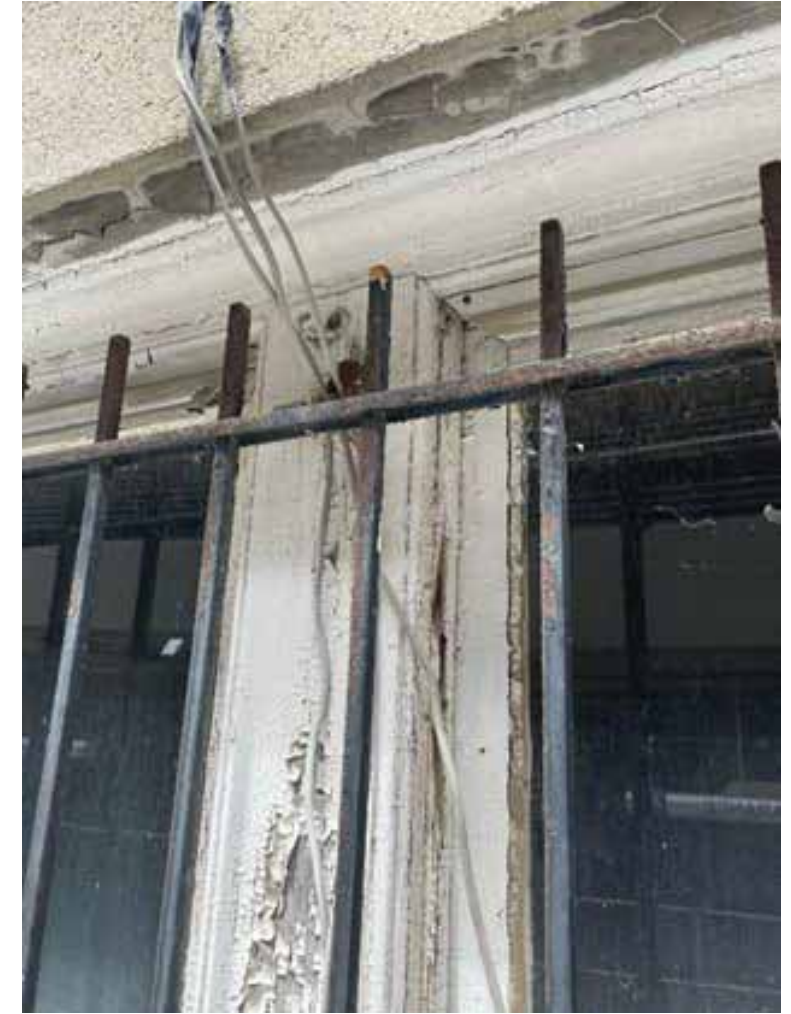
Images showing typical levels of damage to the wood windows at side rail, header, and center stile.

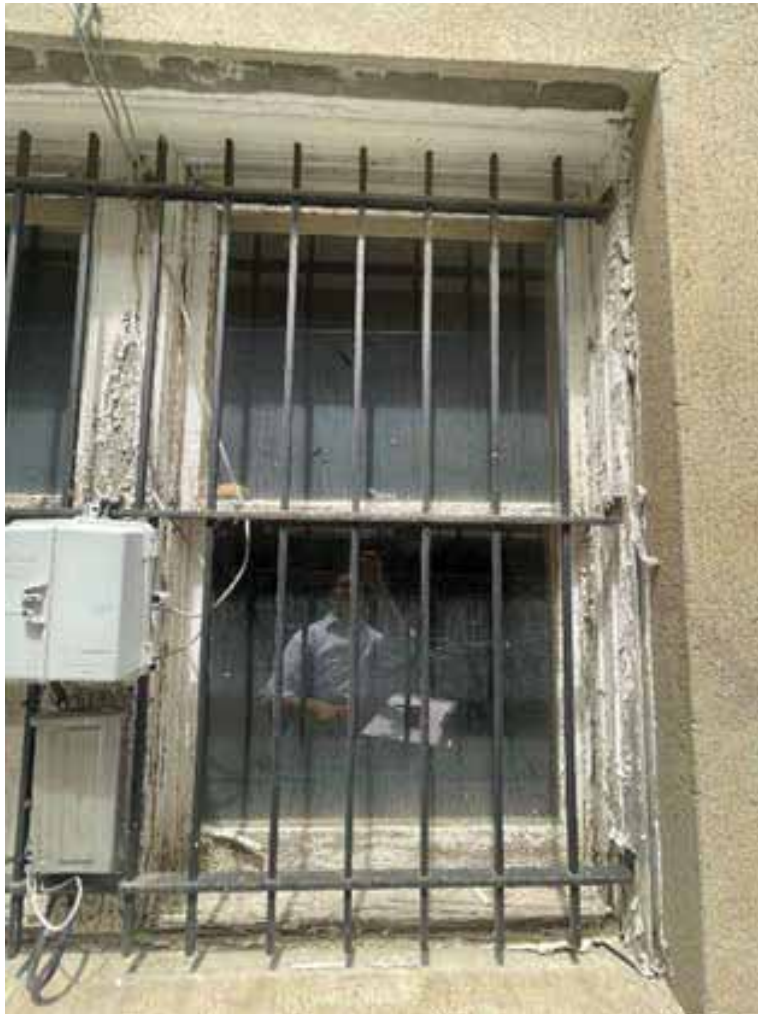
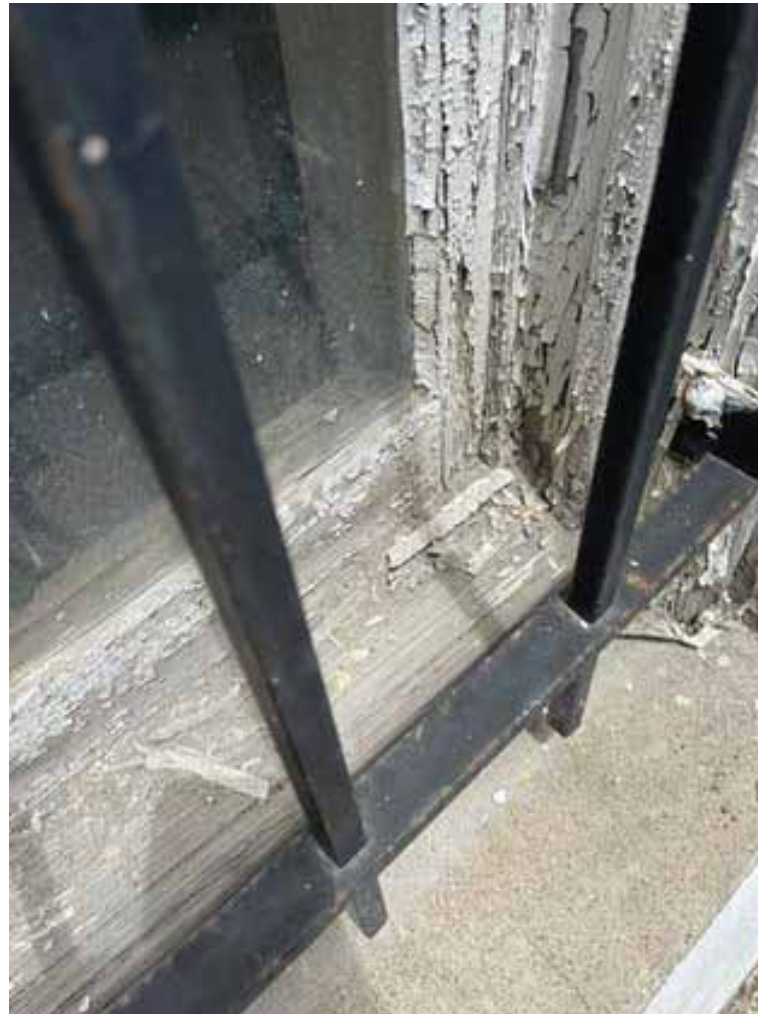
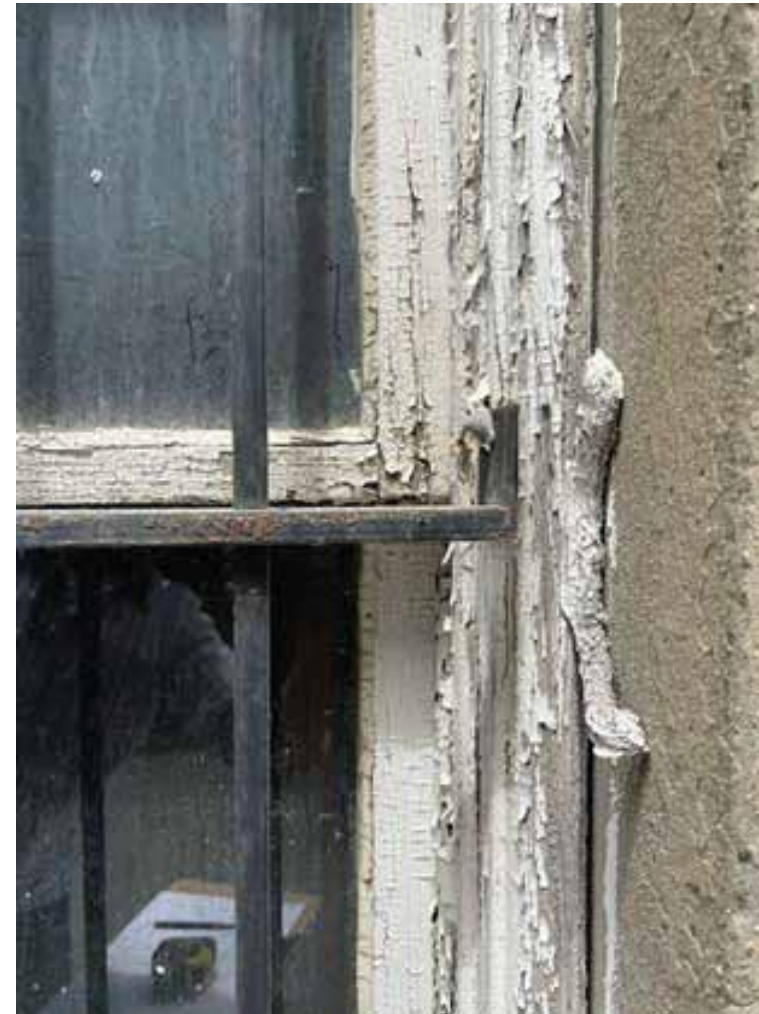
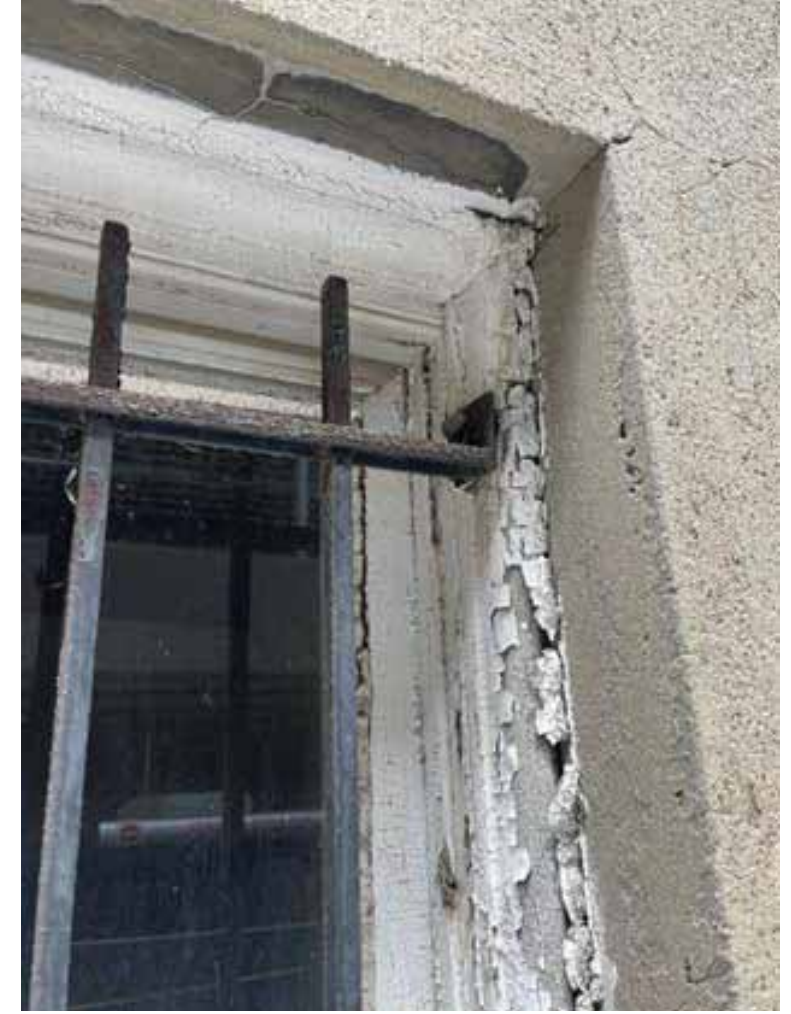
Images showing typical levels of damage to the wood windows at side rails
