CITY OF DETROIT HISTORIC DISTRICT COMMISSION

92 E. Forest. Detroit, MI

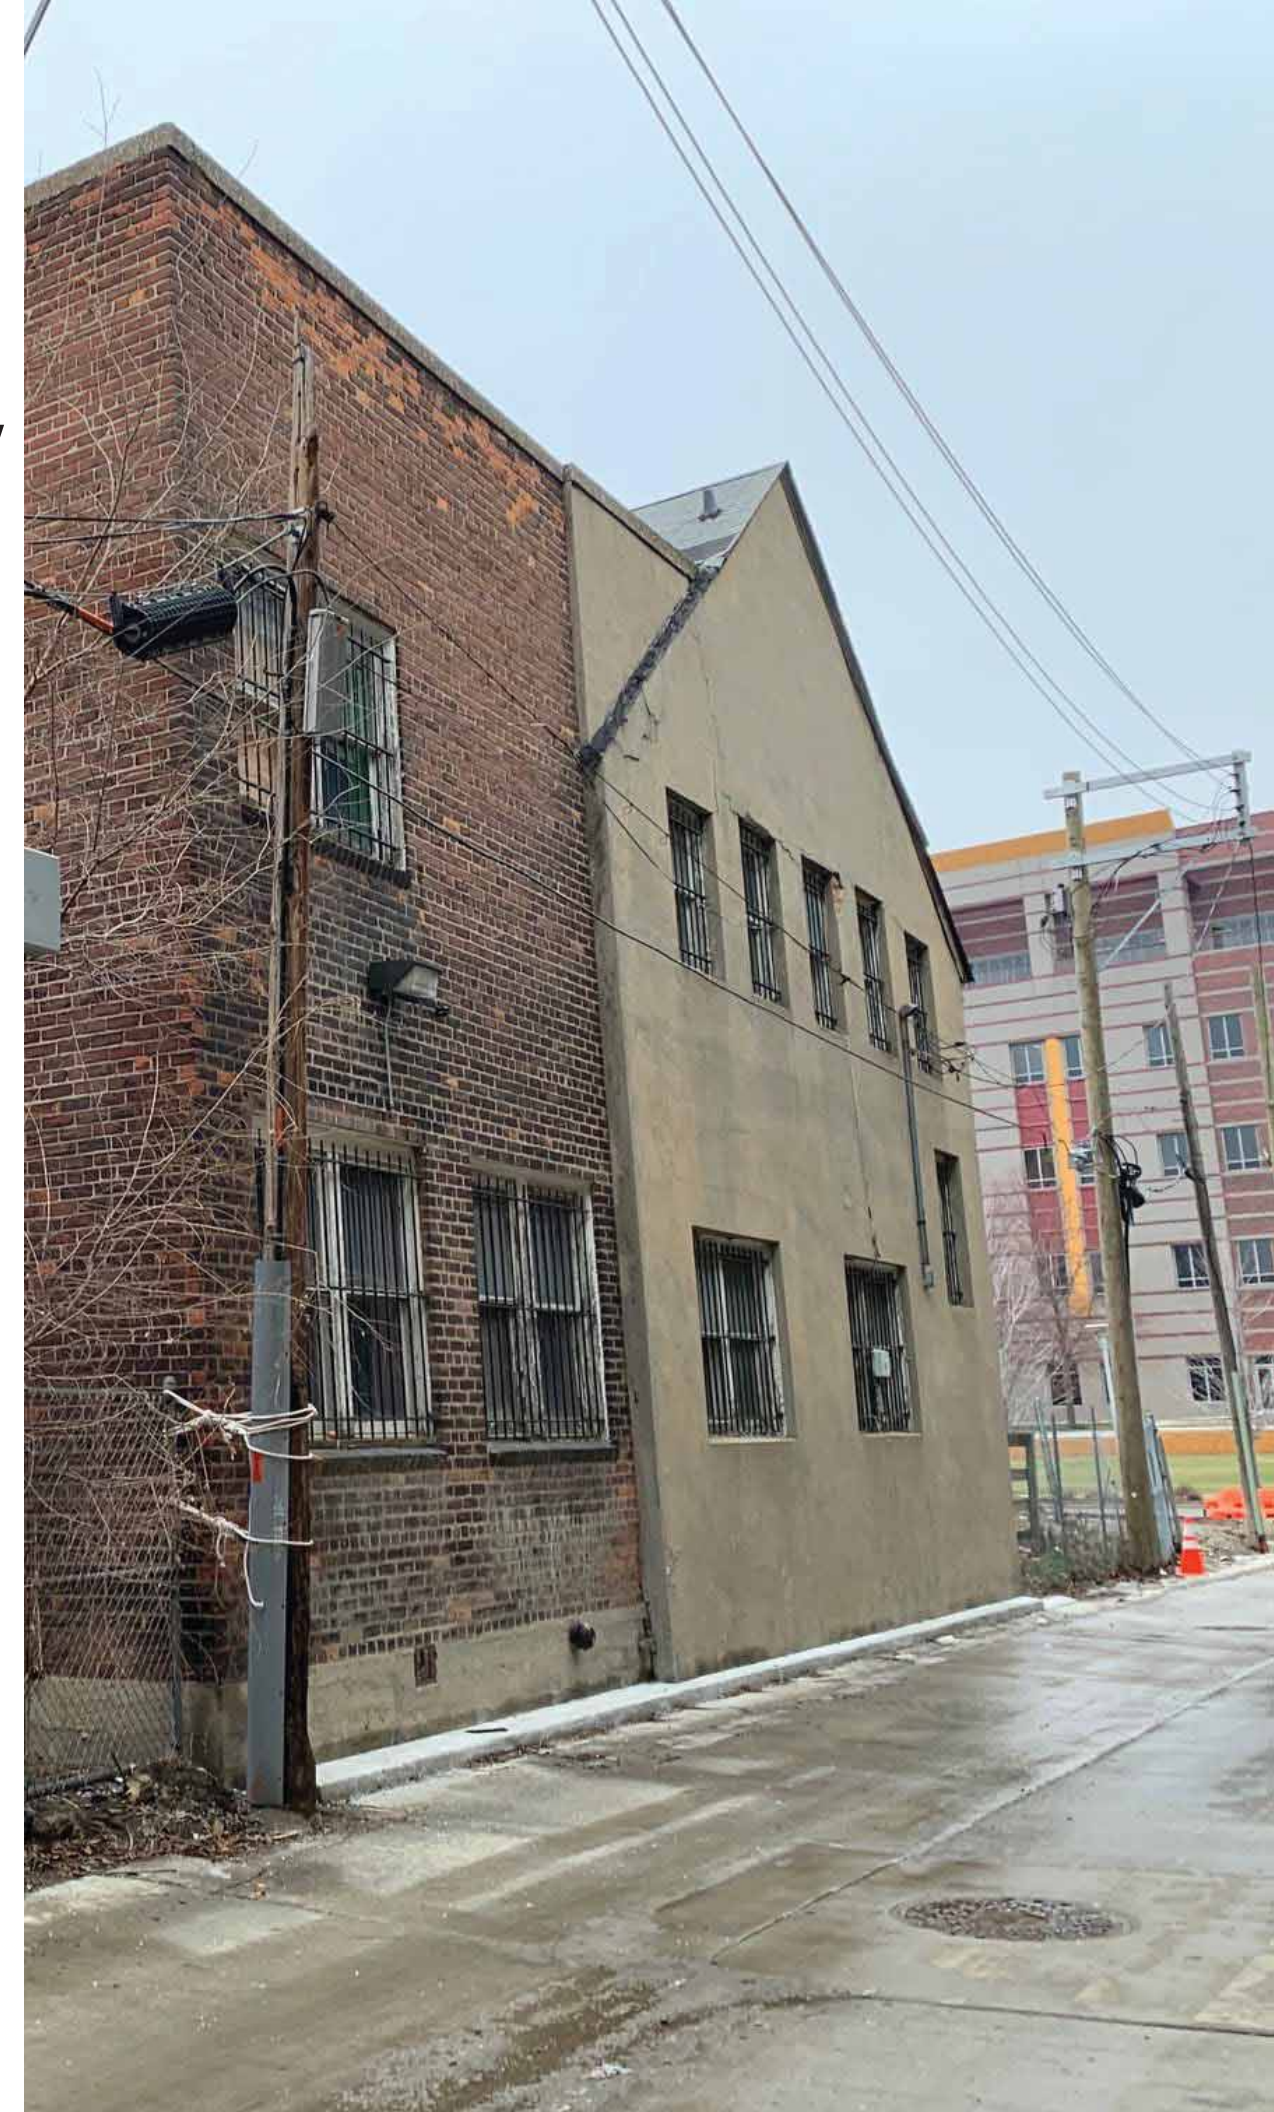
1. Original Wood Windows were constructed of poor-quality lumber and parts. "Builder grade".
2. Multiple portions of existing trim and brickmould are deteriorated
3. Restoration of current windows will only extend life for approximately 5 years
4. New Windsor Pinnacle Windows are the ideal historic replacement – high quality and thermally efficient
5. We are proposing replicating all new trim & brickmold for all 1/1 windows to match around entire building
6. Window will match existing jamb depth placement
7. New, already approved, windows are to be Windsor Pinnacle Windows – Consistent appearance
8. Reside in the Non historic, non original portion of building

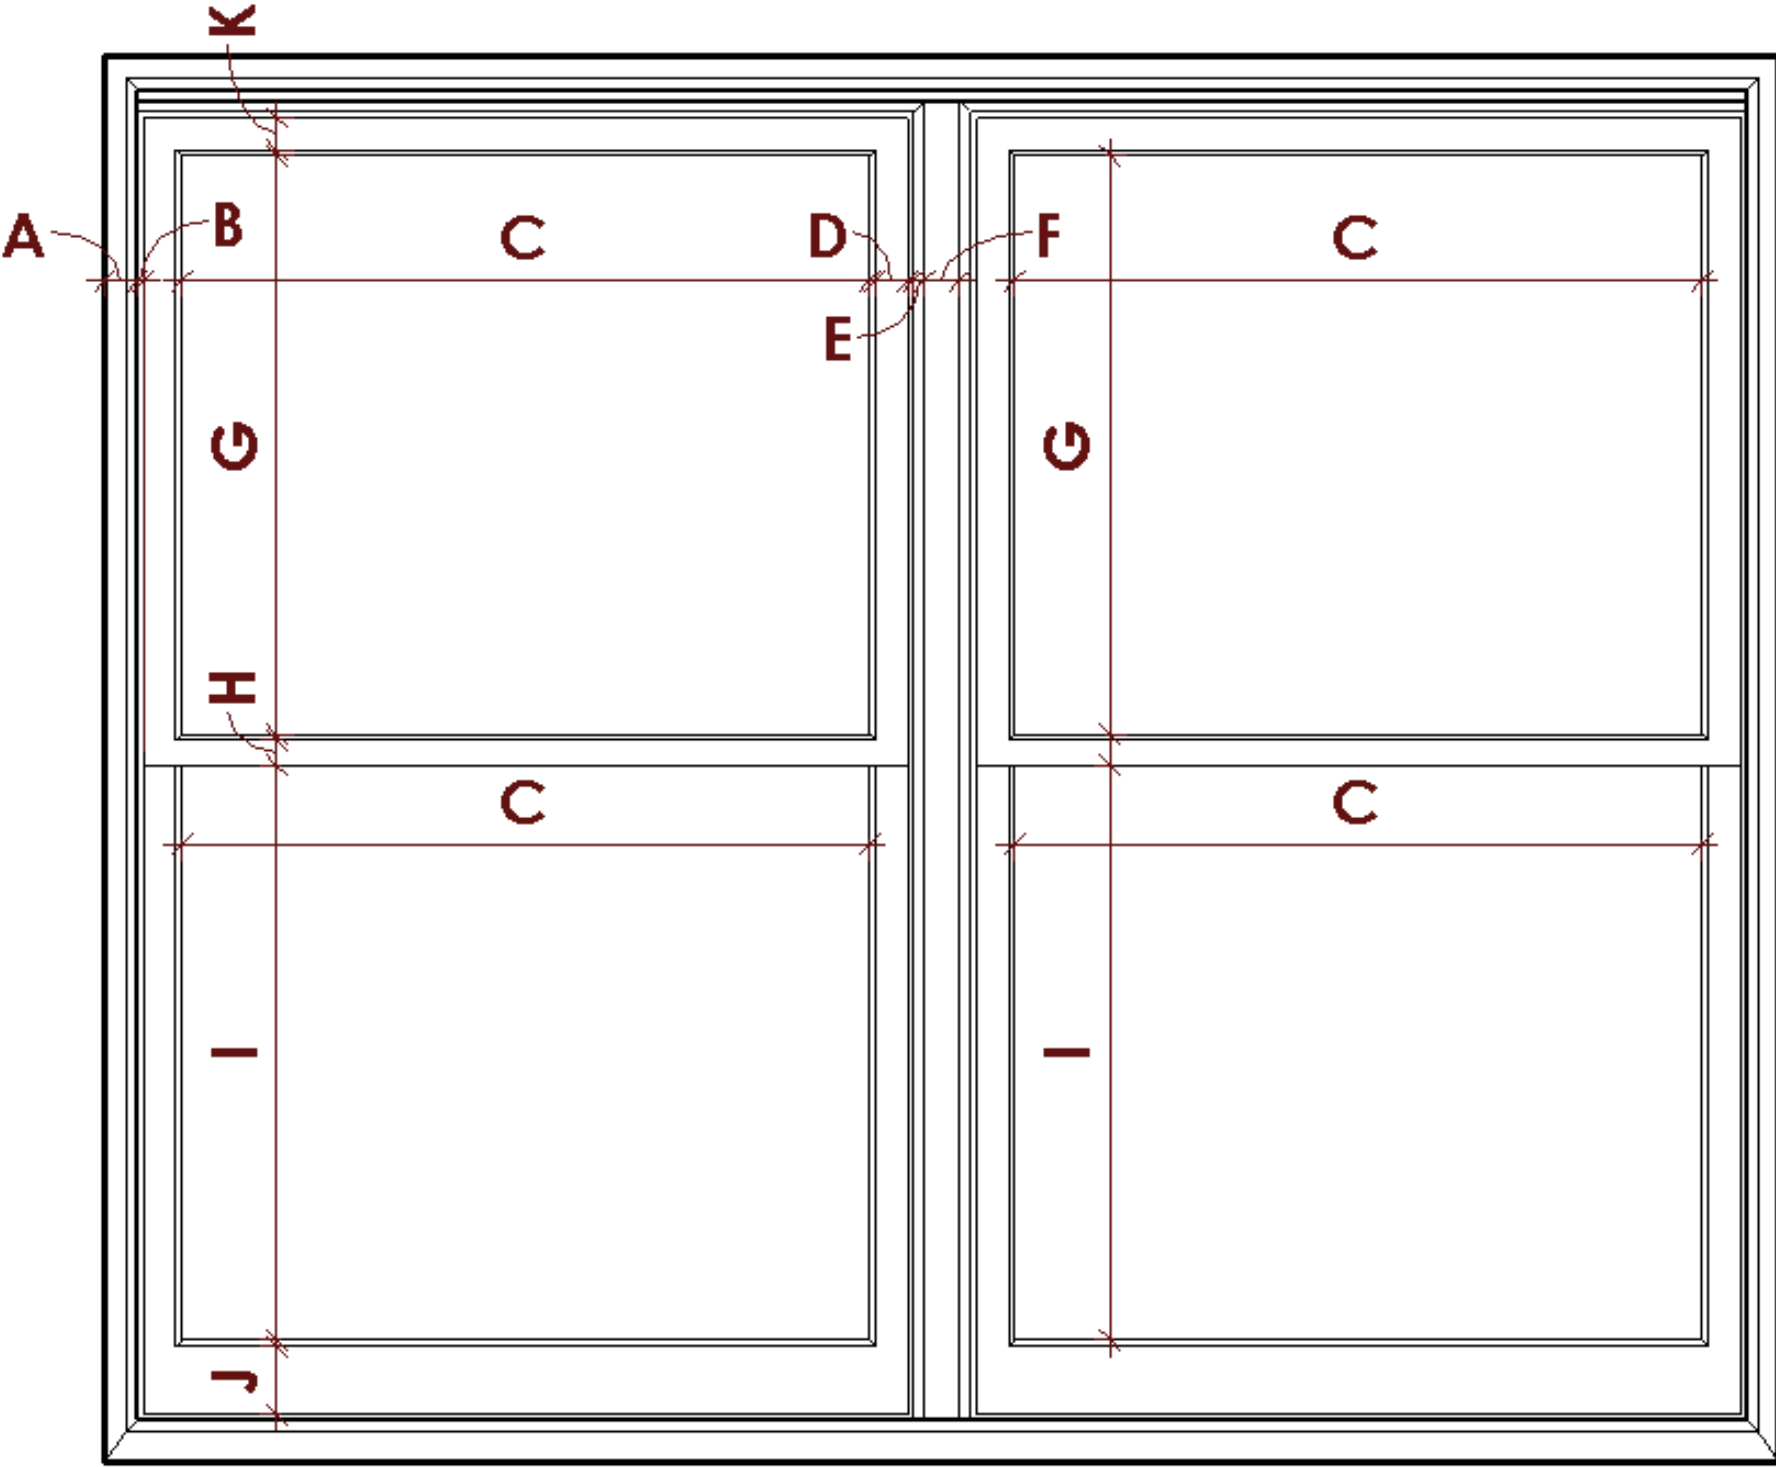
- A: Brickmould
- B: Frame
- C: Glazing Length
- D: Side Sash Rail
- E: Trim
- F: Middle Sash Rail
- G: Upper Glazing Height
- H: Upper Bottom Sash Rail
- I: Lower Glazing Height
- J: Lower Bottom Sash Rail
- K: Top Sash Rail

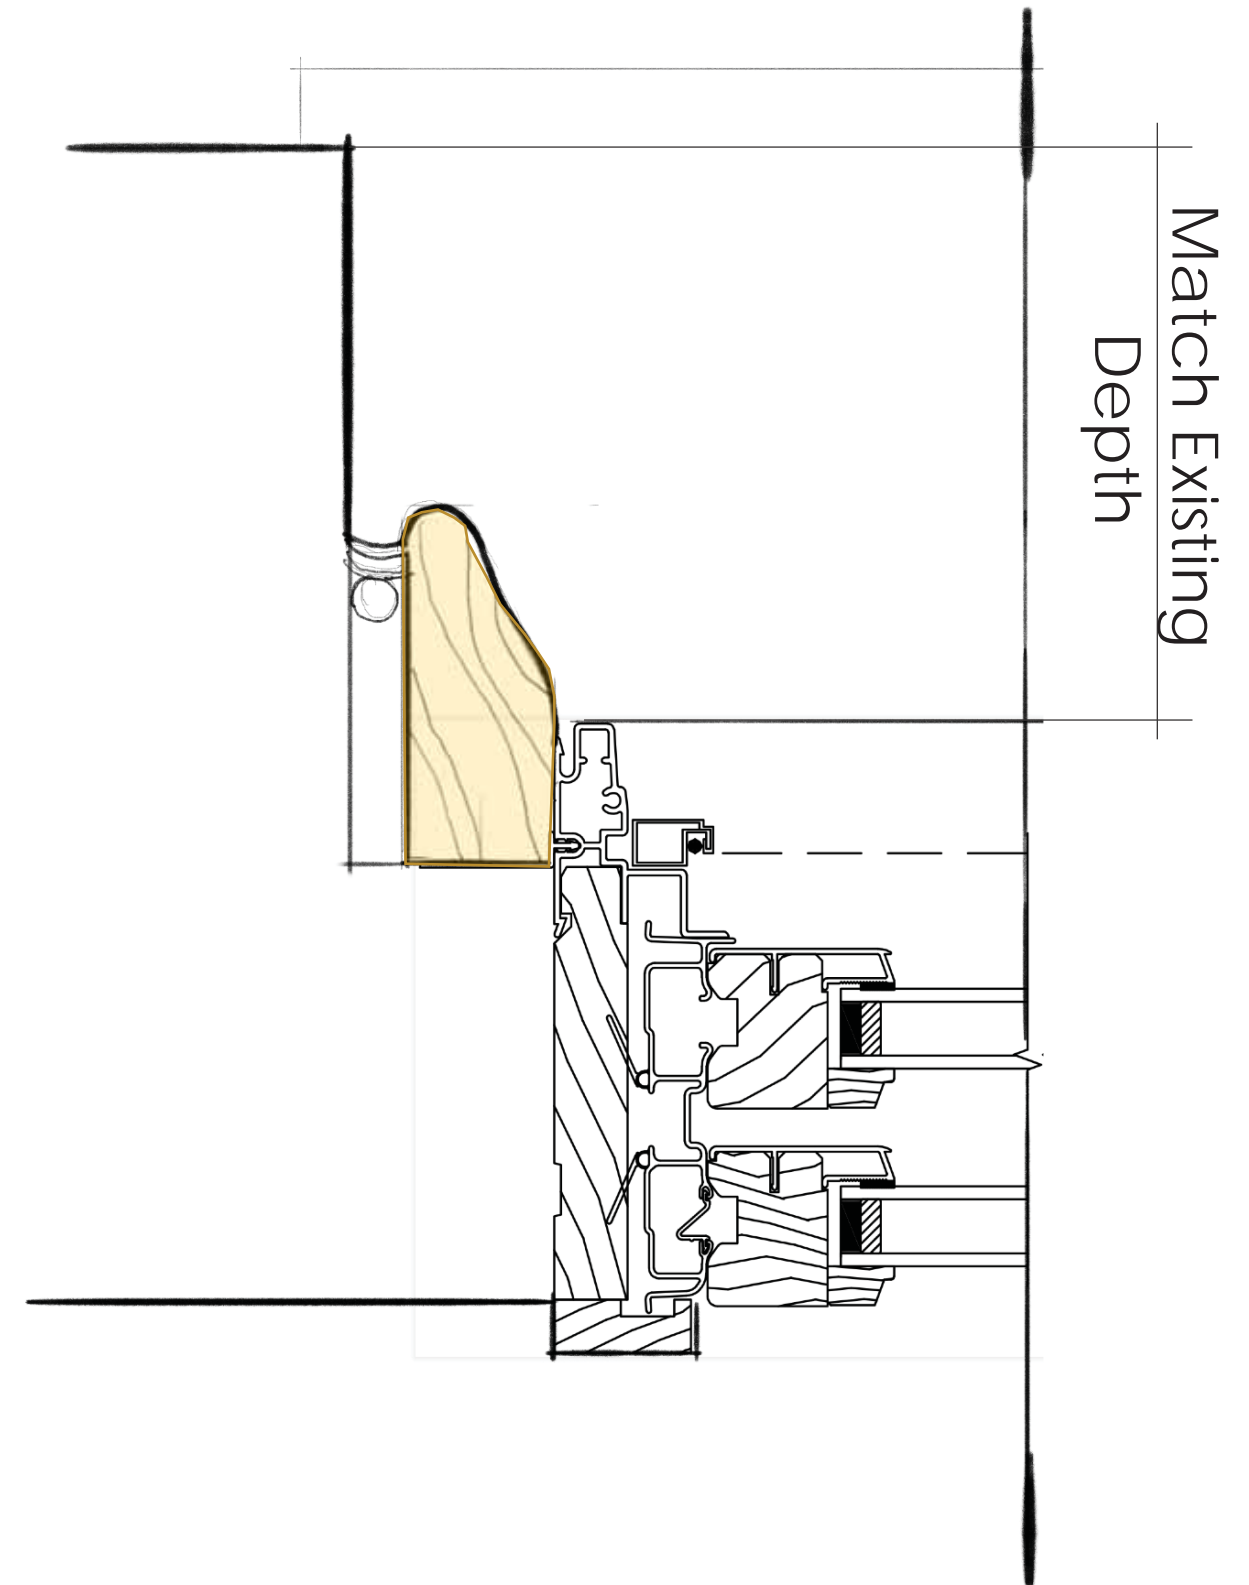
- Match jamb depth of existing
- New brickmould to match existing

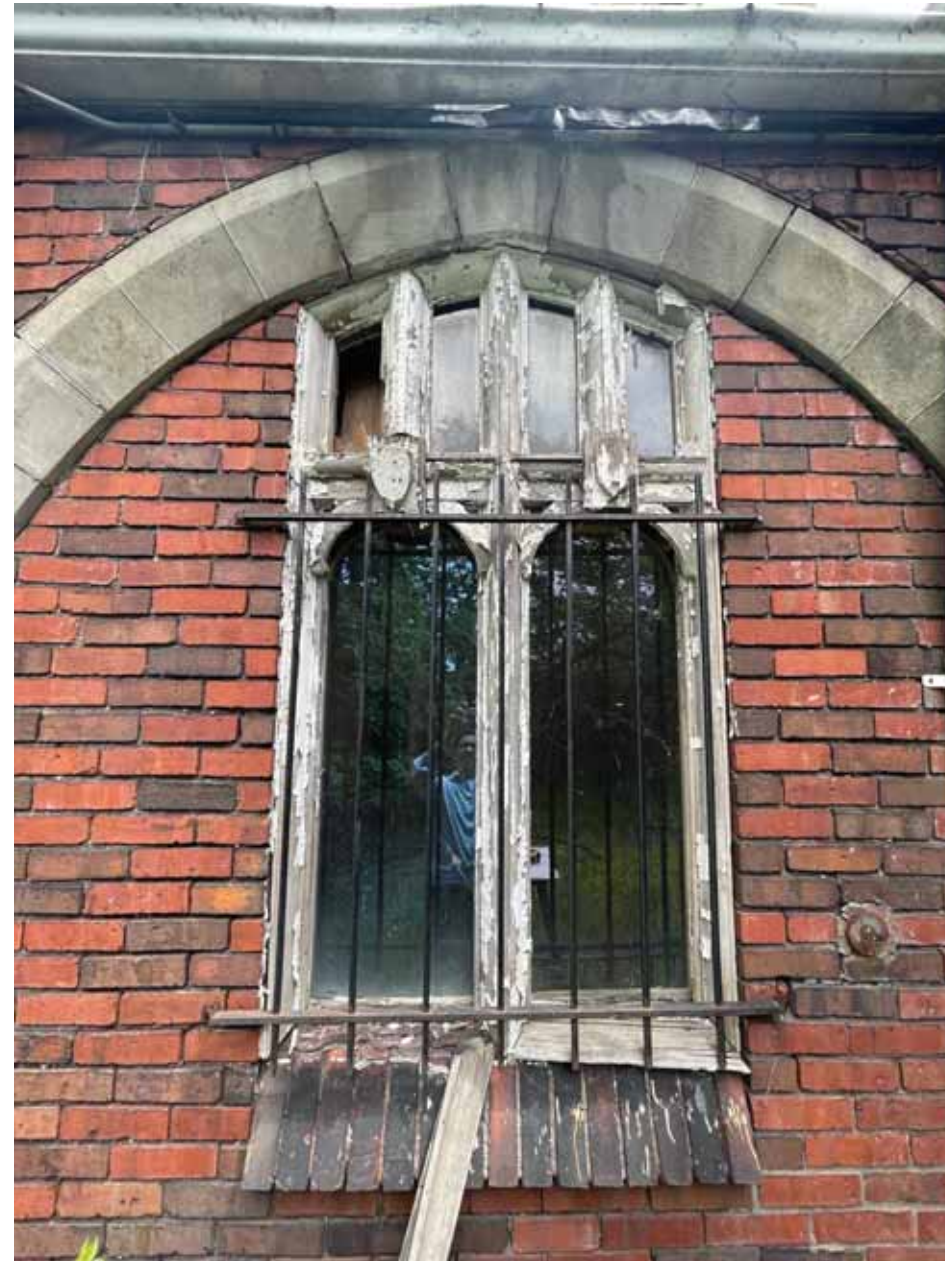
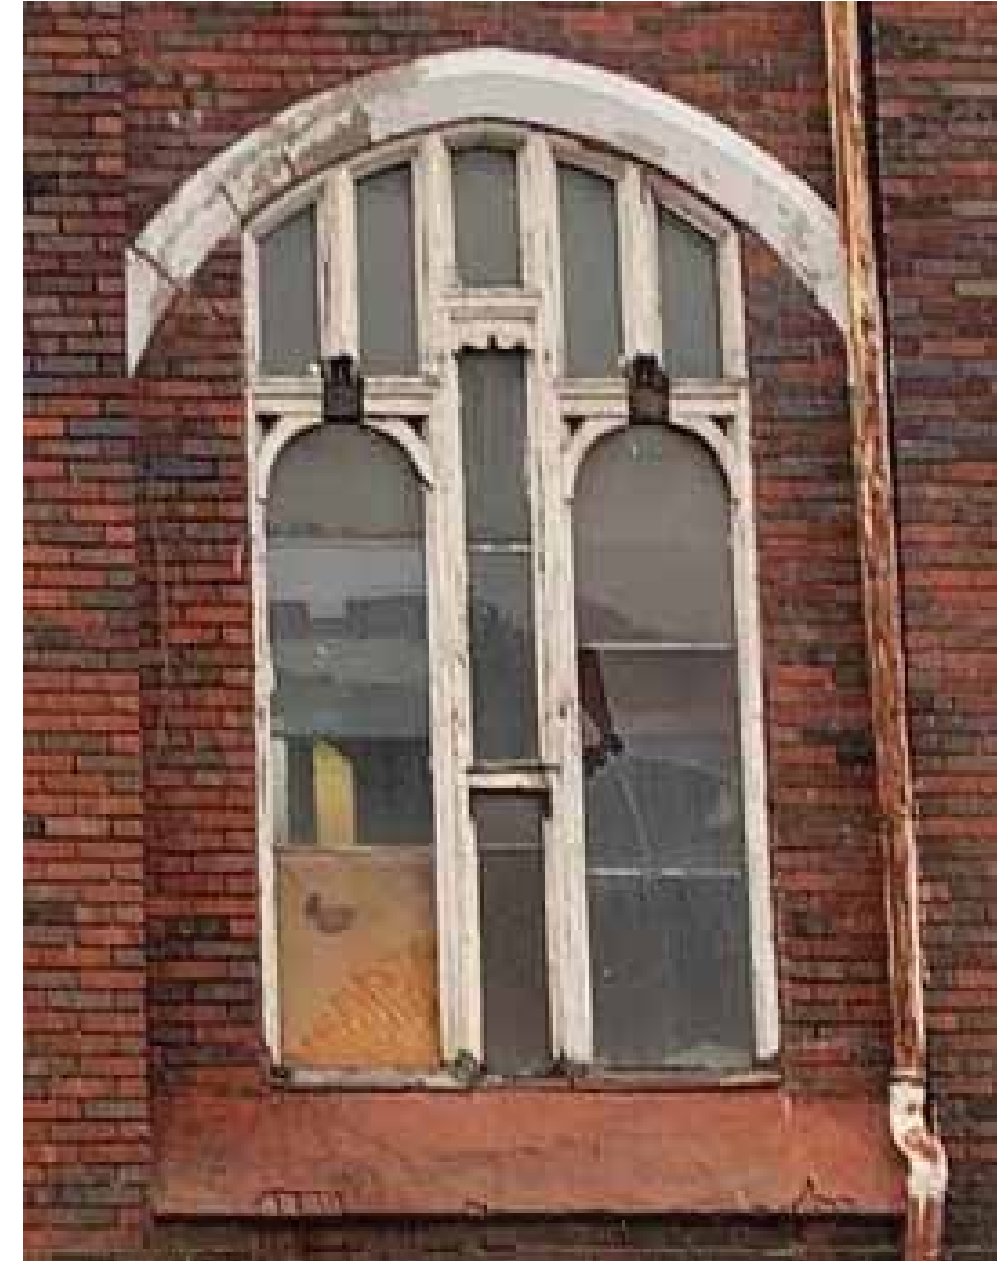
- The Arched Windows are in varied conditions throughout each window.
- **Our request is to repair and refinish as allowable by current conditions, but to fully replicate missing pieces or pieces that we find to not be salvageable during the refinishing process.**
- We will walk you through the assembly process in the following slides.

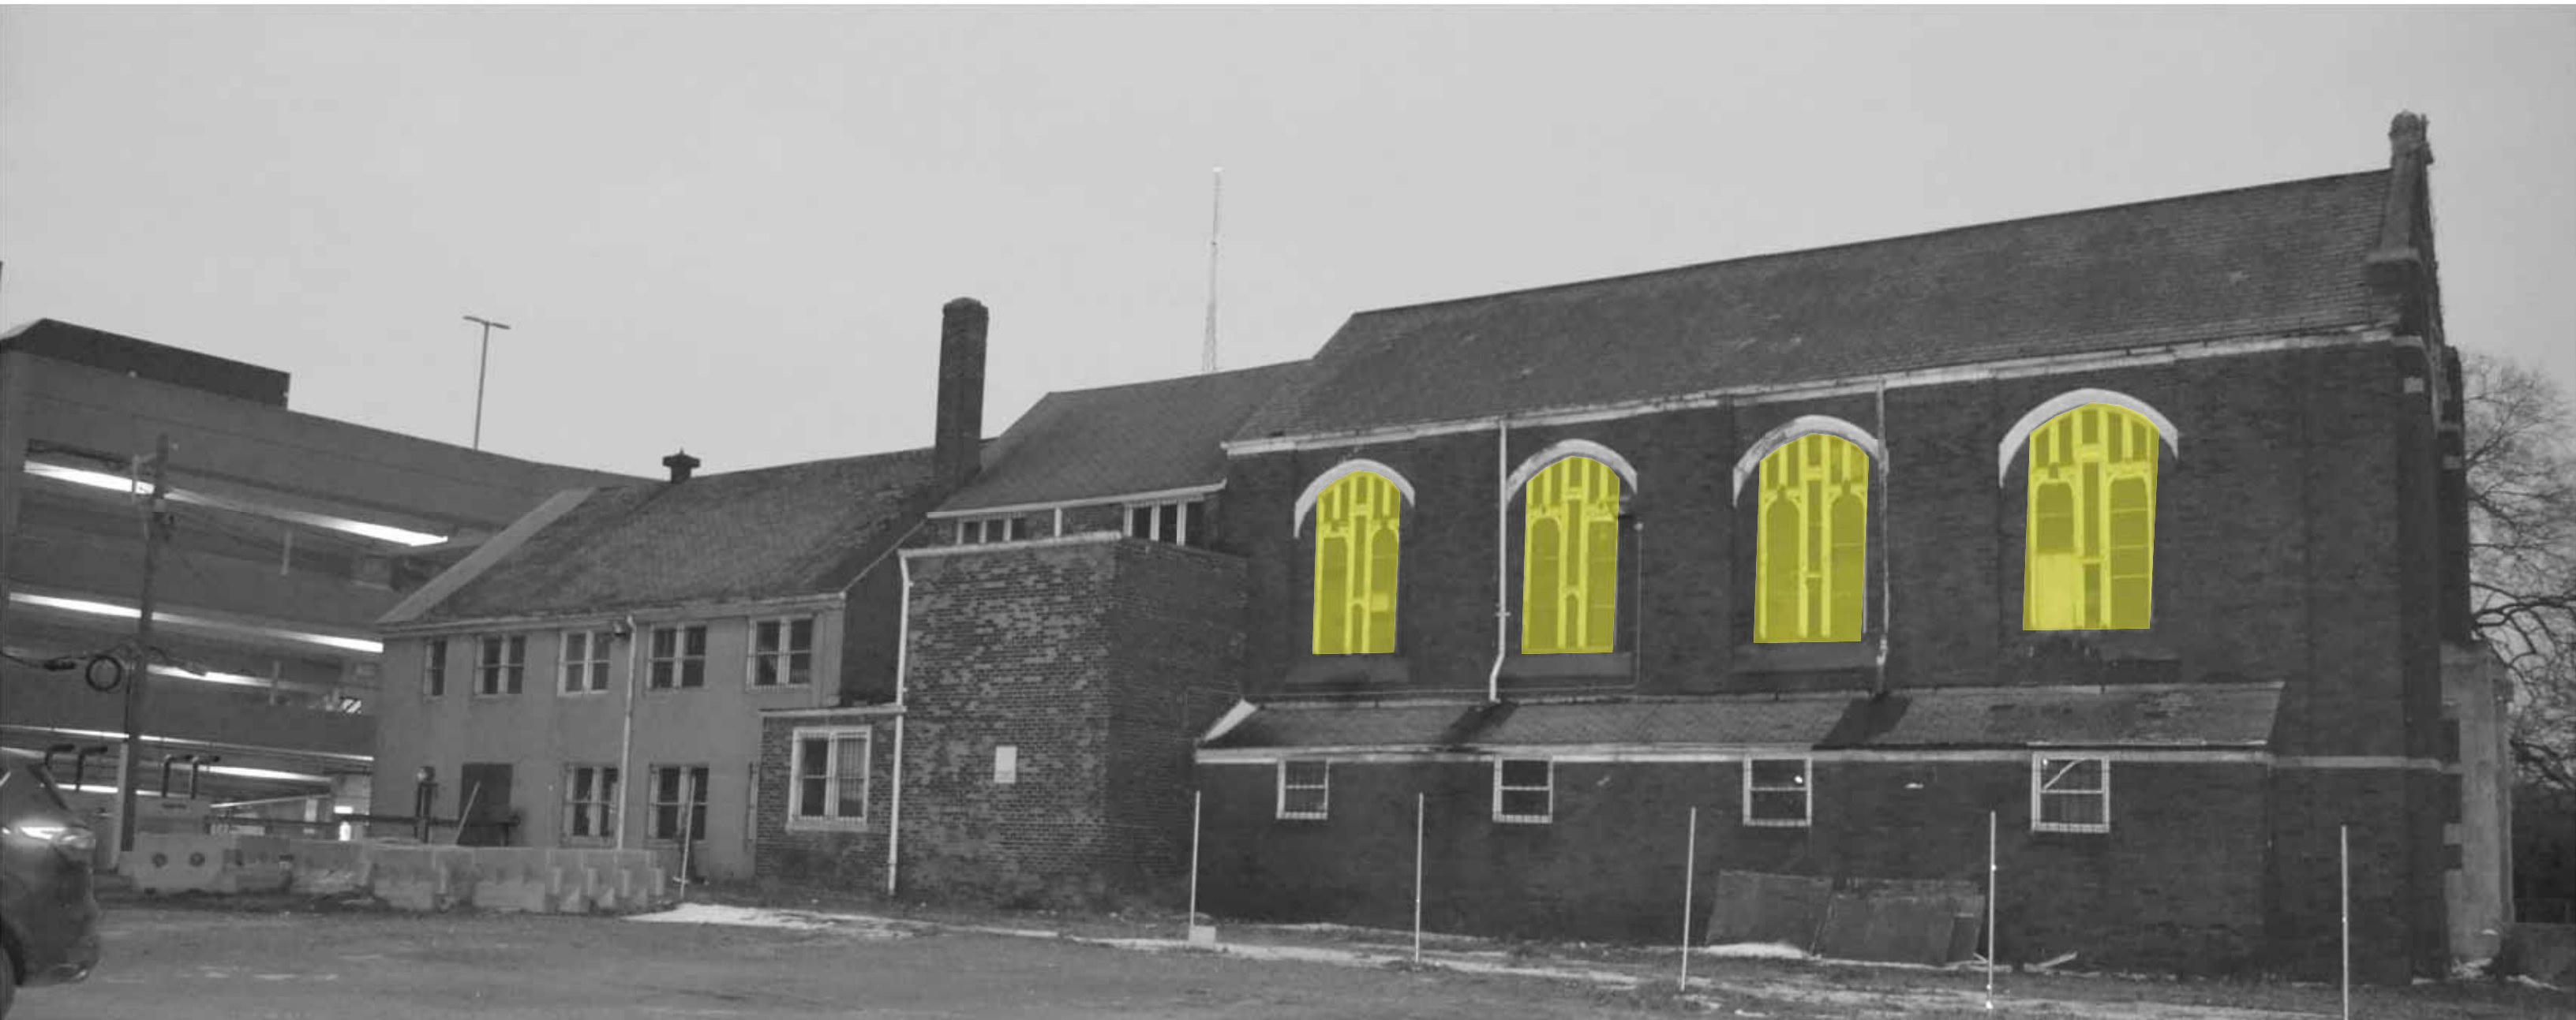
Arched Window Restoration and Repairs

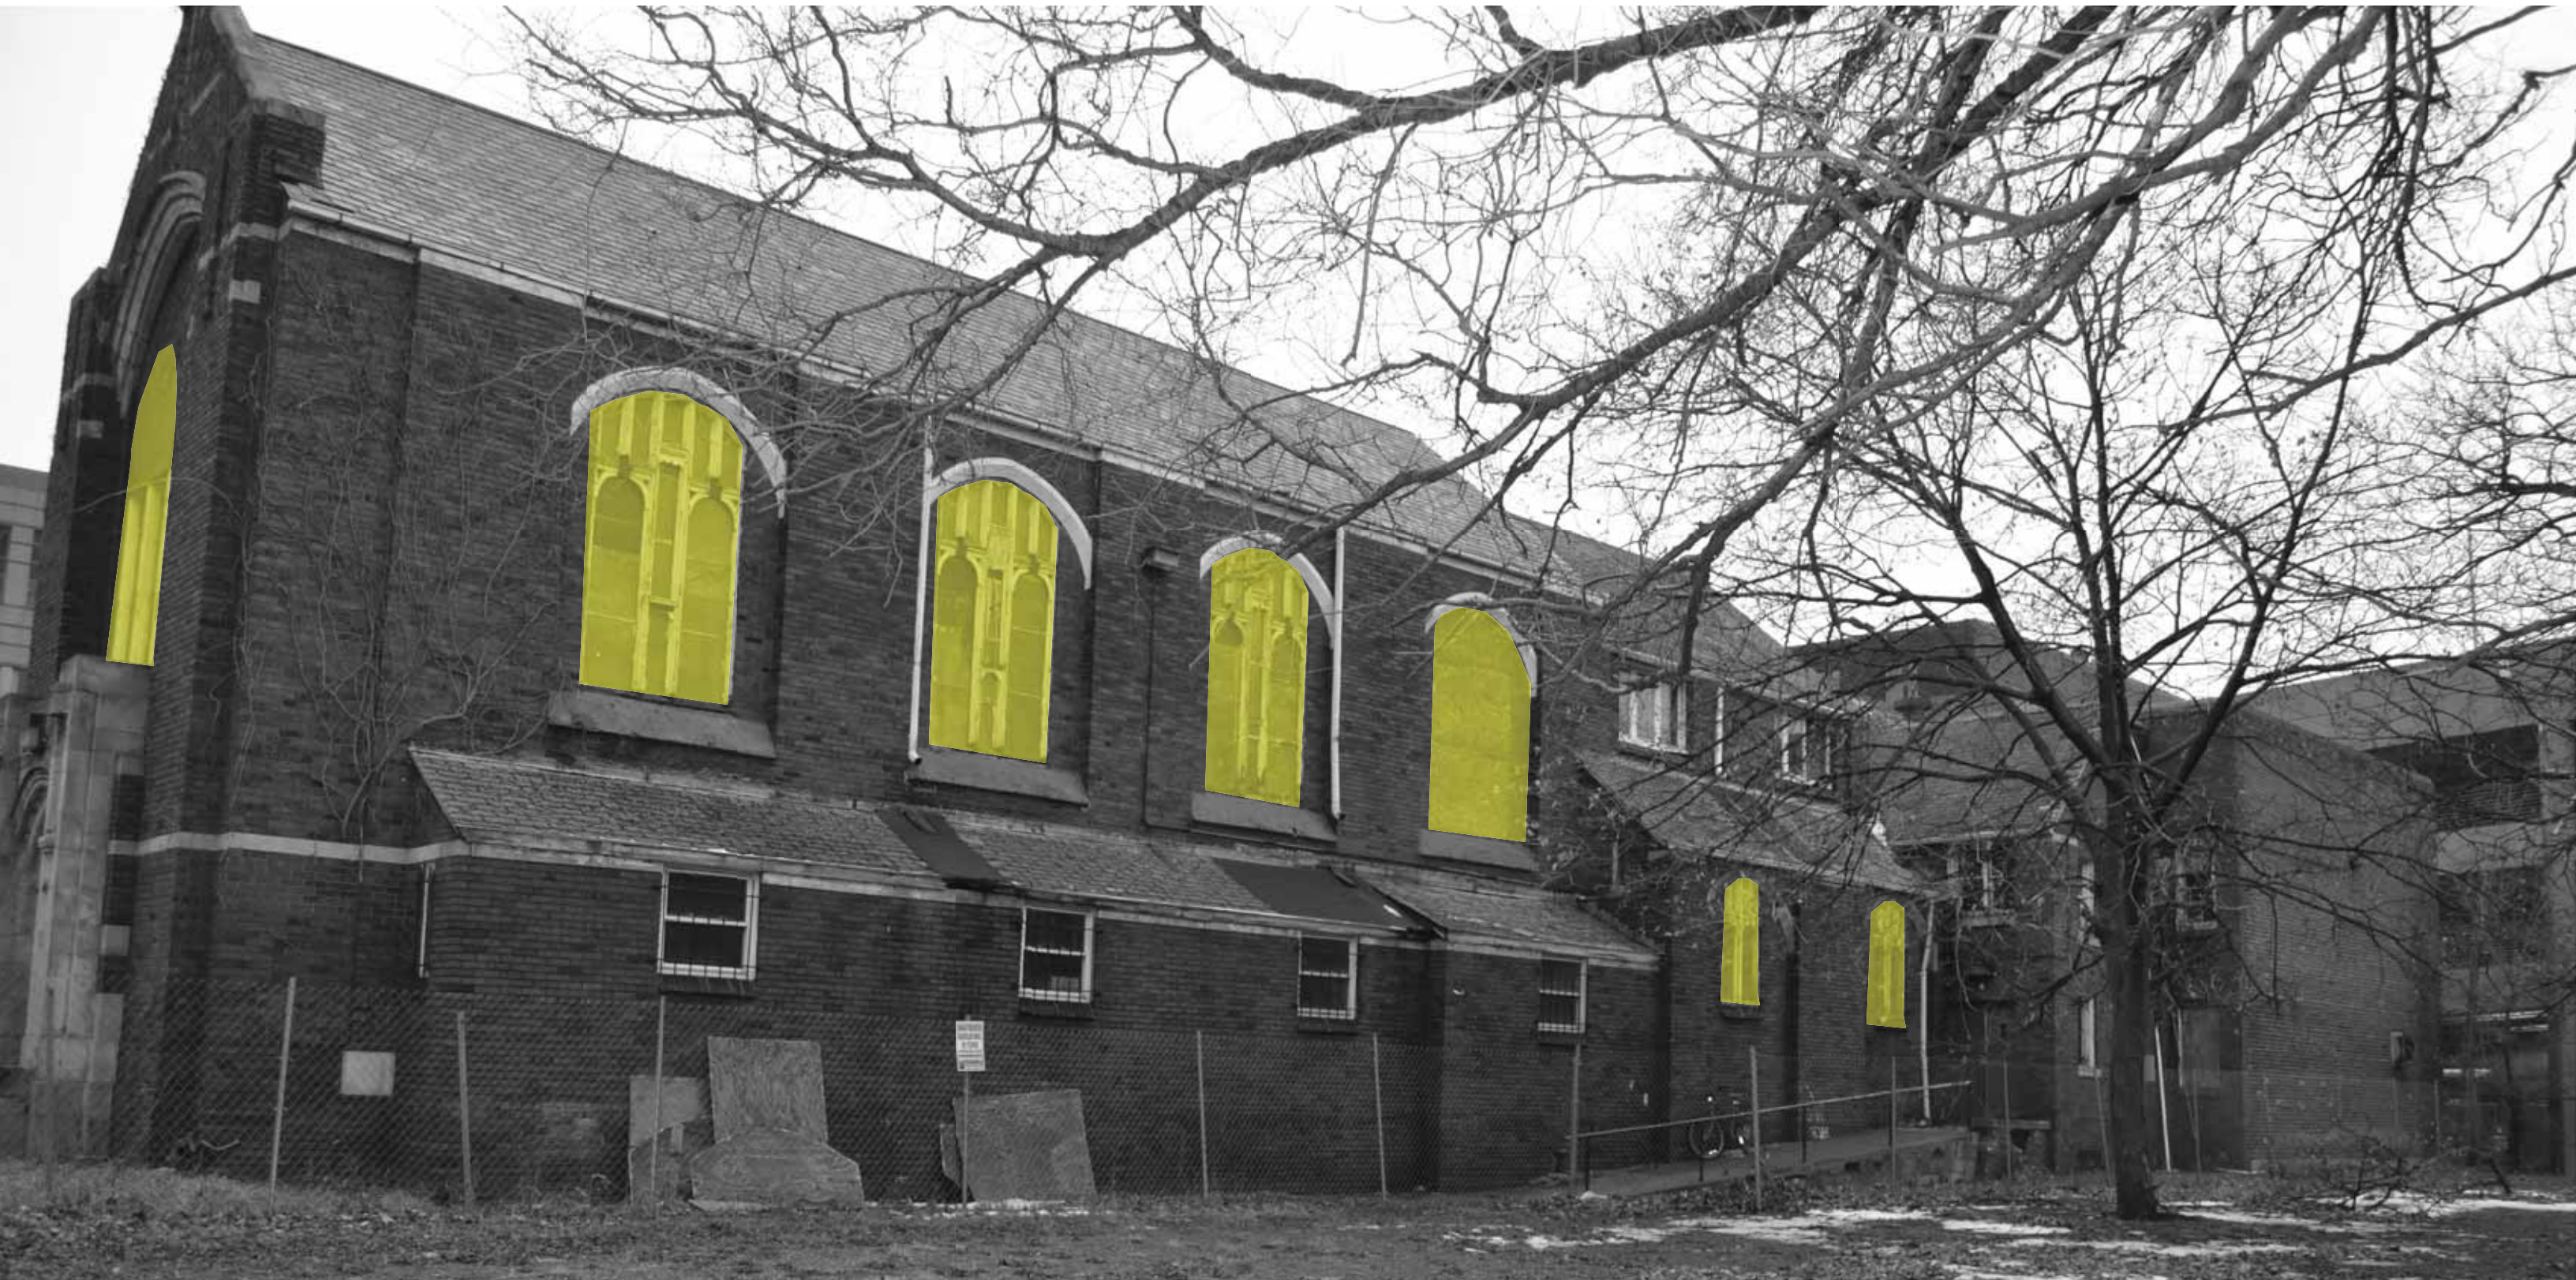
Arched Window Restoration and Repairs

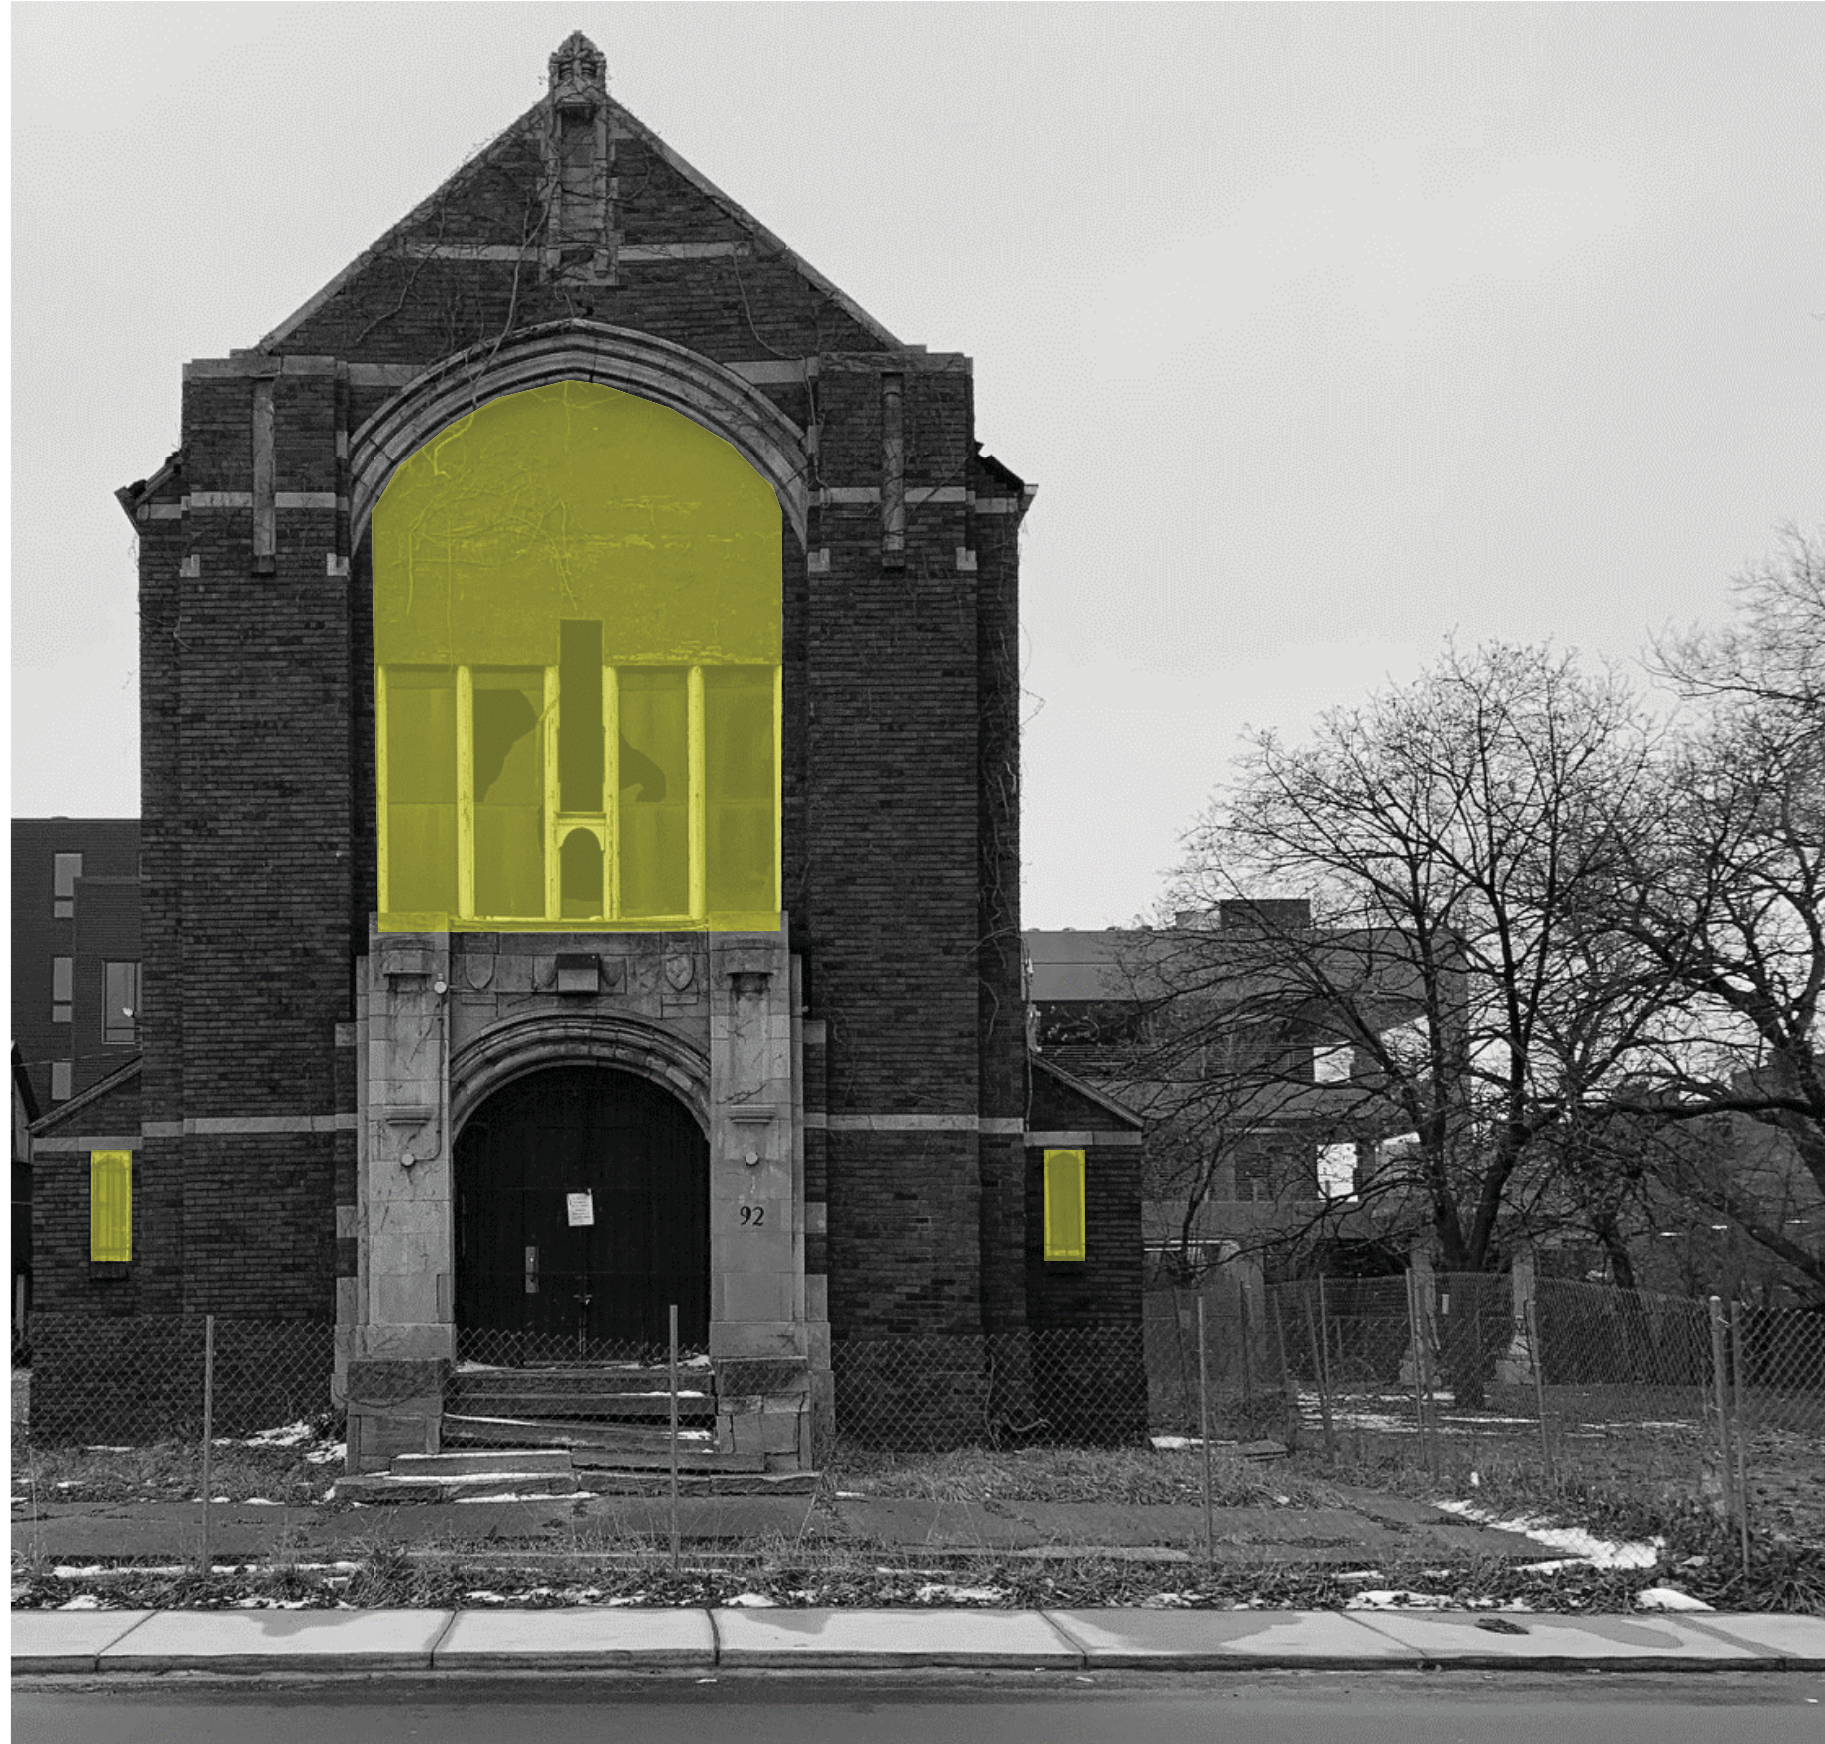
Arched Window Restoration and Repairs

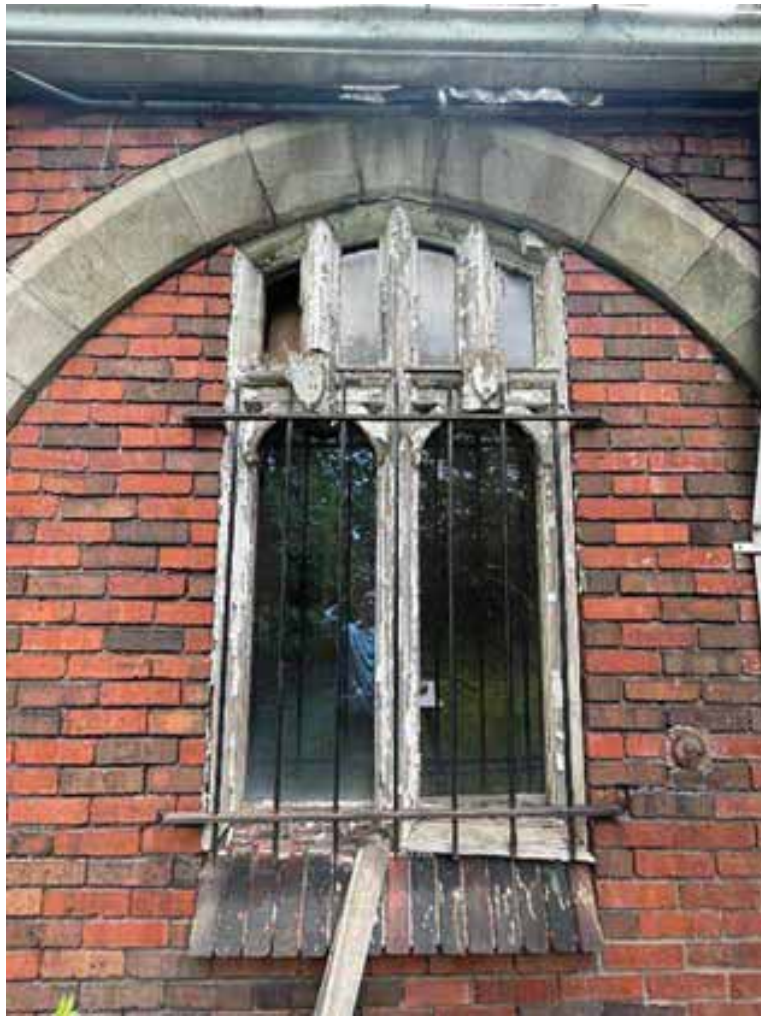
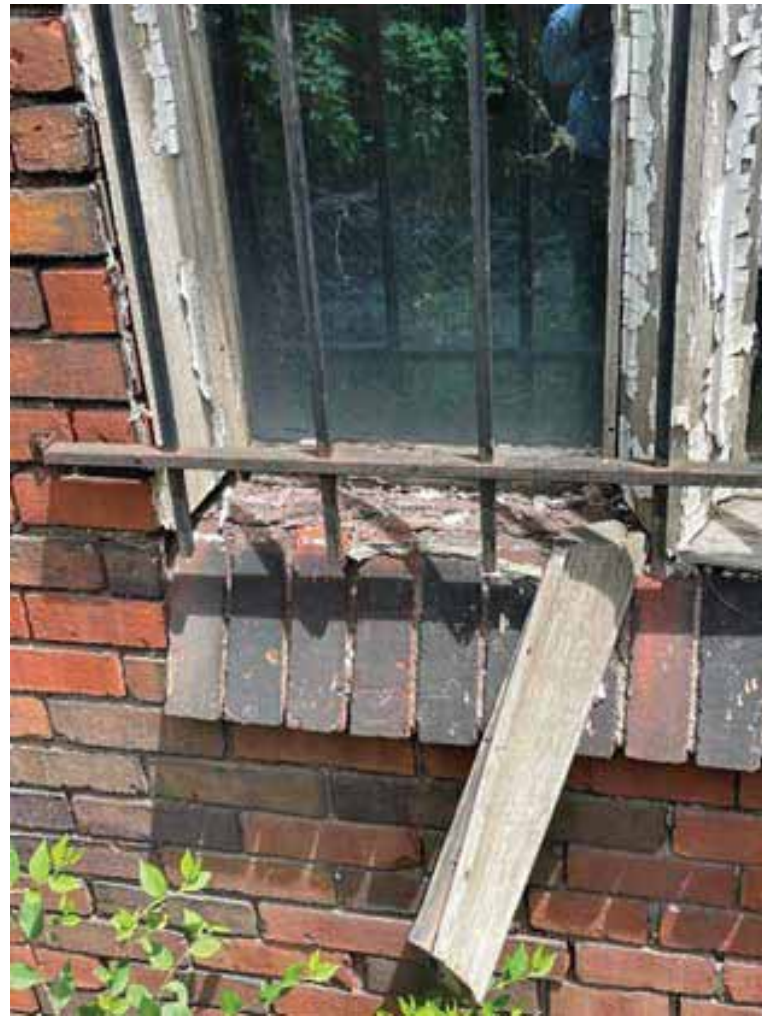
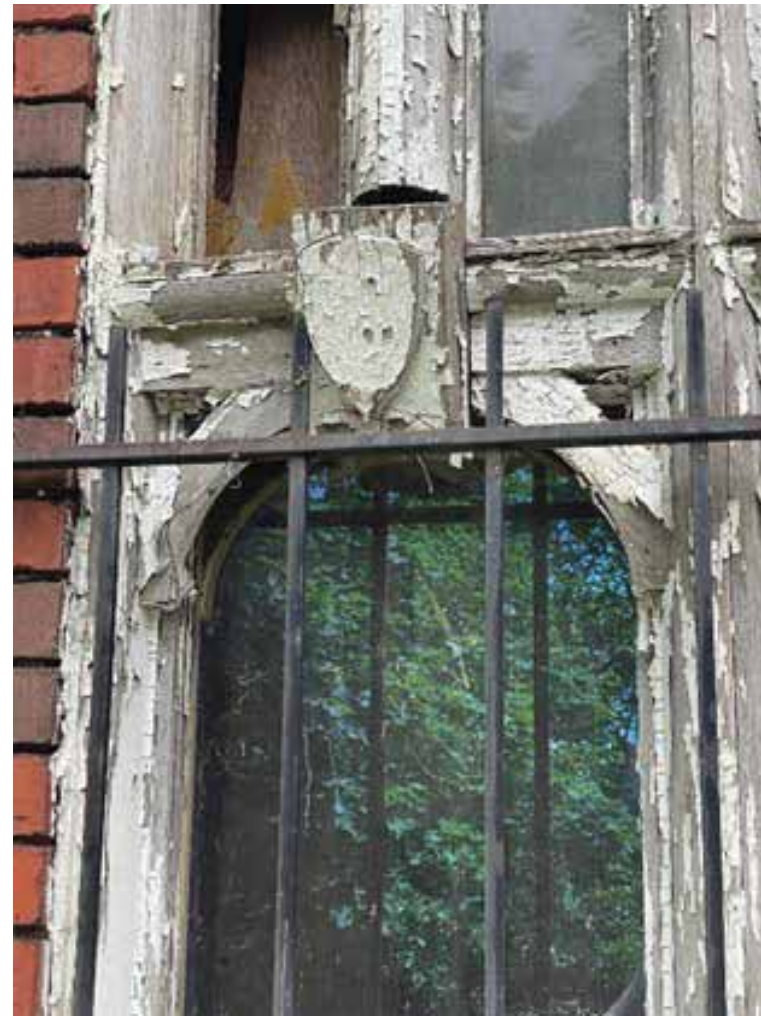
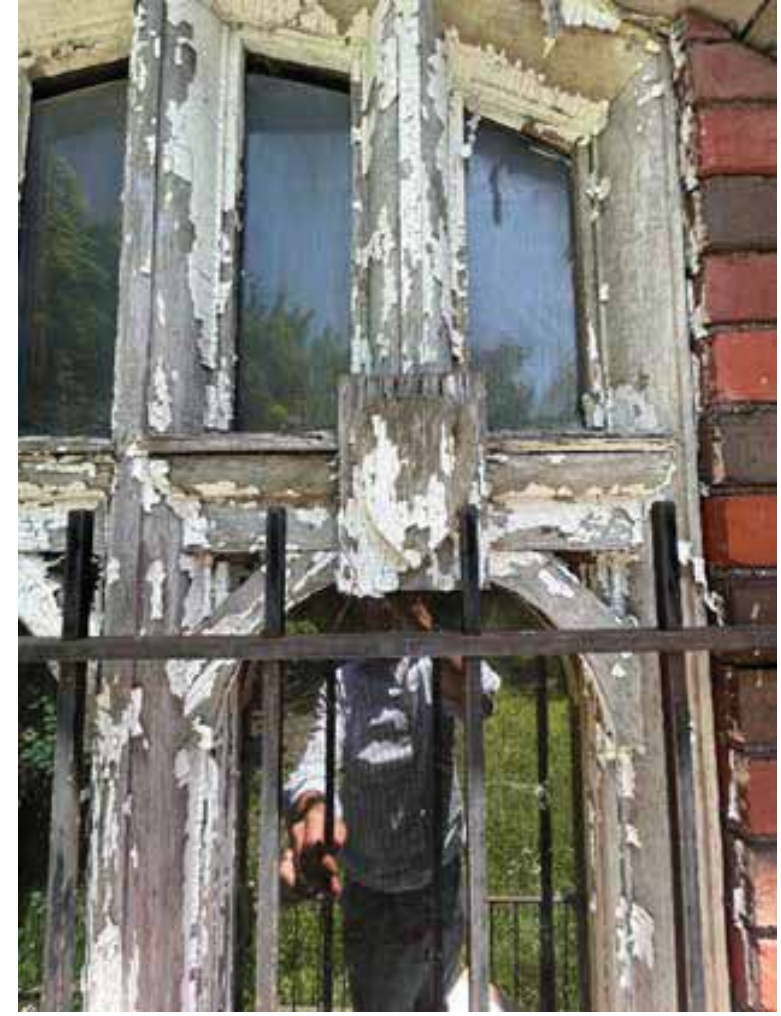
Images showing typical levels of damage to the smaller arched windows
