CITY OF DETROIT HISTORIC DISTRICT COMMISSION

92 E. Forest. Detroit, MI

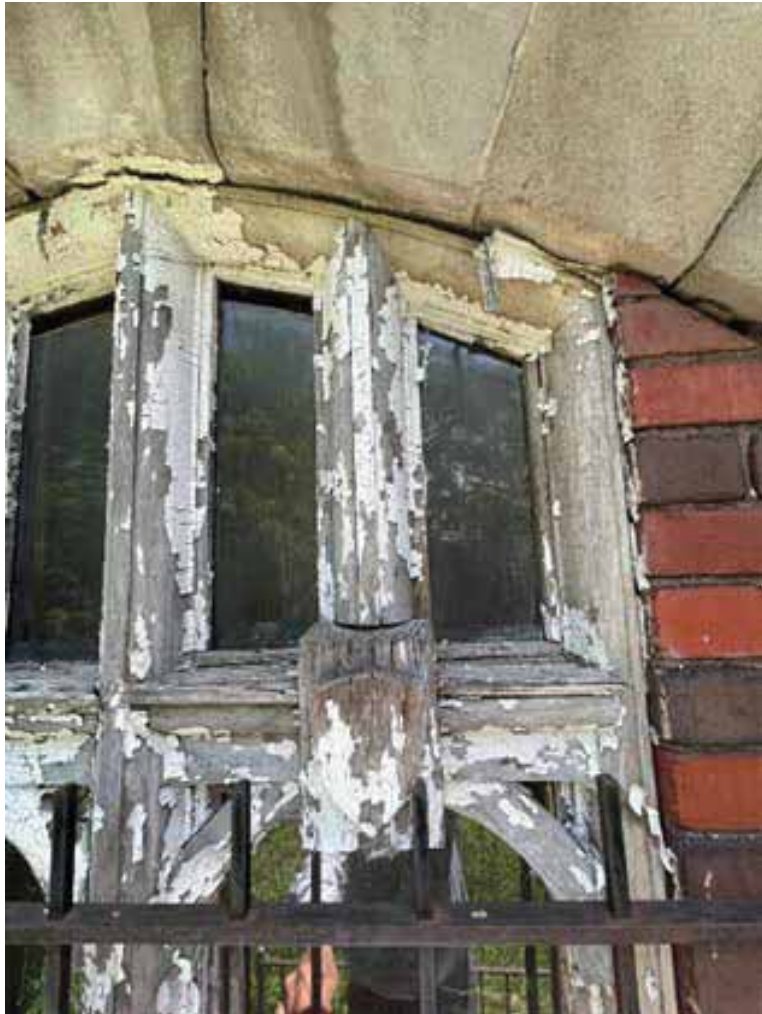
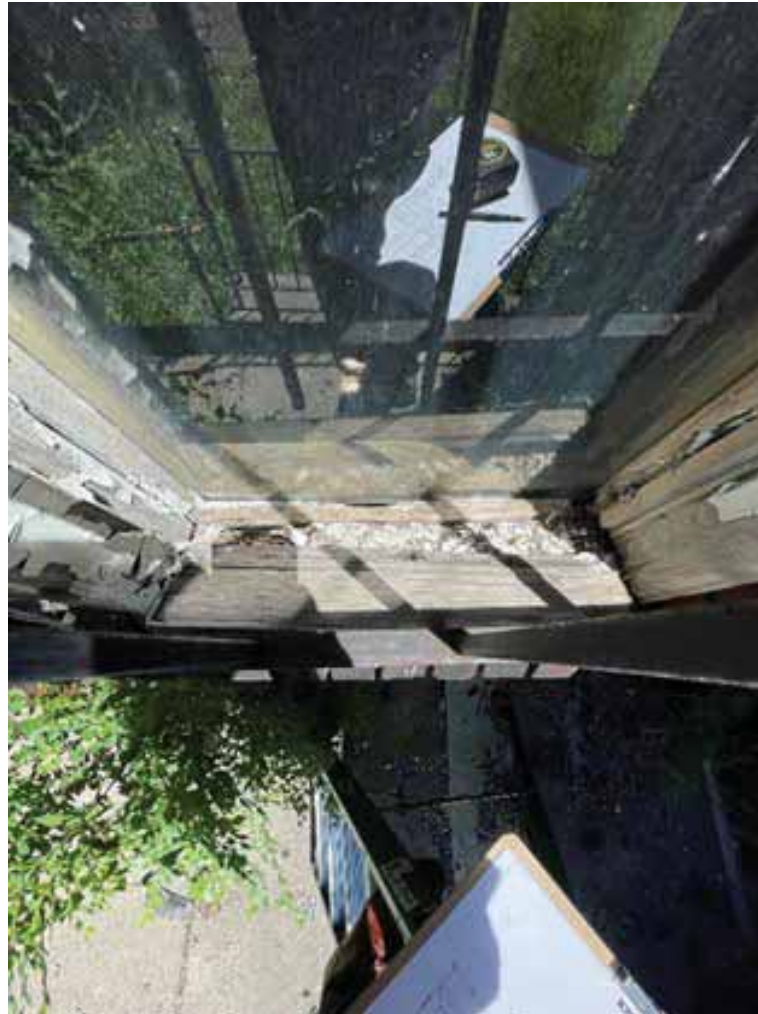
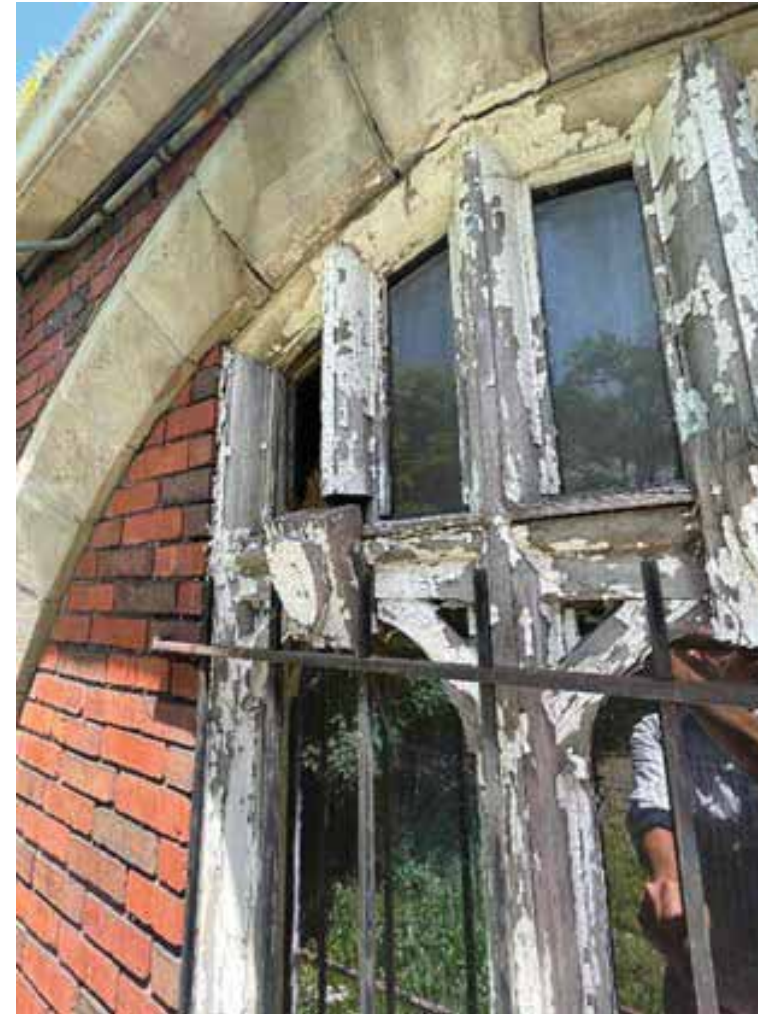
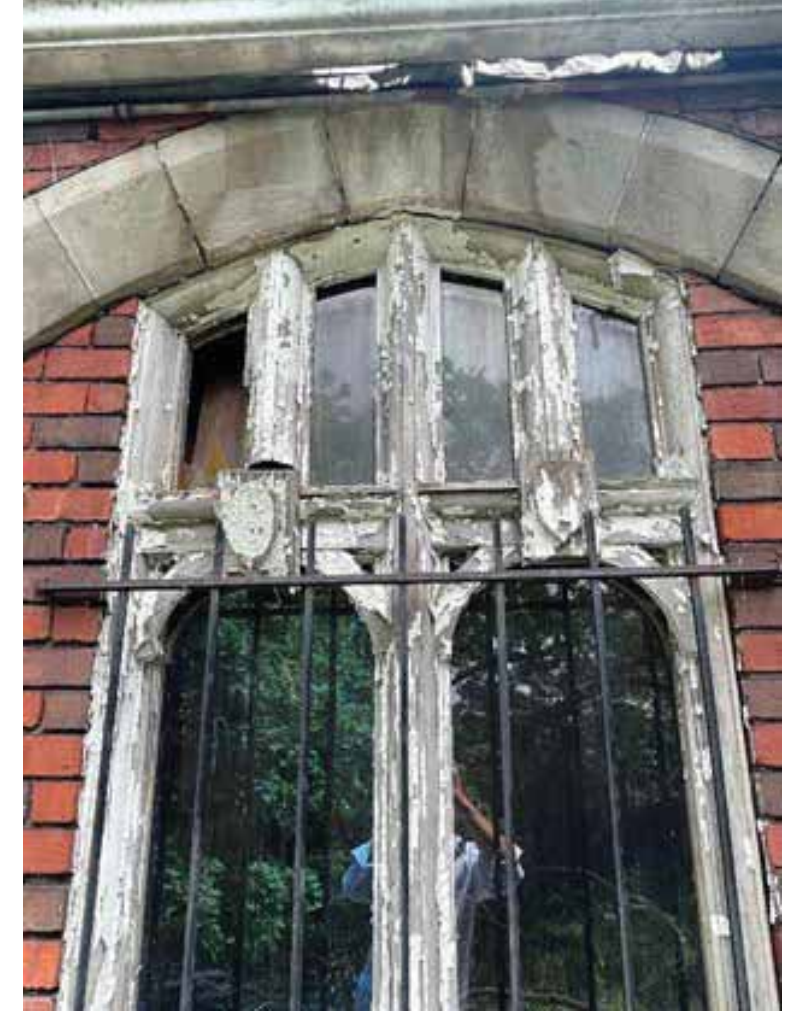
Images showing typical levels of damage to the smaller arched windows

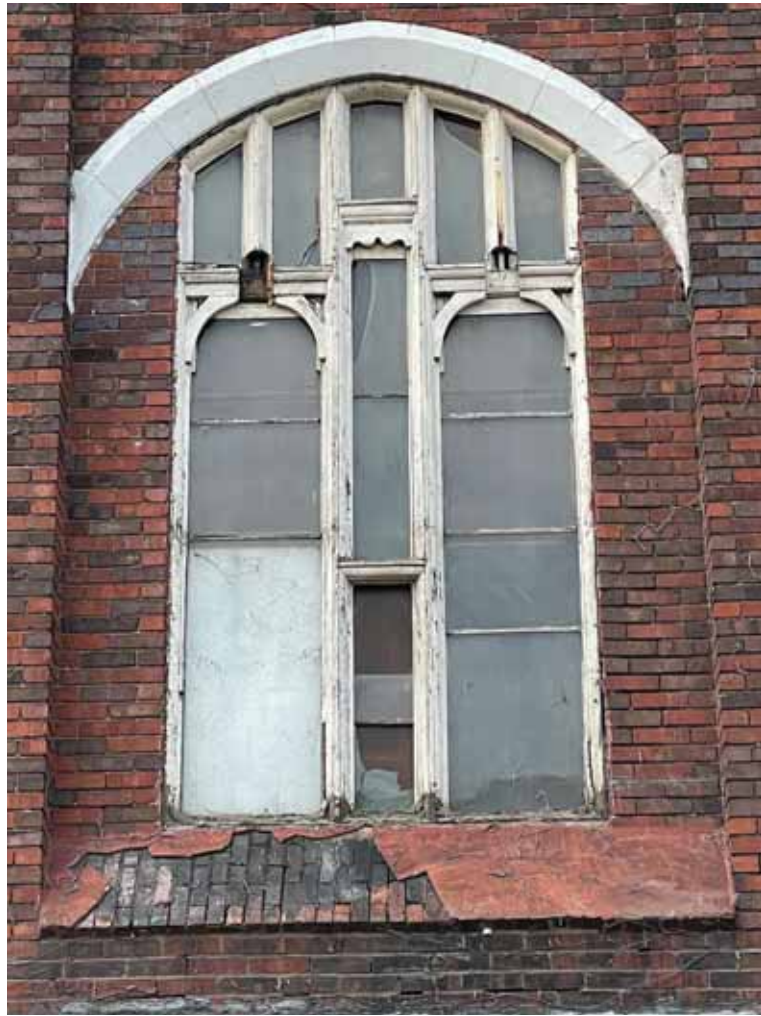
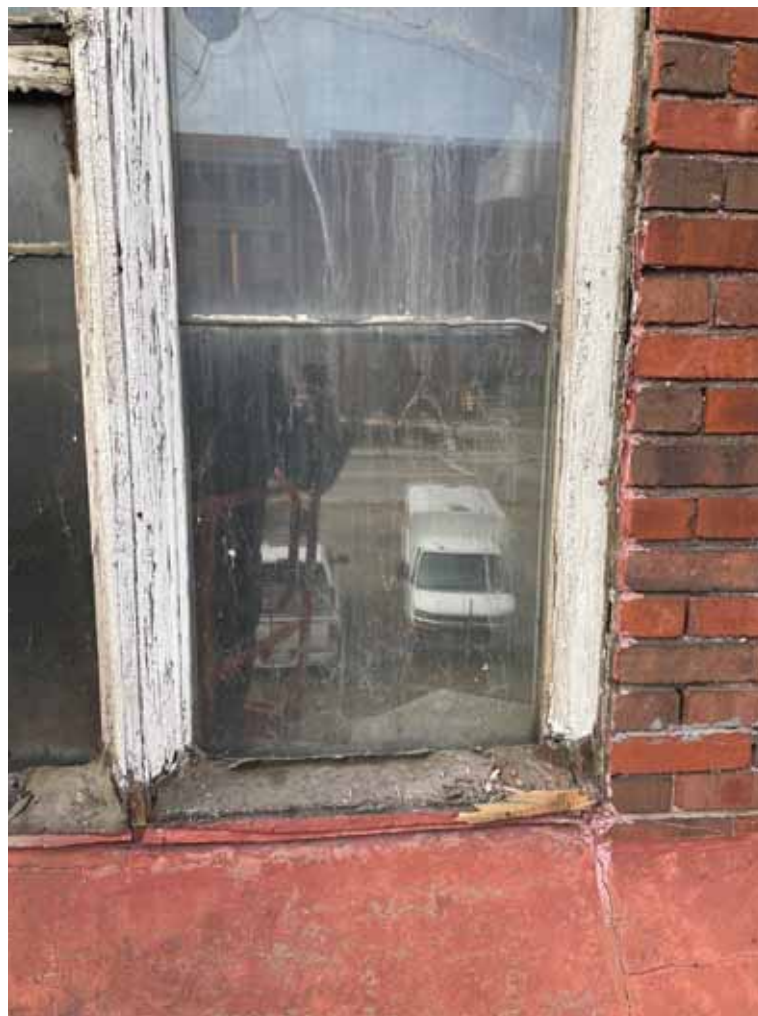
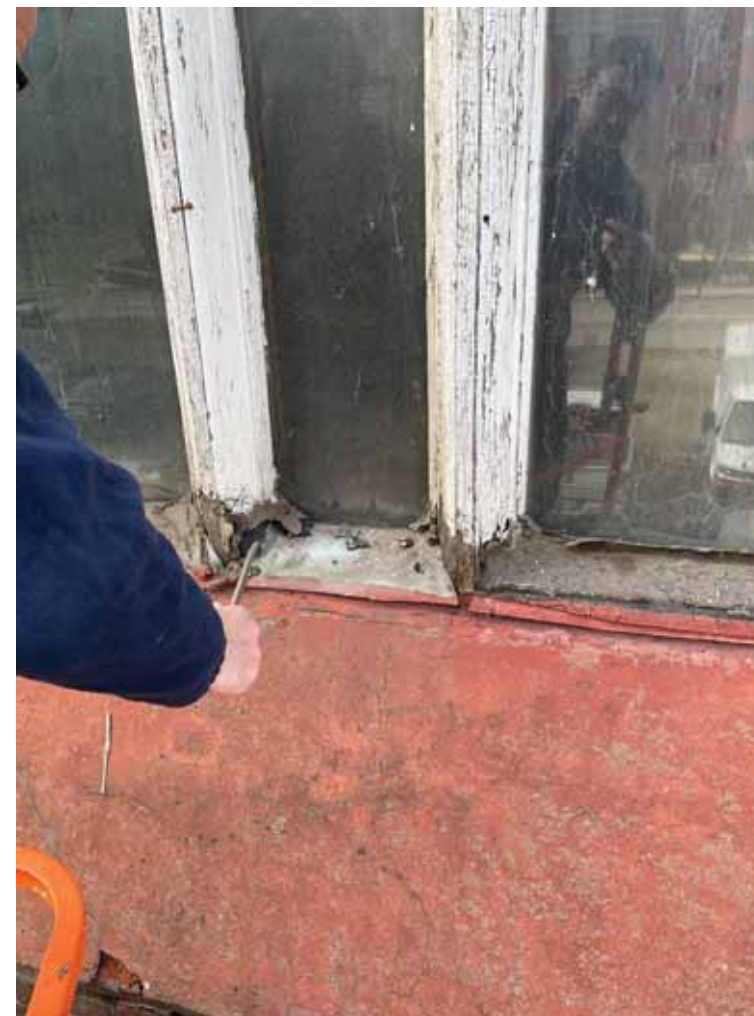
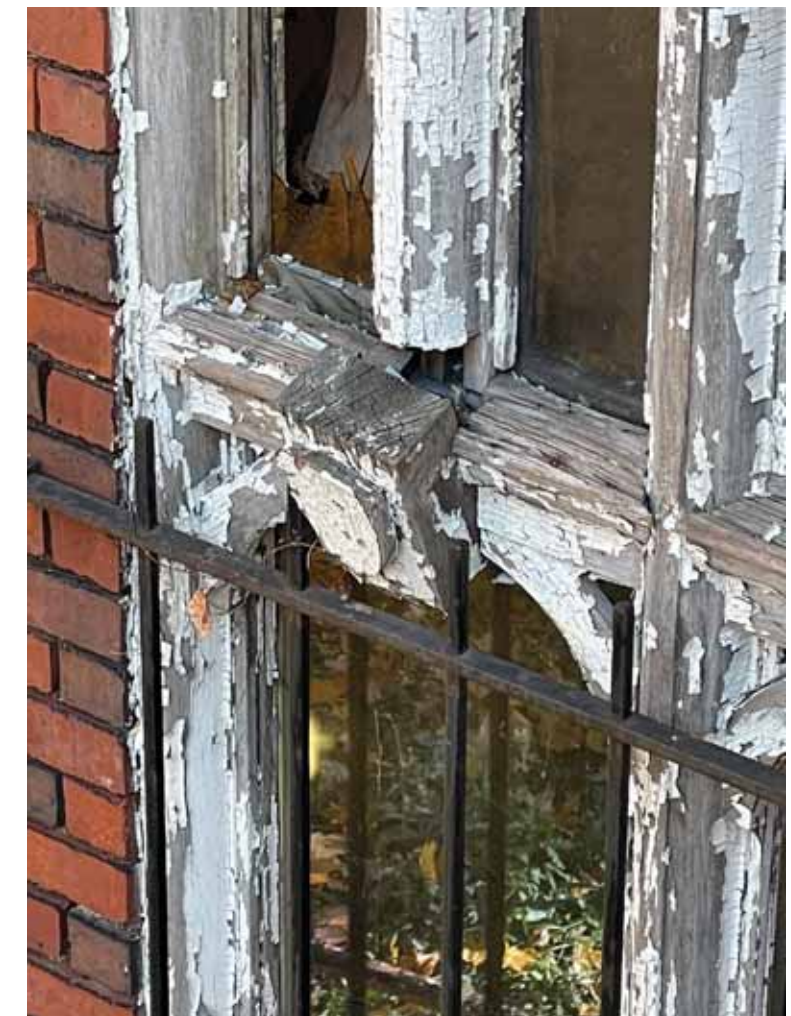
Images showing typical levels of damage to the larger arched windows

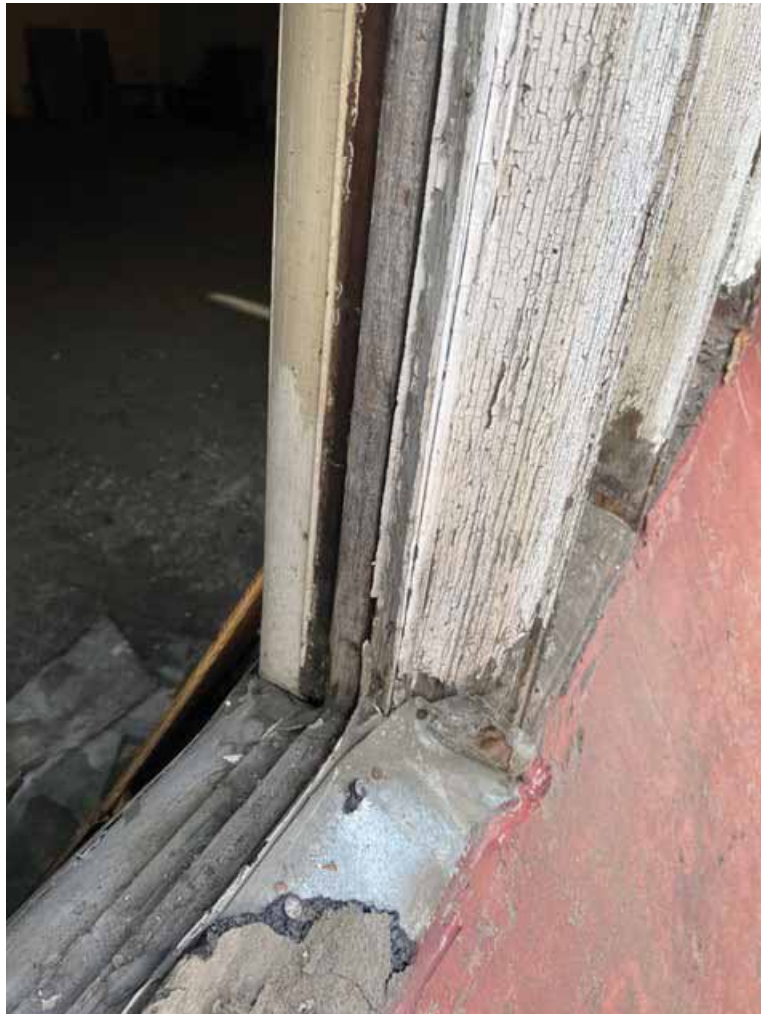
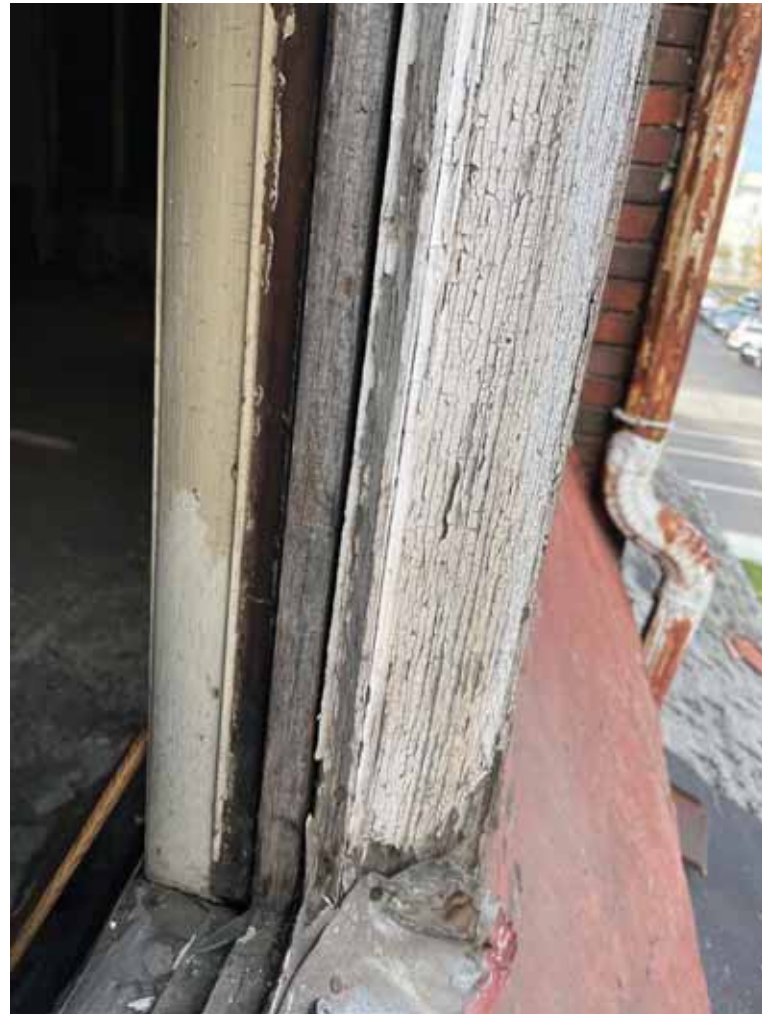
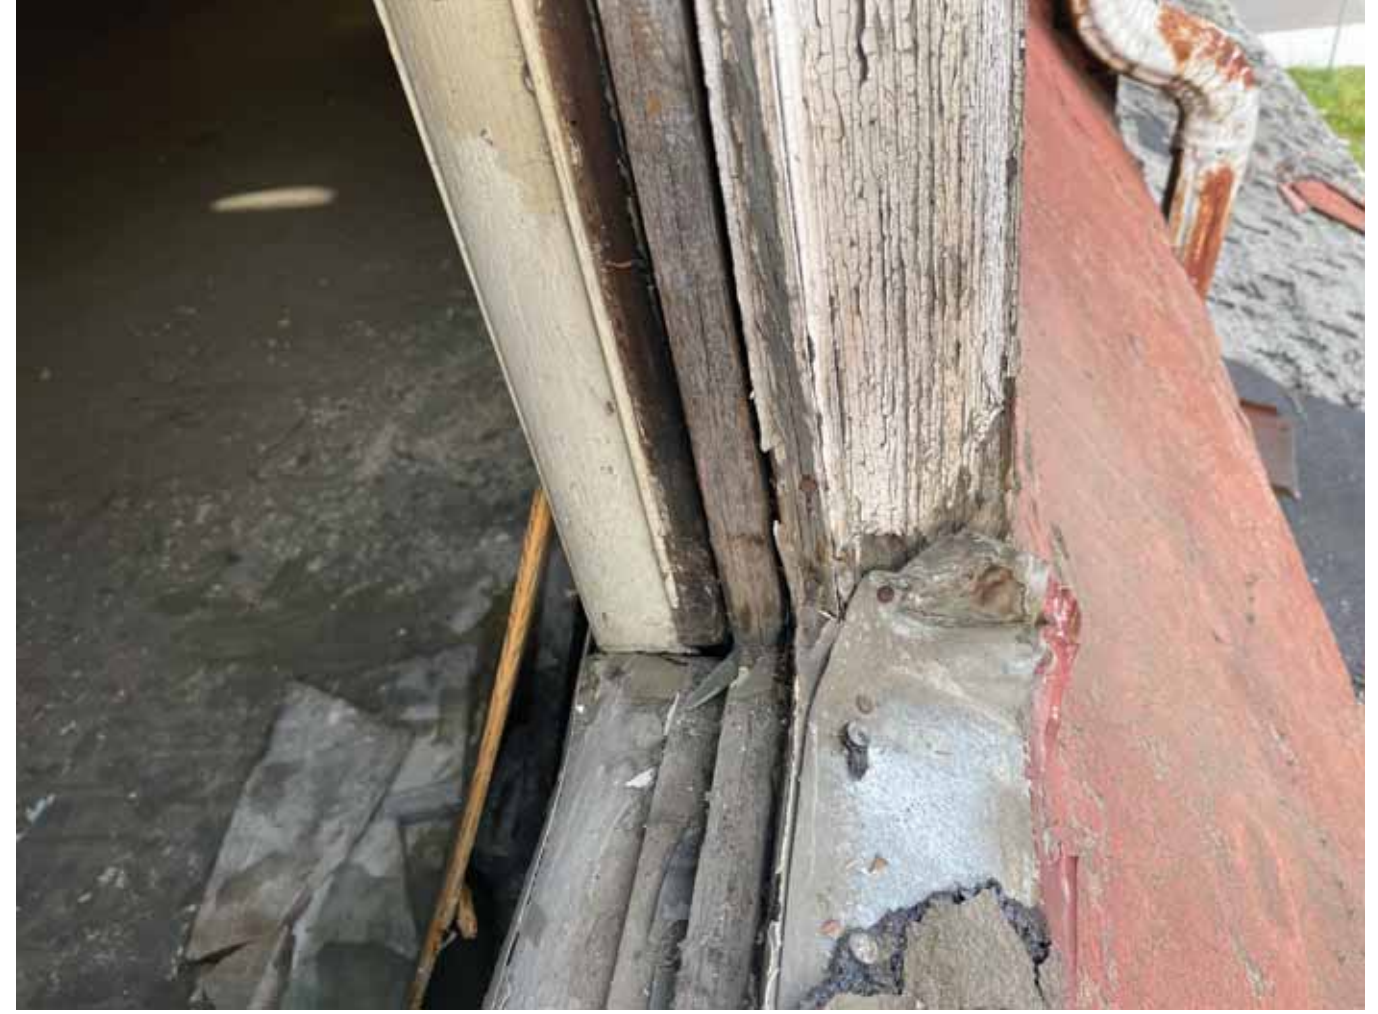
Images showing typical levels of damage to the larger arched windows

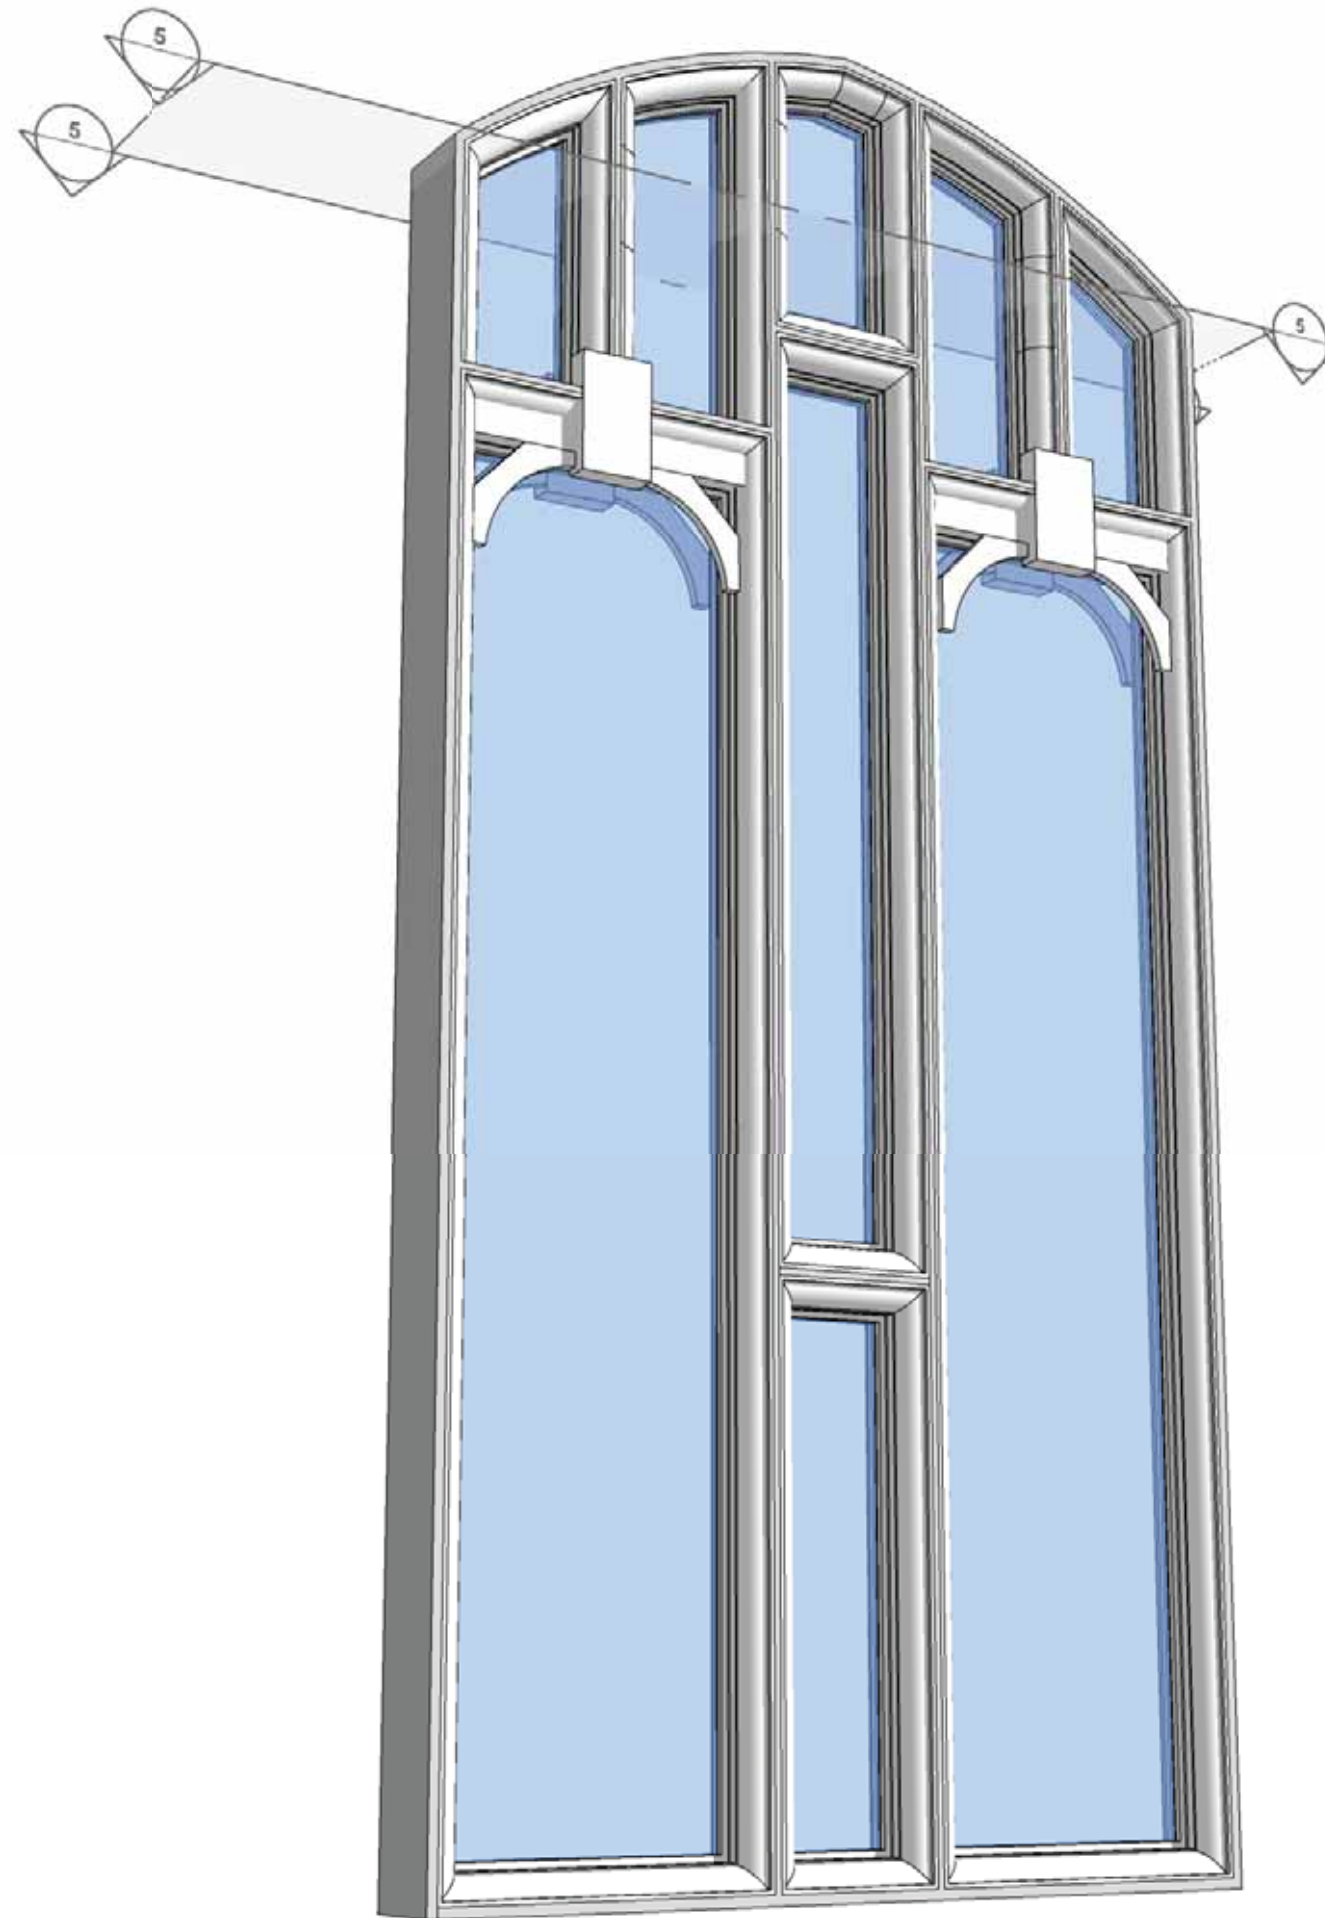
- Images showing typical construction of window system

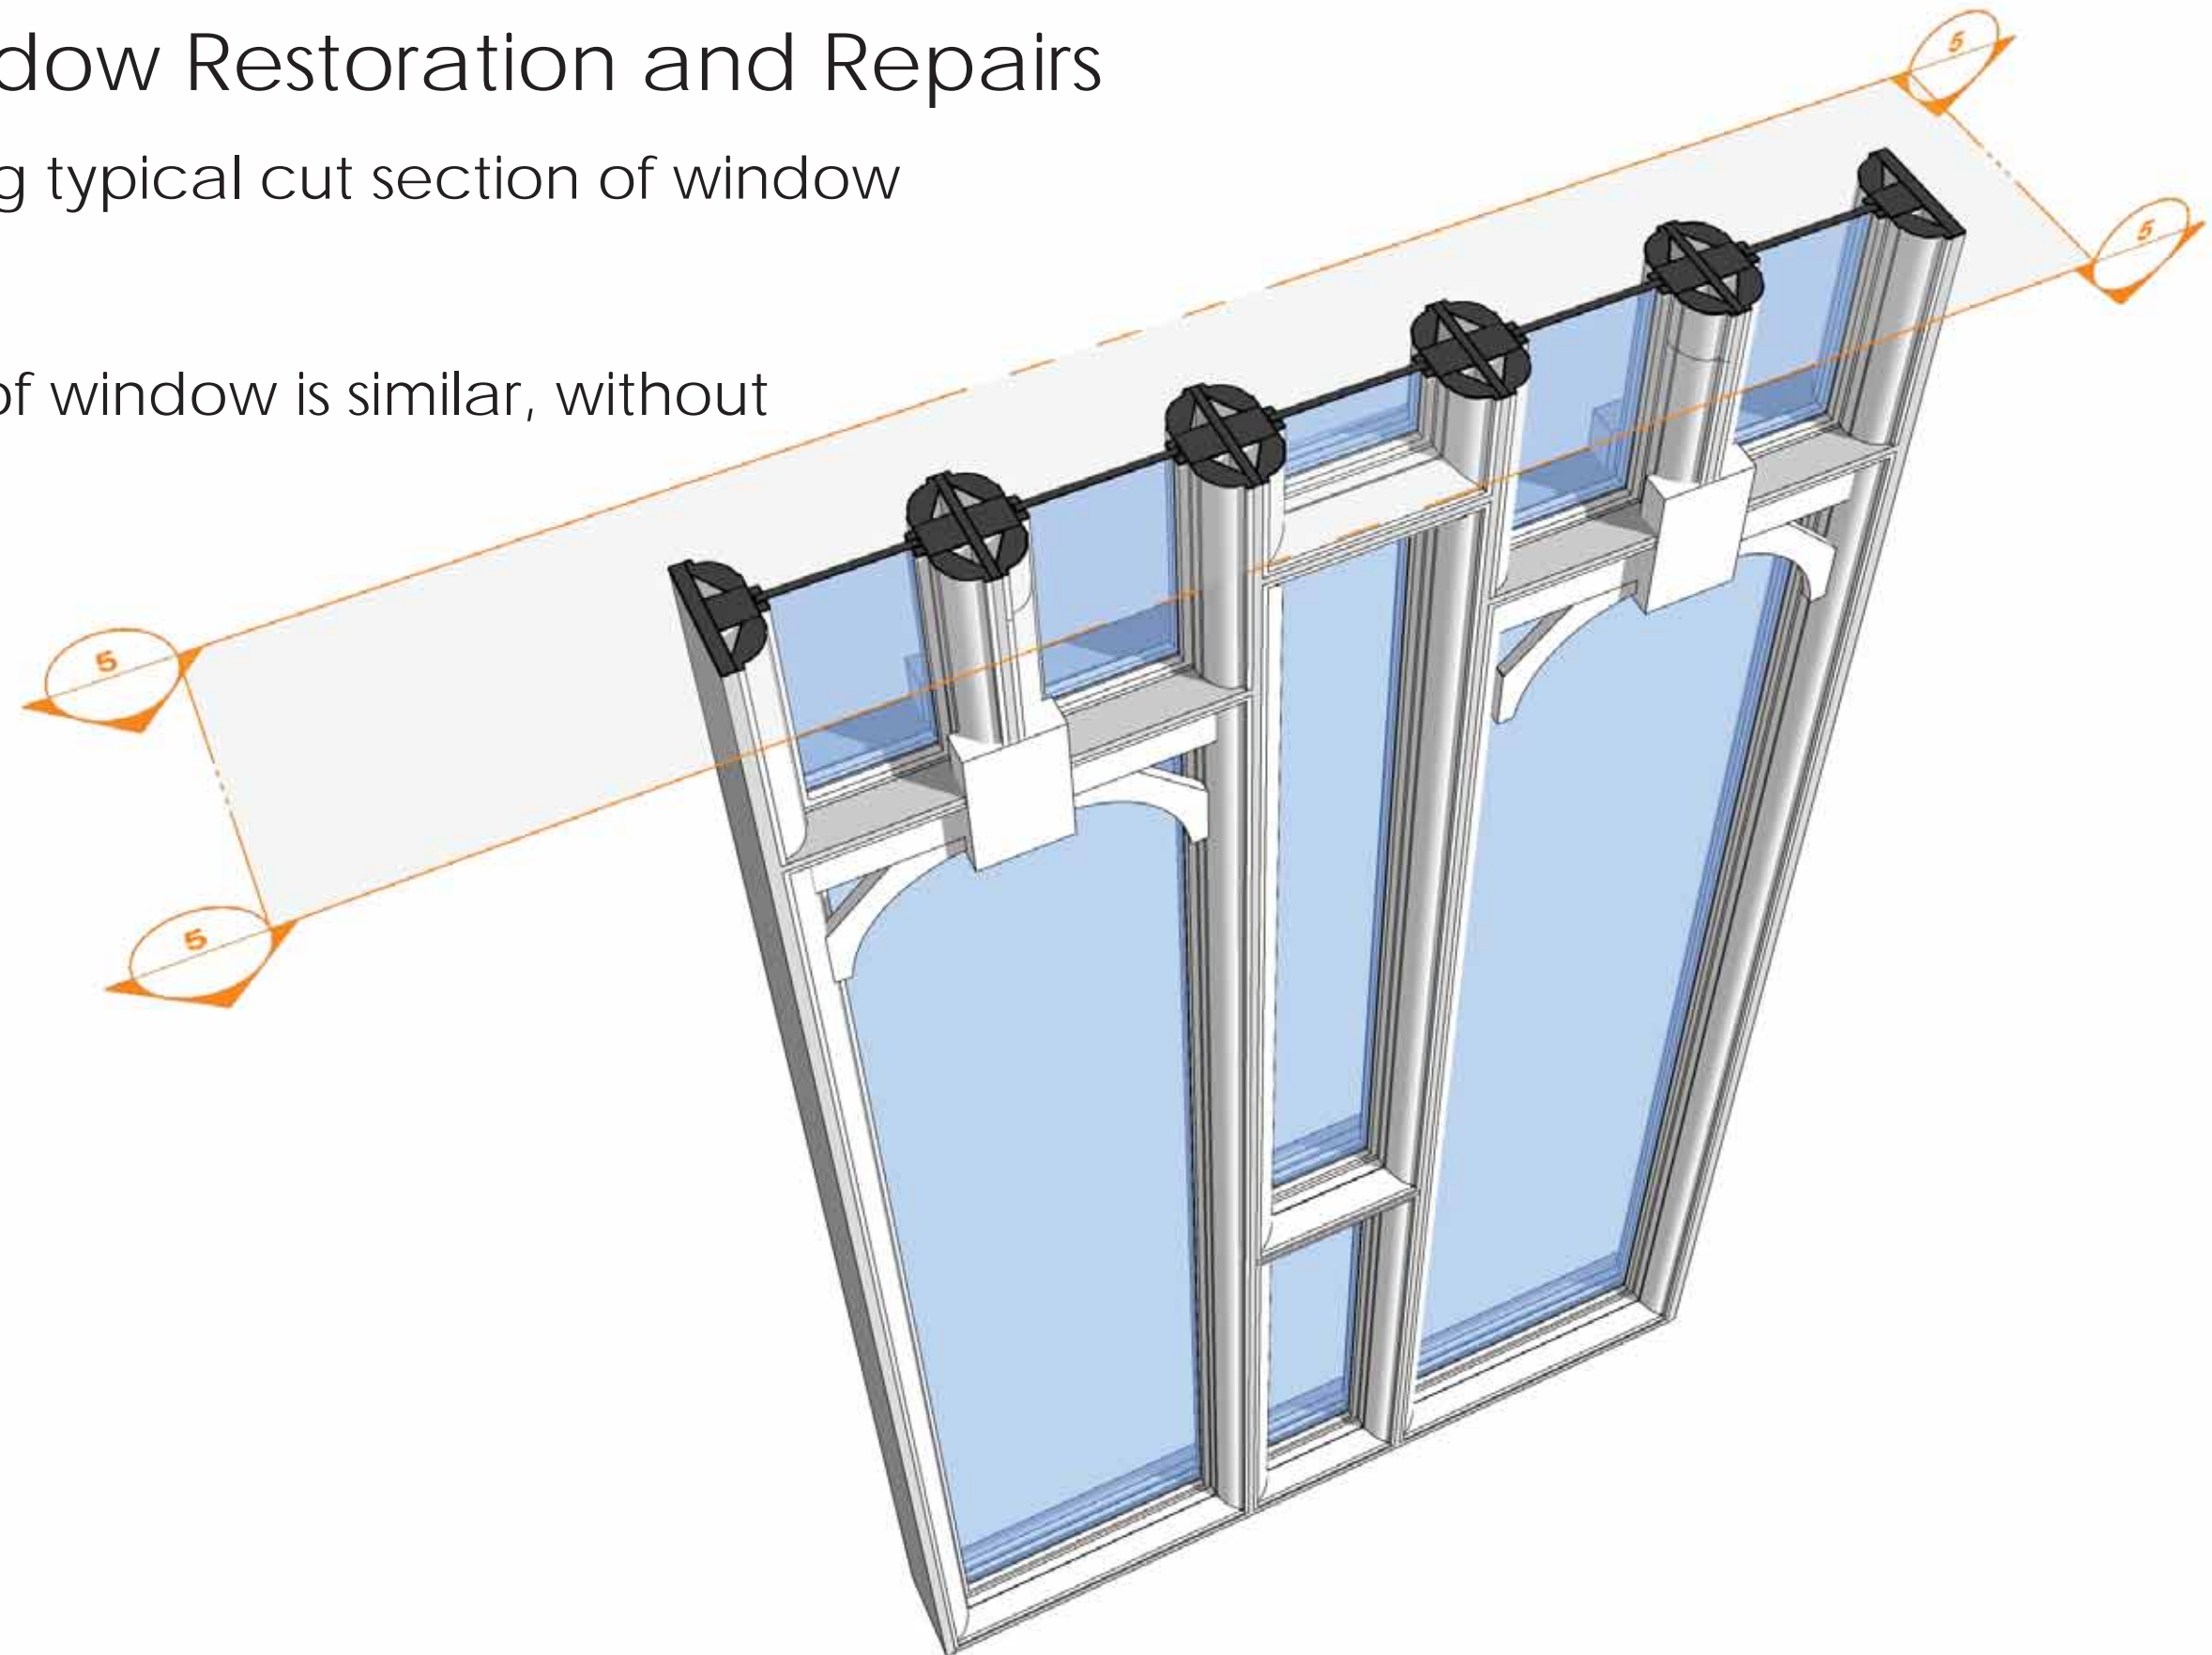
- Images showing typical cut section of window system
- Lower portion of window is similar, without center rails

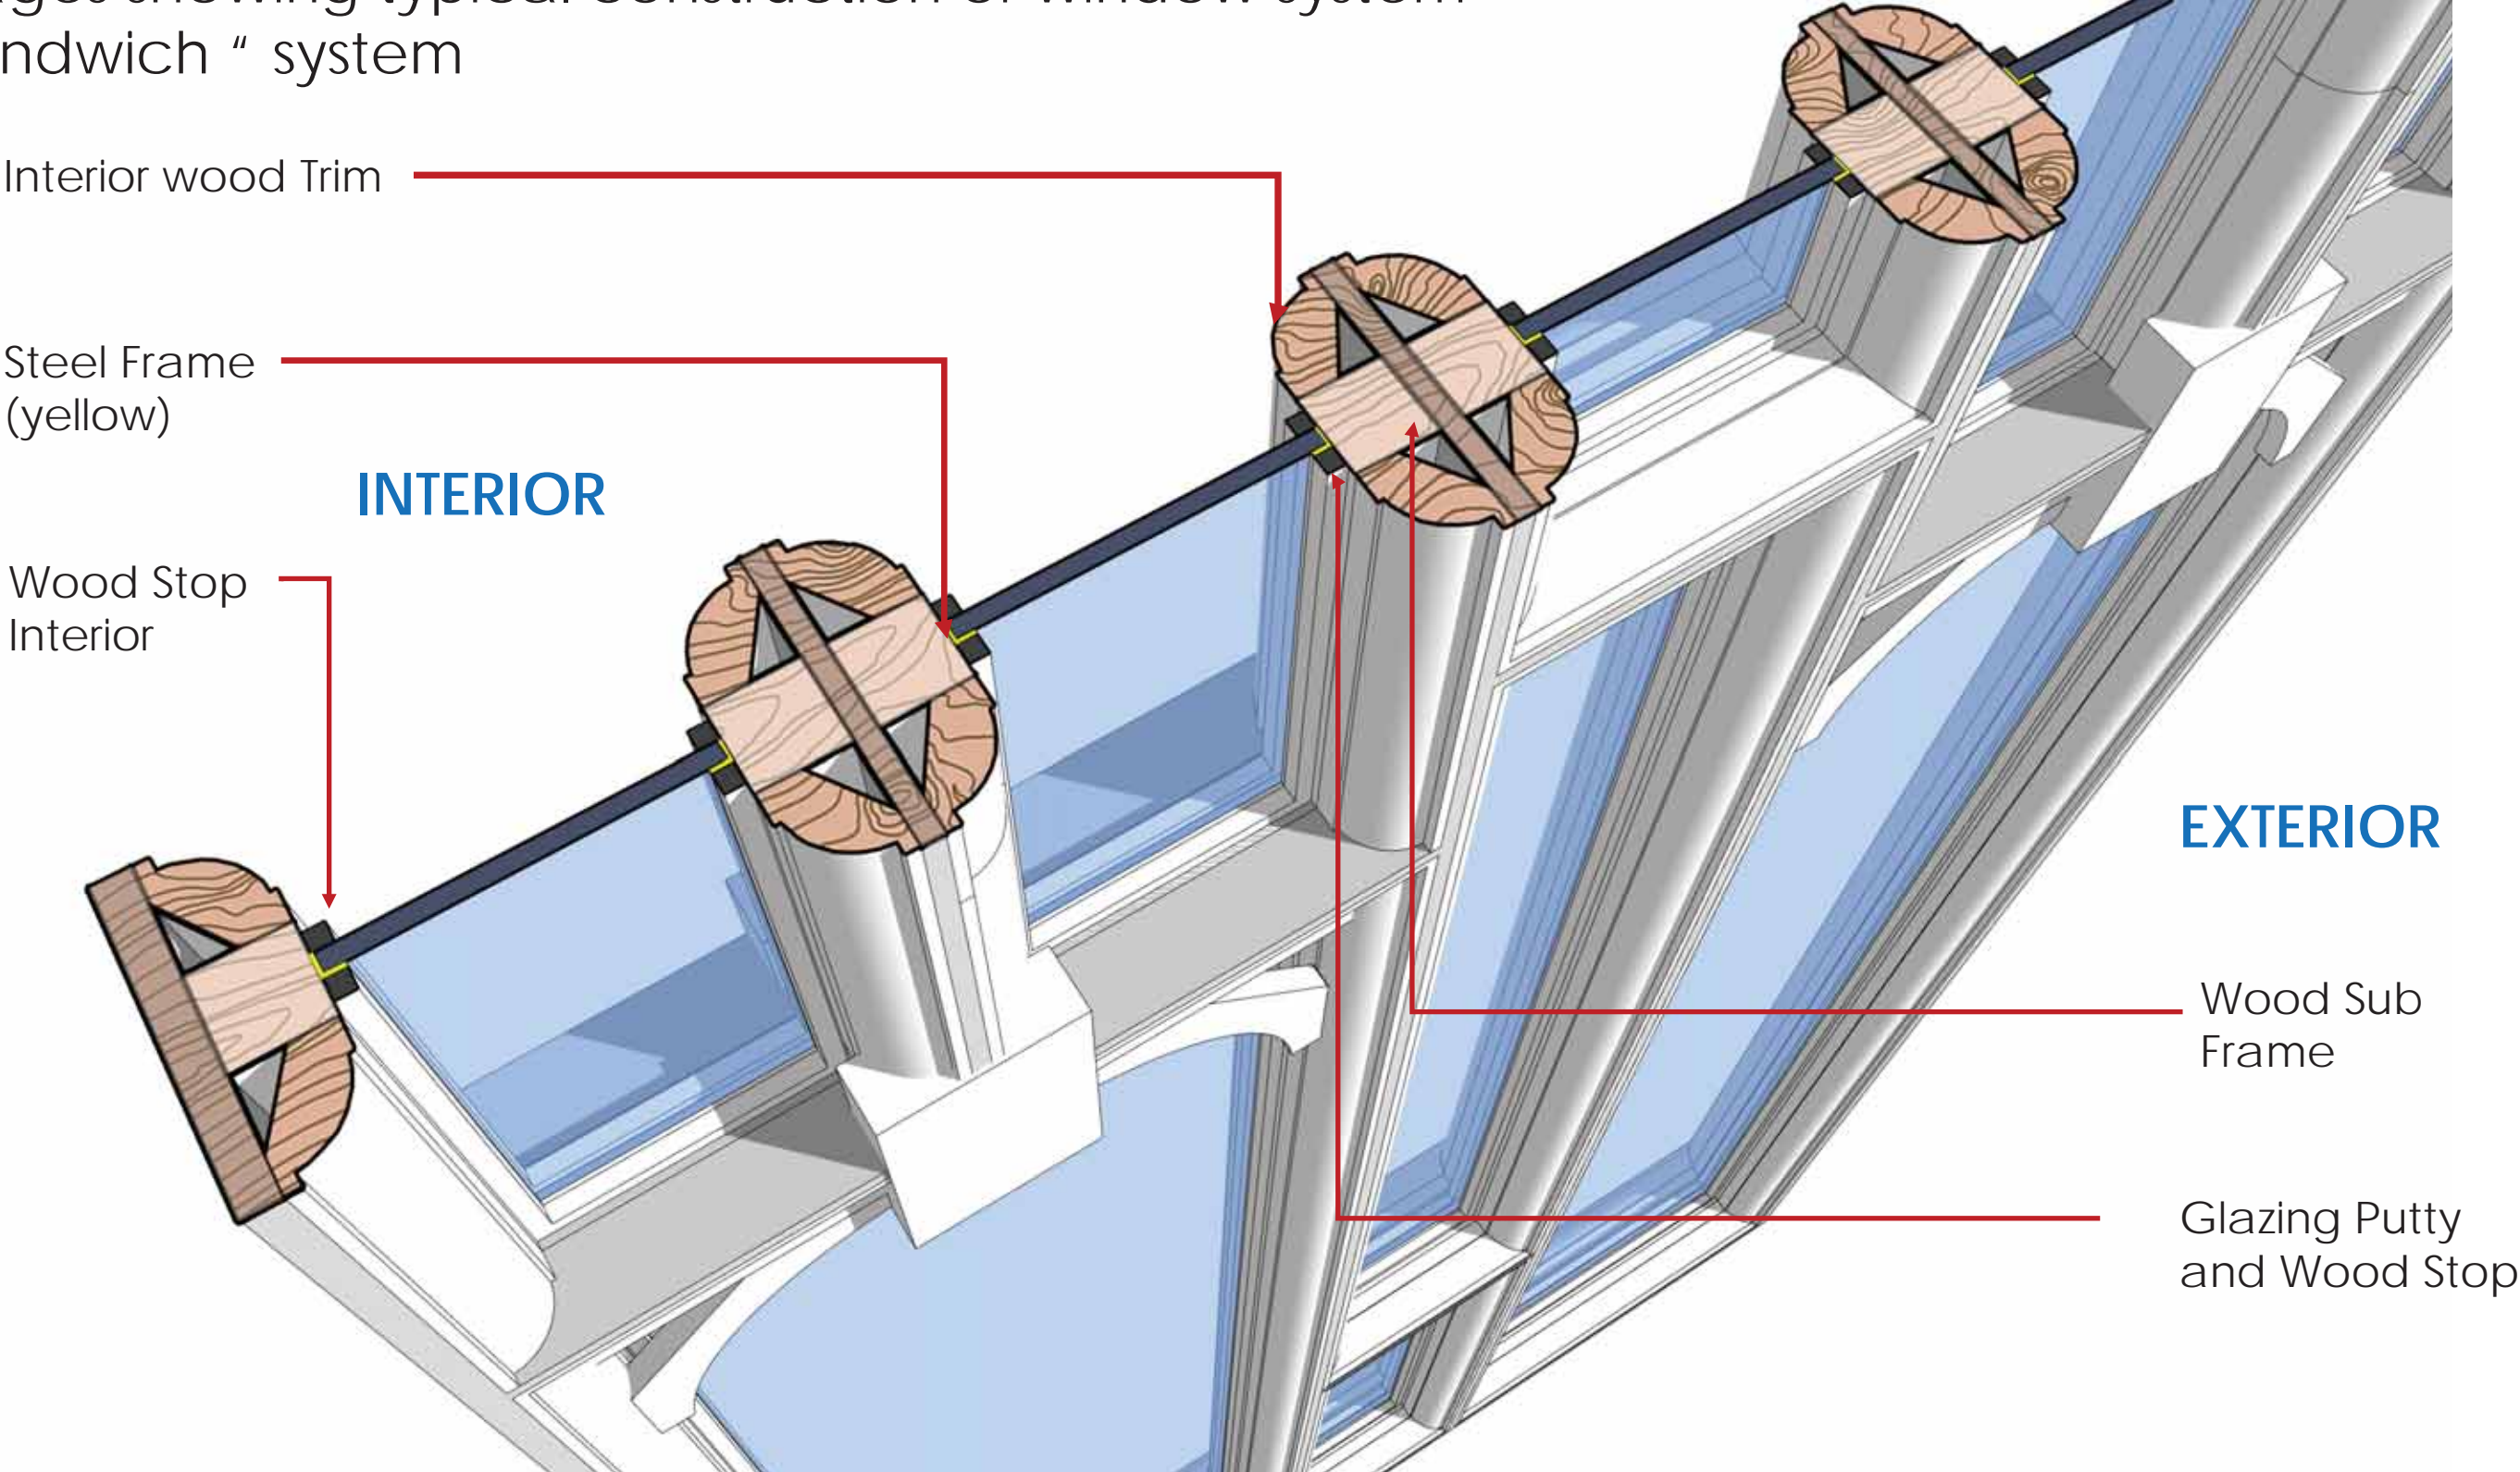
- Images showing typical construction of window system
- "Sandwich" system

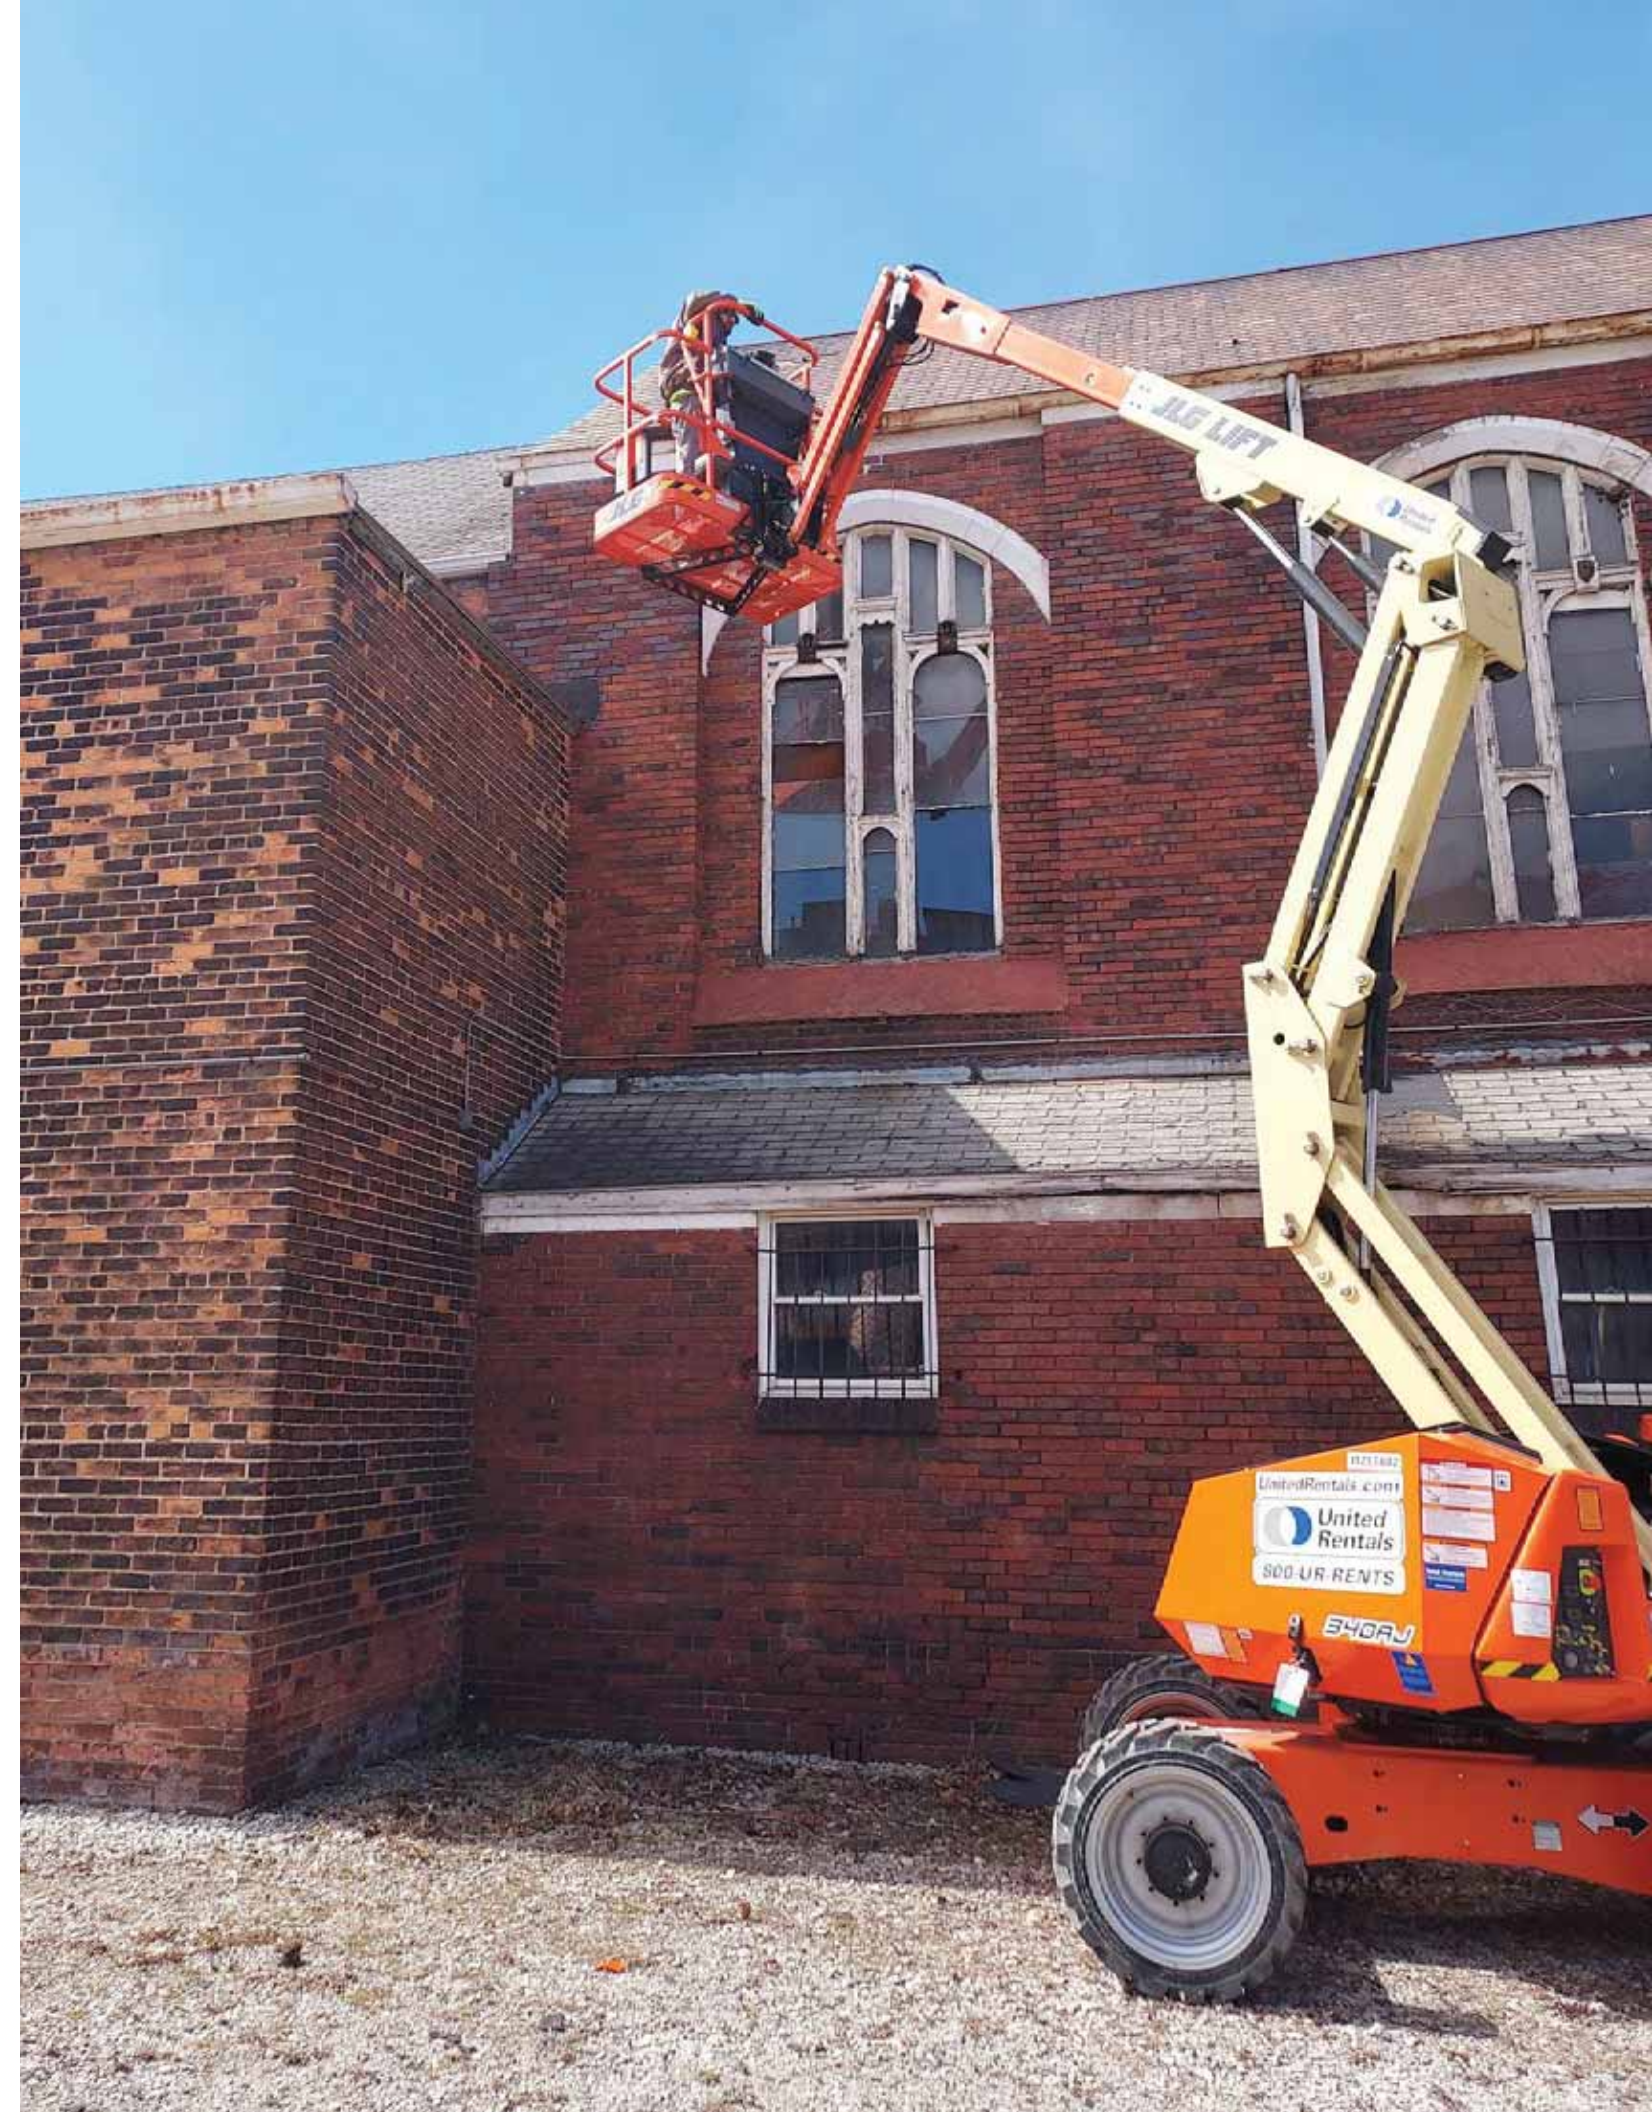
1. Where possible, **repairs and refinishing** of existing will be done
2. Where pieces are missing, replication pieces will be milled/fabricated and installed to match finishes
3. Where pieces are degraded beyond repair, replication pieces will be milled/fabricated and installed to match finishes
4. All glazing to be replaced with new, a more energy efficient low-e clear glazing is proposed, we will work with HDC Staff to get final selection approved.
