CITY OF DETROIT HISTORIC DISTRICT COMMISSION

92 E. Forest. Detroit, MI

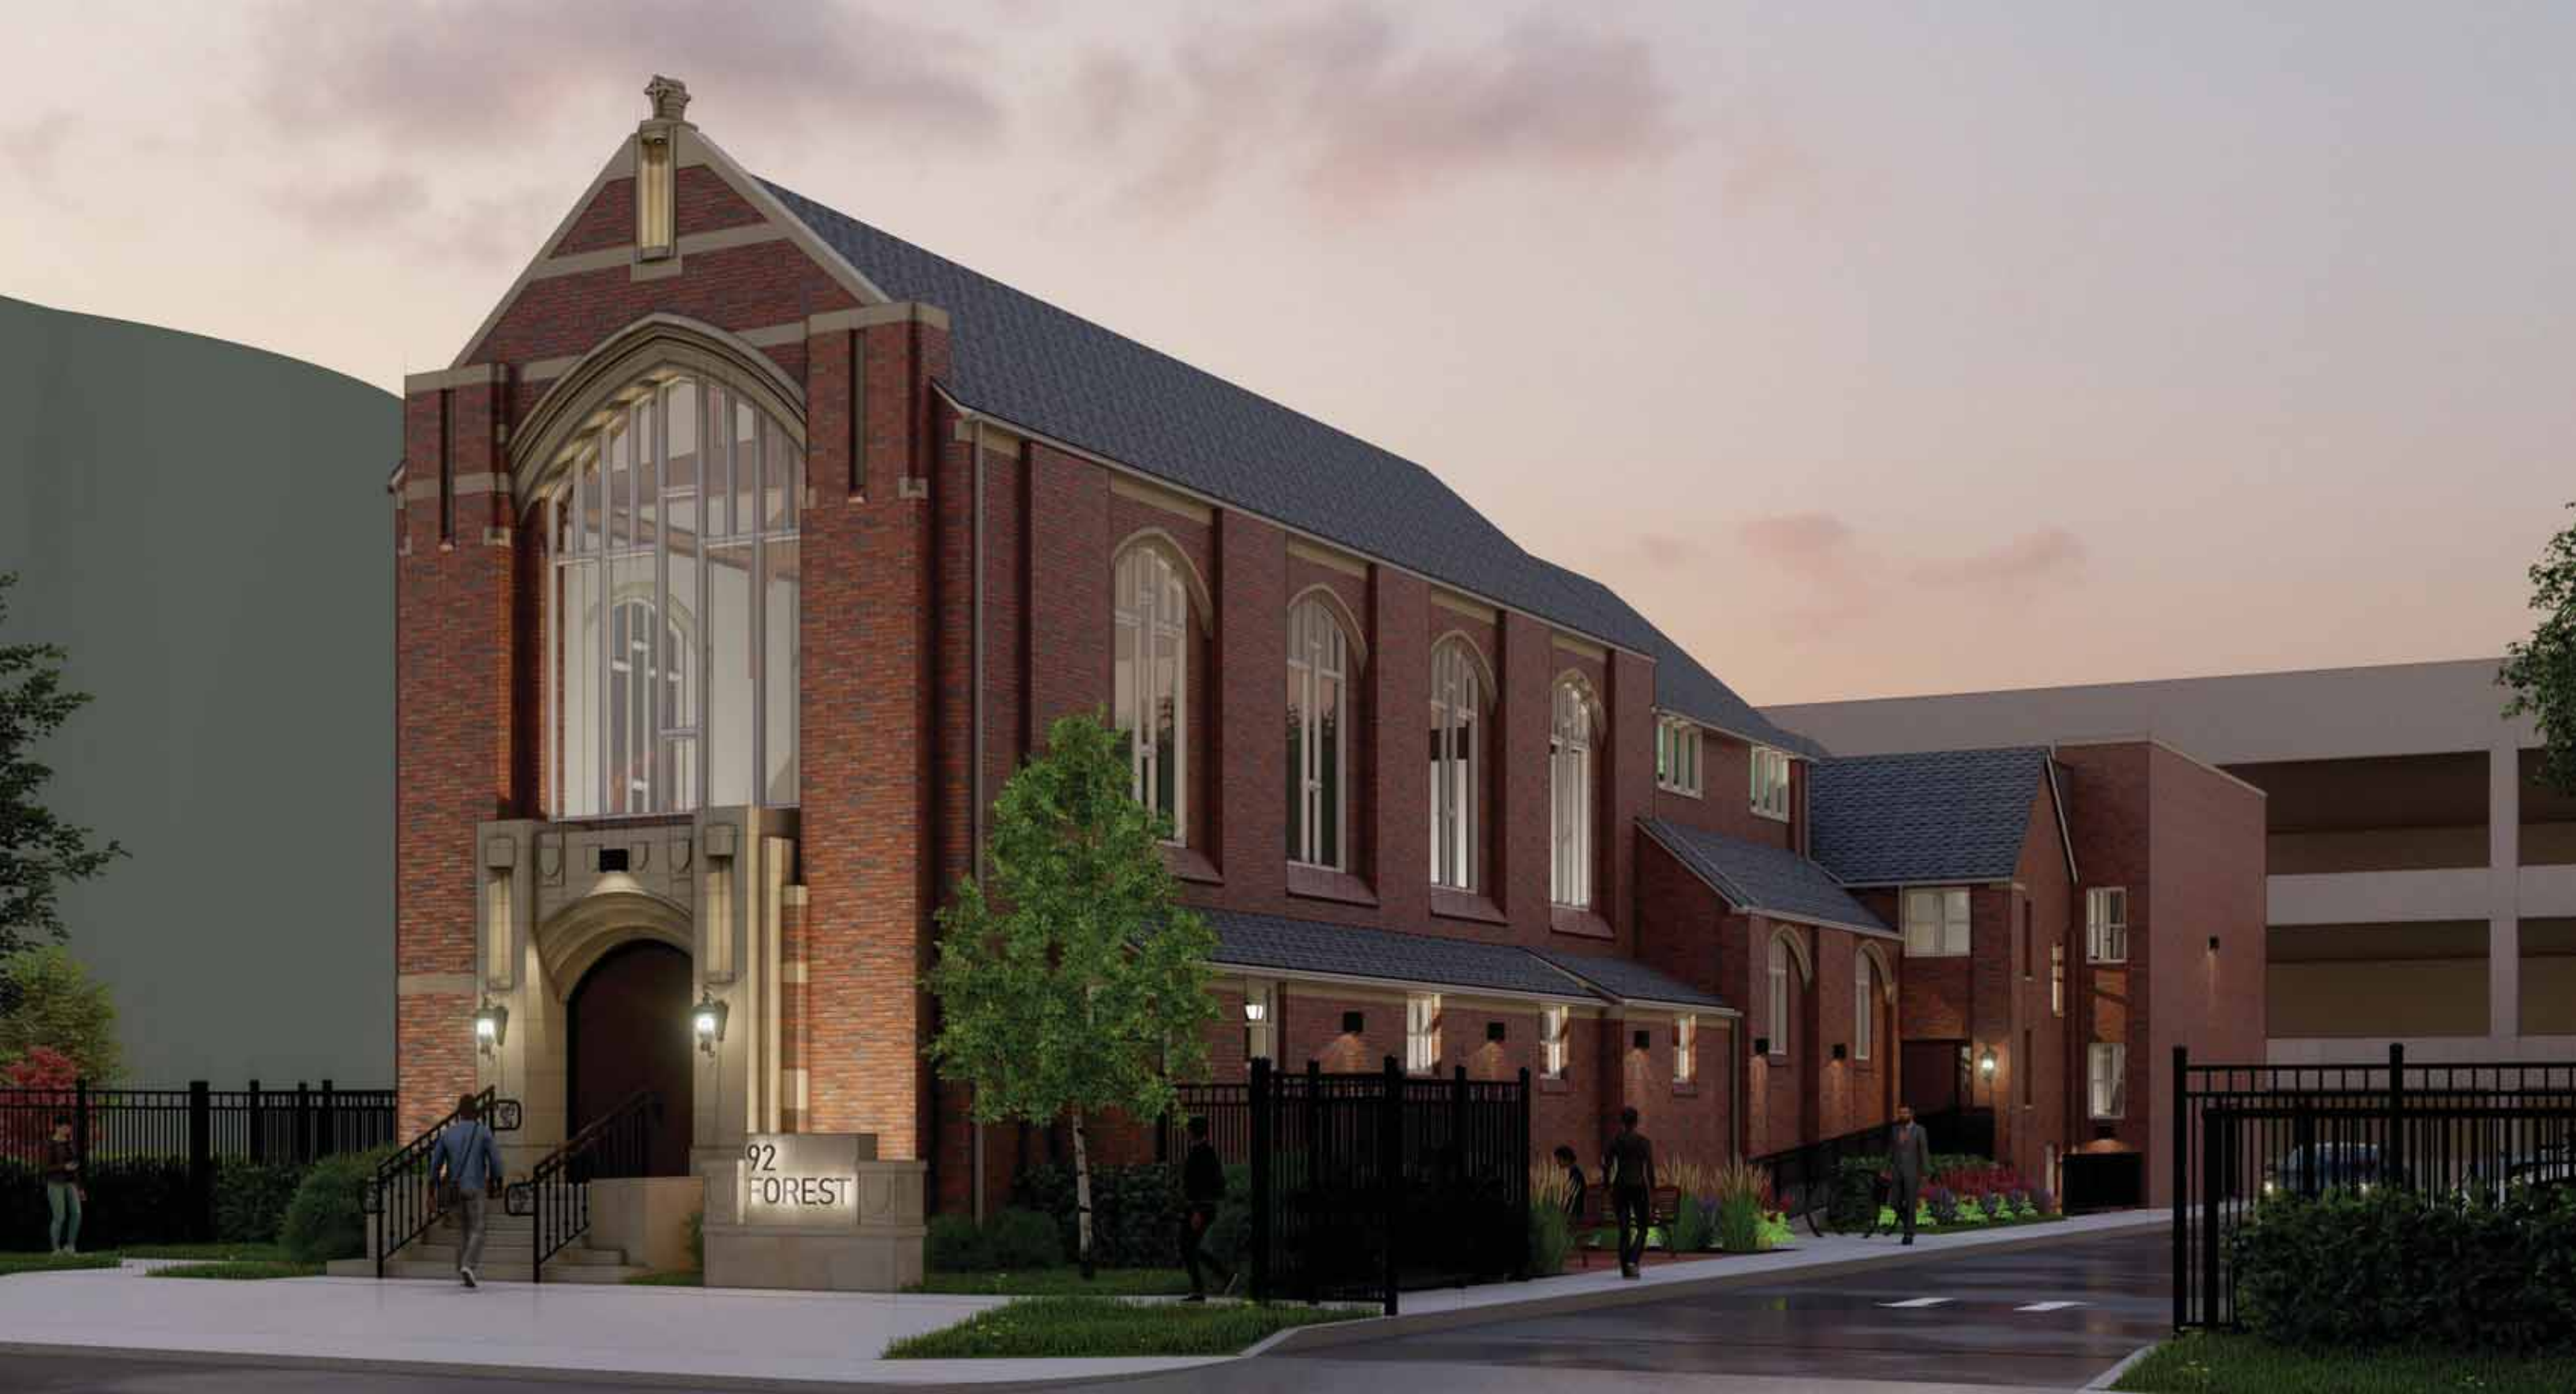
KRIEGER KLATT
ARCHITECTS
